Enlarged Cotter Dam – Stability Review of Dam Post Cracking

Additional Finite Element Analysis of Cracked Section

Document number GHD-ECD-DAM-GN-RPT-0005
DM5 number
Title Additional Finite Element Analysis of Cracked Section
Revision Rev 1
Document status
Date of issue 29 November 2012

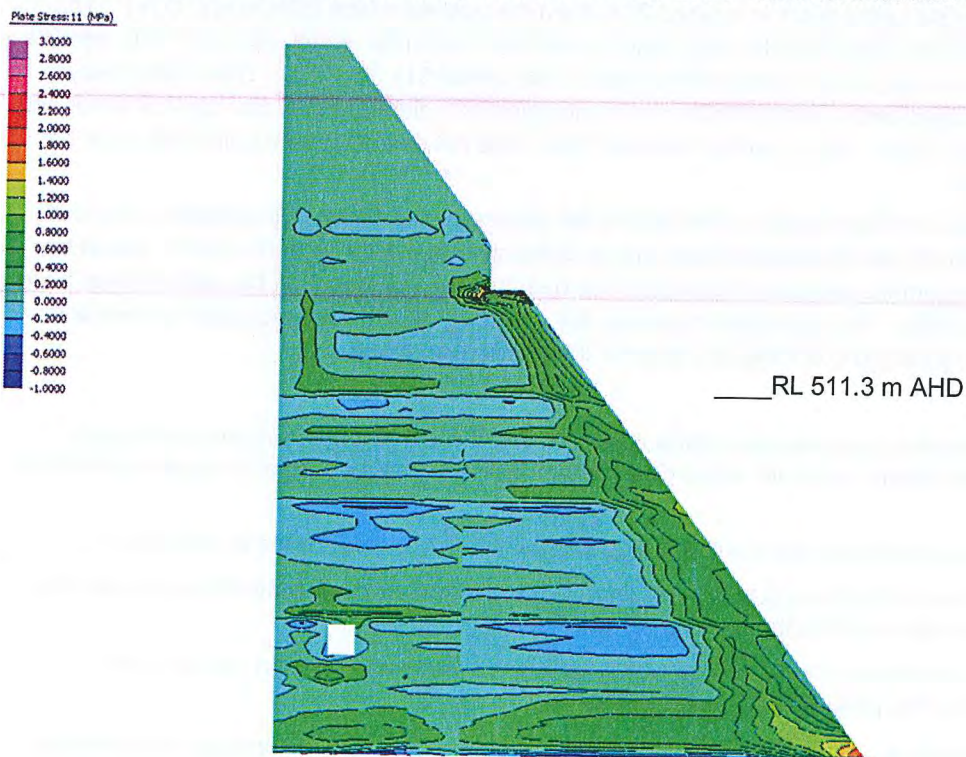
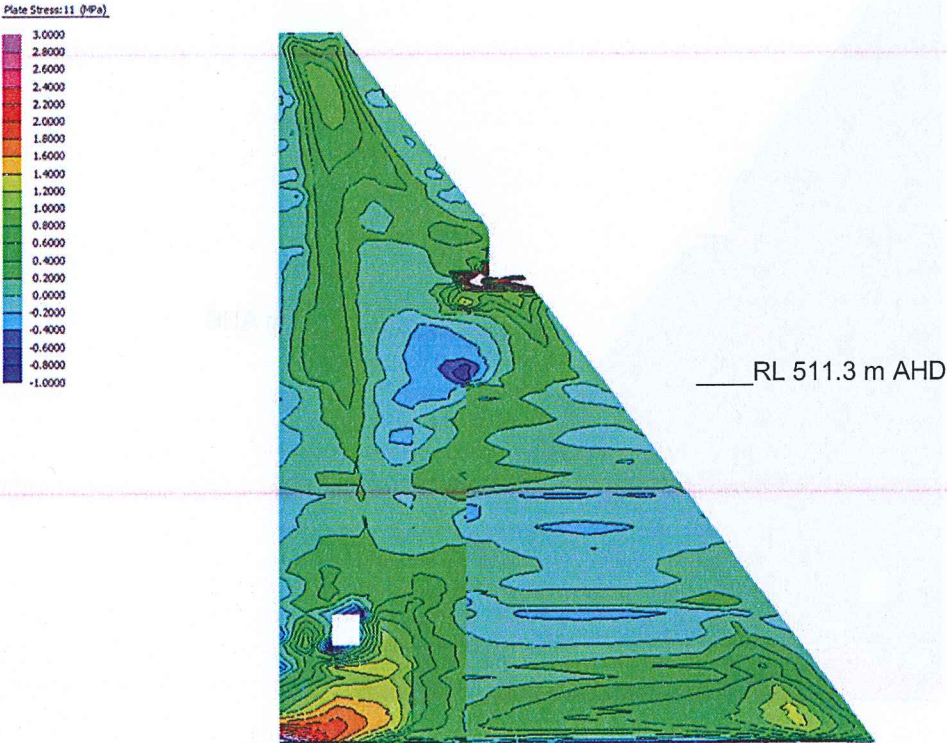
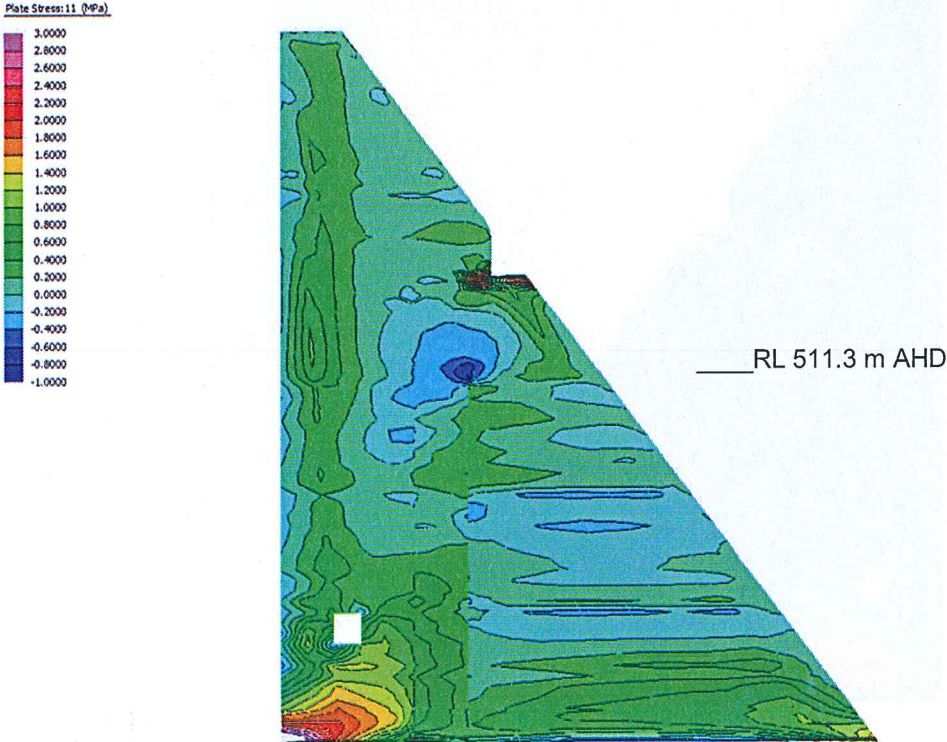
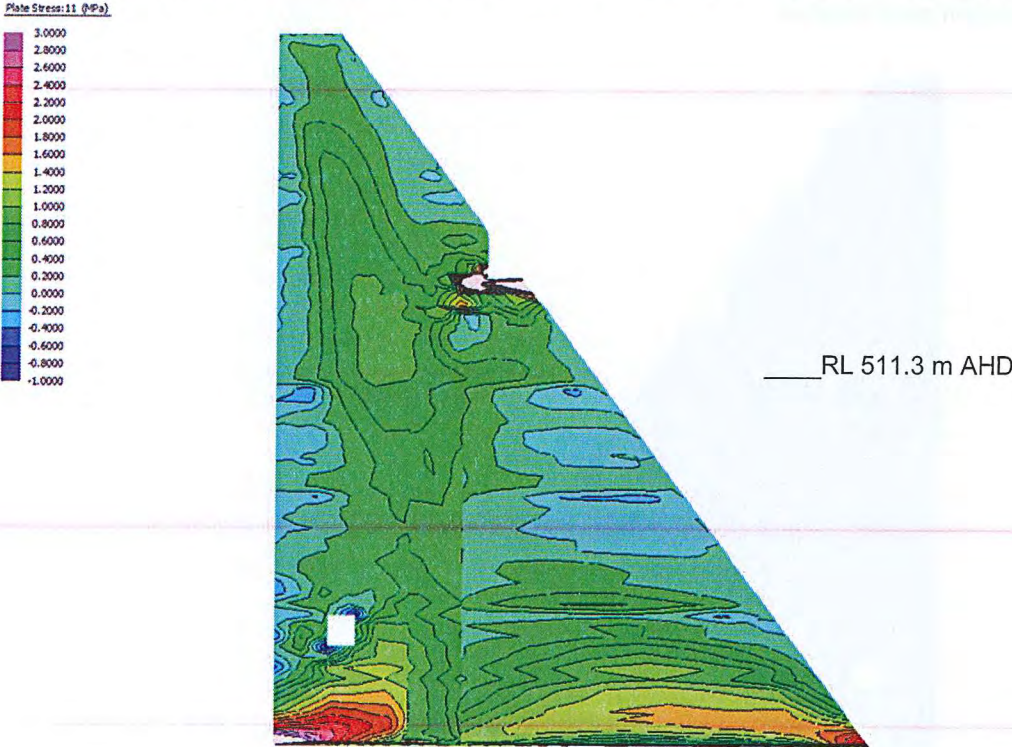
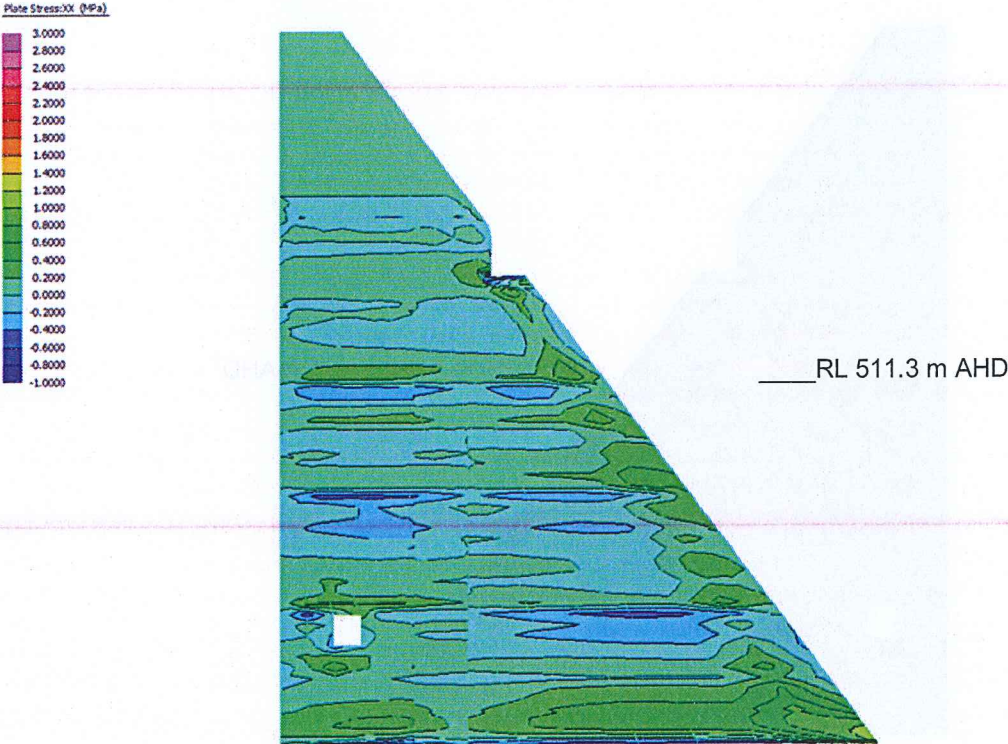
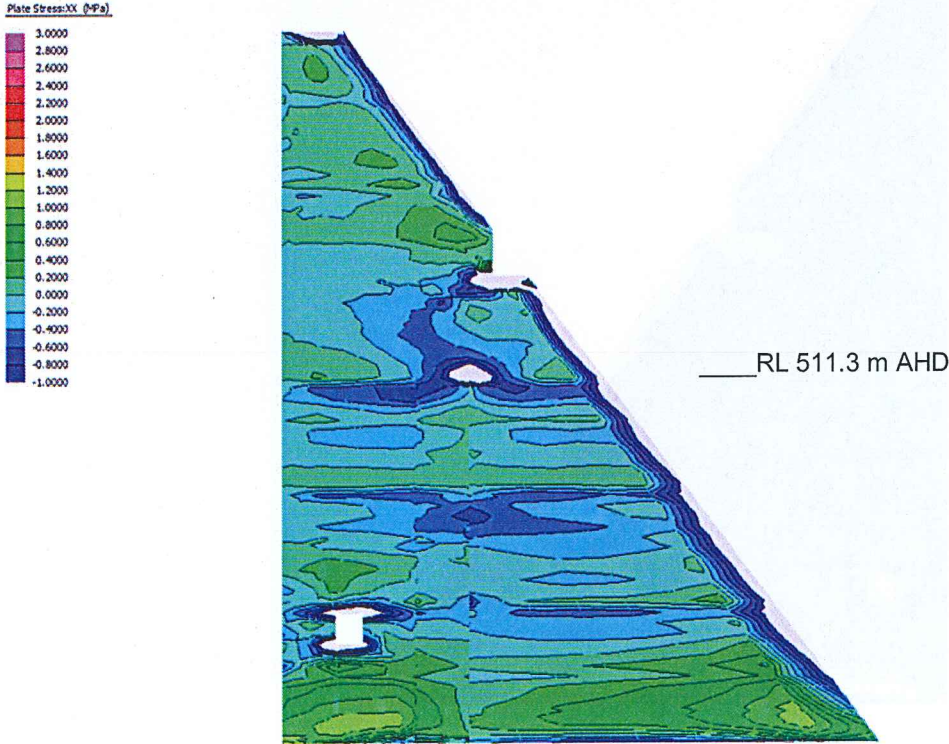
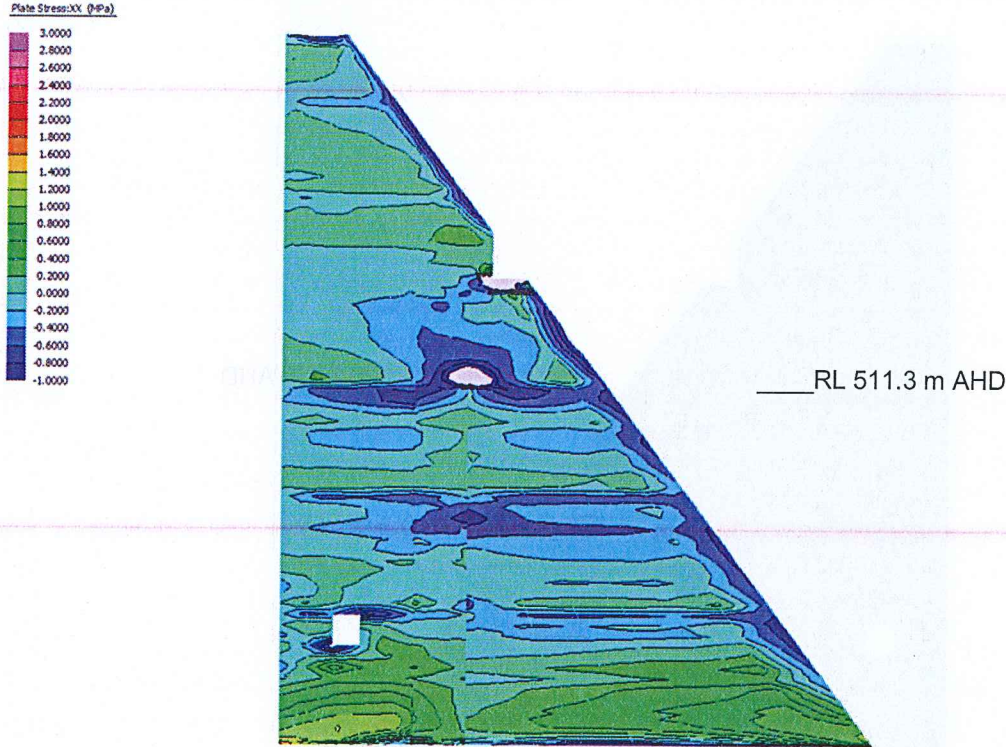
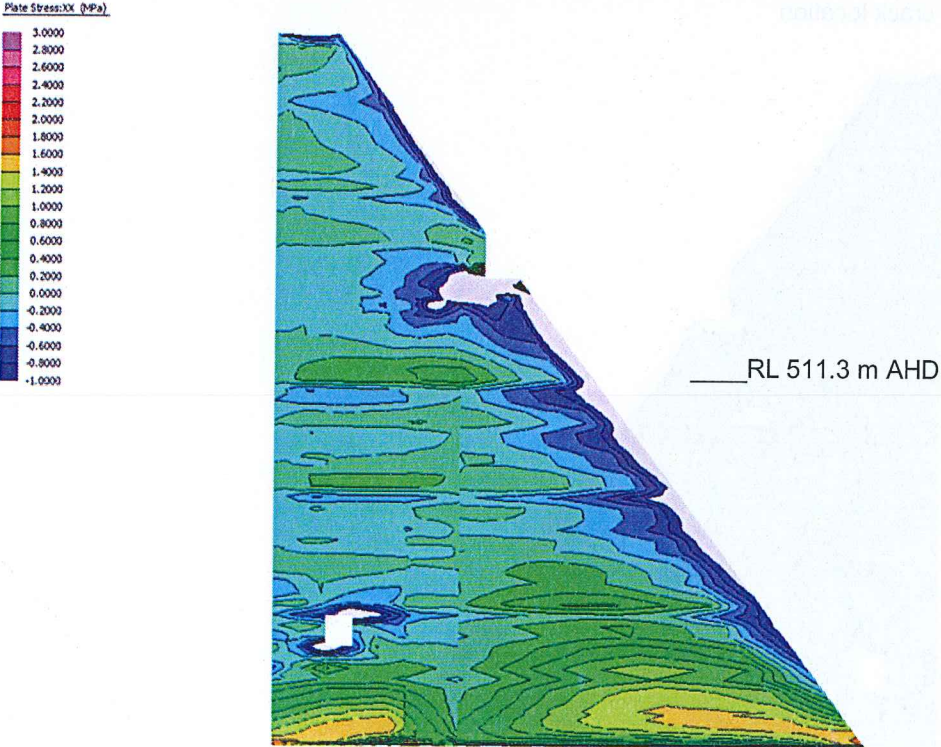
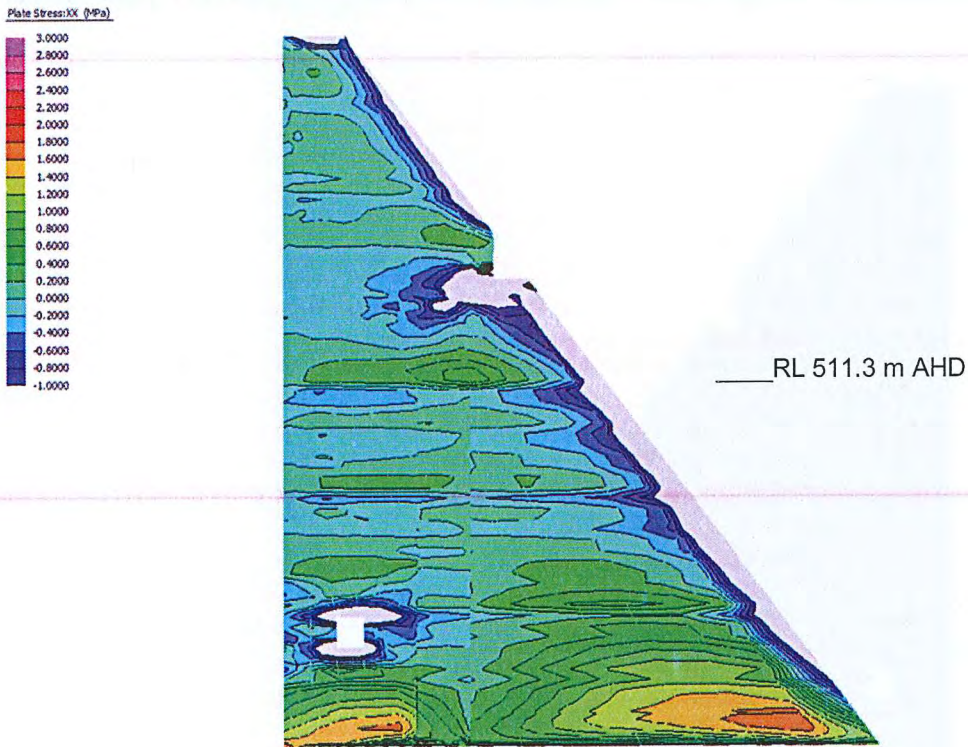
For the model of the most downstream crack location it can be seen in Figure 3.1 **Error! Reference source not found.** to Figure 3.10 that much of the length of the assumed crack is within a zone of compression or of relatively low tension. There does not appear to be a high concentration of tension developing at the tip of the crack with time. This is further observed in Figure 3.20 which shows a negligible opening (less than 0.03 mm) at very early ages and a negligible closing tending towards zero displacement at later ages. Because of these results there does not appear to be a significant indication of further crack propagation of the assumed crack at this location.

These results are similar to those previously published for the initial analysis of the cracked section with the crack in the most upstream observed location (ref 4), indicating that the behaviour of the cracked monolith is not dependent on the position of the crack with the range of observed locations.

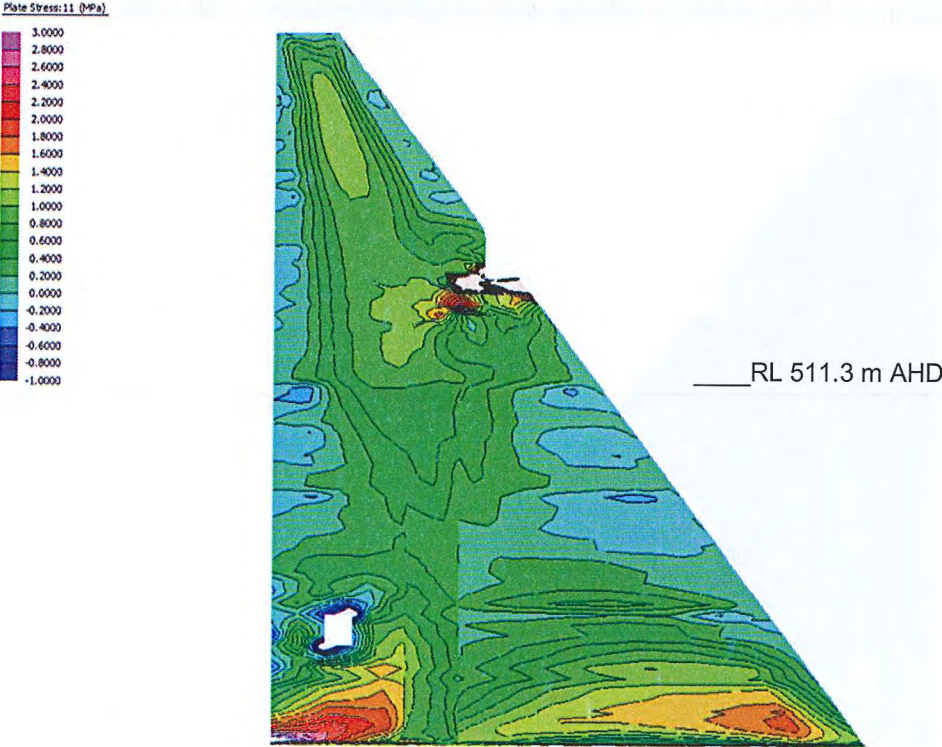
Figure 3.5 Maximum Principal Stress – Summer 2031/32 – Most downstream crack location

A further concern of the most downstream location of the crack was the possibility that the crack may propagate to the aerator notch. The analysis indicates that such propagation of the crack is unlikely. As can be seen in Figure 3.5 tensions are present in the region between the top of the crack at 511.3 and the aerator however these tensions are typically less than 1 MPa and therefore cracking is unlikely.

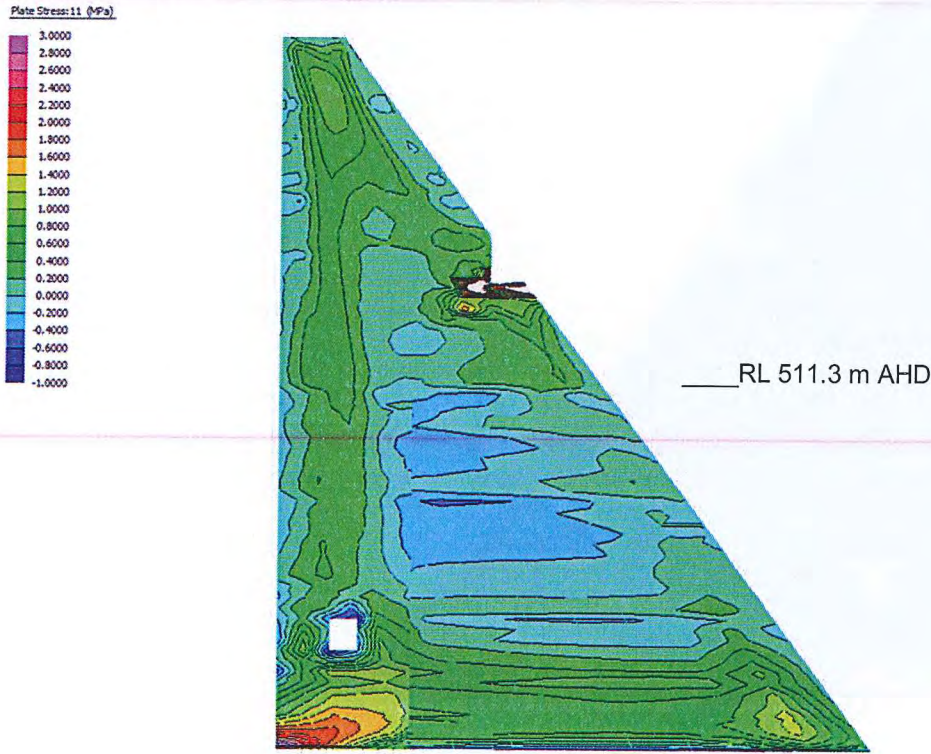
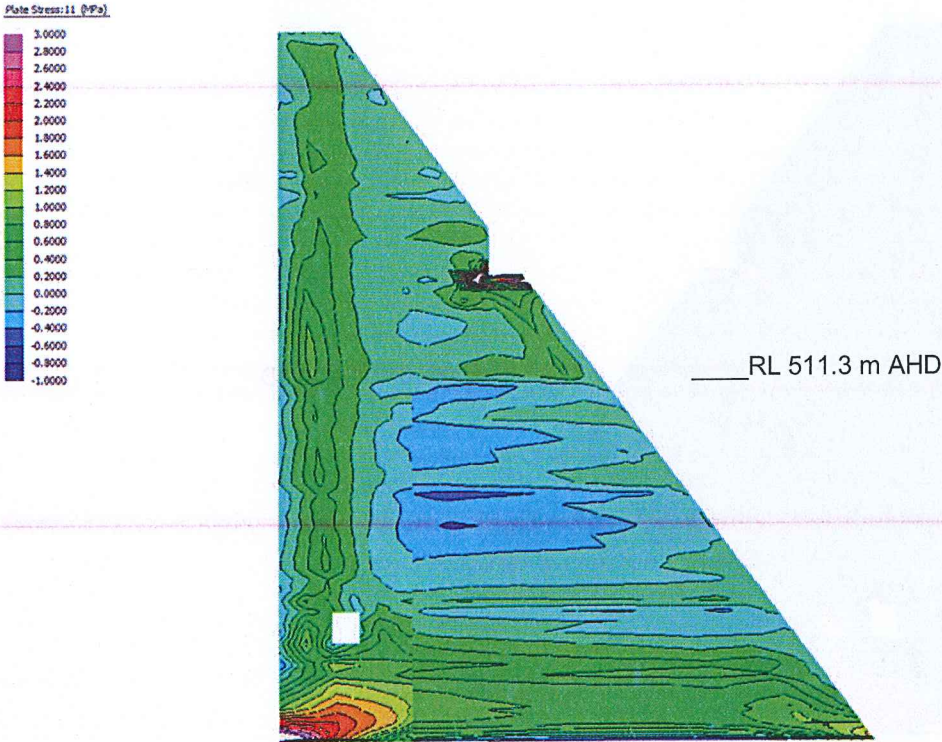
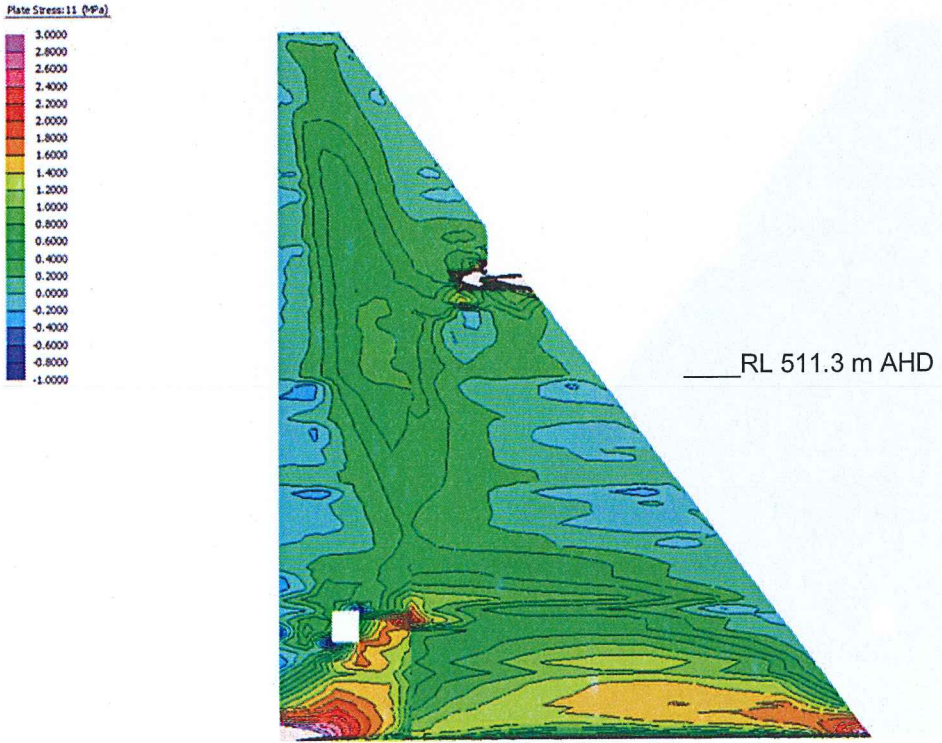
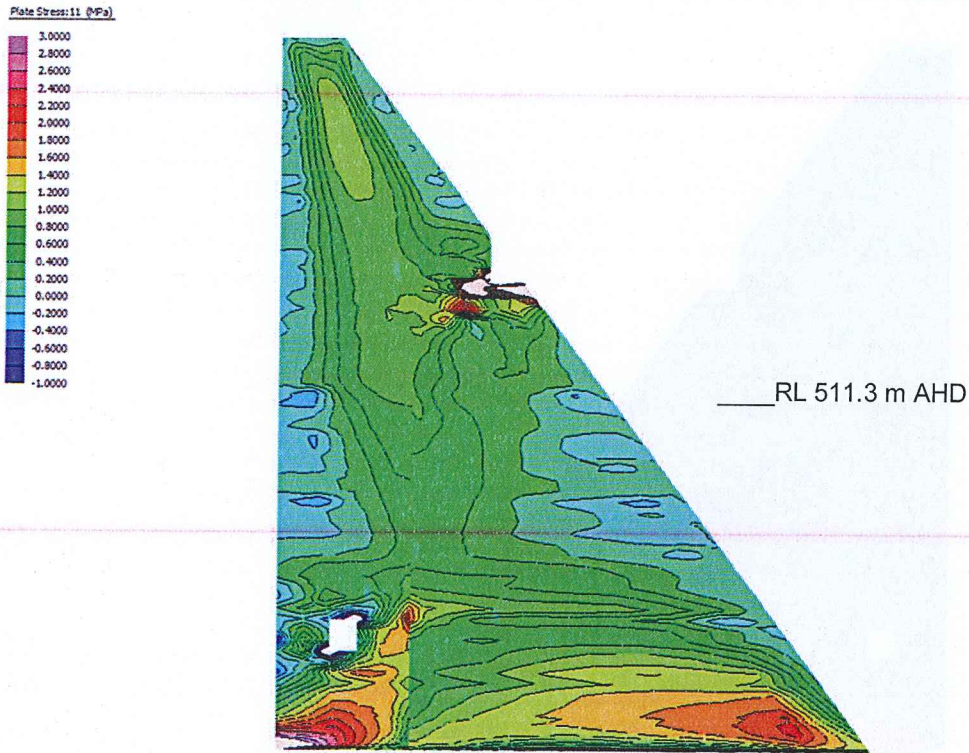
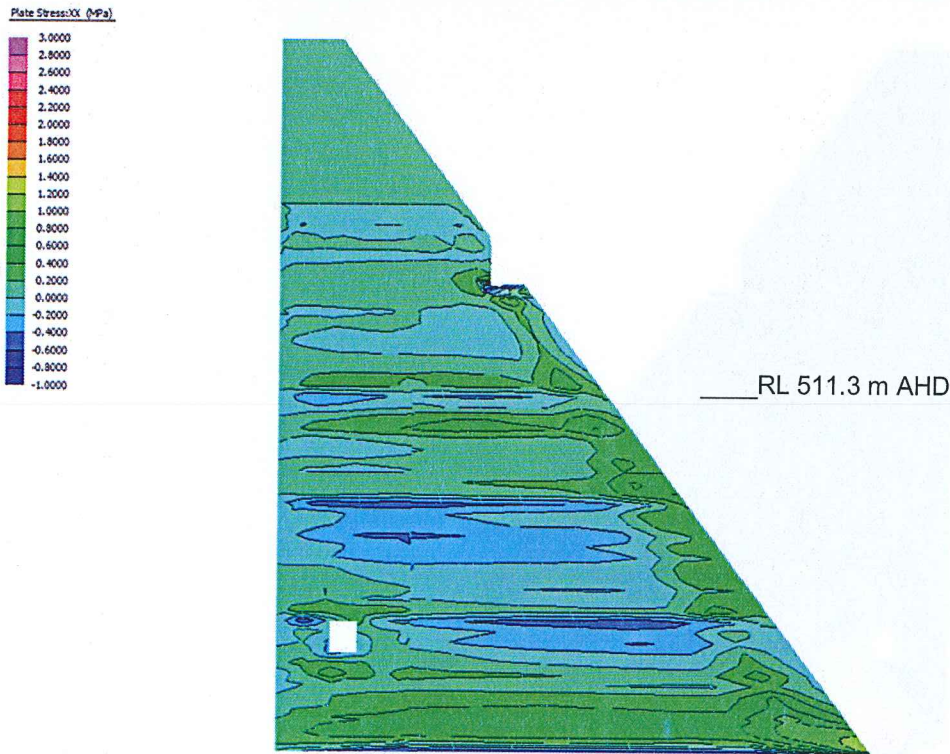
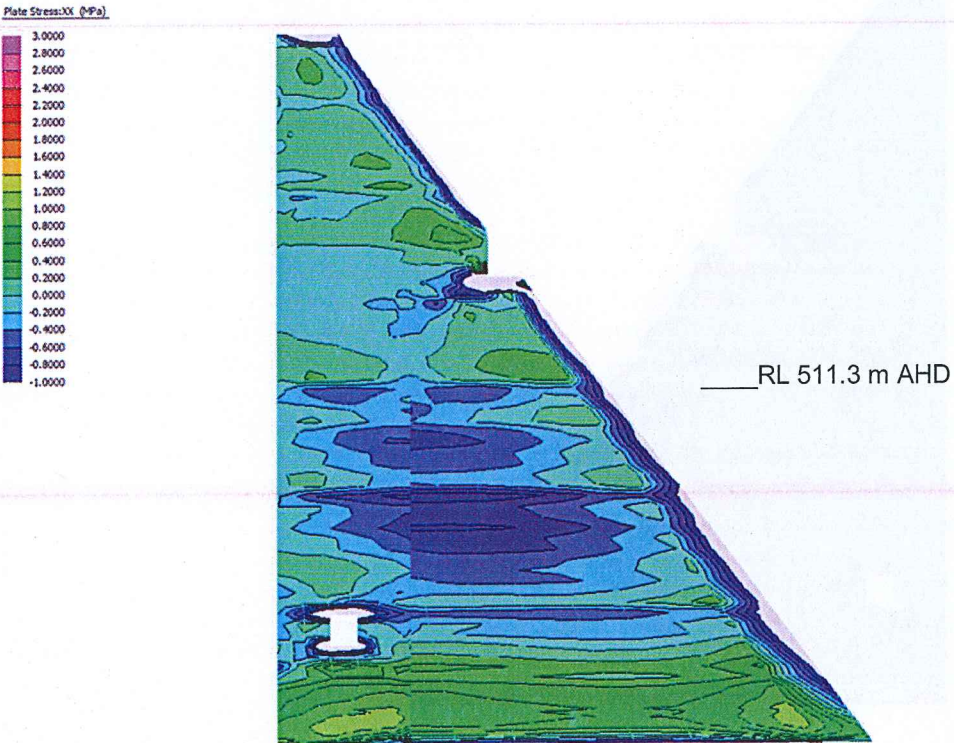
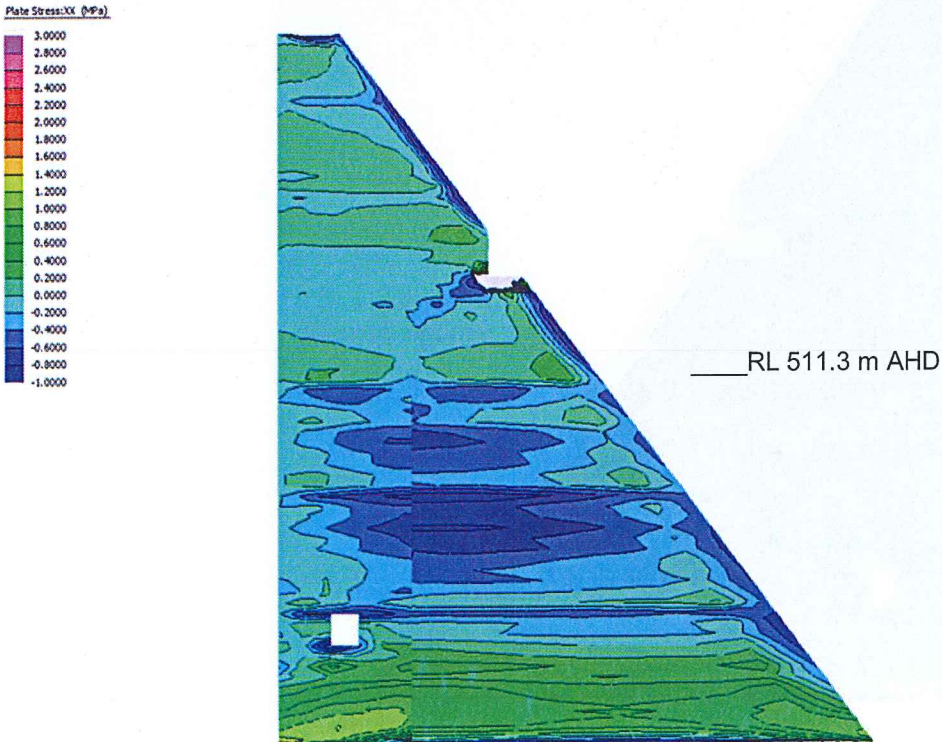
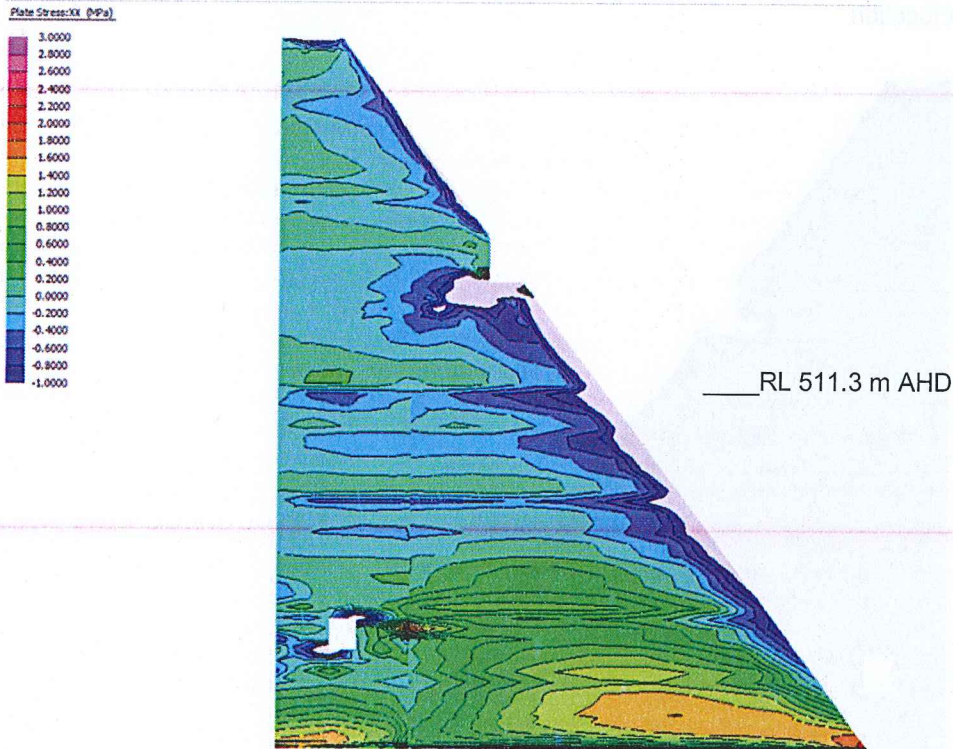
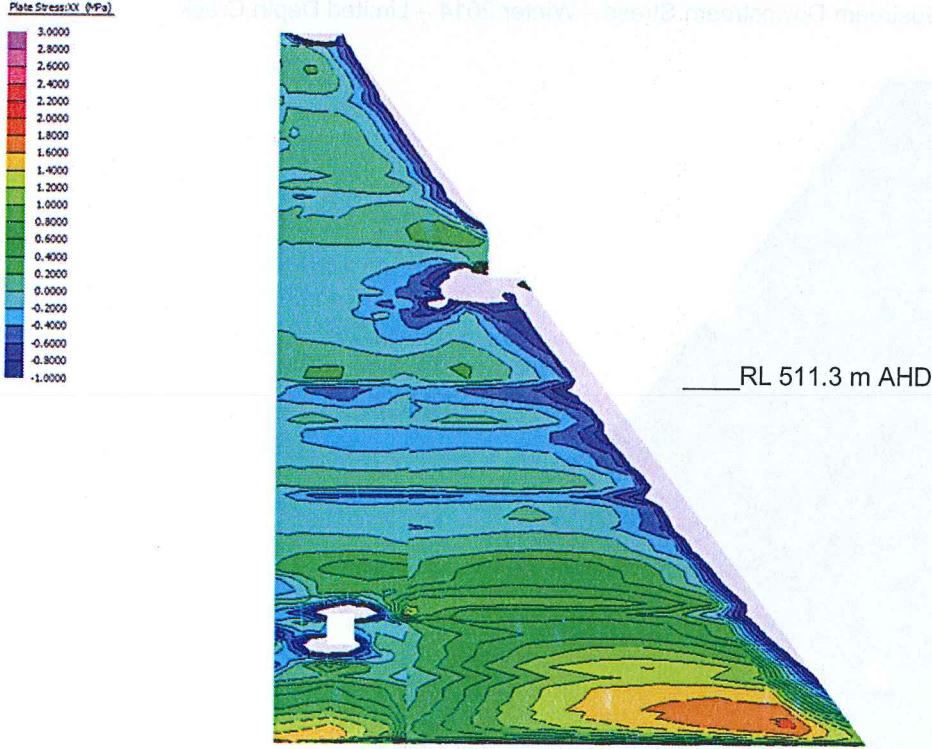
Similarly the results from the limited depth crack model appear to show little indication of crack propagation either upwards or downwards from the assumed 2.4 m deep crack. Figure 3.11 to Figure 3.19 does not show any development of regions of high tensile stress around the top or bottom of the crack 2.4m deep crack. Little relative displacement is observed for the assumed crack except at early ages in Figure 3.21. Additionally a majority of the modelled crack path from the bottom of the assumed crack (RL 508.4) to the foundation does not show any relative displacement or opening of the crack. This is reflected in the stress plots that show a significant amount of the assumed crack path is in a region of compression (in the

upstream downstream direction) or tension which does not exceed the 2 MPa tensile capacity of the modelled crack elements. Furthermore in the vicinity of the crack, where a lower tensile stresses would be required to allow propagation of the crack, the maximum tensions seen are in the order of 100 to 200 kPa, likely to be insufficient to generate further cracking. However some cracking was observed to develop in the model from the base to RL 485.6 which is also shown as opening displacement show for elements close to the foundation in Figure 3.21. This did not appear to connect with the existing crack modelled at RL 510.8.

This analysis indicates that the assumption that the crack will extend to the foundation is conservative, and in all likelihood cracking will not progress more than a few metres below RL 511.3 m AHD, the level at which the cracks were observed. If this is the case the dam will behave almost identically to the uncracked section with short cracks within the body of the dam not having any significant on how the dam will perform.

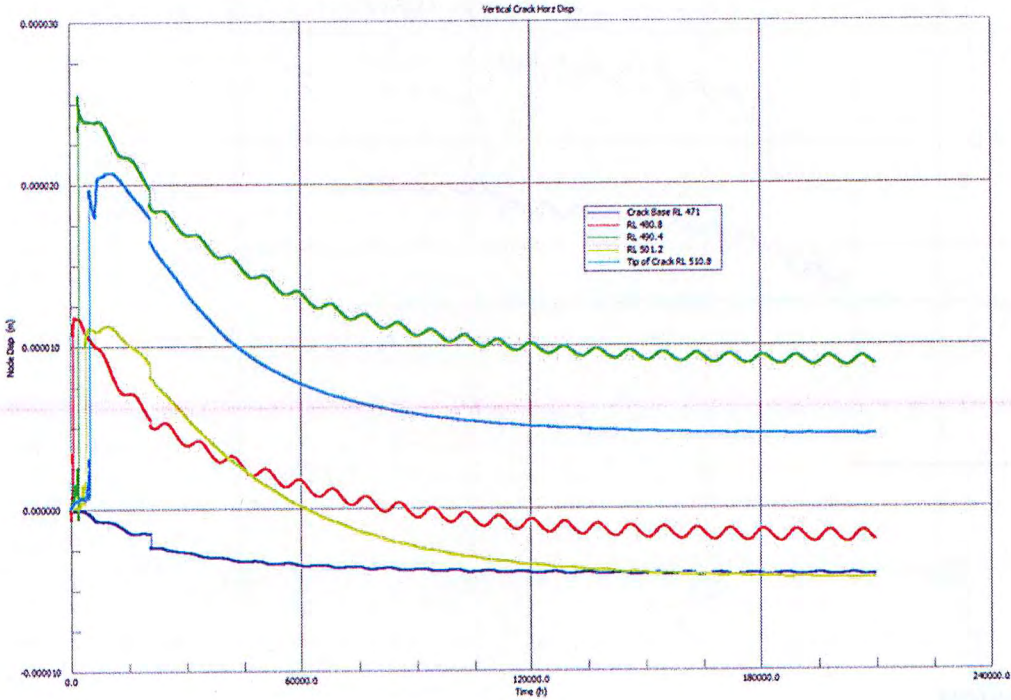
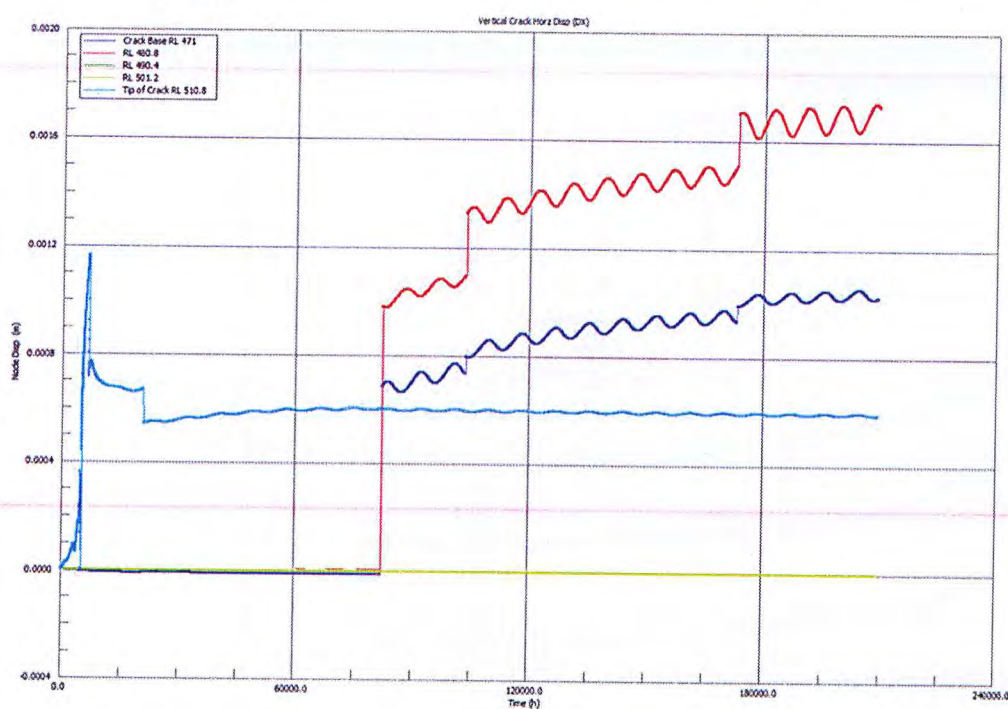
Figure 3.20 and Figure 3.21 show the displacement one side of the crack relative to the other at various heights for the downstream crack model and limited crack depth model respectively.

(Note:- given the coarseness of the model mesh and the scale of the model, the magnitude of the relative displacements observed in the modelled crack should be used only as an indicator of trends within the model. In both models the assumed cracks have shown relative displacement at very early ages which is a result of the model including the development of elastic modulus with time which includes a relatively low modulus at very early ages. This results in larger displacements due to temperature changes particularly when the concrete is generating heat from hydration of the cement. As such the early age displacement in the assumed existing crack (which has no tensile capacity) may not be indicative of actual behaviour.)
