Enlarged Cotter Dam – Stability Review of Dam Post Cracking

Additional Finite Element Analysis of Cracked Section

Document number GHD-ECD-DAM-GN-RPT-0005
DM5 number
Title Additional Finite Element Analysis of Cracked Section
Revision Rev 1
Document status
Date of issue 29 November 2012

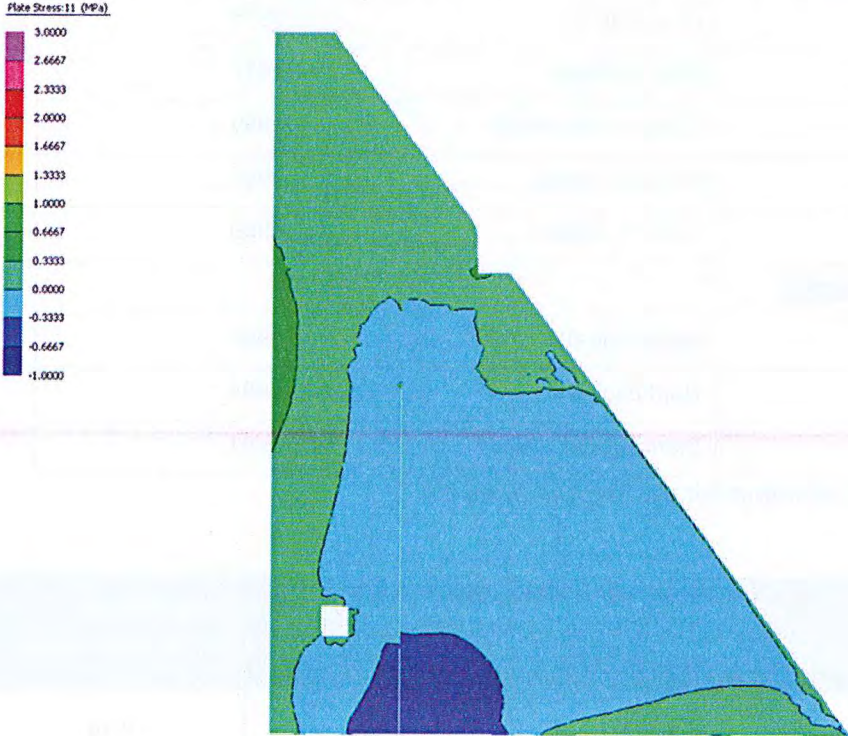
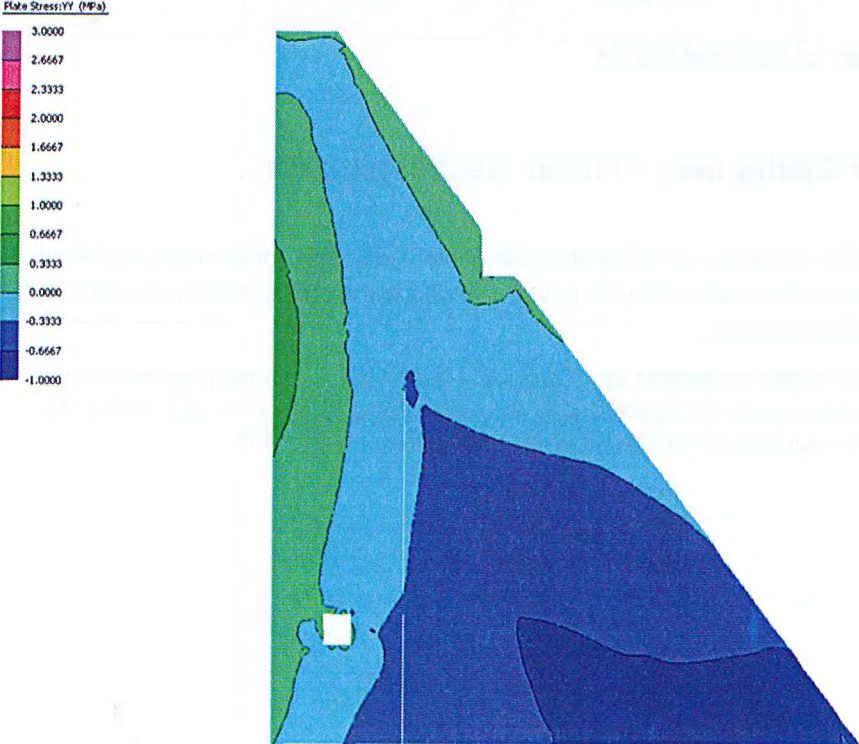
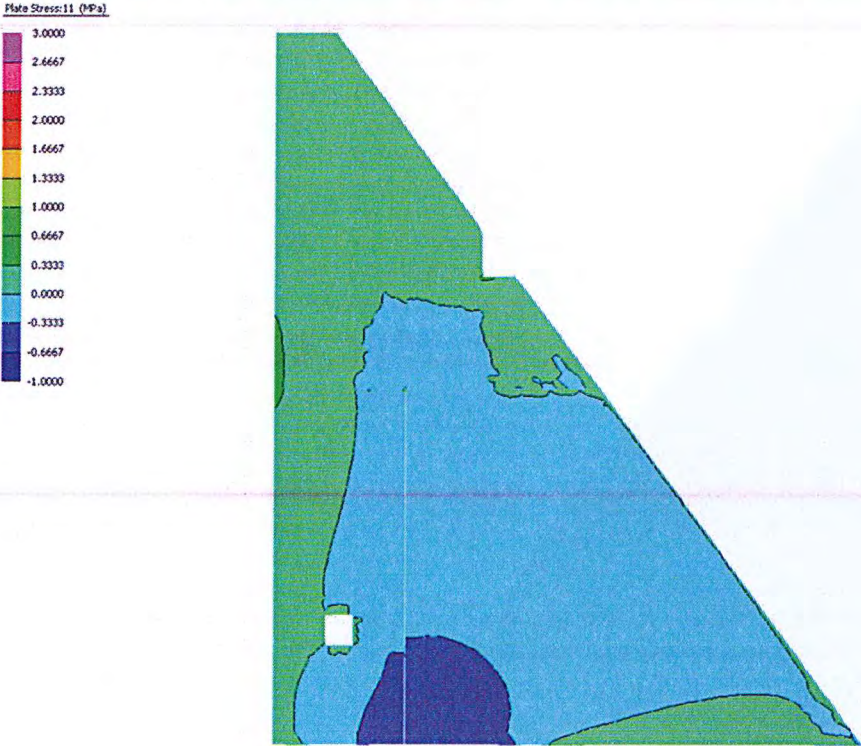
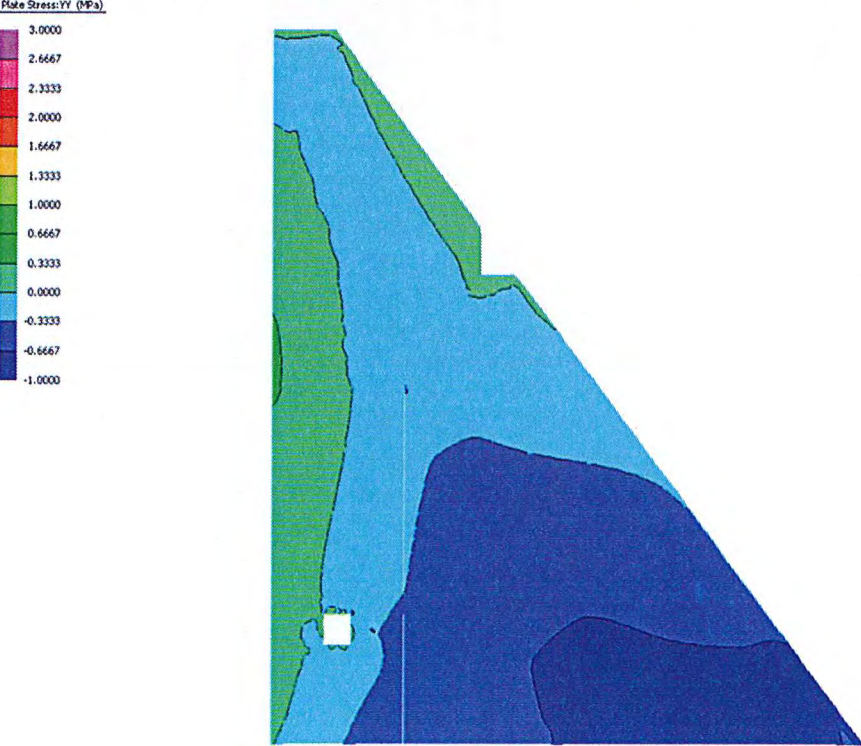
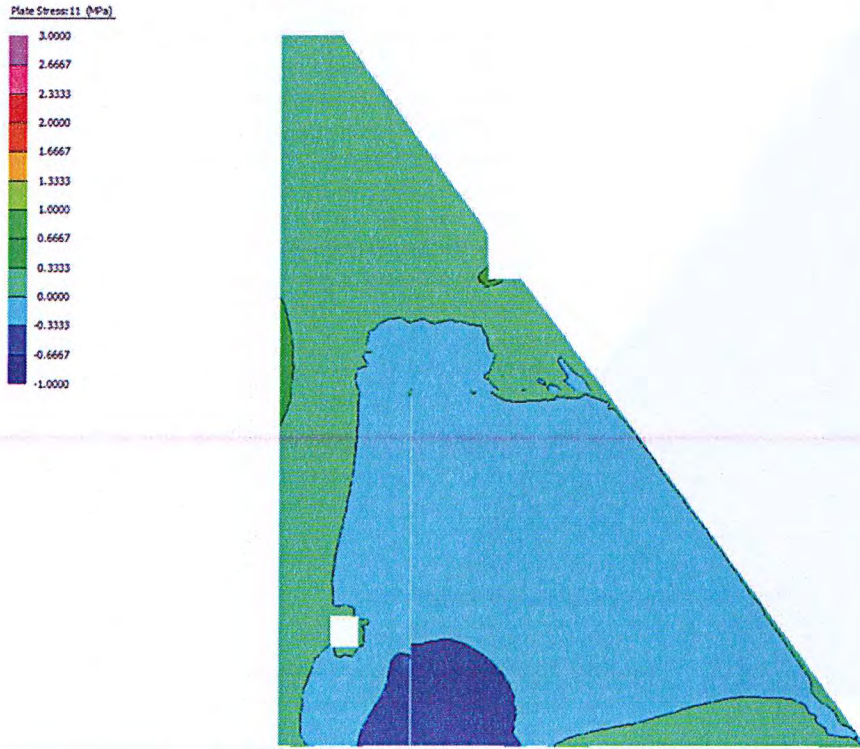
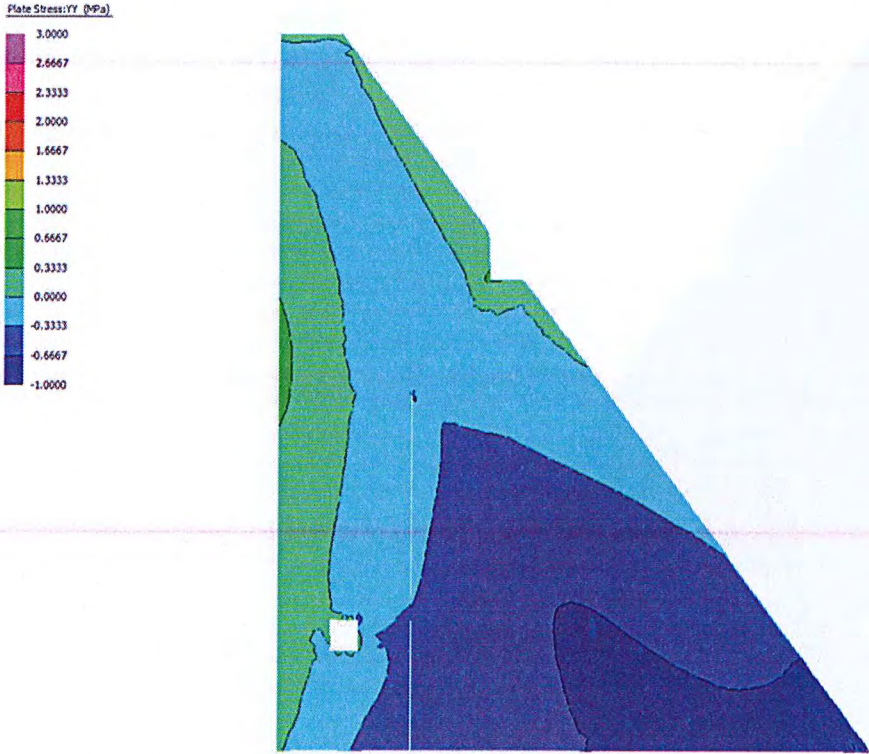
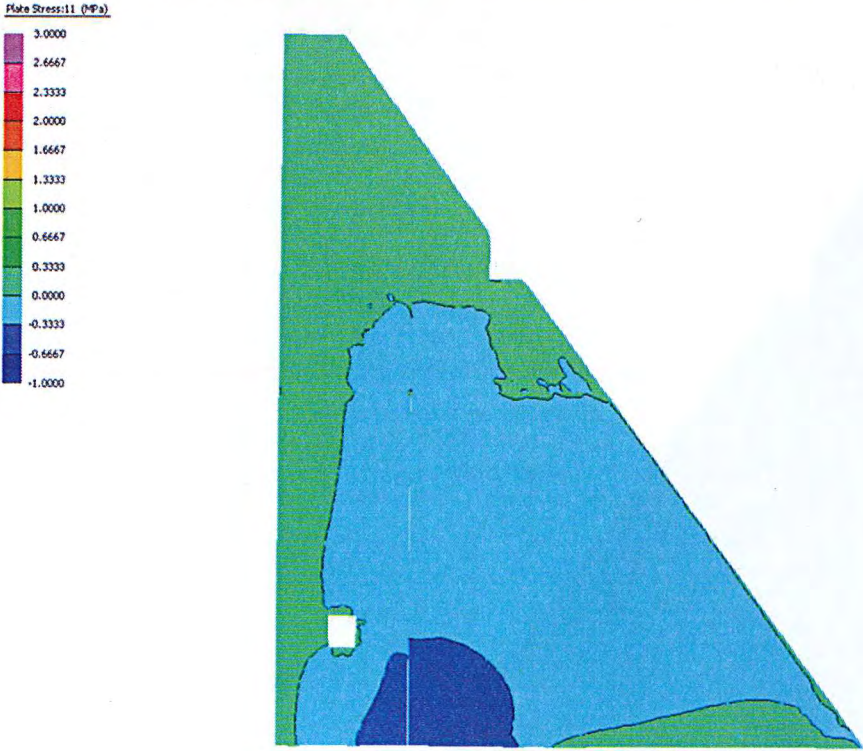
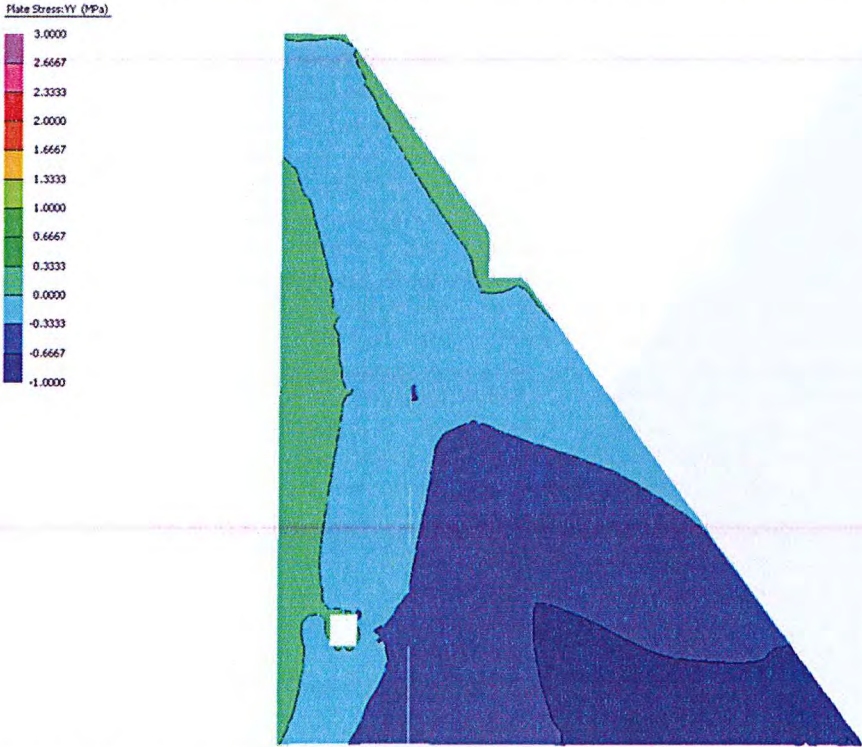
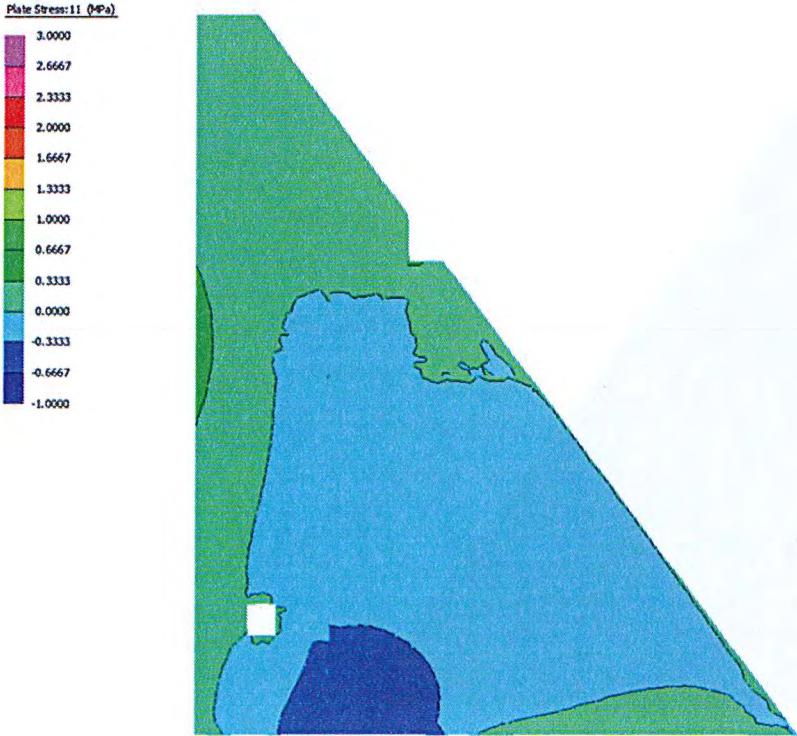
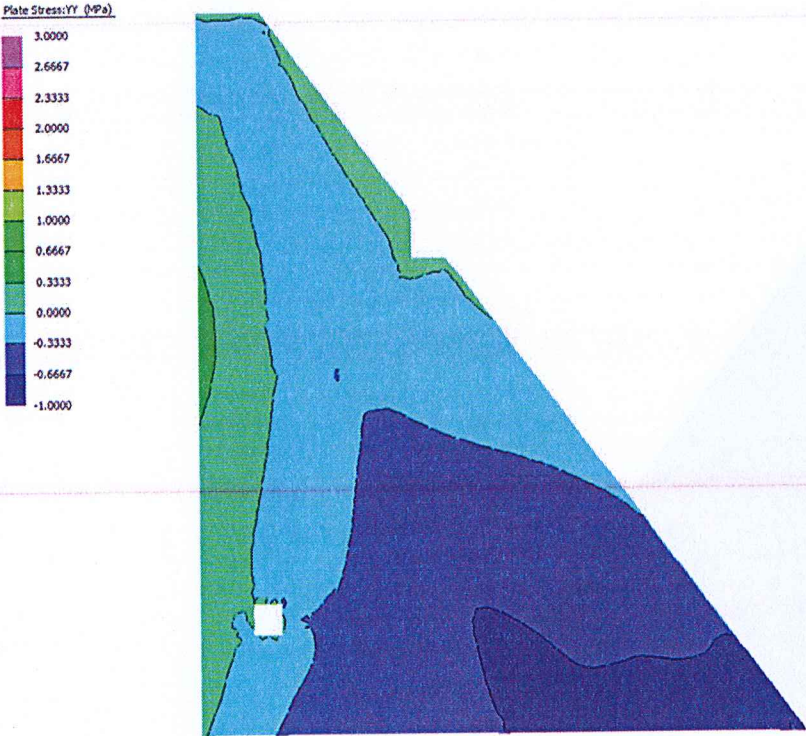
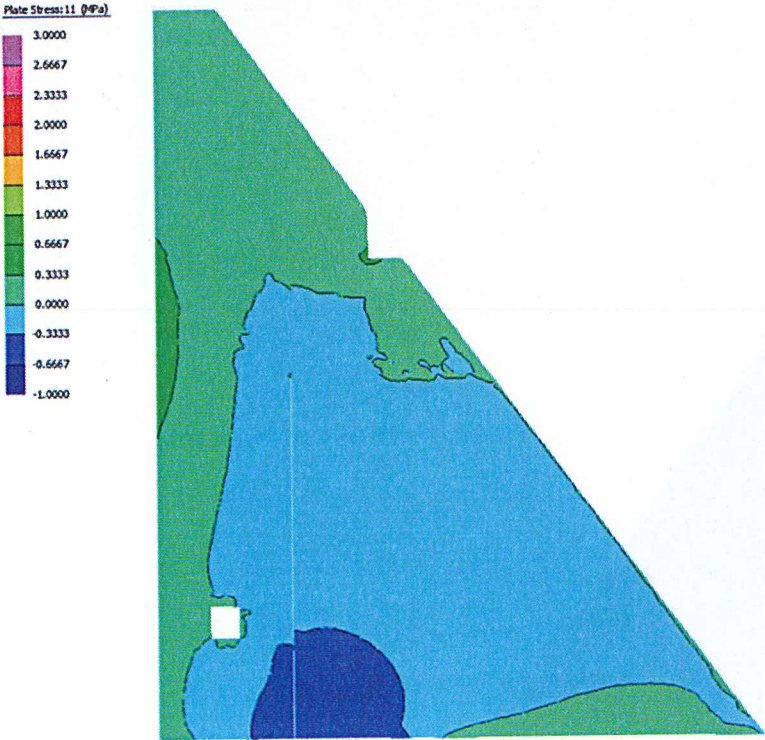
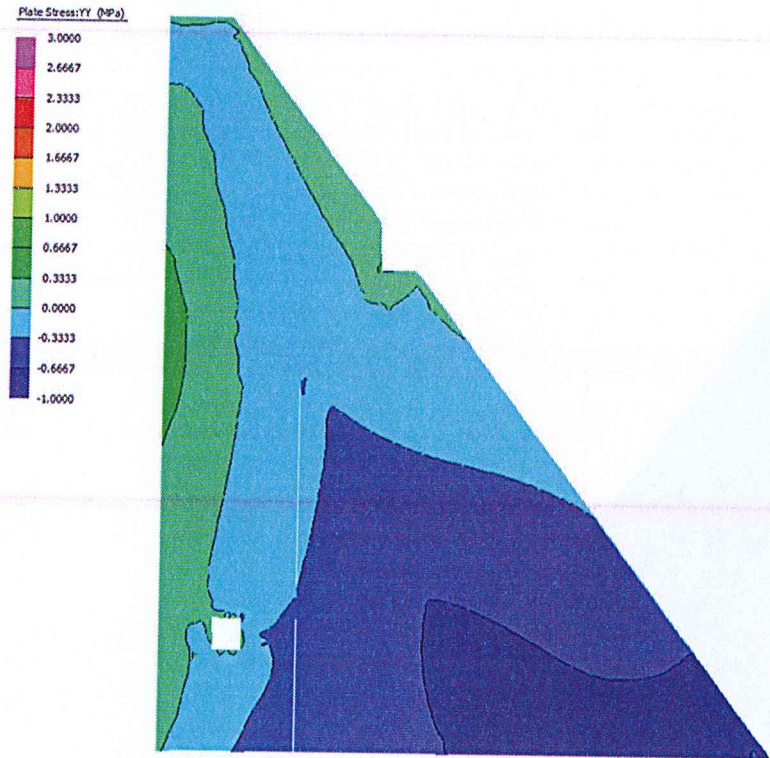
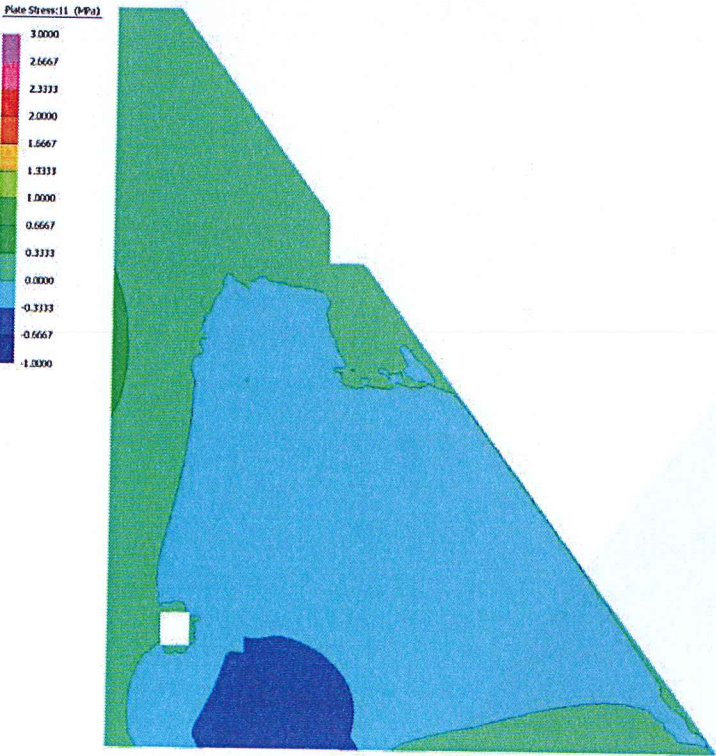
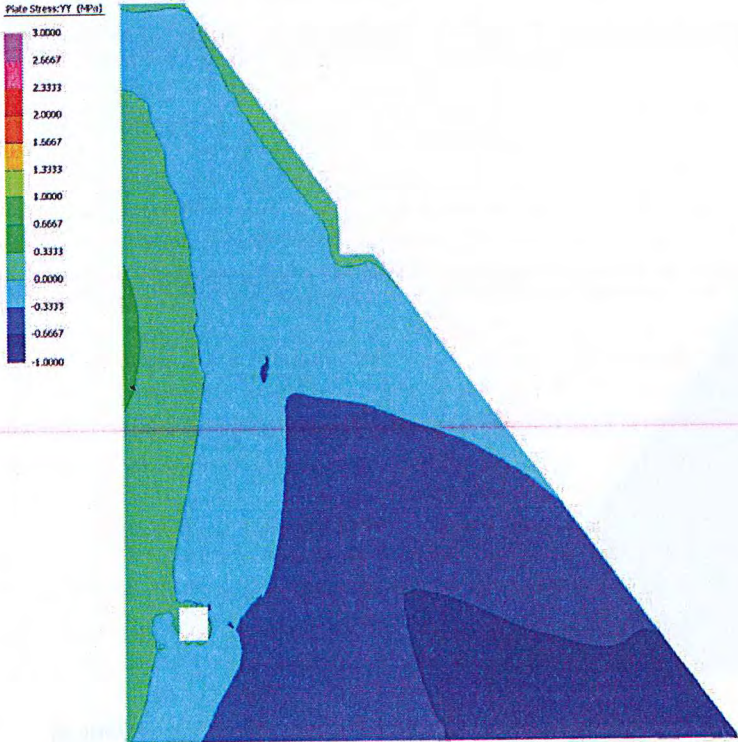
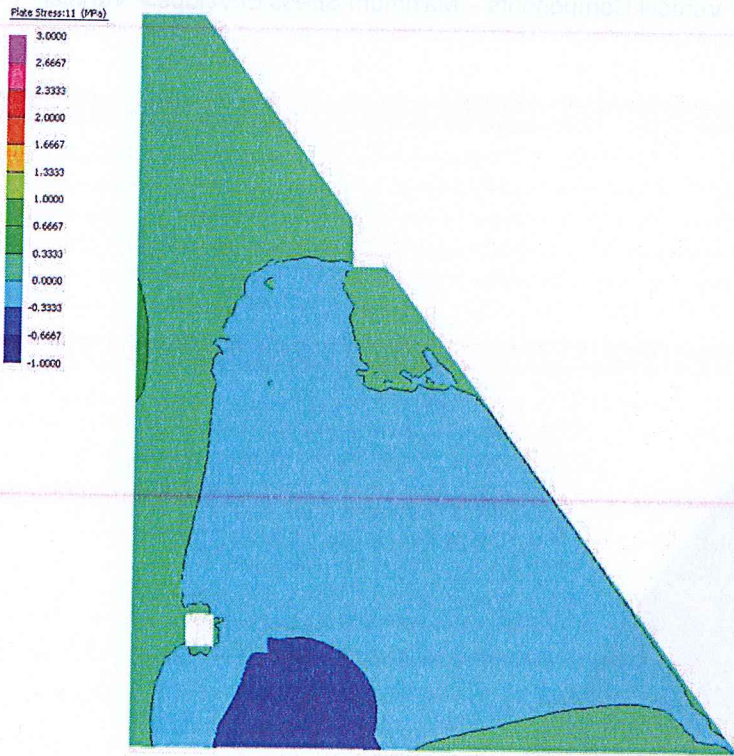
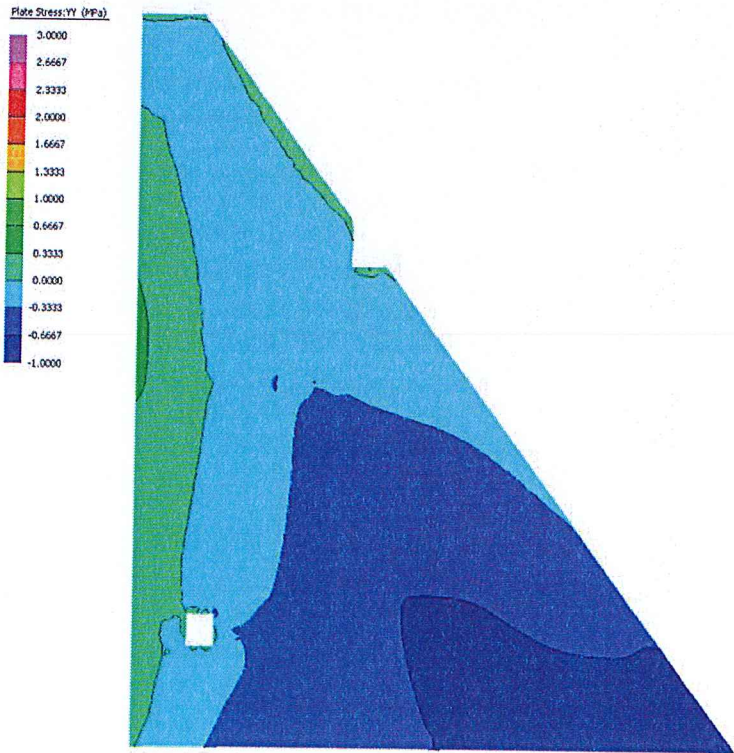
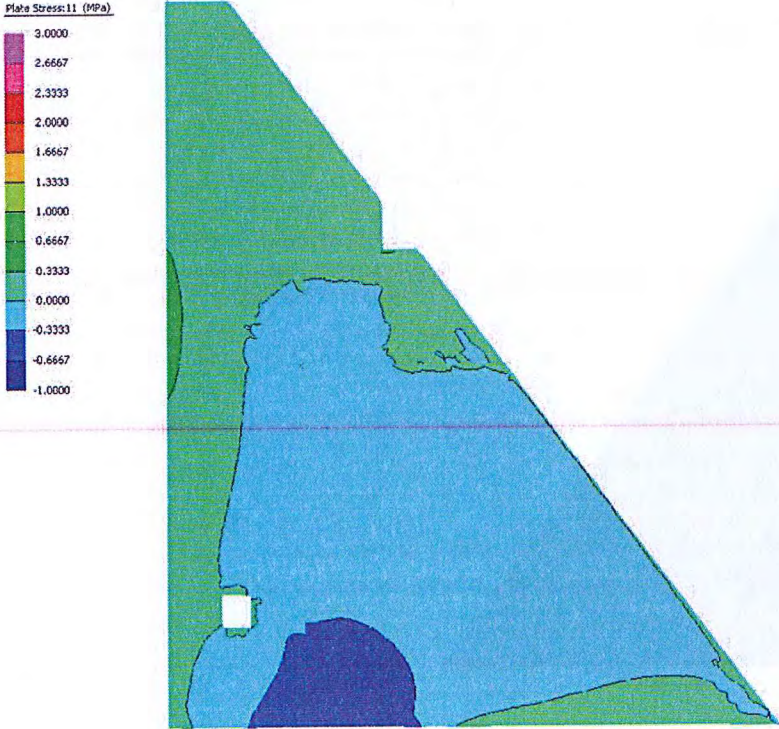
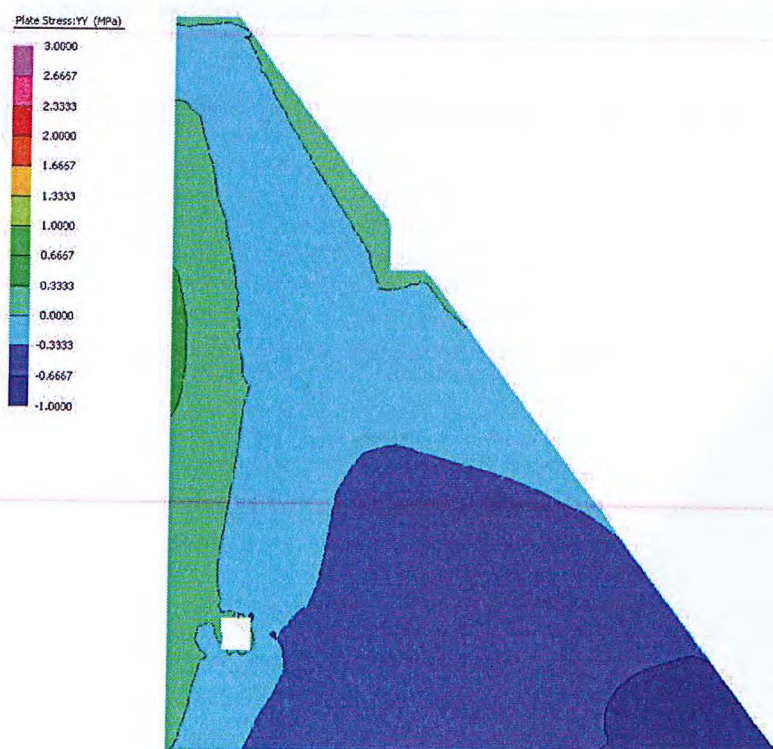
The results from the OBE load cases (as shown in Figure 4.1 to Figure 4.18) demonstrates very small areas on the upstream face where the dynamic tensile capacity of the lift joints (600 kPa) may be exceeded. When compared to the original linear analysis undertaken on the uncracked dam profile the stresses are of a lesser magnitude in this analysis due to the inclusion of the non-linear point contact elements along the dam foundation interface. For all of the OBE load cases negligible displacement was observed in the non-linear elements along the foundation interface. Any recorded residual displacement was less than 3 mm in magnitude which could be considered negligible given the coarseness and scale of the model. The cumulative inelastic duration and the special extent of overstress regions has not been assessed for the OBE load cases as these criteria were met in the previously undertaken analysis and there is no indication that these have been exceeded with the inclusion of the crack within the dam given the reduction of stresses observed in the results. It could therefore be inferred that the inclusion of the crack within the structure has little to no negative impact on the durability of the structure in an OBE event.
