ENLARGED COTTER DAM

TECHNICAL REVIEW PANEL REPORT NO. 20 BY

ON MEETING OF

15 AND 16 AUGUST 2012

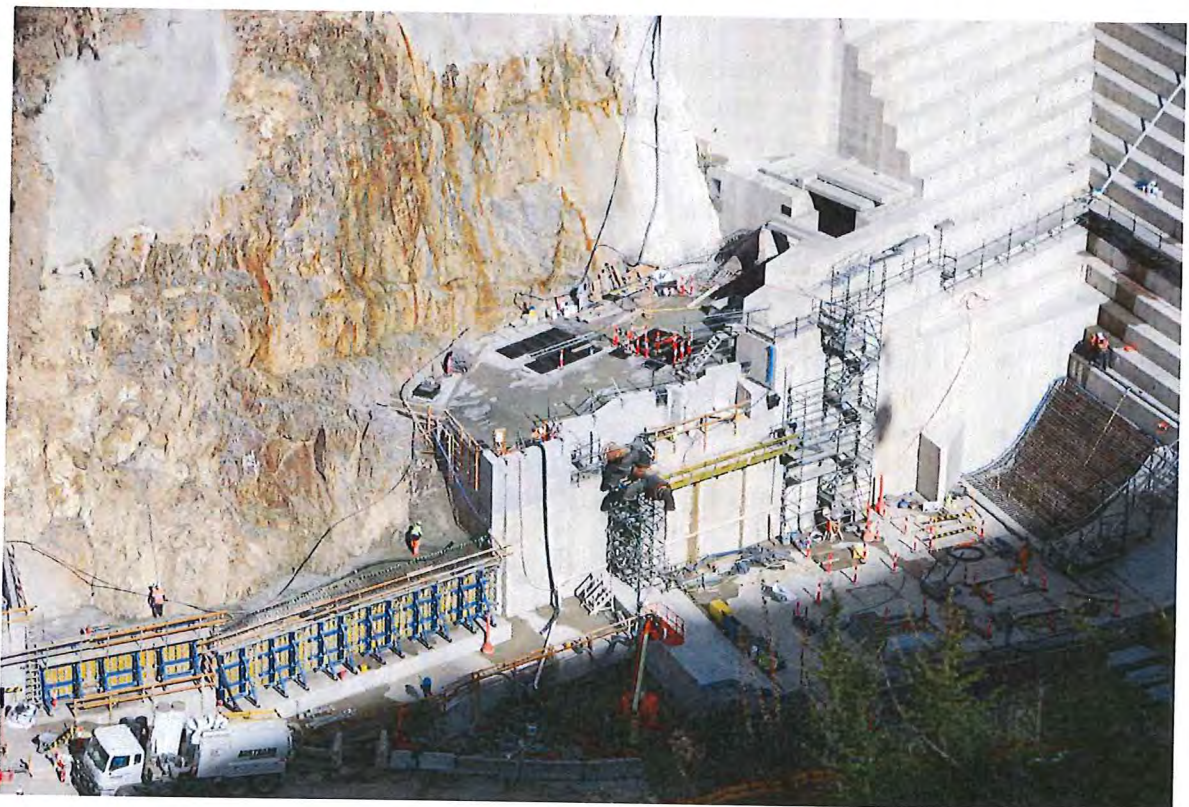
Photograph 3.1 The right hand side of the spillway's stilling basin, showing the partly completed outlet works and the manifold pipework for the Stage 3 of the diversion works.

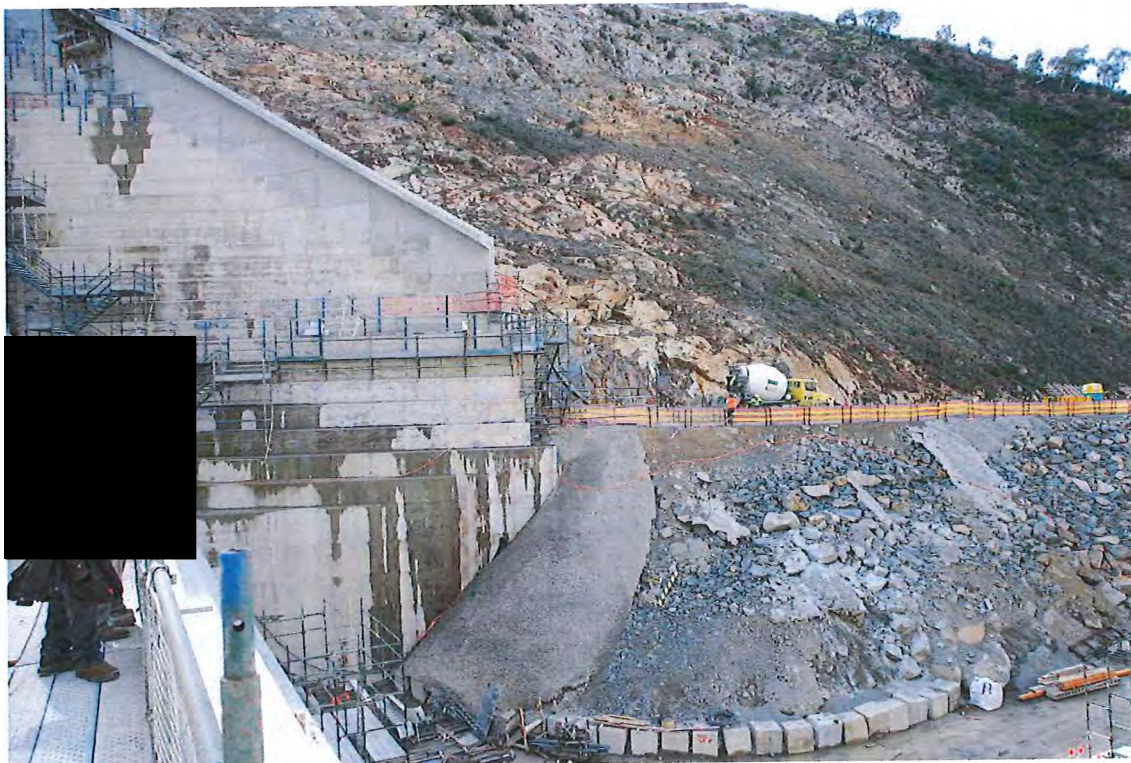
Photograph 3.2 The left hand side of the spillway's stilling basin, showing the way the outlet of the 3 m diameter conduit of the Stage 2 diversion works is now holding up progress on this side of the stilling basin.

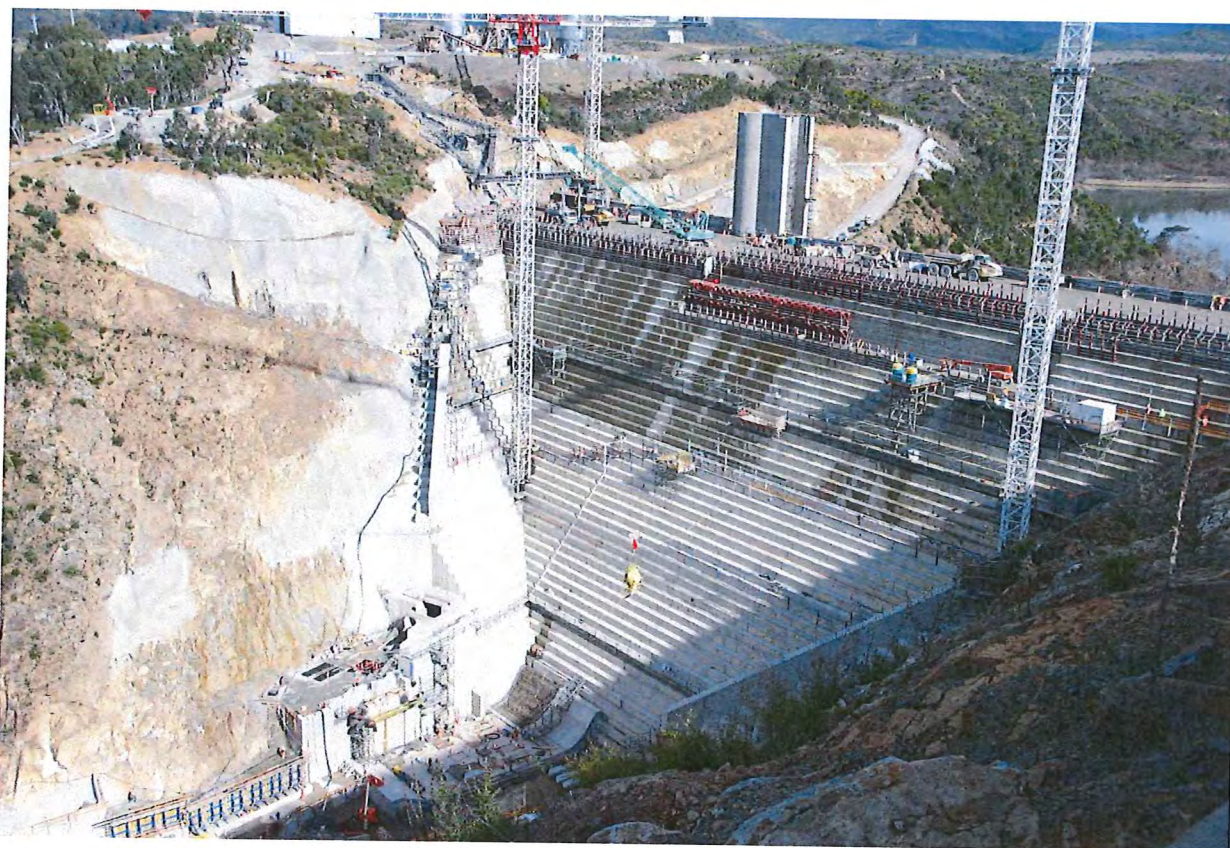
Photograph 3.3 The downstream face of the dam as at 15 August 2012. The RCC deck level was at RL 532, which is 20 m below the crest level of the primary spillway.

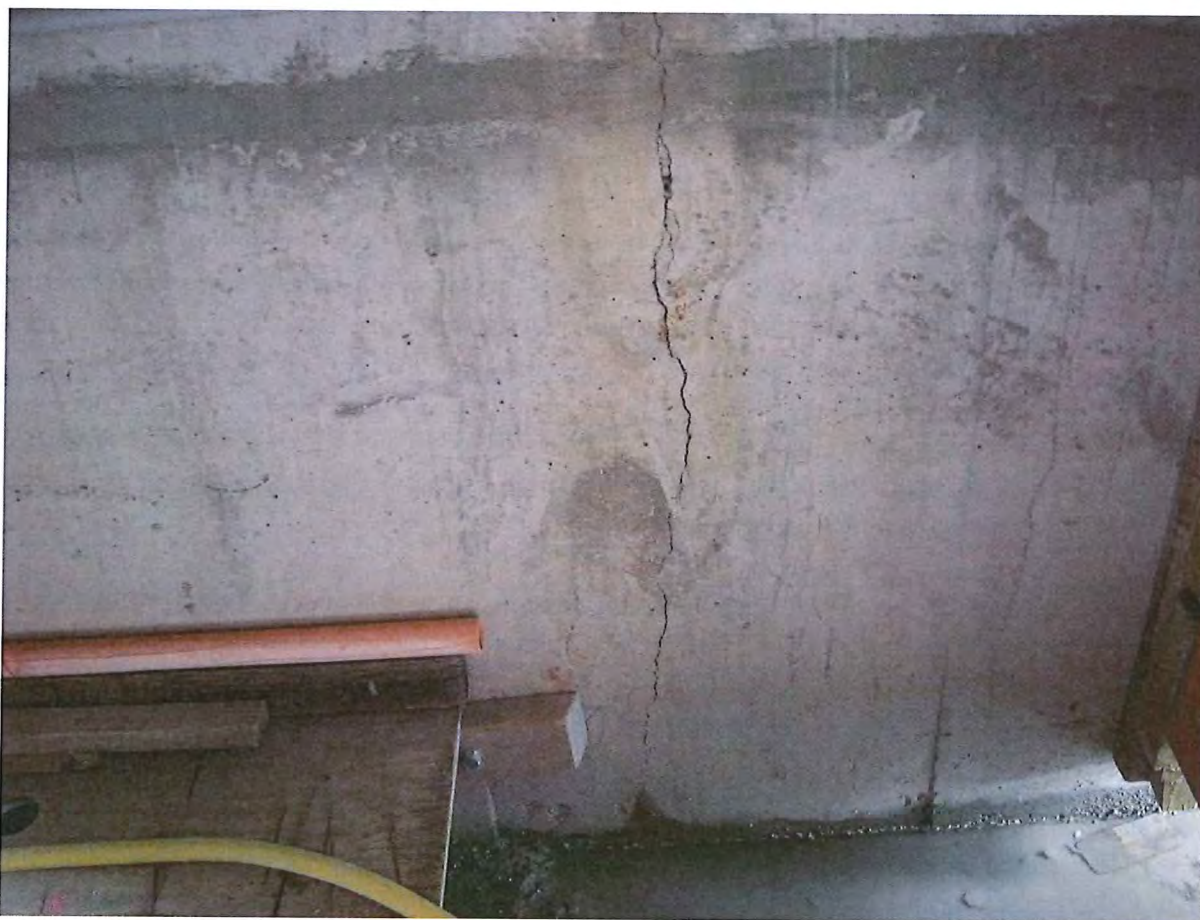
Photograph 5.1 The vertical crack close to the entrance of the gallery on the right side of the spillway's stilling basin. This crack is in the RCC of the secondary spillway toe channel. It has propagated to the surface of the channel.

Not shown in the drawing in Appendix A is a very noticeable crack near the entrance of the gallery, under the secondary spillway channel. This crack is shown in Photograph 5.1. This crack seems to extend to the stepped surface of the secondary spillway channel, where it apparently links up with a crack in the surface of the secondary spillway channel.

BWA's contention is that these cracks are thermal/shrinkage induced cracks, initiated probably by the local cooling along the wall of the entrance gallery. Ambient temperatures as low as 2°C have

been recorded within the gallery this winter, whereas it is 8-9°C 300 mm into the concrete and 16°C about 2 m in. This temperature gradient could have been enough to see cracks initiated.

One of the inner set of cracks is shown in Photograph 5.2. In this photograph and in Photograph 5.1, one can see clearly that the cracks are not planar but do meander from the floor of the gallery to the roof. Certainly, the entrance crack deviates even more off the vertical plane near the roof of the gallery (not shown in Photograph 5.1). We would expect therefore that there is considerable shear strength along any of these cracks, in which case, the body of particular monolith should behave virtually as a monolithic concrete mass.

Unlike the other cracks, the entrance crack does reach the surface, in this case the surface of the secondary spillway channel. **We would suggest that this crack be sealed at the surface to prevent water getting into it during a spill event. BWA probably could wait a while until the concrete “settles” down before it seals the crack. In the meantime, the surface should be covered to keep dirt out of it.**

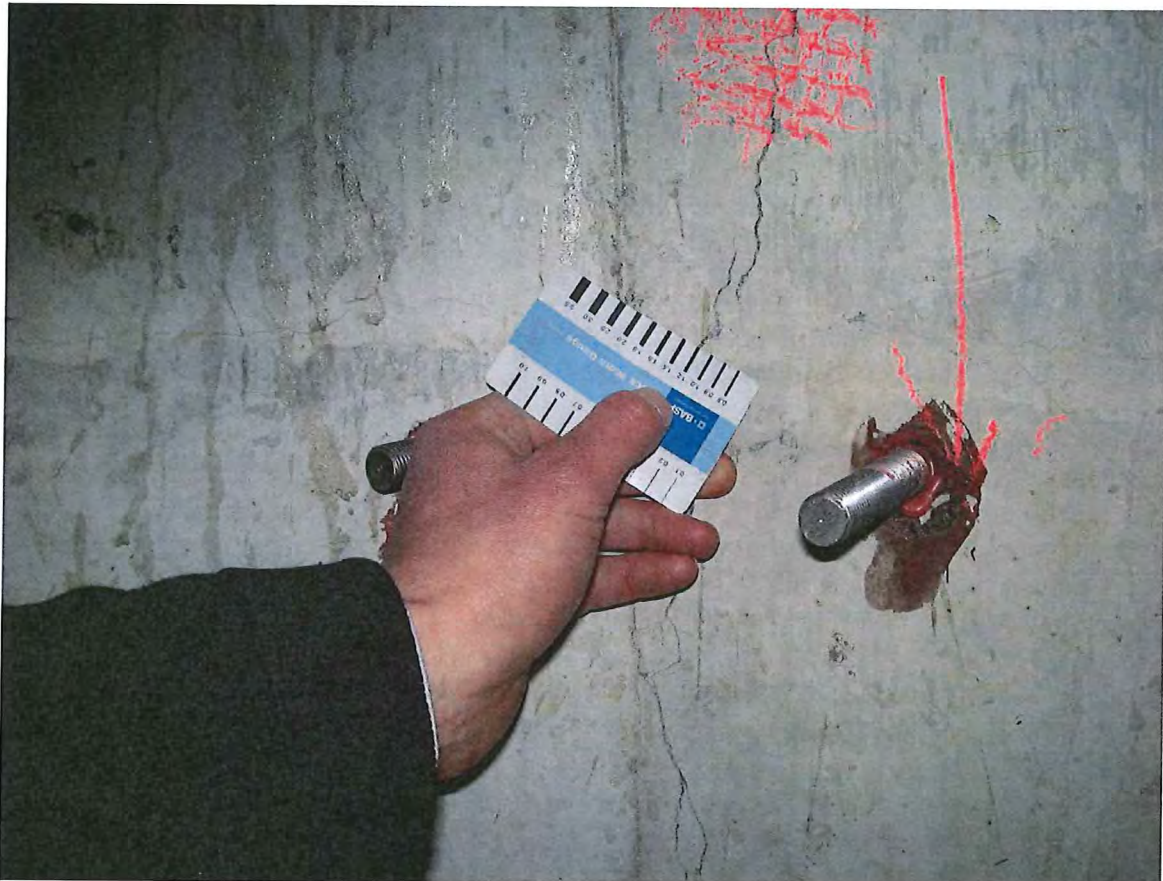
Photograph 5.2 One of the inner cracks along the entrance gallery. Note its significant “waviness”.

We agree in broad terms with BWA's assessment of these cracks and we do support the suggestion that these cracks should be drained.

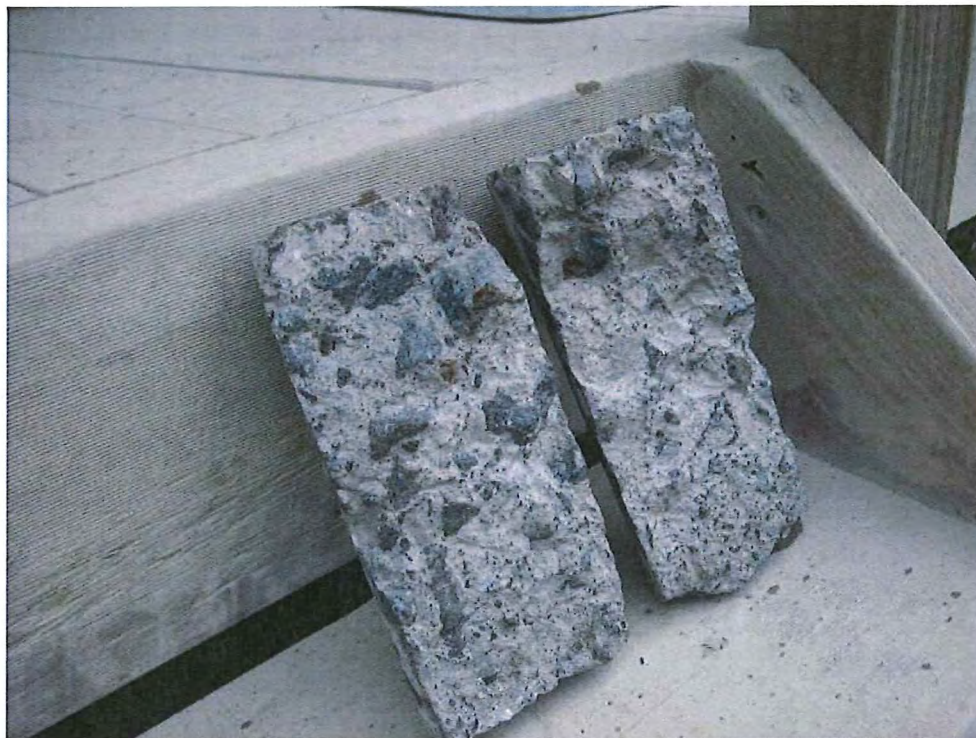
The lower of these two cracks is about halfway up the step. It was cored to a depth of 0.4 m. The core is shown in Photographs 5.3 and 5.4. As may be seen, the break is through good quality RCC, perhaps just getting onto a lift joint. The break includes failures through two pieces of aggregate.

Photograph 5.3 Drilled core along the lower of the two horizontal cracks in the downstream face. The joint surface seems to be at the bottom of the cores – the top of the core is the vertical face of the step. The crack has initiated off the joint at the outer face (see Photograph 5.4).

BWA's suspicion is that these cracks are due to local cooling on top of the step, possibly initiated when the flood overtopping happened in February-March of this year.

We do agree with BWA's basic suspicion for the cause of these cracks. We feel that they are not likely to propagate very far into the RCC mass, given that there will be a quickly increasing vertical stress as we move away from the face, especially from the localized disjointed stress pattern associated with the inner corner of each step.

Why the lower one failed as it did is hard to understand as there does not seem to be any significant tensile strength weakness here. Given that it will shortly be completely buried by the third of the reinforced curved floor slabs at the upstream end of the stilling basin, we would suggest that no further action is required.

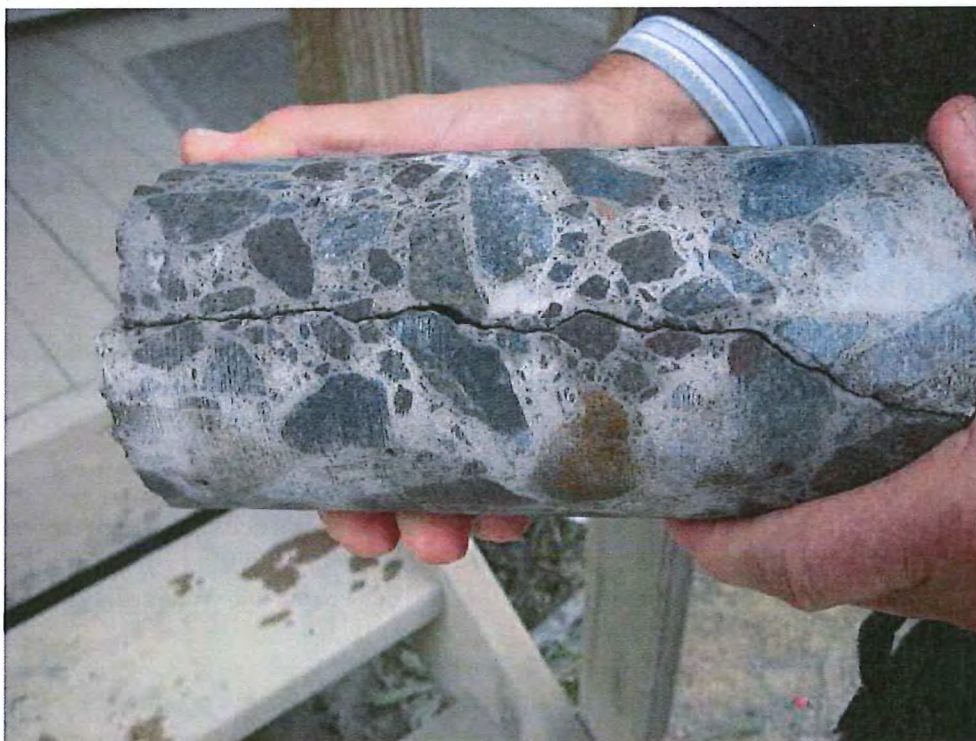
Photograph 5.4 The full core into the lower crack. Note the crack initiating off the lift joint.

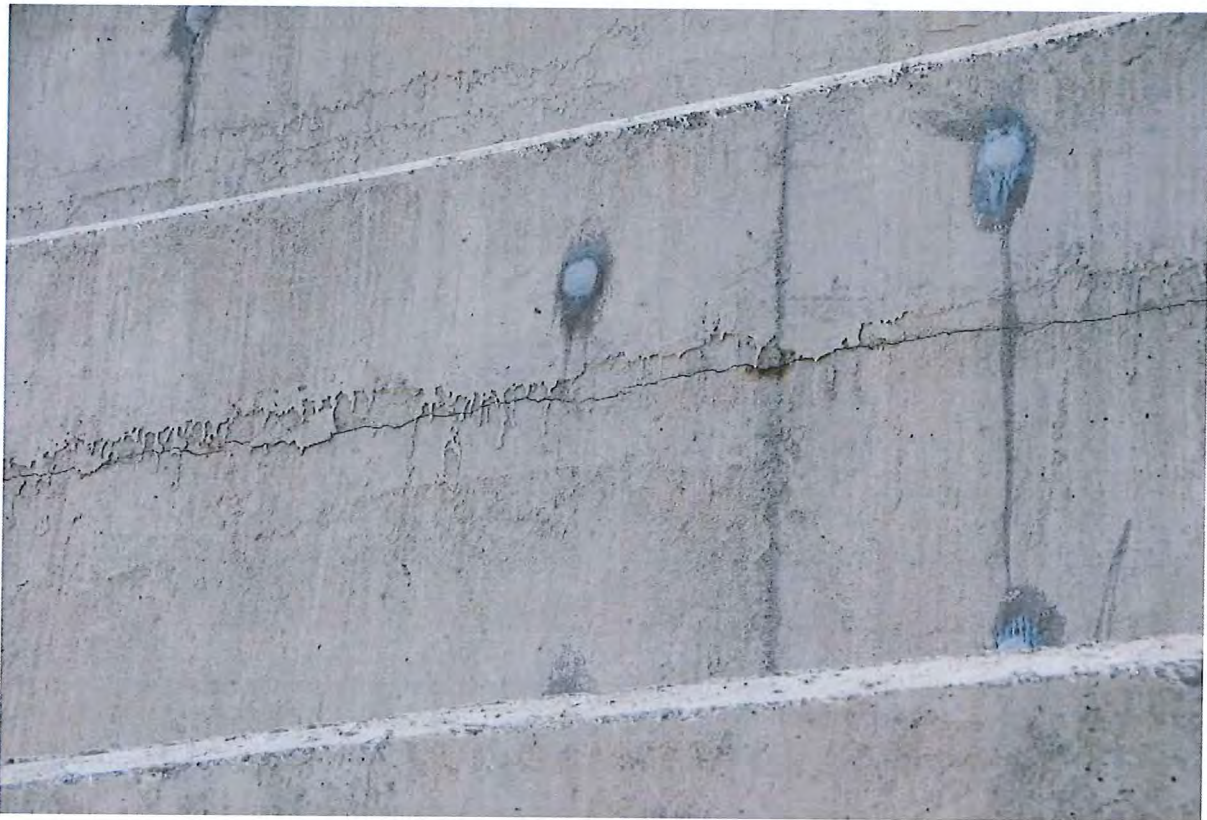
The second crack, the one along the step at RL 486.5, seems to be along the top lift joints (see Photograph 5.5). It will be core-drilled soon.

Photograph 5.5 The higher of the two horizontal cracks on the downstream face, which seems to be along an RCC lift joint. It is on the vertical face of the step at RL 485.3.

The crack along the RL486.5 step should be investigated by drilling, as now proposed by BWA. . Its "straightness, as shown in Photograph 5.5 does suggest that it is wholly along a lift joint, unlike the lower of the two horizontal cracks that have been picked up by BWA. It may be that it is along

a locally poor lift joint. We would suggest that [REDACTED] be sounded out as to what would be the local hydraulic pressures on this part of the step from the turbulent flow down the stepped spillway, both before skimming flow is reached and beyond that stage. Decisions on whether or not anything other than some crack sealing need be done, indeed if anything need be done, can be made after [REDACTED] review.

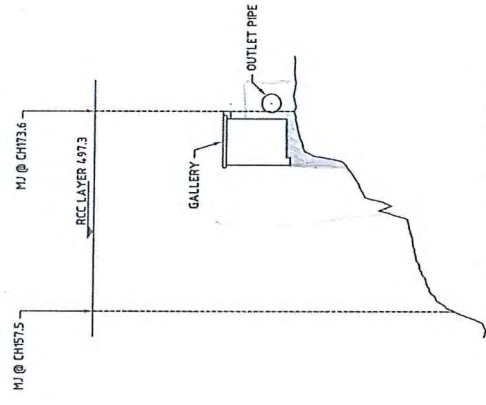
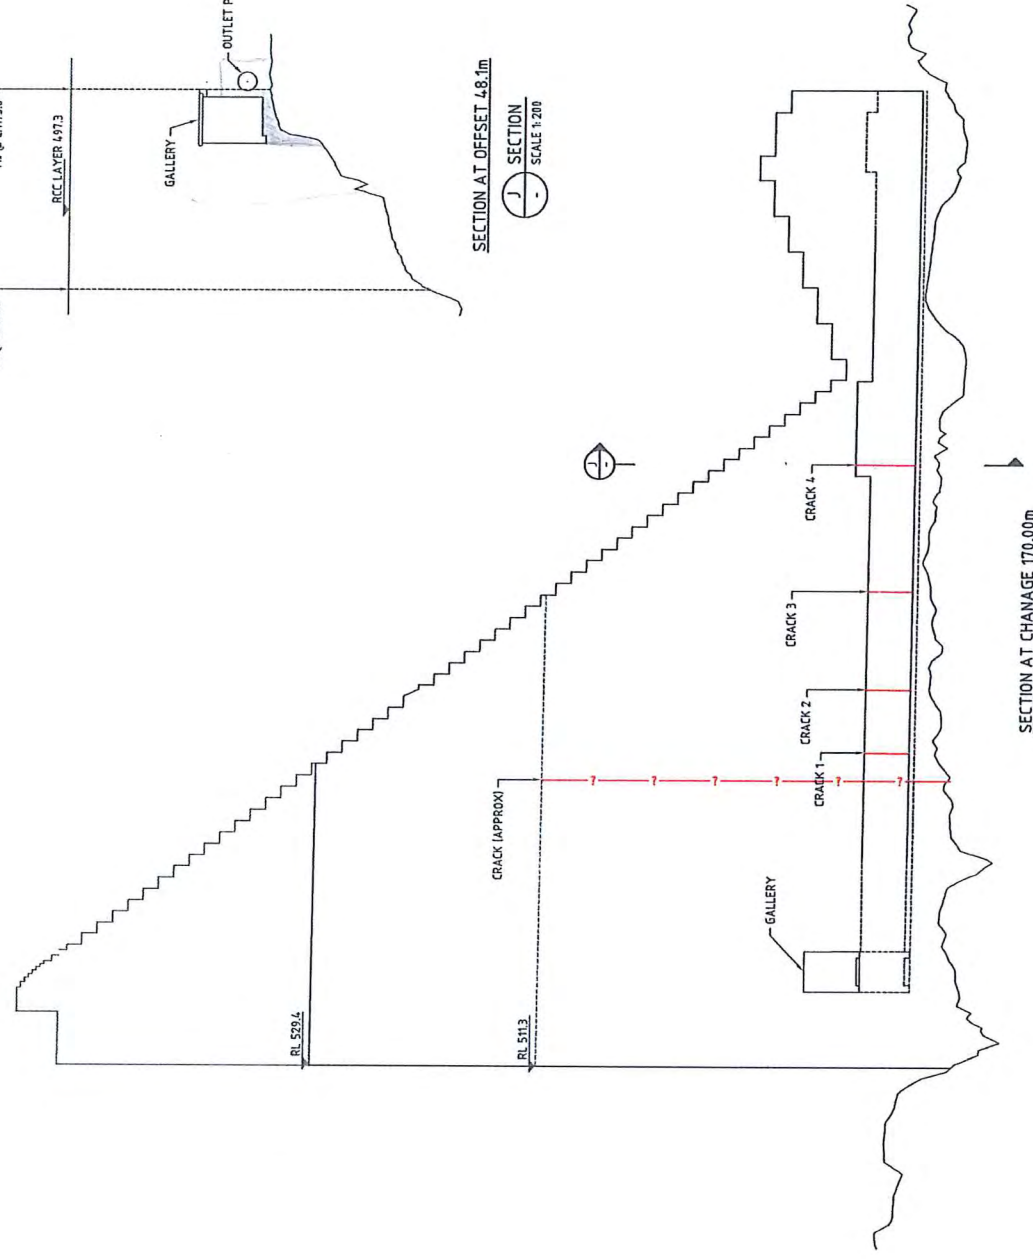
**CROSS-VALLEY CRACKING IN GALLERY ENTRANCE – PLAN SUPPLIED BY BWA
ON 10 AUGUST 2012**

As mentioned earlier in our report and as shown in BWA’s drawing in Appendix A, cross-valley cracking has been found in the entrance gallery. With the right (uphill) side of the gallery being formed by the reinforced concrete surround for the main outlet pipe and with this side also being a monolith joint, the cracks have been picked up only on the other side of the entrance gallery. The drawing in Appendix A shows four cracks, but there are several others. These other cracks are very thin and do not seem to go from top to bottom of the gallery entrance section.

The four cracks shown in Appendix A go from roof level to floor level. At least one of them has propagated across the floor concrete that was placed on the RCC base of the gallery. BWA feels that one of the cracks could link up one of these floor cracks and then with a small one in the reinforced wall. The precast roof slabs masks any propagation of the cracks across the gallery roof.

BWA believes that these cracks should be drained into the gallery by a series of drilled holes from the gallery in case they become pressurized from the foundations. The design team feels that in all other respects this dam monolith should be adequately safe, given that it has the mass of RCC of the secondary spillway channel to act as a buttress.
