## **Asbestos Remediation - Final Report**

**25 Bradfield Street**

**Downer**

**November 2013**

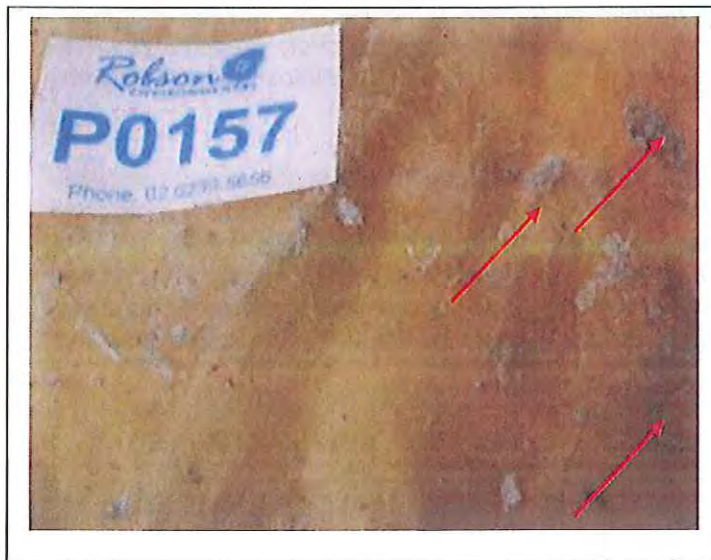
**Photograph 1:**  
Amosite insulation on yellow  
insulation batt from shed (originally  
from attic)  
Sample: P0157

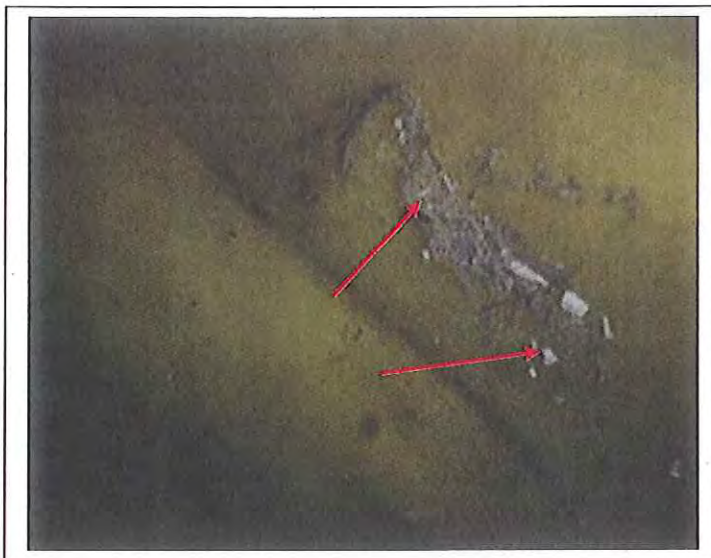
**Photograph 2:**  
Amosite insulation Under yellow  
insulation batts adjacent to attic entry  
hatch  
Sample: A0106

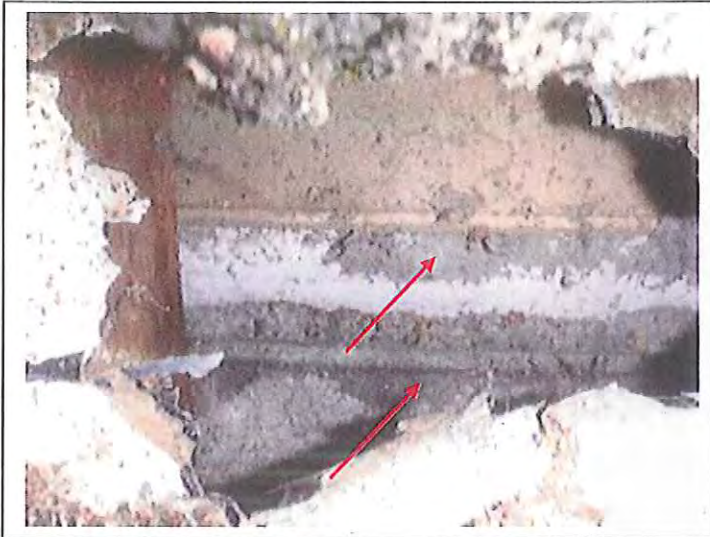
**Photograph 3:**  
**Amosite insulation at front South**  
**West of attic space**  
**Sample: 7696 – A2**

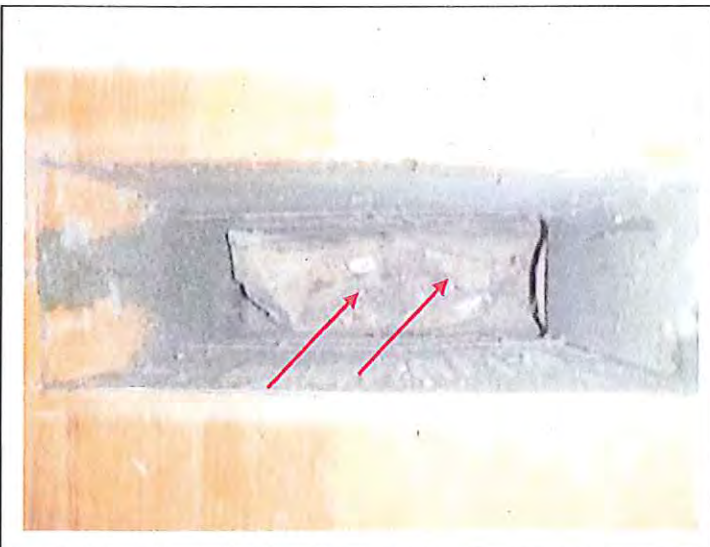
**Photograph 4:**  
**Amosite insulation at end of**  
**corridor by small bedroom in floor**  
**vent duct Sample: 7696 – A6**

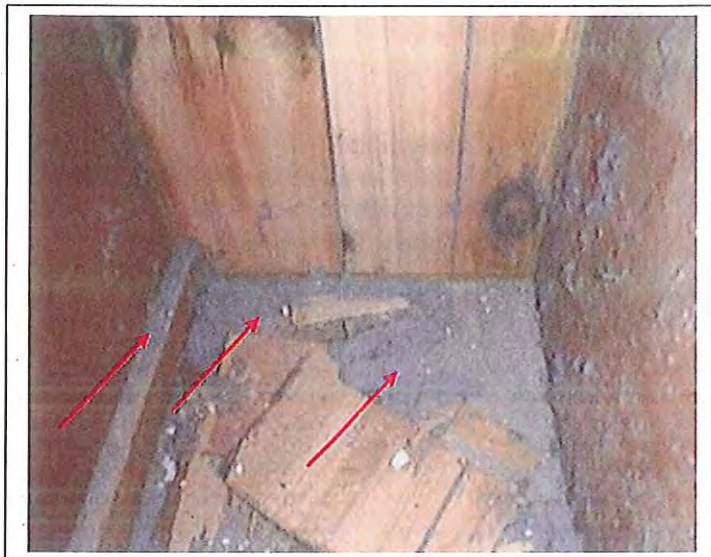
**Photograph 5:**  
**Amosite insulation in old vent duct**  
**near laundry room**  
**Sample: 7696 – A9**
