ENVIRONMENT ACT

OLD CANBERRA BRICKWORKS
YARRALUMLA

*Condition report to formalise
handover from Environment ACT to
Infrastructure and Asset Management*

4 February 2000

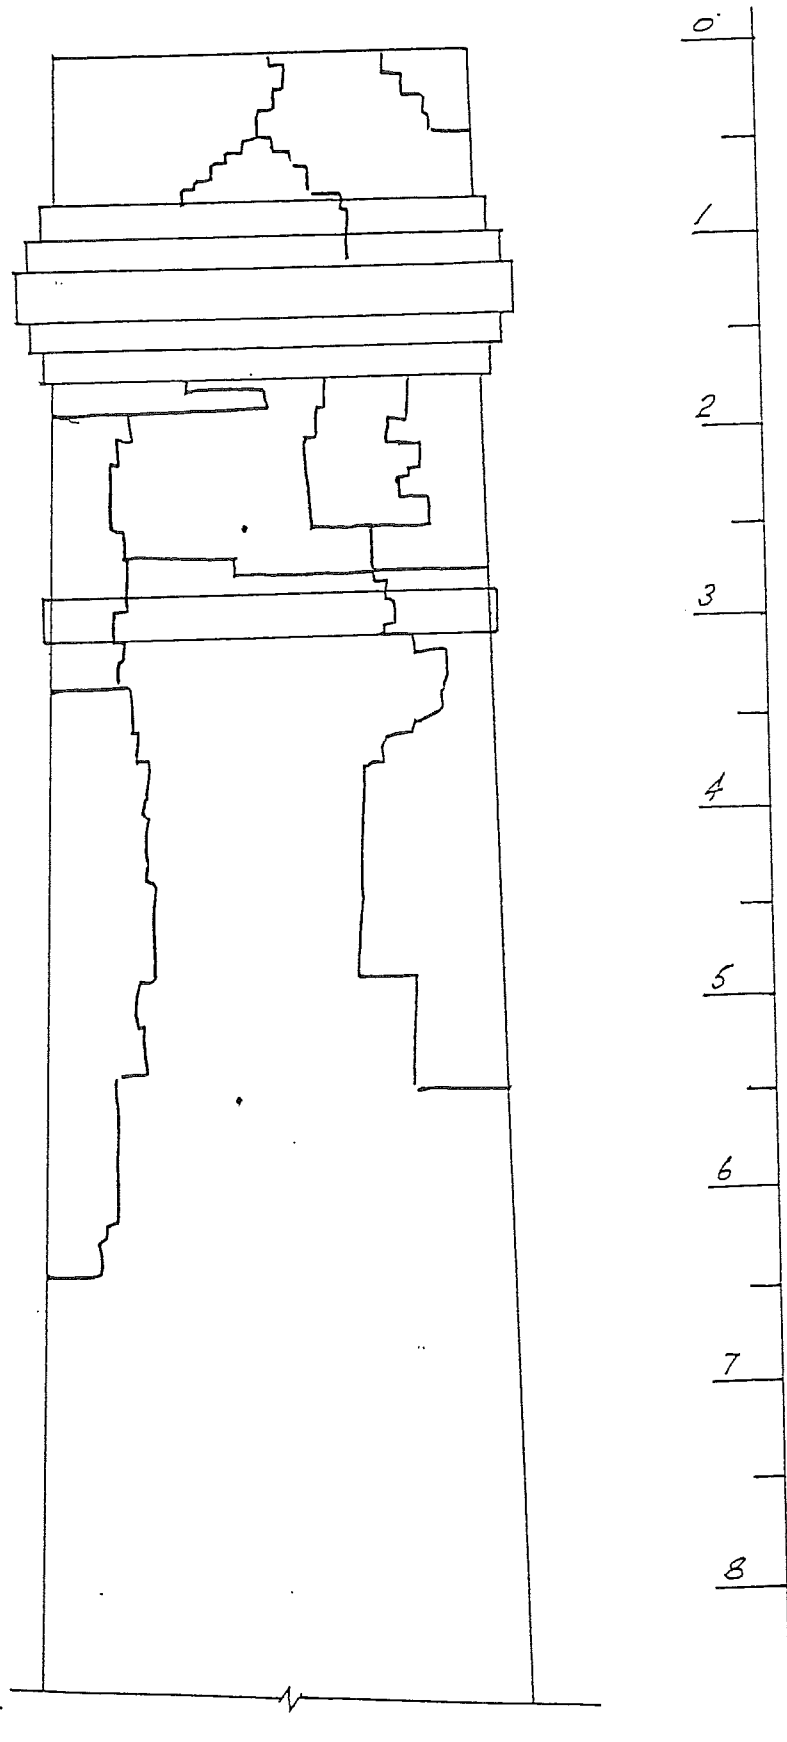
FIGURE 2

YARRALUMLA BRICKWORKS
CHIMNEY S3
INSPECTION - MAY 1998
NORTH FACE CRACKING

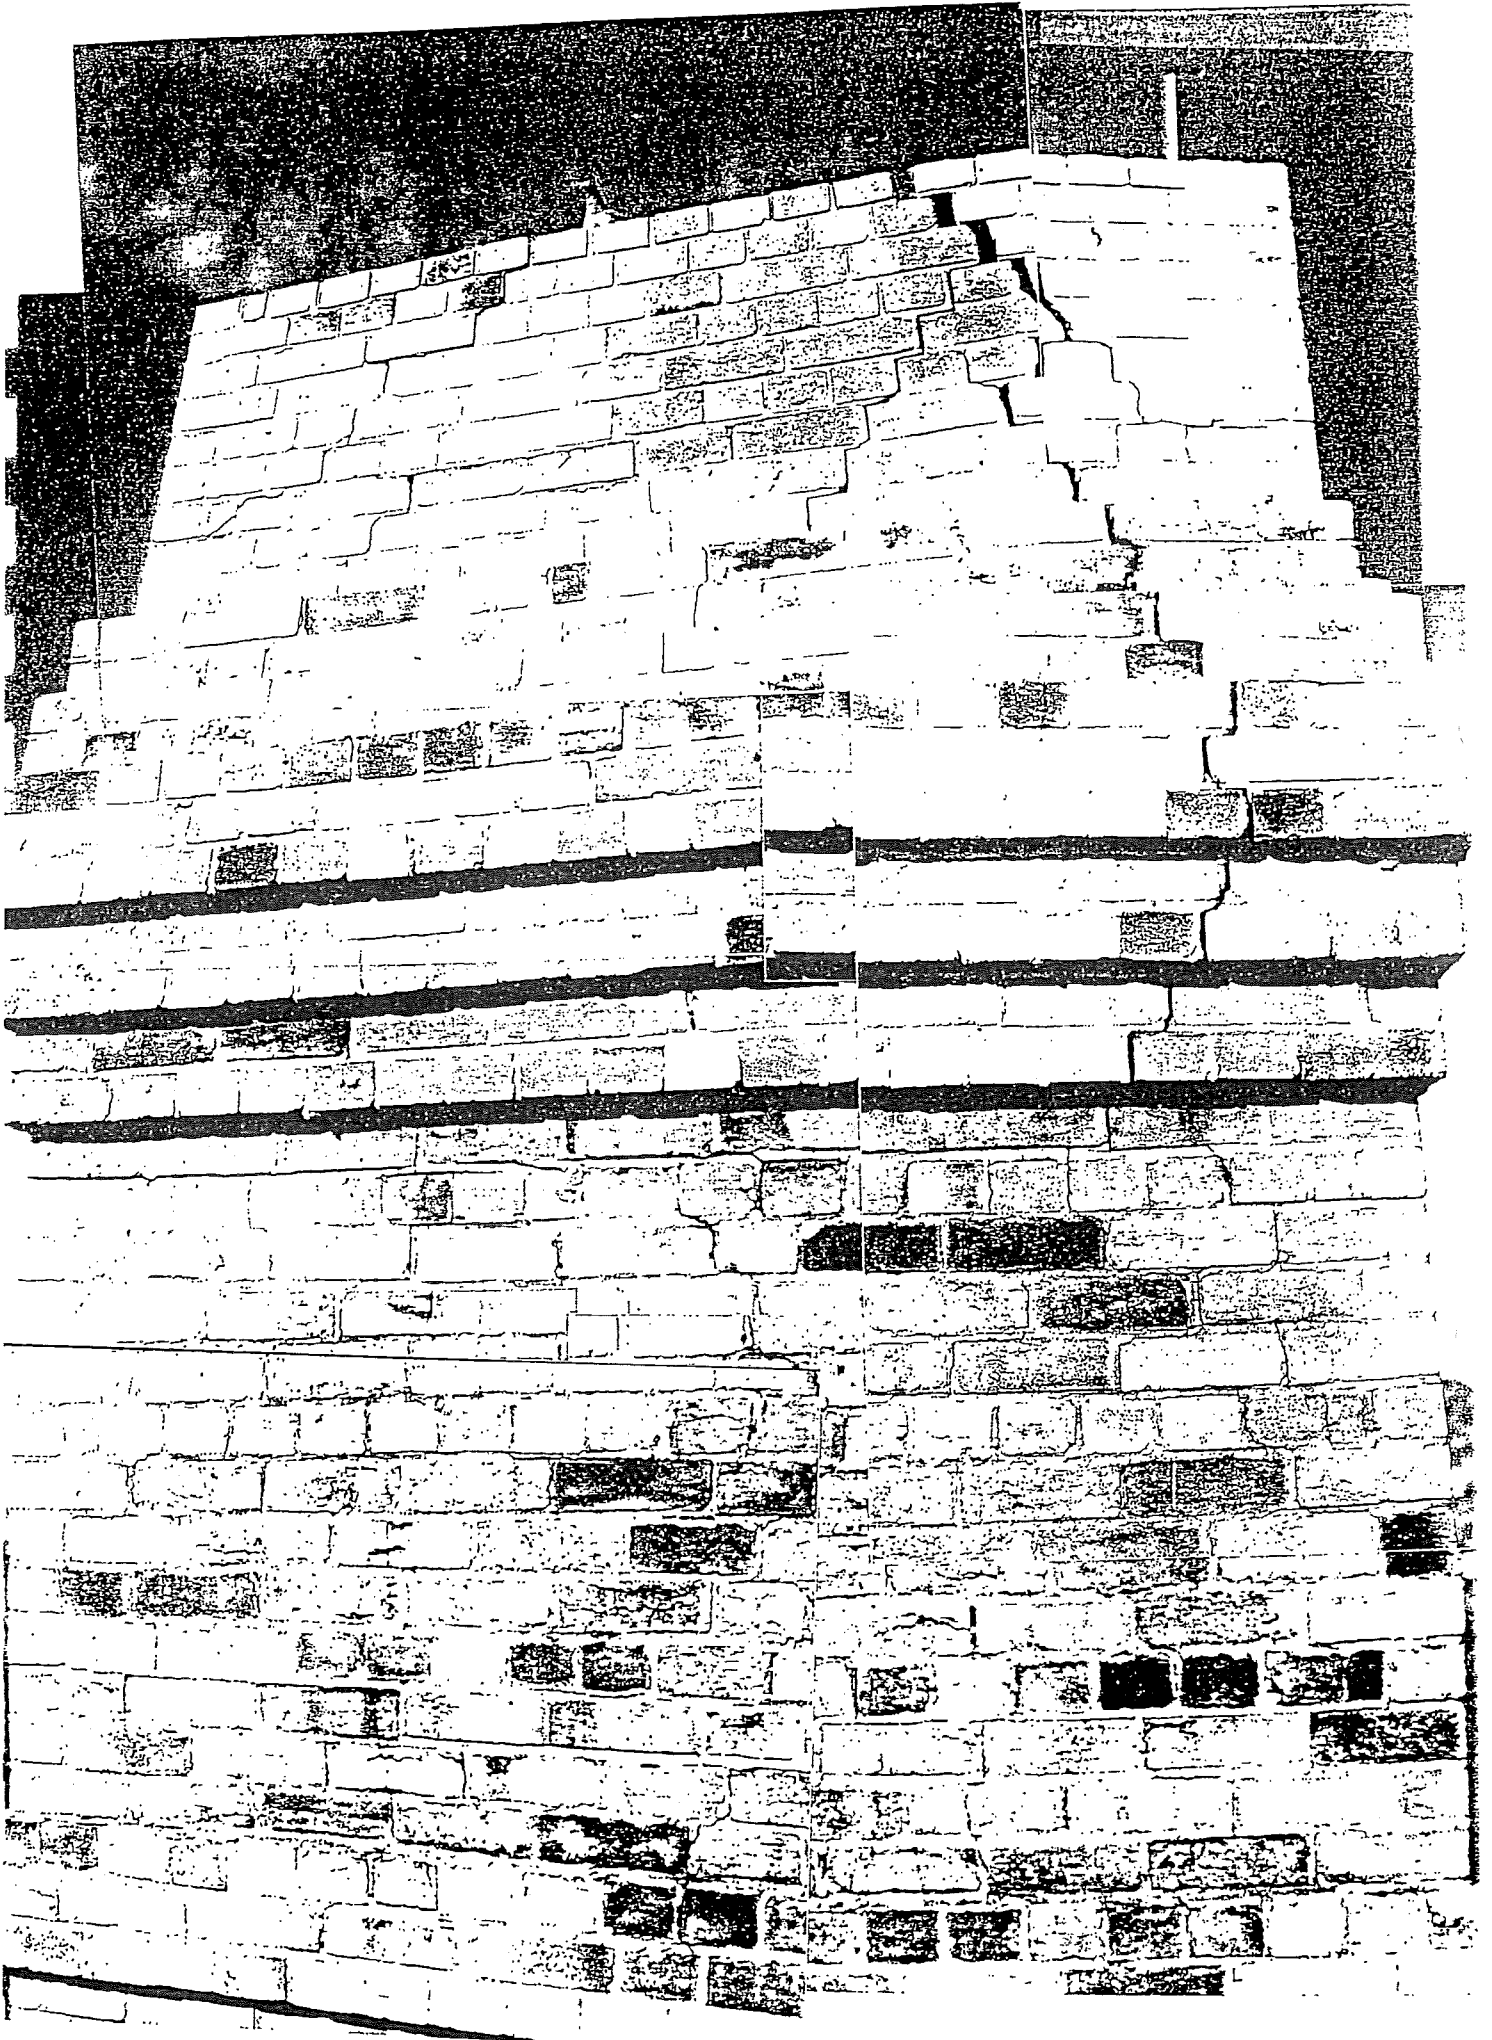
Photograph 3 . Detail of top west face.
New lightning air terminal is on right with original on left.
