Environmental Investigation – Audit Report

**Yarralumla Brickworks
Sandford Street Complex
Block 1 Section 102 Yarralumla
Canberra Central ACT**

**Yarralumla Brickworks
Denman St.
Yarralumla
ACT 2600**

Title: Hazardous Materials Survey
Yarralumla Brickworks
Denman St.
Yarralumla, ACT 2600

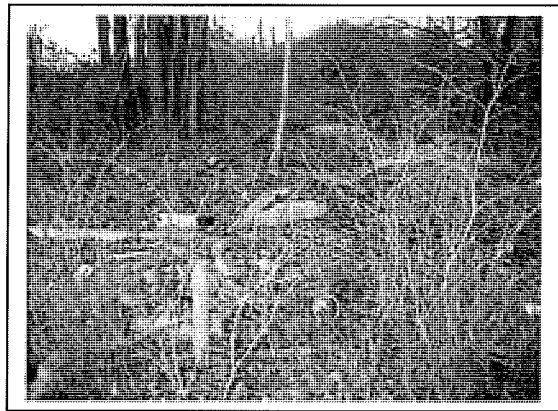
Photograph 1: West view of crusher area.

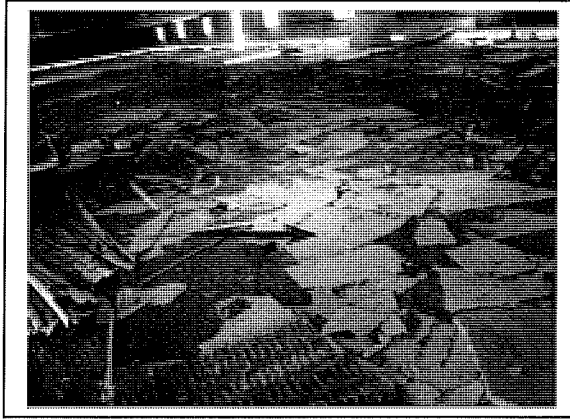
The first floor to building K2 contains large amounts of damaged ACM millboard sheeting. ACM sheet debris is located to the ground throughout the entire site. The small building adjacent the car park entrance (building A4) contains damaged ACM wall and ceiling sheet and damaged ACM corrugated roof sheet. Smaller ACM are noted below.

Photograph 1:
Kiln 2 top floor
Millboard
Refer Sample: 2810 – 40 – A1

- It is highly recommended that the ACM millboard sheet and debris to the 1st floor of building K2 be removed and the area cleaned by an ACT licensed Asbestos Removalist.

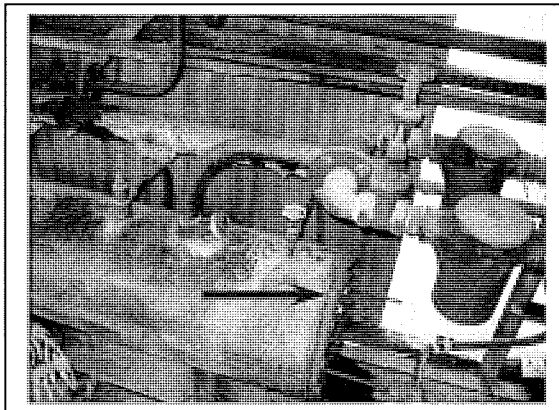
Photograph 3:
Heat exchange gasket Kiln 2 top floor
Gasket
Refer Sample: 2810 – 40 – A3

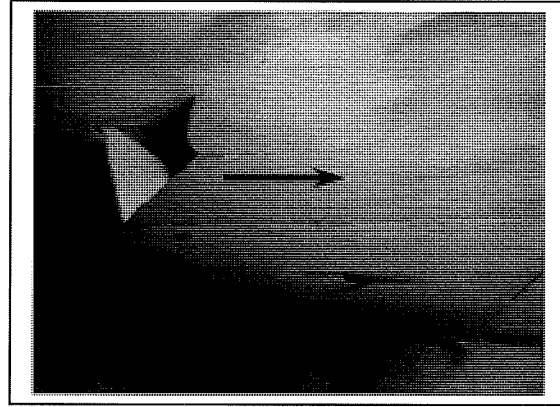
Photograph 6:
Building SS3 ceiling
Sheet
Refer Sample: 2810 – 40 – A7

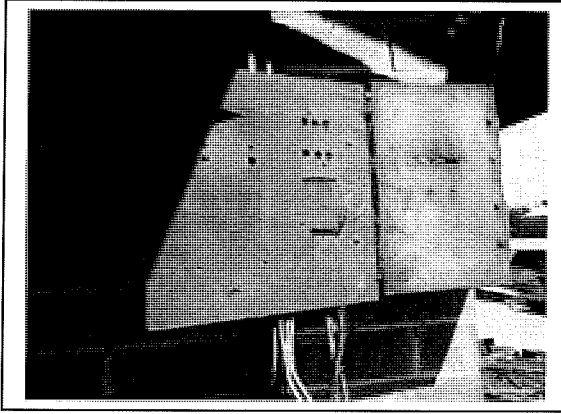
Photograph 9:
Switch board backing sheet**
(in various locations)
Refer Sample: 2810 – 40 – A10

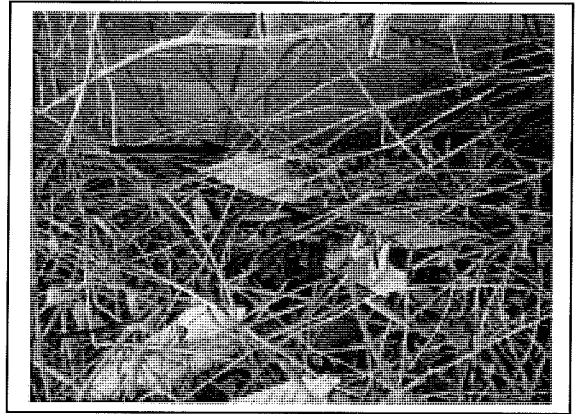
Photograph 10:
Corrugated roof sheet and debris**
(building A3 & Tip area western side)
Refer Sample: 2810 – 40 – A11

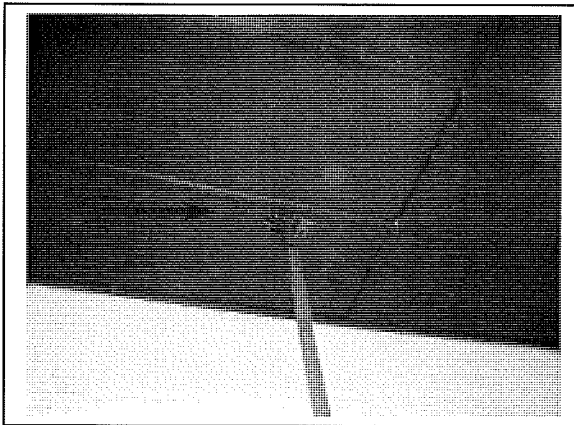
Photograph 11:
Ceiling sheet**
(building A4 & BH)
Refer Sample: 2810 – 40 – A12

- The ACM corrugated roof sheet and damaged wall, ceiling, eave and debris sheet to building A4 should be removed and the area cleaned by an ACT licensed Asbestos Removalist.

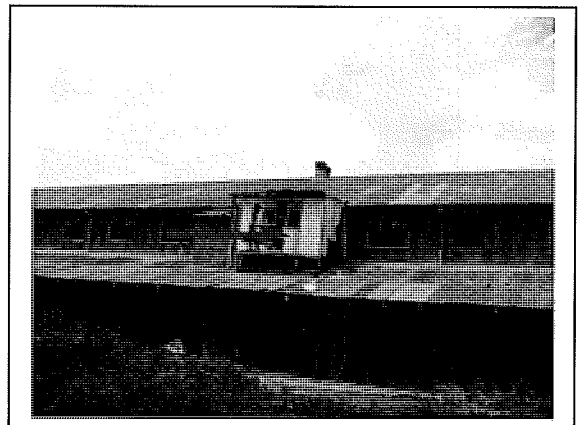
Photograph 12:
External wall sheeting**
(atop kiln 3)
Refer Sample: 2810 – 40 – A13

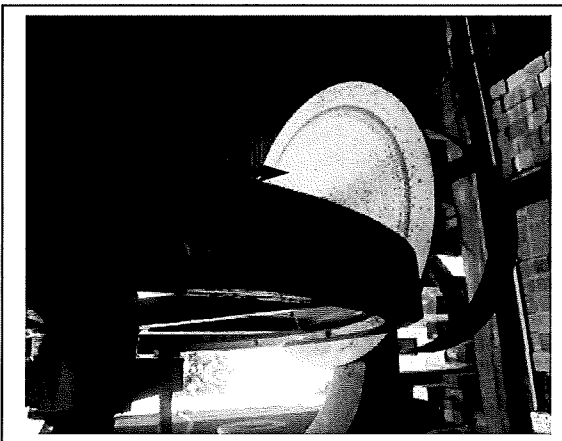
Photograph 14:
Large brake pad to top of old
brick making machine
Refer Sample: 3617 - 103 - A1

- The ACM brake pad to the old brick making machine to building 1 should be encapsulated by an ACT licensed Asbestos Removalist.
- Damaged ACM wall sheet and other various damaged ACM sheeting throughout the site should be removed by an ACT licensed Asbestos Removalist.

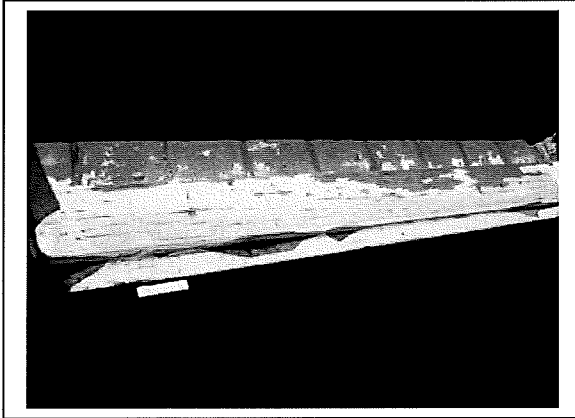
Photograph 20:
Window caulking to BH building
Refer Sample: 3617 – 103 – A3
No asbestos detected

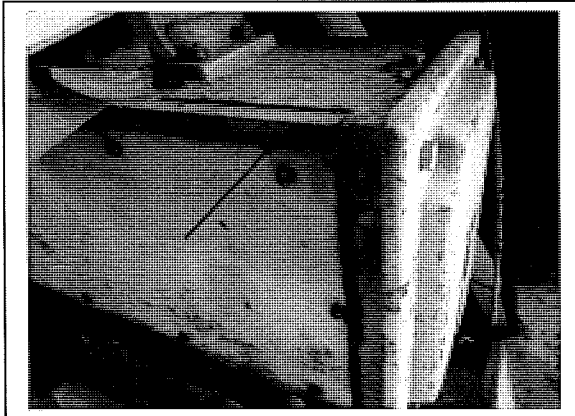
Photograph 21:
Mastic to original distribution board to
K3 building
Refer Sample: 3617 – 103 – A6
No asbestos detected

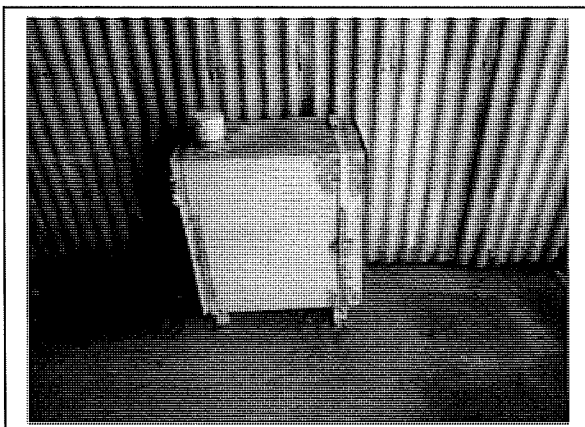
Photograph 22:
 Portable AST to building K3
 Yellow paint
Refer Sample: 3617 – 103 – P1

- The lead paint is in a fairly poor condition and should be repainted. It should be assumed that all similar paint applications throughout the building would contain similar percentages of lead. Refer to Section 15.3 Appendix C for further general information on lead paint.

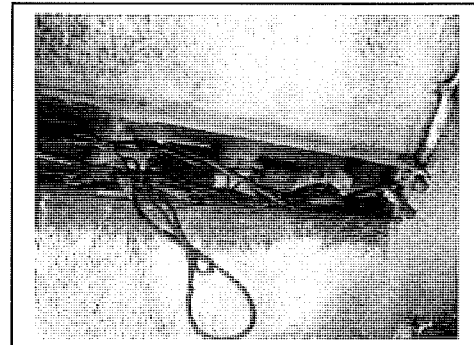
Photograph 30:
Building SS2
Metal – Unidentifiable due to fire damage

| Result | Make - Type | Location | Required action |
|---|--|---|--|
| Presumed PCB | Unknown – Fire damaged | Building SS2 | Remove as soon as practicable |

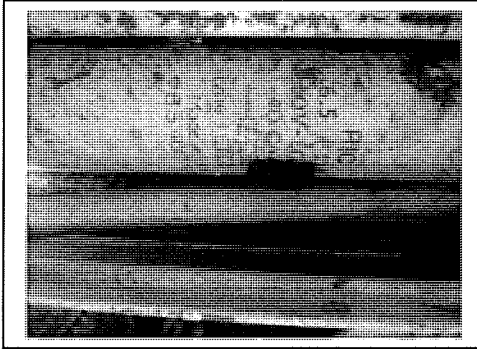
Photograph 31:
Former canteen
RIC – LE 1 EB

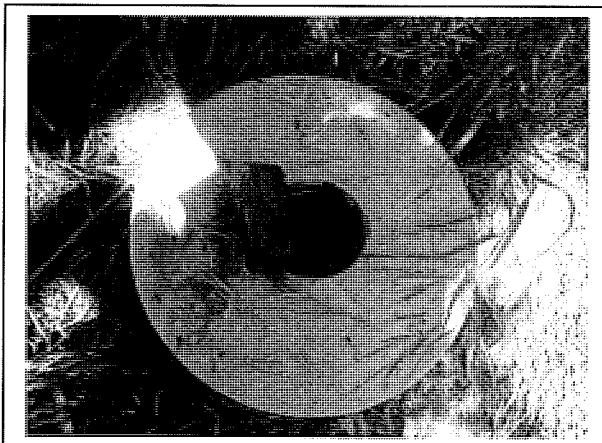
Evidence of an underground storage tank (UST) was identified during the survey suggesting an underground storage tank is present. A dip point was found, refer to plans for location.

Photograph 32:
Dip point to probable UST

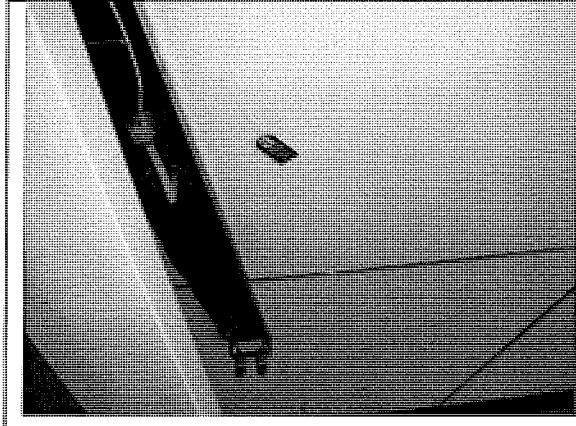
Photograph 13:
SS4 - Ceiling sheet
Refer Sample: RA M0102

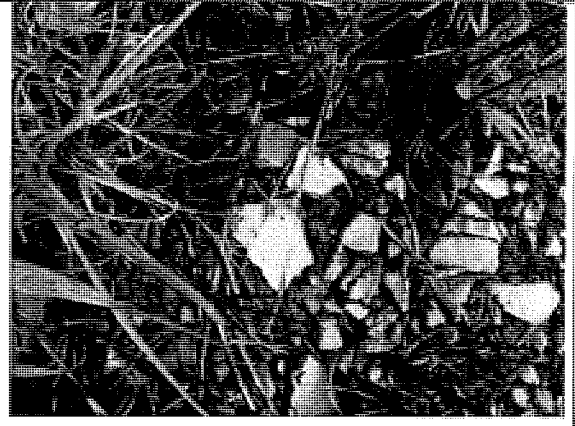
Photograph 14:
Adjacent bridge to K2 - Debris to ground
Refer Sample: M0099 (b)

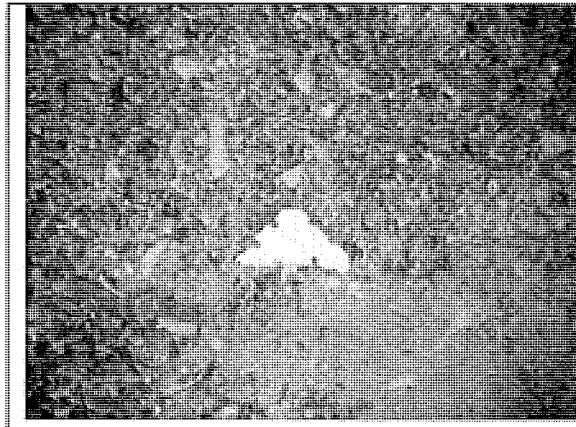
Photograph 15:
K2 - Top floor, debris to top floor
(small amount left post removal)
Refer Sample: M0100

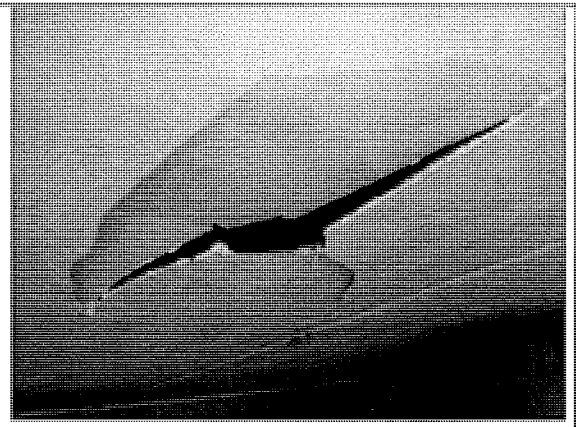
Photograph 16:
SS1 - Ceiling sheet
Refer Sample: M0101

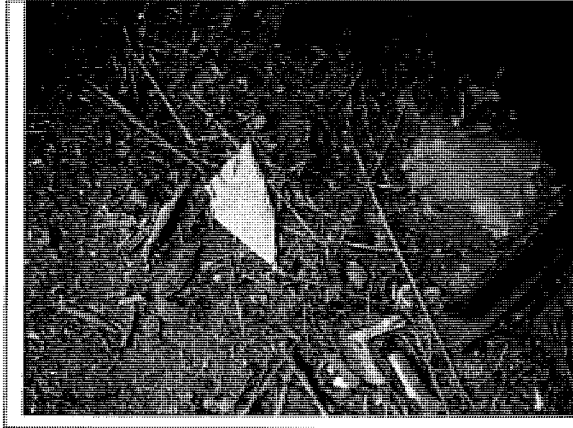
Photograph 17:
Between tall chimney & K3 –
Debris to ground & scattered throughout site
Sheet
Refer Sample: M0102

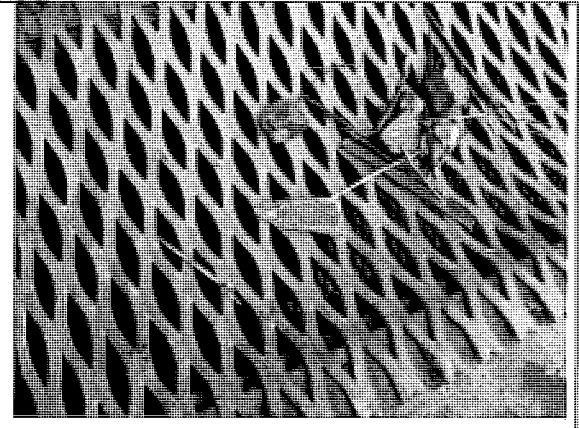
Photograph 18:
Front of B - Moulded sheet debris
to ground & throughout site
Refer Sample: M0103

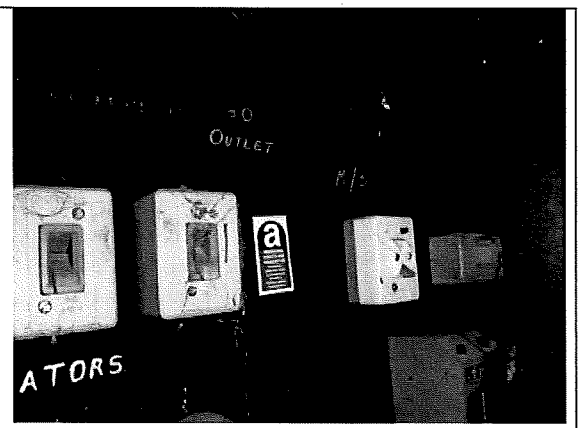
Photograph 20:
All switchboard backing sheets throughout
site
Refer Sample: 7504 – 23 - VA12

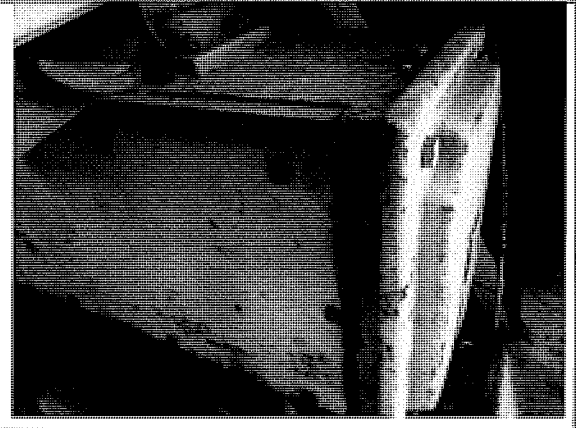
Photograph 22:
M3 - Mastic to original distribution board
Refer Samples: 3617 – 103 – A6

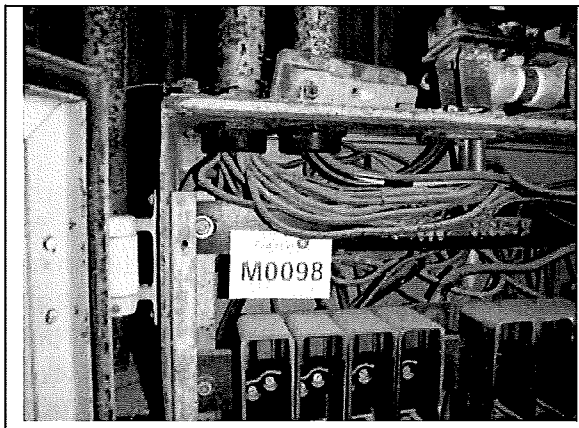
Photograph 23:
M3 - Switch board backing sheet strip
(above switchboard backing sheet)
Refer Sample: M0098

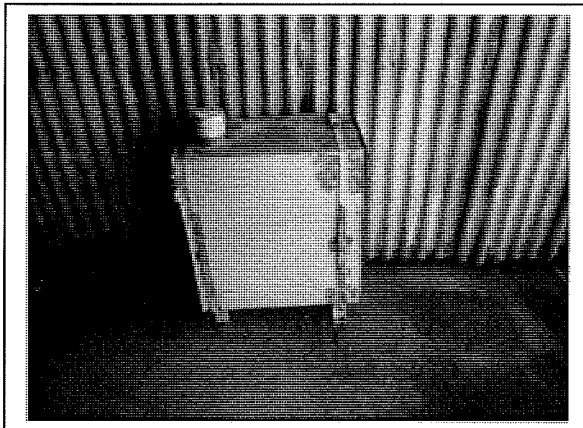
Photograph 24:
 Portable AST to building M3
 Yellow paint
 Refer Sample: 3617 – 103 – P1

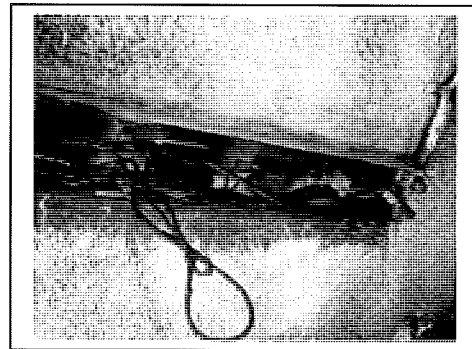
Photograph 31:
Building SS2
Metal – Unidentifiable due to fire damage

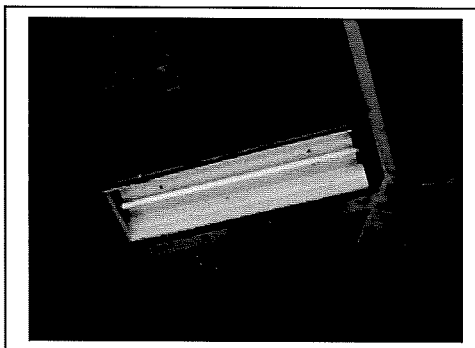
Photograph 32:
Building H
Inaccessible

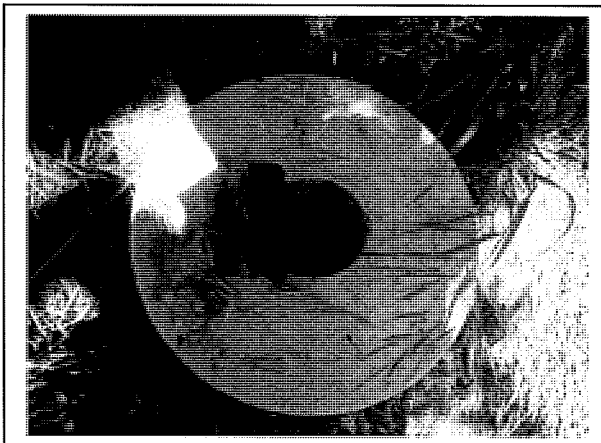
Photograph 34:
Dip point to probable UST

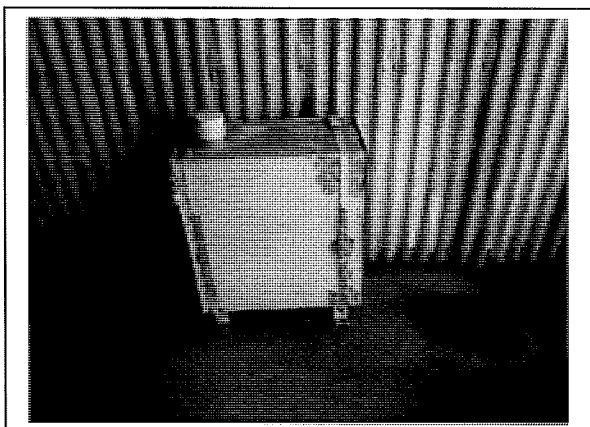
An AST was located and should be disposed of as hazardous waste.

Photograph 35:
Portable AST to building M3

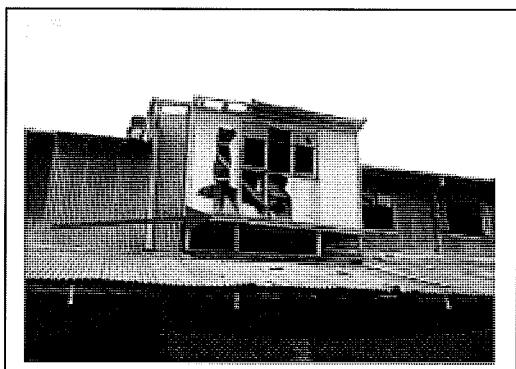
Photograph 3. Broken external wall sheets atop Kiln 3.

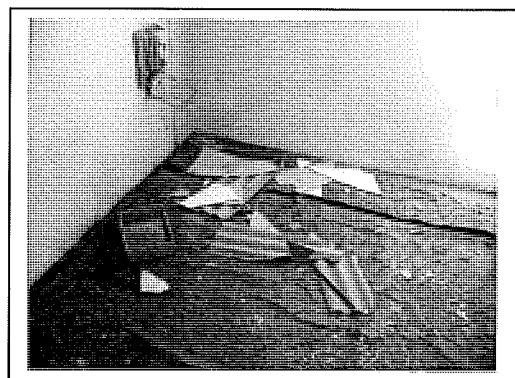
Photograph 4. Damaged sheeting in Building A3.

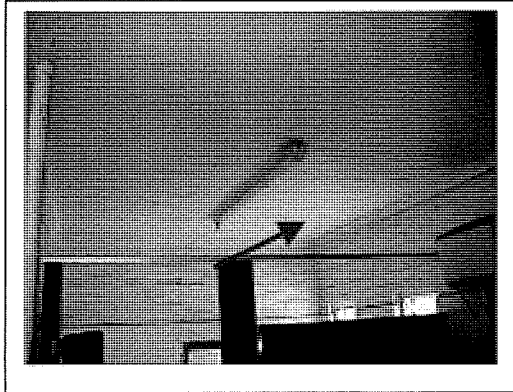
Photograph 5. Former canteen toilet ceiling sheet.

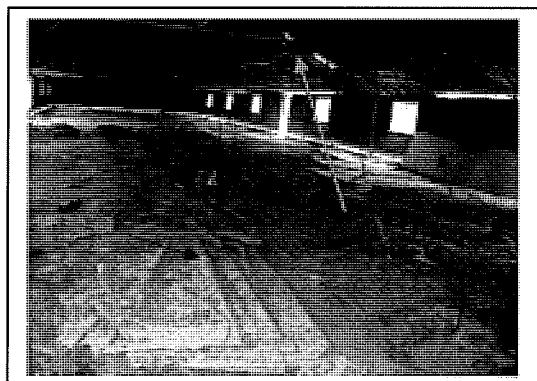
Photograph 1. Millboard, Insulation and debris top floor Kiln 2.

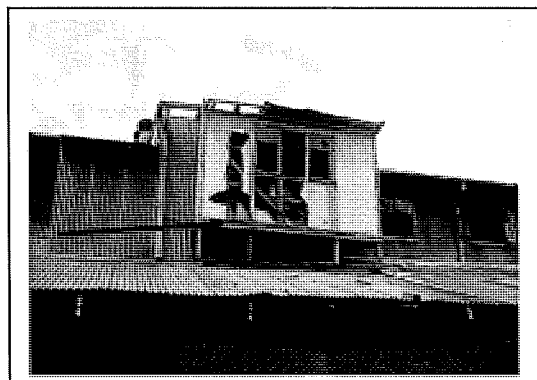
Photograph 3. Broken external wall sheets atop Kiln 3.

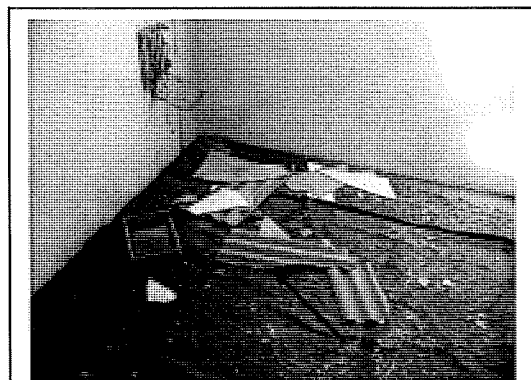
Photograph 4. Damaged sheeting in Building A3.

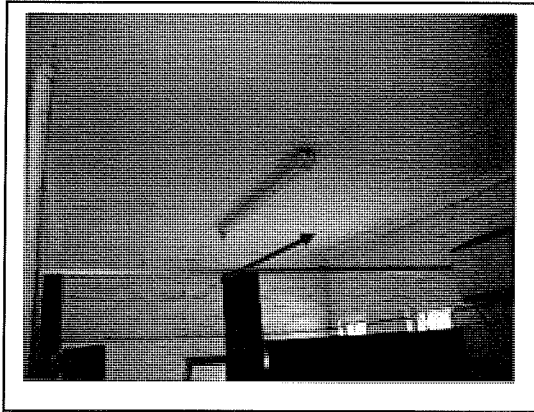
Photograph 5. Former canteen toilet ceiling sheet.

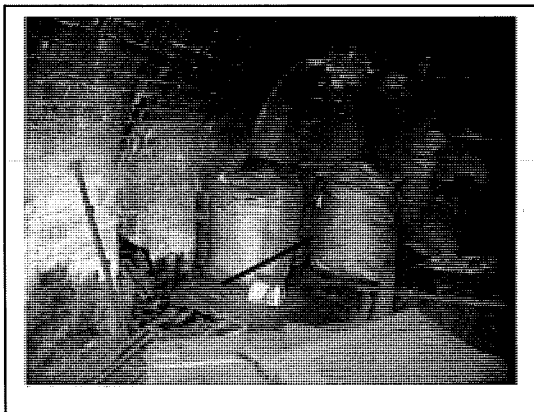
The loose fibreglass insulation in a number of compartments in Kiln 1 and outside Kiln 2 are in fair condition. Given the uncertainty of the origin of the SMF Robson Laboratories Pty Ltd recommends it be disposed of as asbestos waste as this material may contain asbestos dust and debris from the original removal of the corrugated roof sheets. Refer to Appendix D for information on the correct removal procedures.

Photograph 9. Bags of loose fibreglass insulation stored in Kiln 1.

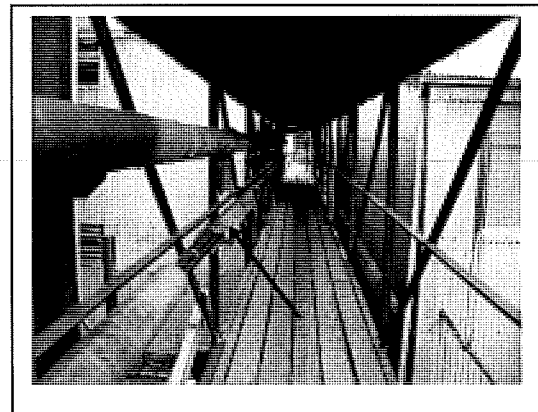
Photograph 10. Fibreglass insulation on water pipes.

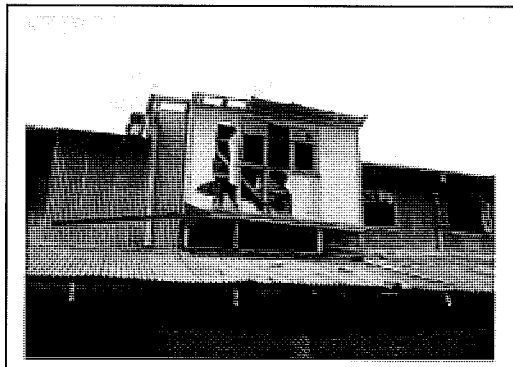
Photograph 3. Broken external wall sheets atop Kiln 3.

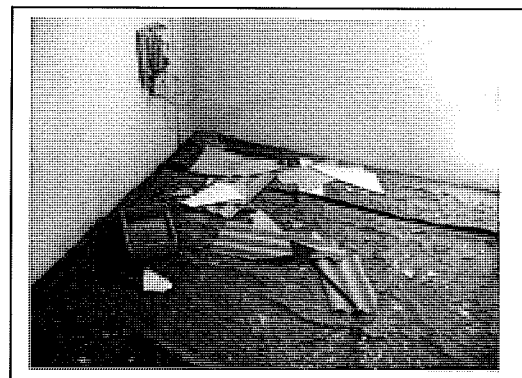
Photograph 4. Damaged sheeting in Building A3.

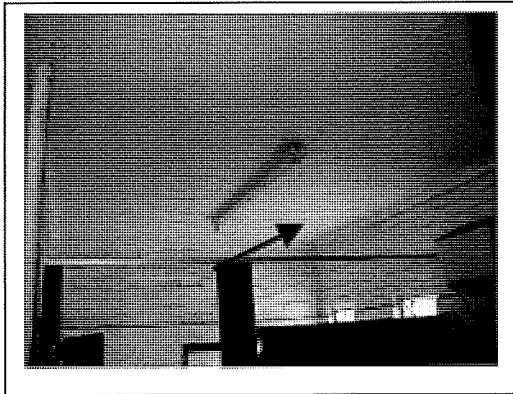
Photograph 5. Former canteen toilet ceiling sheet.

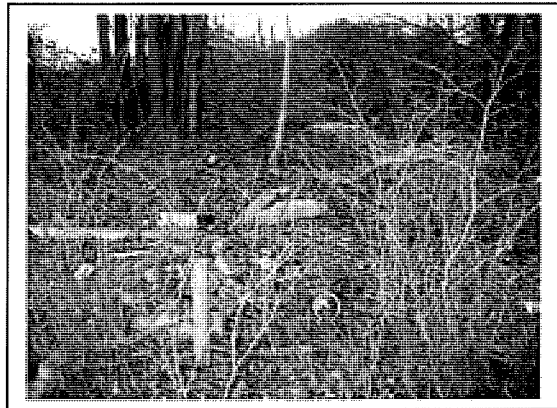
Photograph 3: Evidence of asbestos sheeting in the dump on the west side of the property.
