FOI Reference: CMTEDDFOI 2021-316

Connell Mott MacDonald was engaged by ACT Work Cover to investigate the cause of collapse of a partially constructed aircraft hangar building structure for the Special Purpose Aircraft Facility (SPAF) located at RAAF Fairburn, Canberra. The SPAF was being constructed by Construction Control with the design, erection methodology and construction of the hangar superstructure subcontracted to Strarch International (Strarch International 2003a p9).

This final report describes the analytical work undertaken by Connell Mott MacDonald and the component testing conducted by the University of Western Sydney in an effort to ascertain the cause of the structure collapse. The report is arranged in several parts as follows:

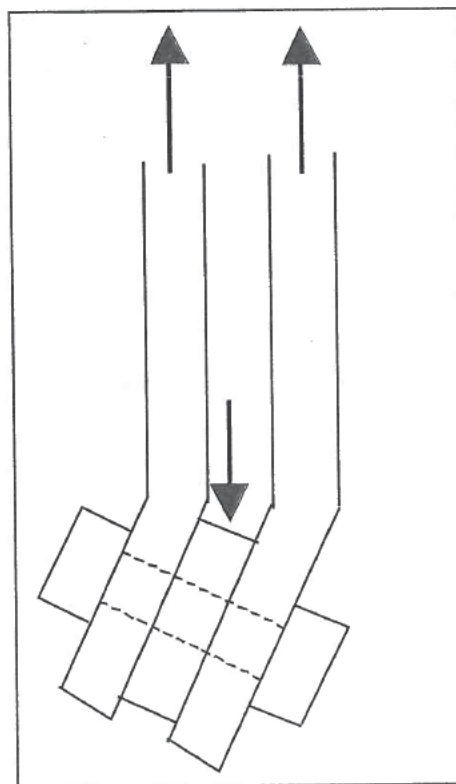
Figure 17: Diagram of forces applied to distorted gap lock (plan view).

The mechanism of failure after lateral distortion of the end plates is depicted in Figure 17. The lateral distortion of end plates leads to a prying effect on the bolted joint and induces a complex loading state in the bolt, beyond the design shear loads. The interaction of combined shear and tension leads to a reduction in the theoretical shear capacity of the bolts. This is supported by the test results, which show gap lock failure loads less than the theoretical failure capacities of the bolts.

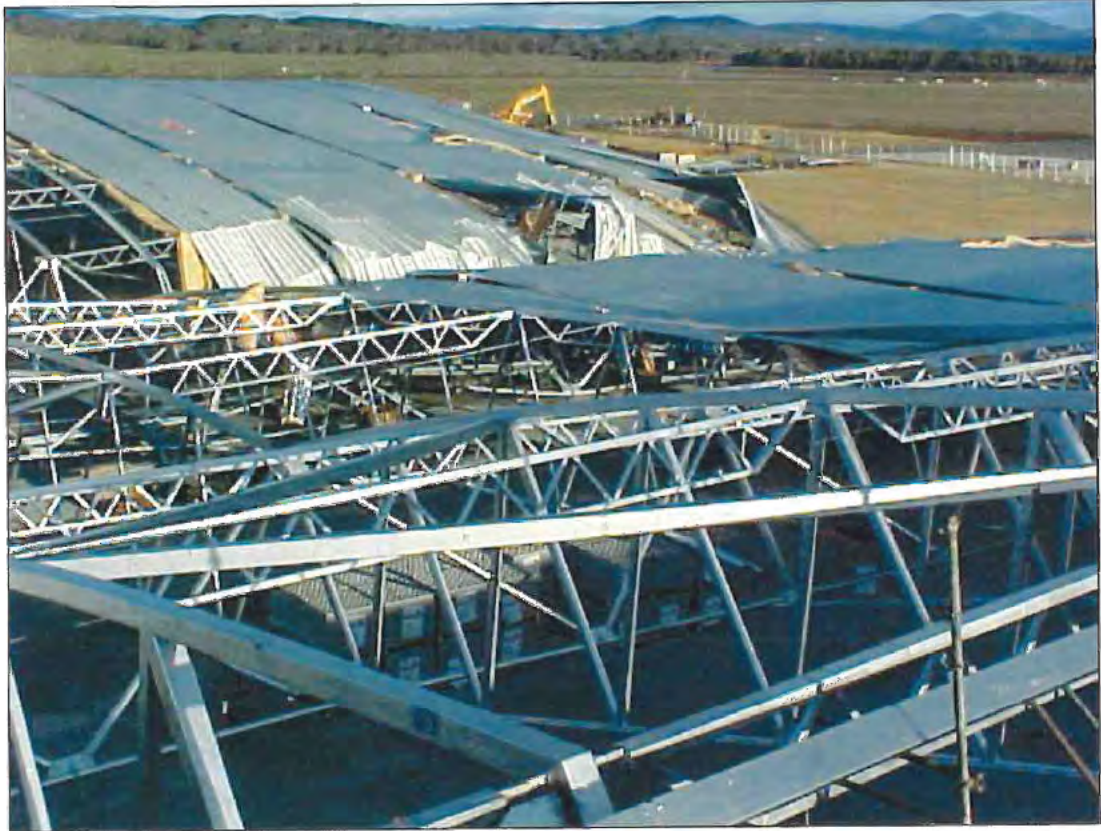
The failed state/position of the structure indicated an "in-plane" failure mode for the critical frames (Figure A1). For this reason and for computational simplicity it was decided to model the frame as a two-dimensional structure. Section 4 of this report includes a more thorough discussion of possible three-dimensional effects between adjacent frames. Out-of-plane movements (along the Z-axis) and rotations (about the X and Y-axes) at all nodes were restrained to simulate this two-dimensional behaviour.

Figure A1: Global View of the failed structure. Note 3.5 bays have had roof sheeting applied.

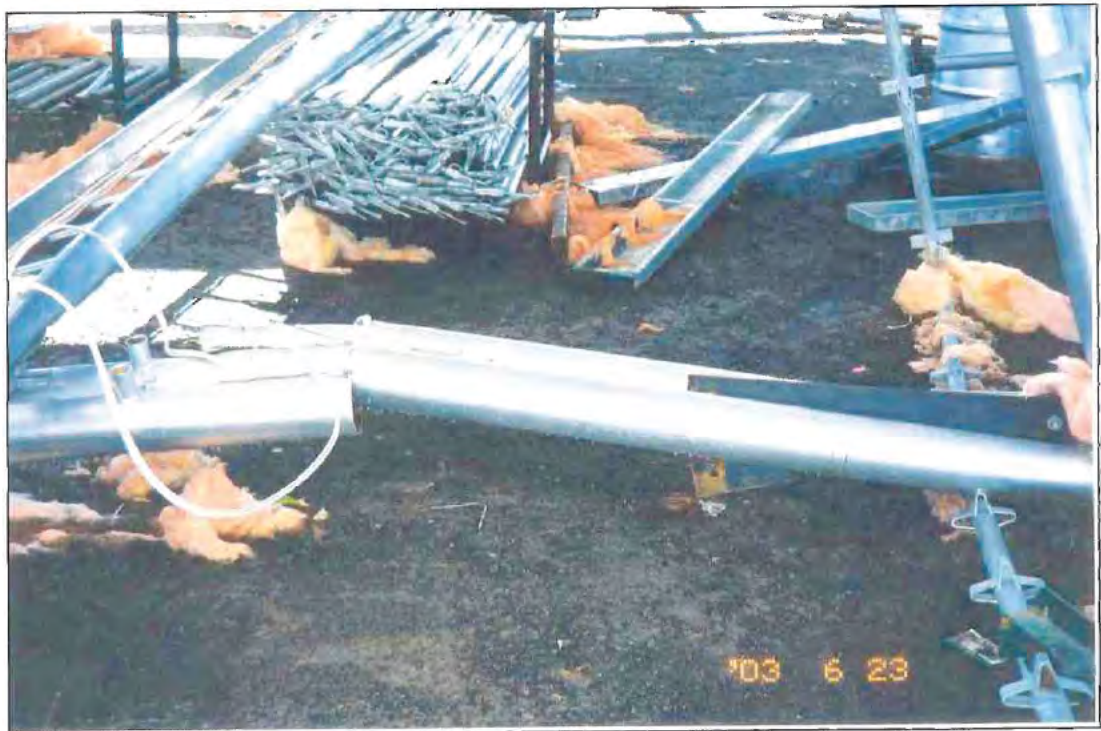
Figure A2: Failed gap lock at SF6

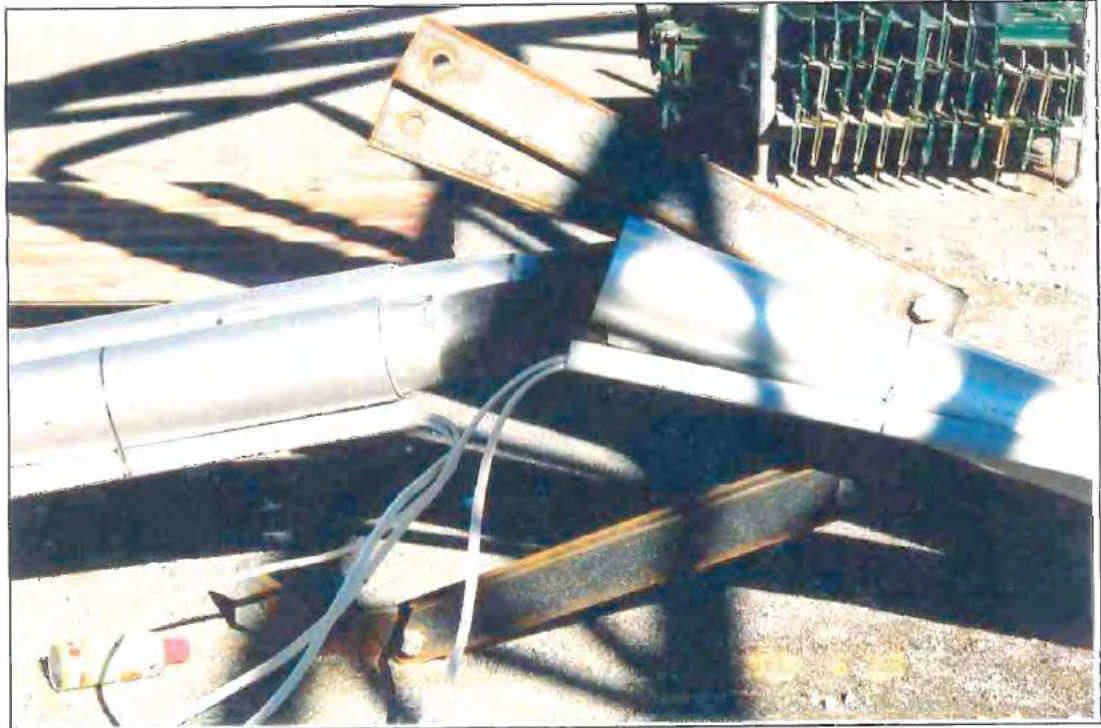
**Figure A3: Failed gap lock plate on SF4.**

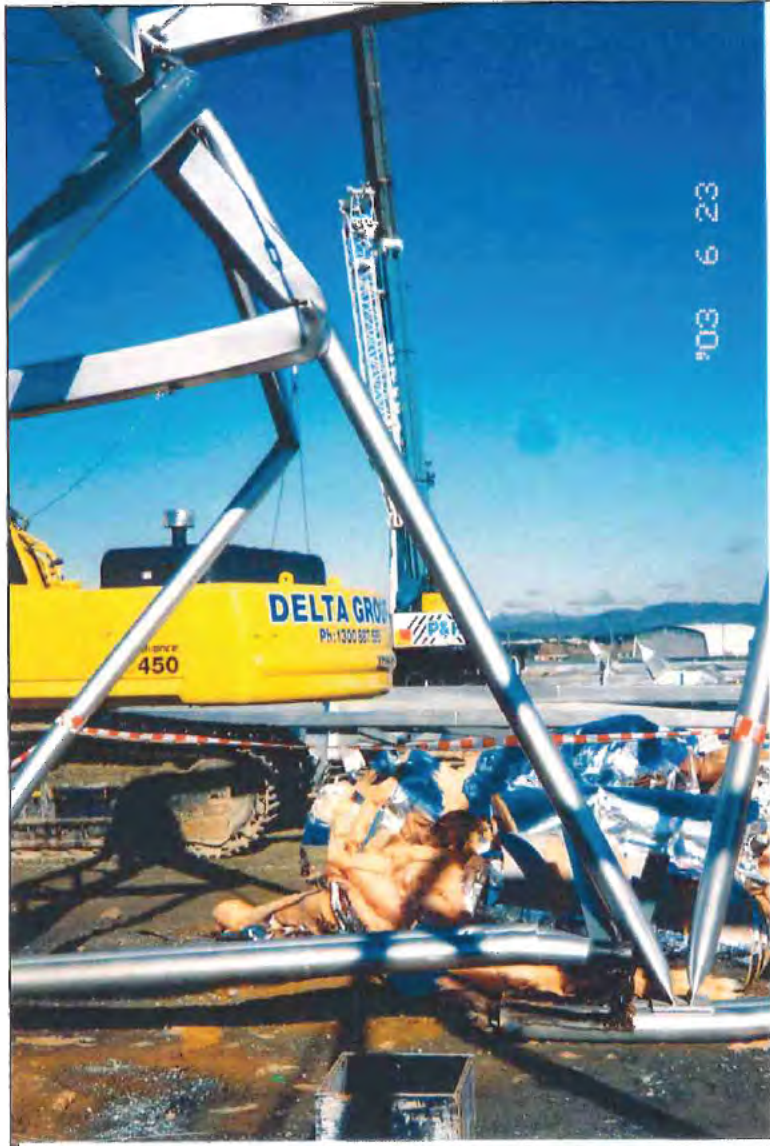
Figure A4: SF8, failed gap lock plate and buckled top chord.

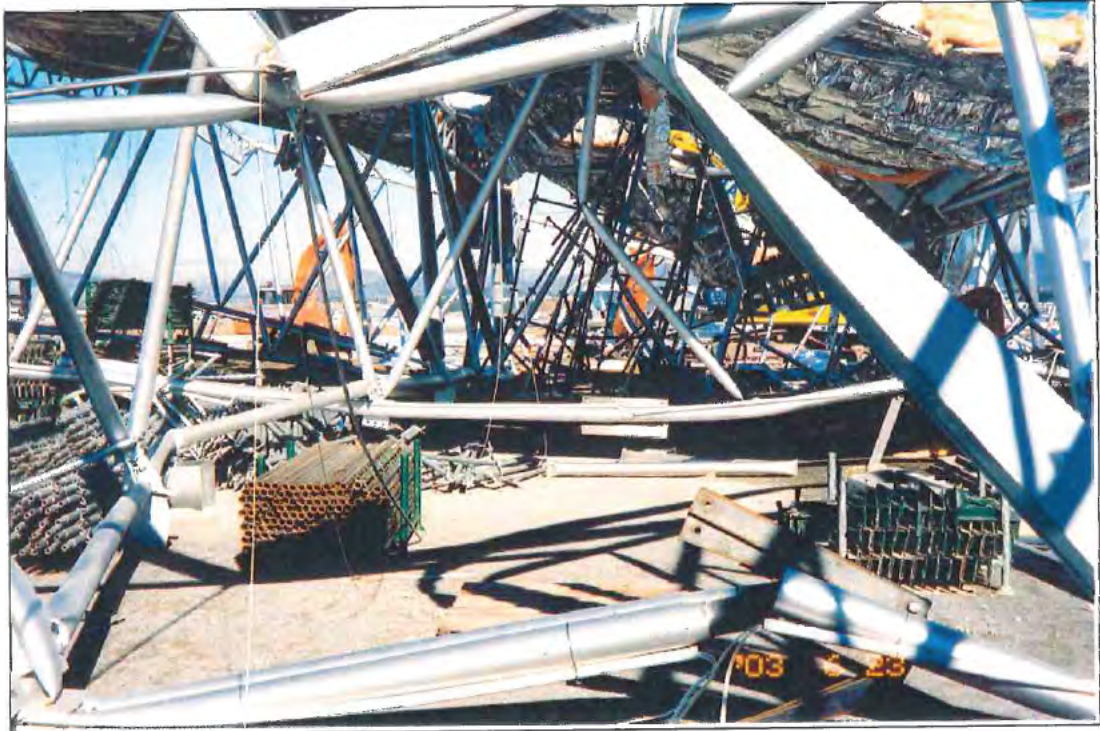
Figure A5: Failed gap lock plate on SF5.

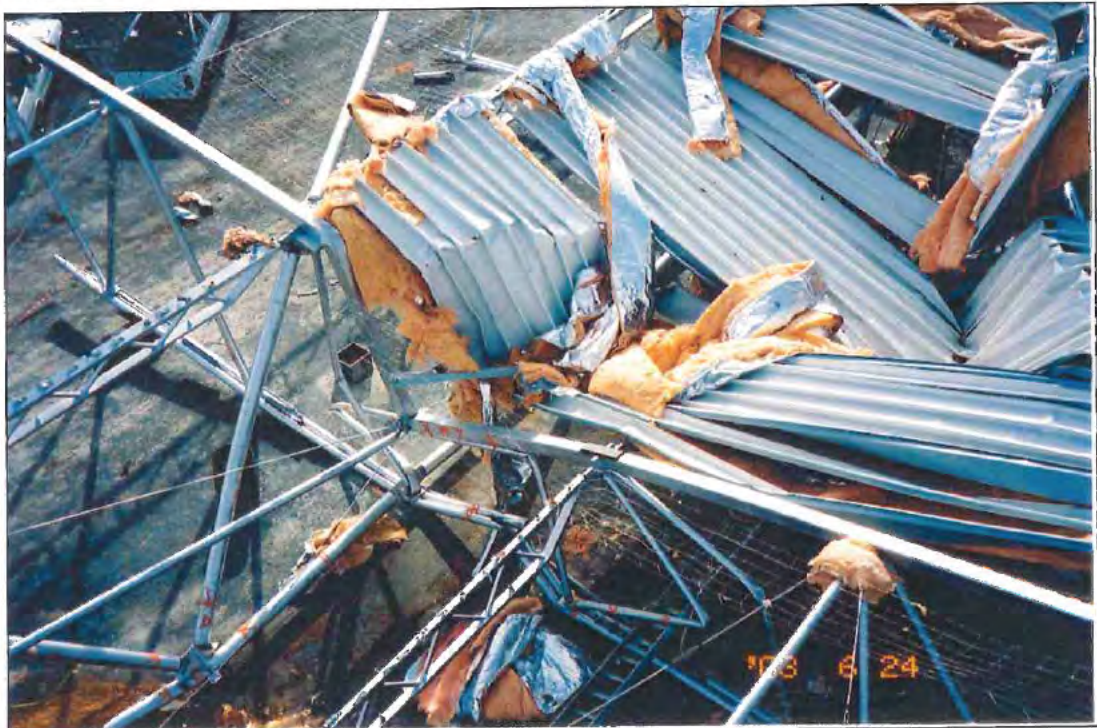
Figure A6: View from above, over central section of SF7. Note the buckled top chord.

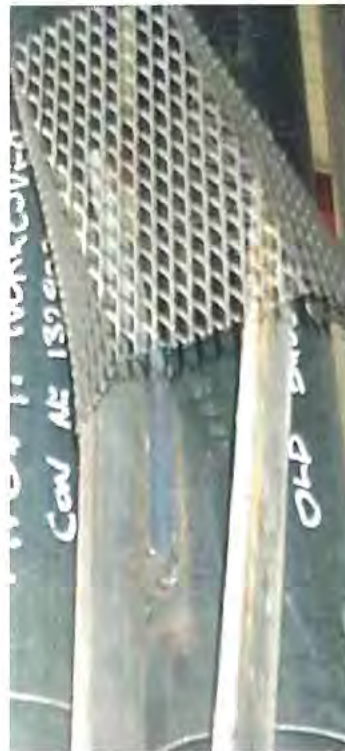
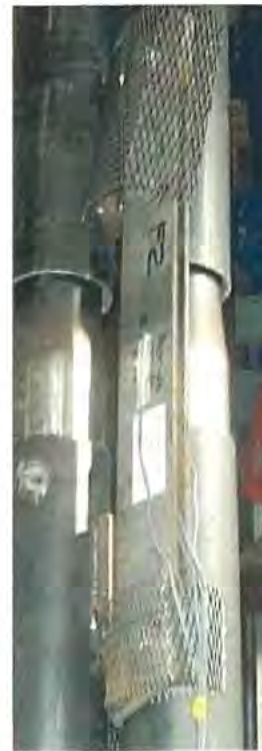
**Figure 11 – Failure Mode of Specimen 2**

The mode of failure is clearly visible in Figure 11(a) with the front strap plate separating from the end plate as a result of shear failure of the bolt. The head-side of the bolt and rear strap plate remained in place and continued to carry over 200 kN. The lateral movement of the end plate was towards the rear of the test assembly as can be seen in Figure 11(b)

*(a) Bolt Shear*

*(b) Lateral Movement*

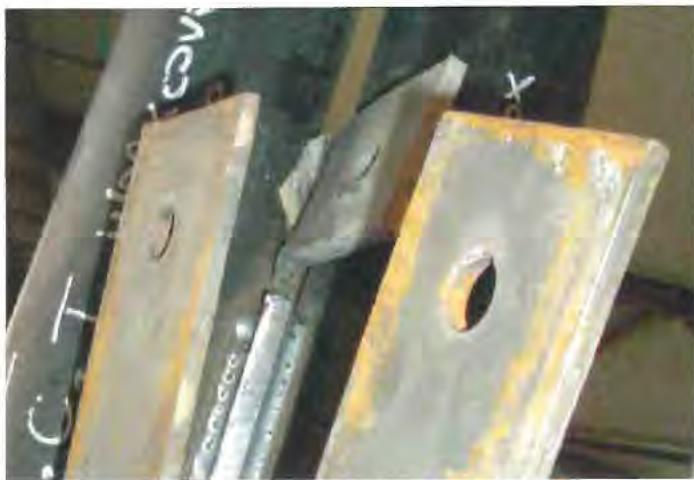
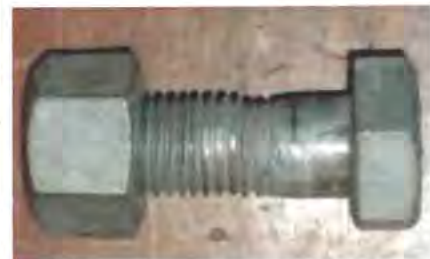
**Figure 15 – Failure Mode of Specimen 3**

The specimen after failure is shown in Figure 15(a). The lateral displacements of the end plate for this test went towards the front, in the direction of the bolt head. The bolt from the lower left side after the test is shown in Figure 15(b). The shear deformation through the threaded section of the bolt shank indicates that the bolt was close to failure.

*(a) Failed bolt Missing*

*(b) Lower bolt, left-hand side*

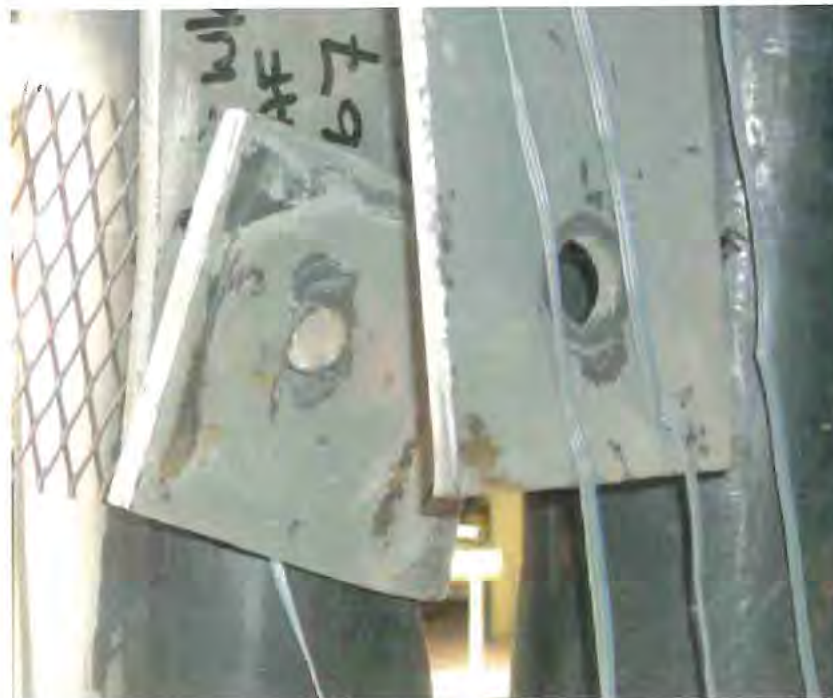
**Figure 19 – Failure Mode of Specimen 1**

Ultimate failure for specimen 1 involved shear failure of the bottom left-hand bolt through one shear plane. The shear plane that failed passed through the threaded section of the bolt. After failure of the bolt, the bolt head and a short section of the shank remained in the specimen, which continued to carry load in excess of 280 kN. The test was stopped and the specimen was unloaded shortly after the bolt failure.

The failed specimen is shown in Figure 19. In this photograph the shank of the bolt just below the head can be seen in the end plate while it still transfers load into one of the strap plates. The load being carried by the gap-lock at fitting the time this photograph was taken was 281 kN.

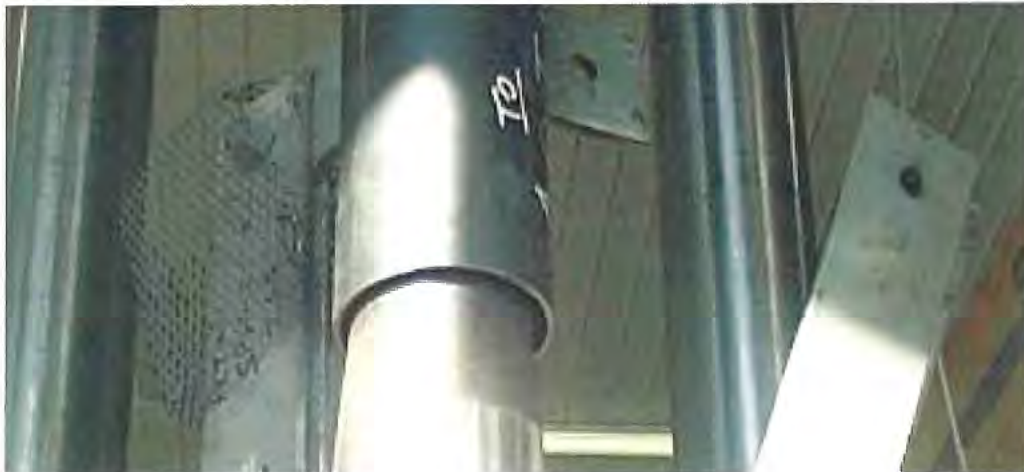
**Figure 23 – Failure Mode of Specimen 5**

Figure 23 shows the specimen just after failure. The deflection of the end plate was forward, towards the bolt heads.

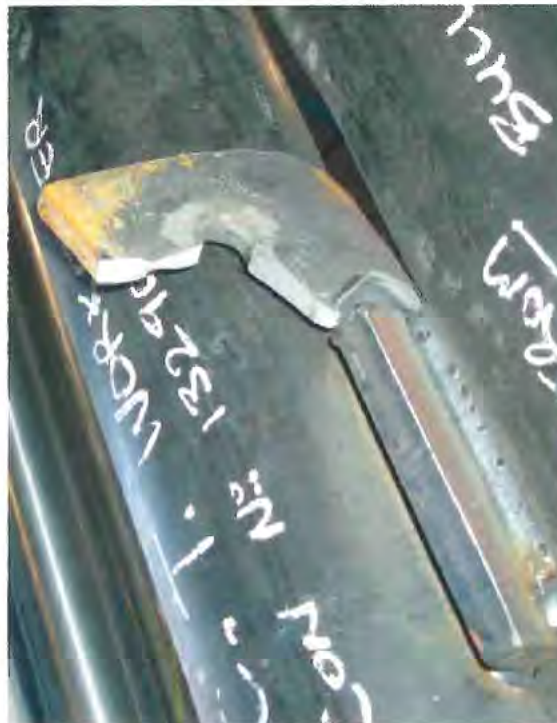
**Figure 27 – Failure Mode of Specimen 4**

For this specimen the lateral deflections of the end plate went towards the rear of the test assembly.

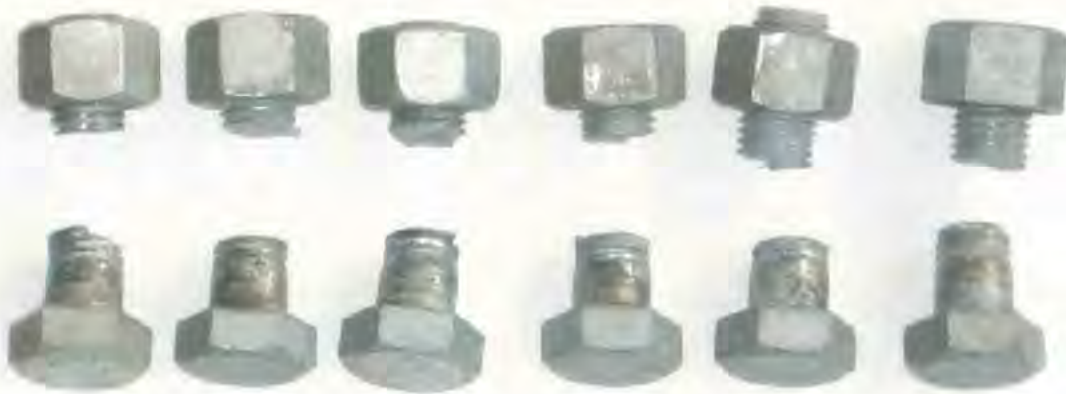
**Figure 47 – Failed bolts**

The specimens with short bolts failed at a single shear plane in the threaded section of one of the bolts. The failed bolts were located on the preferentially loaded side of the gap lock in each instance.
