## **BLACK SPOT FEASIBILITY STUDY 2009**

### **Kingsford Smith Drive / Kuringa Drive FINAL ENGINEERING REPORT**

**JOB NO: C09051**

**OCTOBER 2009**

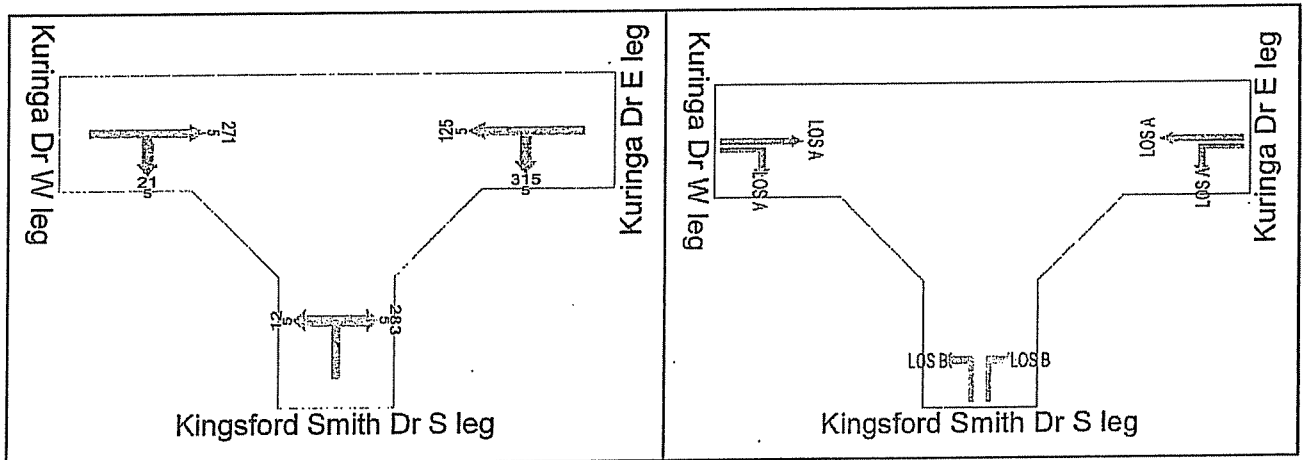
**Figure 1 AM peak period performance for Kingsford Smith Dr / Kuringa Drive**

As illustrated in Figure 1, the intersection performs well during the AM peak period.

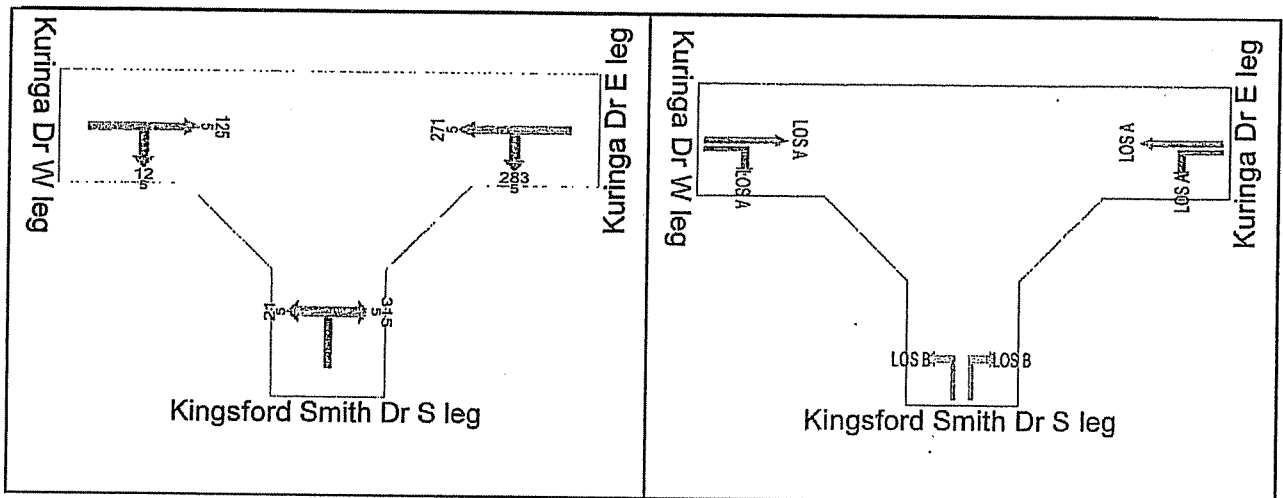
**Figure 2 PM peak period performance for Kingsford Smith Dr / Kuringa Dr**

As illustrated in Figure 2, the intersection performs well during the PM peak period.

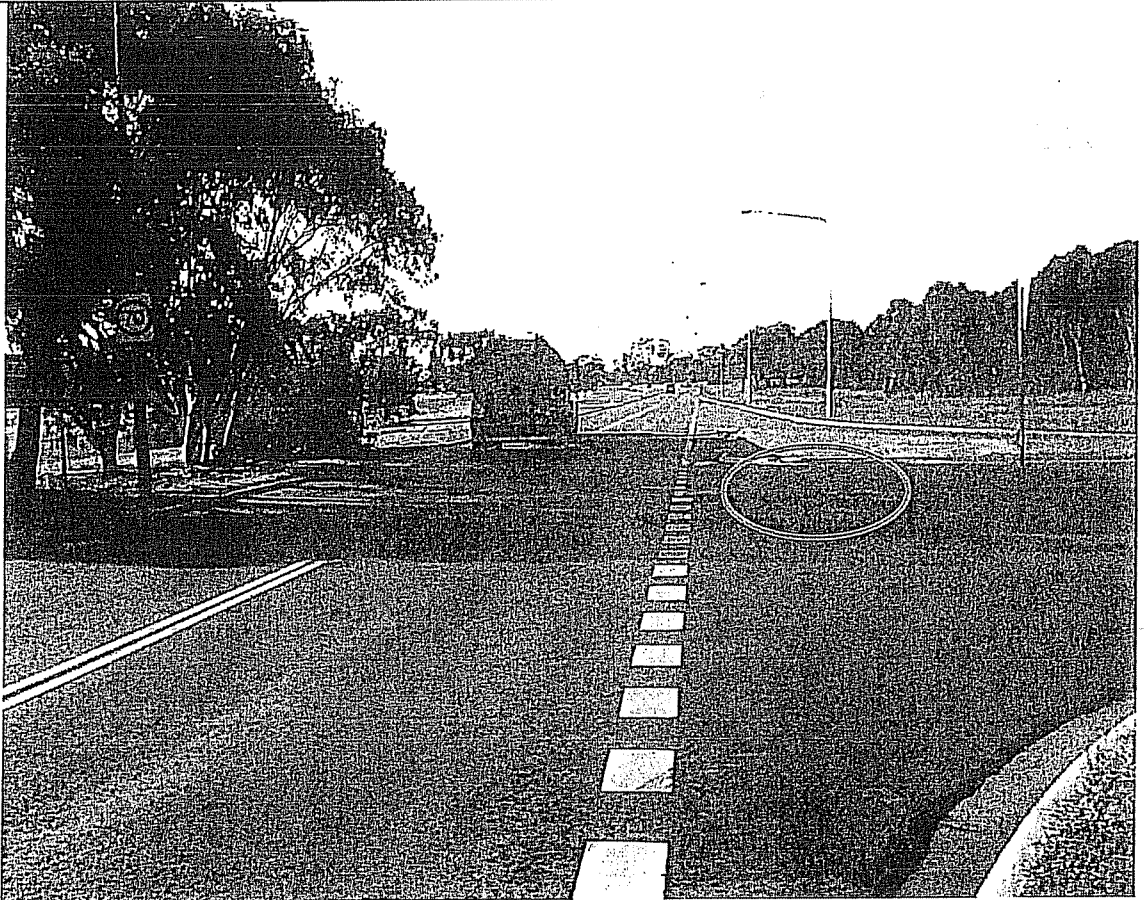
**Figure 3** Kerb is setback to accommodate heavy vehicles, however linemarking would provide better definition for light vehicles

A problem that exists when looking right from the southern approach (refer to Figure 3) is the difficulty in observing a through vehicle immediately behind a left turning vehicle.

A problem that exists when looking right from the southern approach is the difficulty in observing a through vehicle immediately behind a left turning vehicle. In order to address this deficiency it is recommended that the gore area is widened through the use of chevrons. This is likely to reduce the frequency of incidents involving vehicles turning right out of Kingsford Smith Drive and westbound through vehicles on Kuringa Drive (Treatment 5).

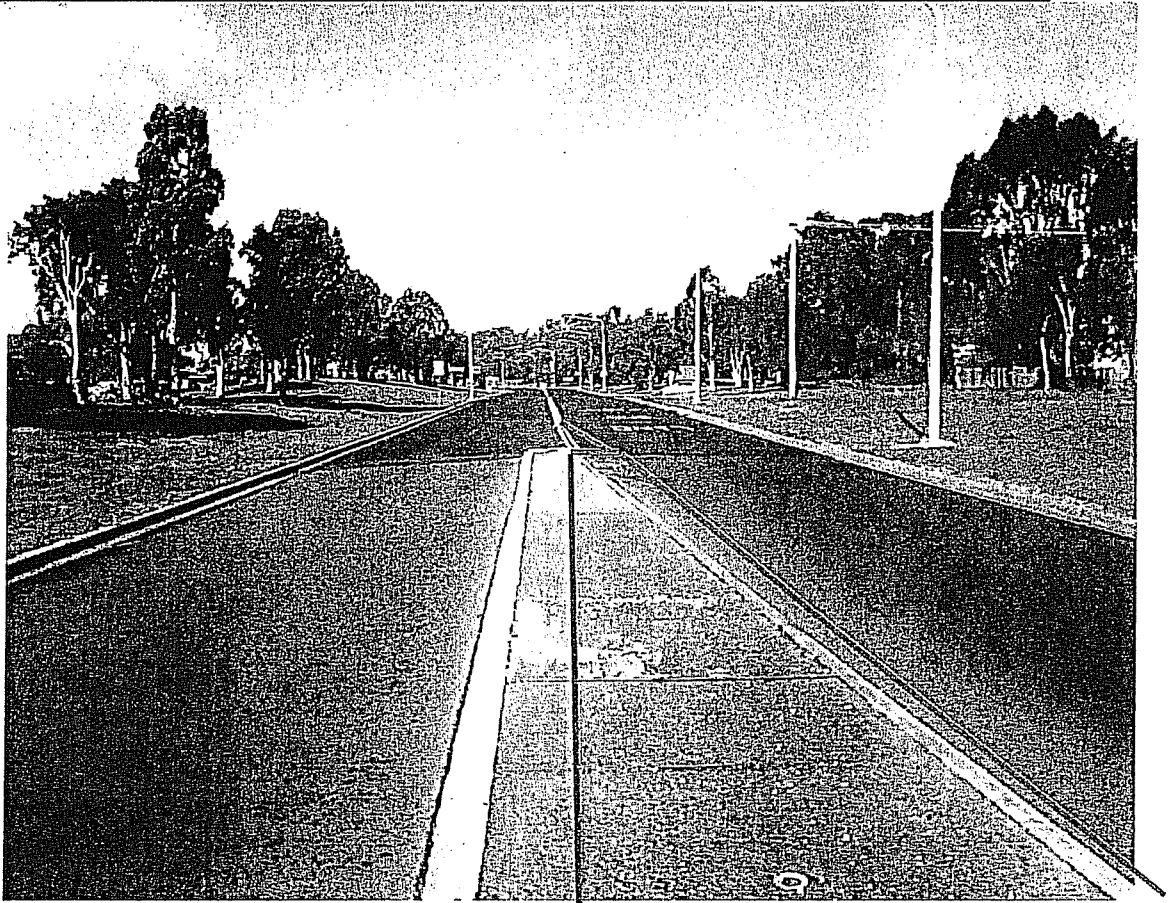
**Figure 4** The median on the southern approach could be reconstructed to permit two southbound lanes

As Figure 4 illustrates, it would be relatively straight forward to widen the southbound exit on Kingsford Smith Drive to two lanes, allowing a continuous left turn movement from Kuringa Drive (east). While this would address audit deficiency 11 and reduce eliminate the potential left through conflict, following a review of the traffic volumes, which revealed that the counter Kuringa Drive right turn movement was very light during peak periods and an examination of the crash history; no such crashes have occurred during the past five years, no action is recommended.

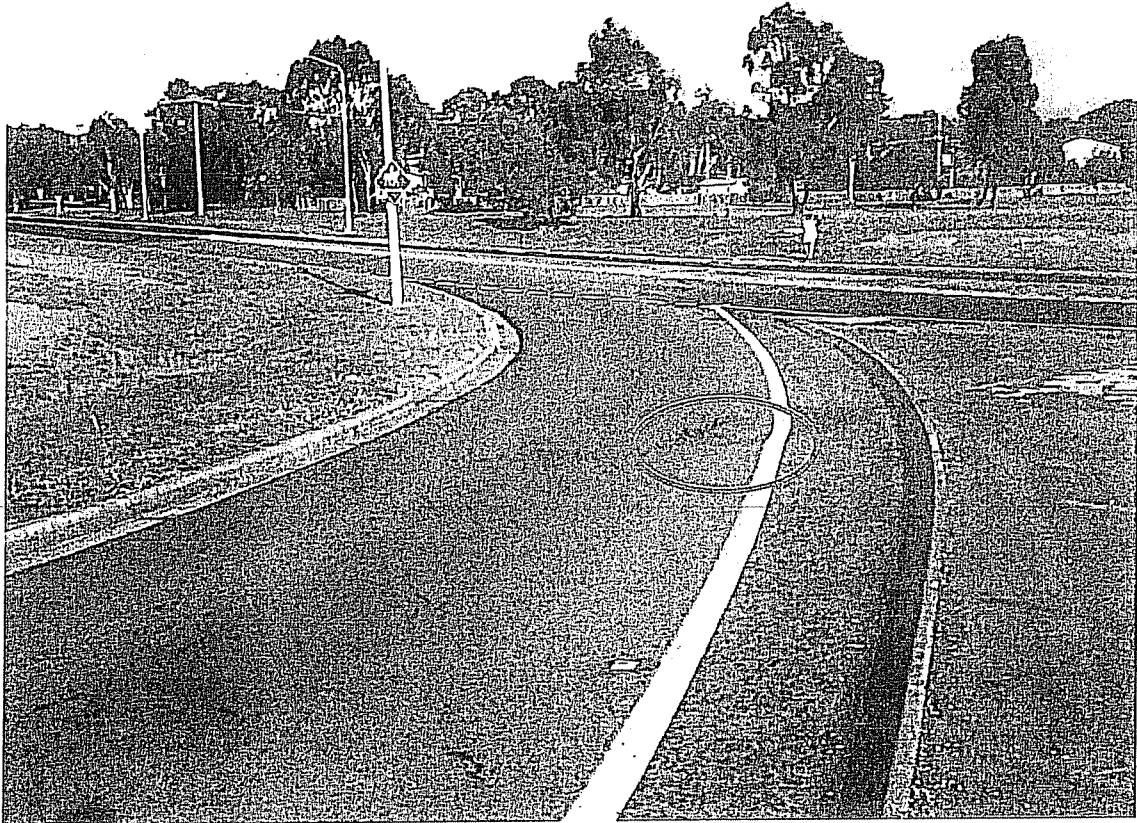
**Figure 5 Pavement deterioration on westbound left slip**

Pavement surface is Dense Grade Asphalt with some coarse aggregate surface texture in good condition. All pavement is bounded by kerb & gutter. The left turn slip lane to Kingsford Smith has 5m of shear cracking at start of the splitter island & 3m of shear cracking with deformation mid-way along island. Existing surface is 40 – 80mm higher than lip of gutter due to not being keyed-in during the overlay.

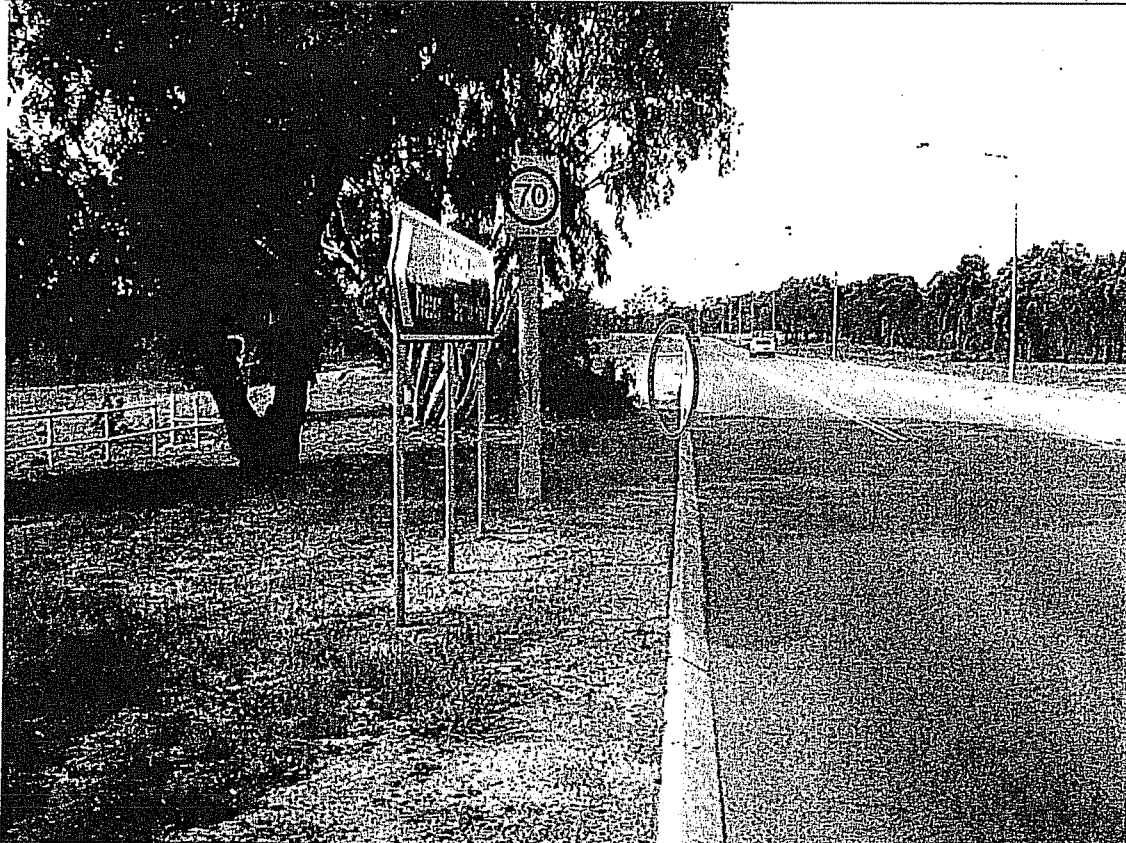
**Figure 6** Lack of grass & loss of backfill behind Kuringa Drive eastbound kerb indicates possible use of verge by heavy vehicles

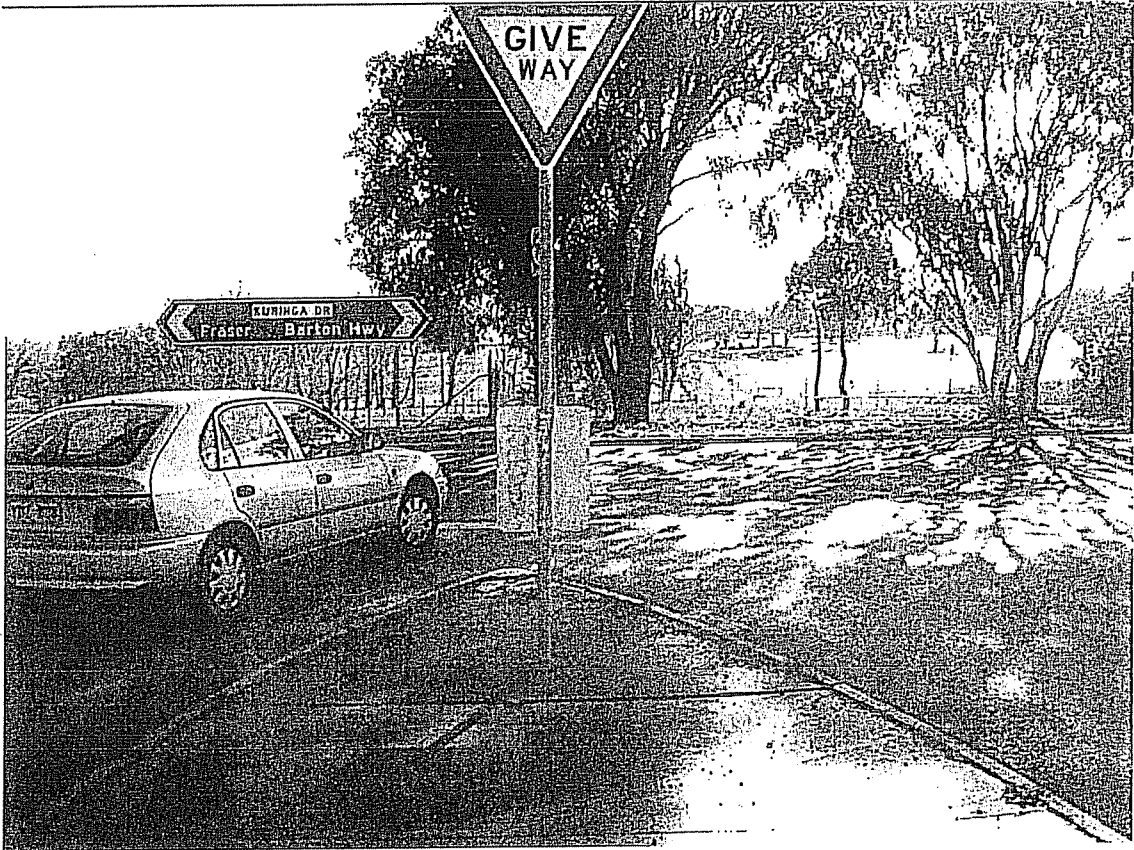
During inspection vehicles waiting to turn right into Kuringa Dr stopped 2 – 3m before Hold Line probably due to obscured vision from signage due to street light columns to the left. Deficiencies 1, 2 while considered low risk are inexpensive and signage should be instated (refer to Figure 7).

**Figure 7** Sightboard required
