Appendix D – Progress Report

Re: Progress Report for 25 Bradfield Street, Downer, ACT 2602.

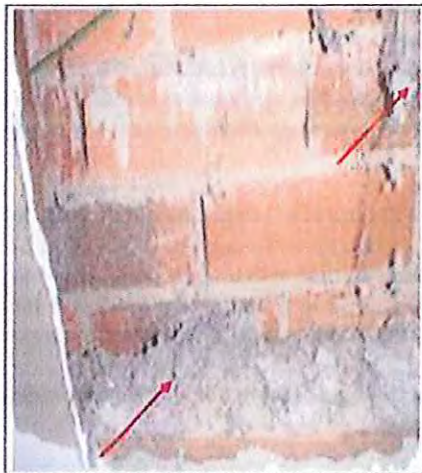
Photograph 1:
West Gable end wall

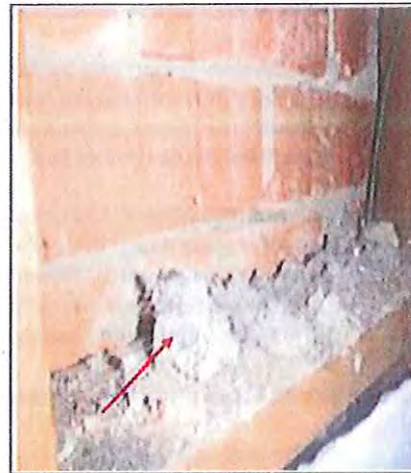
Photograph 2:
West Gable end wall

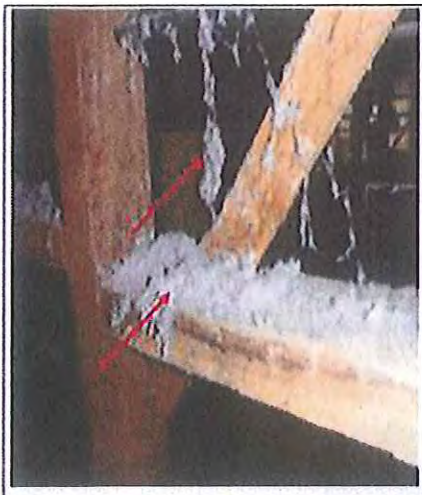
Photograph 3:
Corridor timber stud East end

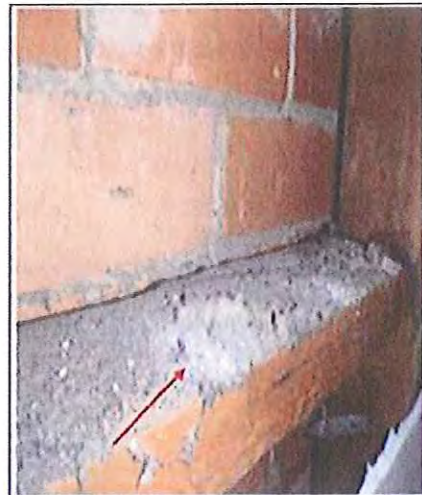
Photograph 4:
South wall in South East bedroom

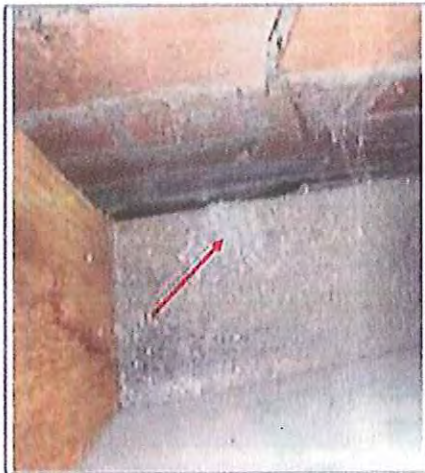
Five samples taken from the timber stud walls once the plasterboard had been removed tested positive for amosite asbestos. The migration, spread and settling of the loose asbestos insulation in this house is extensive and has migrated from the ceiling space to the bottom of the timber stud.

Photograph 5:
South wall in South East bedroom
bottom of timber stud

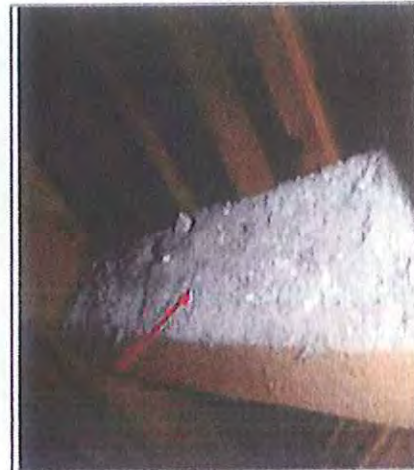
Photograph 6:
Internal timber stud adjacent bathroom

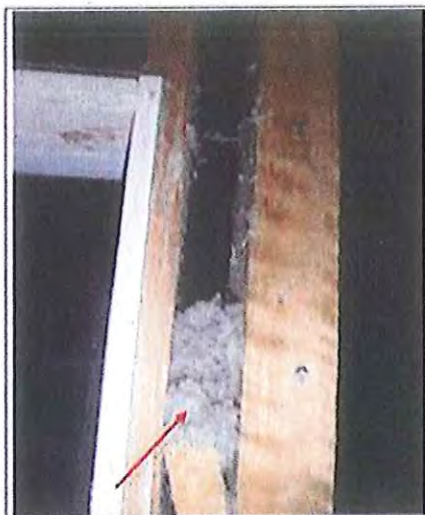
Photograph 7:
Door jamb to bedroom adjacent living
room

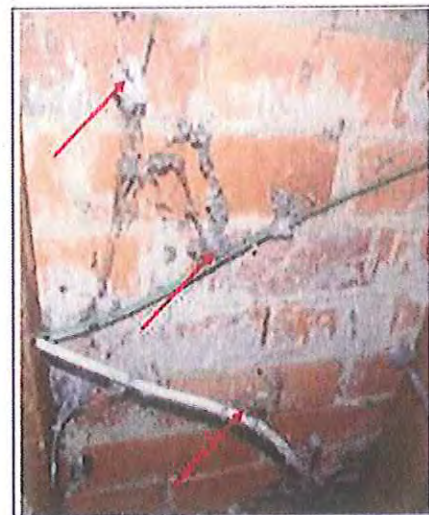
Photograph 8:
East gable end on wiring

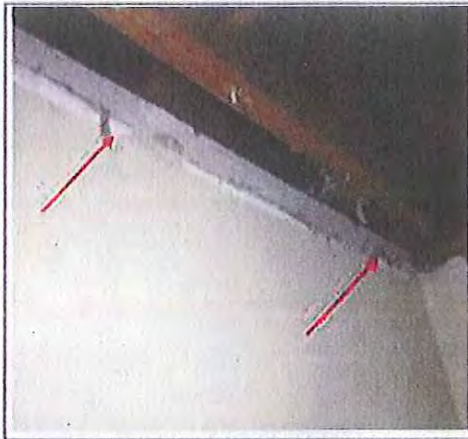
Initial investigation into the ceiling space revealed that the loose asbestos fill contamination had been partially removed and modern yellow synthetic mineral fibre batts placed to disguise the contamination. A large amount of loose asbestos insulation was seen when the cornices were removed from the ceiling.

Photograph 9:
Ceiling area with cornices removed

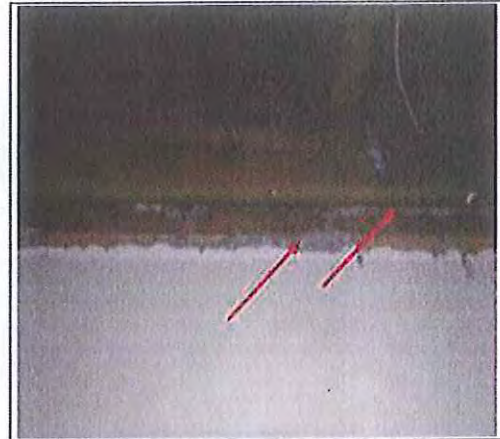
Photograph 10:
Ceiling area with cornices removed
