APPENDIX B

**RCC PLACEMENT BY LANE METHOD – BWA’S PROPOSAL, TRP COMMENTS ON
PROPOSAL AND BWA’S PROPOSED SPECIFICATION CHANGES
25-27 JULY 2012**

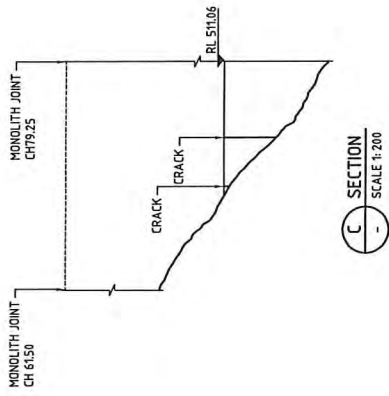
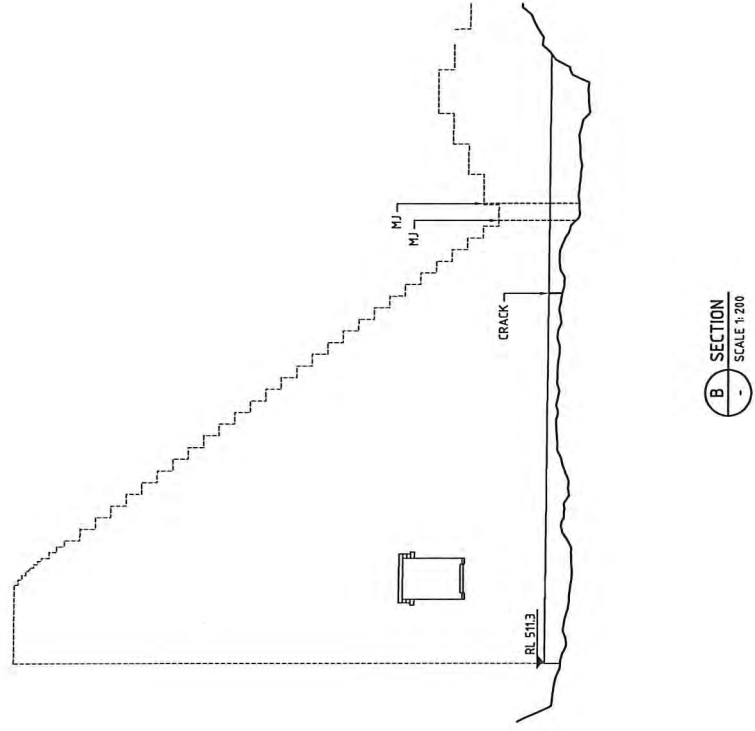
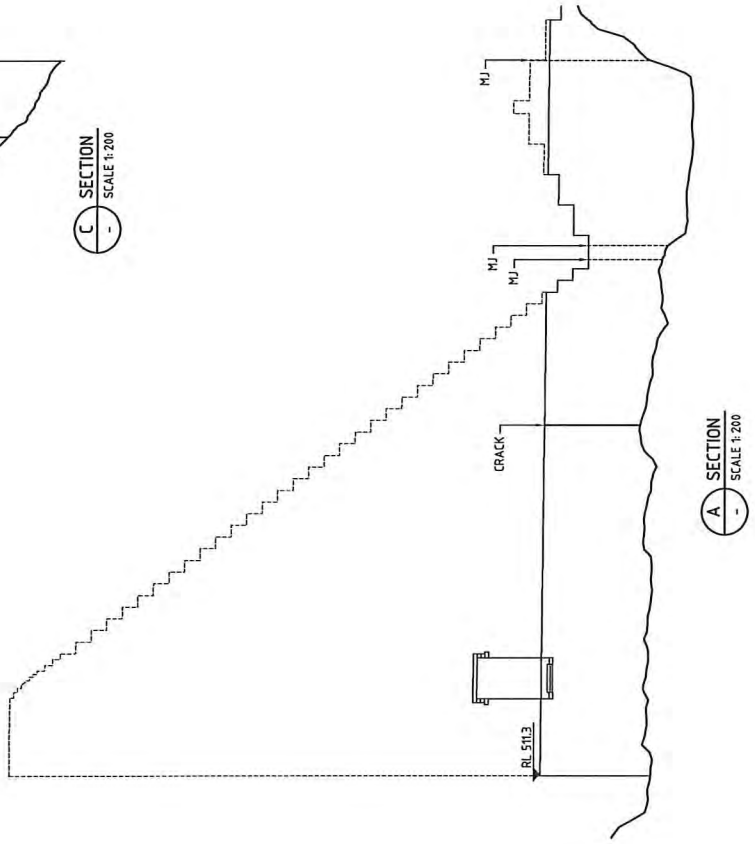
Appendix A **Plans, Sections and Photographs**

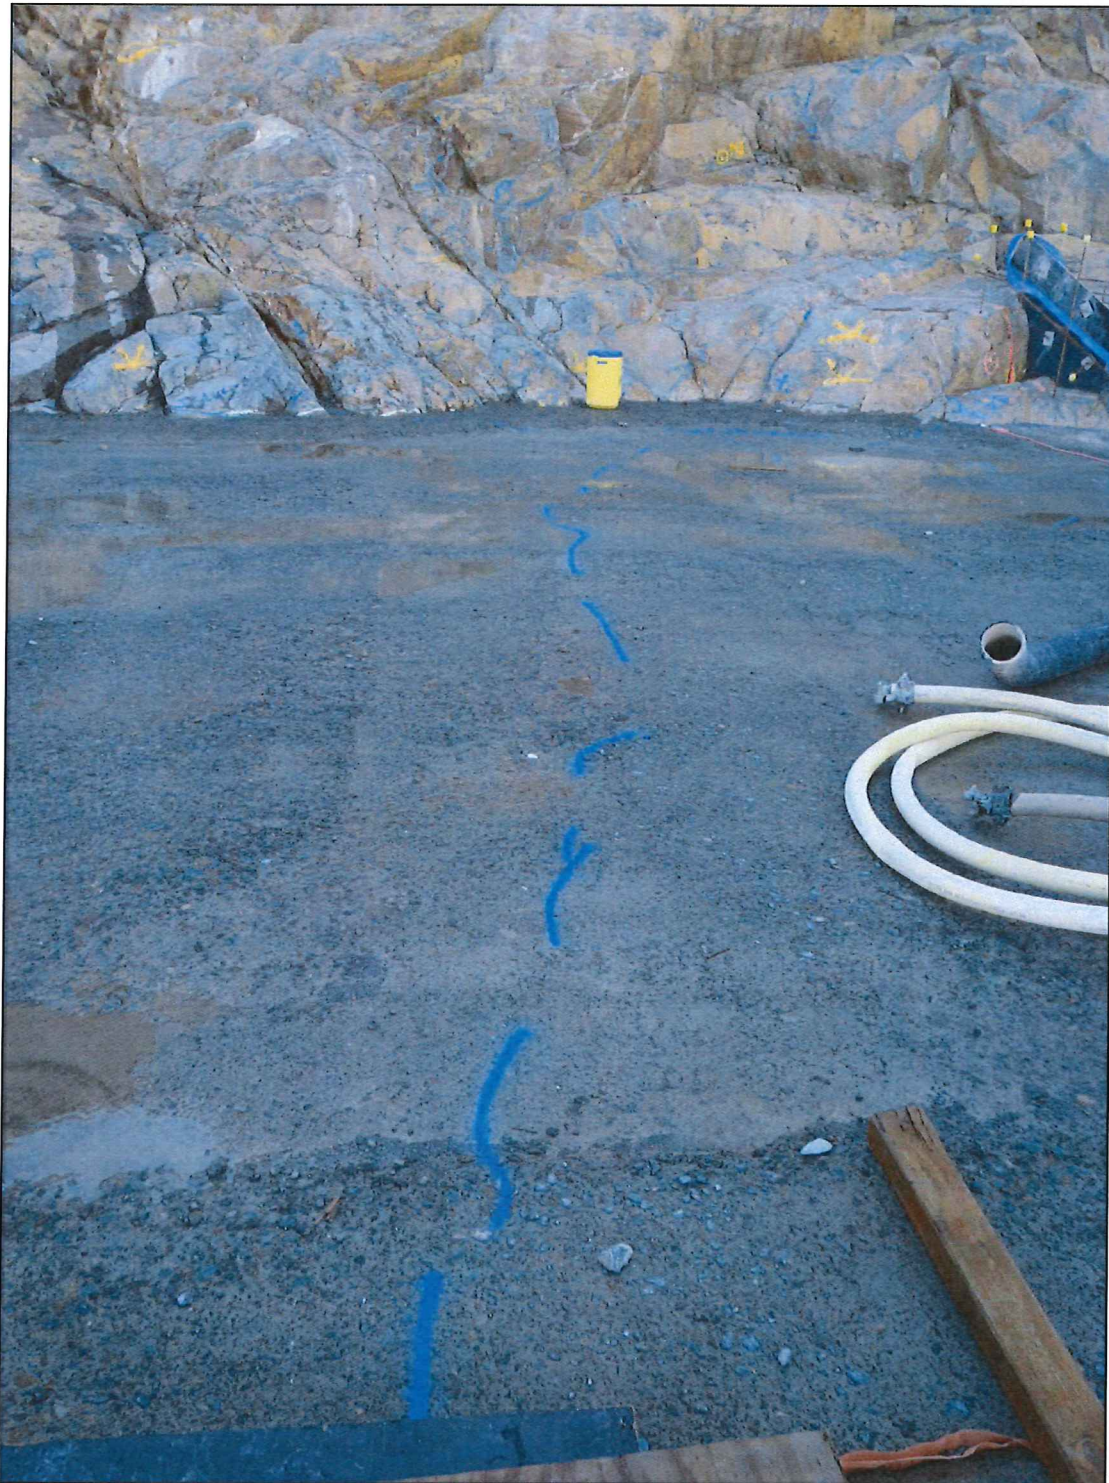
Photo A.1 - Cross valley crack in Monolith D. Taken looking towards left abutment.

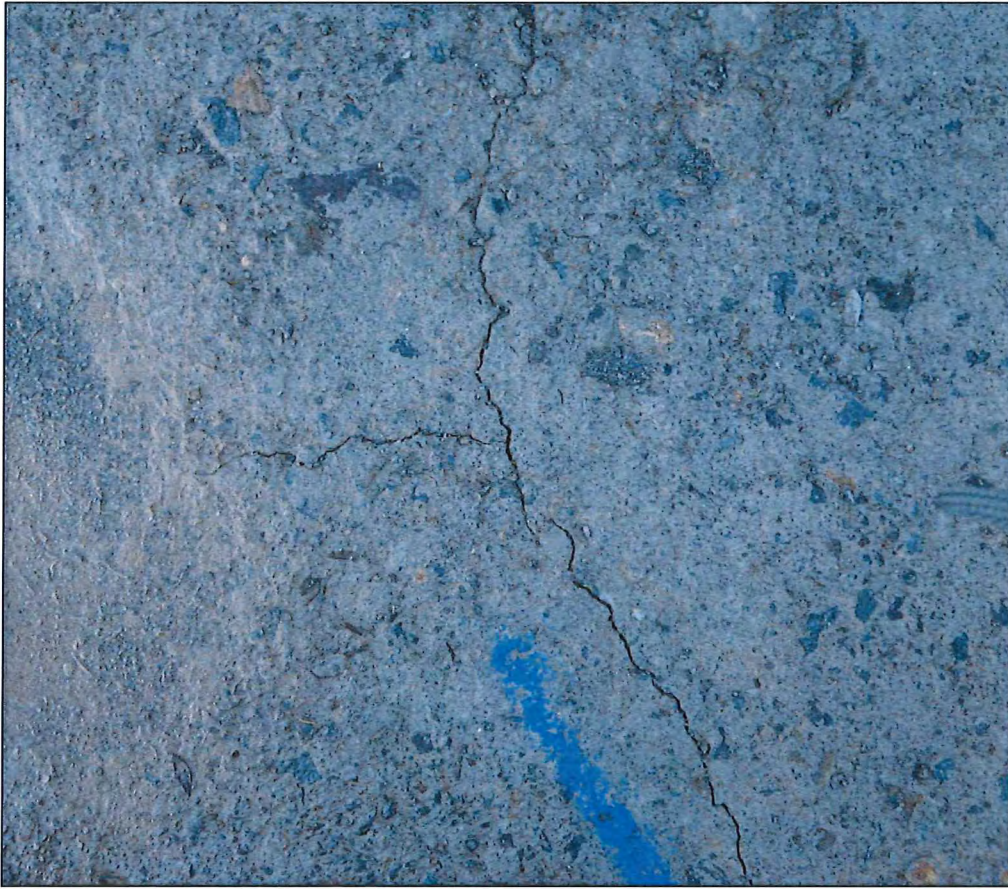
Photo A.2 – Bifurcation of upstream downstream crack with cross valley crack.

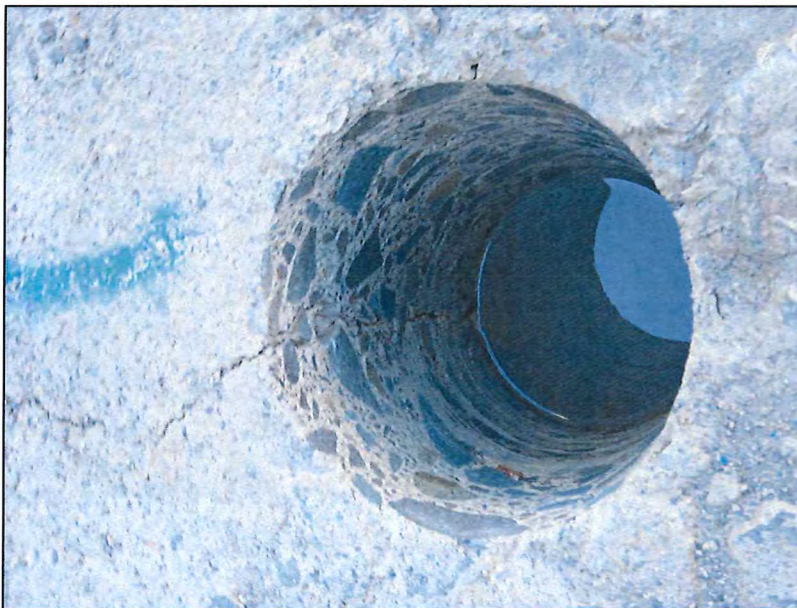
Photo A.3 – 150mm core through upstream-downstream crack.

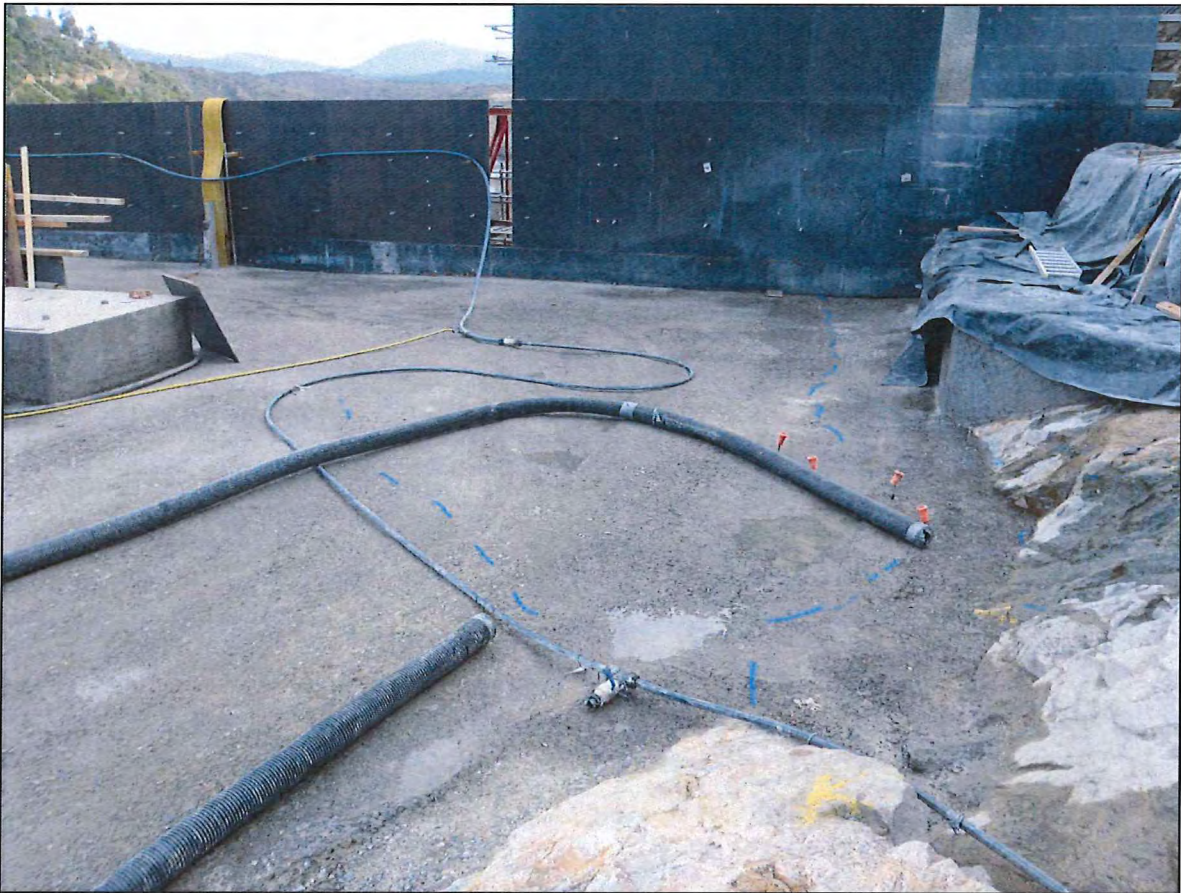
Photo A.4 – Cracking on upstream left abutment (cracking outlined with blue paint).

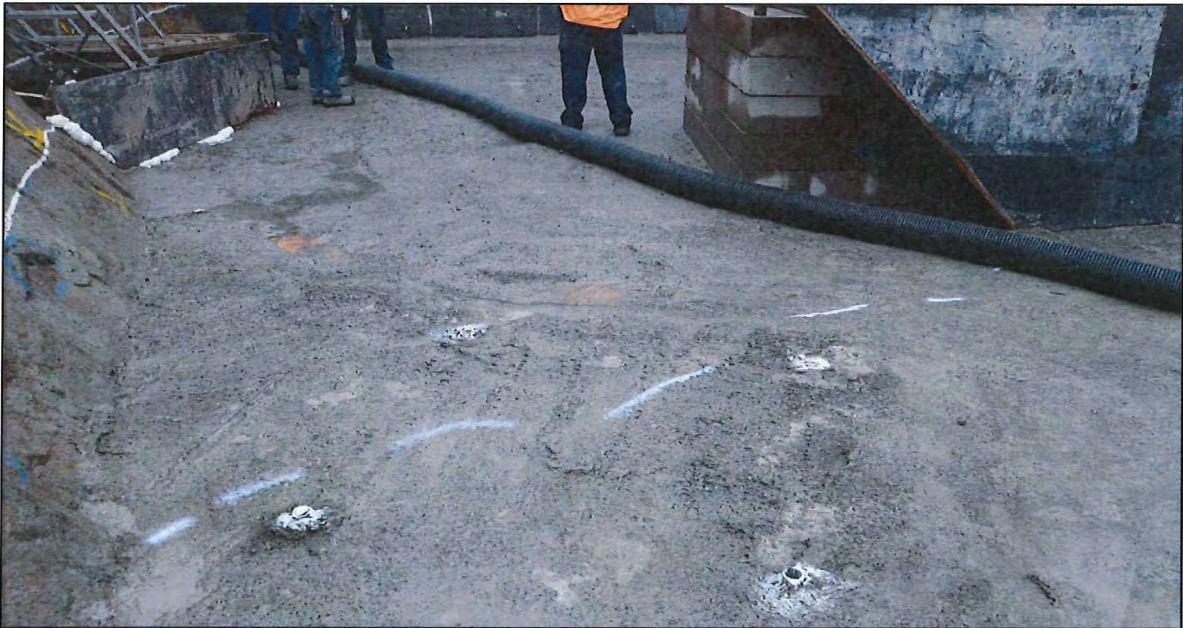
Photo A.5 – Cracking from right abutment to gallery blackout on RL510.9 (cracking outlined with white paint).

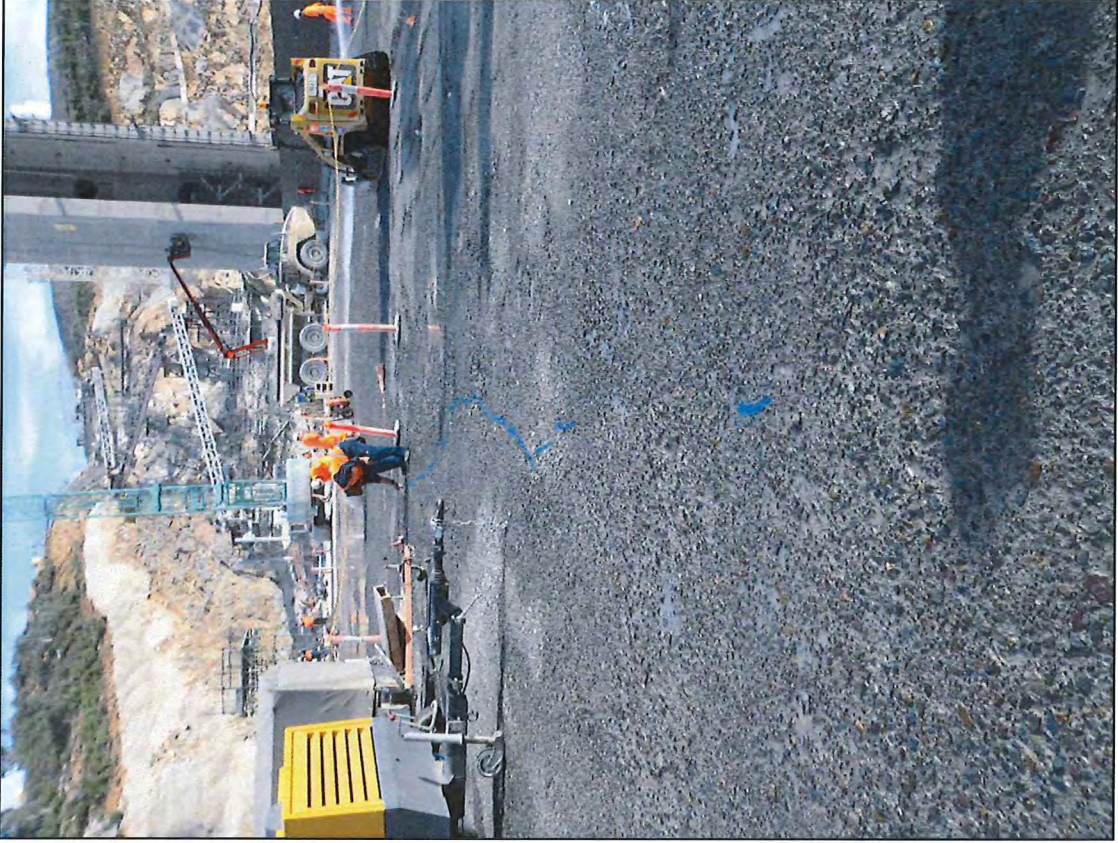
Photo A.7 – Cracking in Monolith G, looking towards right abutment.

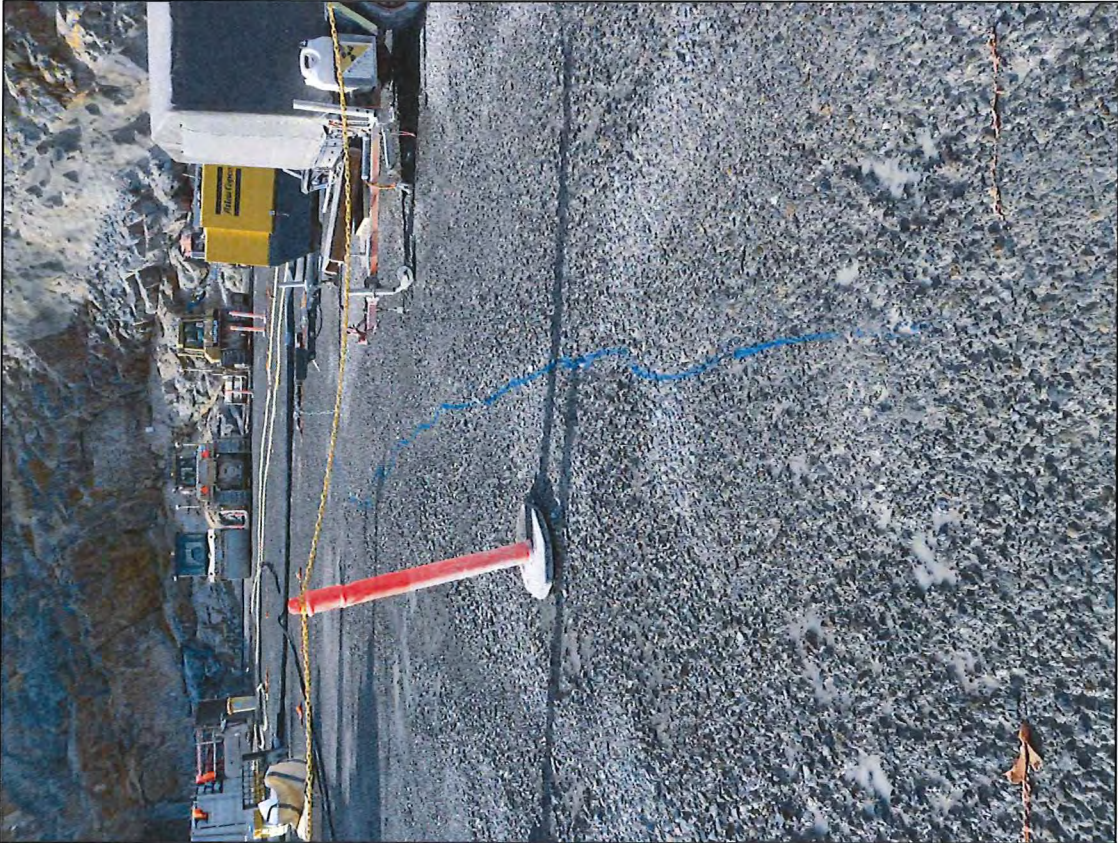
Photo A.6 – Cracking in Monolith F, looking towards left abutment (cracking outlined with blue paint).

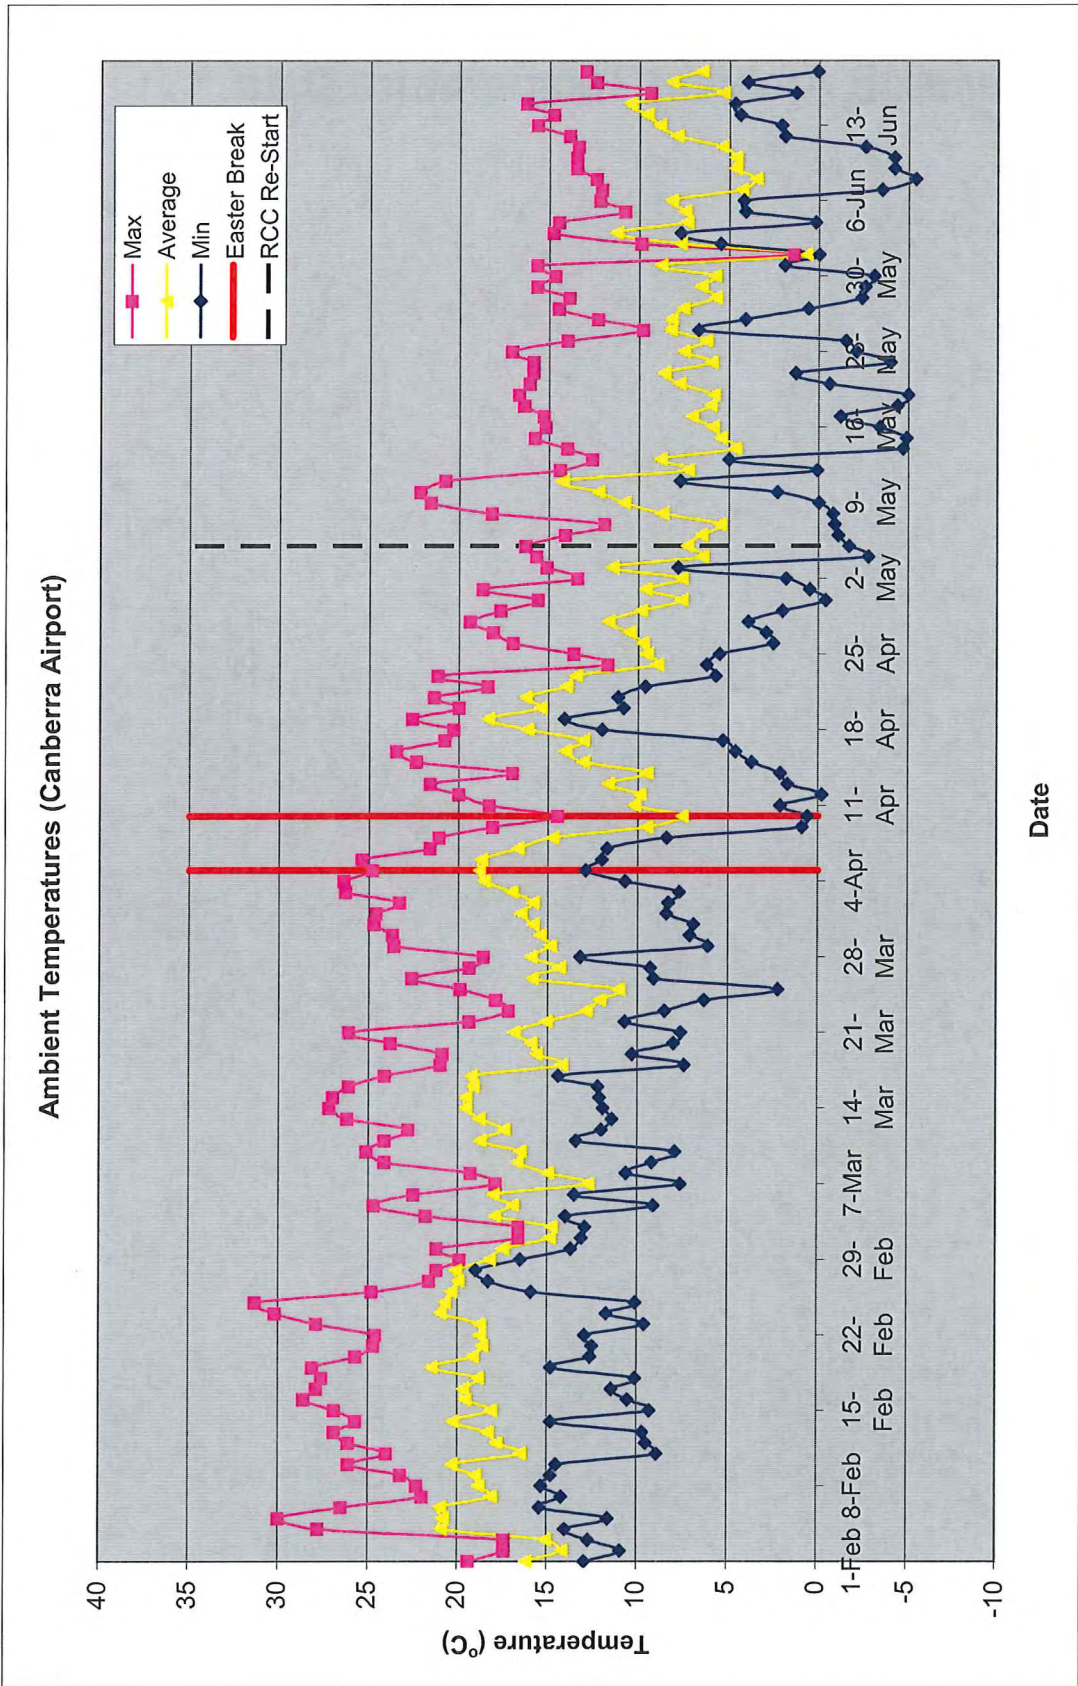
Appendix C Thermal Monitoring of Dam Foundation Concrete Pour

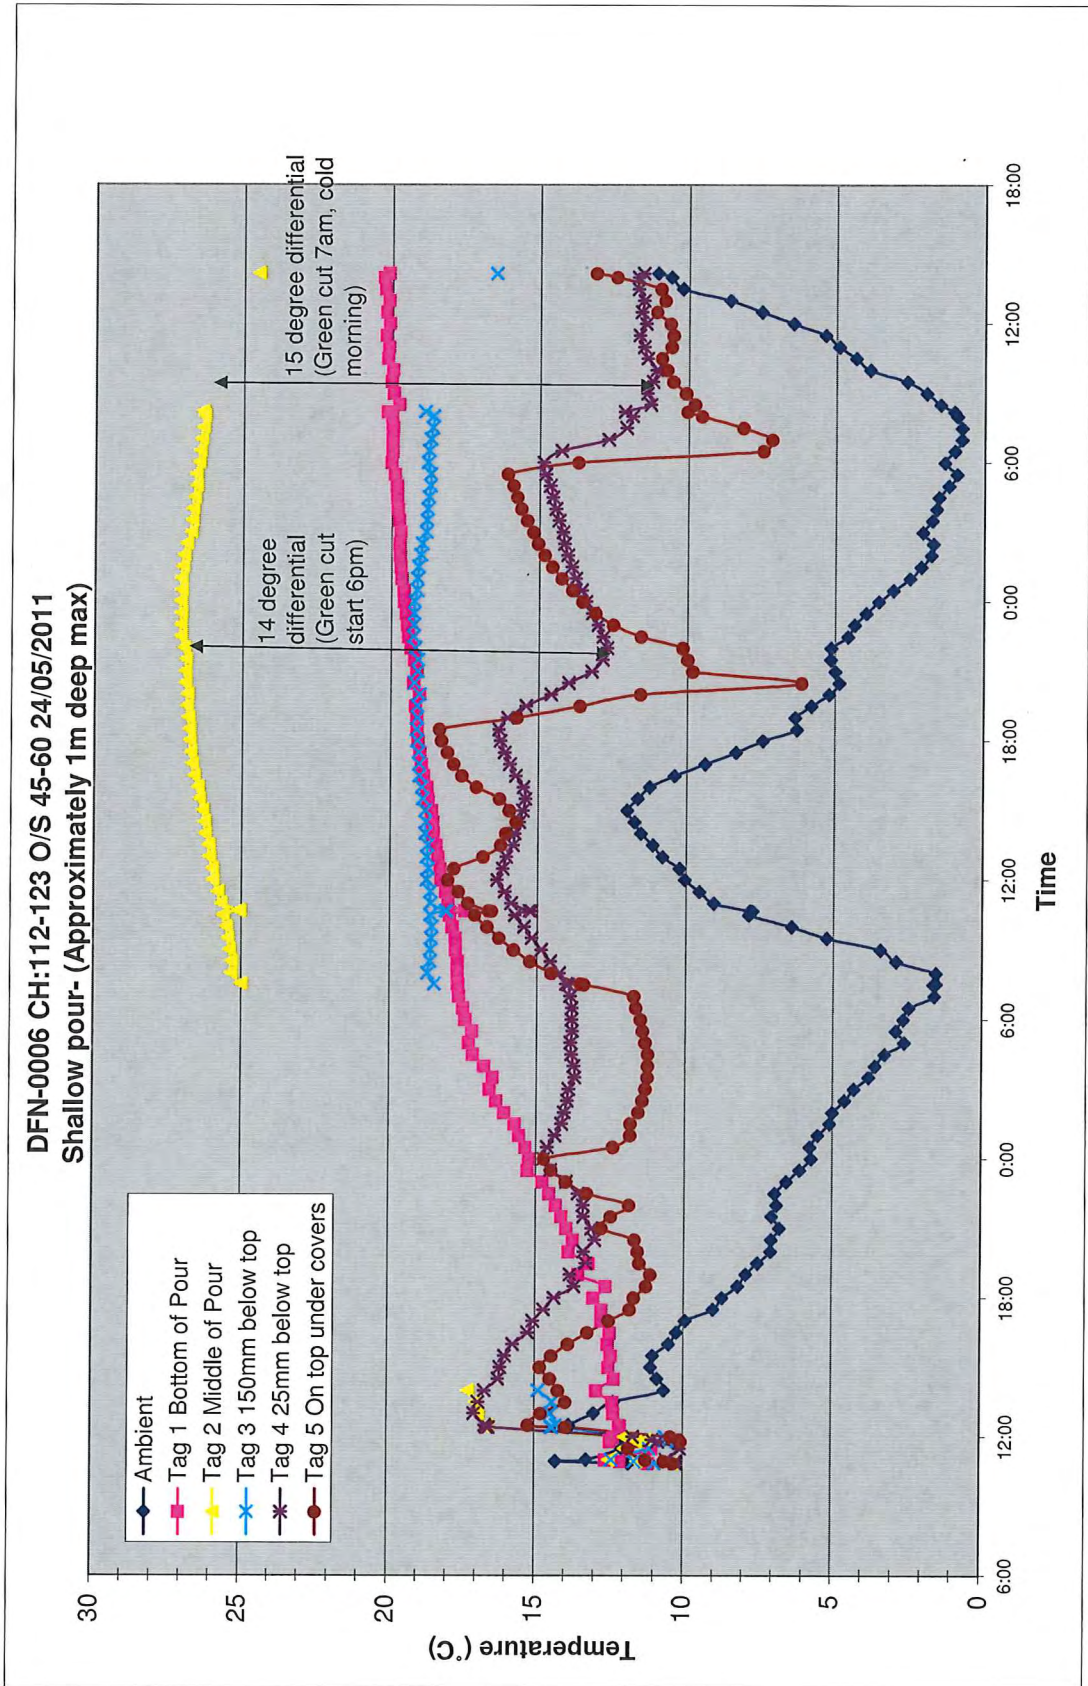
Appendix D **Crack Treatment**

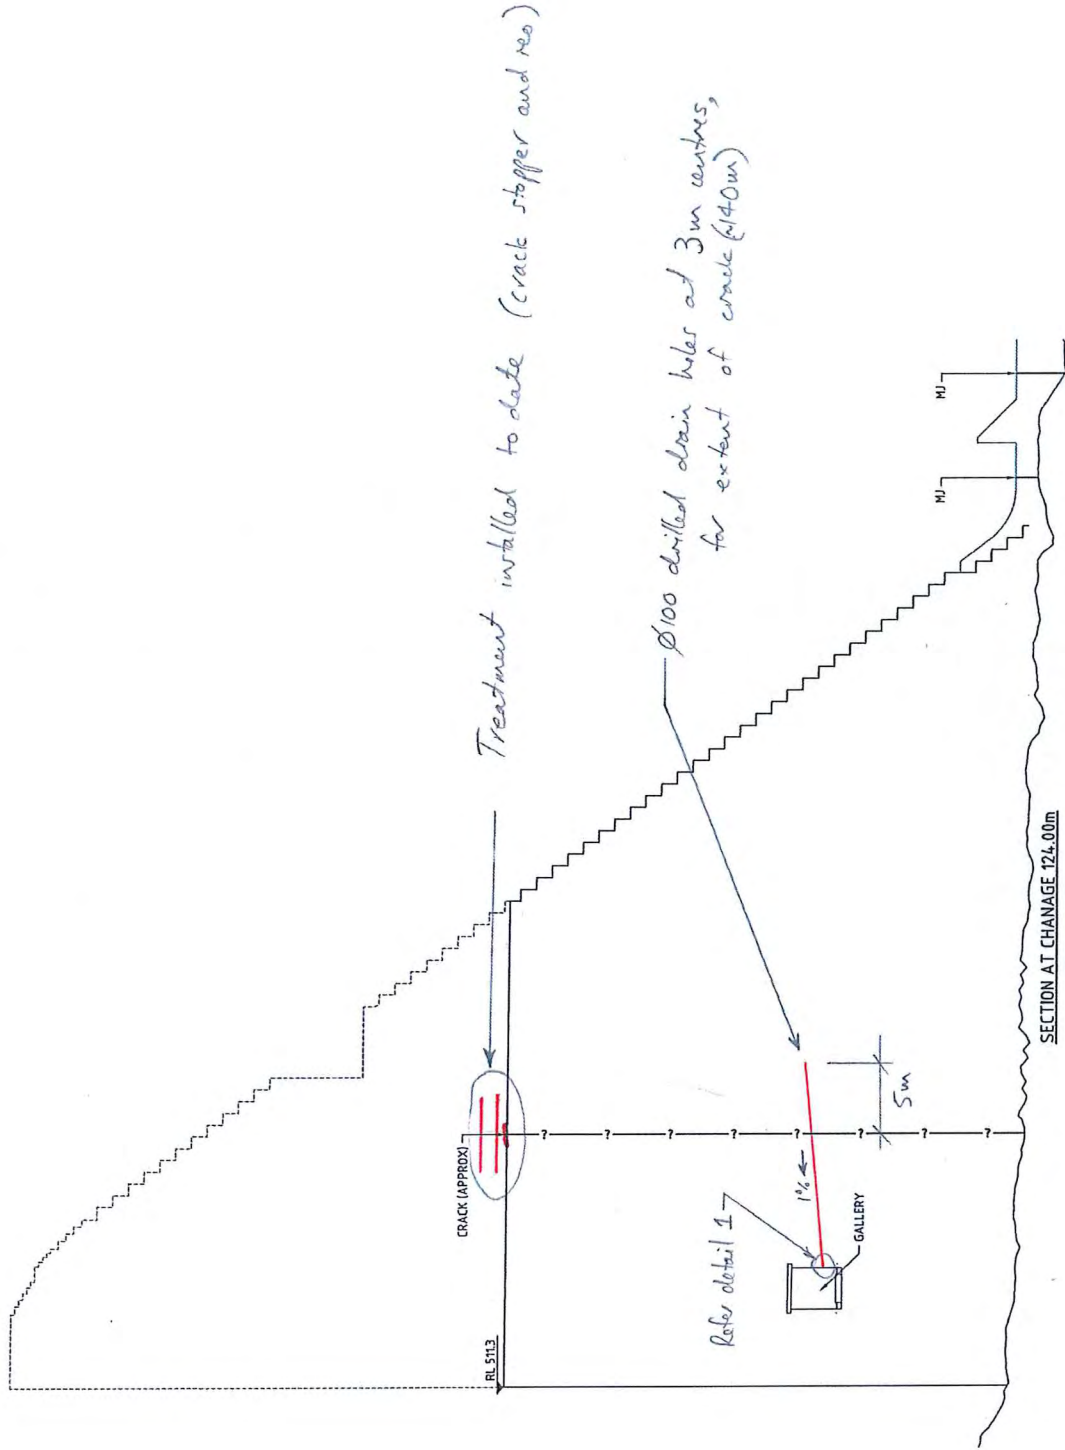
Possible Crack Treatment

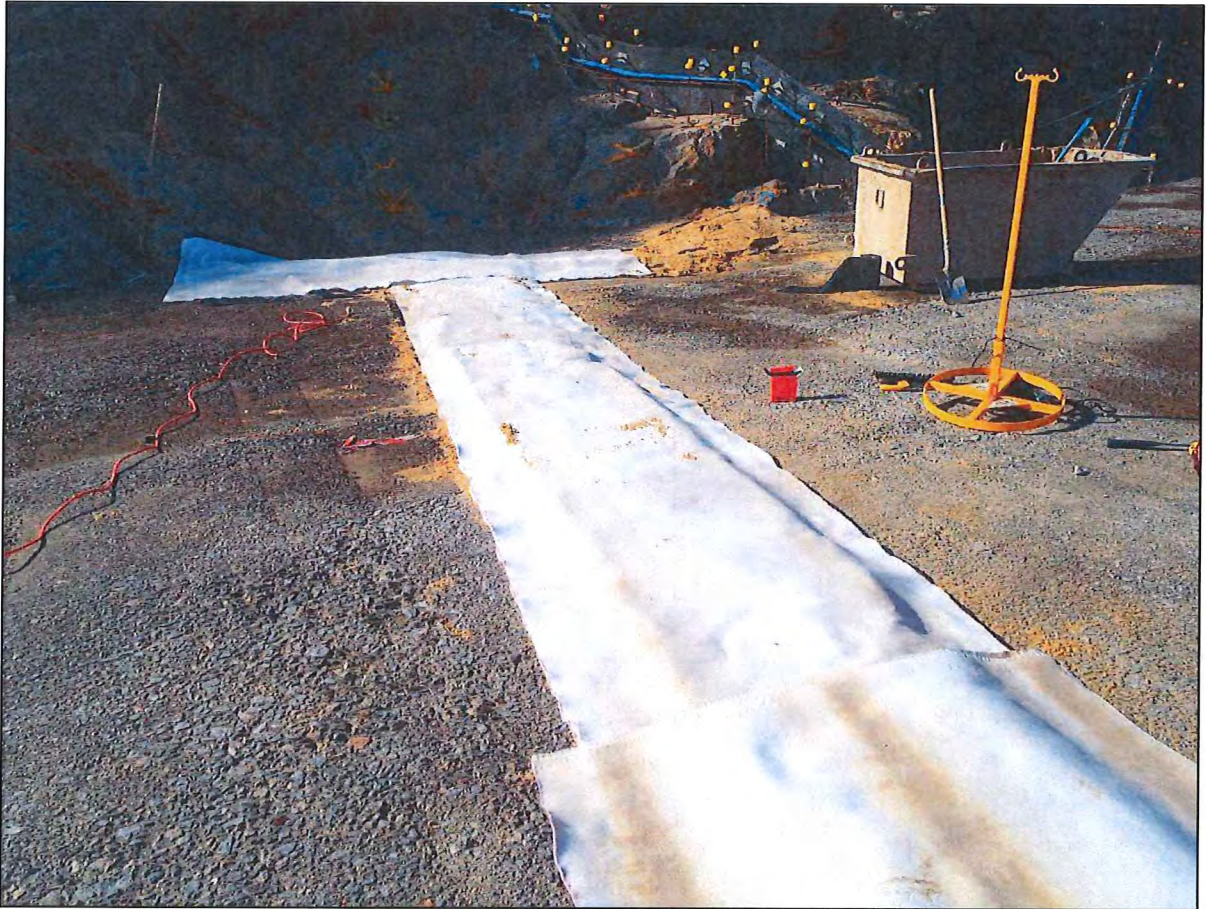
Photo D.1 – Sand crack stopper and strip drain being installed in Monolith D.

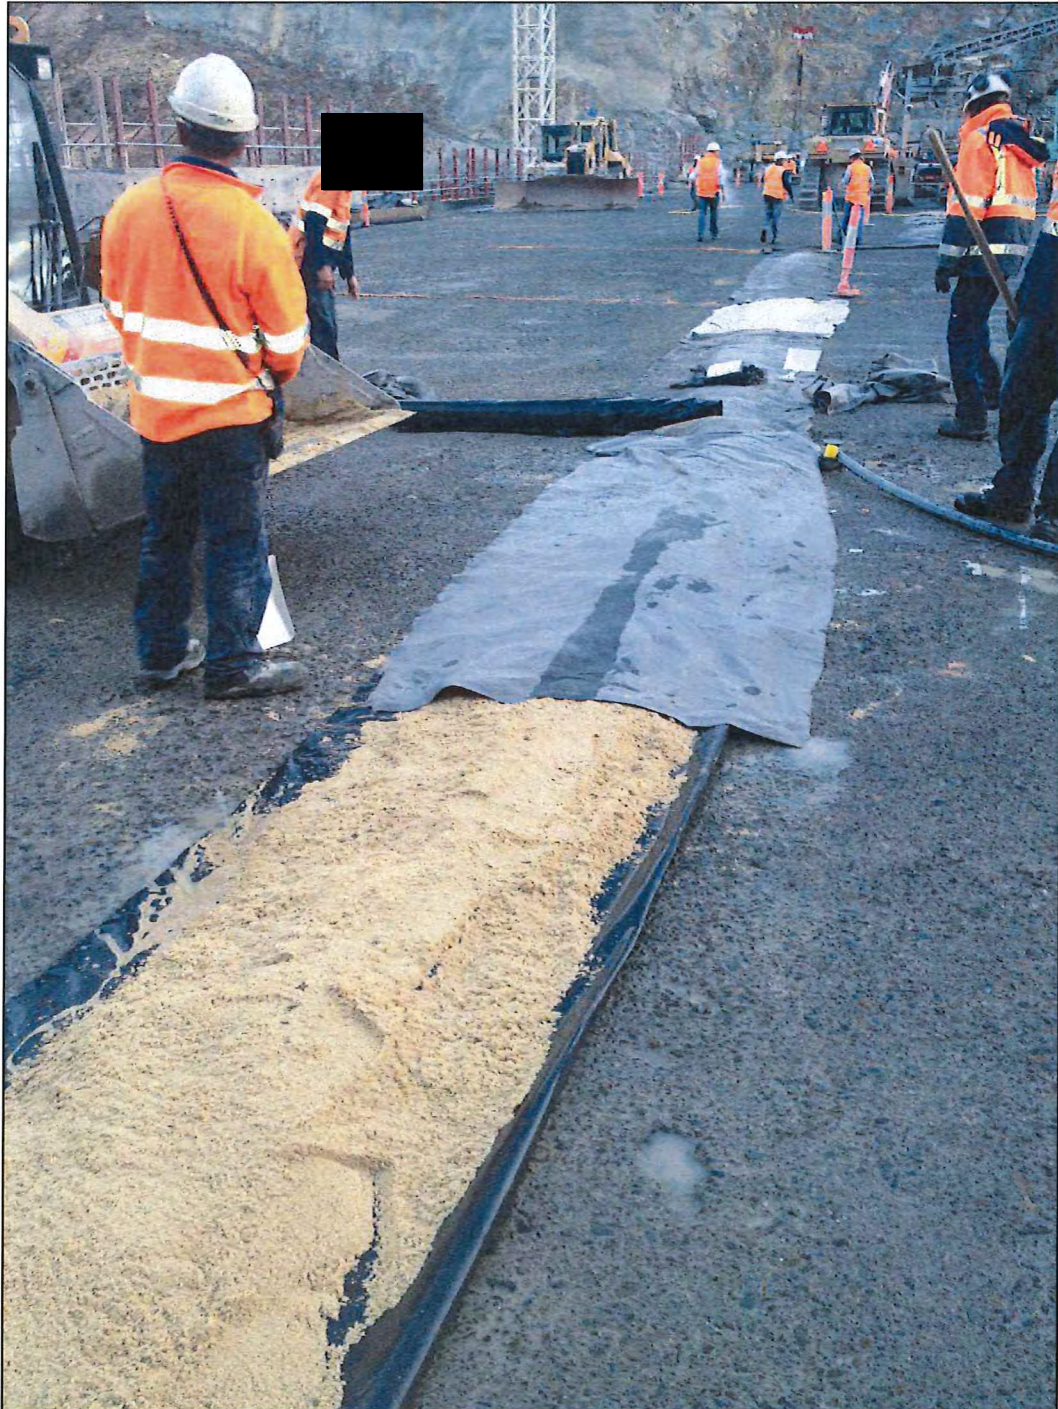
Photo D.2 – Sand crack stopper and strip drain being installed in Monolith E.

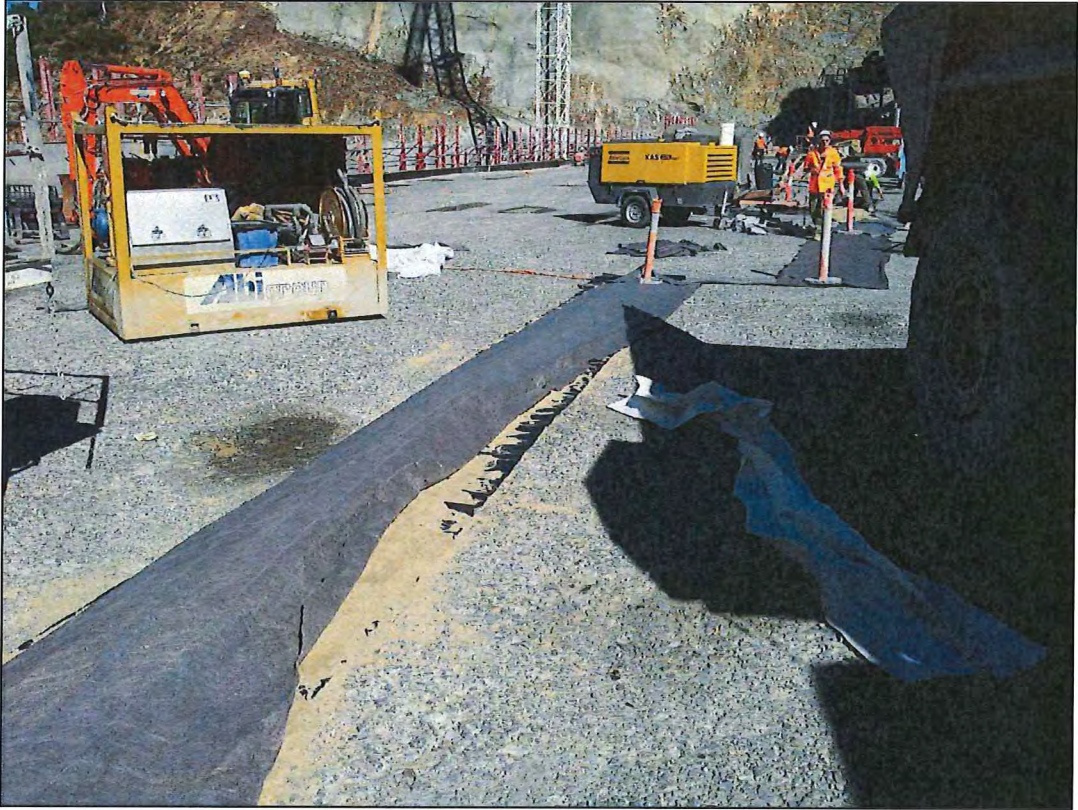
Photo D.3 – Sand crack stopper and strip drain being installed in Monoliths F and G

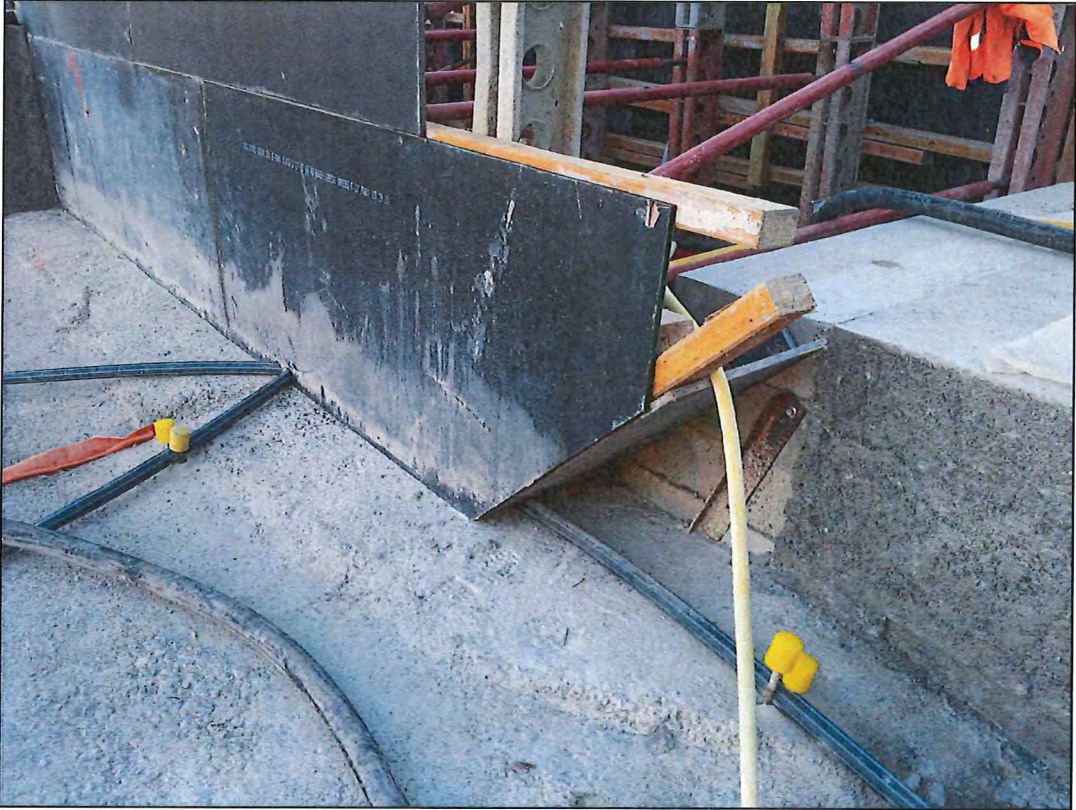
Photo D.4 – Drain pipes connecting strip drains to left hand gallery.

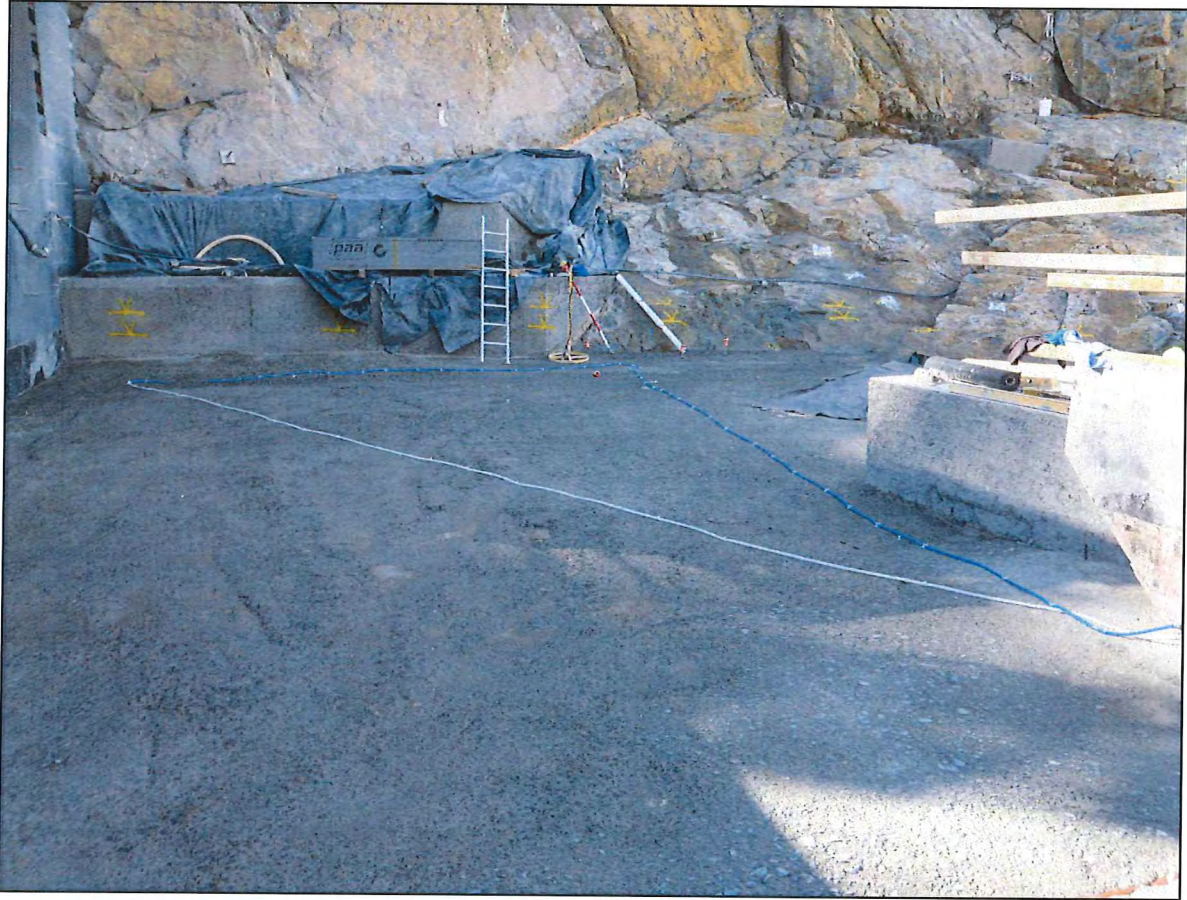
Photo D.5 – TAMs injection and non-injection grout tubes installed on transverse crack on upstream left abutment.

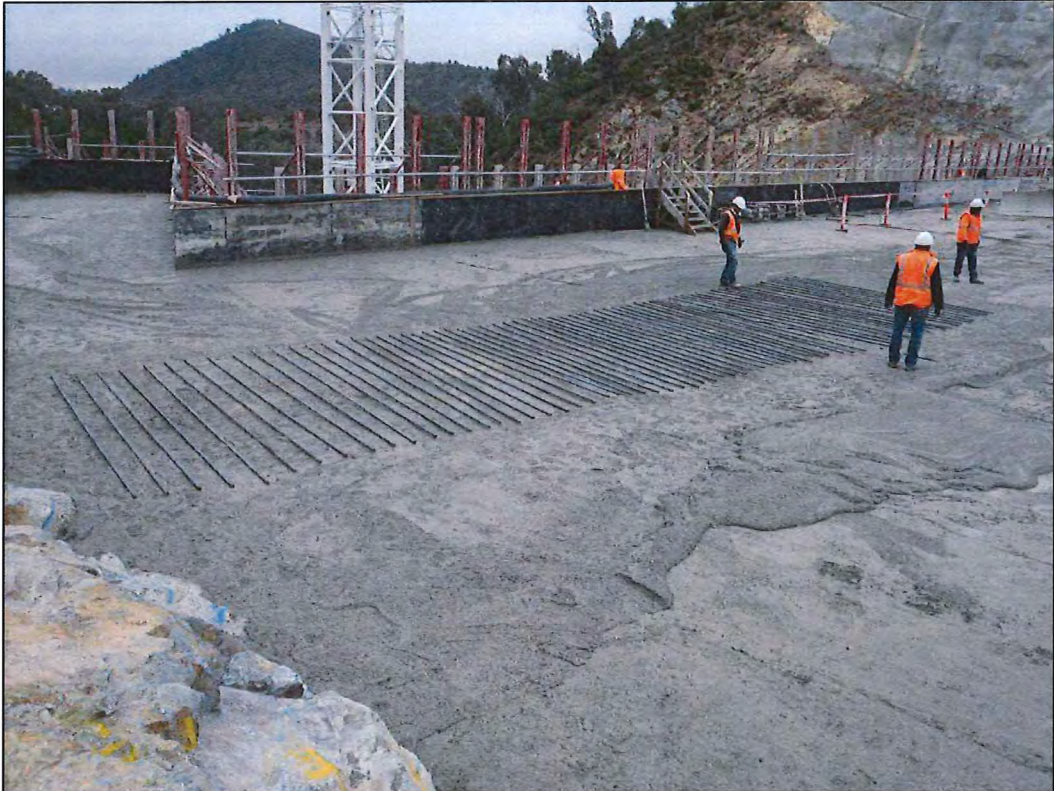
Photo D.6 – N28 reinforcement bars being installed on top of the cross valley cracks in Monolith D.

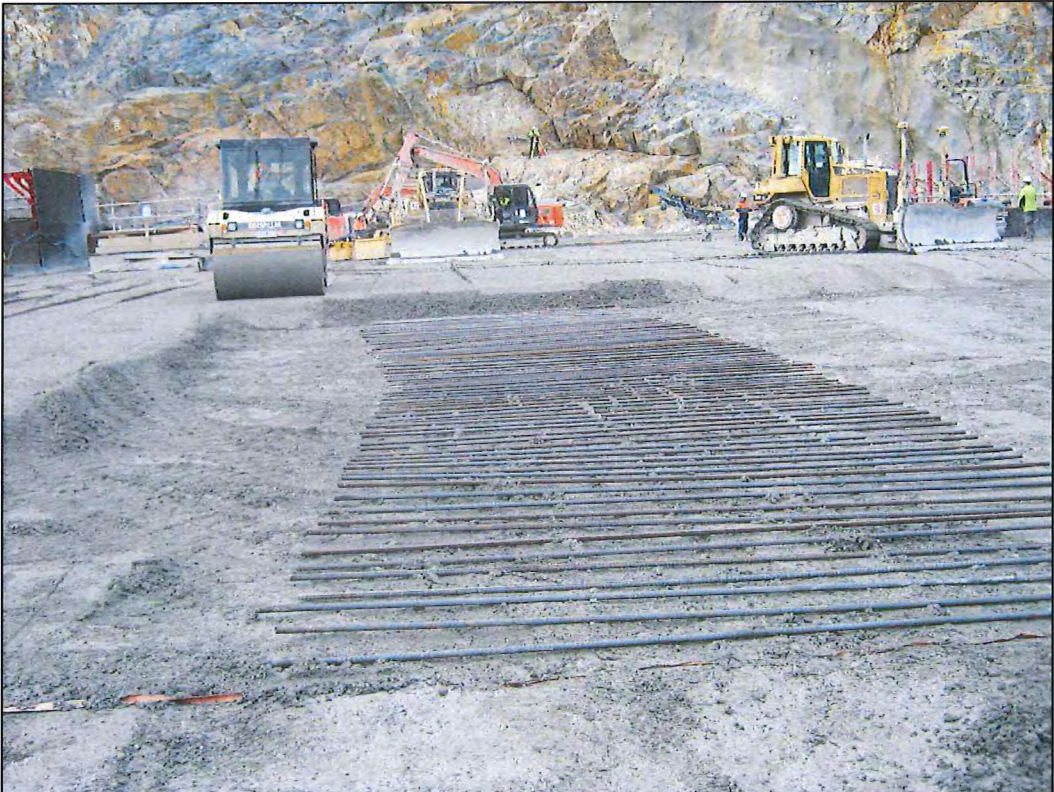
Photo D.7 – N28 reinforcement bars being installed on top of the cross valley cracks in Monolith G.

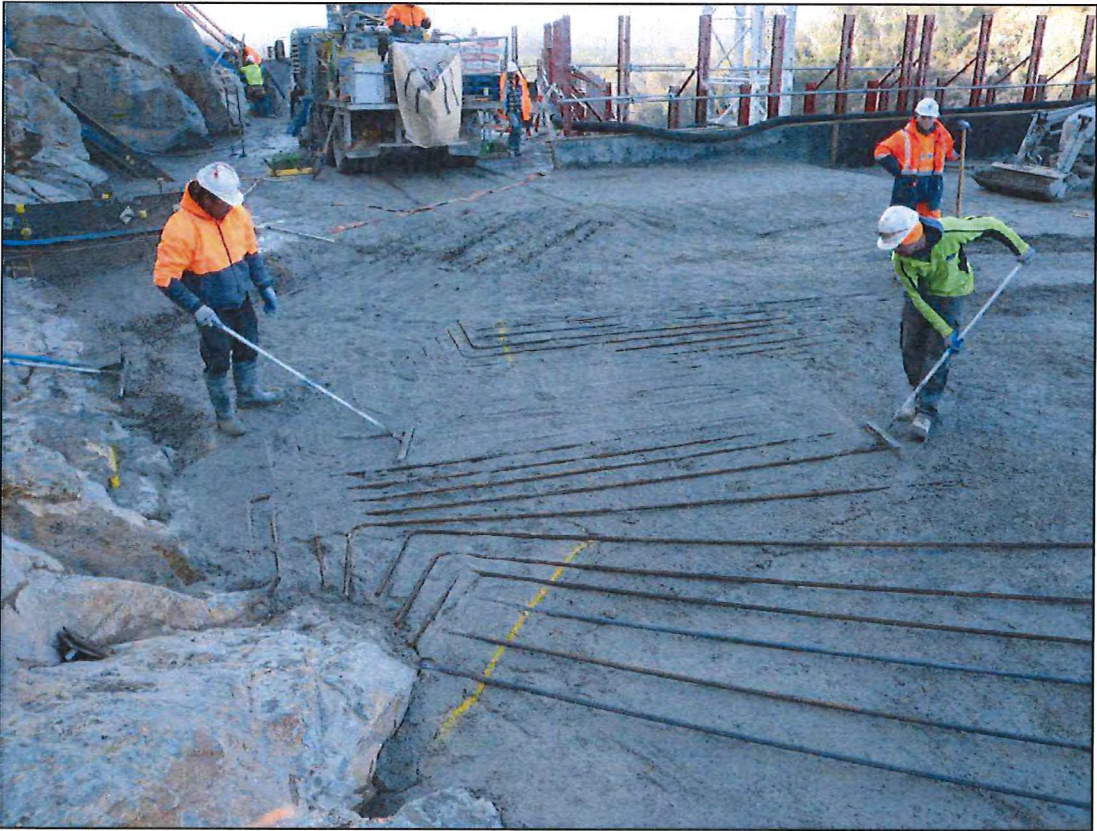
Photo D.8 – N24 cogged reinforcement bars installed across transverse crack on left hand abutment groin.

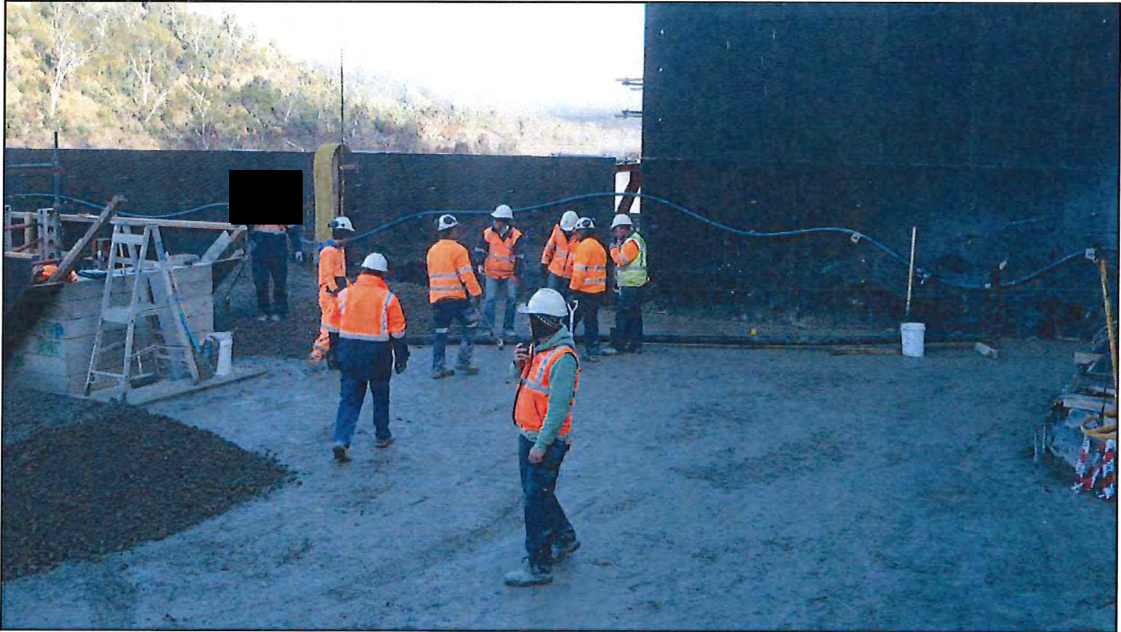
Photo D.9 – Installation of 100mm diameter riser pipe and drain connecting to gallery.

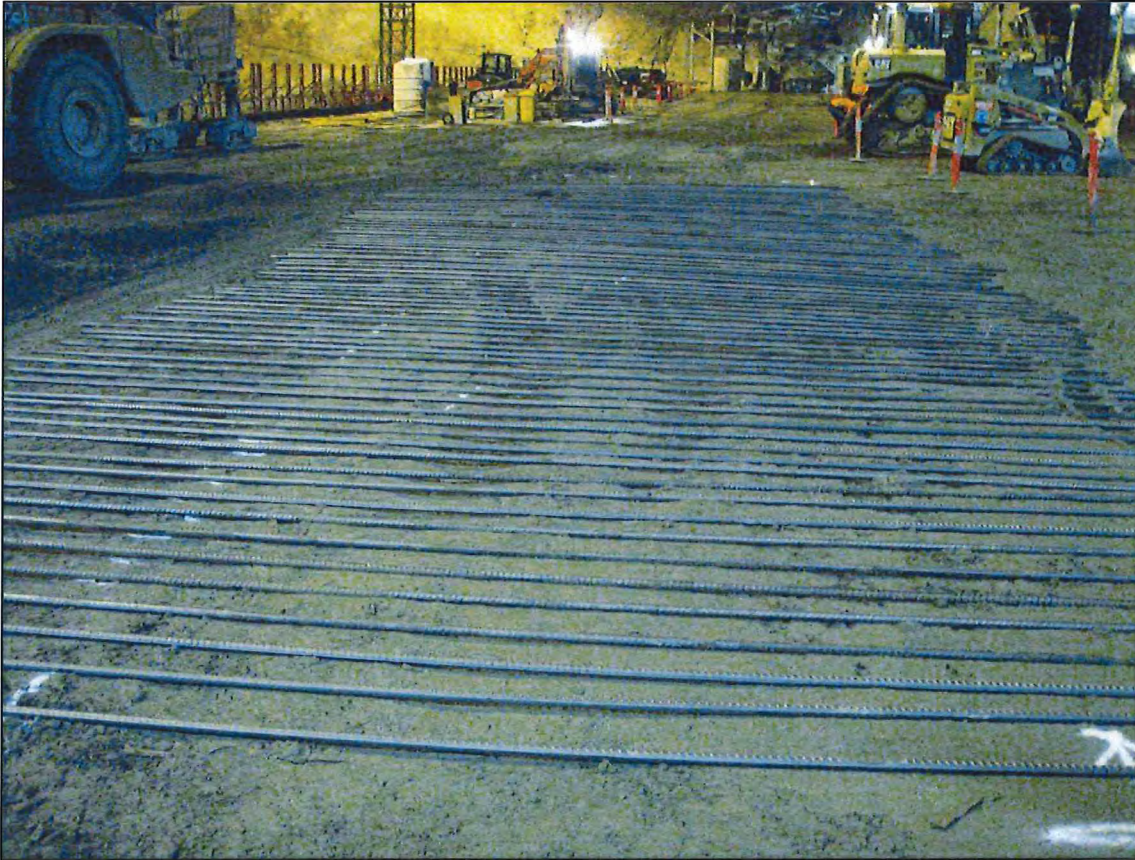
Photo D.10 N28 reinforcement placed abutment to abutment on cross valley cracks, shown here in Monolith G.
