APPENDIX B

**RCC PLACEMENT BY LANE METHOD – BWA’S PROPOSAL, TRP COMMENTS ON
PROPOSAL AND BWA’S PROPOSED SPECIFICATION CHANGES
25-27 JULY 2012**

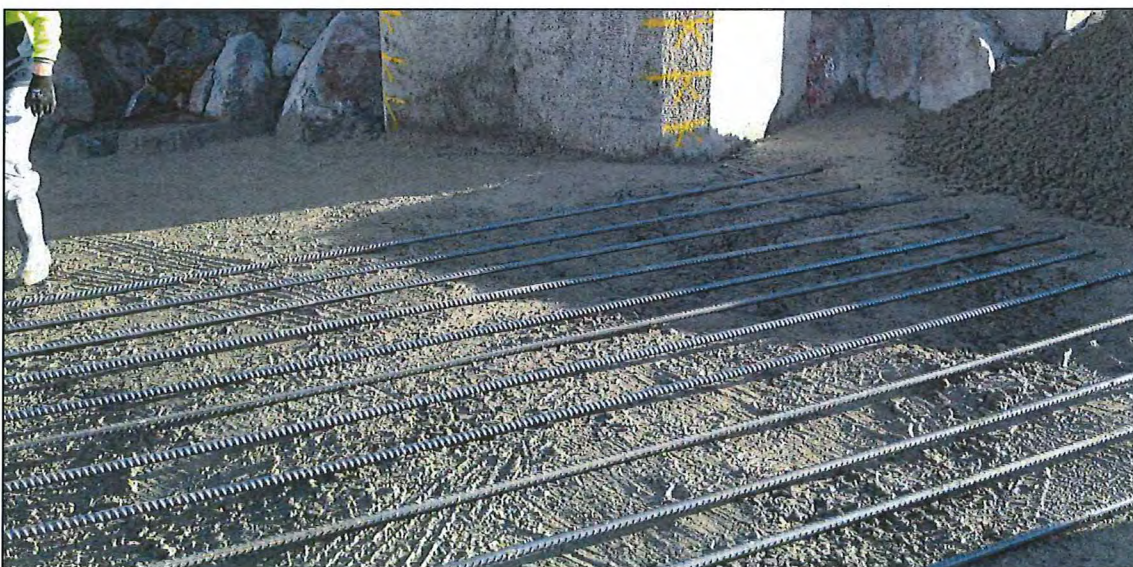
Photo D.11 – N28 reinforcement placed abutment to abutment on cross valley cracks, shown here in Monolith M.
