## Appendix E – SEM Inspection Report

24 August 2013

Re: Preliminary inspection and SEM sampling report for 25 Bradfield Street,  
Downer, ACT, 2602.

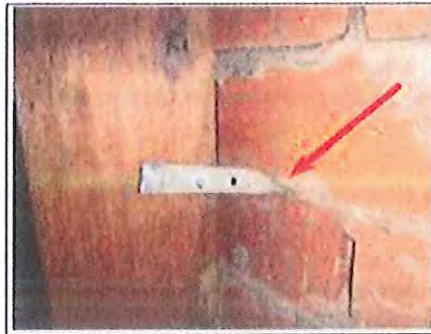
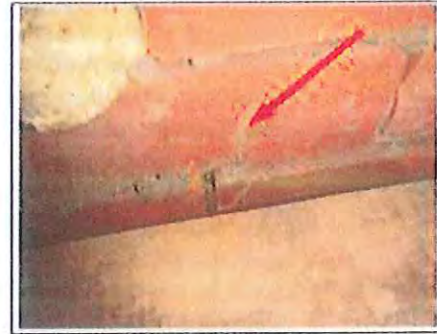
Sample Number	Description/Location	* Action rating	ACM type	Fibrous Content	Recommended Action
J0709 - SEM	Surface dust to rough mortar to eastern gable end brick wall	1A	Loose insulation	Amosite Asbestos	Spray heavily with sealant and demolish with effective dust control procedures
J0710 - SEM	Surface dust to wall bracing, stud and rafter timbers to north-eastern area	1A	Loose insulation	Amosite Asbestos	
J0711- SEM	Surface dust to smooth bricks to southern wall adjacent electrical switchboard recess	1A	Loose insulation	Amosite Asbestos

**Photographs 1 and 2:** Eastern gable end brick wall, surface dust to rough mortar. Surface dust sample location – sample J0709

All surfaces to all building materials of the residence must be heavily sprayed with a binding sealant prior to demolition. Effective dust control procedures must be implemented during all phases of the demolition and during the removal of 300mm of topsoil to the residential Block, 25 Bradfield Street, Downer.

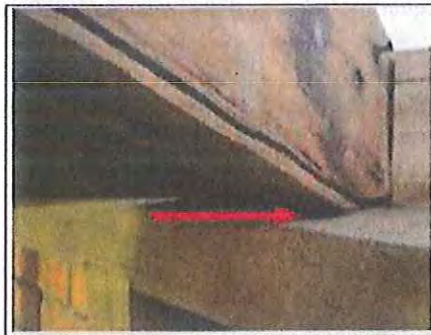
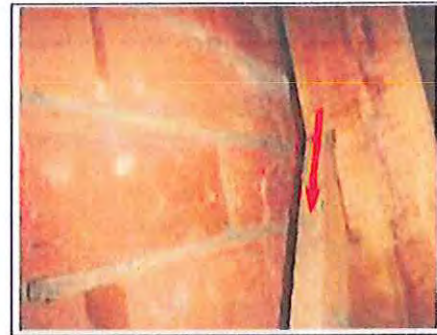
**Photographs 3 and 4:** North-eastern area wall, surface dust to wall bracing, stud and rafter timbers. Surface dust sample location – sample J0710

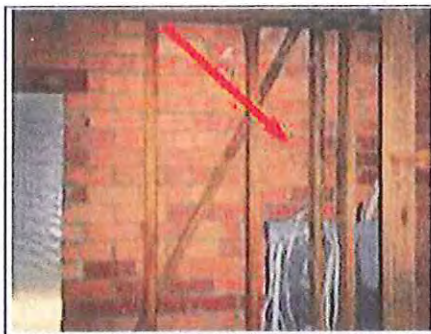
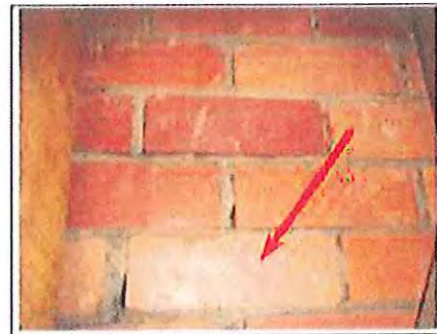
**Photographs 5 and 6:** Southern side brick wall, surface dust to smooth bricks adjacent electrical switchboard recess. Surface dust sample location – sample J0711

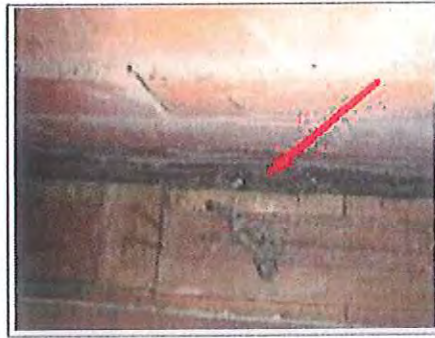
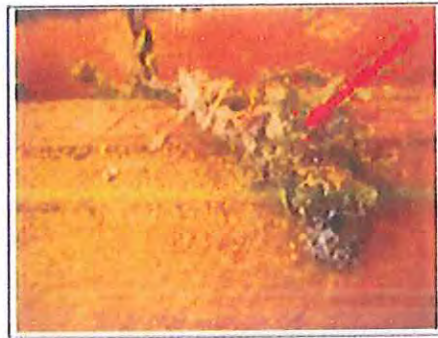
An inspection of the base of the perimeter wall cavities below floor level revealed clumps of insulation consistent with amosite asbestos. The migration, spread and settling of the loose asbestos insulation in the house is extensive and has migrated from the ceiling space to the bottom of the perimeter timber stud walls and into the sub-floor space, including adjacent wet area floor waste locations.

**Photographs 7 and 8:** Wall cavity and clump of asbestos insulation collected from cavity resting on stud wall timber base plate.

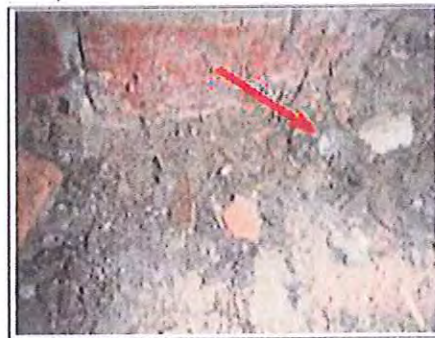
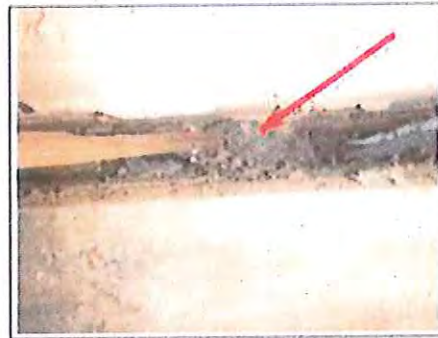
**Photographs 9 and 10:** Clumps of loose asbestos resting on the floor of the sub-floor space and in the perimeter wall cavity.

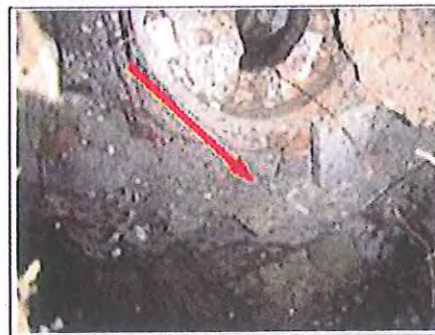
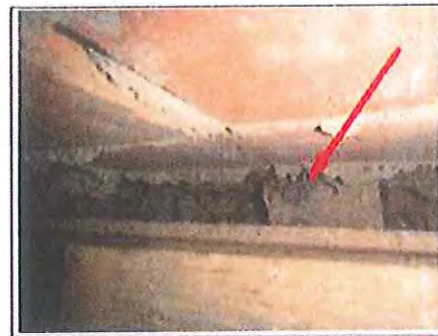
**Photographs 11 and 12:** Clumps of loose asbestos resting on the floor of the sub-floor space adjacent sewer and in the perimeter wall cavity.

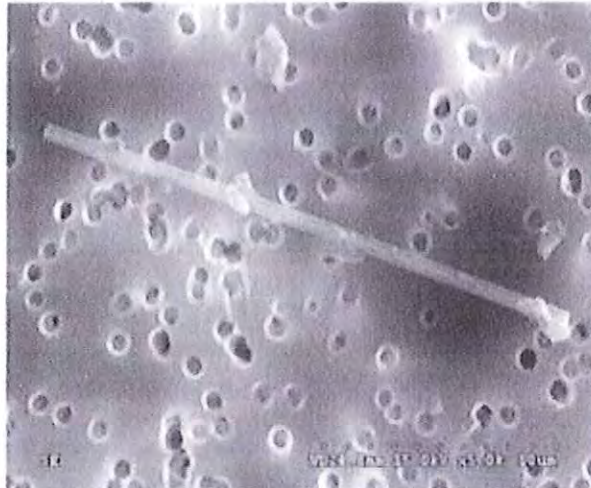
Fig 1: SEM micrograph of an Amosite fibre using the secondary electron signal (SE)

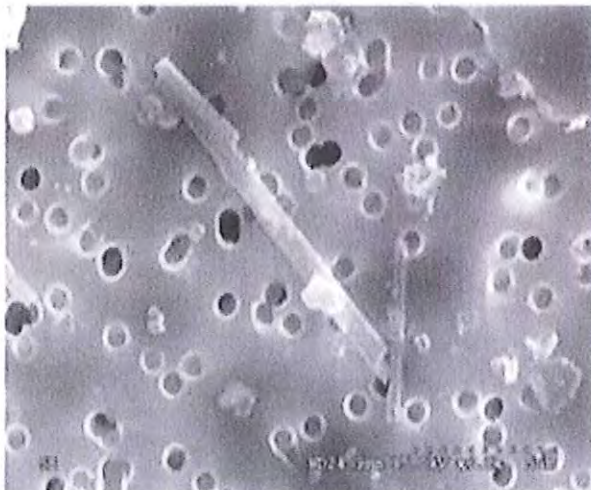
Fig 2: SEM micrograph of an Amosite fibre using the secondary electron signal (SE)

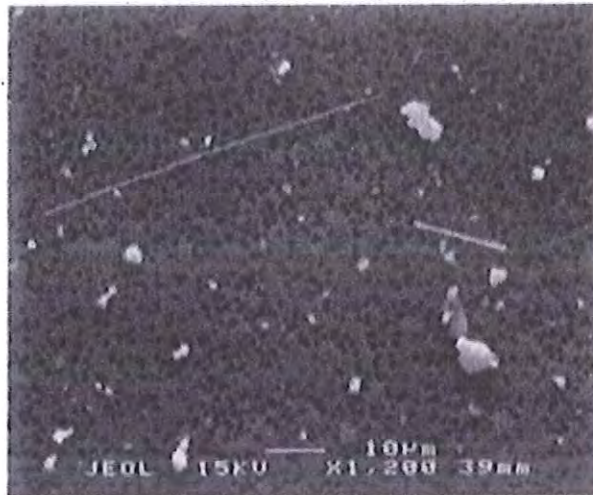
Fig 3: SEM micrograph of a typical Amosite fibre, using the backscattered electron signal (BSE)

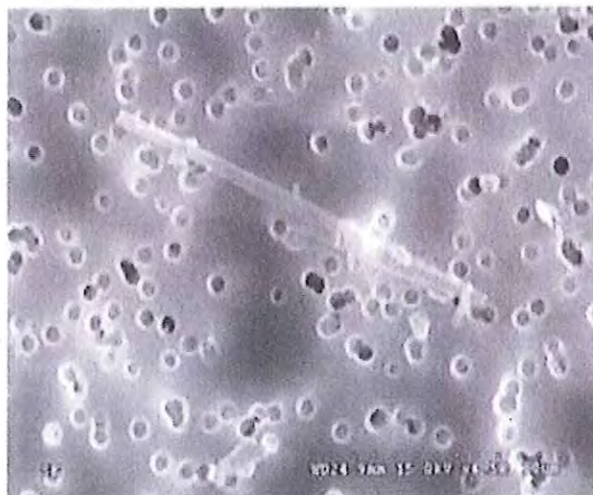
Fig 4: SEM micrograph of an Amosite fibre using the secondary electron signal (SE)

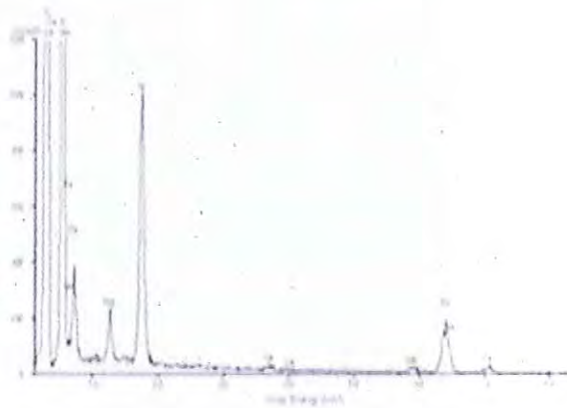
Fig 5 X-ray spectrum from a typical 'clean' Amosite fibre found in samples J0709 and J0710

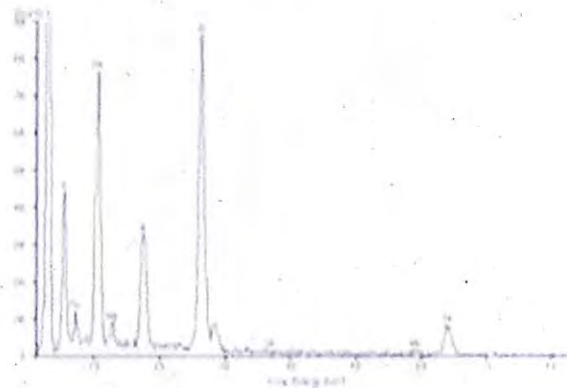
- (a) Fibres were found on all filters examined. Some typical images and spectra are shown in the attached figures below. Most fibres analysed contained significant Si and Fe with lesser amounts of Mn and Mg. In the case of filter J0711-ISEM many fibres also showed additional Na and Cl, thought to be due to some form of contamination from the environment. Semi quantitative analysis performed on a range of fibres indicate a (Fe+Mg+Mn) to Si ratio of around 7.5 : 7.5 when based on a total of 15 cations. This appears to be largely consistent with the asbestos form of Grunerite  $(\text{Fe}, \text{Mg}, \text{Mn})_3(\text{Si}_2\text{O}_7)_2(\text{OH})_2$  a variety of Amosite asbestos.

Fig 5 X-ray spectrum from a fibre in sample J0711 showing significant Na and Cl contamination. Mg, Si, Fe and Mn peak ratios remain the same as in samples J0709 and J0710, suggesting these fibres are also Amosite asbestos
