Parkes Way Bridge Widening  
Roads ACT  
15 September 2010

# Load Rating of the Clunies Ross and Sullivans Creek Bridges

Prepared for  
Roads ACT

15 September 2010

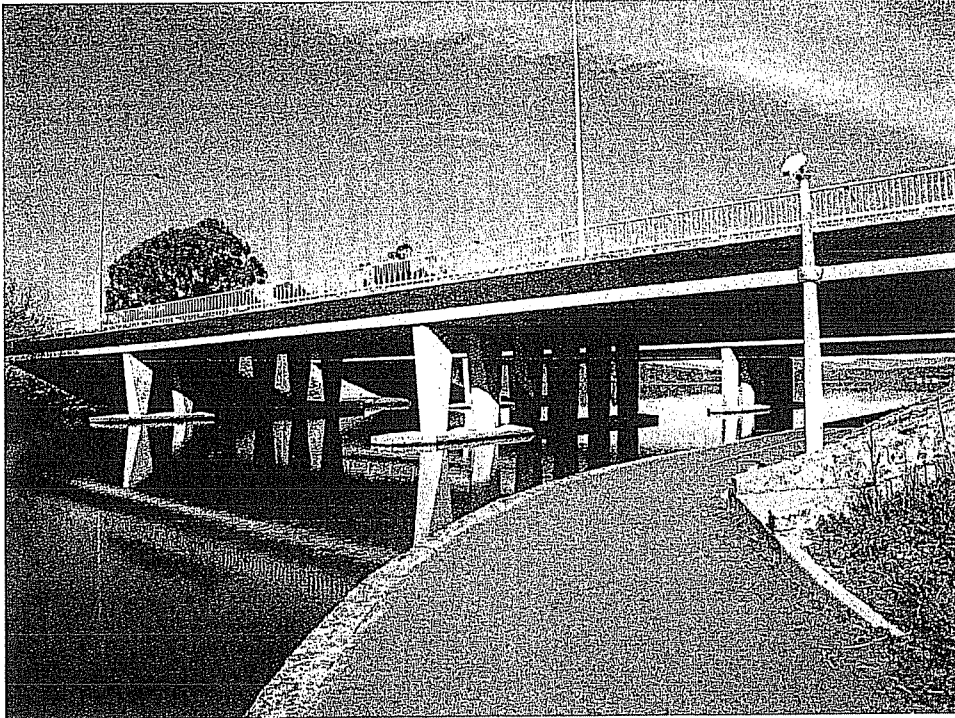
Item	Component	Condition	Comments	Repairs Required	Photos		
1.	Footings	NI	Pile caps - binocular inspection, OK		Photo 1		
		NI	Abutment footings not visible

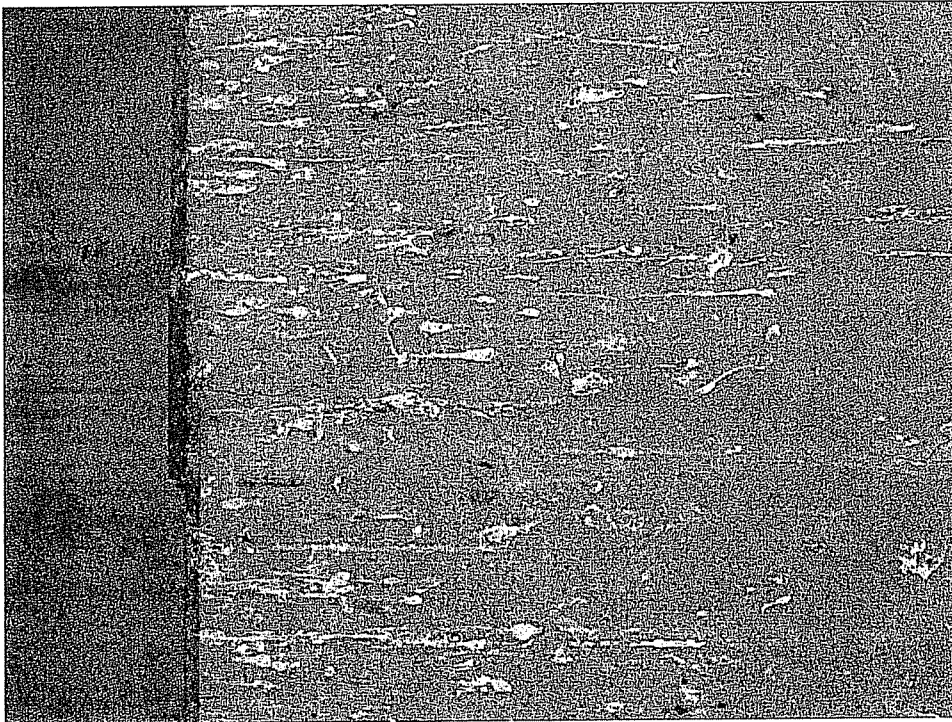
2.	Abutment / Restraints	A	1	Minor crack at top of shelf between girders G1 and G2		Photo 2	
			1	Vertical cracks between girders G3 and G4 and under g4, full height of abutment			
			1	water stains on face of abutment and down batter slope		Photo 3	
		B	1	Repaired vertical cracks at girder G4		Photo 4	
			1	minor vertical crack at girder G5		Photo 5	
			1	some staining on back wall of abutment; notably at location where drainage/services penetrate wall; possible water penetrating at expansion joint	Investigate source of water	Photo 6

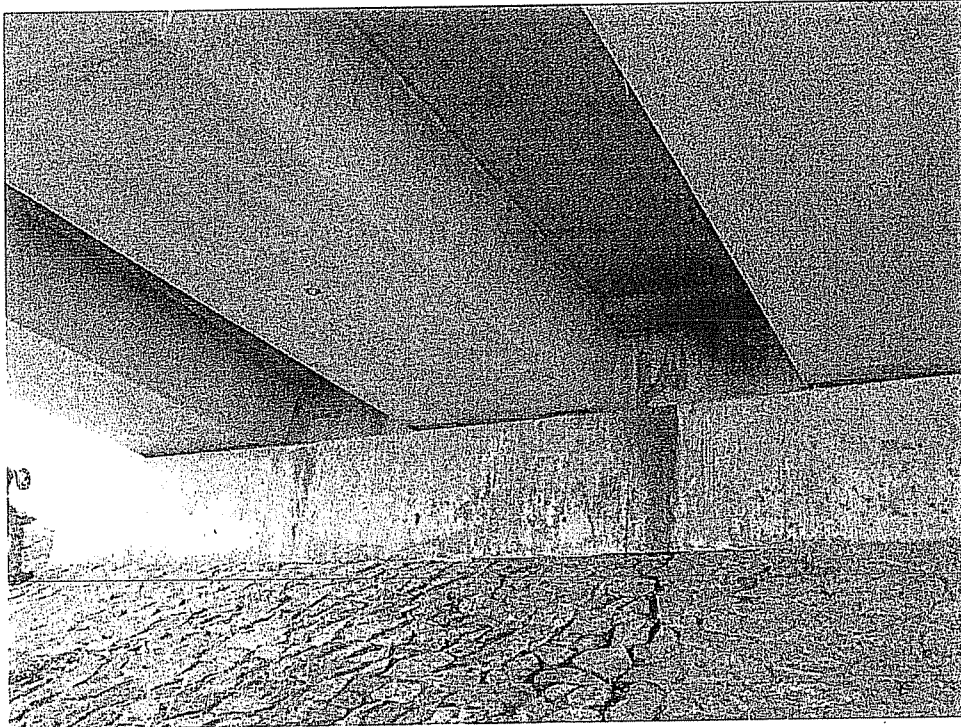
3.	Batter Protection	Abut A	2	Some leaching through back wall		Photo 7	
			1	Some vegetation		Photo 8	
4.	Piers / Restraints	Abut B	1	water stains on face of abutment and down batter slope		Photo 3	
			1	OK

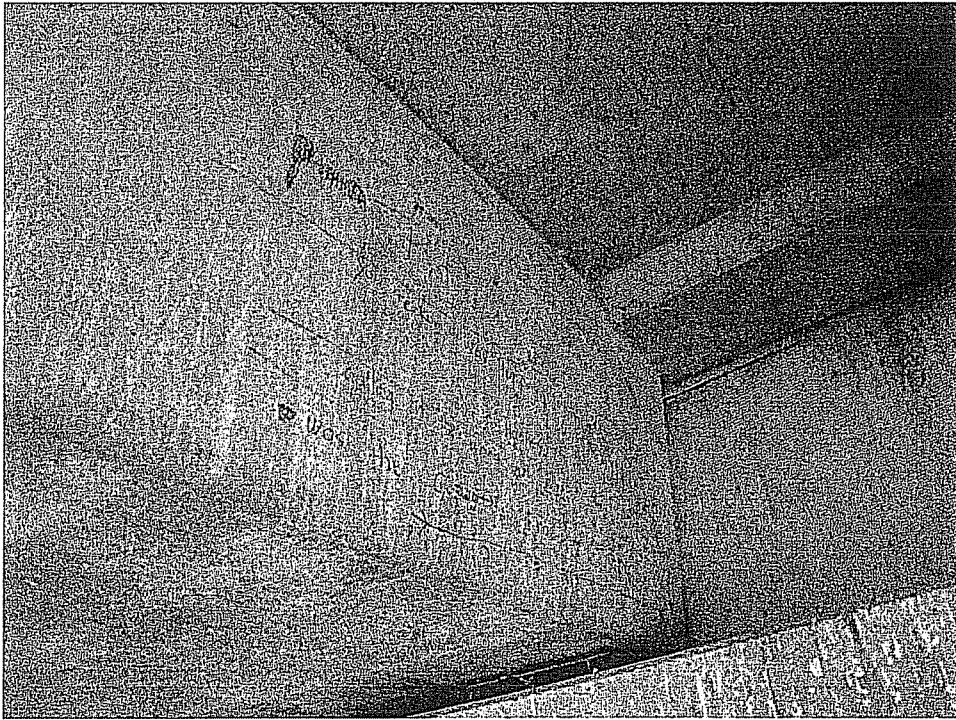
5.	Girders	S1	1	OK, binocular inspection			
			2	OK, binocular inspection			
5.	Girders	S1	1	Graffiti on girders near abutment	Clean graffiti	Photo 9	
			2	leachate on girder G3 @ slab/girder joint		Photo 10	
		S2					Photo 11
			1	minor cracks in top of footpath slab over Piers 1 and 2			
		2	evidence of crack (leachate) on soffit of girder G1 top flange at Pier 2	monitor cracking		Photo 12	
		S3	1	Graffiti on girder G3 at abutment			
1	efflorescence stains on soffit of girder G1 N/S flange				Photo 13
