**Bulk Water
Alliance**

Memorandum

SUBJECT ECD – Thermal Analysis – Cracked Section

Interim Incident Report – Cotter Dam flooding during construction – 1 March – 5 March 2012

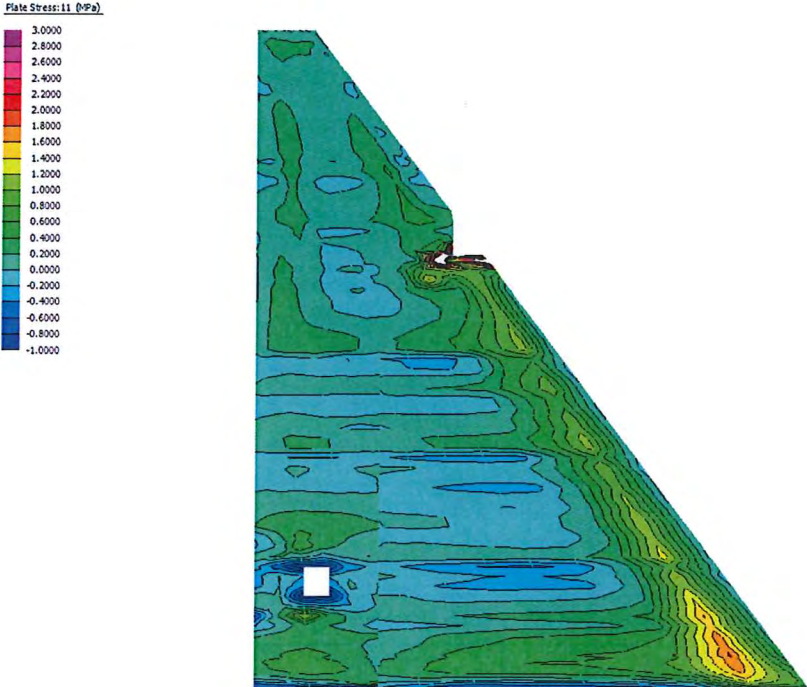
Figure 1 Maximum Principal Stresses at Summer 2012/3 (End of Construction)

As can be seen in the above plots, significant tensile stresses will not be developed above the crack. The maximum principal tensile stress occurs in the summer of 2031/2, with a magnitude of approximately 1 MPa, (within the capacity of the concrete). Stress concentrations may develop at the tip of the crack, however the sand "crack stopper" will reduce the risk of it propagating and the reinforcement will provide additional tensile strength in this vulnerable area.

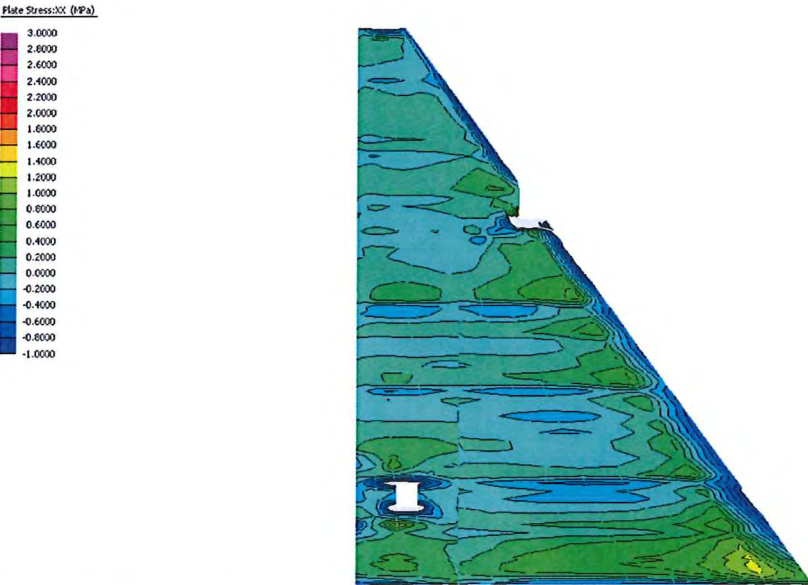
Figure 4 - Upstream – Downstream Stresses Sxx at Summer 2012/3 (End of Construction)

Furthermore it would appear that the aerator step does not cause stress concentrations and therefore this should not promote the extension of the existing crack.

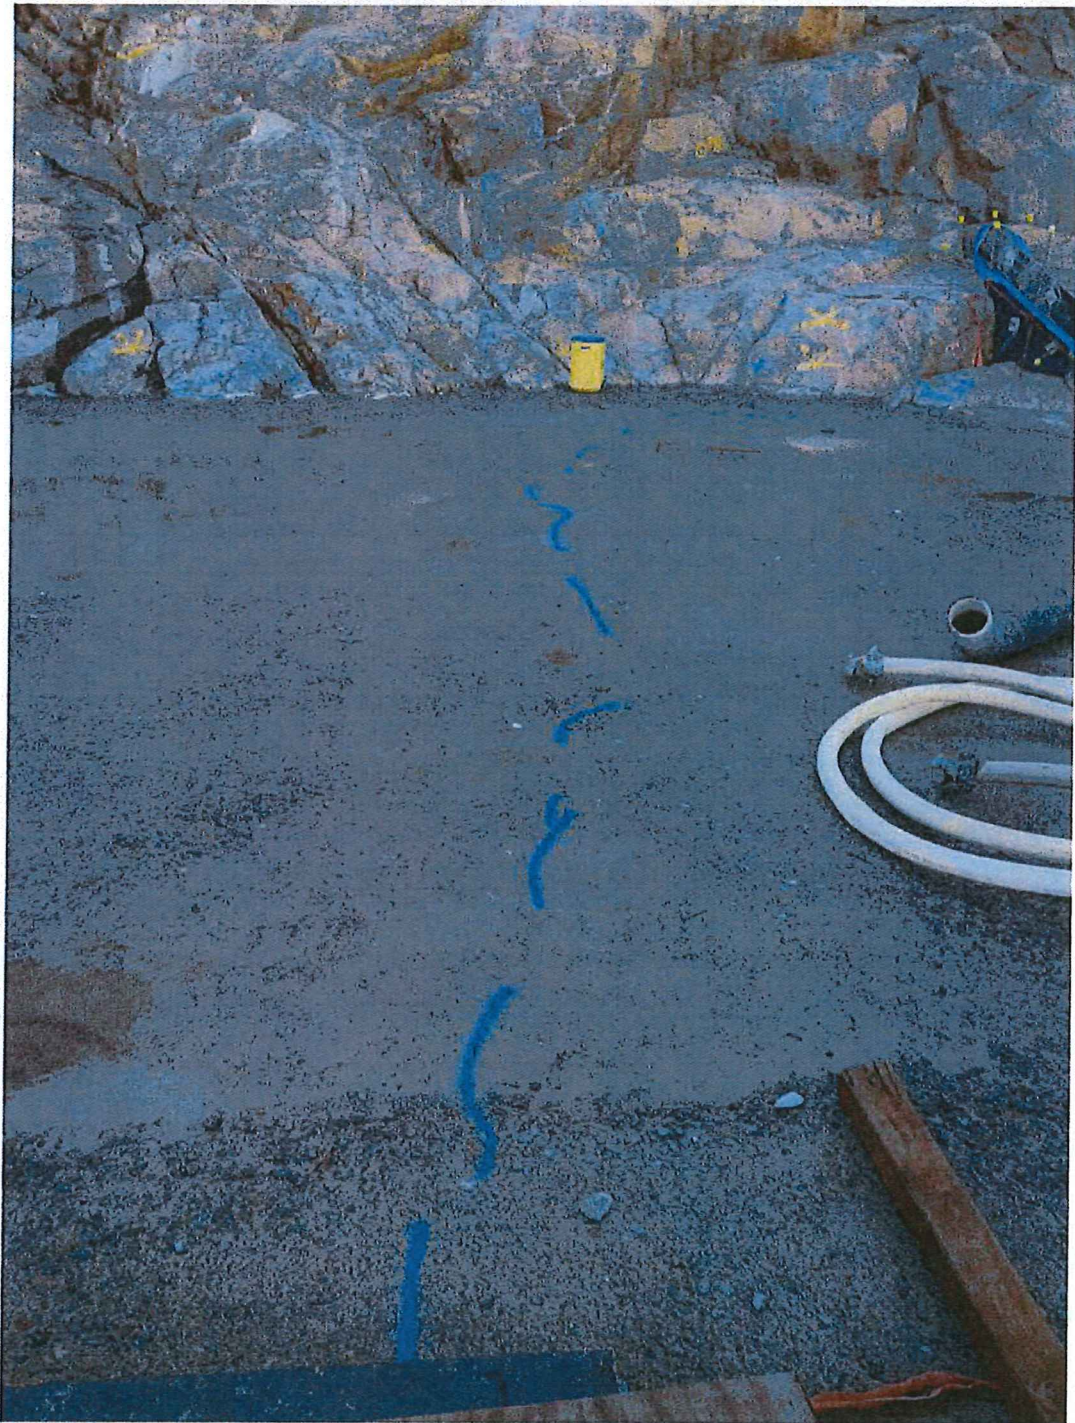
Photo 1 - Cross valley crack in Monolith D. Taken looking towards left abutment.

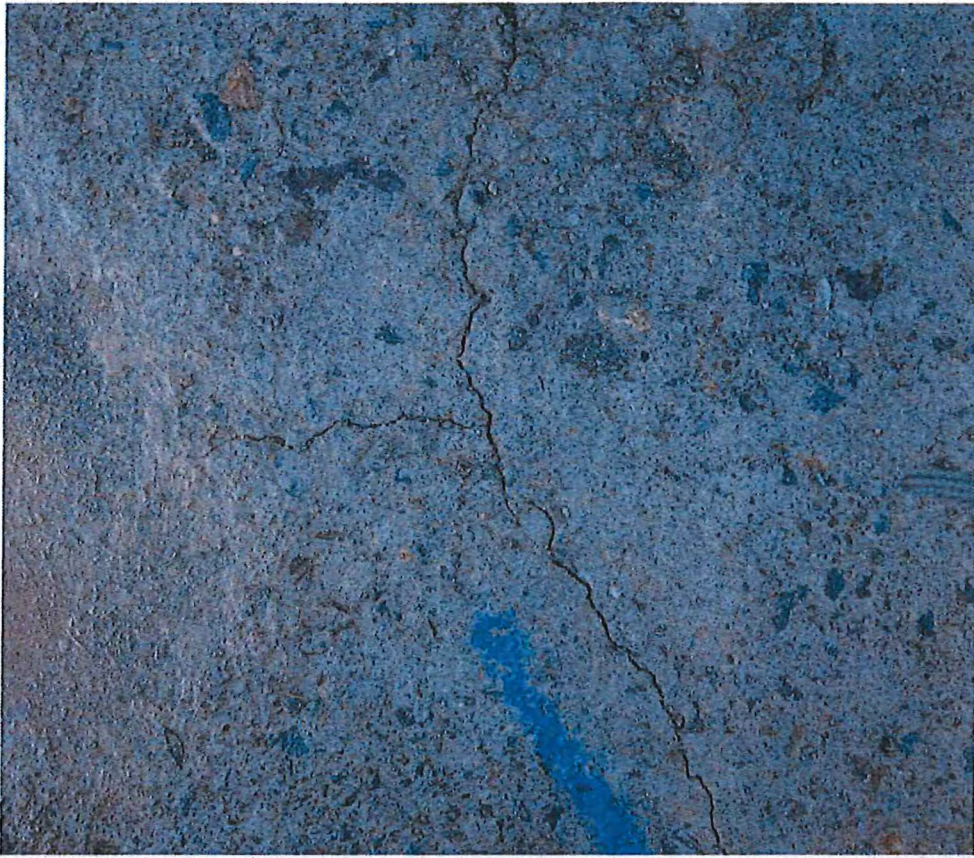
Photo 2 – Bifurcation of upstream downstream crack with cross valley crack.

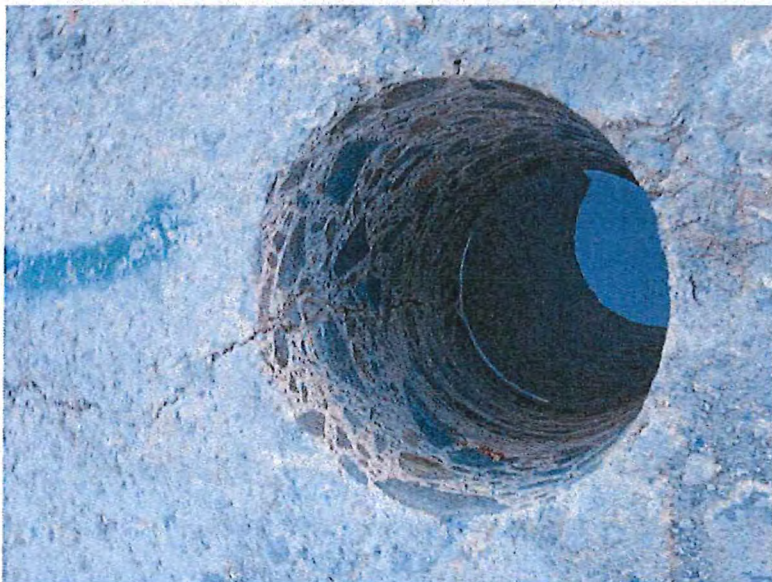
Photo 3 – 150mm core through upstream-downstream crack.
