Report on
Geotechnical Assessment – Urban Capability

Proposed Subdivision
Blocks 1605 – 1607, West Belconnen, ACT

Prepared for
The Riverview Group

Project 77356
February 2014

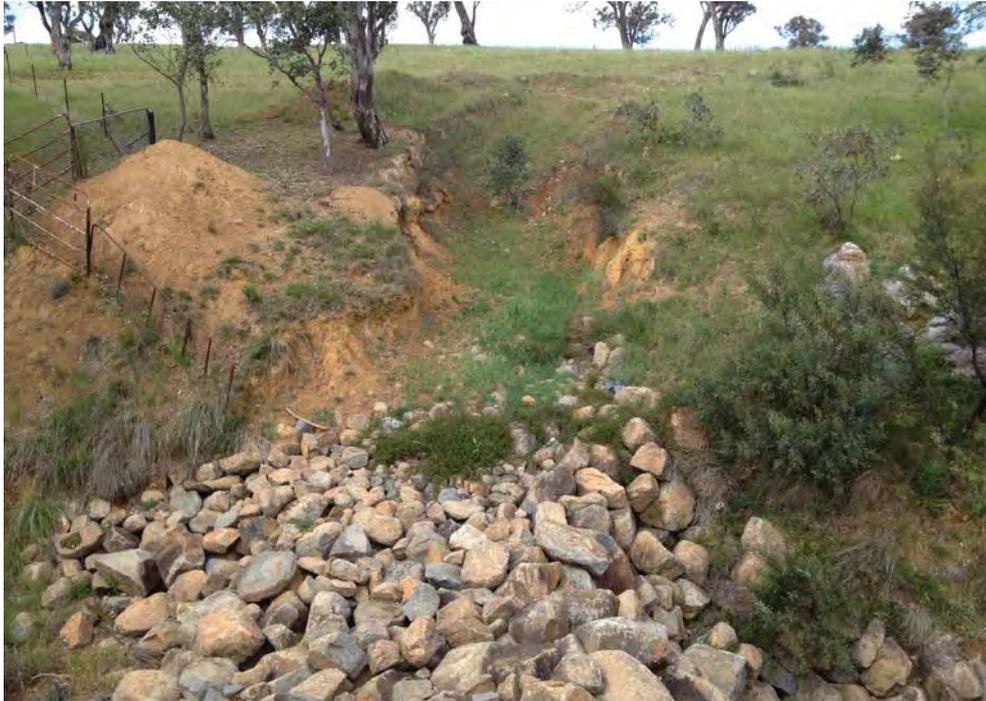
Photo A37 – Placed cobbles and modification of creek line. Refer Drawing 4 for locality and direction

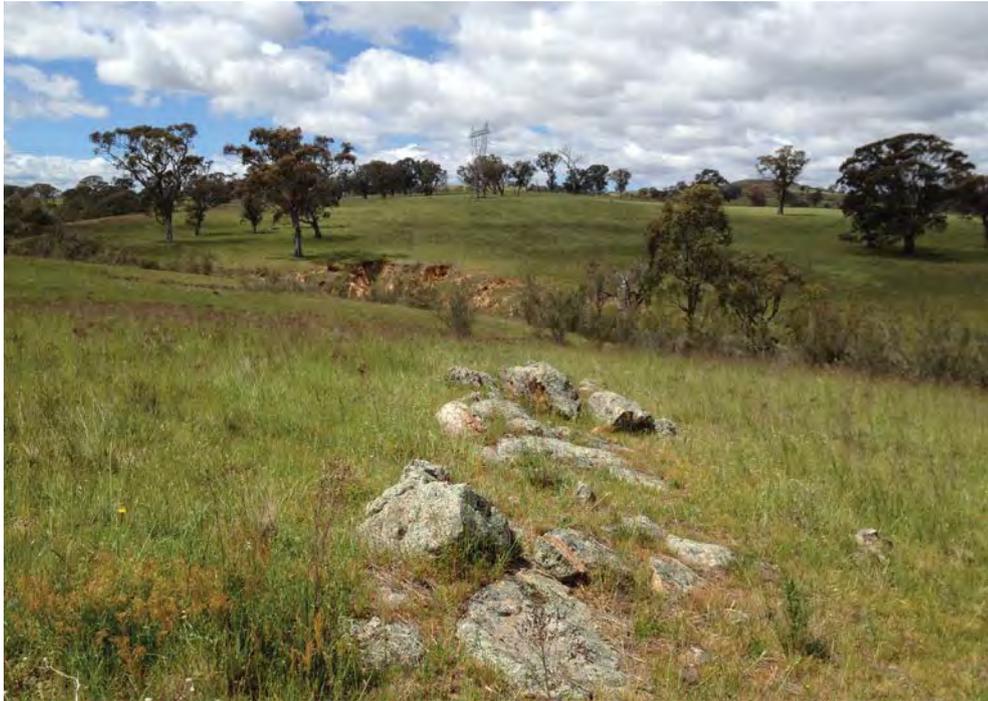
Photo A45 – Rock outcropping. Refer Drawing 4 for locality and direction

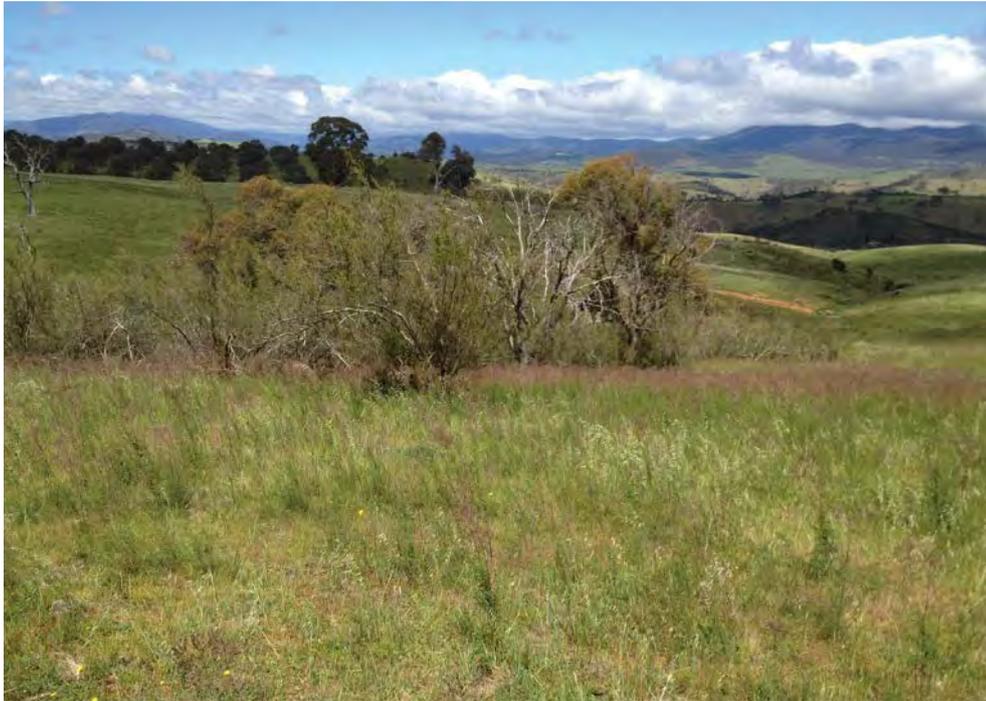
Photo A47 – Rock outcropping. Refer Drawing 4 for locality and direction

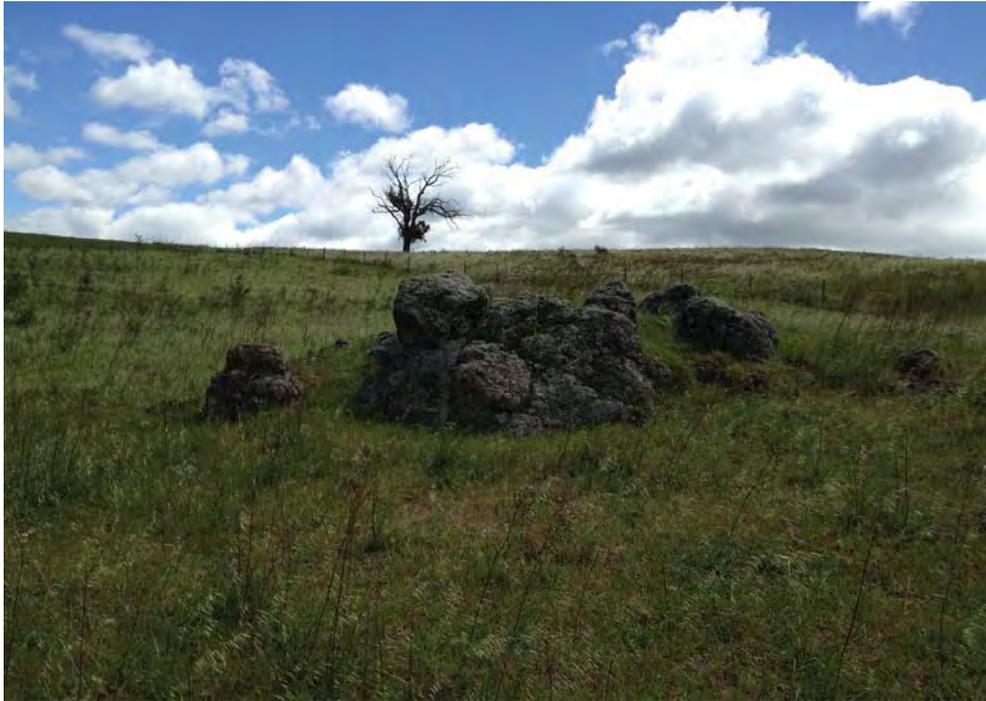
Photo A51 – Rock pillars. Refer Drawing 5 for locality and direction

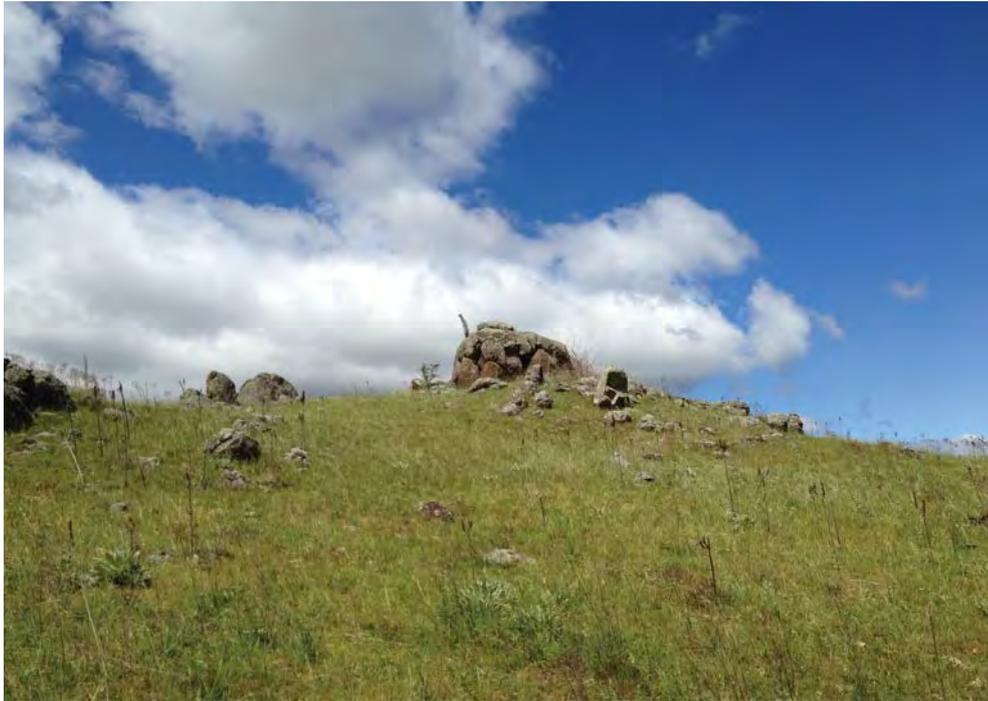
Photo A55 – Rock pillars. Refer Drawing 5 for locality and direction

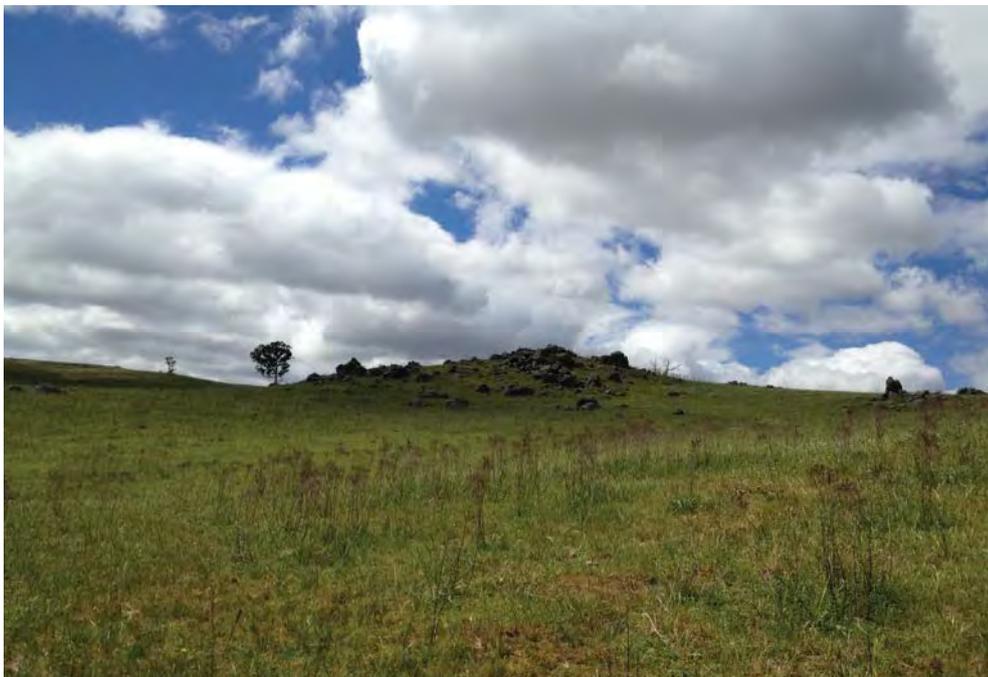
Photo A56– Rock pillars. Refer Drawing 5 for locality and direction

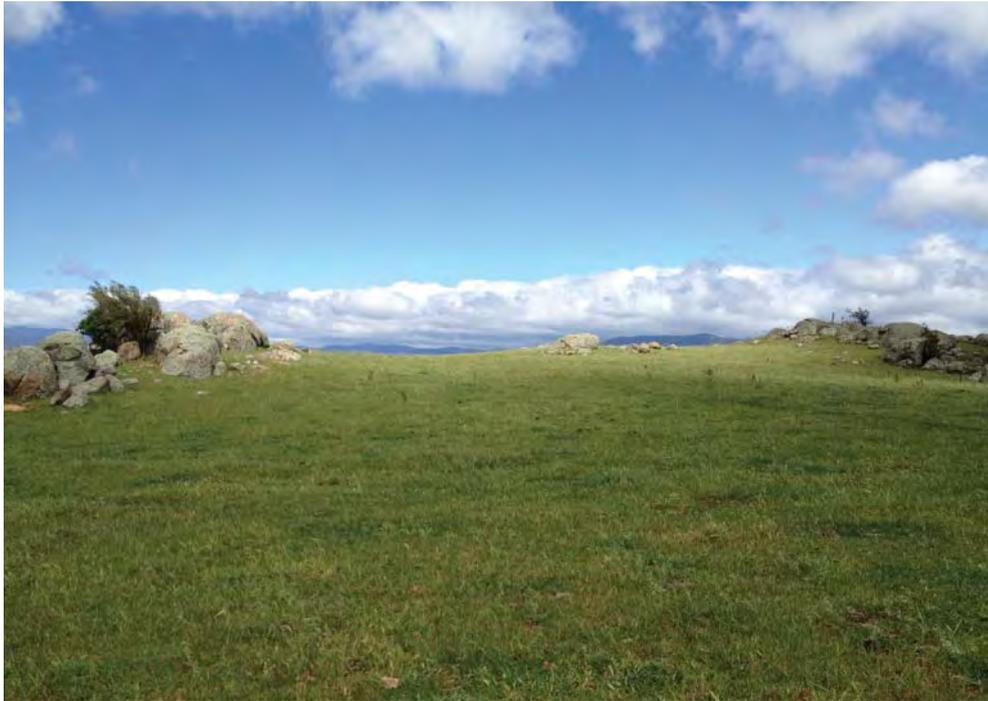
Photo A59 – Rock pillars. Refer Drawing 5 for locality and direction

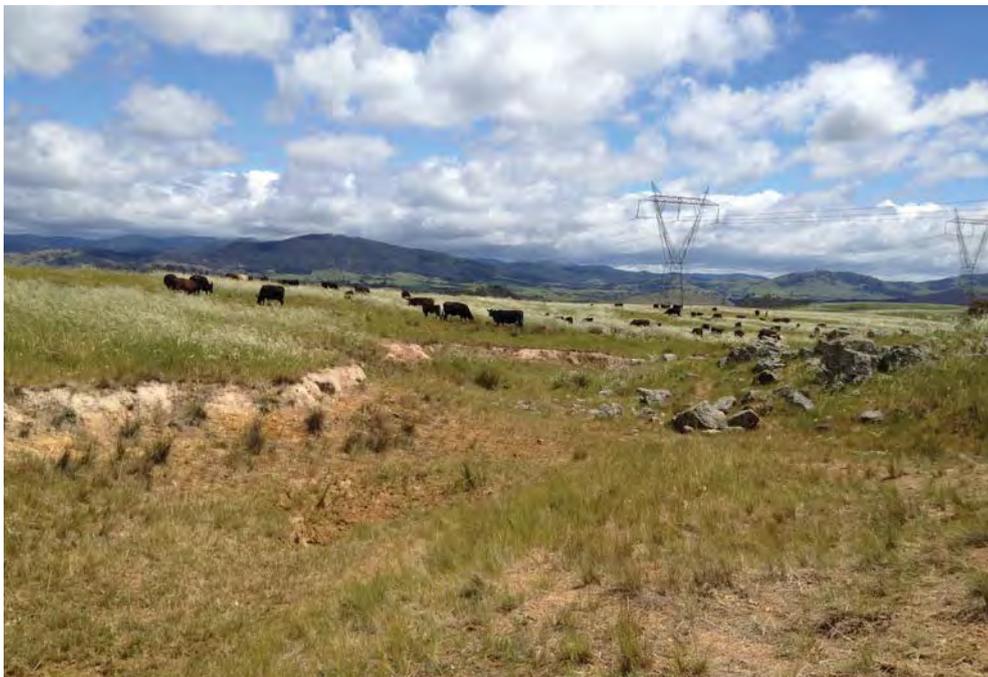
Photo A66– Erosion and rock outcropping in gully line. Refer Drawing 5 for locality and direction

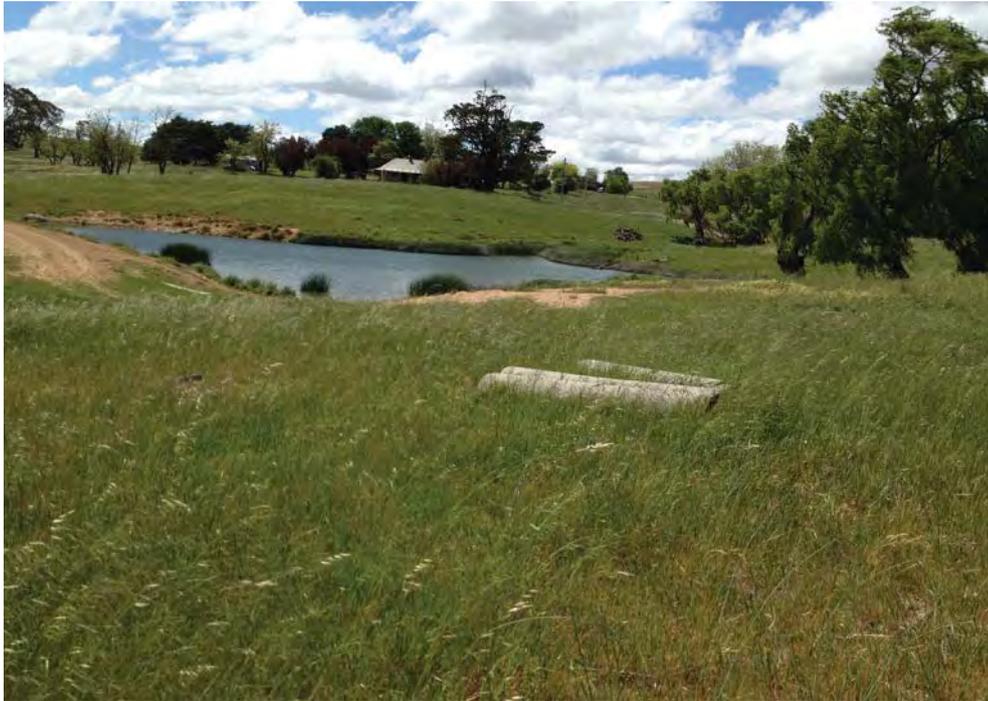
Photo A77 – Concrete pipes. Refer Drawing 5 for locality and direction

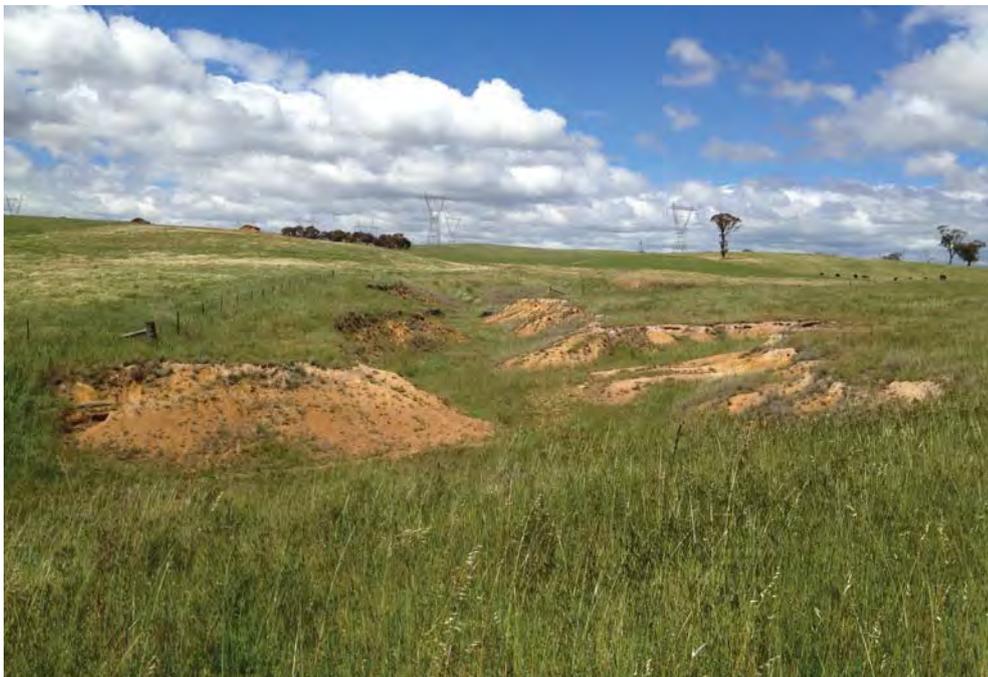
Erosion: Where the previous vegetation cover has been removed, which is mostly in gully lines, evidence of erosion ranging from slight to severe was observed.

Photo A78– Erosion in gully line. Refer Drawing 5 for locality and direction

- filling using select materials (i.e. non – dispersive or erodible) placed under controlled conditions;
- provision of temporary surface cover (e.g. pegged matting) during the period of valley floor revegetation;
- channel lining in sections of rapid change in gully floor grade;
- piping of flow where appropriate;
- the re-establishment of a zone of tree cover along gully banks.
