ACT
Government

Chief Minister, Treasury and
Economic Development

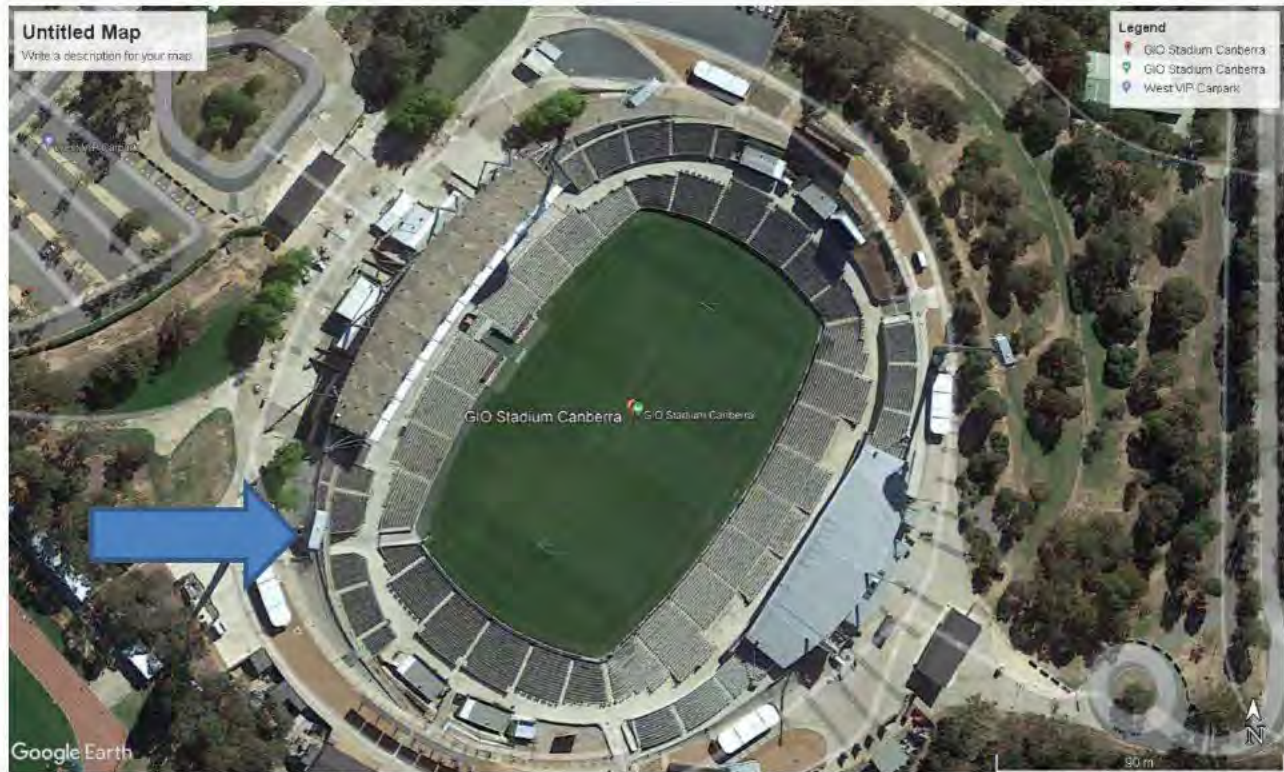
Aerial View on Stadium

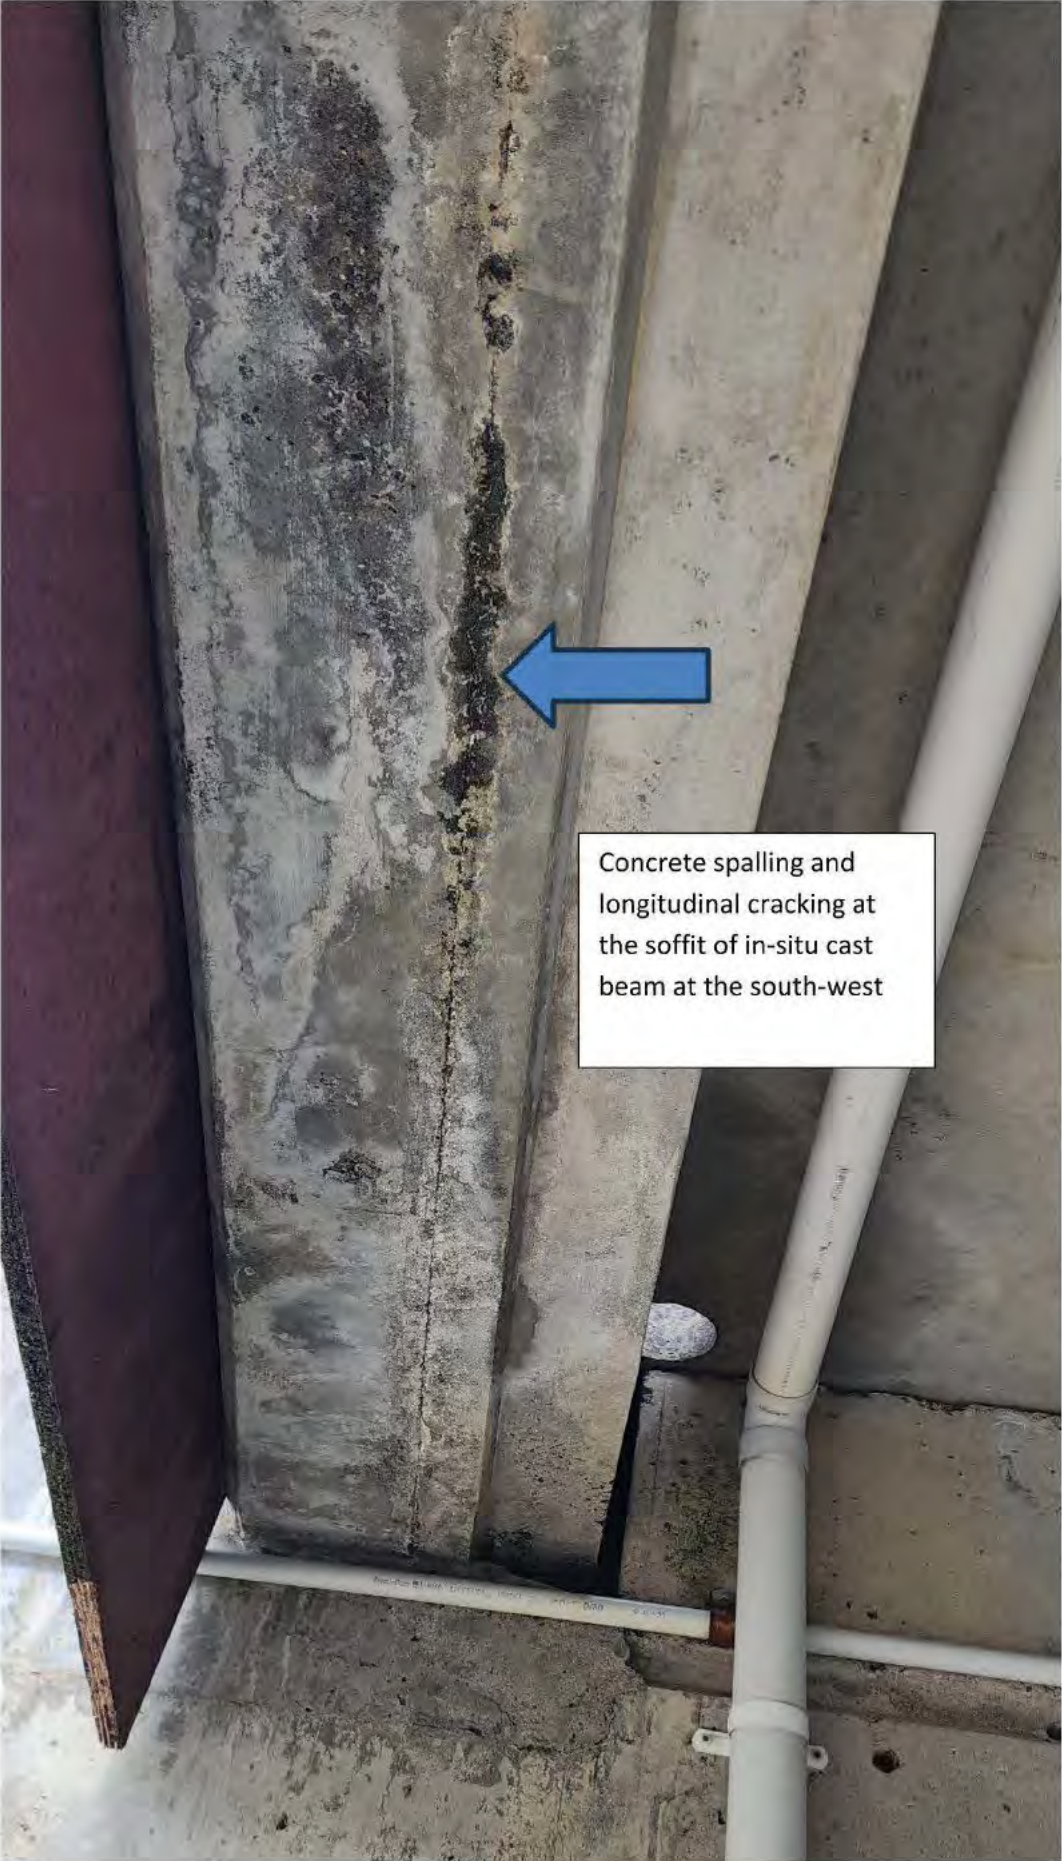
Concrete spalling and longitudinal cracking at the soffit of in-situ cast beam at the south-west

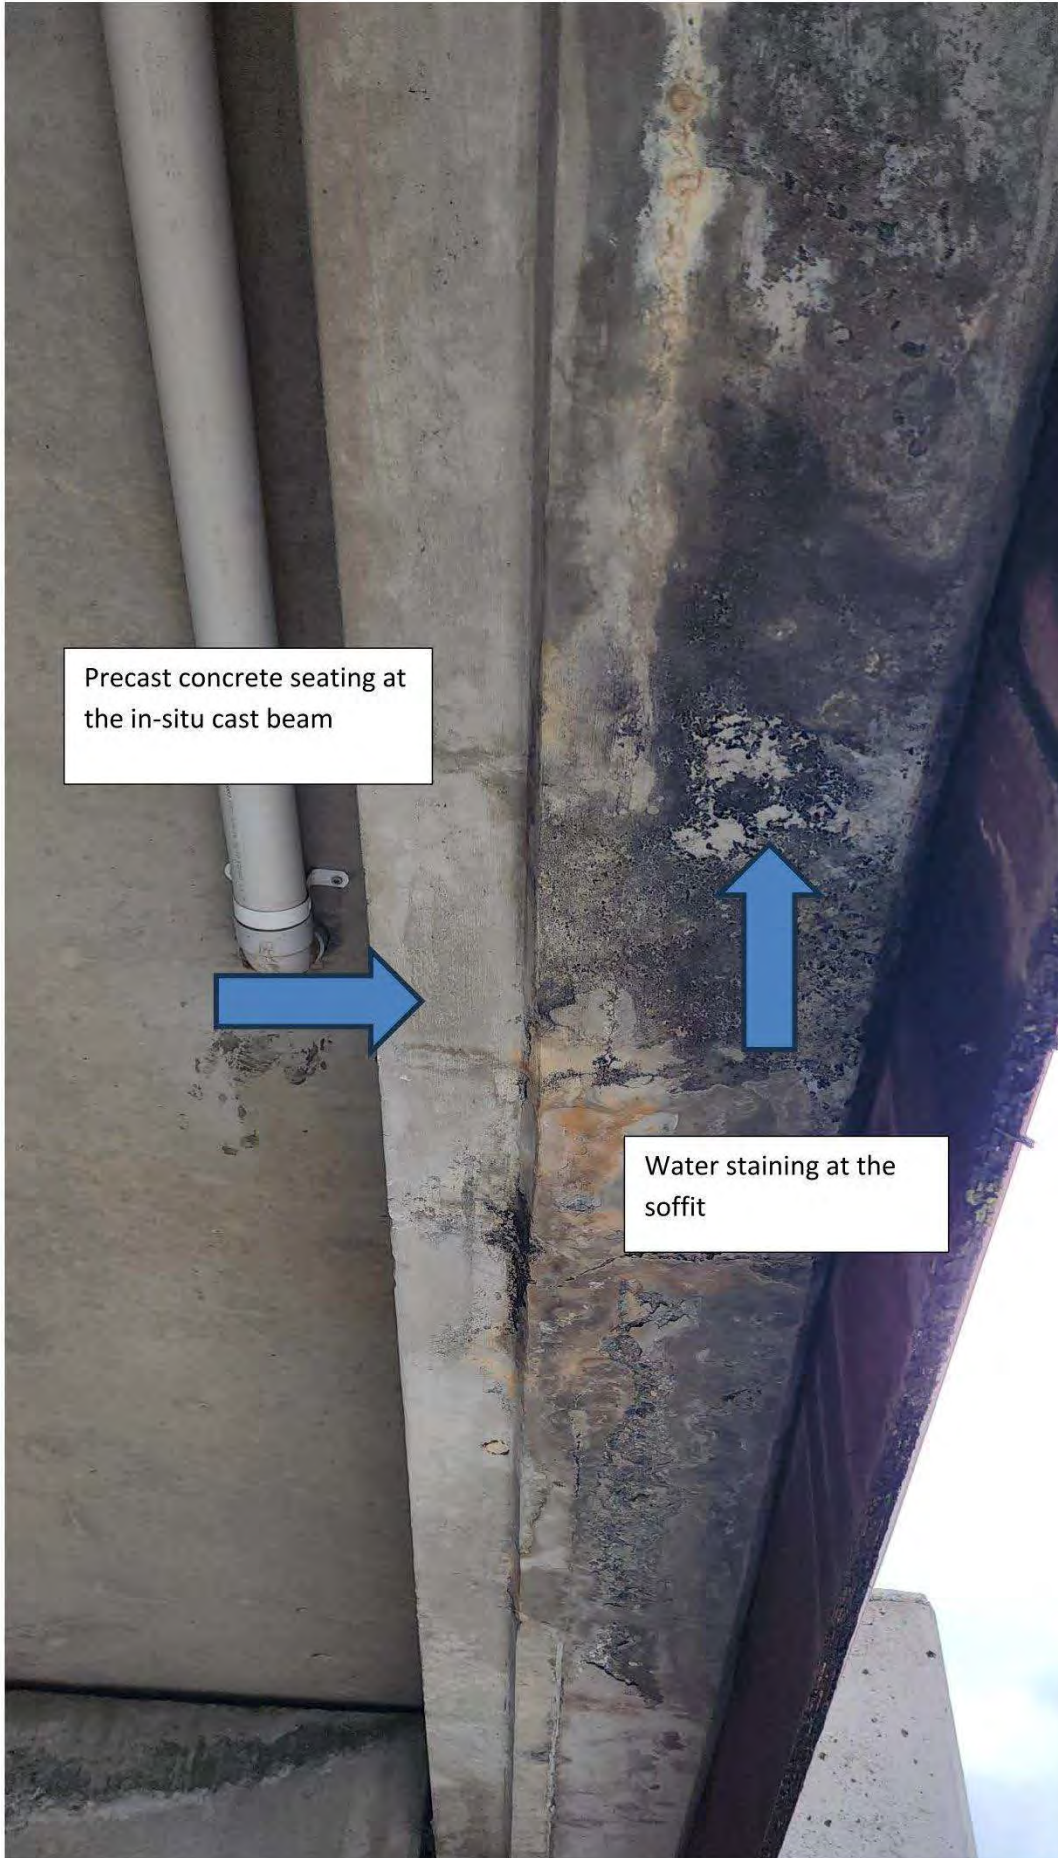
Precast concrete seating at the in-situ cast beam

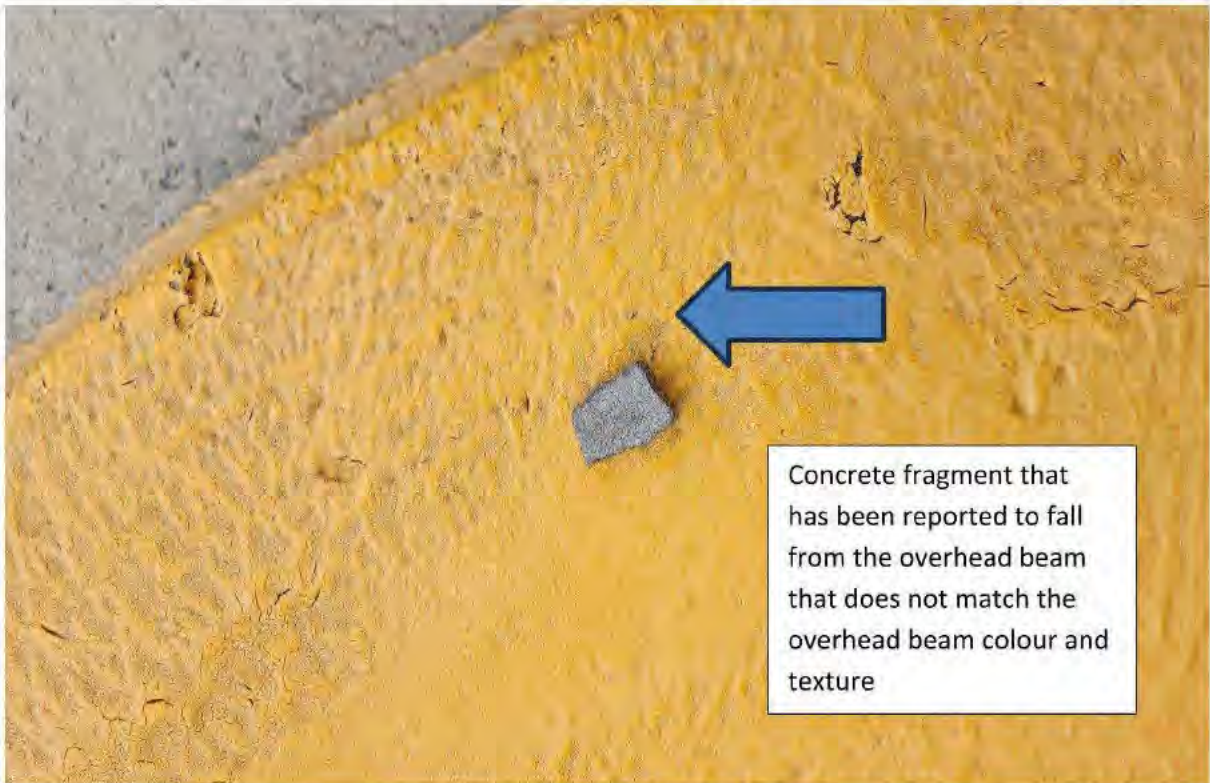
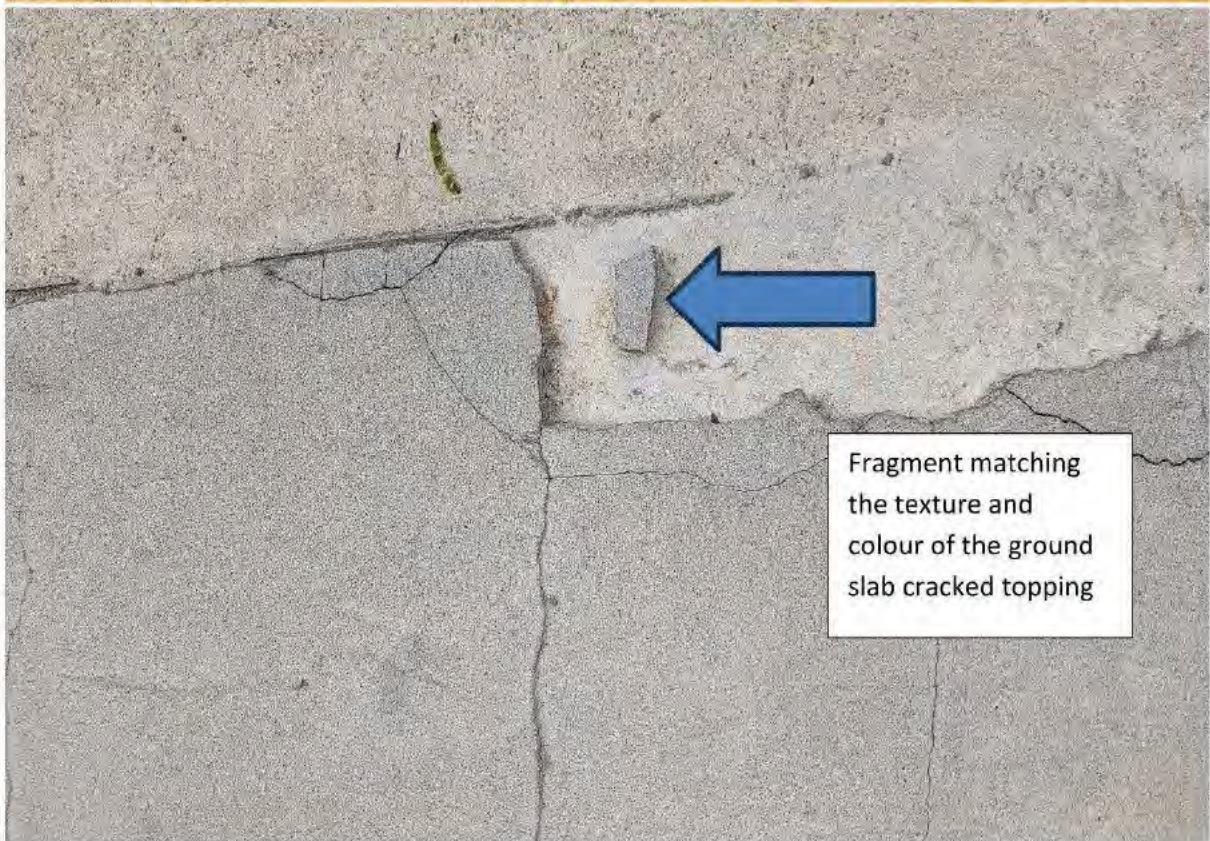
GIO STADIUM BRUCE ACT – SOUTHERN ENTRY OVERHEAD BEAM

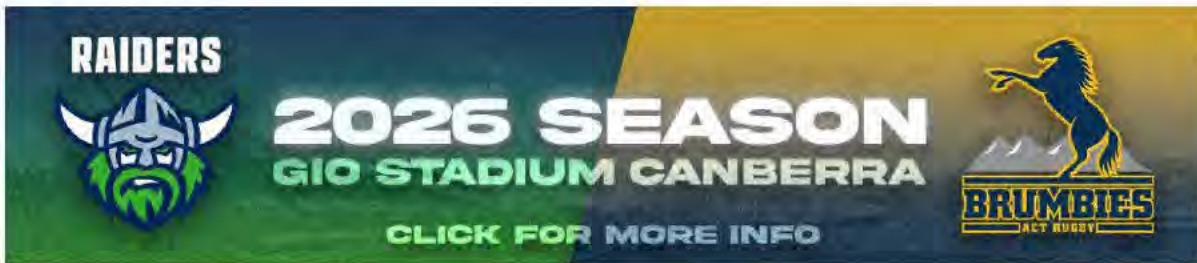
From: WorkSafe ACT <worksafe@worksafe.act.gov.au>
Sent: Tuesday, 24 March 2026 1:50 PM
To: Robertson, Alex <Alex.Robertson@act.gov.au>; Rando, Jared <Jared.Rando@act.gov.au>
Cc: Siwakoti, Sundar <Sundar.Siwakoti@worksafe.act.gov.au>
Subject: Work Place Visit - 00007428

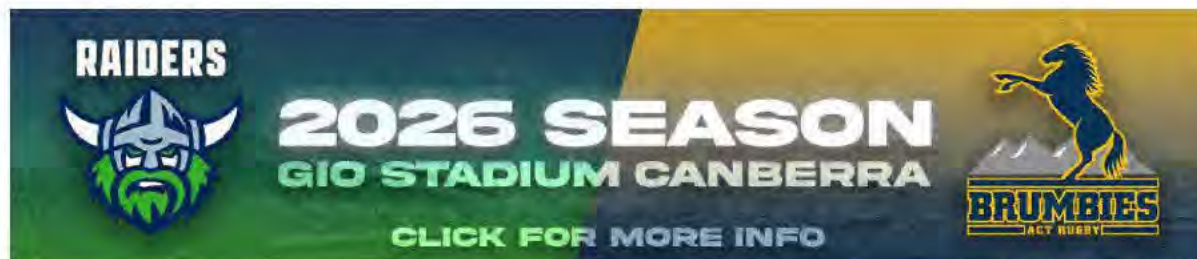
I acknowledge the Ngunnawal People as traditional custodians of the ACT and recognise any other people or families with connection to the lands of the ACT and region.
I acknowledge and respect their continuing culture and the contribution they make to the life of this city and this region.

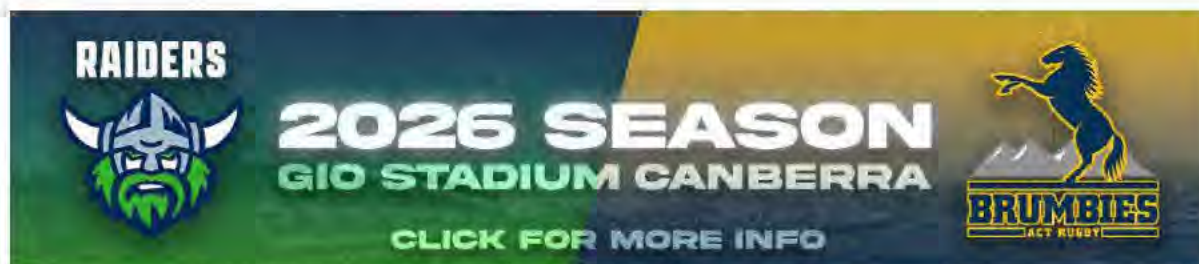
From: Siwakoti, Sundar <Sundar.Siwakoti@worksafe.act.gov.au>
Sent: Wednesday, 25 March 2026 7:55 AM
To: Rando, Jared <Jared.Rando@act.gov.au>
Cc: Gray, Adam <Adam.Gray@act.gov.au>; De Boni, Andrew <Andrew.deBoni@act.gov.au>
Subject: Re: Coaches Box Incident - GIO Stadium

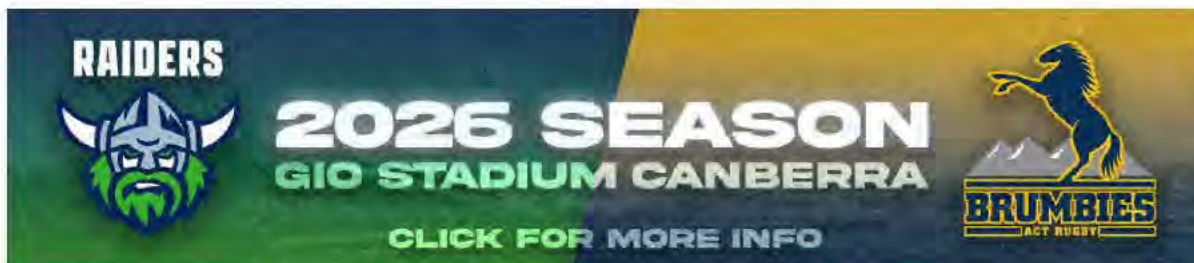
From: Elkins, Matthew
Sent: Wednesday, 25 March 2026 2:30 PM
To: De Boni, Andrew ; Orr, Melissa ; Bonny, Carly ; Gray, Adam
Cc: Bailey, Daniel
Subject: RE: GIO Stadium

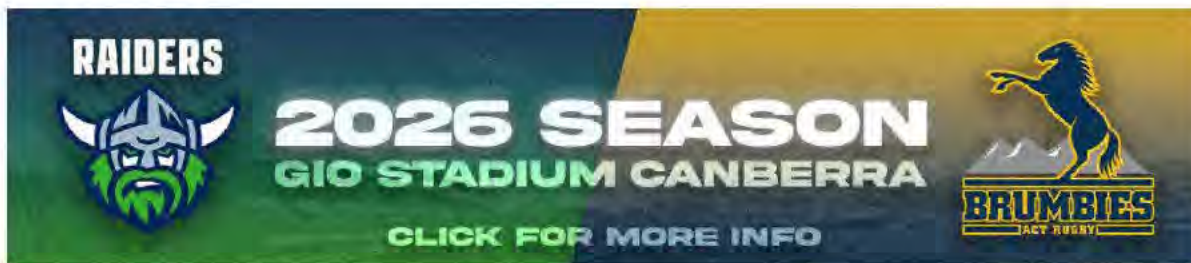
From: Elkins, Matthew <Matthew.Elkins@act.gov.au>

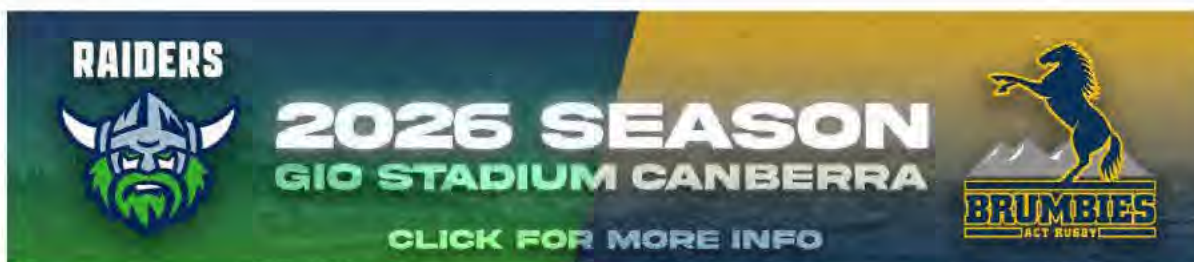
From: Elkins, Matthew
Sent: Wednesday, 25 March 2026 8:51 AM
To: Gray, Adam ; De Boni, Andrew ; Orr, Melissa ; Bonny, Carly
Cc: Bailey, Daniel
Subject: Information required

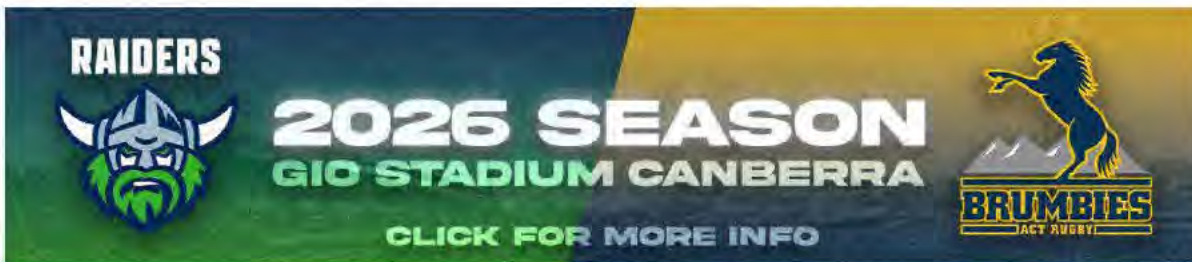
I acknowledge the Ngunnawal People as traditional custodians of the ACT and recognise any other people or families with connection to the lands of the ACT and region.
I acknowledge and respect their continuing culture and the contribution they make to the life of this city and this region.

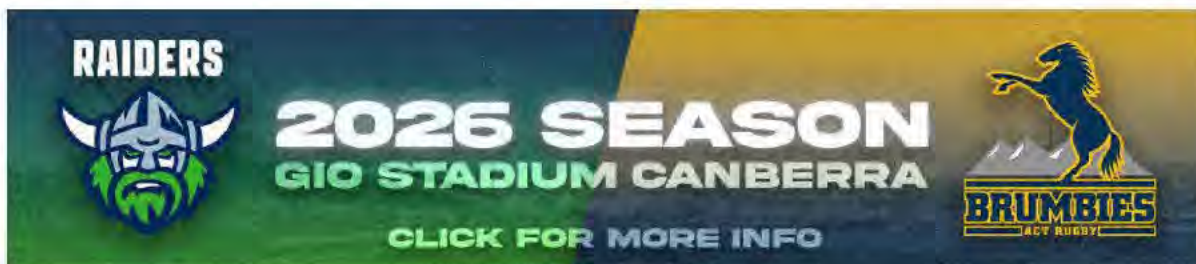
From: Elkins, Matthew <Matthew.Elkins@act.gov.au>
Sent: Wednesday, 25 March 2026 8:51 AM
To: Gray, Adam <Adam.Gray@act.gov.au>; De Boni, Andrew <Andrew.deBoni@act.gov.au>; Orr, Melissa <Melissa.Orr@act.gov.au>; Bonny, Carly <Carly.Bonny@act.gov.au>
Cc: Bailey, Daniel <Daniel.Bailey@act.gov.au>
Subject: Information required

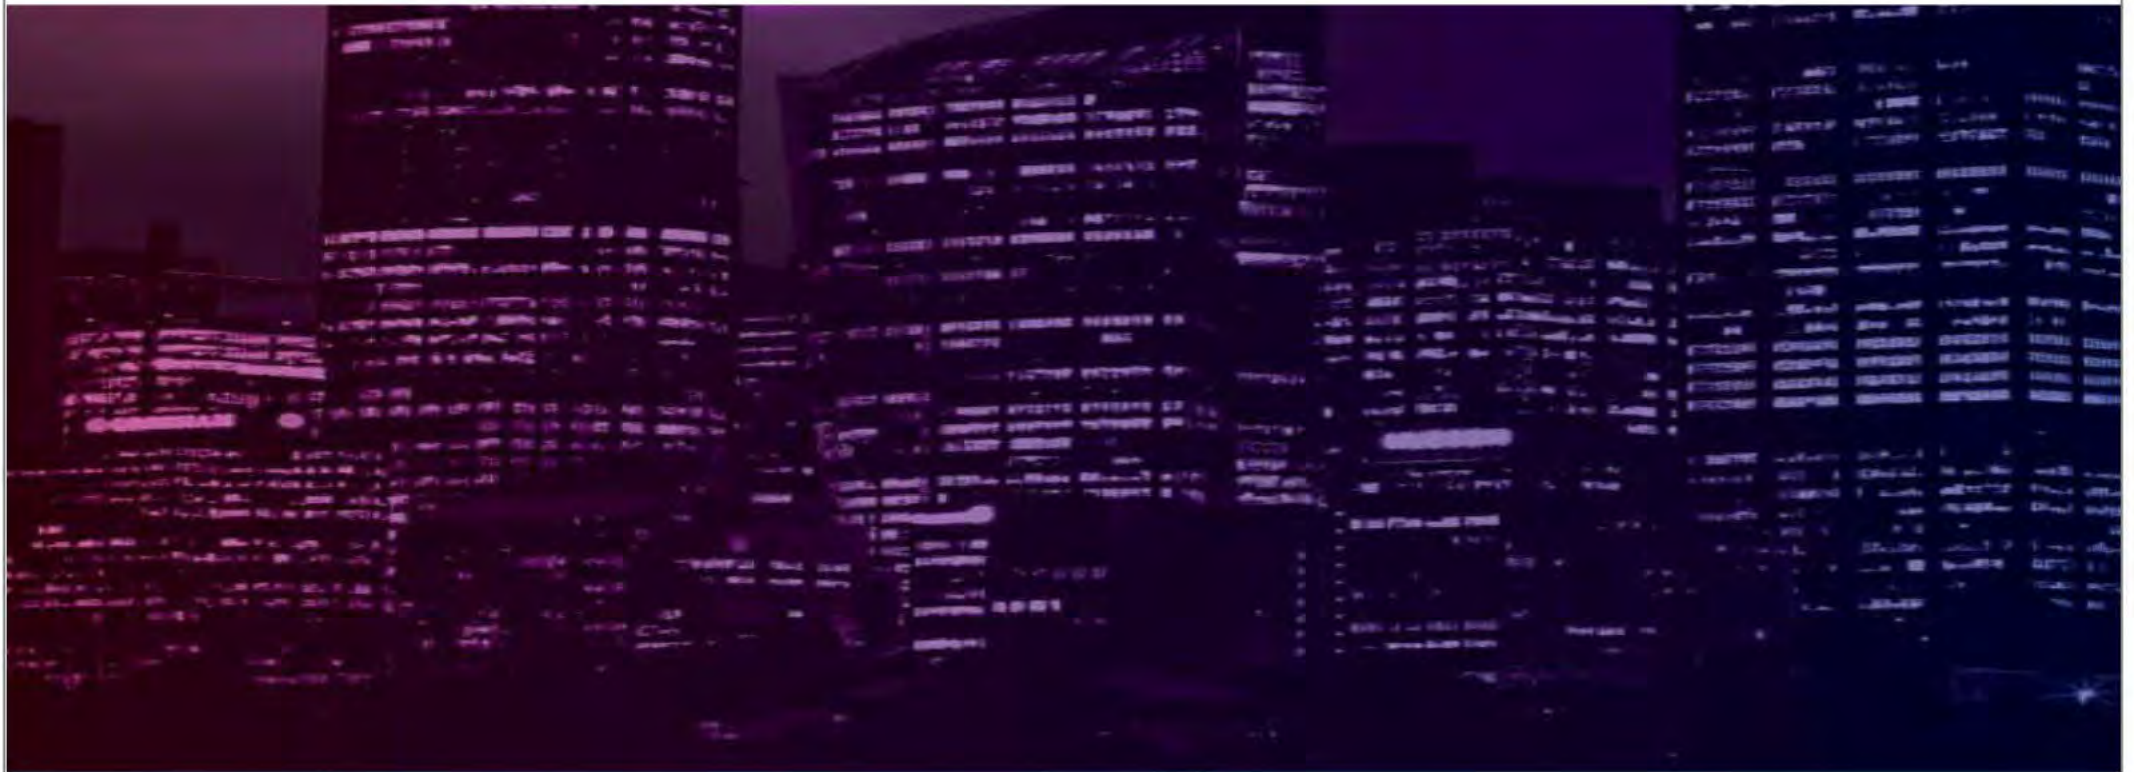
Document Control: Draft V.02

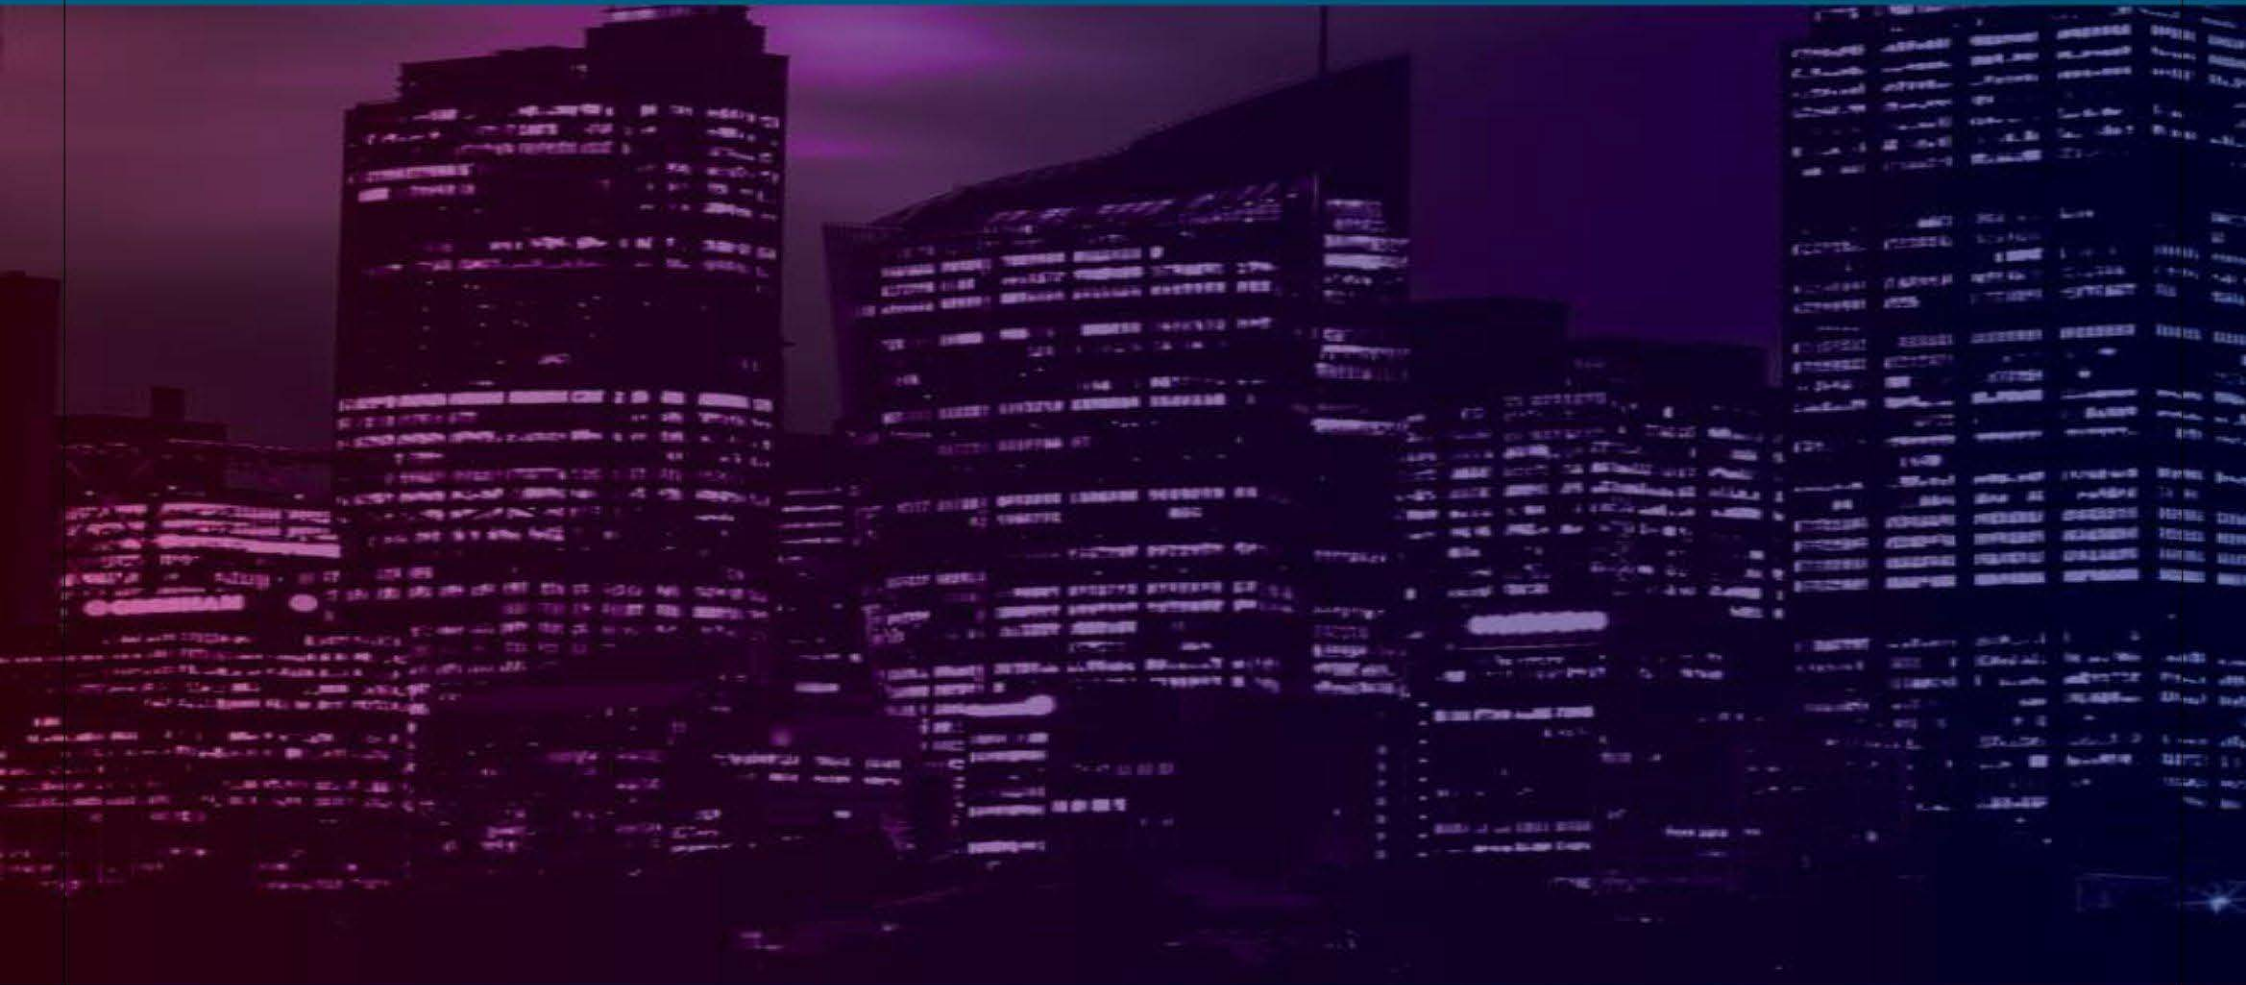
1.0. Executive Summary

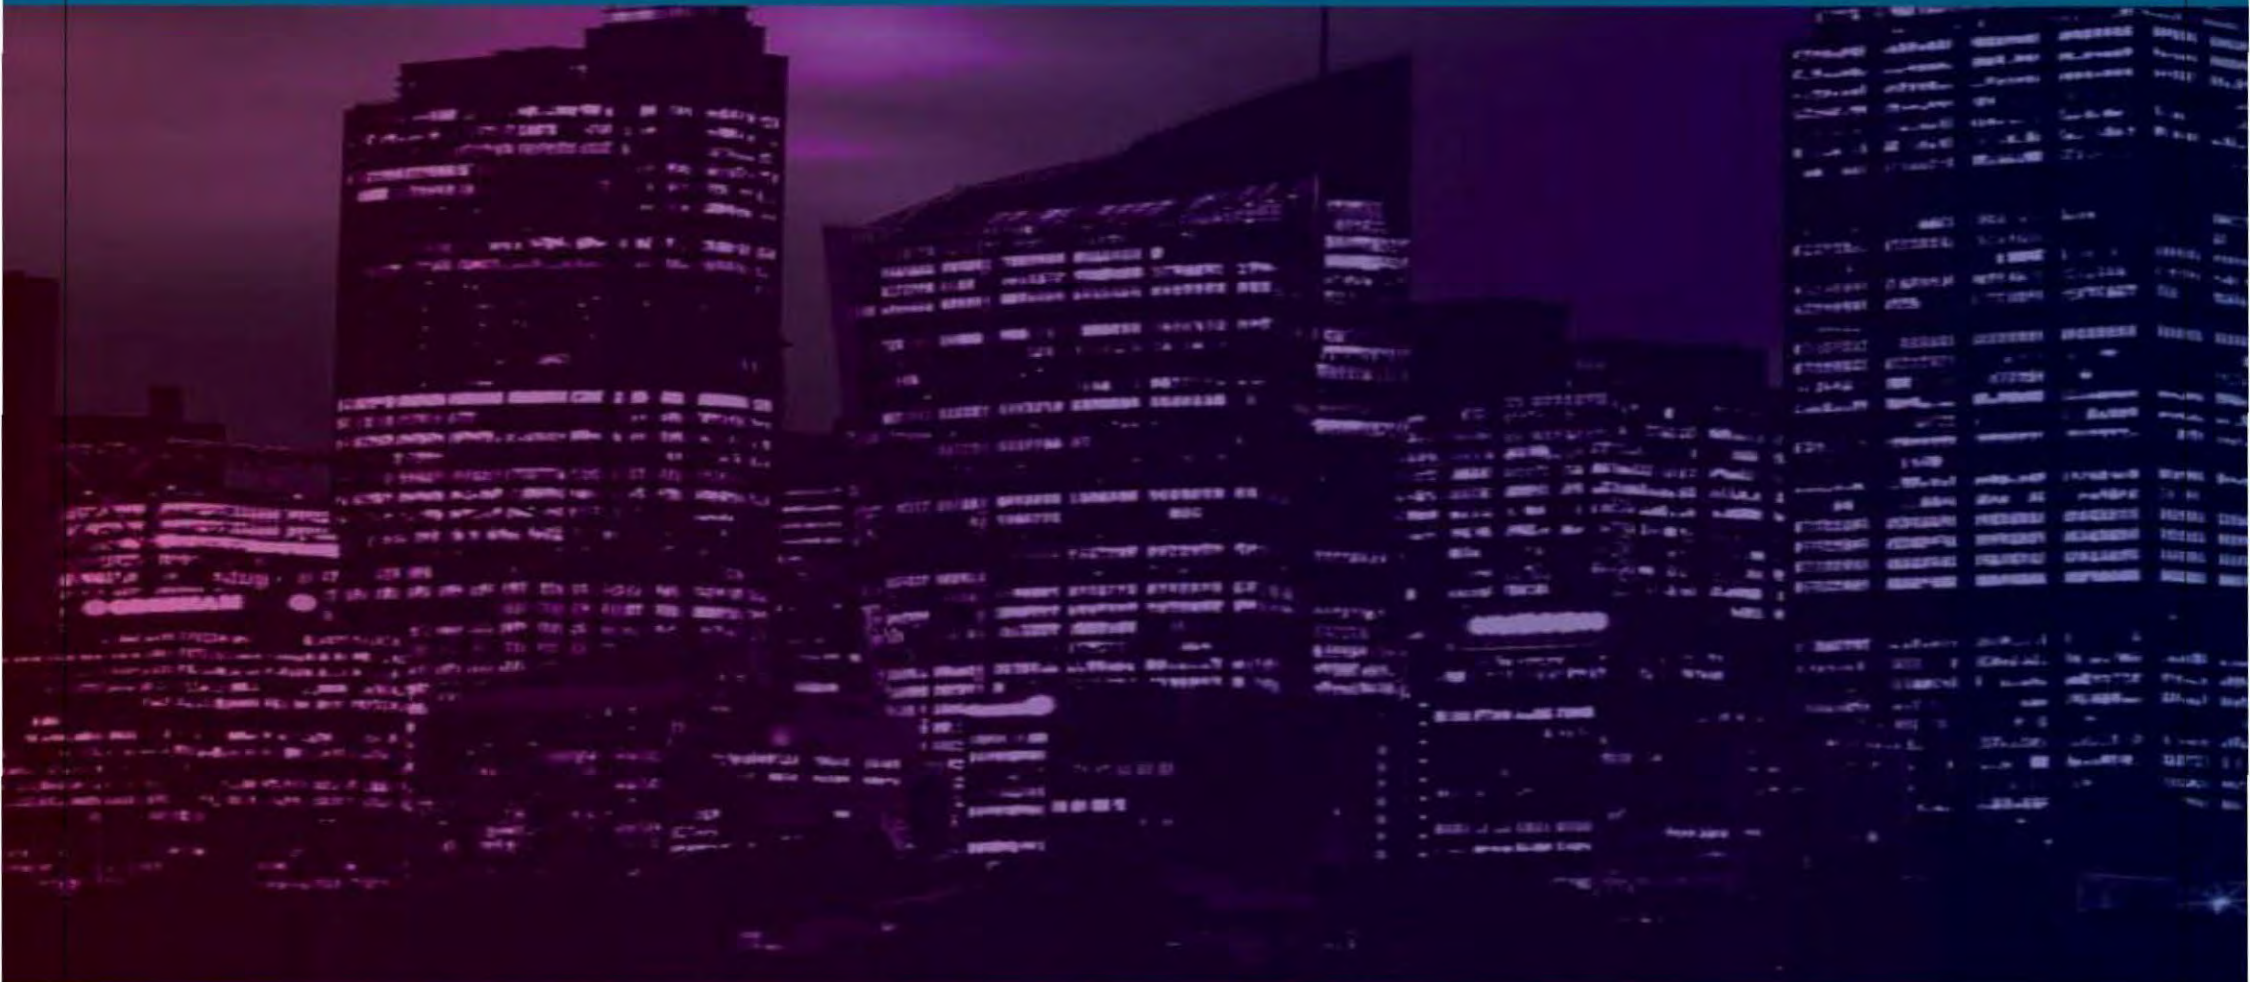
3.0. Condition Assessment Findings

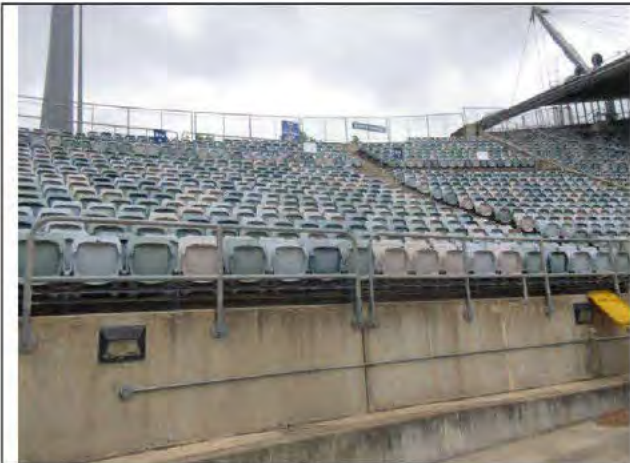
General view of South Terrace

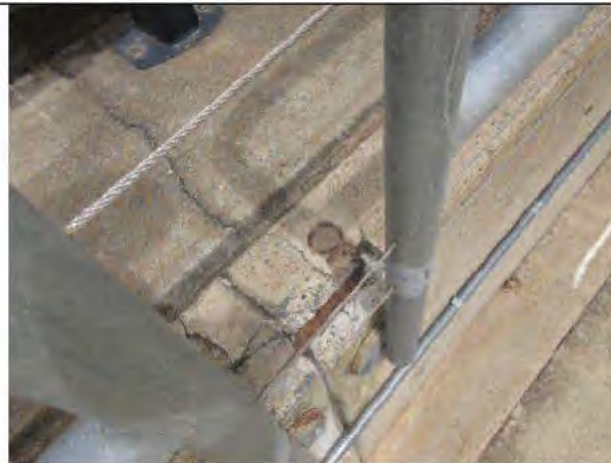
Damaged concrete and exposed steel reinforcing.

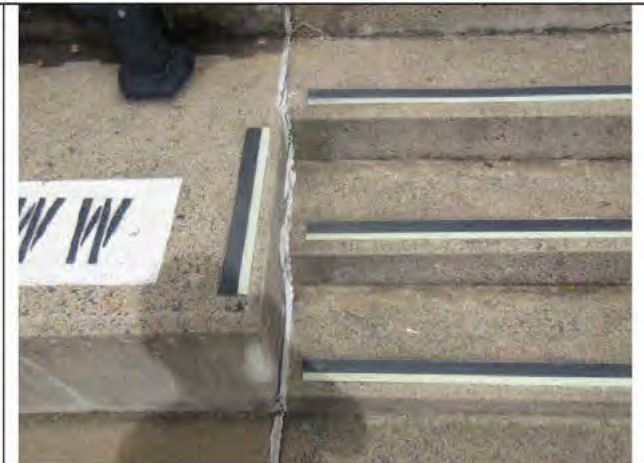
Degrading sealant expansion joints to the South Terrace.

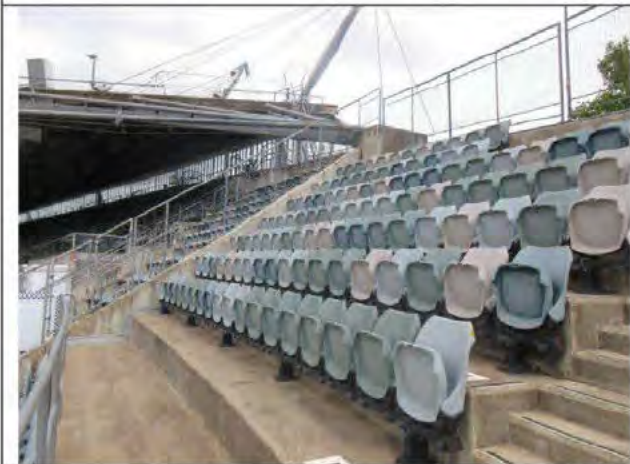
General view of North Terrace

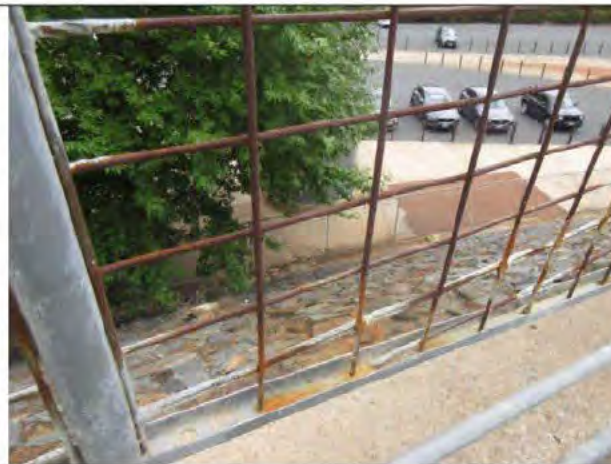
Rear balustrading/fencing to the top of the terraces corroded.

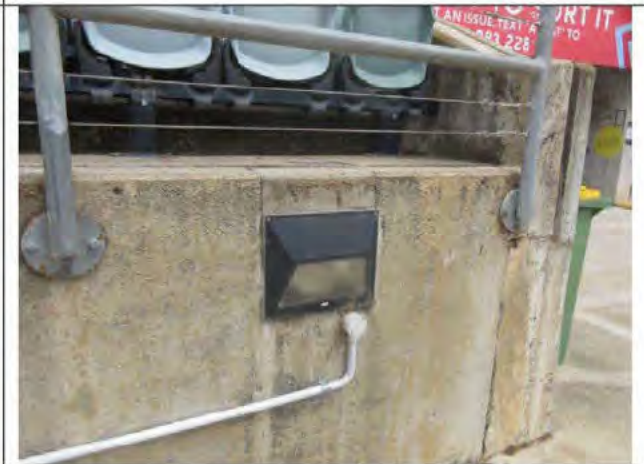
Typical luminaire to base of terraces.

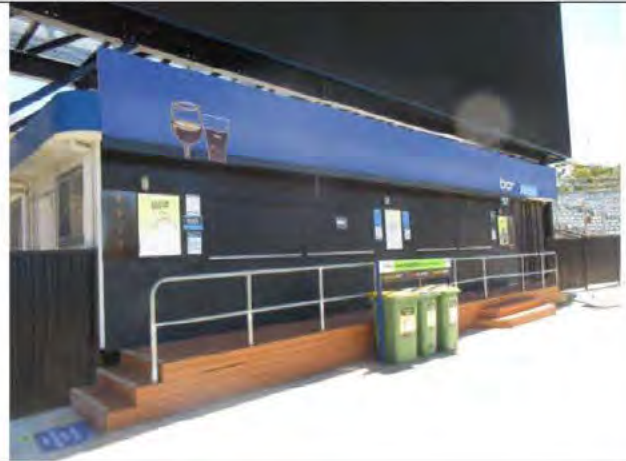
General view of K5 Food Concession.

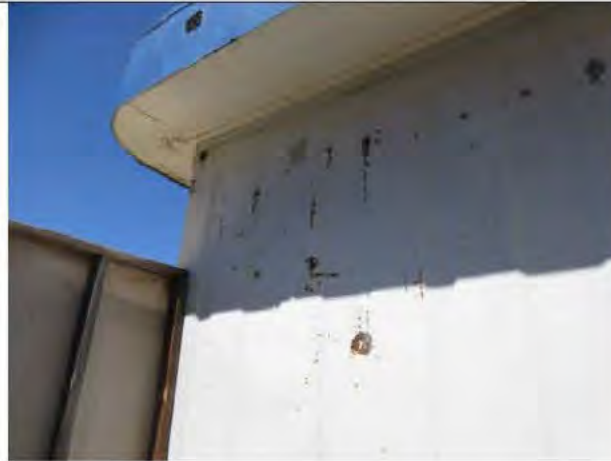
Degradation of coating and minor surface corrosion to container walls.

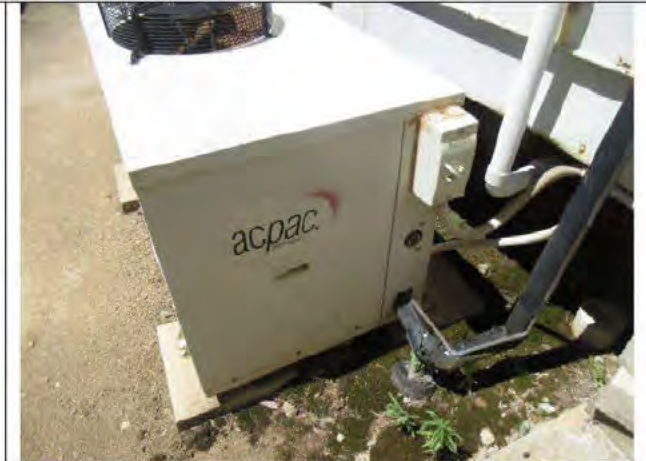
Typical external compressor/condenser serving Food Concessions.

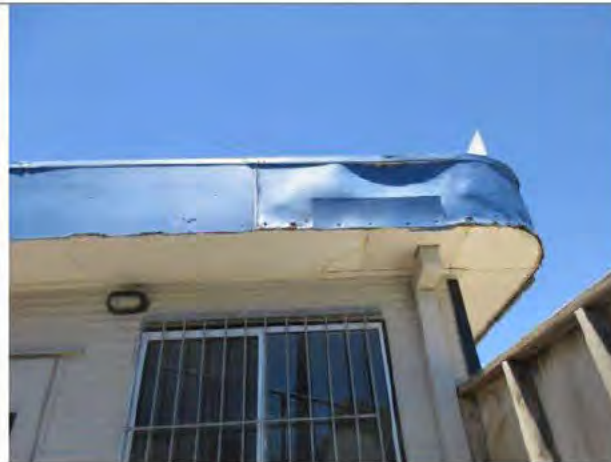
Damaged FC cladding to K9 Food Concession.

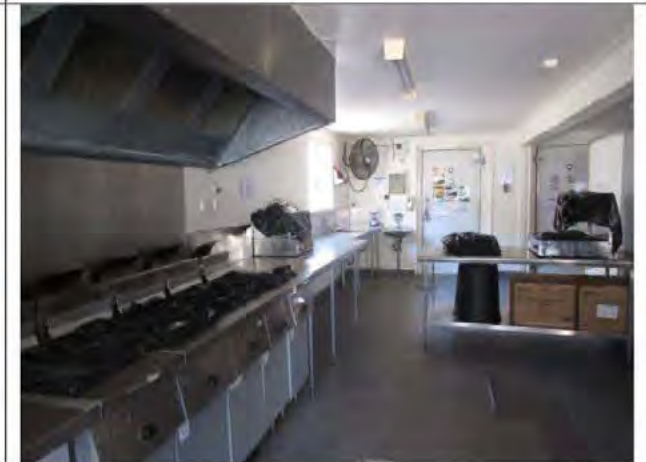
Internal view of K9 Food Concession.

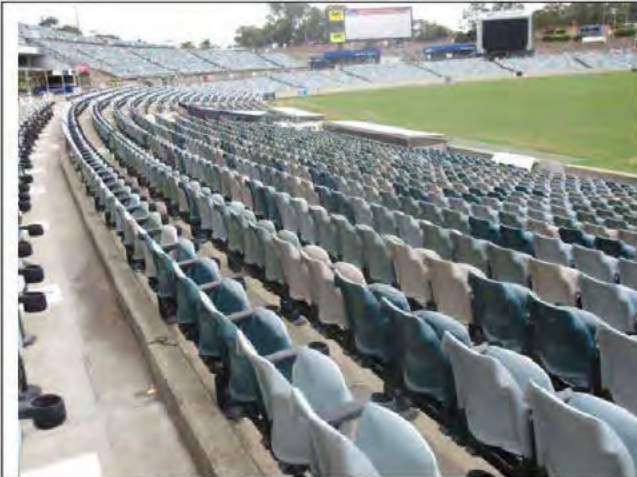
View of west section of Inner Bowl.

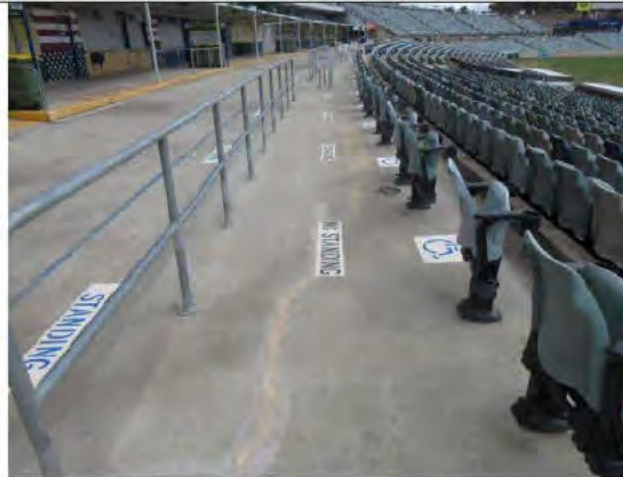
Cracking to top level of inner bowl to the West, adjacent to the L2 Concourse.

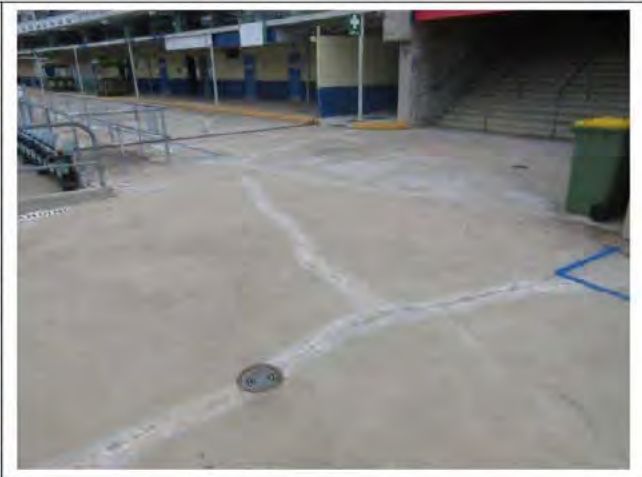
Cracking and evidential historic repairs to north-west corner of concourse.

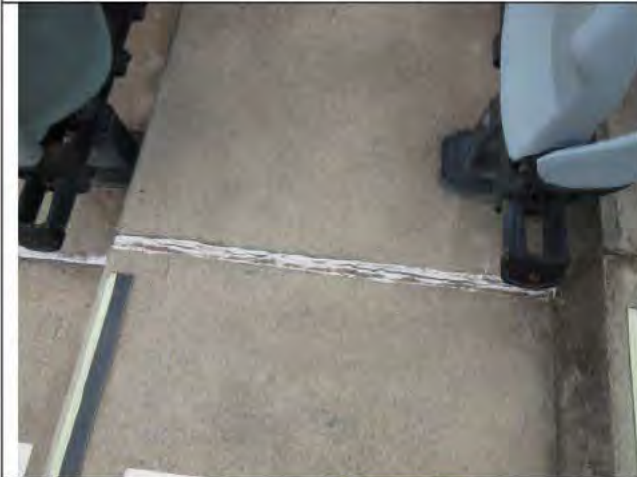
Typical example of deteriorated sealant expansion joints.

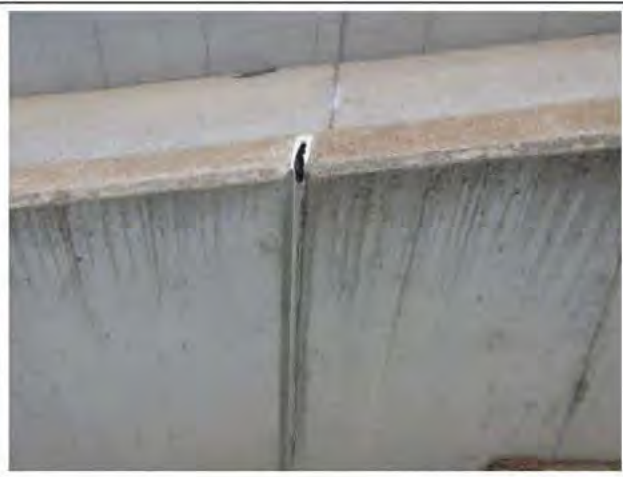
Deteriorating sealant to perimeter concrete wall expansion joint

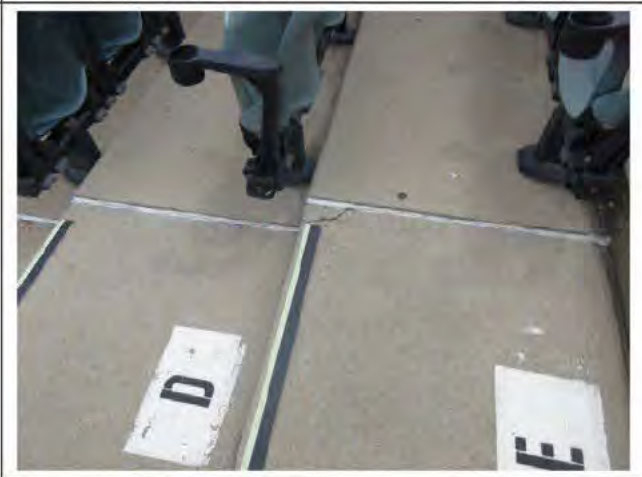
Cracking and potential of spalling damage to north section of Inner Bowl.

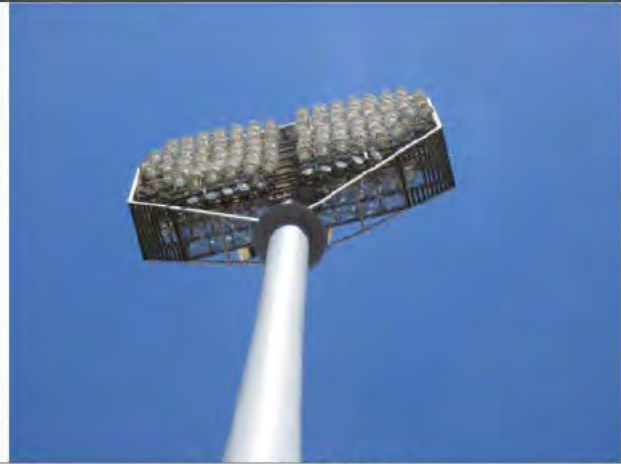
Typical light tower.

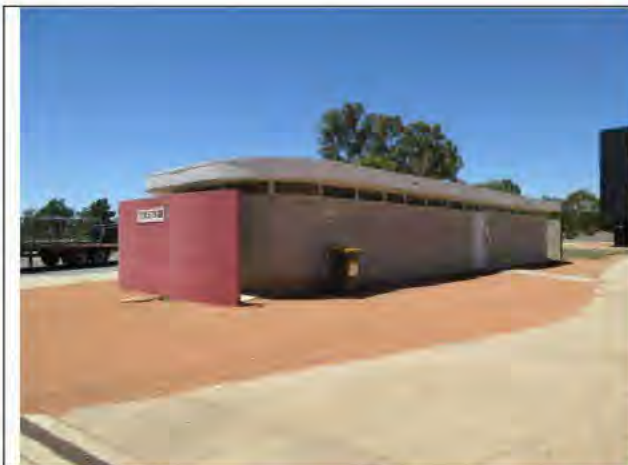
General Photo of North-West Toilet Block

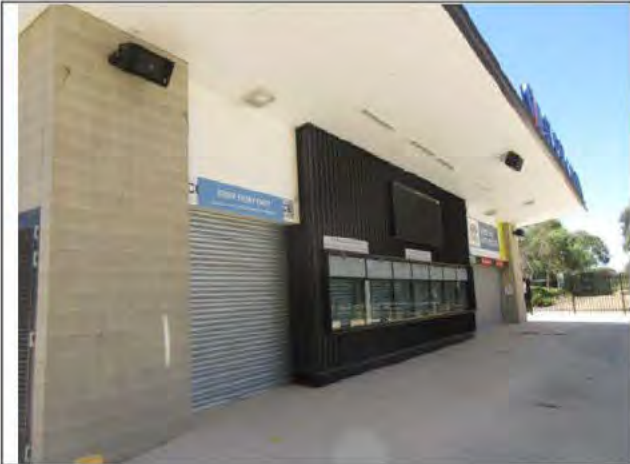
General view of West Ticketing Office.

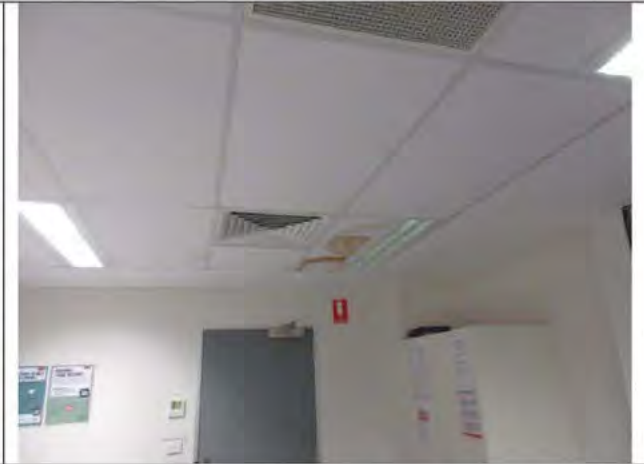
Moisture damaged ceiling tiles to West Ticketing Office.

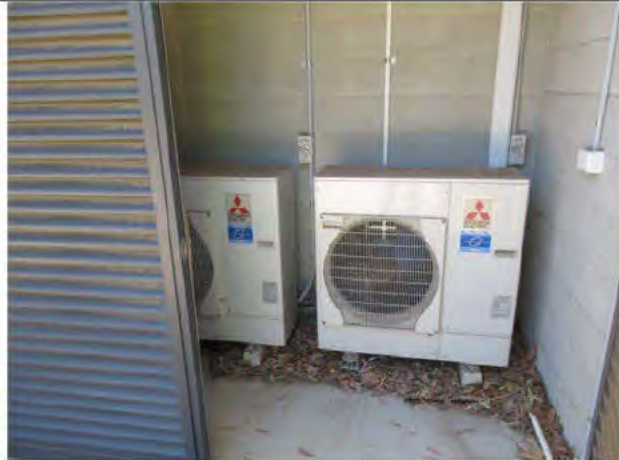
AC Condensers serving the West Ticketing Office.

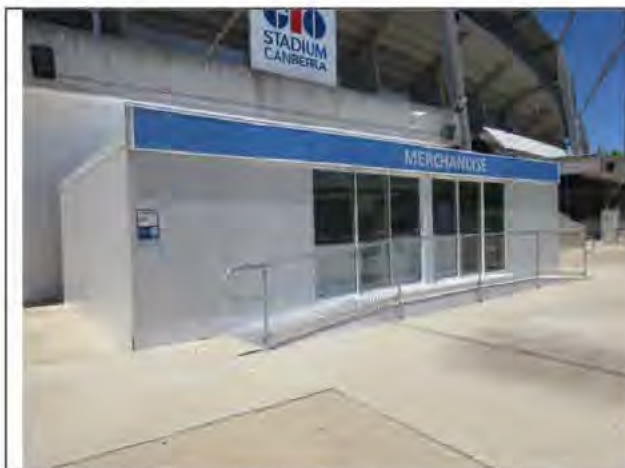
West Merchandise Structure.
