ACT
Government

Chief Minister, Treasury and
Economic Development

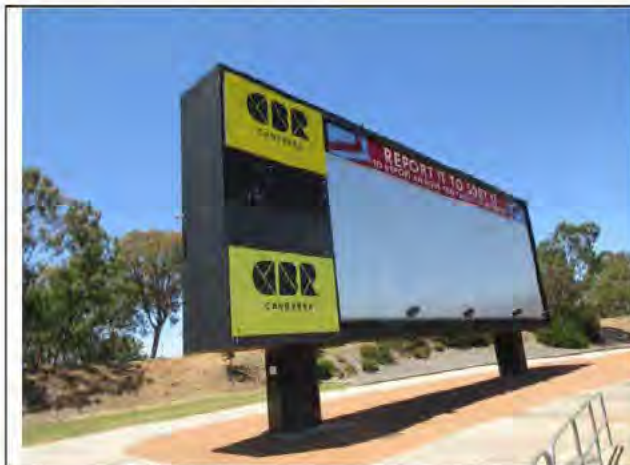
Front Face to Tri-Vision Screen.

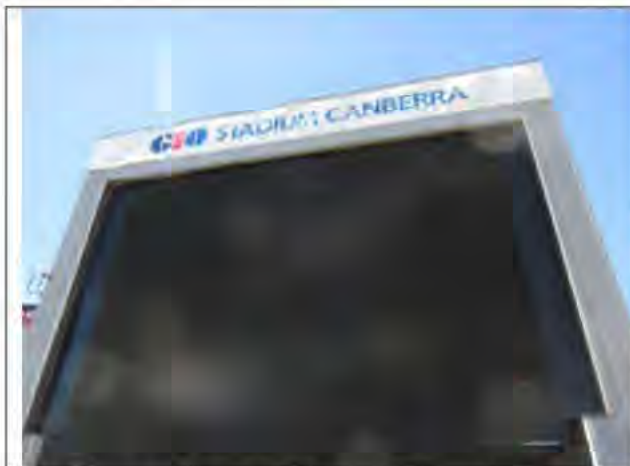
General Photo of the North Video Screen.

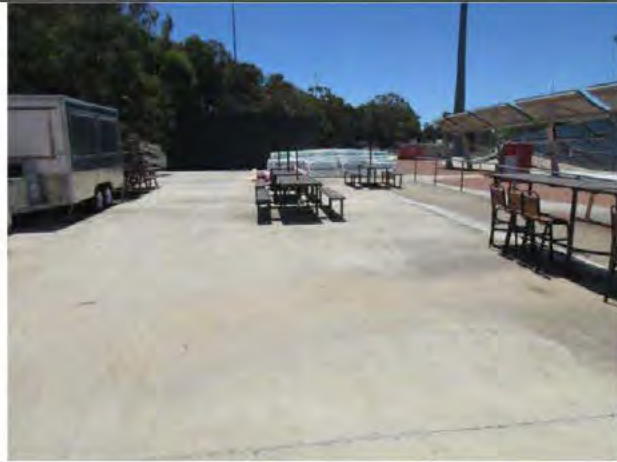
Hardstand to 'Slab' Area.

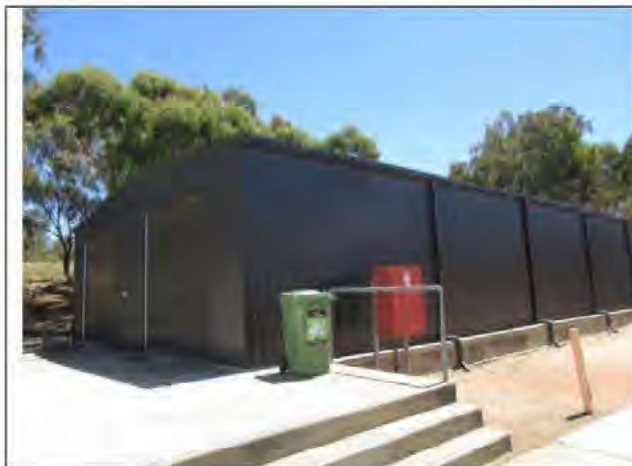
Component Type	General Condition	Issue	Risk	Priority
Op's Shed	Good	- No major issues sighted.	Low	Low
Op's Area	Fair	- No major issues sighted. Refrigerated containers are of mixed age and condition. The electric water storage heater has a lifecycle of 15 years and should be replaced in 10 years.	Low	Low
Maintenance Sheds	Fair	- One roller shutter is damaged, requiring immediate replacement. - Roof insulation is recommended to be replaced in the short term. - Minor cracking noted to the concrete floor should be monitored.	Low	Medium
Canopy	Fair	- Damaged barge flashing to a canopy is recommended to be repaired. - Steel frame to canopies should be treated for corrosion, prior to repainting.	Low	Low

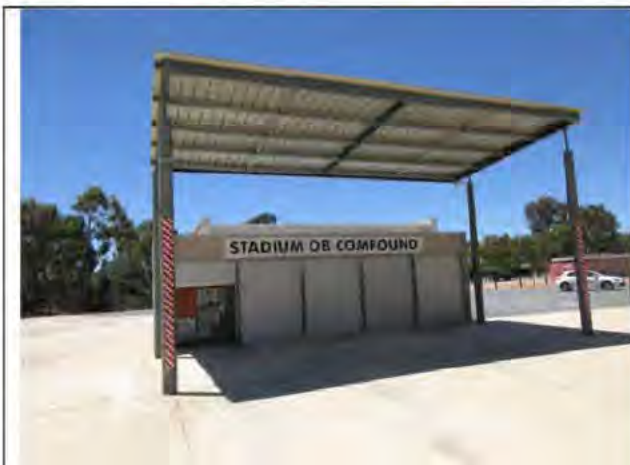
General view of OB Compound.

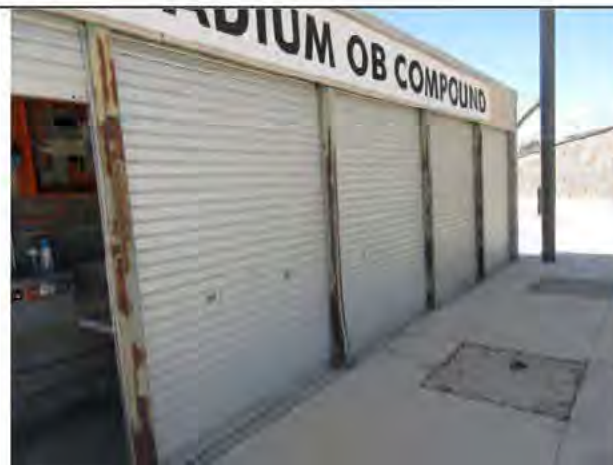
Corrosion to steel columns.

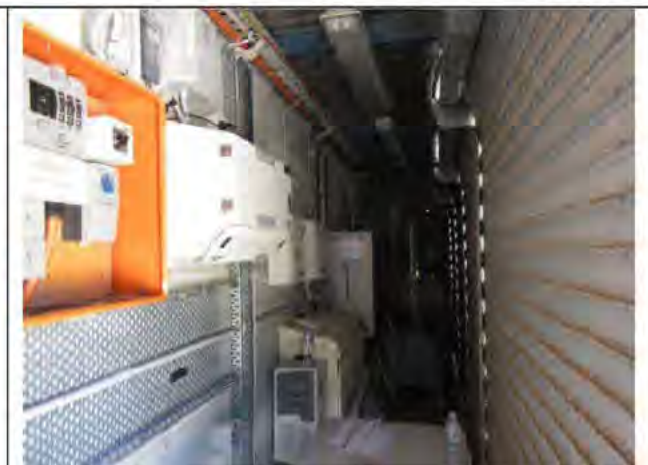
Internal view of OB Compound.

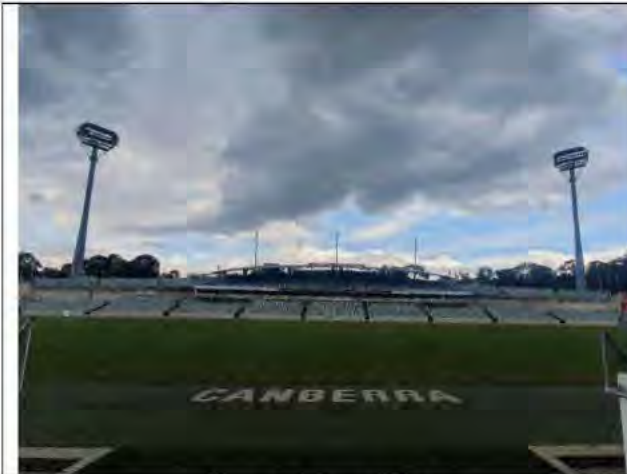
General view of turf.

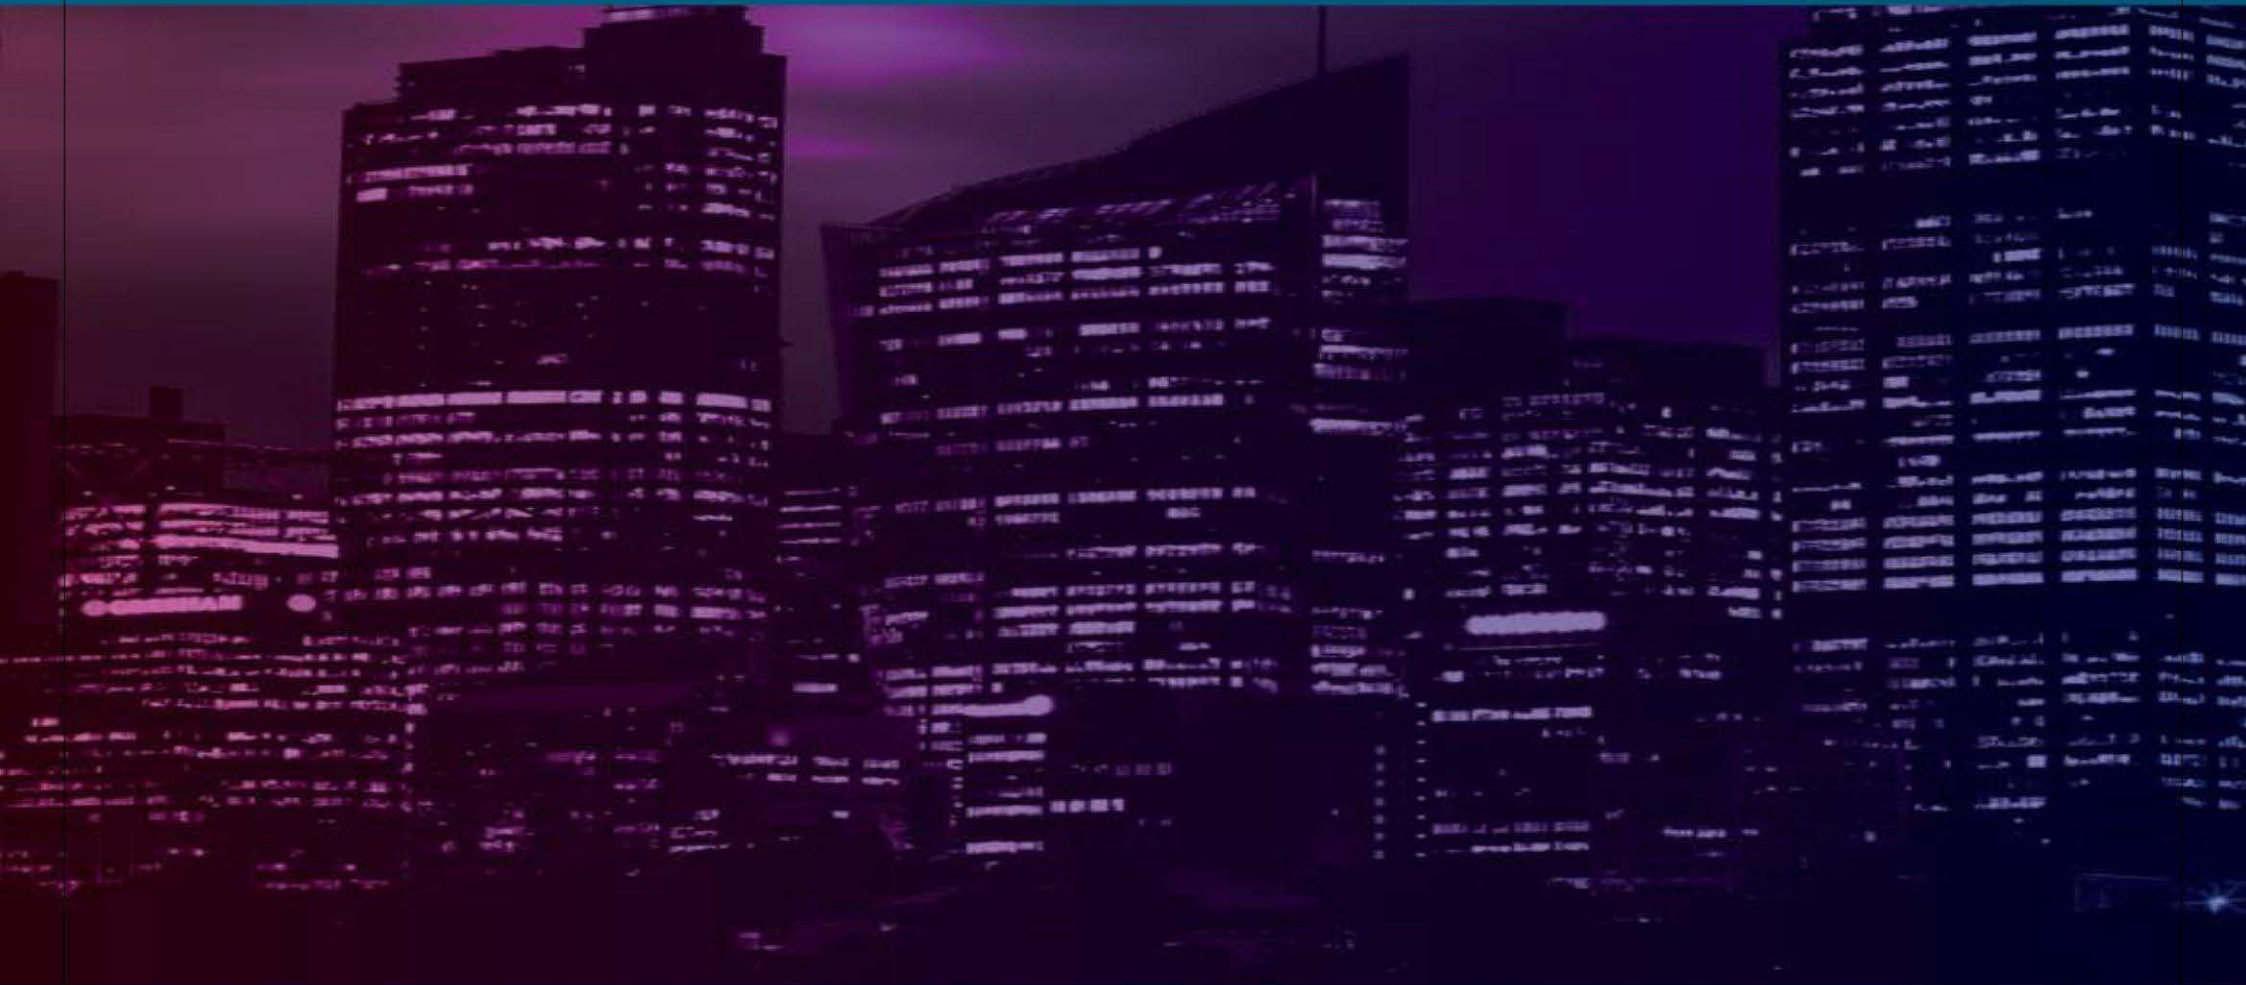
Appendix A – 10-Year CAPEX Forecast

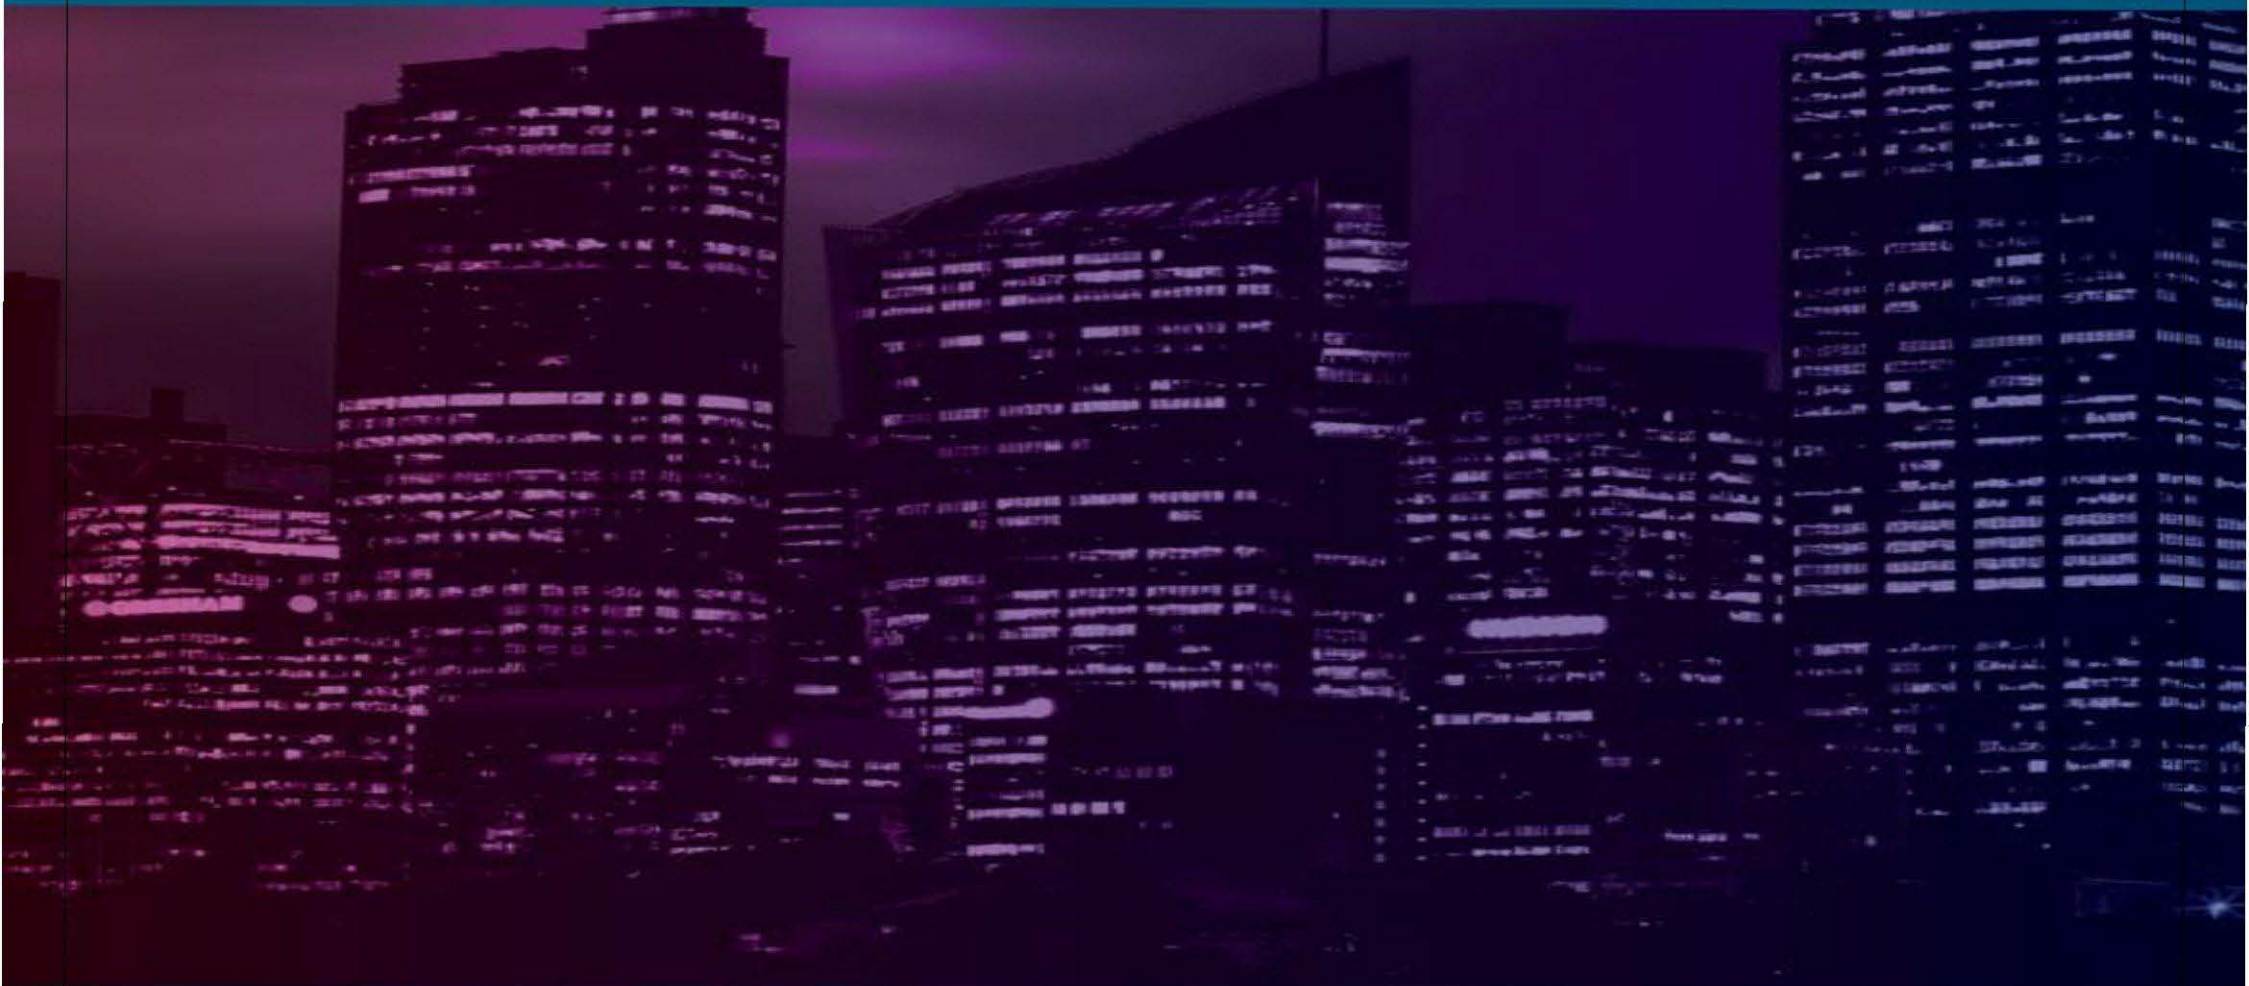
- Our inspection comprised a visual, non-destructive or testing, walkthrough site inspection of the building(s) to allow commentary on the standard of construction and general quality of workmanship, and reporting by exception on any defects sighted, including compliance issues, supported with photographs.

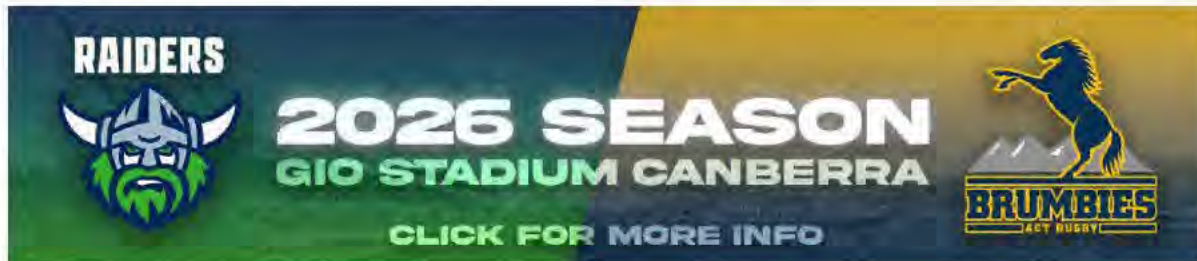
From: iCBR, Response <iCBR.Response@act.gov.au>
Sent: Friday, 20 March 2026 8:52 AM
To: De Boni, Andrew <Andrew.deBoni@act.gov.au>
Subject: Infrastructure Canberra PGI Work Order 303486 Confirmation

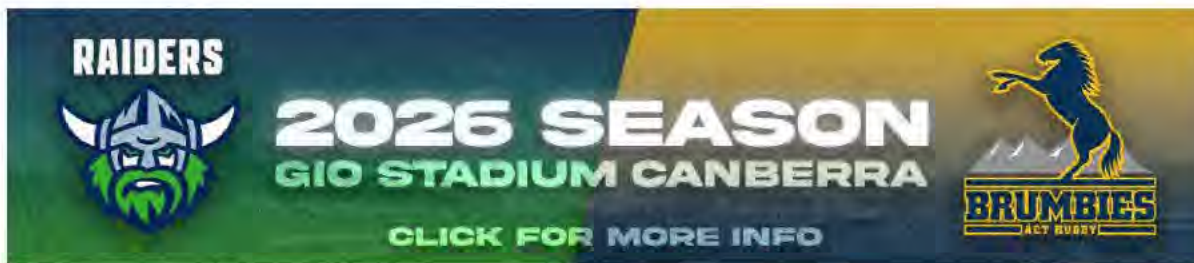
From: Elkins, Matthew <Matthew.Elkins@act.gov.au>

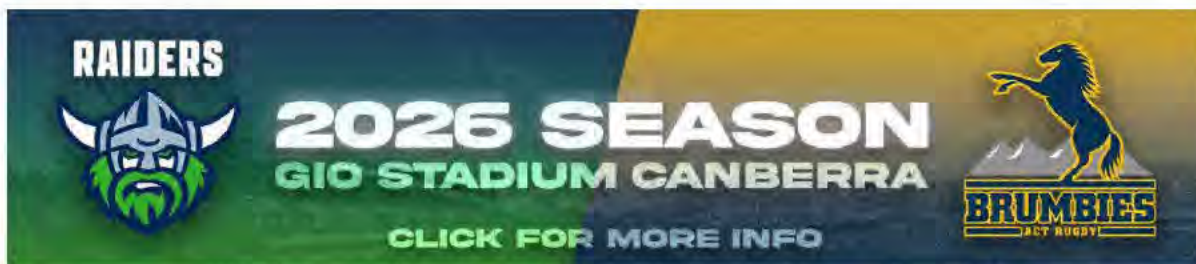
From: Elkins, Matthew <Matthew.Elkins@act.gov.au>
Sent: Friday, 20 March 2026 8:28 AM
To: De Boni, Andrew <Andrew.deBoni@act.gov.au>; Bailey, Daniel <Daniel.Bailey@act.gov.au>; de la Rue, Annie <Annie.delaRue@act.gov.au>; Spring, Harriet <Harriet.Spring@act.gov.au>
Subject: RE: Water ingress GIO Stadium

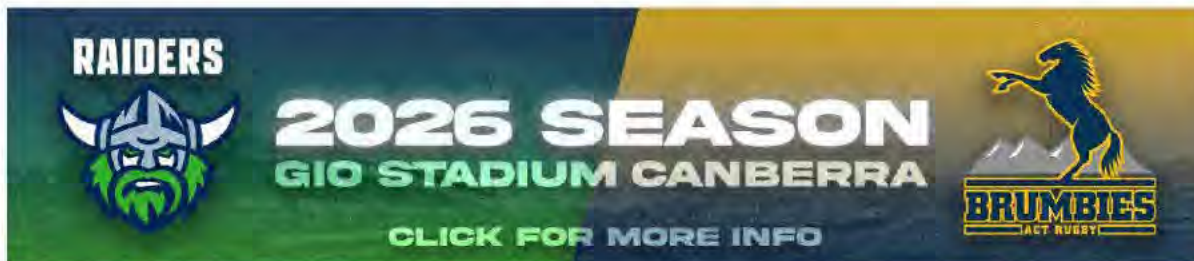
I acknowledge the Ngunnawal People as traditional custodians of the ACT and recognise any other people or families with connection to the lands of the ACT and region.
I acknowledge and respect their continuing culture and the contribution they make to the life of this city and this region.
