# Report on Geotechnical Assessment – Urban Capability Proposed Subdivision Lots 1 – 5 and 7 DP771051, Parkwood, NSW

This report presents the results of a geotechnical assessment for urban capability undertaken for the proposed subdivision located within Lots 1 – 5 and 7 DP771051, Parkwood, NSW. The work was requested by The Riverview Group, project managers for the development.

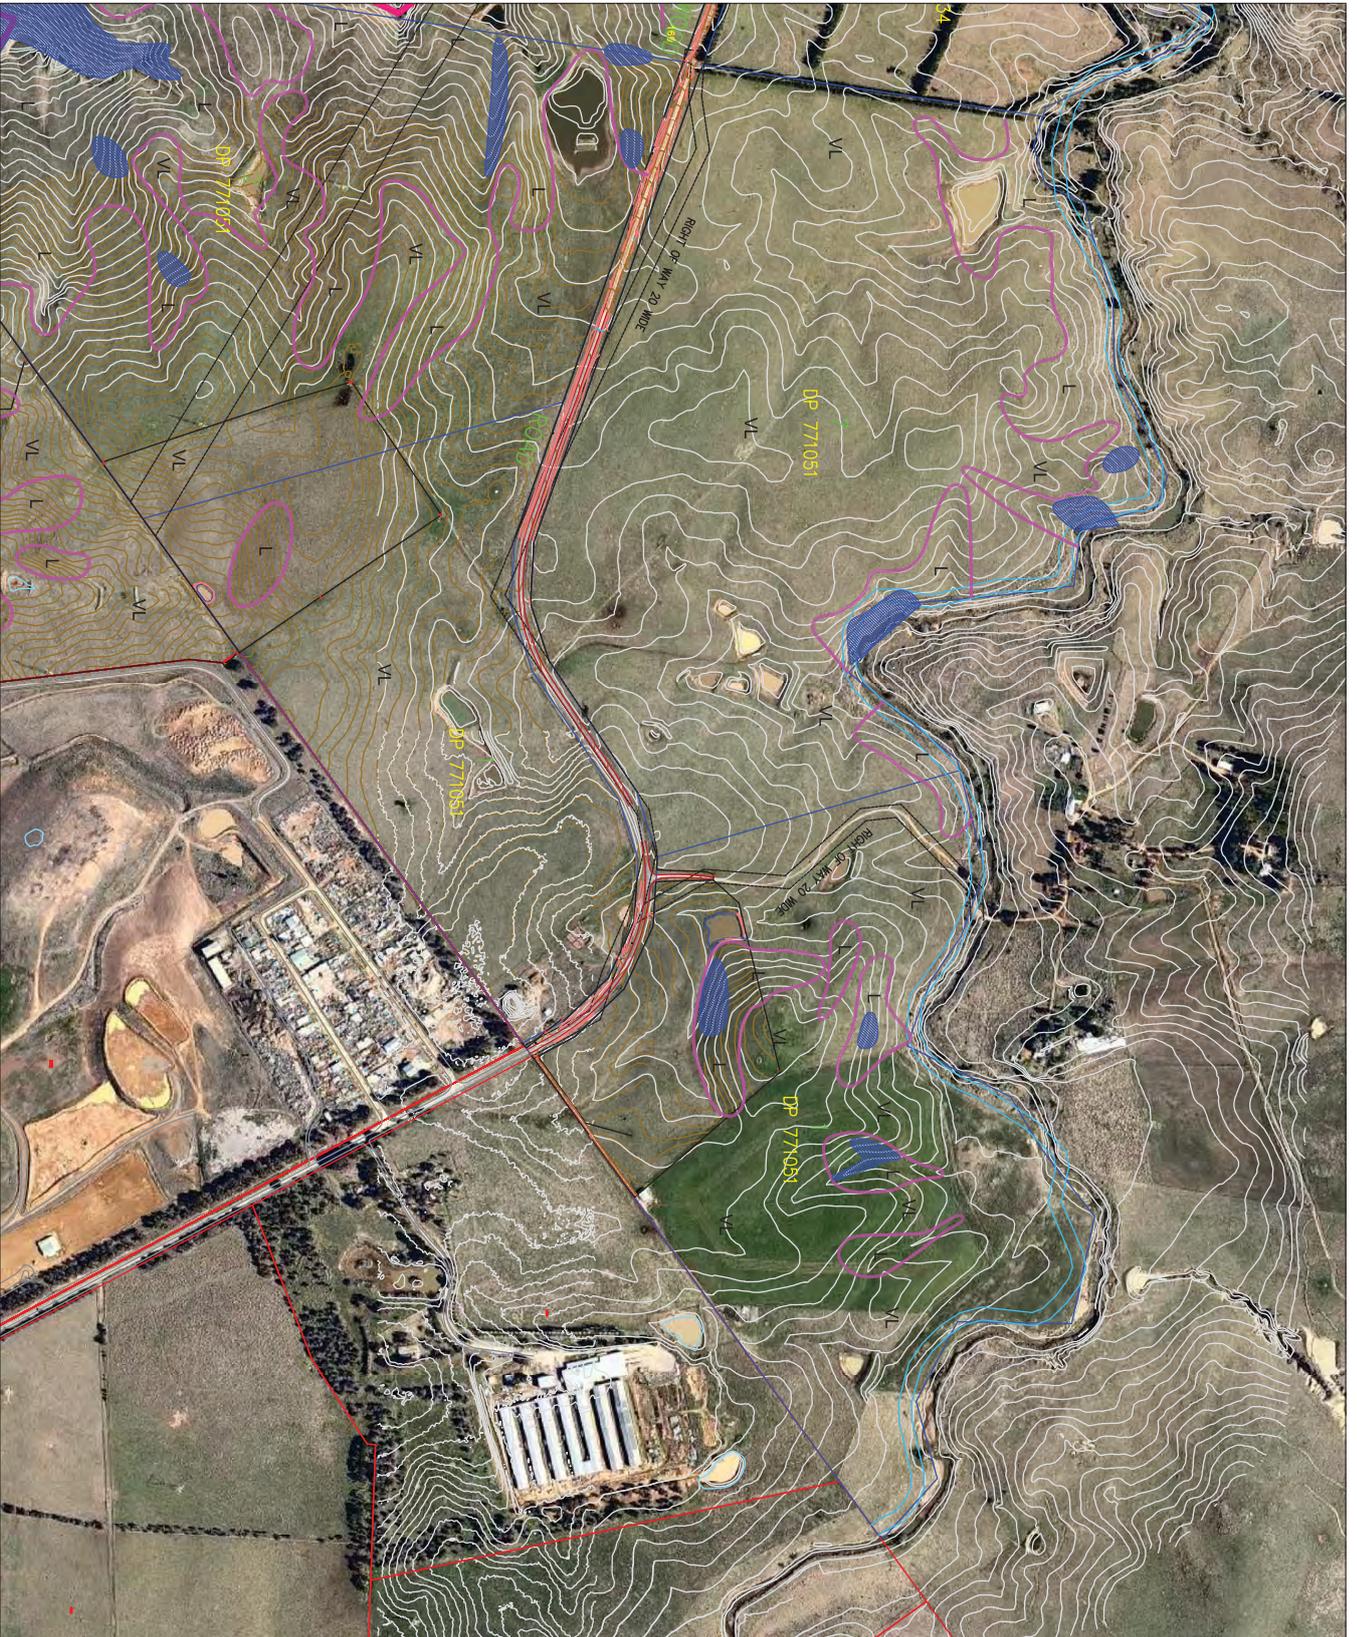
TITLE: **Approximate Locations of Potential Instability Risk Areas/Proposed Subdivision**  
**Lots 1 - 5 & 7 DP 771051 Parkwood, NSW**

In summary, it is considered that most of the site is classified as very low or low risk of damage to property occurring as a result of slope instability. Several areas are considered of moderate or high risk (refer Drawings 5 and 6) of causing property damage due to the steep ground slopes and possible unsuitable design and construction practice.

Areas of steeply sloping land (moderate and high risk) are not recommended for residential development at this stage. A detailed site stability assessment including subsurface investigations must be undertaken in these areas to establish an appropriate site model for analysis purposes to assess whether development is feasible in the high risk zones.

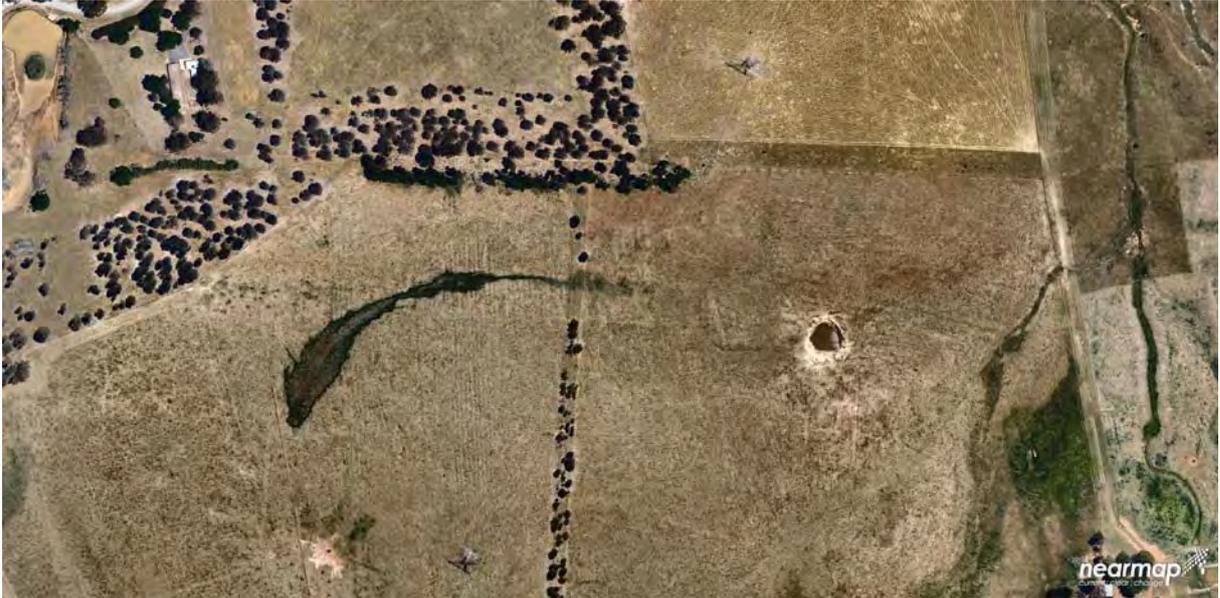
**Figure 3: December 2013 aerial photograph of Part of Block 1622. Recently burnt ground evident with the initial point of origin likely on the lower left hand side.**

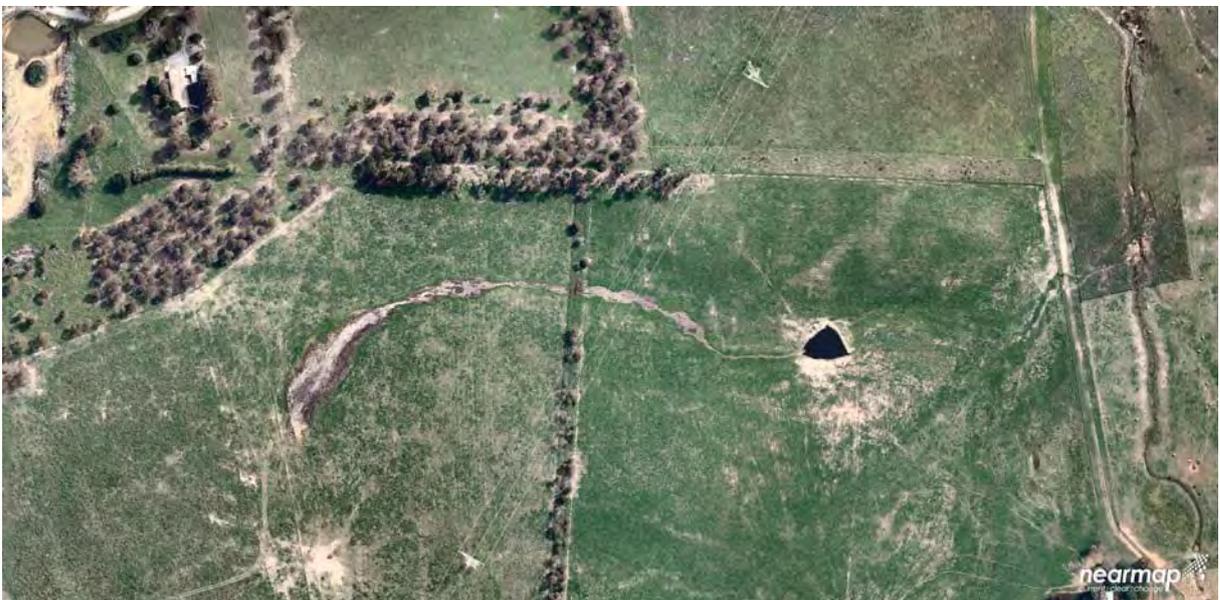
**Figure 4: March 2014 aerial photograph of Part of Block 1622. Burnt ground still evident somewhat slightly recovered but spread further to the east ending at existing farm dam.**

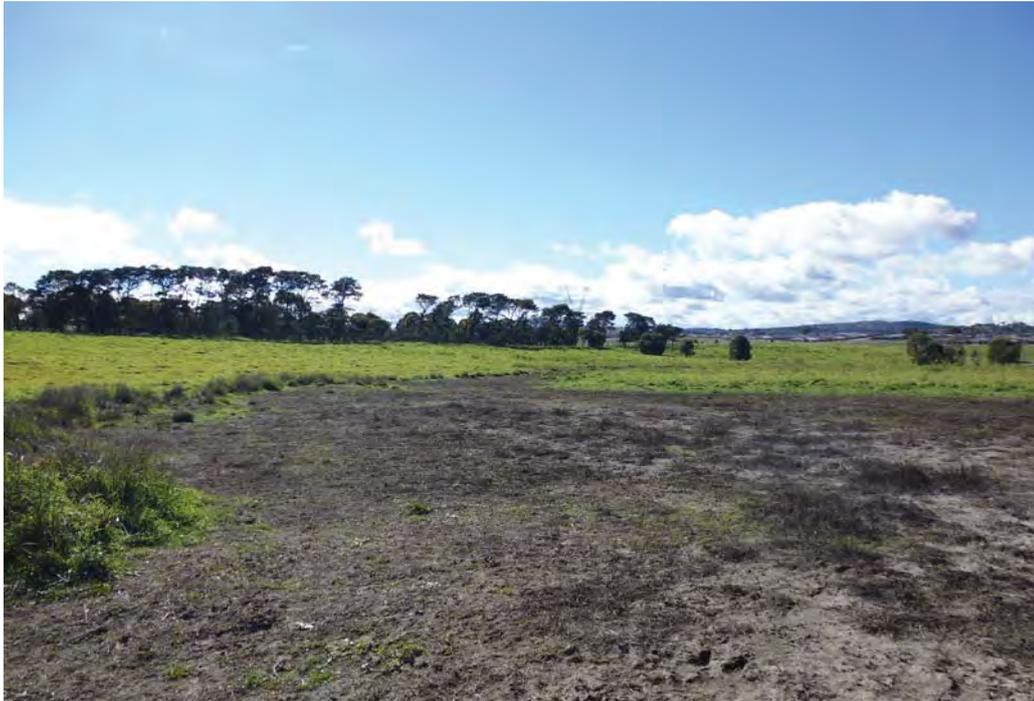
Photo A103 – View northeast at burnt/stripped ground. Refer Drawing 3 for location.

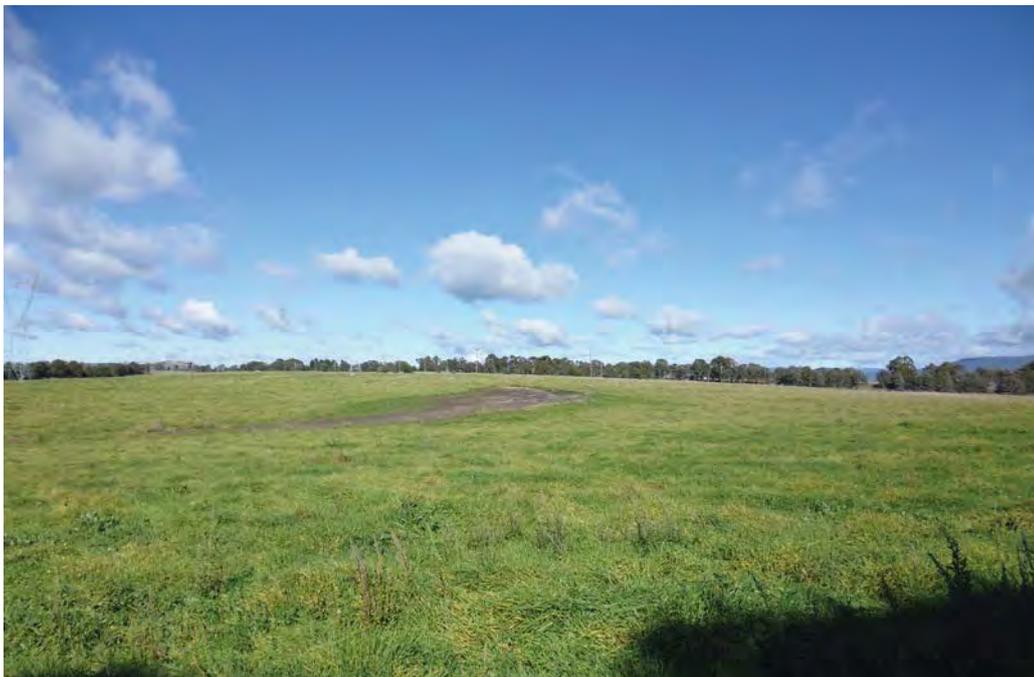
Photo A104 – View south at burnt/stripped ground and surrounding paddock. Refer Drawing 3 for location.

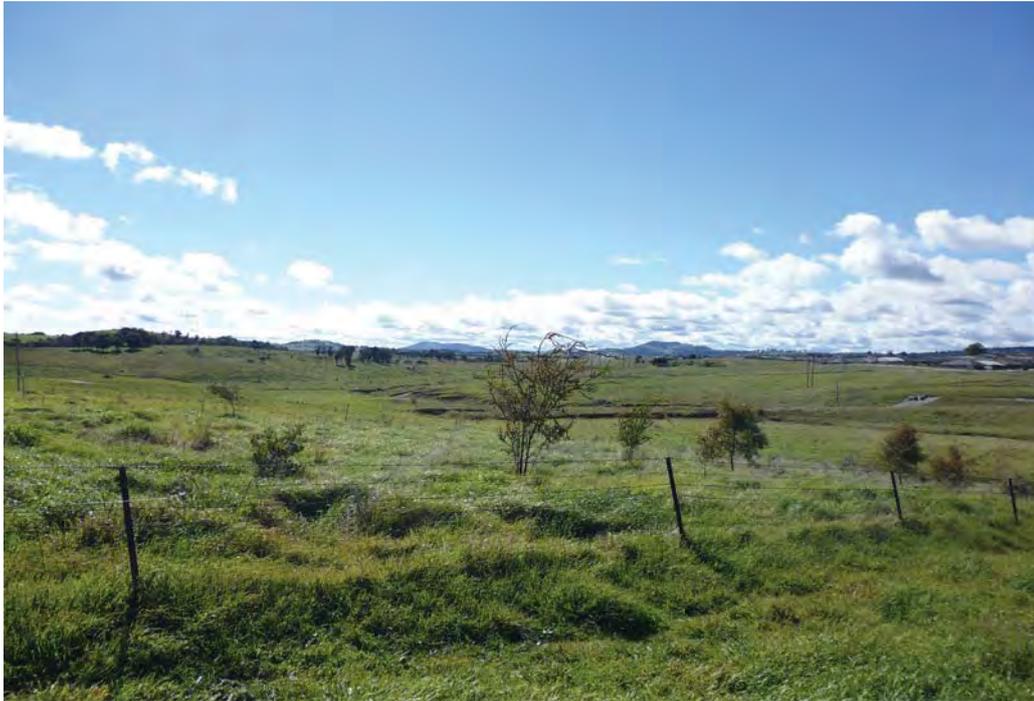
Photo A121 – View northeast at paddocks and erosion of lowest gully lines. Refer Drawing 3 for location.

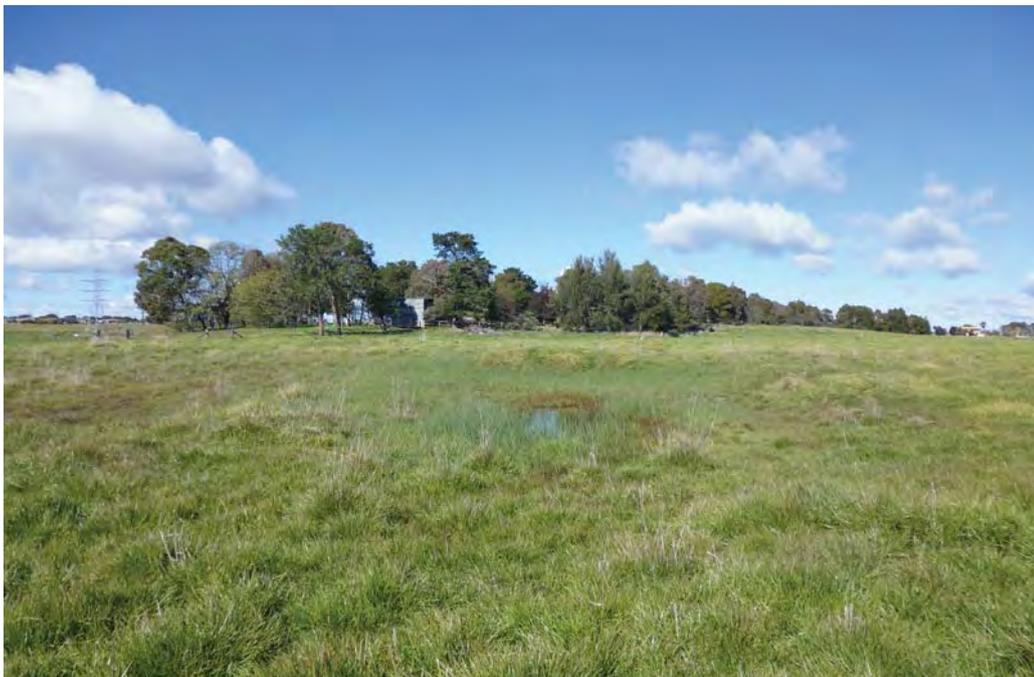
Photo A124 – View south towards horse agistment sheds at possible spring. Refer Drawing 3 for location.

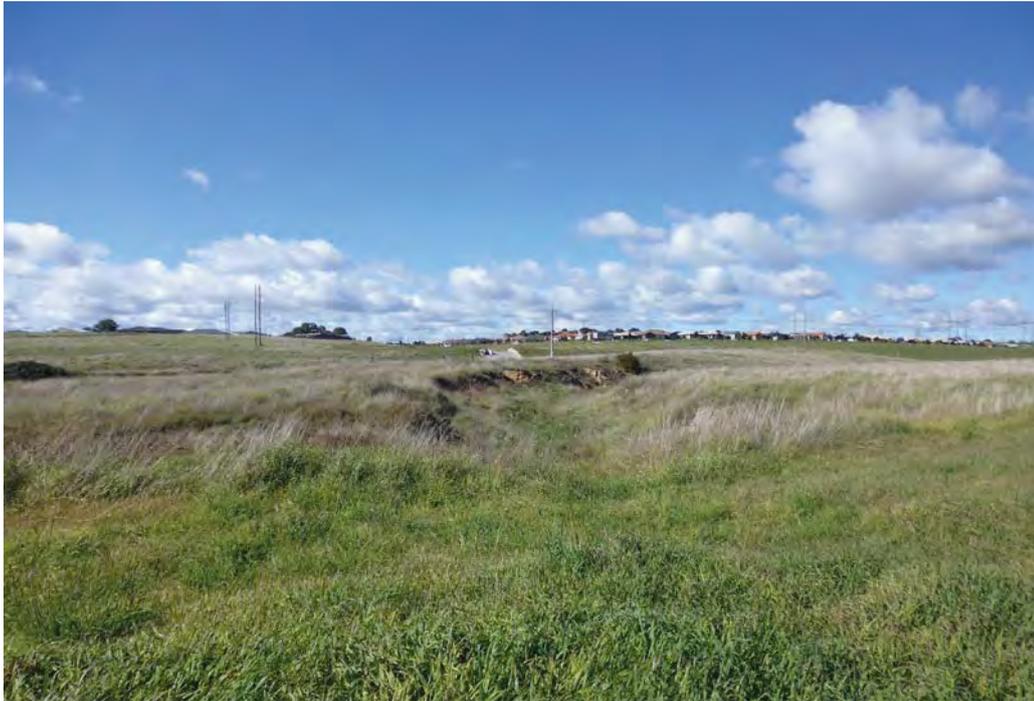
Photo A127 – View east/south east at erosion in gully line. Refer Drawing 3 for location.

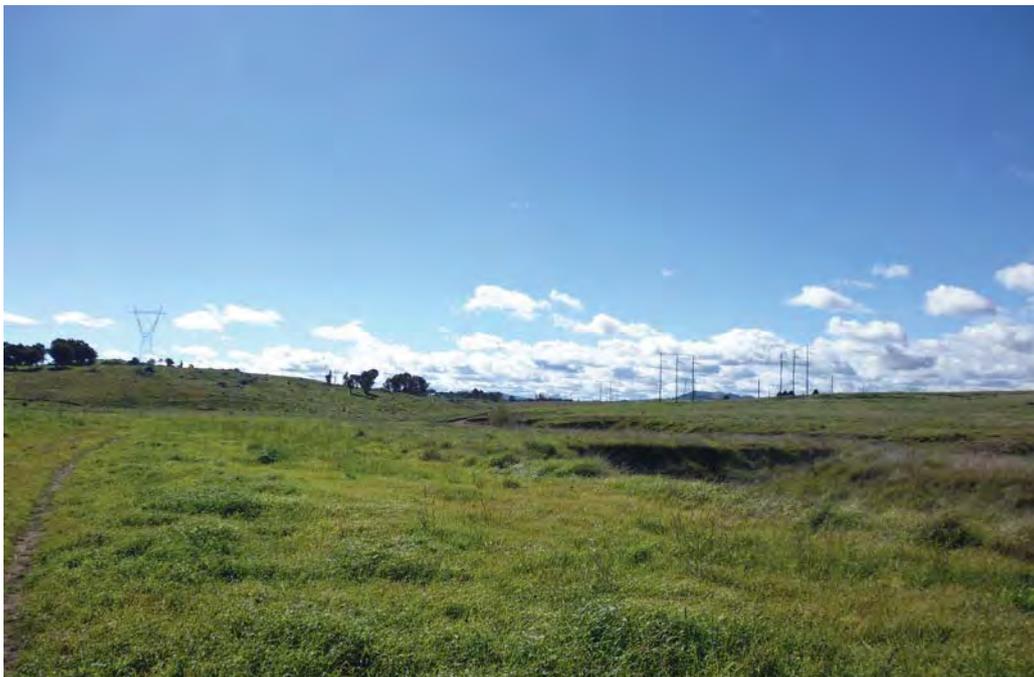
Photo A128 – View north/north east at erosion in gully lines. Refer Drawing 3 for location.

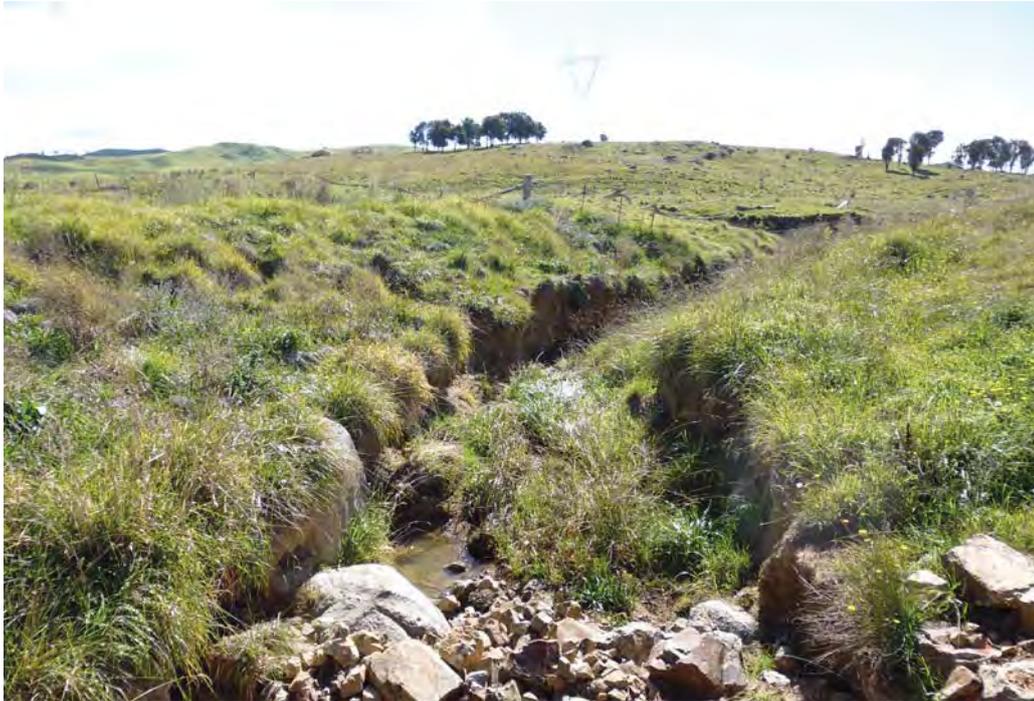
Photo A129 – View north at erosion in gully line. Refer Drawing 3 for location.

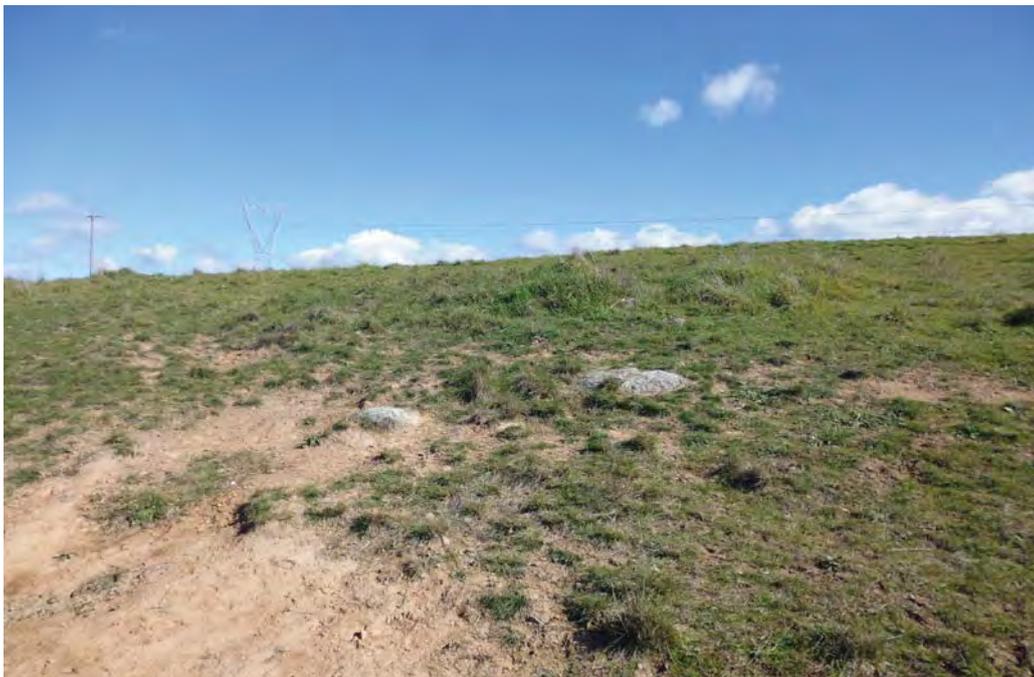
Photo A130 – View west at exposed cobbles in hill flank. Refer Drawing 3 for location.

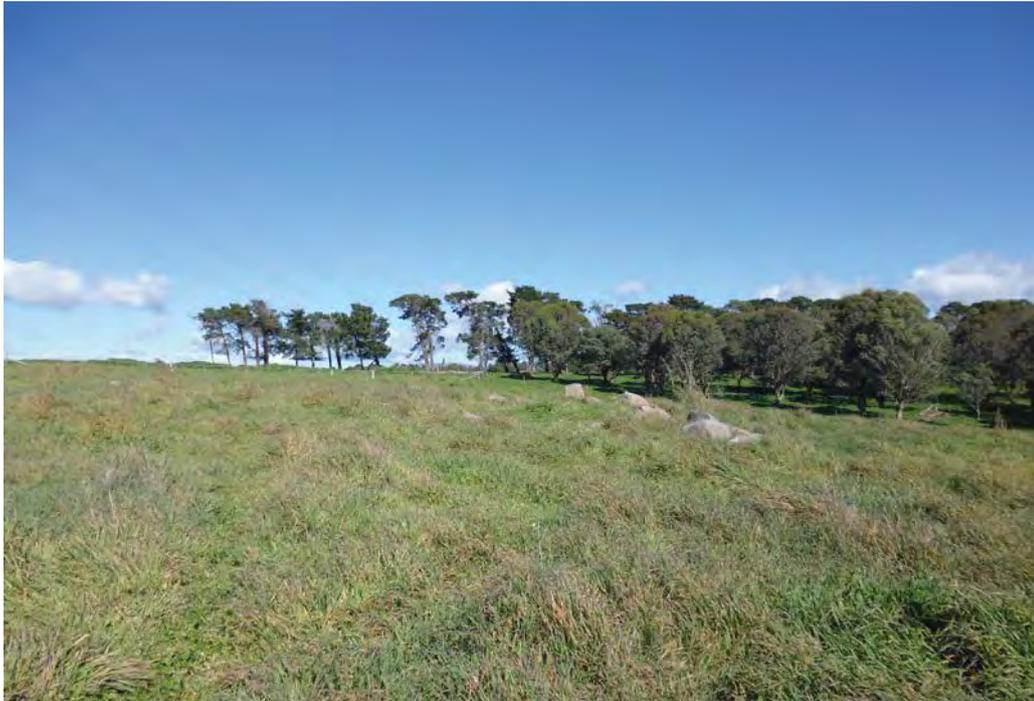
Photo A137 – View west at rock outcrops/exposed boulders. Refer Drawing 3 for location.
