FOI Reference: CMTEDDFOI 2019-184

From: [EPSDFOI](#)
To: [CMTEDD FOI](#)
Subject: Partial Transfer - 72 Printers Way Kingston
Date: Thursday, 8 August 2019 12:16:19 PM

Site Inspection	3
1. Assumptions.....	3
2. Areas Inspected	3
3. Overview / Acceptance Criteria	4
4. Assessment/(Methodology).....	5
5. Inspection Findings	6
Terms and Conditions	50

The purpose of this inspection was to provide a list of defective items that are not in compliance with the relevant building code and other standards.

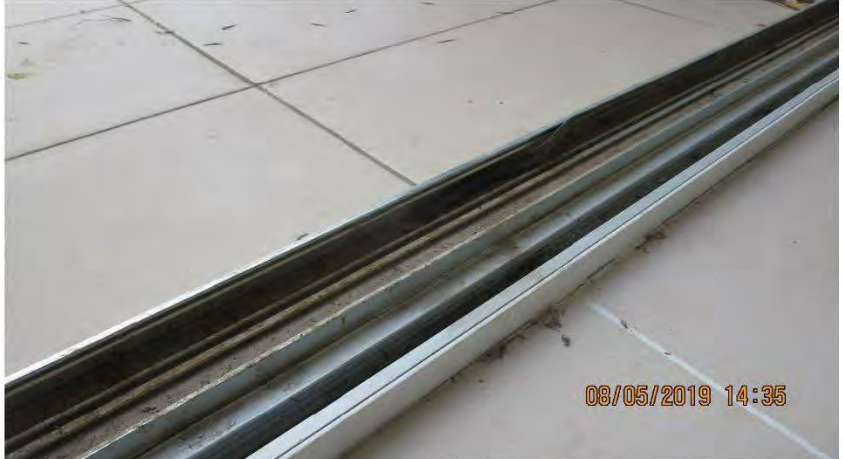
Item No.	Location	Description / Findings	Image Reference
1	Lounge room.	The door seal attached to the sill of the bi-fold doors servicing the front entrance of the lounge room is broken and is catching when the doors are operated.

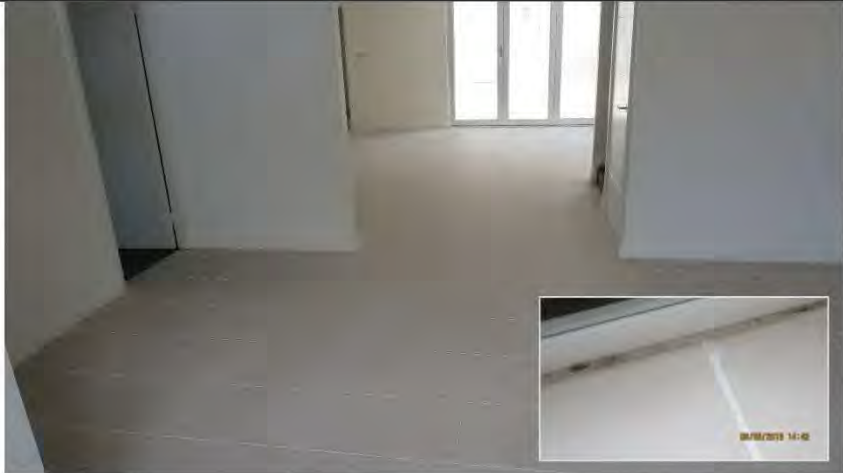
Item No.	Location	Description / Findings	Image Reference
3	Lower level.	<p>No control joint has been provided to the floor tiling on the lower level.</p> <p>A measurement was taken of 10.62m which exceeds the distance for the tolerance without a control joint installed. It was also observed that no movement joints have been provided at junctions. Floor grout has been installed in lieu of a recommended flexible sealant to allow for expected expansion and contraction of the floor tiling.</p>

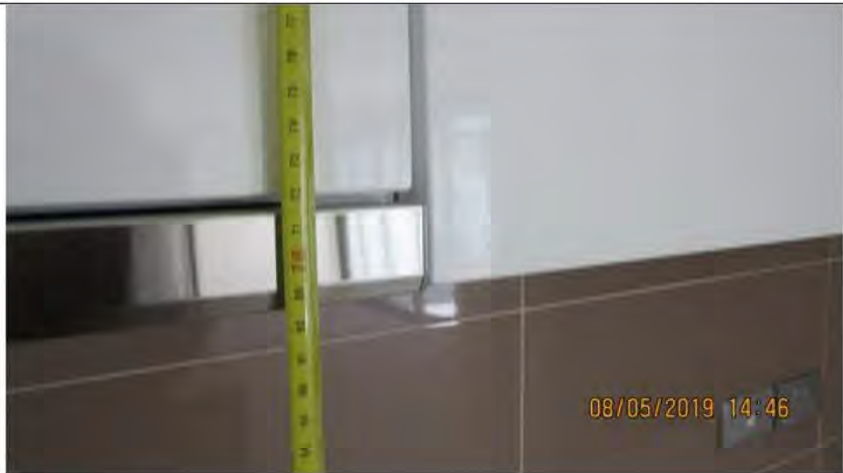
4	Kitchen.	<p>A measurement was taken from the top of the cooktop turrets to the underside of the kitchen cabinetry of the overhead cabinets and rangehood. This measurement was 685mm. An additional measurement was taken from the uppermost point of the central burner of the cooktop and it measured 695mm.</p> <p>Refer to manufacturers specifications for clearance measurements between components.</p>

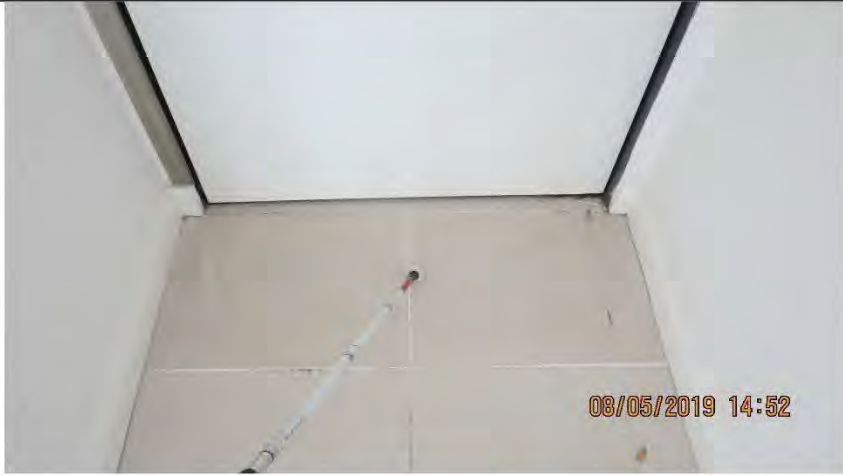
Item No.	Location	Description / Findings	Image Reference
5	Entry.	<p>Four floor tiles adjacent to the entrance door were Noted under test to be drummy.</p> <p>These tiles were lightly struck with a striking tool indicated in the image here in to confirm this.</p>

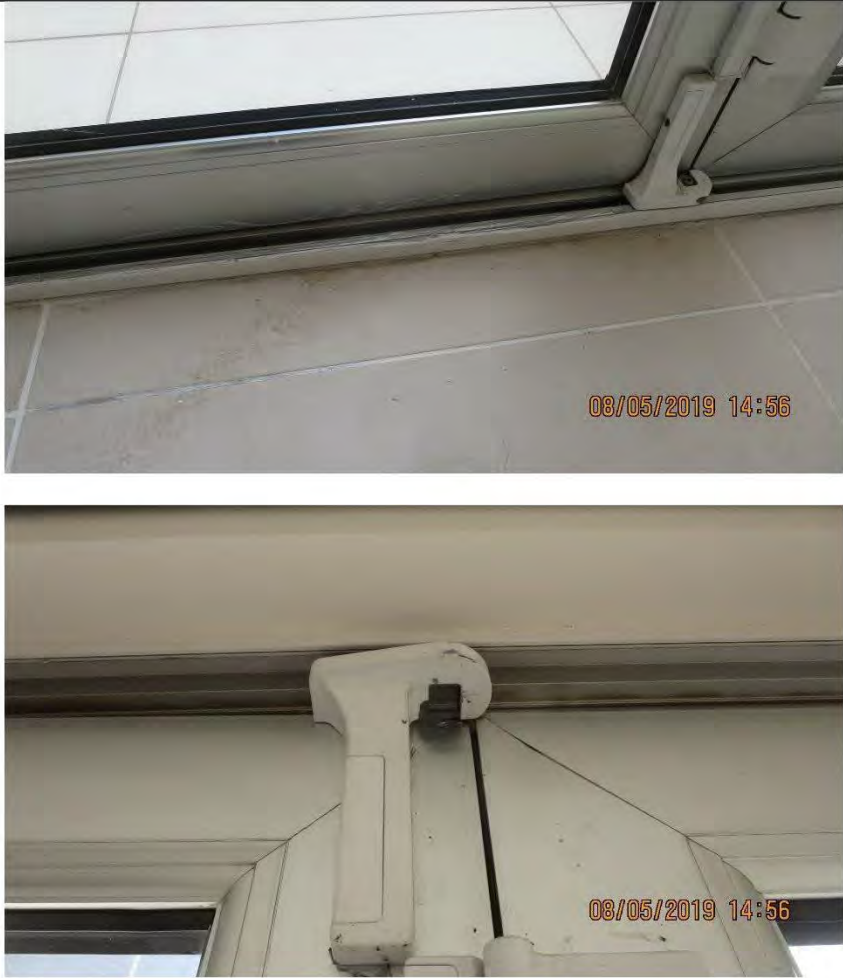
Item No.	Location	Description / Findings	Image Reference
6	Living room.	<p>The bifold doors servicing the rear of the living room were unable to be opened due to a guide bearing not being in position on the top rail.</p> <p>It was observed that heavy collision between the door threshold and the bottom of the bi-fold door is apparent.</p>

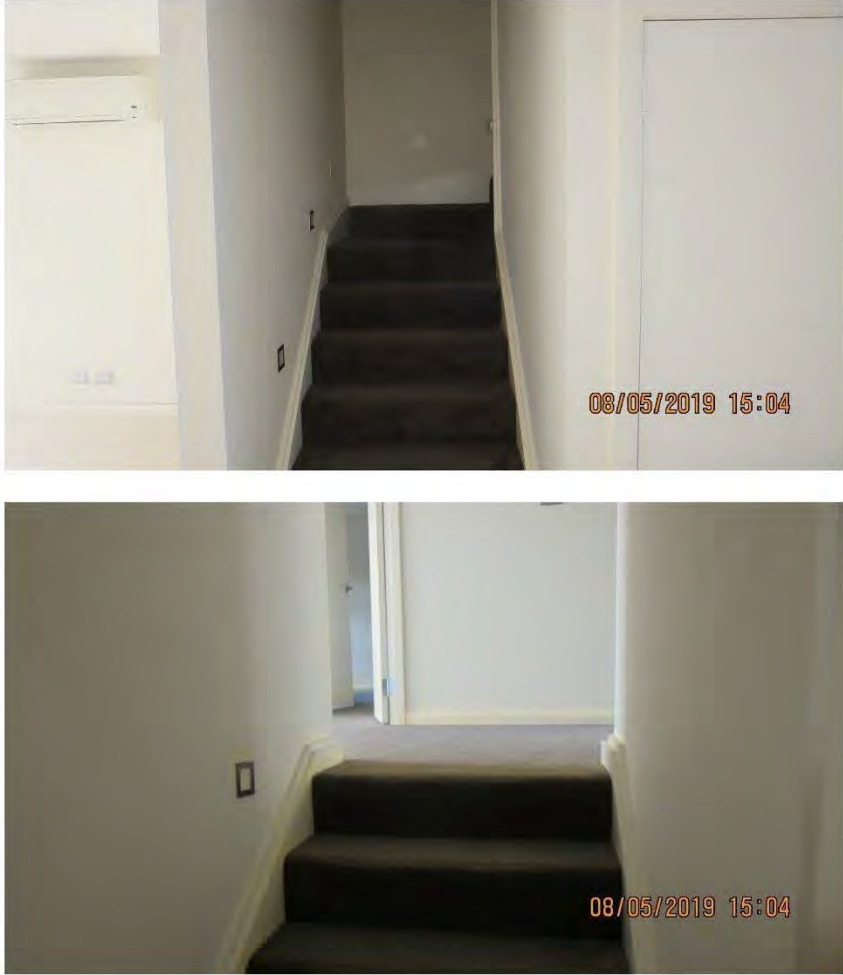
Item No.	Location	Description / Findings	Image Reference
9	Stairwell.	No handrails have been fitted to the stairwell leading from the ground floor to level 1.

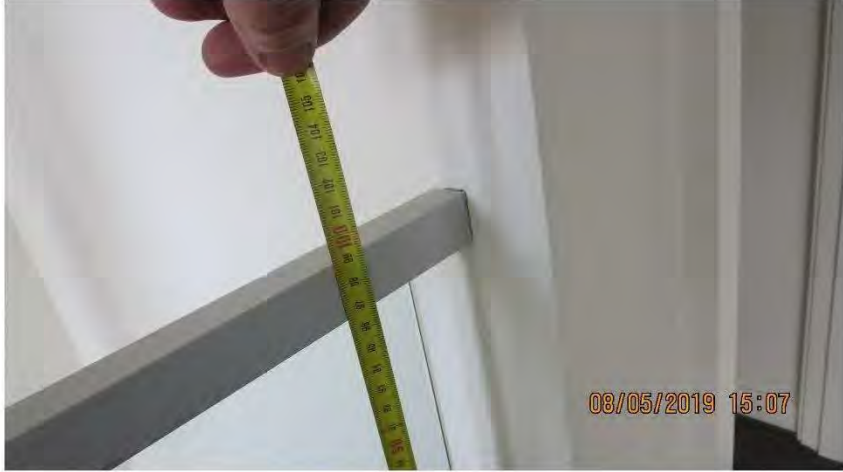
Item No.	Location	Description / Findings	Image Reference
10	Upper-level mezzanine area.	<p>The glass handrail and balustrading to this mezzanine area is under height as per the related building code.</p> <p>The measurement taken was observed to be 990mm.</p> <p><i>Refer to NCC 2016 Vol.2 Part 3.9.2 (Barriers and Handrails)</i></p> <p><i>Part 3.9.2.3 (ii)(A) The height must be 1 m above any access path, balcony, landing or the like.</i></p>

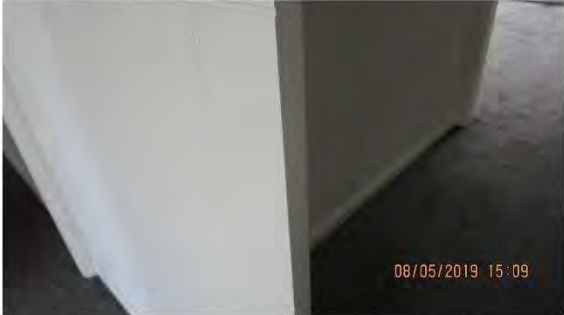
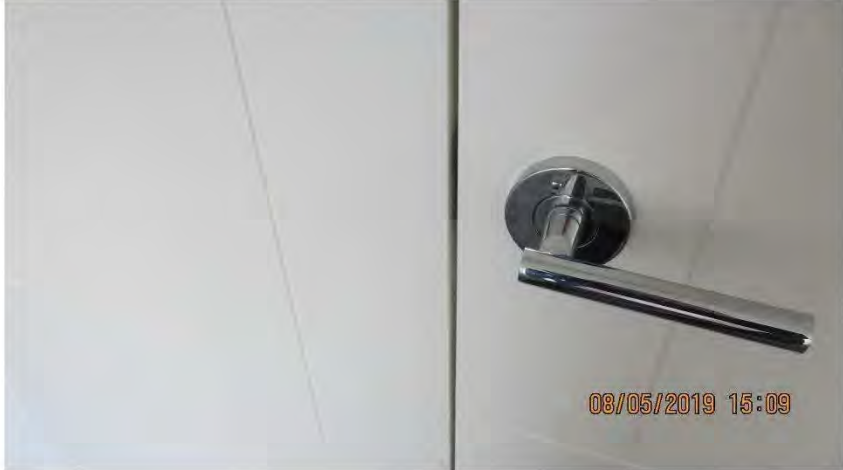
11	Upper-level mezzanine area	<p>No striker plate has been fitted to the left-hand leaf of the double doors.</p> <p>A door latch has been fitted to the right-hand door but with the striker plate being not in place, the doors cannot be closed properly.</p>

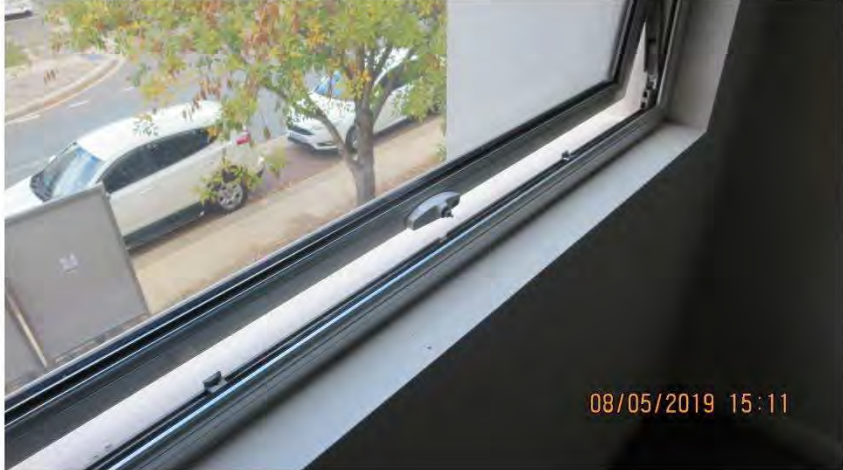
Item No.	Location	Description / Findings	Image Reference
12	Bedroom 1.	<p>It was observed that no handle was fitted to the bottom section of the awning window. The absence of same does not enable the window to be closed securely.</p> <p>The awning window was also able to be opened greater than the required measurement of 125mm for an upper level opening.</p> <p><i>Refer to NCC 2016 Vol.2 Part 3.9.2 (Barriers and Handrails)</i></p> <p><i>Part 3.9.2.5 (a) A window opening must be provided with protection, if the floor below the window in a bedroom is 2m or more above the surface beneath.</i></p>

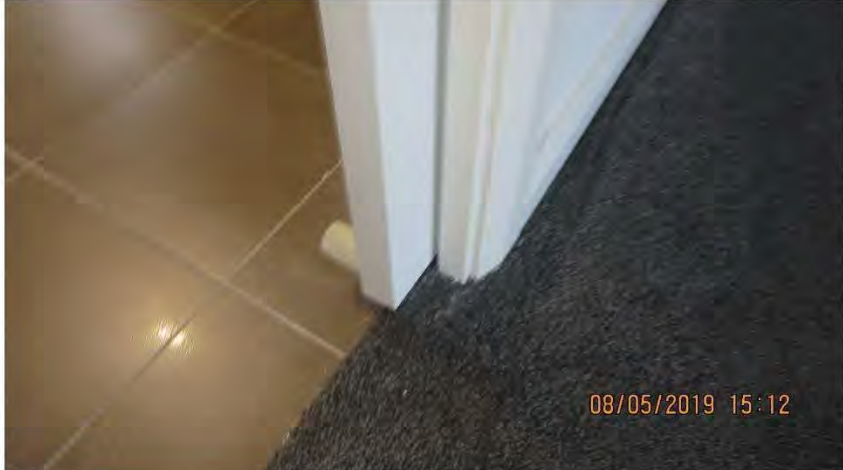
13	Ensuite.	<p>Door guides have not been fitted to the cavity sliding door.</p> <p>Whilst the door does slide effectively, there is the likelihood of potential damage to the surfaces of the door, being scratched by the cavity door unit itself in the absence of physical door guides which should be installed.</p>

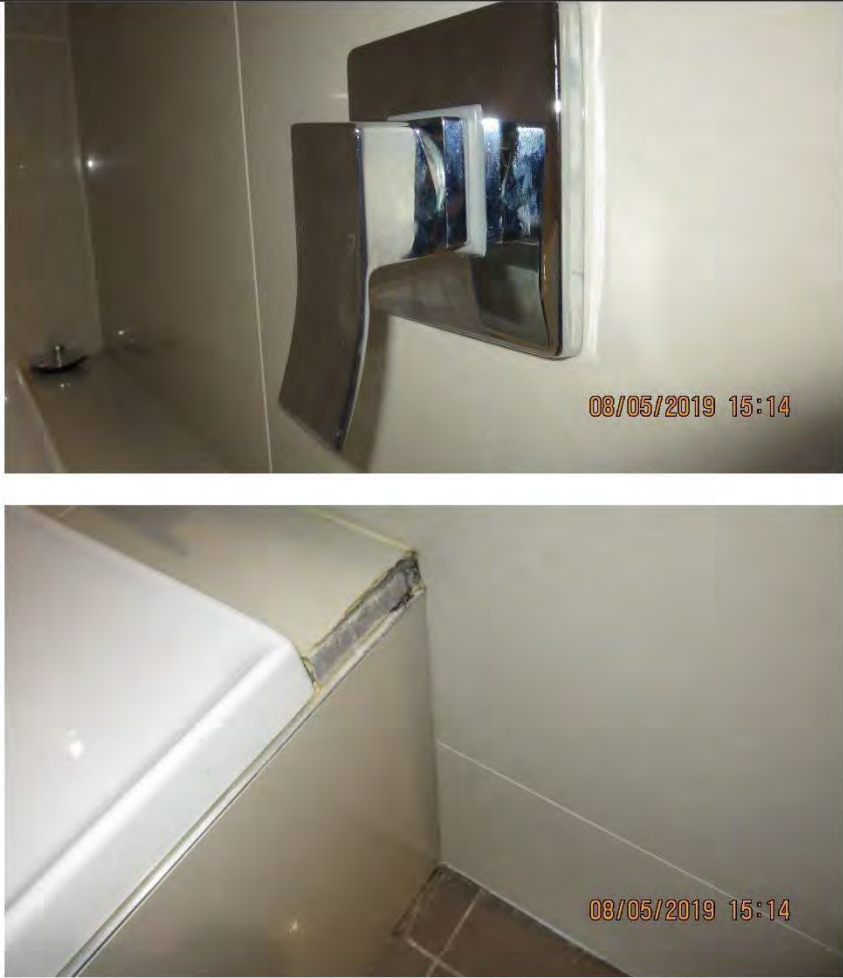
Item No.	Location	Description / Findings	Image Reference
14	Ensuite.	<p>It appears the tap fitting for the bathtub is leaking.</p> <p>It was observed some resultant damage from this leaking to the edge of the bathtub hob and also some deterioration to the grout and floor tiling.</p>

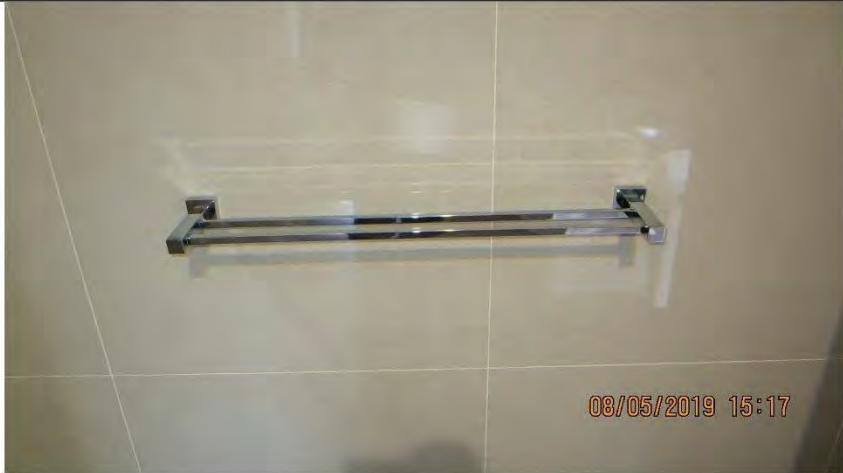
Item No.	Location	Description / Findings	Image Reference
15	Ensuite.	The double towel rail fitted to the wall tiles is loose and requires re-tightening.

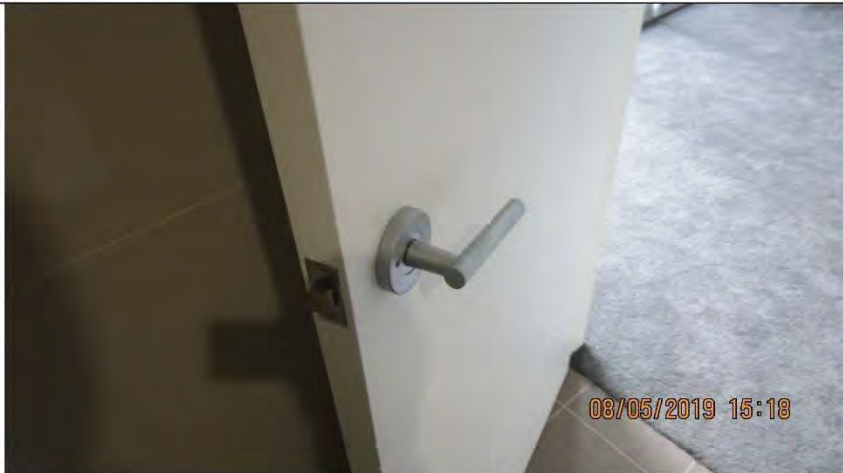
16	Ensuite.	The door furniture fitted to the swinging door of the ensuite is loose and requires re-tightening.

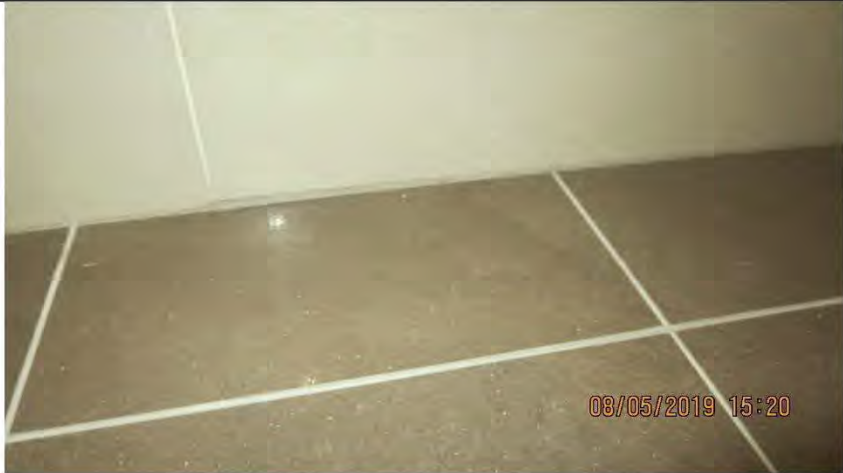
Item No.	Location	Description / Findings	Image Reference
17	Ensuite.	<p>Rigid grout has been installed between the floor tiles and the wall tiles.</p> <p>This does not allow for any movement between the floor and the walls causing the grout to crack nor cater for any building movement.</p> <p>A bathroom grade flexible sealant is recommended to be installed along this junction between the floor and wall tiles.</p>

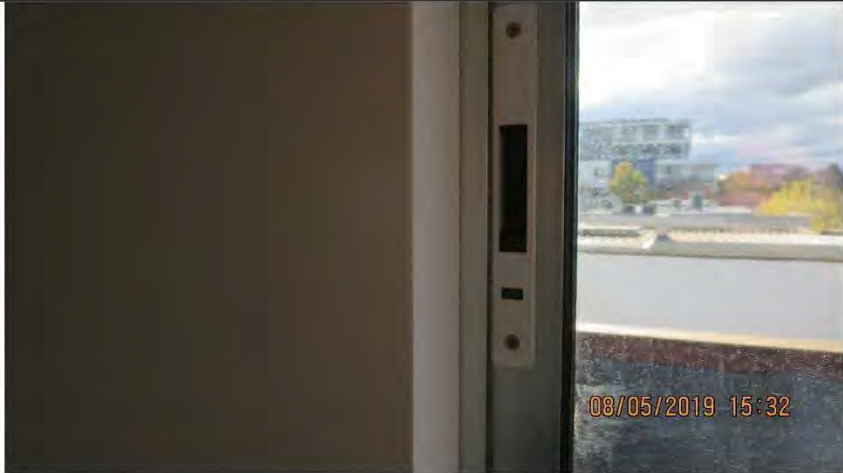
Item No.	Location	Description / Findings	Image Reference
20	Bedroom 3.	<p>The lock fitted to the north facing window is not operating as intended.</p> <p>It is unable to be locked therefore not providing the intended security.</p>

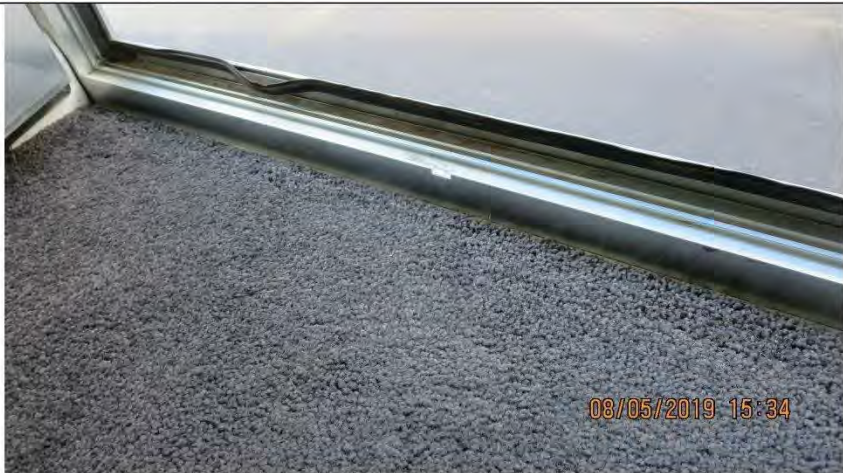
21	Bedroom 3.	<p>The door threshold fitted to the exterior swinging door has no provision for drainage to the exterior of the building.</p> <p>It was observed that a notching has been taken out of the internal section of the threshold which may indicate this is the intended relief point for the threshold if any water gathers within.</p> <p>It was also observed that no damp proof course (DPC) has been fitted to the underside of this subject door.</p>

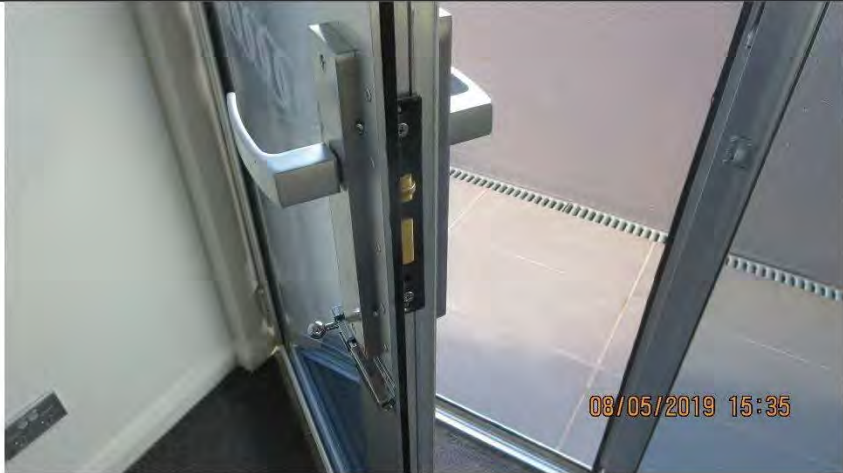
Item No.	Location	Description / Findings	Image Reference
22	Bedroom 3.	<p>It appears the door is fitted with a mismatch of door furniture.</p> <p>The mortise lock is fitted with a roller catch and also a deadbolt, but the deadbolt cannot be operated due to the door furniture not allowing for any key entry.</p> <p>A slide deadbolt has been installed to secure the building.</p>

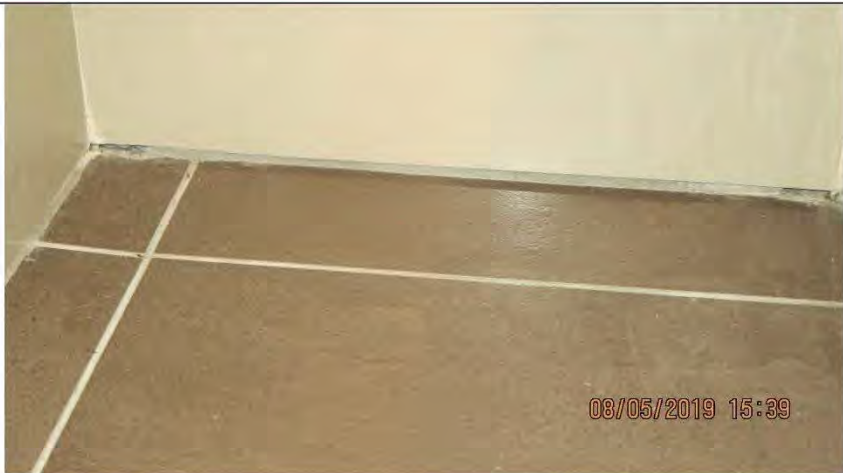
23	Upper bathroom.	<p>Rigid grout has been installed between the floor tiles and the wall tiles.</p> <p>This does not allow for any movement between the floor and the walls causing the grout to crack nor cater for any building movement.</p> <p>A bathroom grade flexible sealant is recommended to be installed along this junction between the floor and wall tiles.</p> <p>It was also observed adjacent to the toilet suite that some gaps appear at the subject junction where the grout has become dislodged.</p>

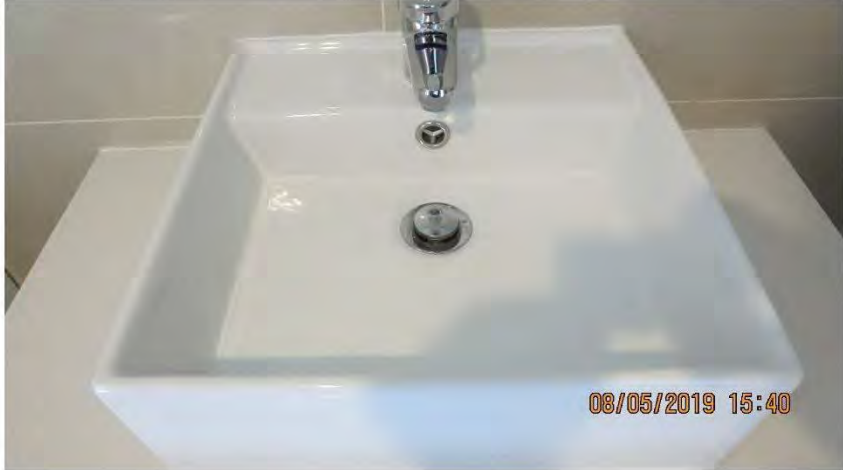
Item No.	Location	Description / Findings	Image Reference
24	Upper bathroom.	<p>Both basins fitted to the vanity units are fitted with a push plug waste.</p> <p>These wastes cannot be operated as intended as the push plug wastes are seized.</p>

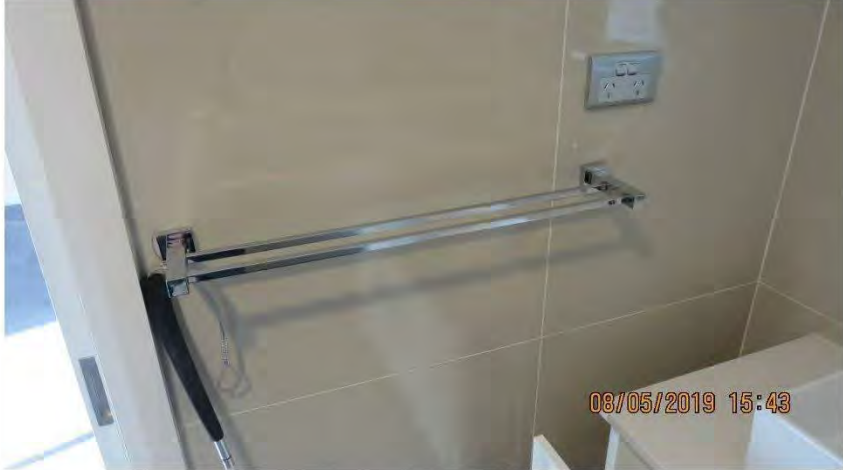
25	Upper bathroom.	<p>The double towel rail fitted to the wall tiles is loose and requires retightening.</p>

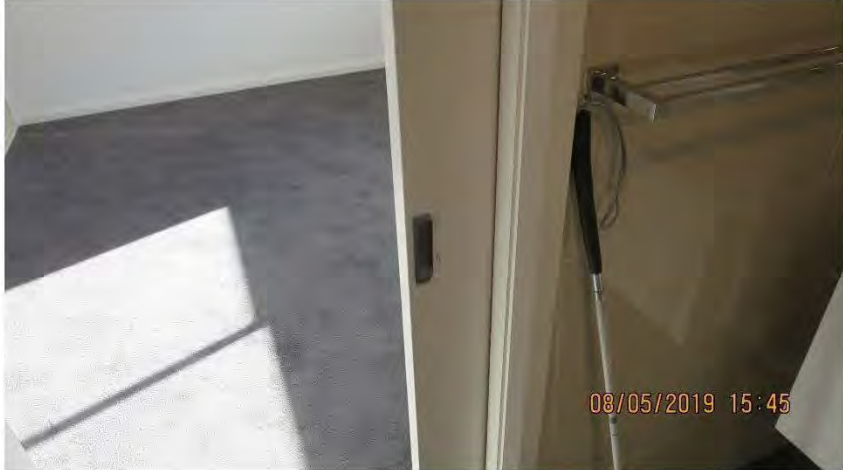
Item No.	Location	Description / Findings	Image Reference
26	Upper bathroom.	<p>The sliding door from bedroom 2 is not operating as intended.</p> <p>It is difficult to slide when being operated.</p> <p>Also, there is a significant amount of paint overrun to the flush pull handles.</p>

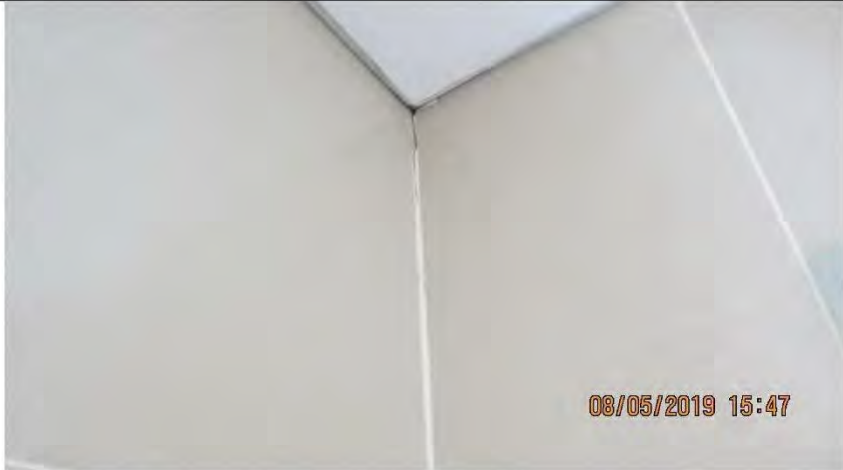
27	Upper bathroom.	<p>The internal wall junctions have been filled with rigid wall grout.</p> <p>The wall grout does not allow for any movement and therefore with any movement, the grout becomes dislodged.</p> <p>A flexible sealant is recommended in these areas to cater for the expected movement and to provide water protection to the junctions.</p>

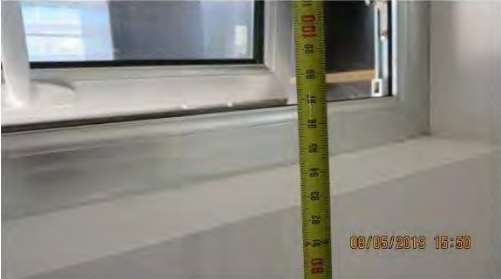
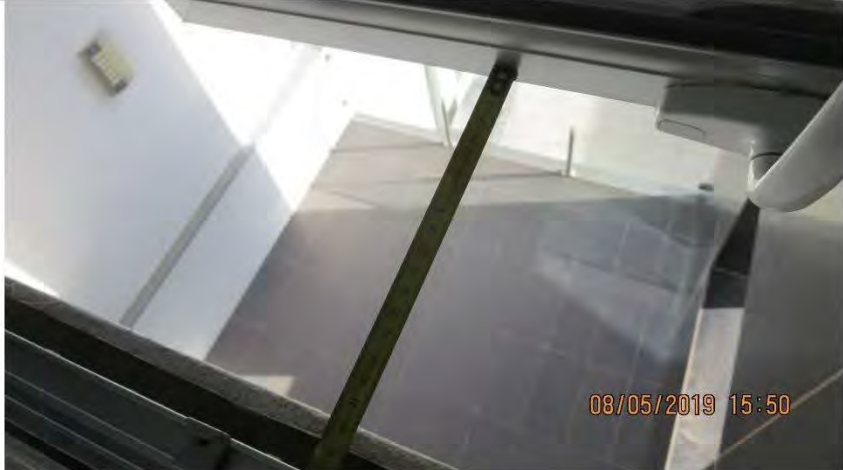
29	Bedroom 2.	<p>The sill height of the windows on the south-west elevation of the building is 955 mm and the awning window can be opened up greater than 125 mm.</p> <p><i>Refer to NCC 2016 Vol.2 Part 3.9.2 (Barriers and Handrails)</i></p> <p><i>Part 3.9.2.5 (a) A window opening must be provided with protection, if the floor below the window in a bedroom is 2m or more above the surface beneath.</i></p>

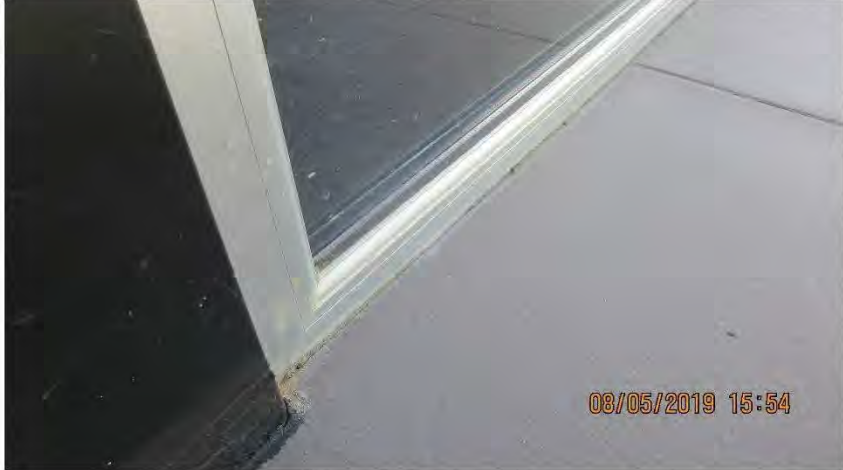
Item No.	Location	Description / Findings	Image Reference
30	Bedroom 3 – External balcony.	<p>It appears this balcony is provided with adequate fall to tiled floor surface.</p> <p>It was observed that the waterproofing upturn can be seen to the building edge and balustrade edge.</p> <p>No upturn can be observed to the external door of the bedroom. Where the tiles are fitted against the aluminium frame, the installed grout has cracked and subsequently provides for water entry to the substrate or under the door threshold into the building.</p> <p>As previously mentioned, this door is not fitted with a DPC to protect water entry into the building.</p> <p>Proper waterproofing detailing is required at this location to eliminate any water ingress into the building.</p>

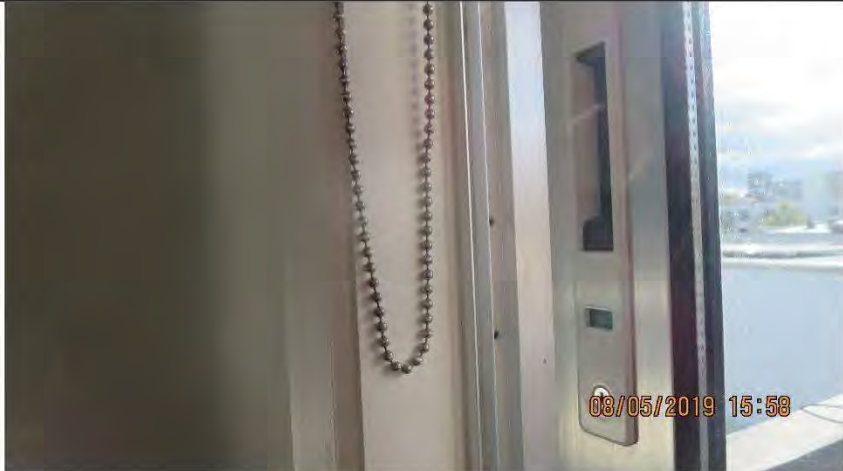
Item No.	Location	Description / Findings	Image Reference
31	Bedroom 2.	The locking mechanism fitted to the north facing window is incomplete. This does not allow for the sliding window to be locked to secure the building from this opening point.

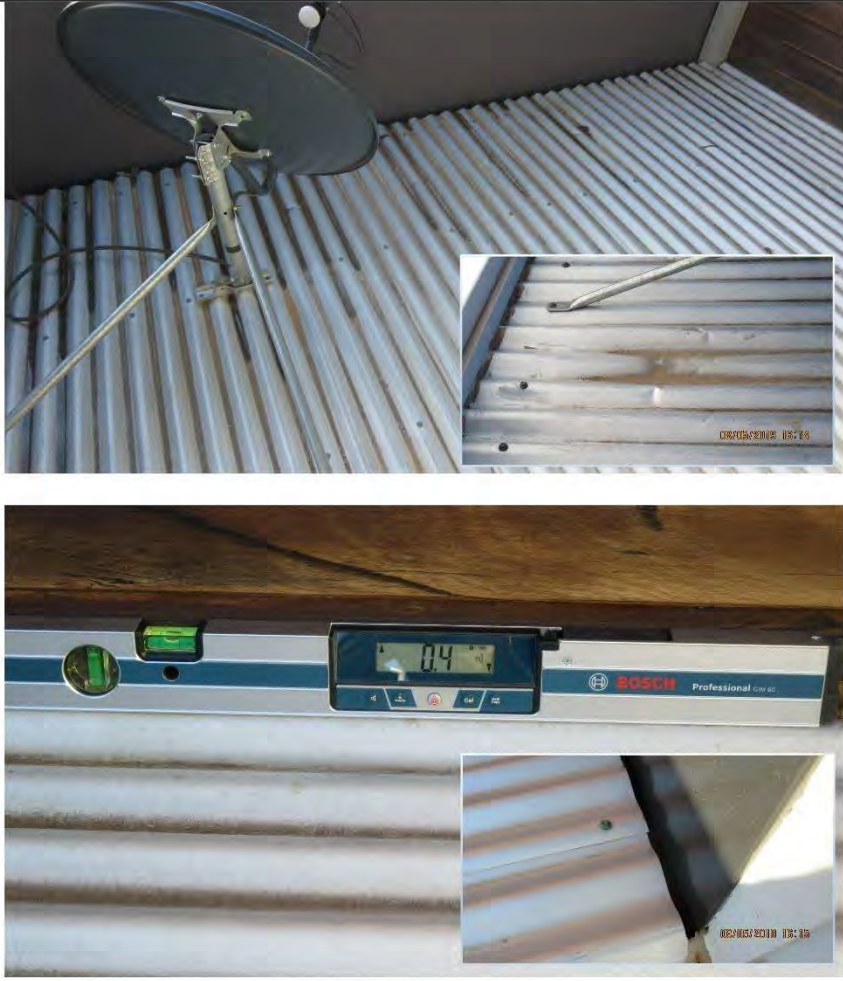
Item No.	Location	Description / Findings	Image Reference
32	Exterior roof covering (bedroom 2).	<p>The roof covering fitted to the northern elevation adjacent to bedroom 2 has been fitted with corrugated roof sheeting.</p> <p>The roof gradient provided is inadequate for this particular sheet profile. It is also heavily dented and areas of the roof sheeting is holding water.</p> <p>It appears that this roof covering is a secondary measure as another level of sheeting can be seen between the gapping of the roof sheeting and the wall linings.</p> <p>Little effort has been conducted to provide any flashings being fitted to the building edge to prevent any water entering the under surface.</p> <p>This roof surface is in direct correlation with the room below (and as discussed with the perspective purchaser), the ceiling had collapsed and water stains are evident surrounding the recessed light fittings in the bedroom retreat area.</p>

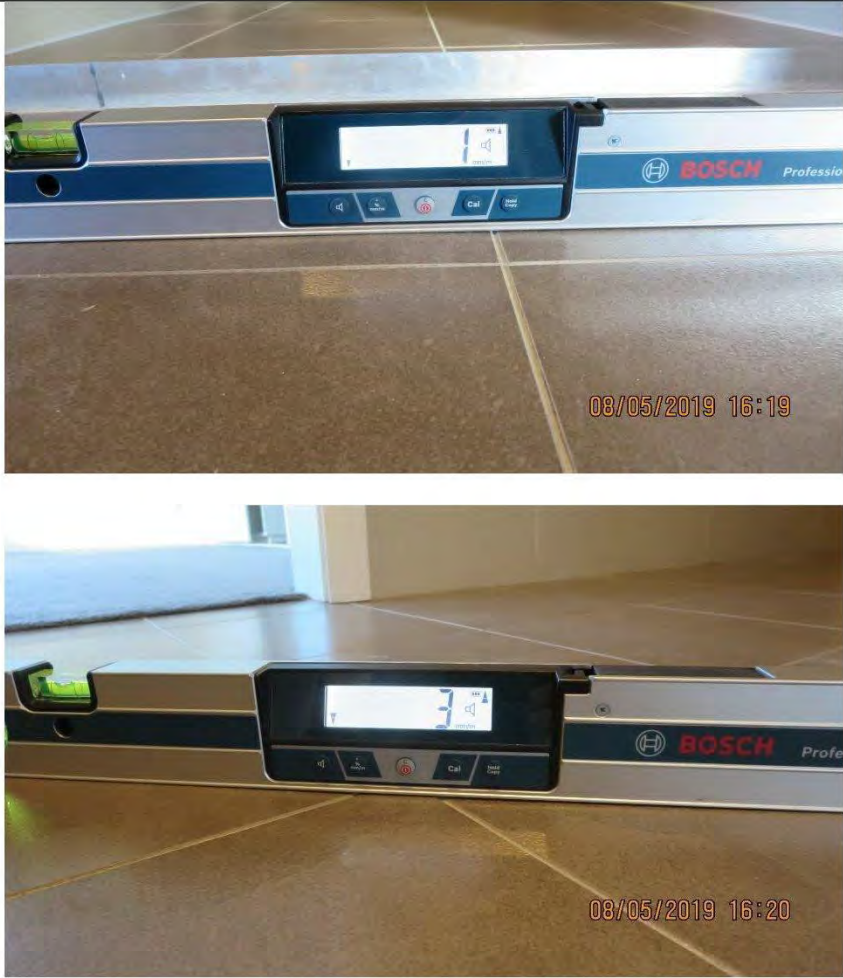
Item No.	Location	Description / Findings	Image Reference
33	Upper bathroom.	<p>There is inadequate fall to the tiled surface in the bathroom area.</p> <p>Measurements were also taken within the shower recess and were observed to be adequate.</p> <p>No shower screens were fitted to the opening of the shower recess allowing for water to escape the shower recess. Subsequently, water migrate onto the floor outside the shower recess where there is inadequate falls to the tiled surface and can allow for the pooling of water over.</p>

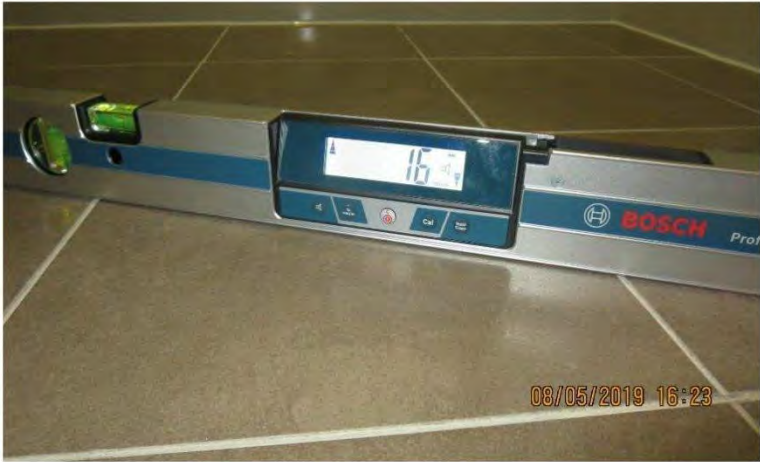
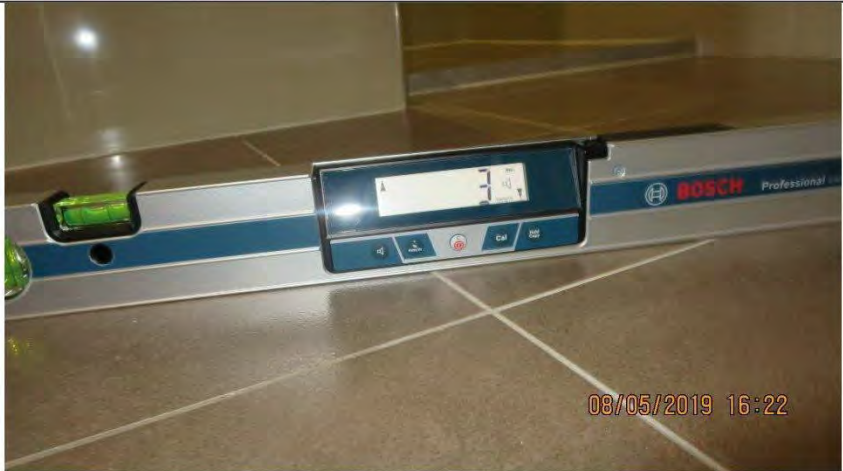
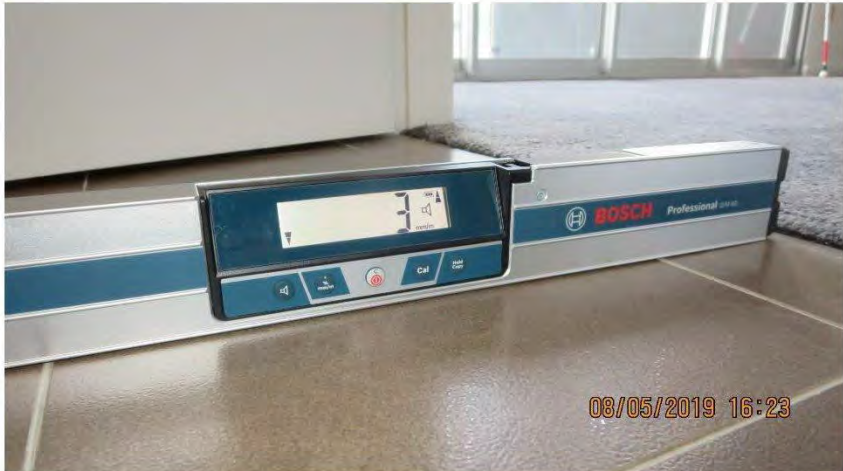
Item No.	Location	Description / Findings	Image Reference
34	Bedroom 1 ensuite.	<p>There is inadequate fall to the tiled surface in the ensuite area.</p> <p>Measurements were also taken within the shower recess and were observed to be adequate.</p> <p>No shower screens were fitted to the opening of the shower recess allowing for water to escape the shower recess. Subsequently, water migrate onto the floor outside the shower recess where there is inadequate falls to the tiled surface and can allow for the pooling of water over.</p>

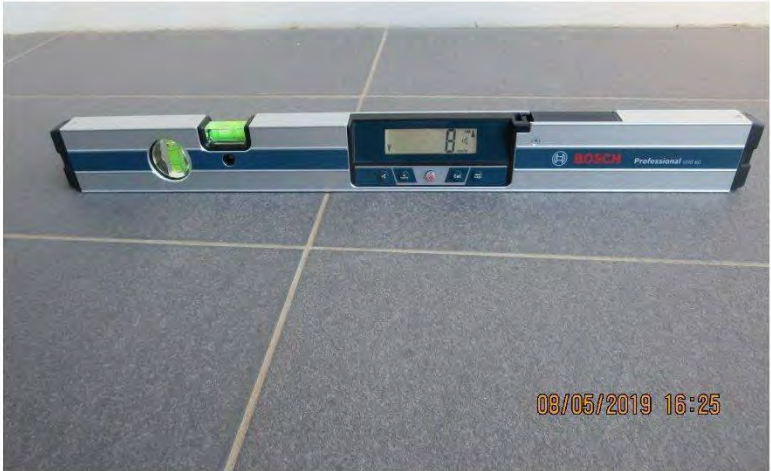
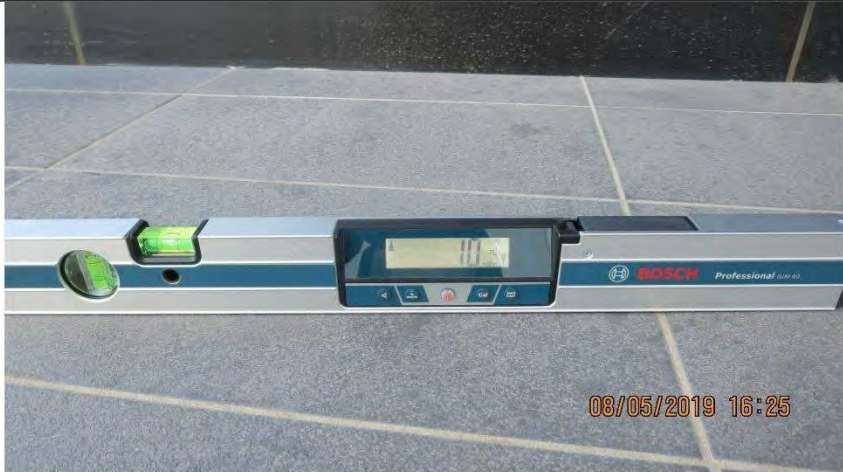
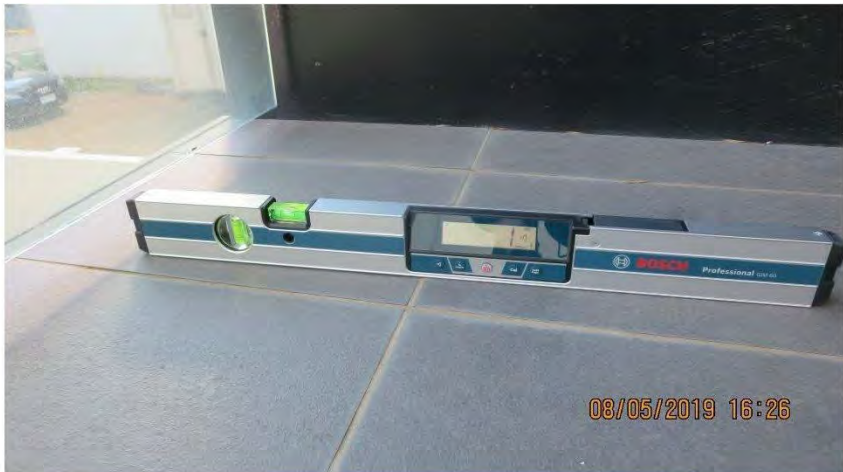
Item No.	Location	Description / Findings	Image Reference
35	Exterior balcony (bedroom 1 retreat)	<p>There is inadequate falls to the balcony adjacent to bedroom 1 retreat.</p> <p>Areas closest to the sliding door were measured with adequate falls but approaching the edge of the balcony, the fall provided is inadequate.</p> <p>There is visible gapping between the tiled edge and the building envelope. The gapping provides for an entry point for water to enter the areas below.</p> <p>It was also observed that there is no upturn of the waterproofing membrane to this area.</p>

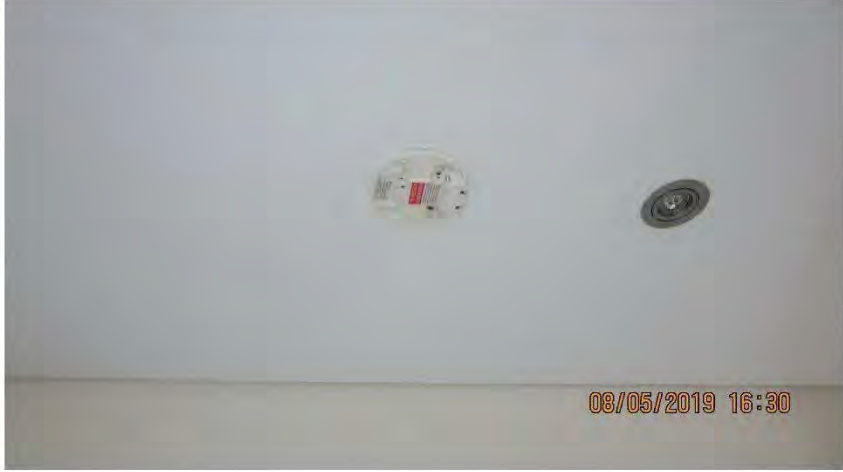
37	General.	The smoke detector fitted between bedrooms 2 and 3 is incomplete.

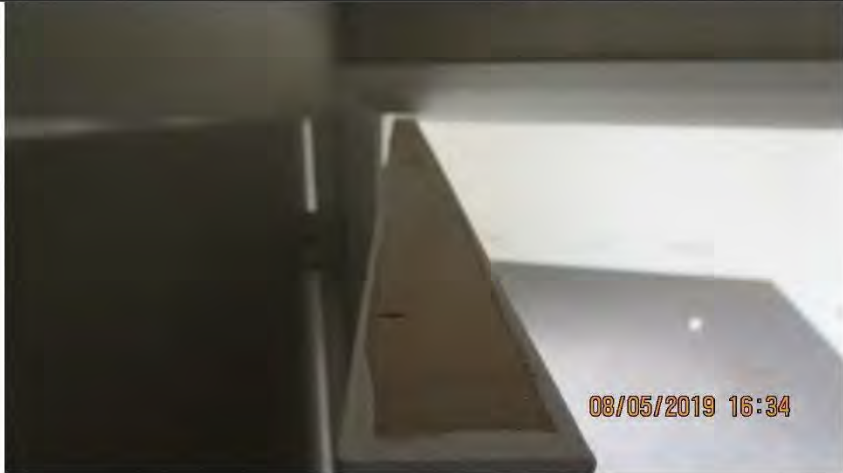
Item No.	Location	Description / Findings	Image Reference
38	General.	<p>The top edges of the internal doors have not been sealed throughout the residence.</p> <p>The bottom edges were unable to be observed without physically removing them. It is required that all edges are to be sealed to eliminate moisture uptake and meet the requirements of the door manufacturer.</p>

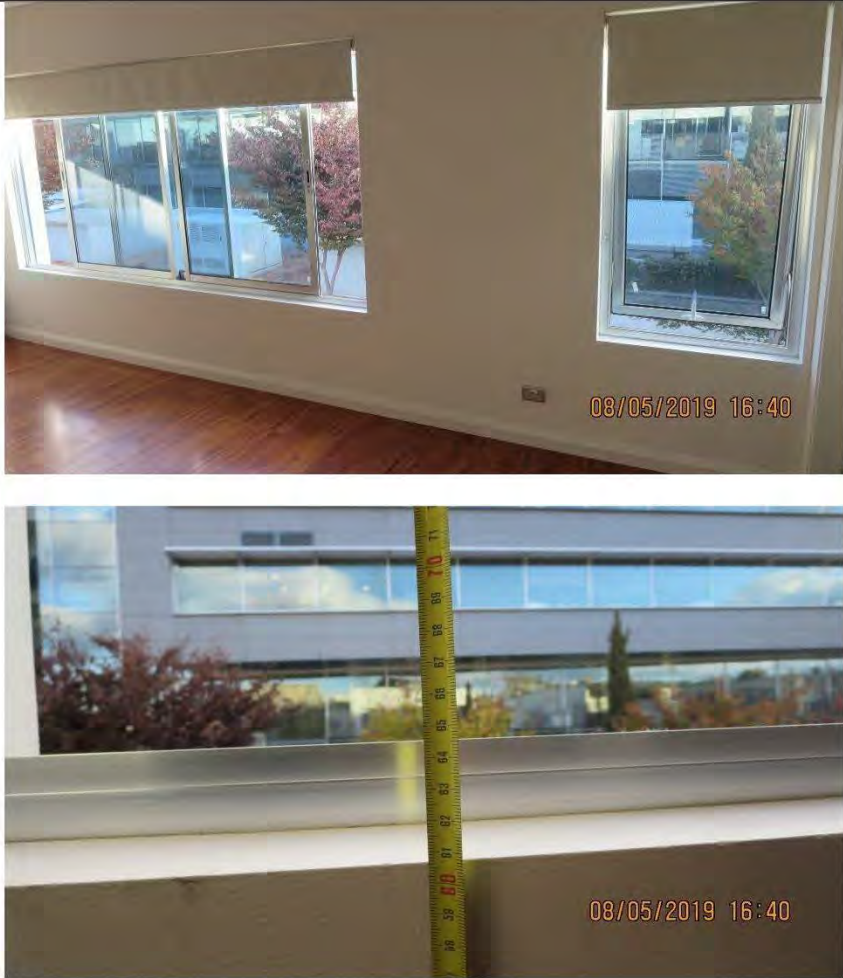
Item No.	Location	Description / Findings	Image Reference
41	Living room.	<p>The sill height of the windows on the south-west elevation measured 650mm. All movable panes of glass to these windows were able to be opened greater than 125mm and greater than the required measurement for an upper level opening.</p> <p>It was also observed the locking mechanism to the sliding windows were incomplete with no engagement plate being fitted to the stiles of the window.</p> <p><i>Refer to NCC 2016 Vol.2 Part 3.9.2 (Barriers and Handrails)</i></p> <p><i>Part 3.9.2.5 (b) Where the lowest level of the window opening is less than 1.7 m above the floor, a window opening covered by (a) must comply with the following.</i></p>

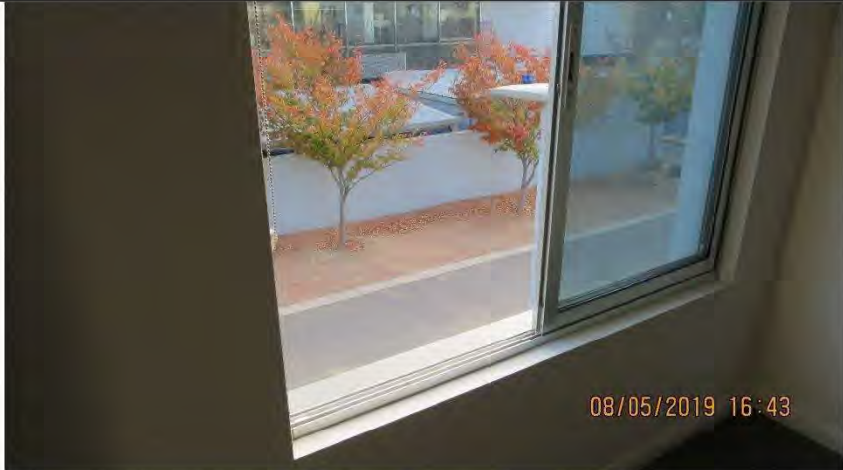
Item No.	Location	Description / Findings	Image Reference
42	Bedroom 2.	<p>The sill height of the sliding window on the south-west elevation measured 650mm. The window was able to be opened greater than 125mm and greater than the required measurement for an upper level opening.</p> <p>It also was observed that the locking mechanism to the window is not working as intended. It was unable to be locked.</p> <p><i>Refer to NCC 2016 Vol.2 Part 3.9.2 (Barriers and Handrails)</i></p> <p><i>Part 3.9.2.5 (a) A window opening must be provided with protection, if the floor below the window in a bedroom is 2m or more above the surface beneath.</i></p>

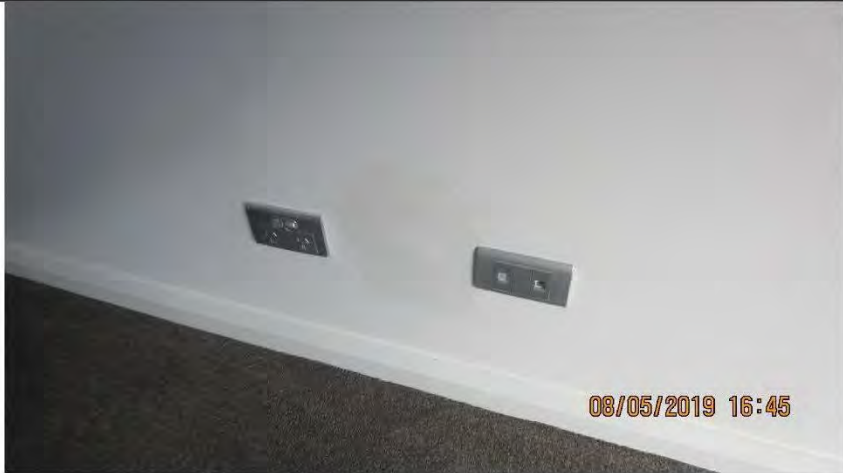
Item No.	Location	Description / Findings	Image Reference
43	Bedroom 2.	Between the data and double power point on the bedroom wall, some repairs have been conducted but are yet to be completed.

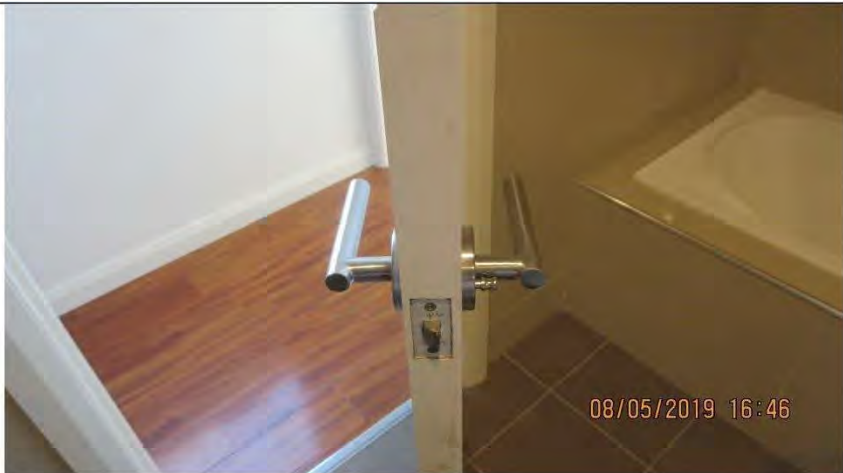
44	Bathroom.	<p>The door furniture fitted to the bathroom door is not operating as intended.</p> <p>A snib lock is fitted to the door furniture and is not operating as intended.</p>
