FOI Reference: CMTEDDFOI 2019-184

From: [EPSDFOI](#)
To: [CMTEDD FOI](#)
Subject: Partial Transfer - 72 Printers Way Kingston
Date: Thursday, 8 August 2019 12:16:19 PM

Site Inspection	3
1. Assumptions.....	3
2. Areas Inspected	3
3. Overview / Acceptance Criteria	4
4. Assessment/(Methodology).....	5
5. Inspection Findings	6
Terms and Conditions	50

The purpose of this inspection was to provide a list of defective items that are not in compliance with the relevant building code and other standards.

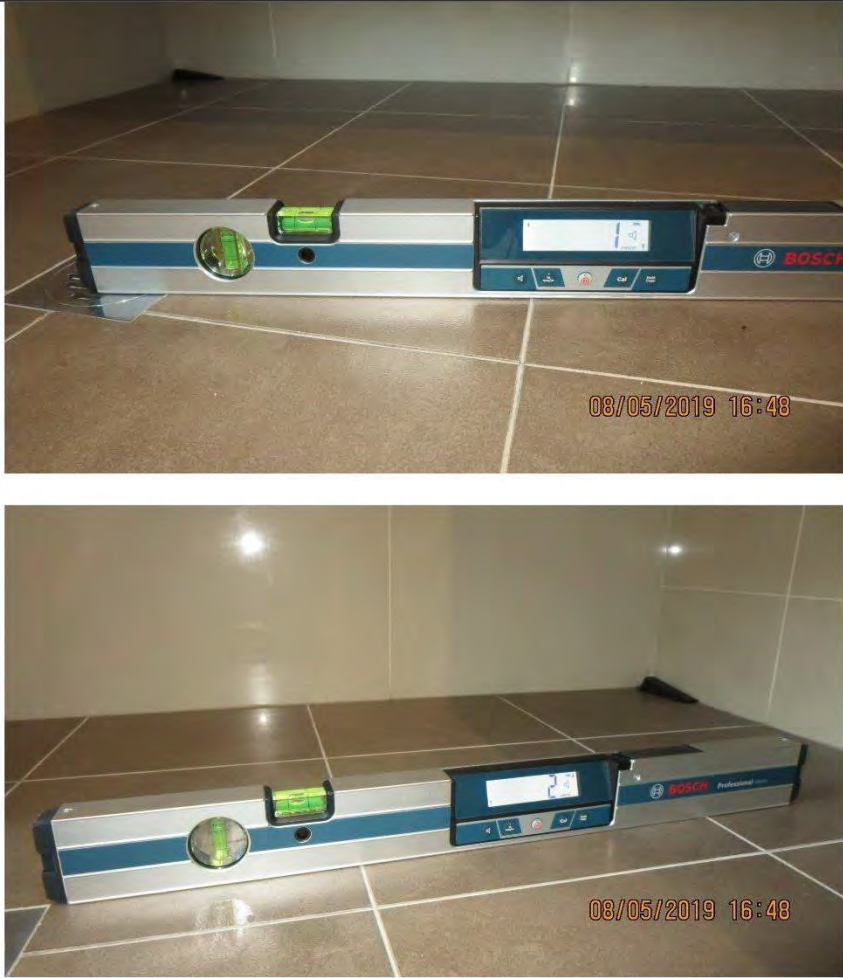
Item No.	Location	Description / Findings	Image Reference
45	Bathroom.	<p>Inadequate falls were observed to the bathroom floor.</p> <p>The falls were also measured within the shower recess but were observed to be adequate.</p> <p>A shower screen was fitted to this shower recess.</p>

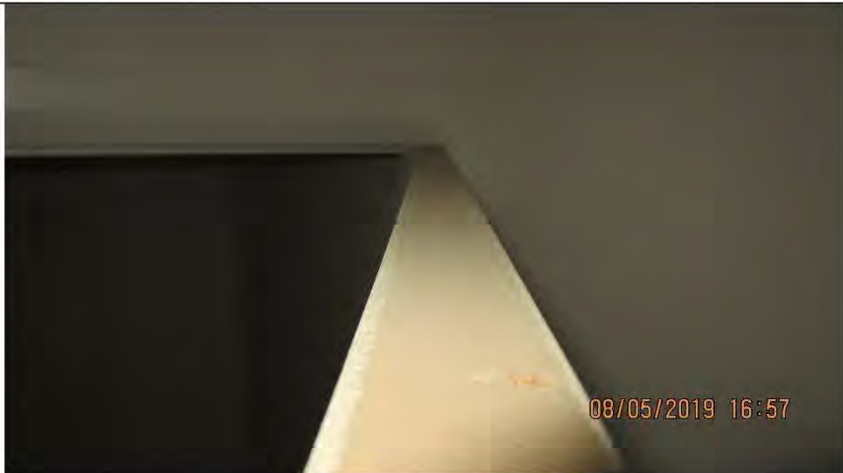
50	General.	<p>It was observed that the top edges of the internal doors and exterior doors were not sealed.</p> <p>The bottom edges were unable to be observed without removing the doors it is difficult to determine this.</p> <p>It is required that all edges are sealed to eliminate moisture uptake and meet the requirements of the door manufacturer.</p>

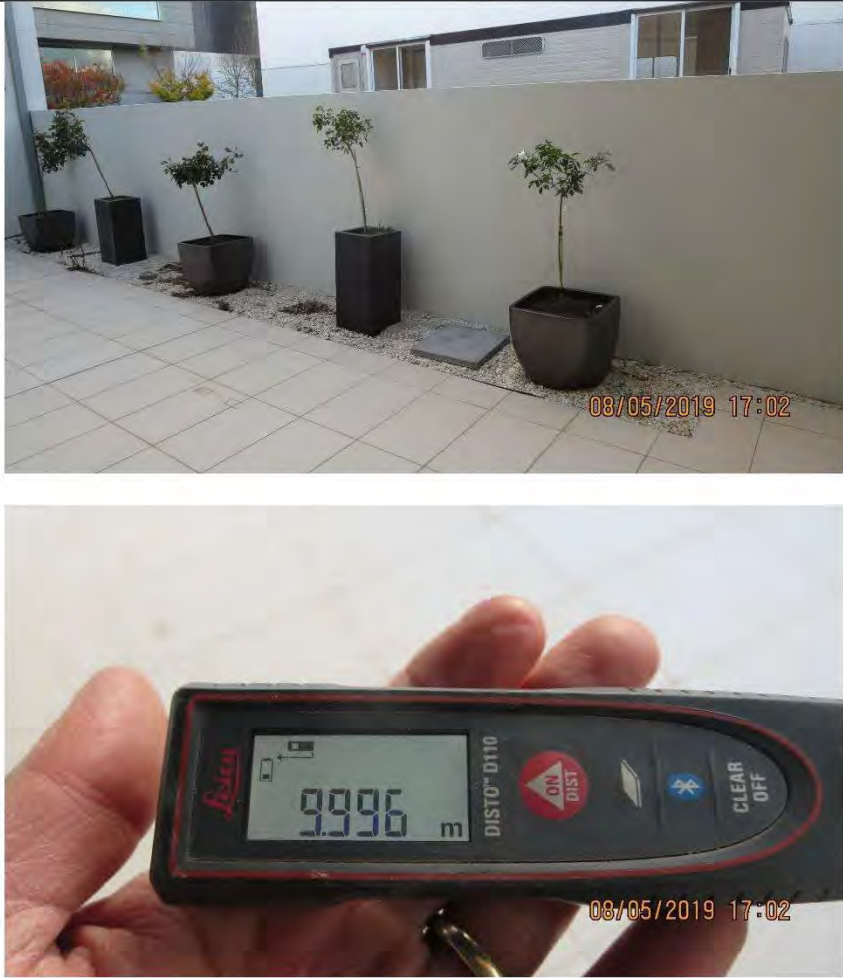
Item No.	Location	Description / Findings	Image Reference
52	Exterior.	<p>The boundary masonry fence to the courtyard has been constructed with no articulation joints (control joints) to control the expected expansion and contraction of the masonry product.</p> <p>A measurement was taken and recorded to be 9.99m. Articulation joints are required at 6m intervals.</p> <p>No large cracks were observed at the time of inspection and as such, this will structure is performing as reasonably as expected.</p>

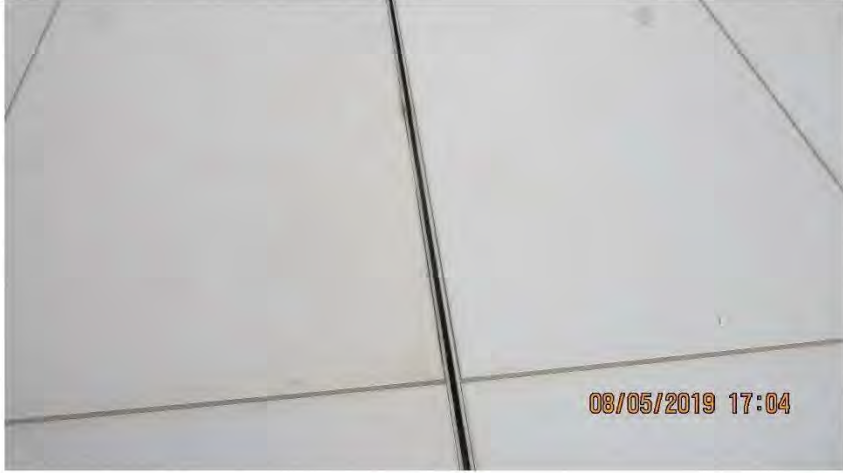
Item No.	Location	Description / Findings	Image Reference
53	Exterior.	<p>A control joint has been provided to the courtyard tiling surface as required.</p> <p>The courtyard control joint has been fitted with an aluminium angle each side of the tiles, but the internal area of these angles has not been filled and would allow water to enter the joint.</p> <p>It is recommended an exterior grade flexible sealant be applied to this joint to eliminate water entry and deterioration of the substrate.</p>

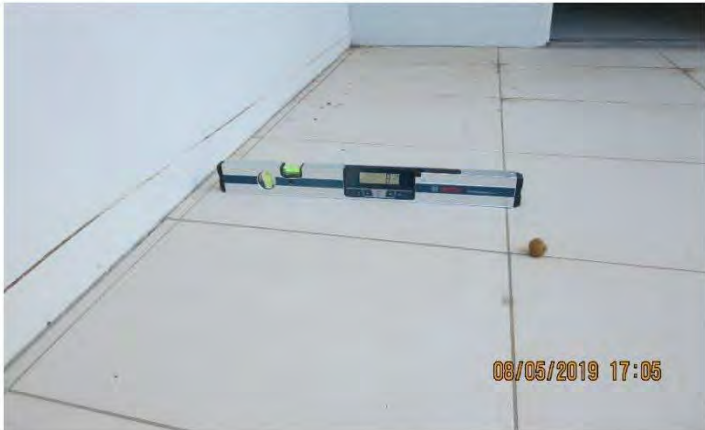
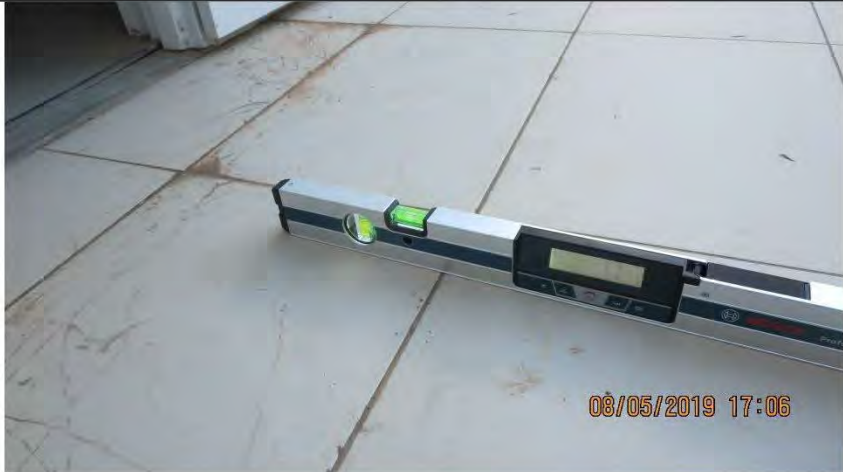
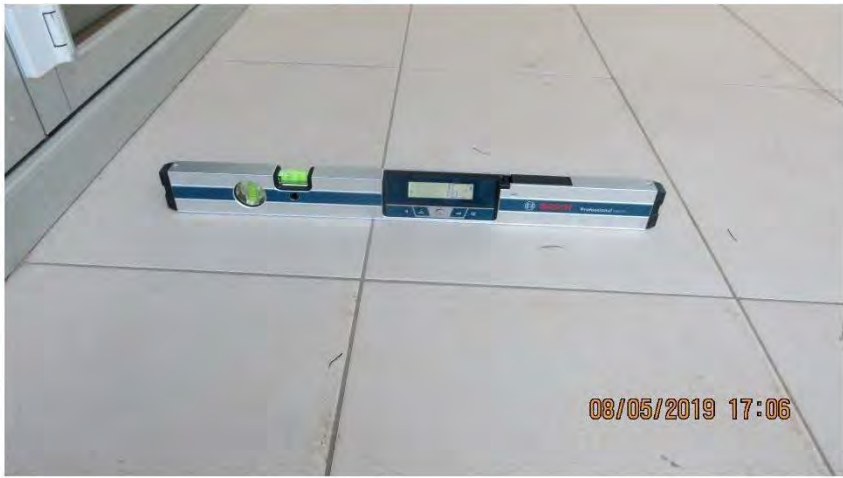
Item No.	Location	Description / Findings	Image Reference
54	Exterior.	<p>There are inadequate and non-compliant falls away from the building edge.</p> <p>It appears by the visible staining present at the time of inspection, silt build-up and gradients recorded, water gathers at the threshold of the external garage door of the 2 bedroom apartment. It would be likely during heavy rainfall that this area of the garage floor would become wet, even possibly flood. This analogy would have to be observed during heavy rainfall to be confirmed.</p> <p><i>Refer NCC 2016 Vol.2 Part 3.1.2 (Drainage)</i></p> <p><i>Part 3.1.2.3 (Surface water drainage)(a)(i) 25 mm over the first 1 m from the building in low rainfall intensity areas for surfaces that are reasonably imperable (such as concrete or clay paving).</i></p>

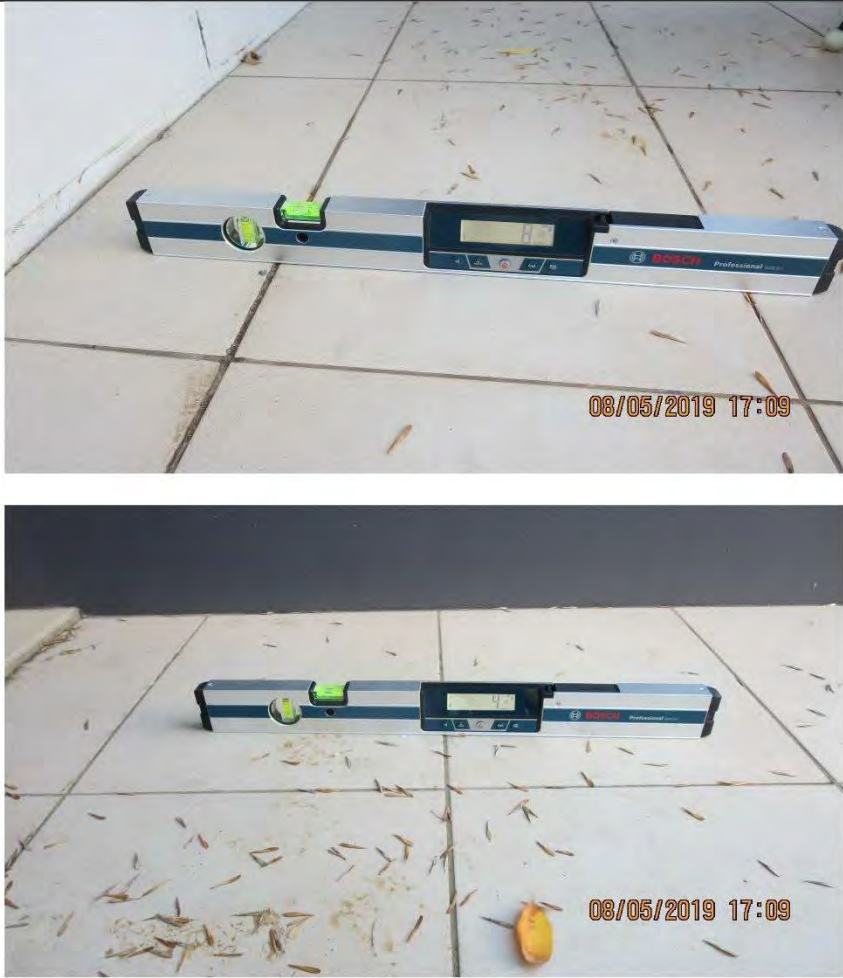
Item No.	Location	Description / Findings	Image Reference
55	Exterior.	<p>Inadequate falls have been provided to the front porch adjacent to the front bedroom and entrance door.</p> <p>A large portion of the tiled surface were observed to be drummy, displaying delamination from the substrate.</p>
