Hazardous Material Survey & Management Plan

Canberra Brickworks
Yarralumla ACT 2600

February 2012

Title: Hazardous Materials Survey & Management Plan
Canberra Brickworks
Yarralumla ACT 2600

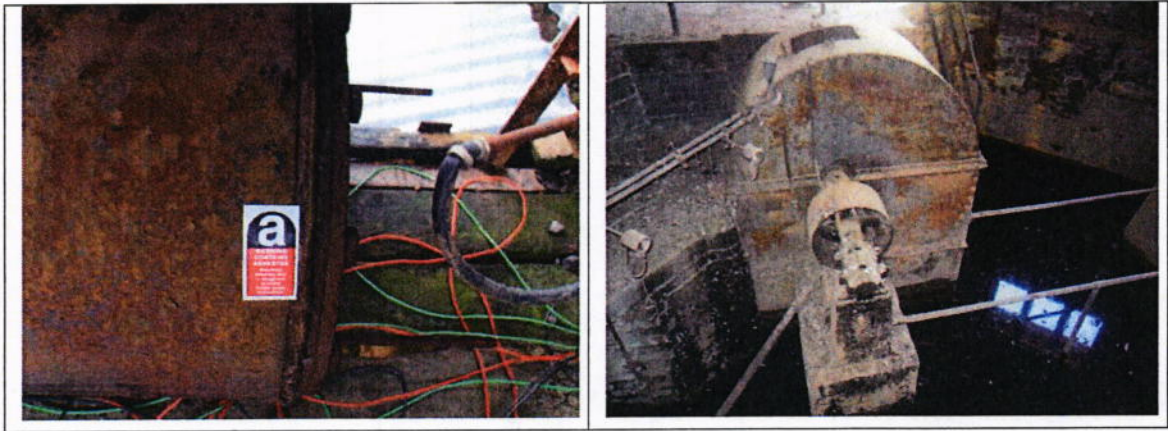
Photograph 1:
Kiln 2 - Top floor, heat exchange gasket
Refer Sample: 2810 – 40 – A3

Photograph 2:
FH1 & 2 - Duct flange joints
*Refer Samples:
2810 – 40 – A4 & 3617 – 103 – A5*

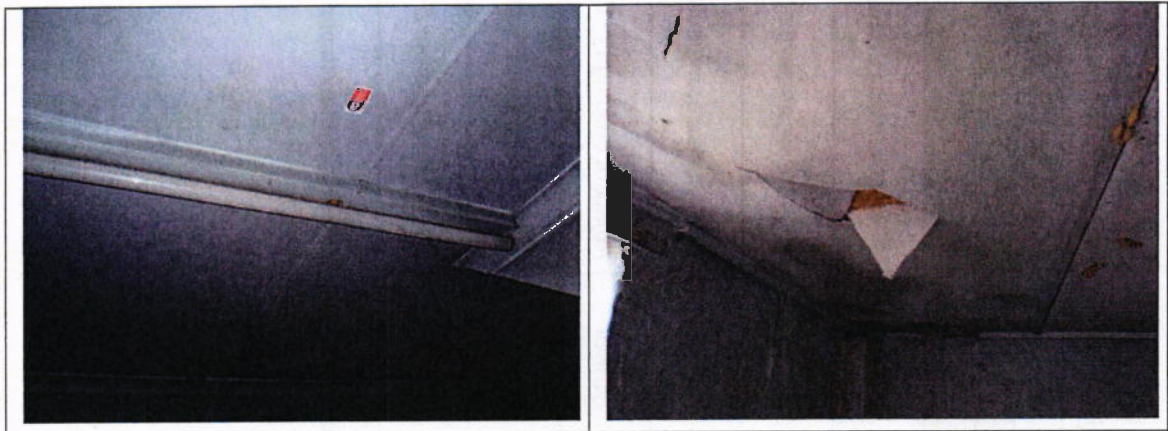
Photograph 3:
Former canteen - Ceiling sheet
Refer Sample: 2810 – 40 – A5

Photograph 4:
SS3 – Ceiling sheet
Refer Sample: 2810 – 40 – A7

- Damaged ACM ceiling sheet to the former canteen should be repaired (conceal damage ideally by gluing a boards over the holes in the sheet).
- All Asbestos identified in this report that is in a good condition should be inspected on a yearly basis by a Class A asbestos assessor to ensure no deterioration of the ACM has occurred

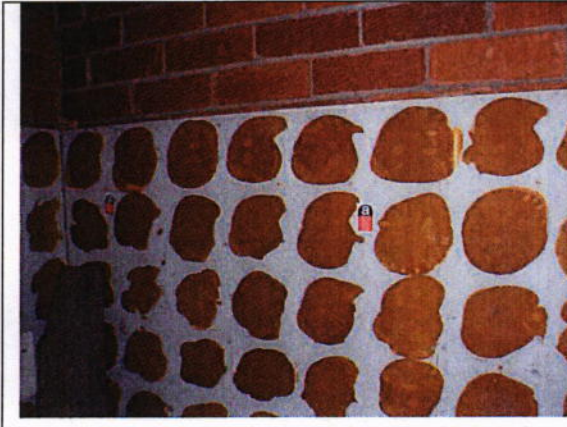
Photograph 5:
SS4 - Shower wall sheet
Refer Sample: 2810 – 40 – A8

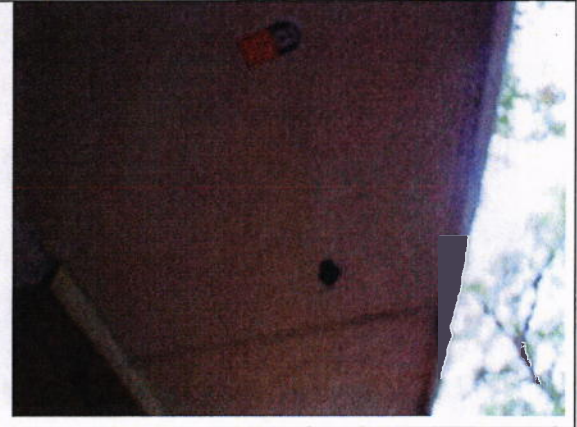
Photograph 6:
A4 - Perimeter eave & soffit sheet
Refer Sample: 2810 – 40 – A9

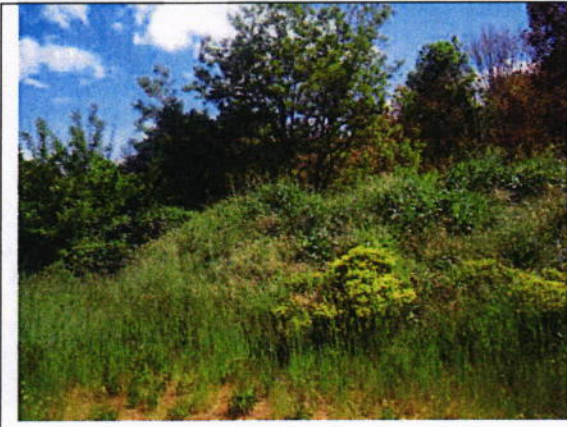
2810 – 40 – A11	7	Sheet	Tip area western side - Corrugated roof sheet & debris	2	B	debris	Remove		
	RA M0102	8	Sheet	A4 (room 6 only) - Ceiling sheet (presumed still present however, building was inaccessible)	-	-	4m ²	Requires re-inspection to asses condition		
	2810 – 40 – A13	-	Sheet	Atop kiln 3 - External wall sheet	-	-	6m ²	-	Removed	M. Robson

Photograph 7:
Tip area western side –
Corrugated roof sheet & debris
Refer Sample: 2810 – 40 – A11

- Damaged ACM ceiling sheet to SS1, SS2 & SS3 should be removed.
- The ACM corrugated roof sheet and debris to the tip area western side should be thoroughly checked and all found materials should be removed.

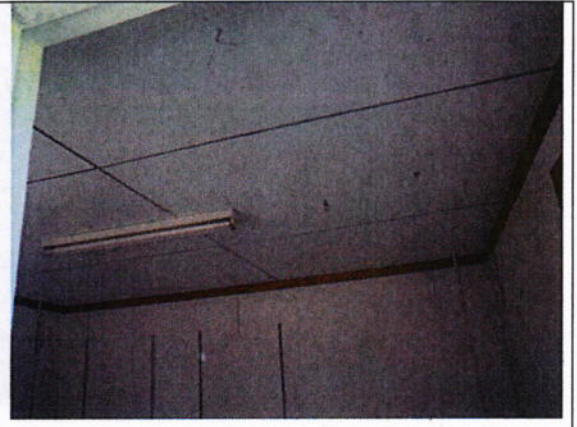
Photograph 8:
A4 (room 6 only) - Ceiling sheet (presumed
still present however, building was
inaccessible)
Refer Sample: RA M0102

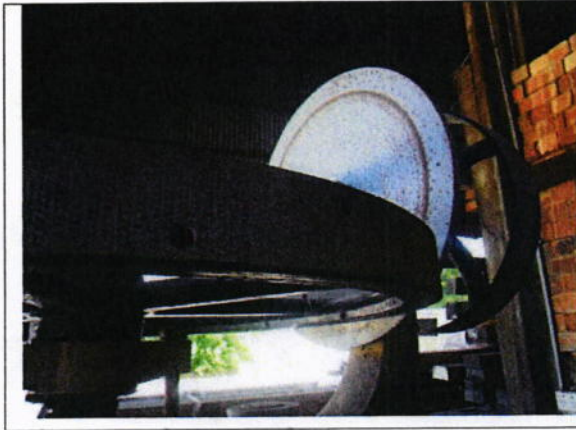
Photograph 9:
B - Large brake pad to top of
old brick making machine
Refer Sample: 3617 - 103 - A1

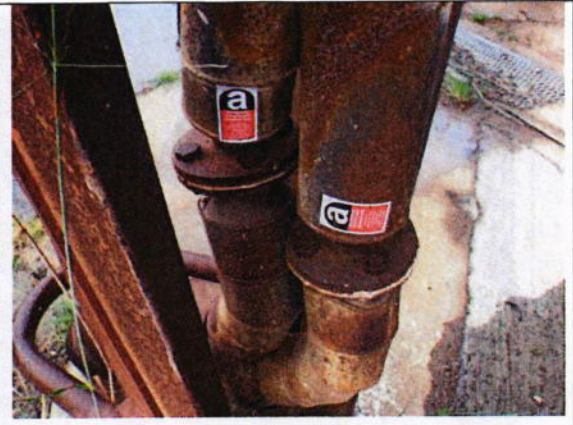
Photograph 10:
B - Front corner, gaskets adjacent
downpipe
Refer Sample: 3617 - 103 - A4

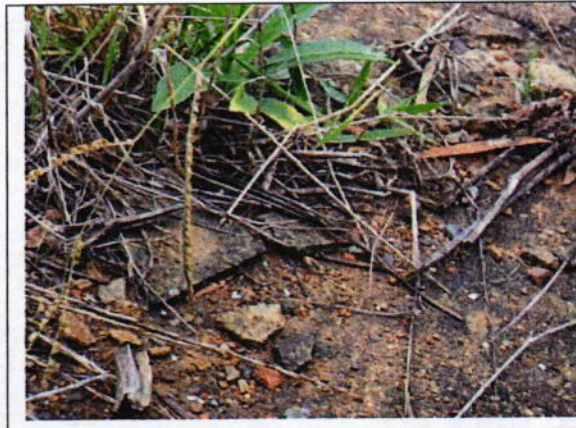
Photograph 11:
Adjacent FH2 - Sheet debris to soil
& scattered throughout site
Refer Sample: 3617 - 103 - A7

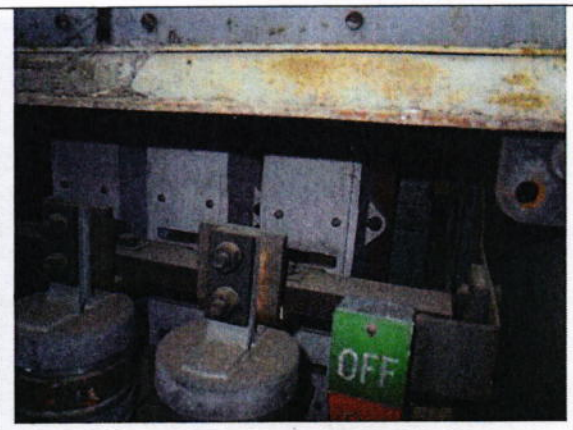
Photograph 12:
M2 & M3 - Flash guards to distribution
board *Refer Sample: 3617 - 103 - VA1*

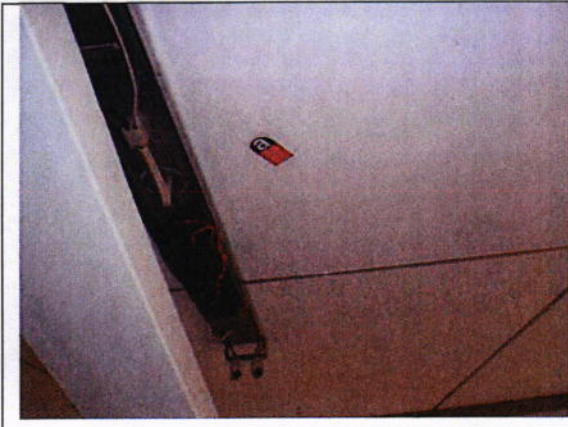
Photograph 13:
SS4 - Ceiling sheet
Refer Sample: RA M0102

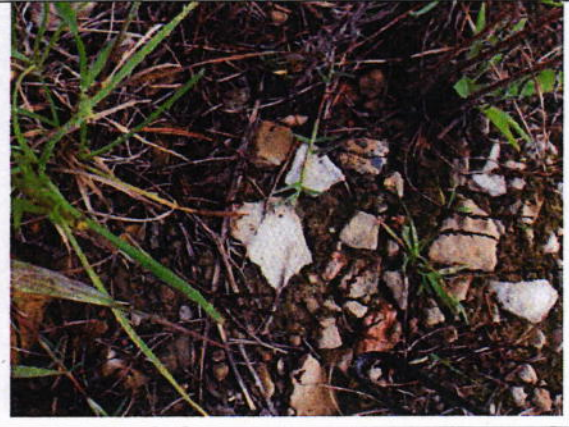
Photograph 14:
Adjacent bridge to K2 - Debris to ground
Refer Sample: M0099 (b)

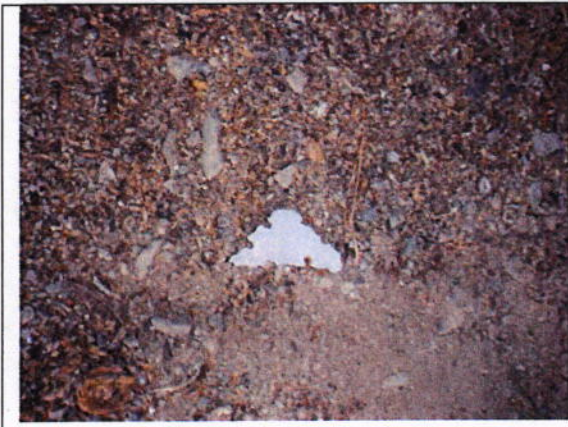
Photograph 15:
K2 - Top floor, debris to top floor
(small amount left post removal)
Refer Sample: M0100

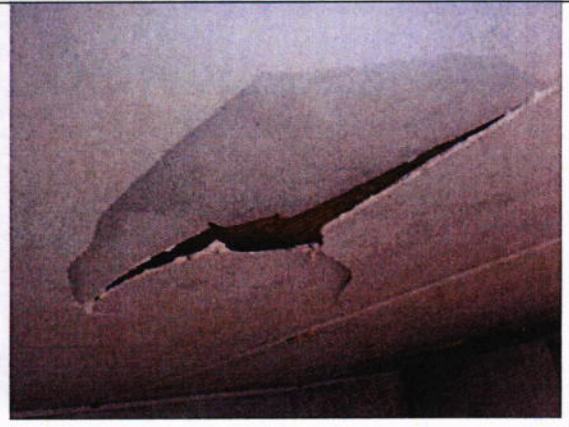
Photograph 16:
SS1 - Ceiling sheet
Refer Sample: M0101

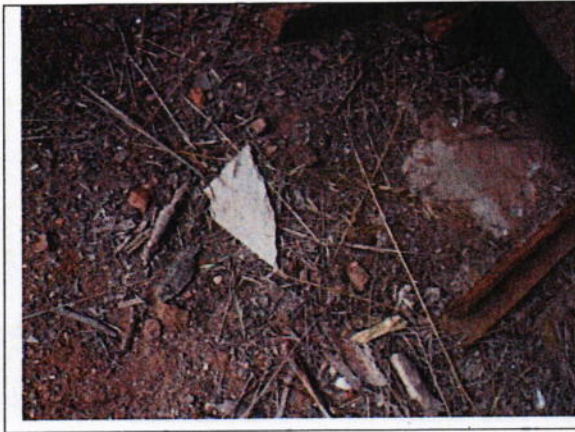
Photograph 17:
Between tall chimney & K3 –
Debris to ground & scattered throughout site
Sheet
Refer Sample: M0102

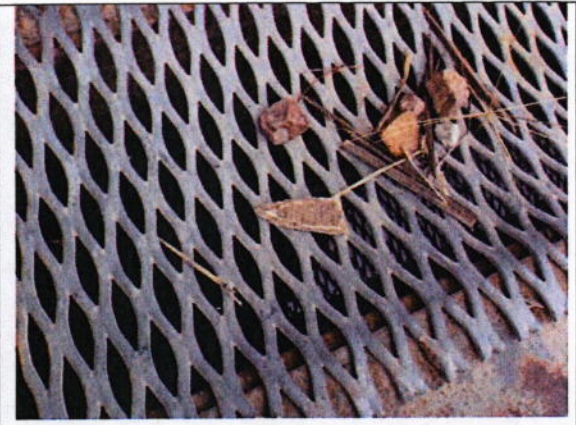
Photograph 18:
Front of B - Moulded sheet debris
to ground & throughout site
Refer Sample: M0103

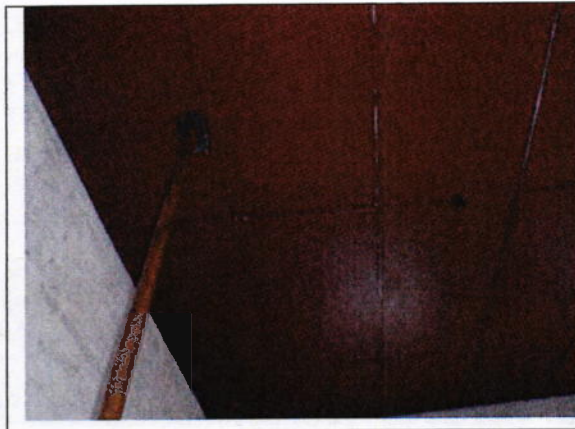
Photograph 19:
BH & SS2 - Ceiling sheet
Refer Sample: RA M0102

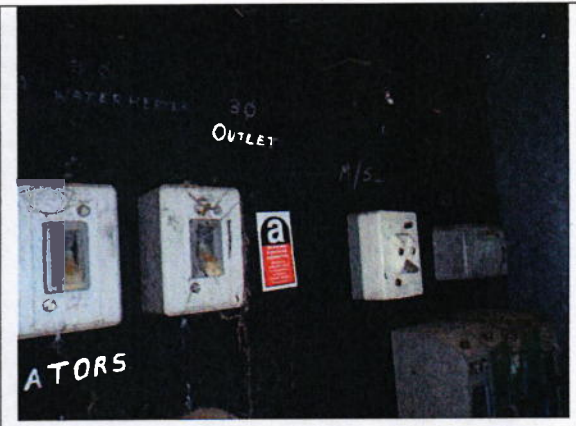
Photograph 20:
All switchboard backing sheets throughout
site
Refer Sample: 7504 – 23 - VA12

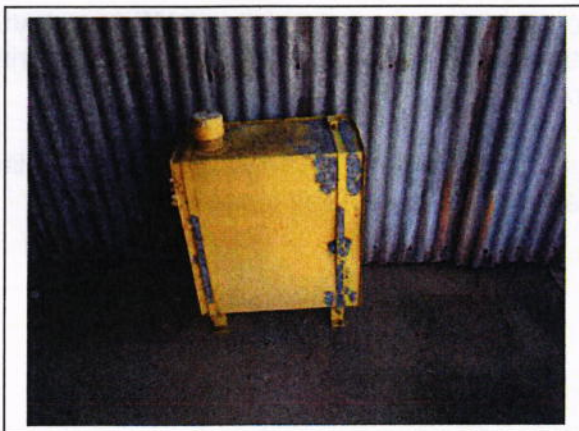
Photograph 24:
 Portable AST to building M3
 Yellow paint
 Refer Sample: 3617 – 103 – P1

The lead paint is in a reasonably poor condition and should be repainted or the unit should be disposed of as hazardous waste.

- The lead paint is in a fairly poor condition and should be repainted. It should be assumed that all similar paint applications throughout the building would contain similar percentages of lead. Refer to Section 15.3 Appendix C for further general information on lead paint.

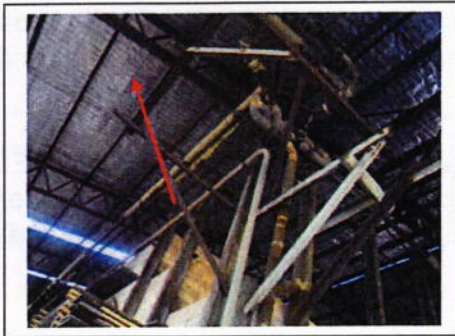
Photograph 25:
To underside of roofs throughout
Refer Sample: 3617 – 103 – S2

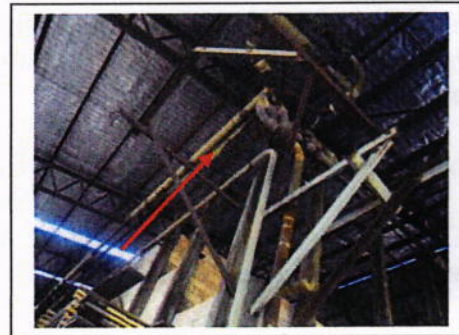
Photograph 26:
SMF as insulation to
Pipes throughout
Refer Sample: 3617 – 103 – S3

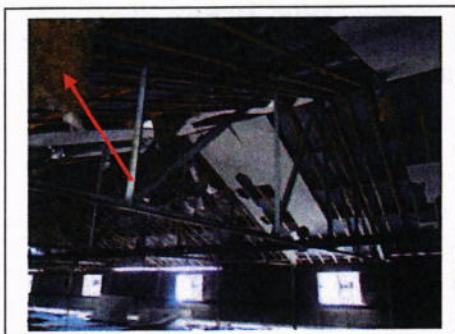
Photograph 27:
SMF as insulating batts to
various ceiling spaces
Refer Sample: 3617 – 103 – S4

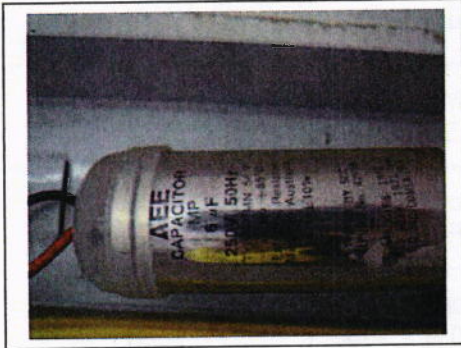
Photograph 28:
Former canteen ground floor
AEE MP – PMN 5417

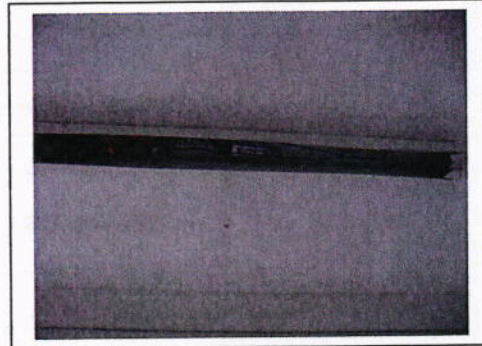
Photograph 29:
Building A4 1 Tube
Dawco metal – BS 4017 - 1966

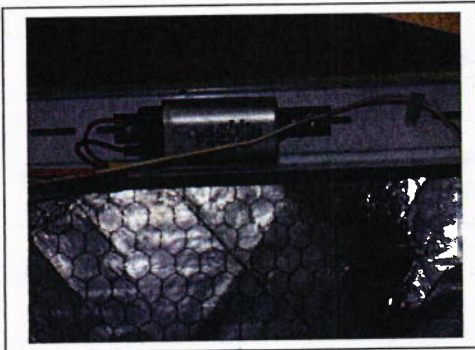
Photograph 30:
Building R1
Ducon metal APF 260CR

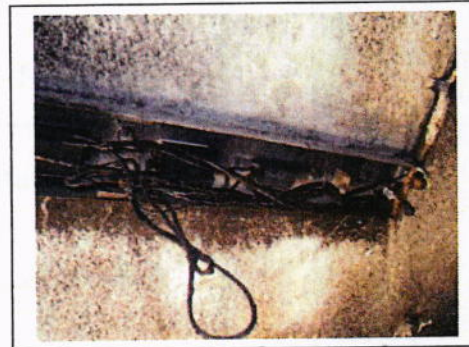
Photograph 31:
Building SS2
Metal – Unidentifiable due to fire damage

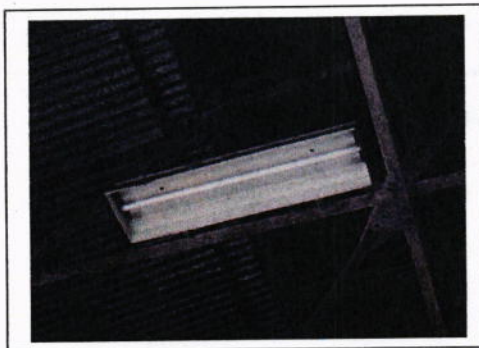
Photograph 32:
Building H
Inaccessible

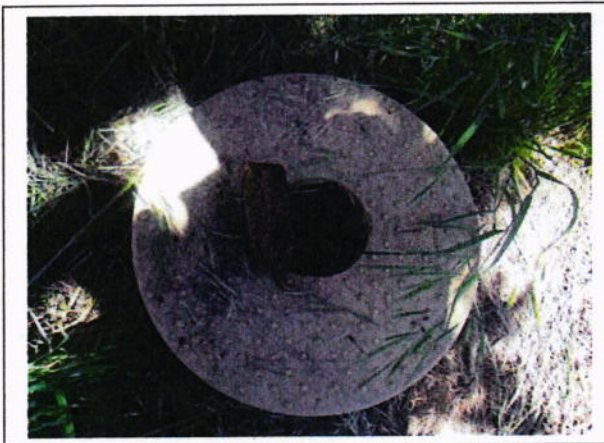
Evidence of an underground storage tank (UST) was identified during the survey suggesting an underground storage tank is present. A dip point was found, refer to plans for location.

Photograph 34:
Dip point to probable UST

- A dip point was found during the survey, however further investigation is required to establish whether or not a UST is still in place and its condition.
- The aboveground storage tank (AST) should be removed if there are no as hazardous waste.

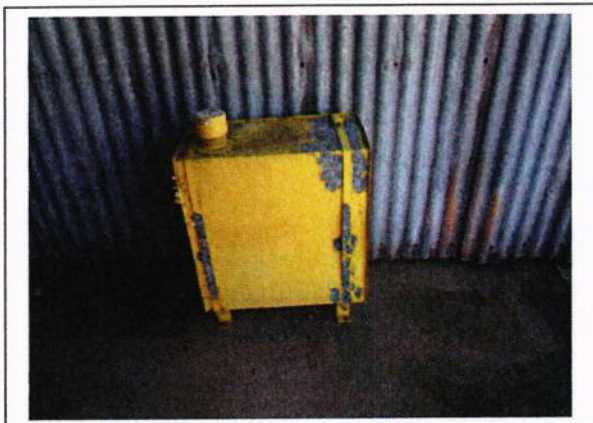
An AST was located and should be disposed of as hazardous waste.

Photograph 35:
Portable AST to building M3
