## Freedom of Information Publication Coversheet

FOI Reference: CMTEDDFOI 2019-262

Construction Control  
PO Box 750  
CANBERRA ACT 2601**Attention: 2.2(a)(ii)****KINGSBOROUGH APARTMENTS - BLOCKS B & C - BLOCK 1, SECTION 60, KINGSTON  
GEOTECHNICAL ASSESSMENT OF BATTER FAILURE - 12 JULY 2017****1 Introduction**

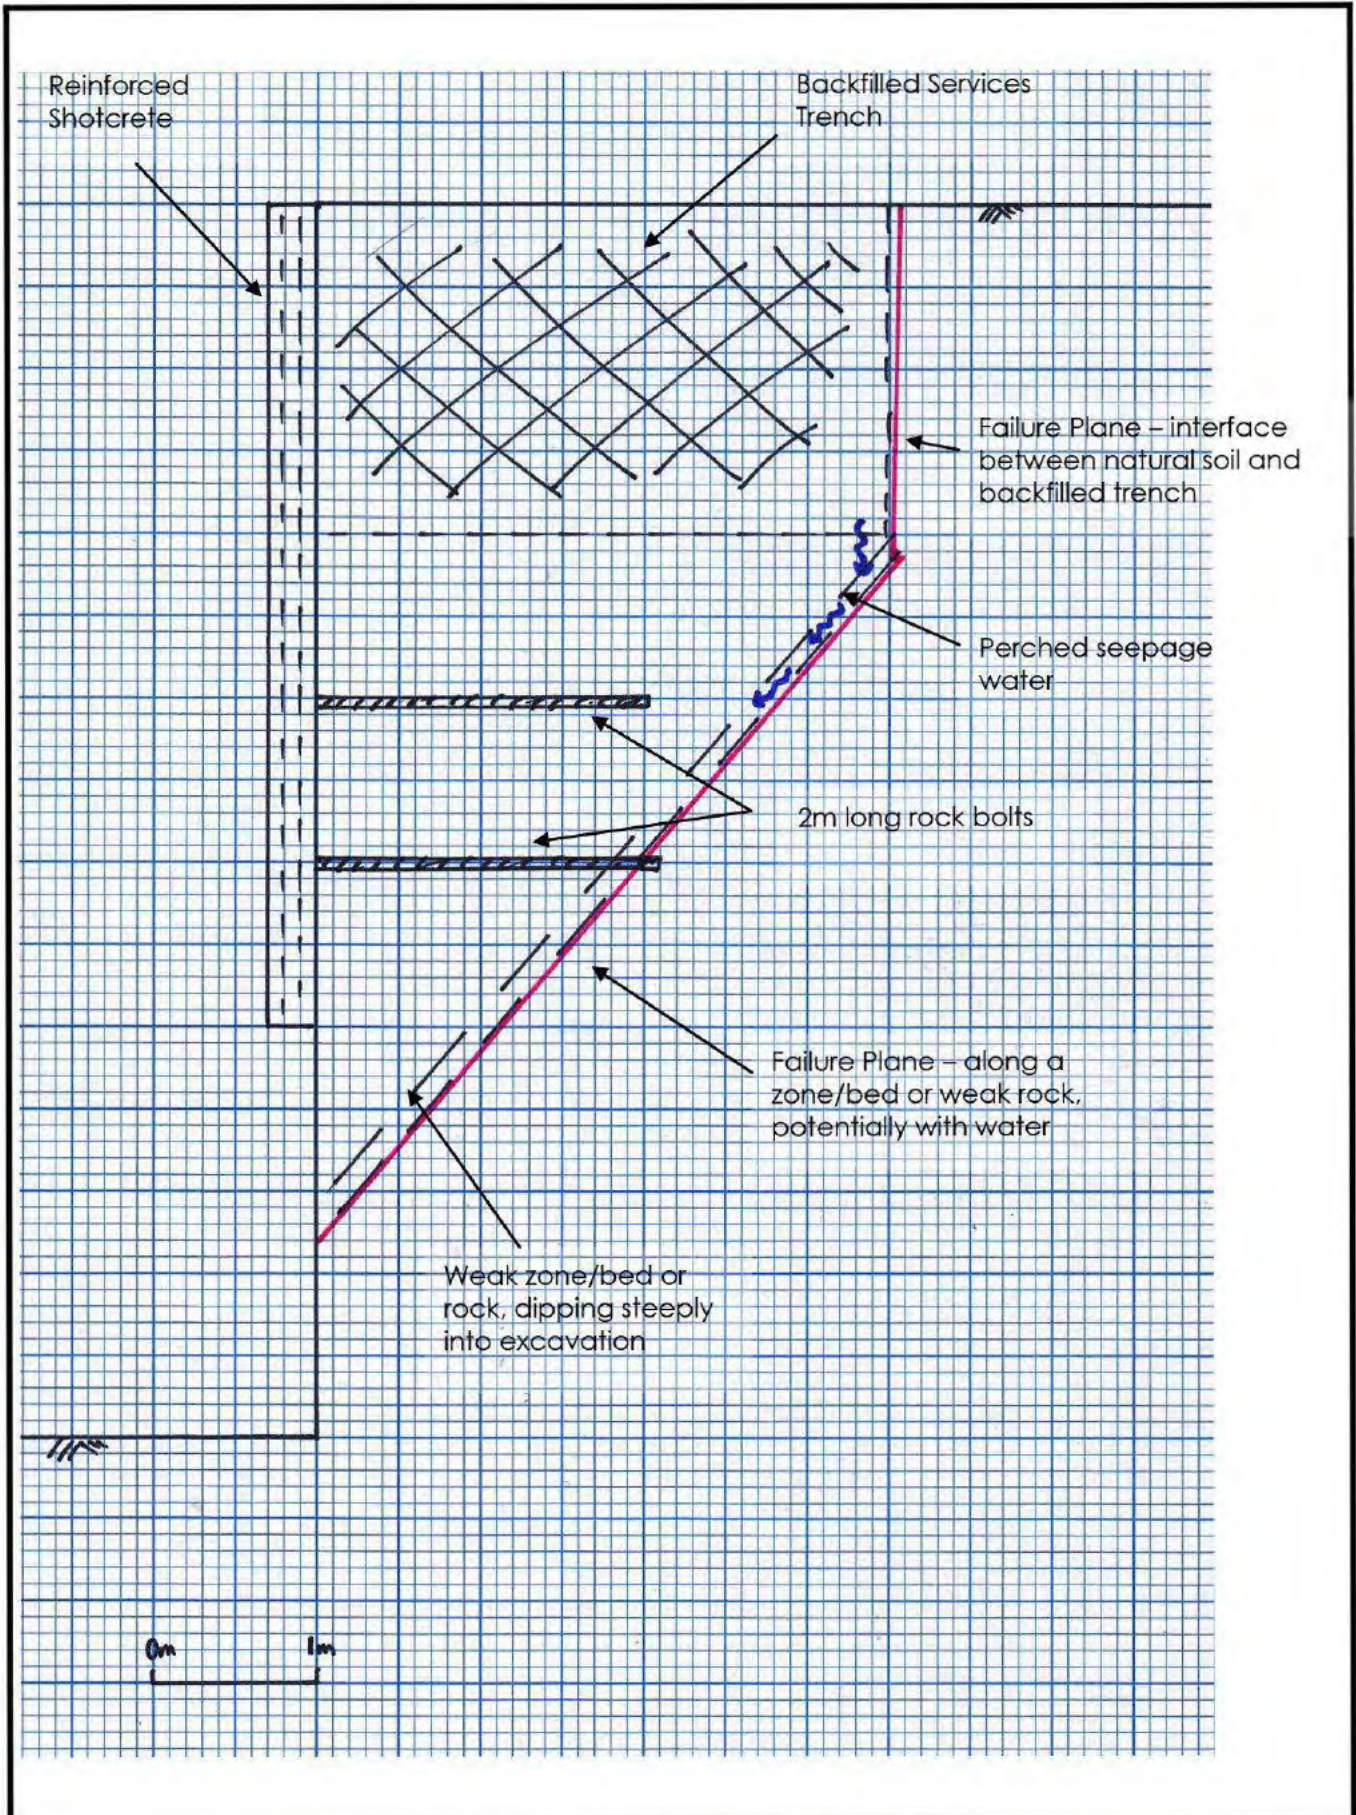
**CONSTRUCTION CONTROL**  
**KINGSBOROUGH APARTMENTS - BLOCK 1, SECTION 60, KINGSTON**  
**SKETCH OF FAILED BATTER**

- The poorly compacted fill in the upper ~2m of the soil profile (the very loose backfill of the shared services trench) has completely lost all shear strength, and a slip failure has initiated. The failure plane is the interface between the natural soil and the edge of the backfilled trench.

- It appears that there is a zone/bed of weak rock behind the batter face (hidden behind the face and not seen during inspection of the exposed rock face). This zone/bed was orientated to be dipping steeply into the excavation, and it appears that the plane of this zone coincided with the failure plane in the backfilled trench above.

- There was water ponded at the base of the backfilled services trench, and this perched water would have infiltrated into the weak rock zone, causing a decrease in friction and a loss of shear strength on that rock plane. The confluence of the two failure planes, combined with perched water infiltration is the primary cause of the failure. Given the recent cold snap with overnight temperatures as low as -8°, there is potential for the perched water within the rock joints or weak zone to have frozen and expanded, causing the rock to separate from the face.

- In the failed sections, the reinforced shotcrete has not been able to stabilise the batter sufficiently due to inadequate "hold" on the batter faces. This appears to be due to the fact that the rock bolts that are supposed to hold the shotcrete to the face are not long enough. The rock bolts were 2m long, and the failure plane is up to 3.6m back from the batter face. There appeared to be no reason for the rock bolts to be longer than 2m given that (1) there were no geological reason as there appeared to be no unfavourable joint sets on this batter face, and (2) the backfilled trench was indicated to be ~1m wide, so 2m long rock bolts would extend past this zone. If the rock bolts were longer, and extended past the failure plane, then it is less likely that the failure would have occurred.

- Figure 1 is a sketch showing the likely failure mechanism is the localised failed section.

- The use of soldier piles as the temporary excavation support system, rather than reinforced shotcrete stabilisation. It should be noted that even with this methodology, local failures could still have occurred between the soldier piles, especially in the very loose backfill zone in the upper ~2m. Also, as stated in Section 3, the bedrock was assessed as being too strong to be able to drill soldier pile holes, so this method was not suitable for this site.
- If still using the reinforced shotcrete stabilisation, the rock bolts could have been longer to extend past the failure plane (say 6m long).
- Excavating the rock material of the 3<sup>rd</sup> lift in alternate stages to provide more support below the reinforced shotcrete.
