**Rivett Block 13
Section 28**

Rivett Section 28 Block 13

Site Investigation Report

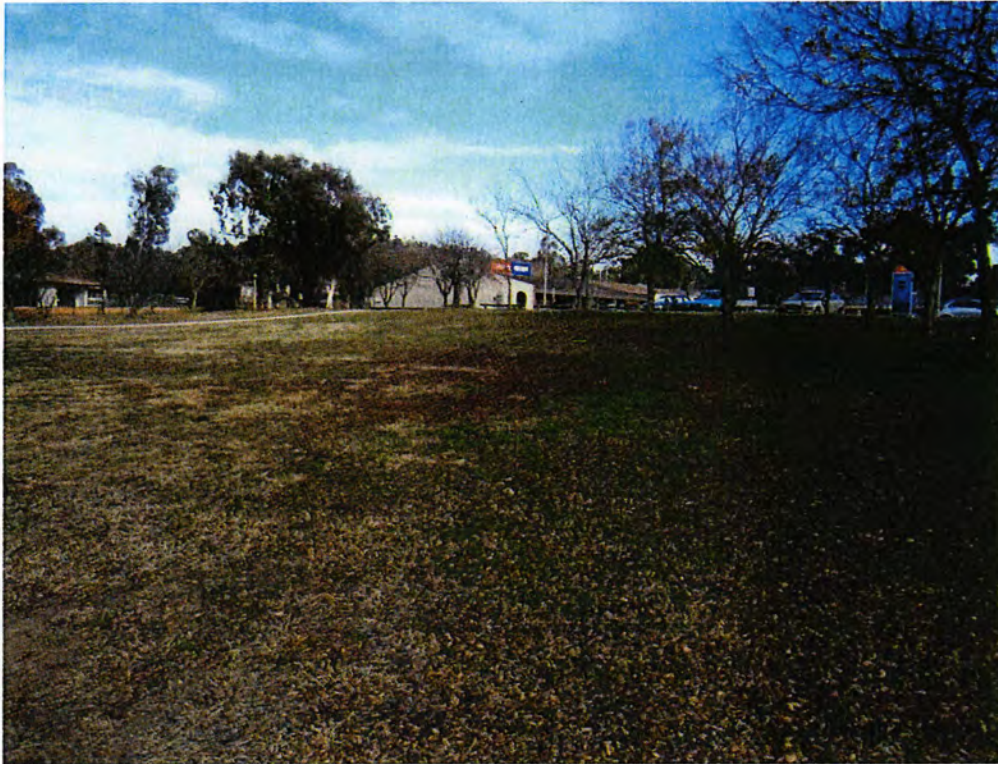
Site Photo 1 – General View Looking Towards Rivett Shops from Near Clubhouse

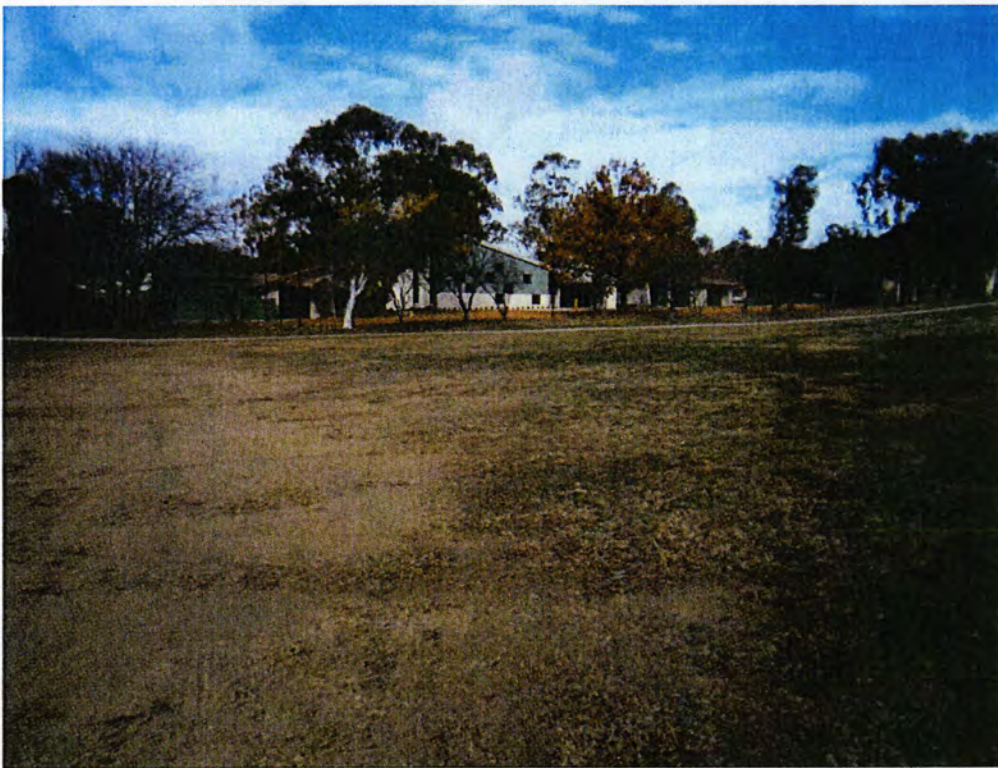
Site Photo 2 – General View Looking South Towards Church

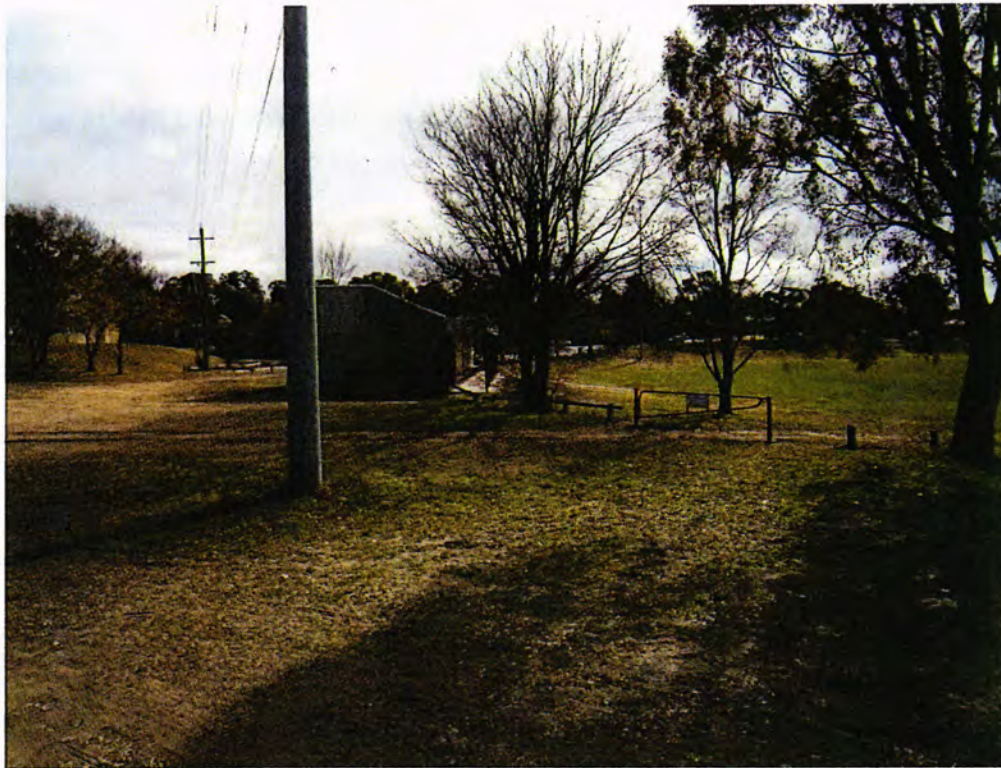
Site Photo 3 – General View Looking North Towards Clubhouse

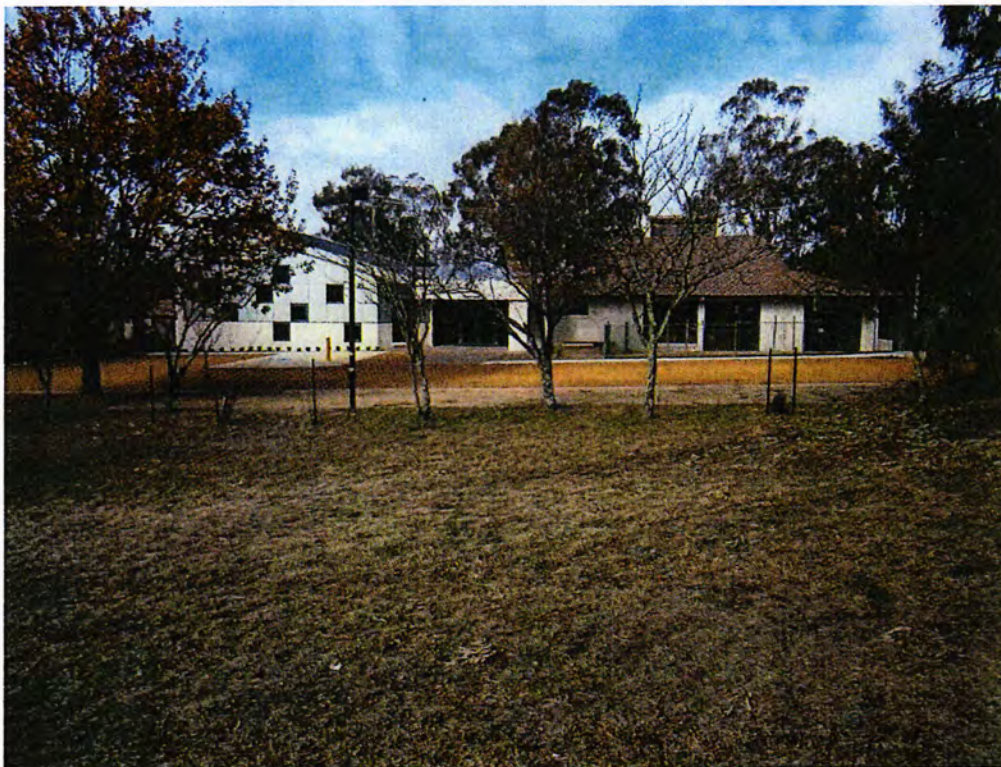
Site Photo 4 – General View Looking North Towards Care Home

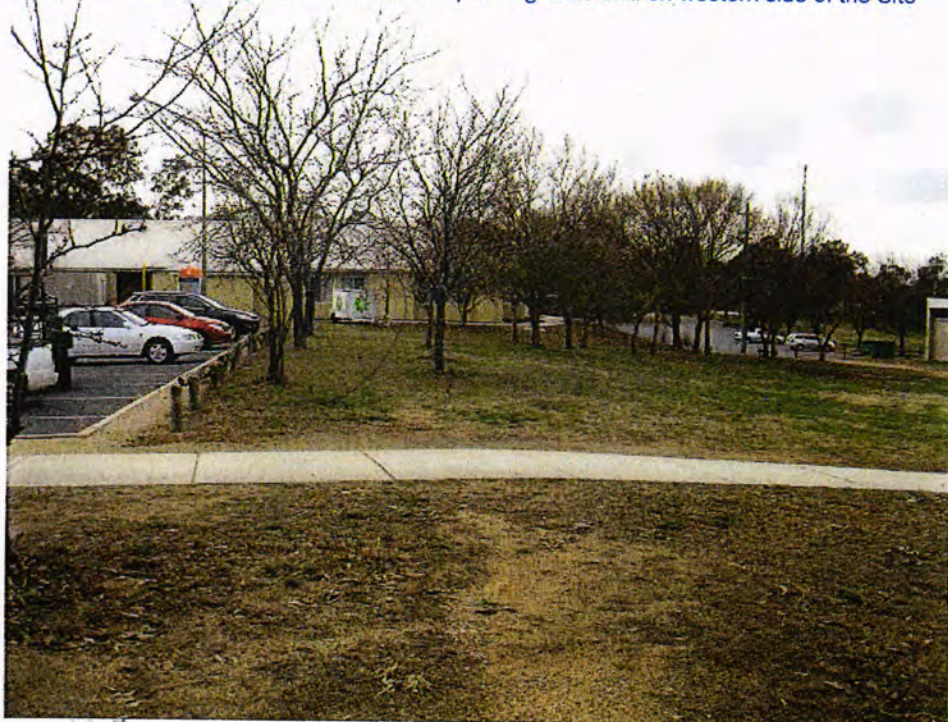
Figure 1.2 – Existing log barriers and decomposed granite infill on western side of the Site

It is proposed that vergeworks on public land would be minimal consisting of hard paving to the existing verge at the northern end of the block in the vicinity of the telephone box. The lack of verge width adjacent to the parking spaces may be addressed with the provision of paving gas easement which occupies the frontage to the block.
