## Controlled Activity/Construction Occupations Complaint Form

### Record of Inspection

**Block:** 17    **Section:** 17    **Division:** MACQUARIE    **Unit:**

### NOTICE OF INTENTION TO MAKE RECTIFICATION

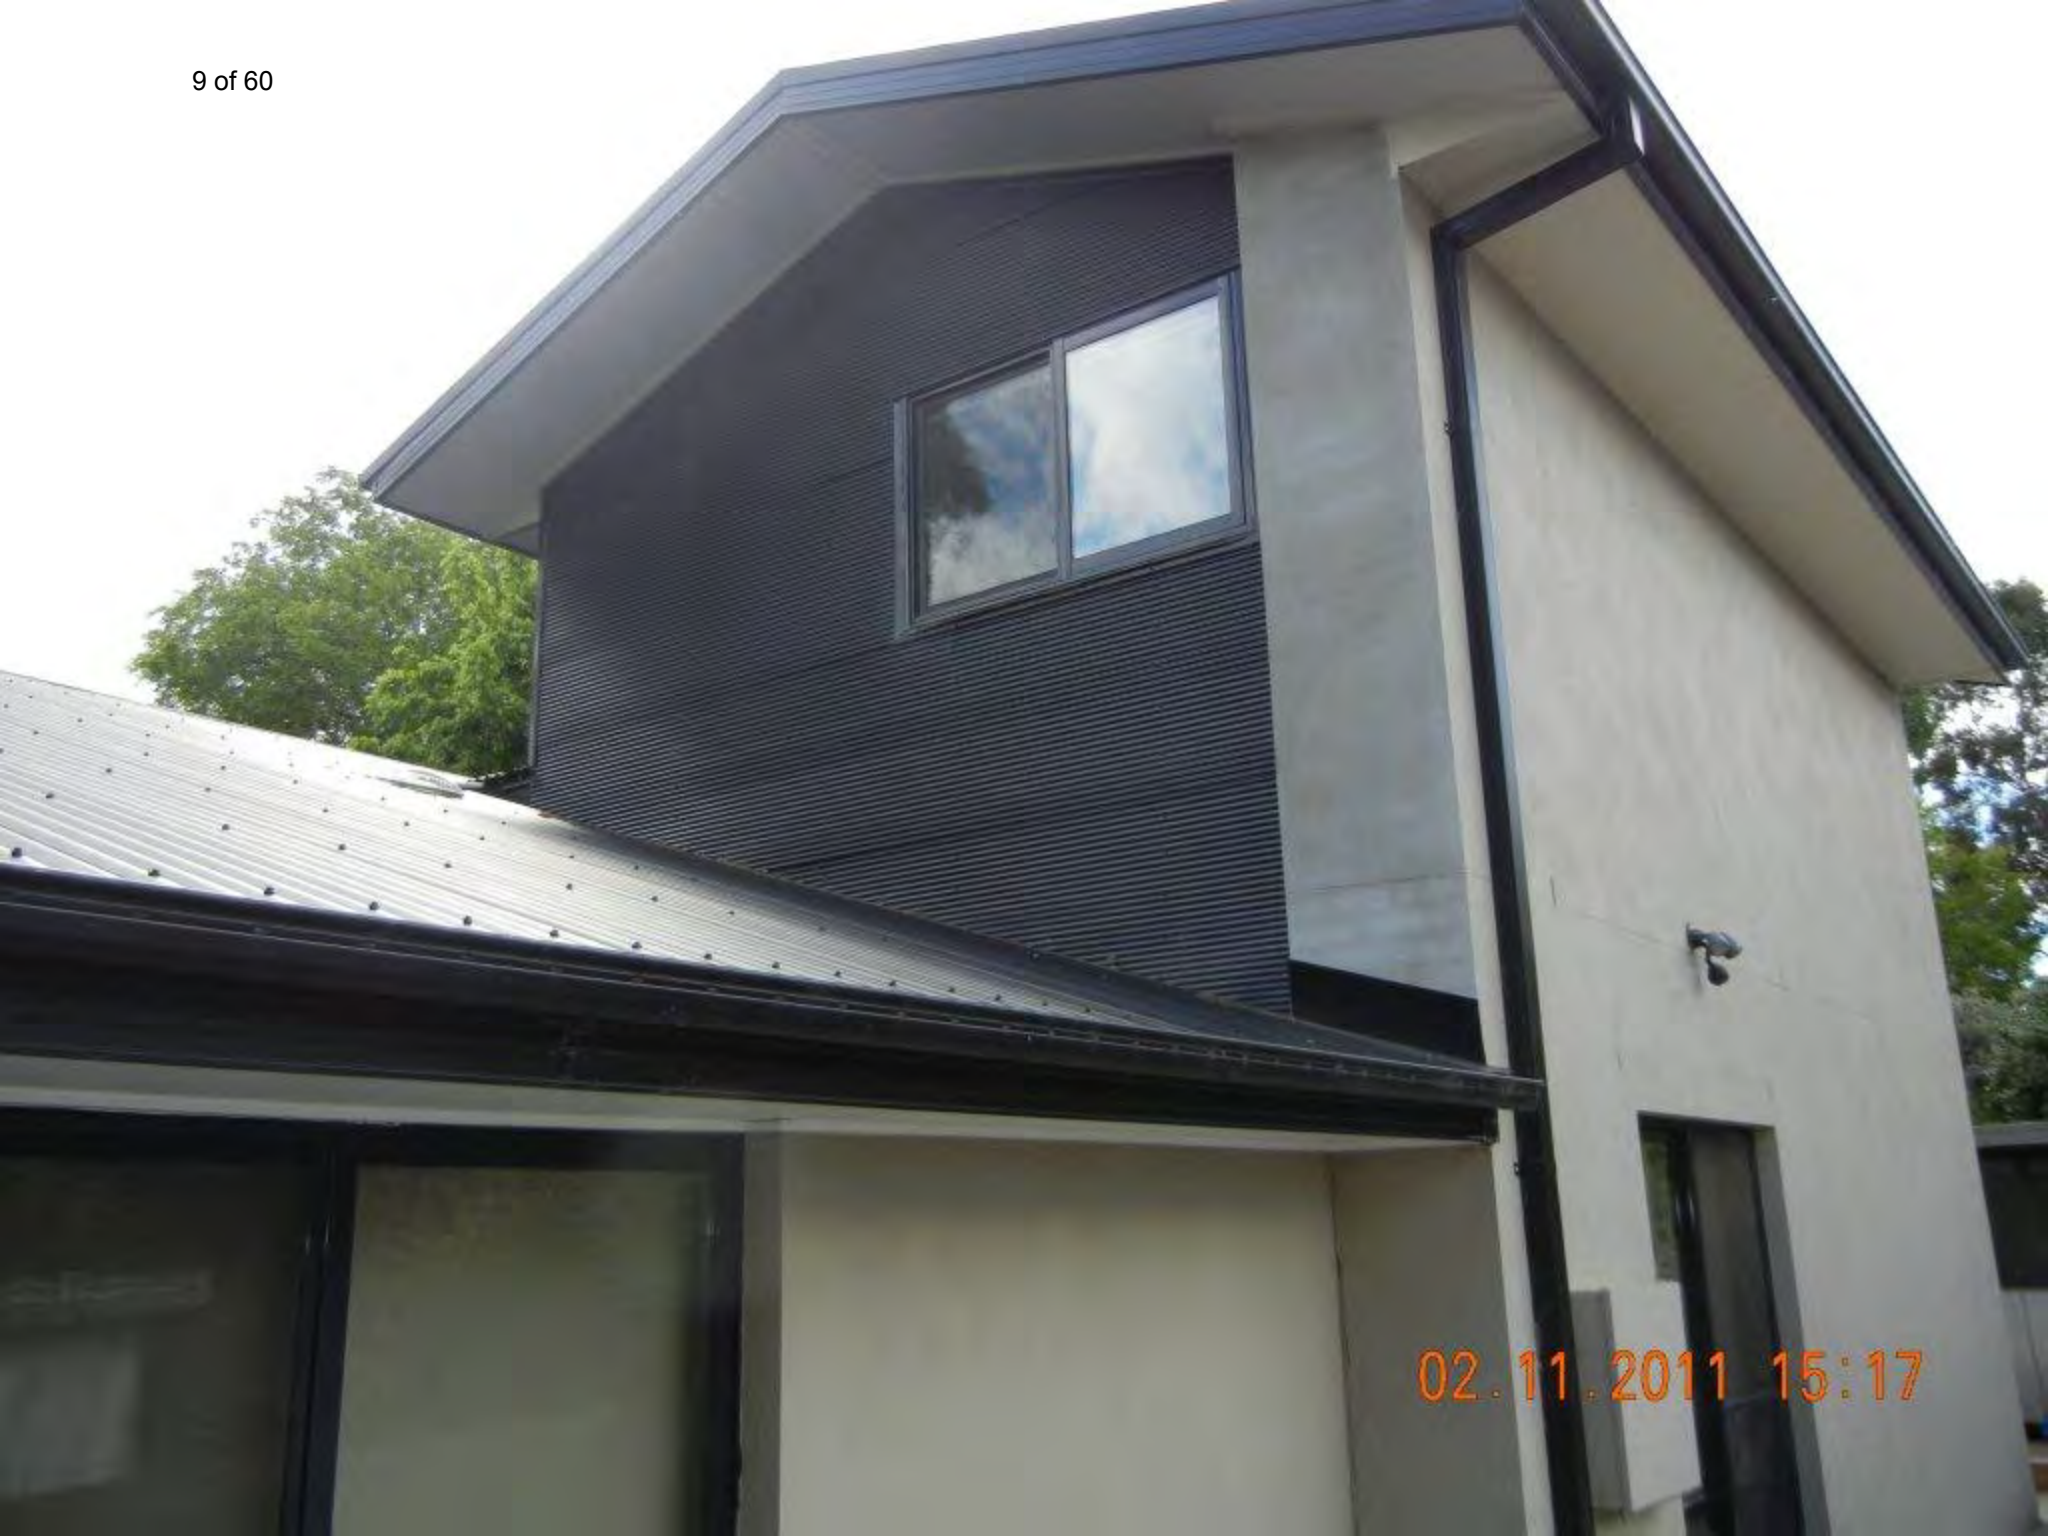
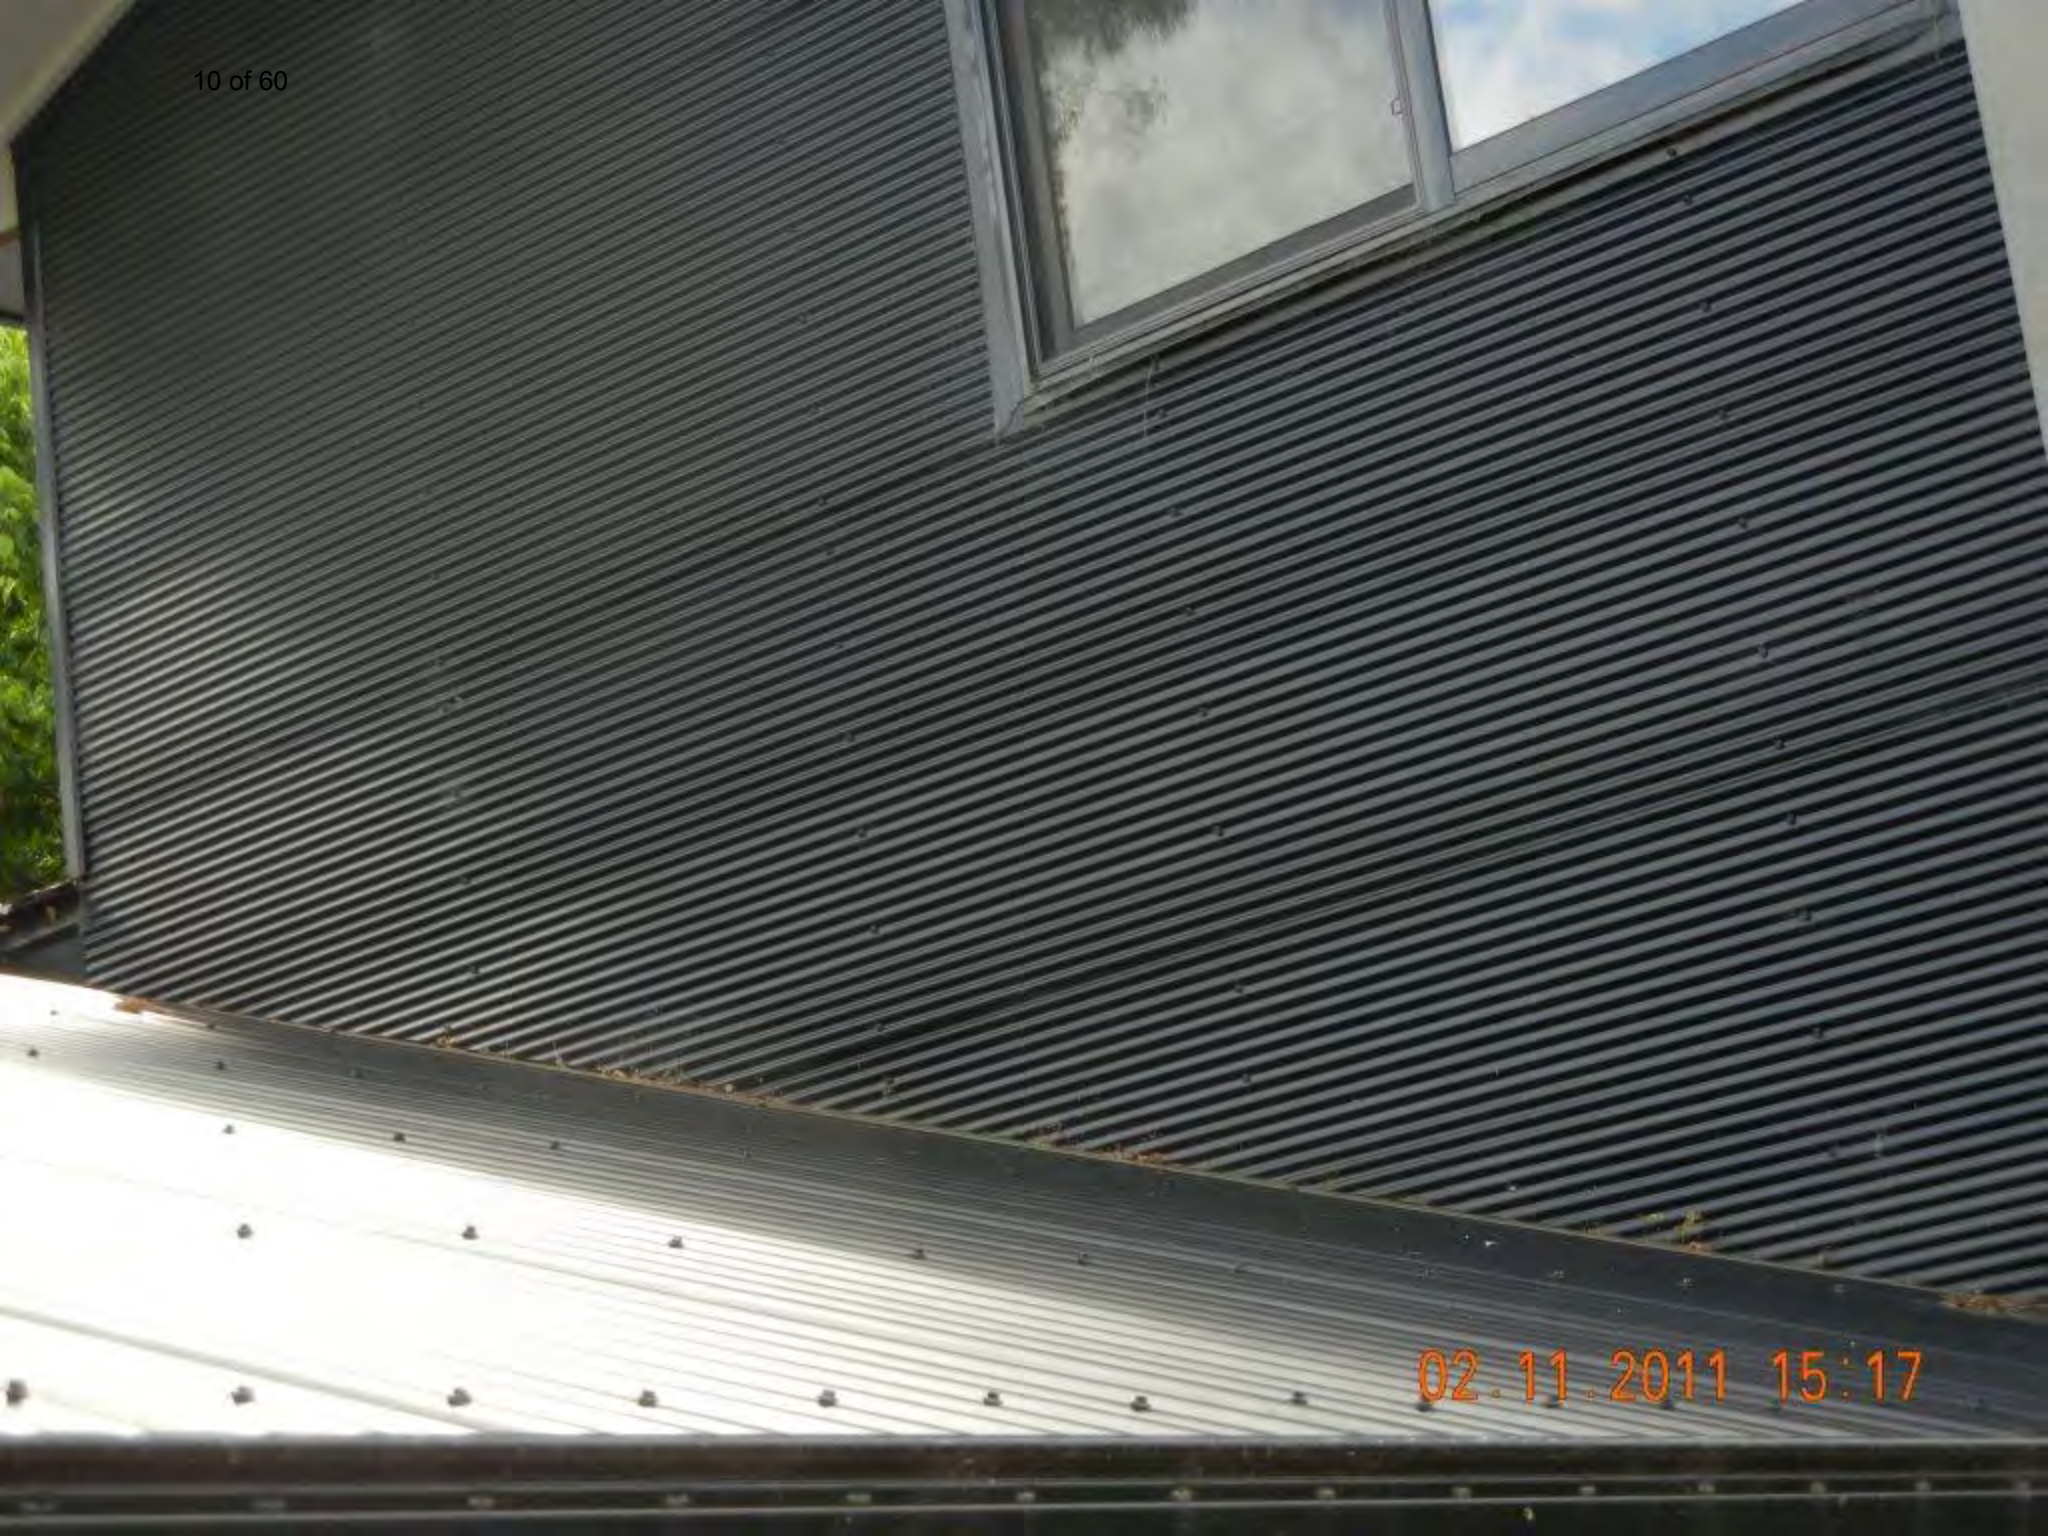
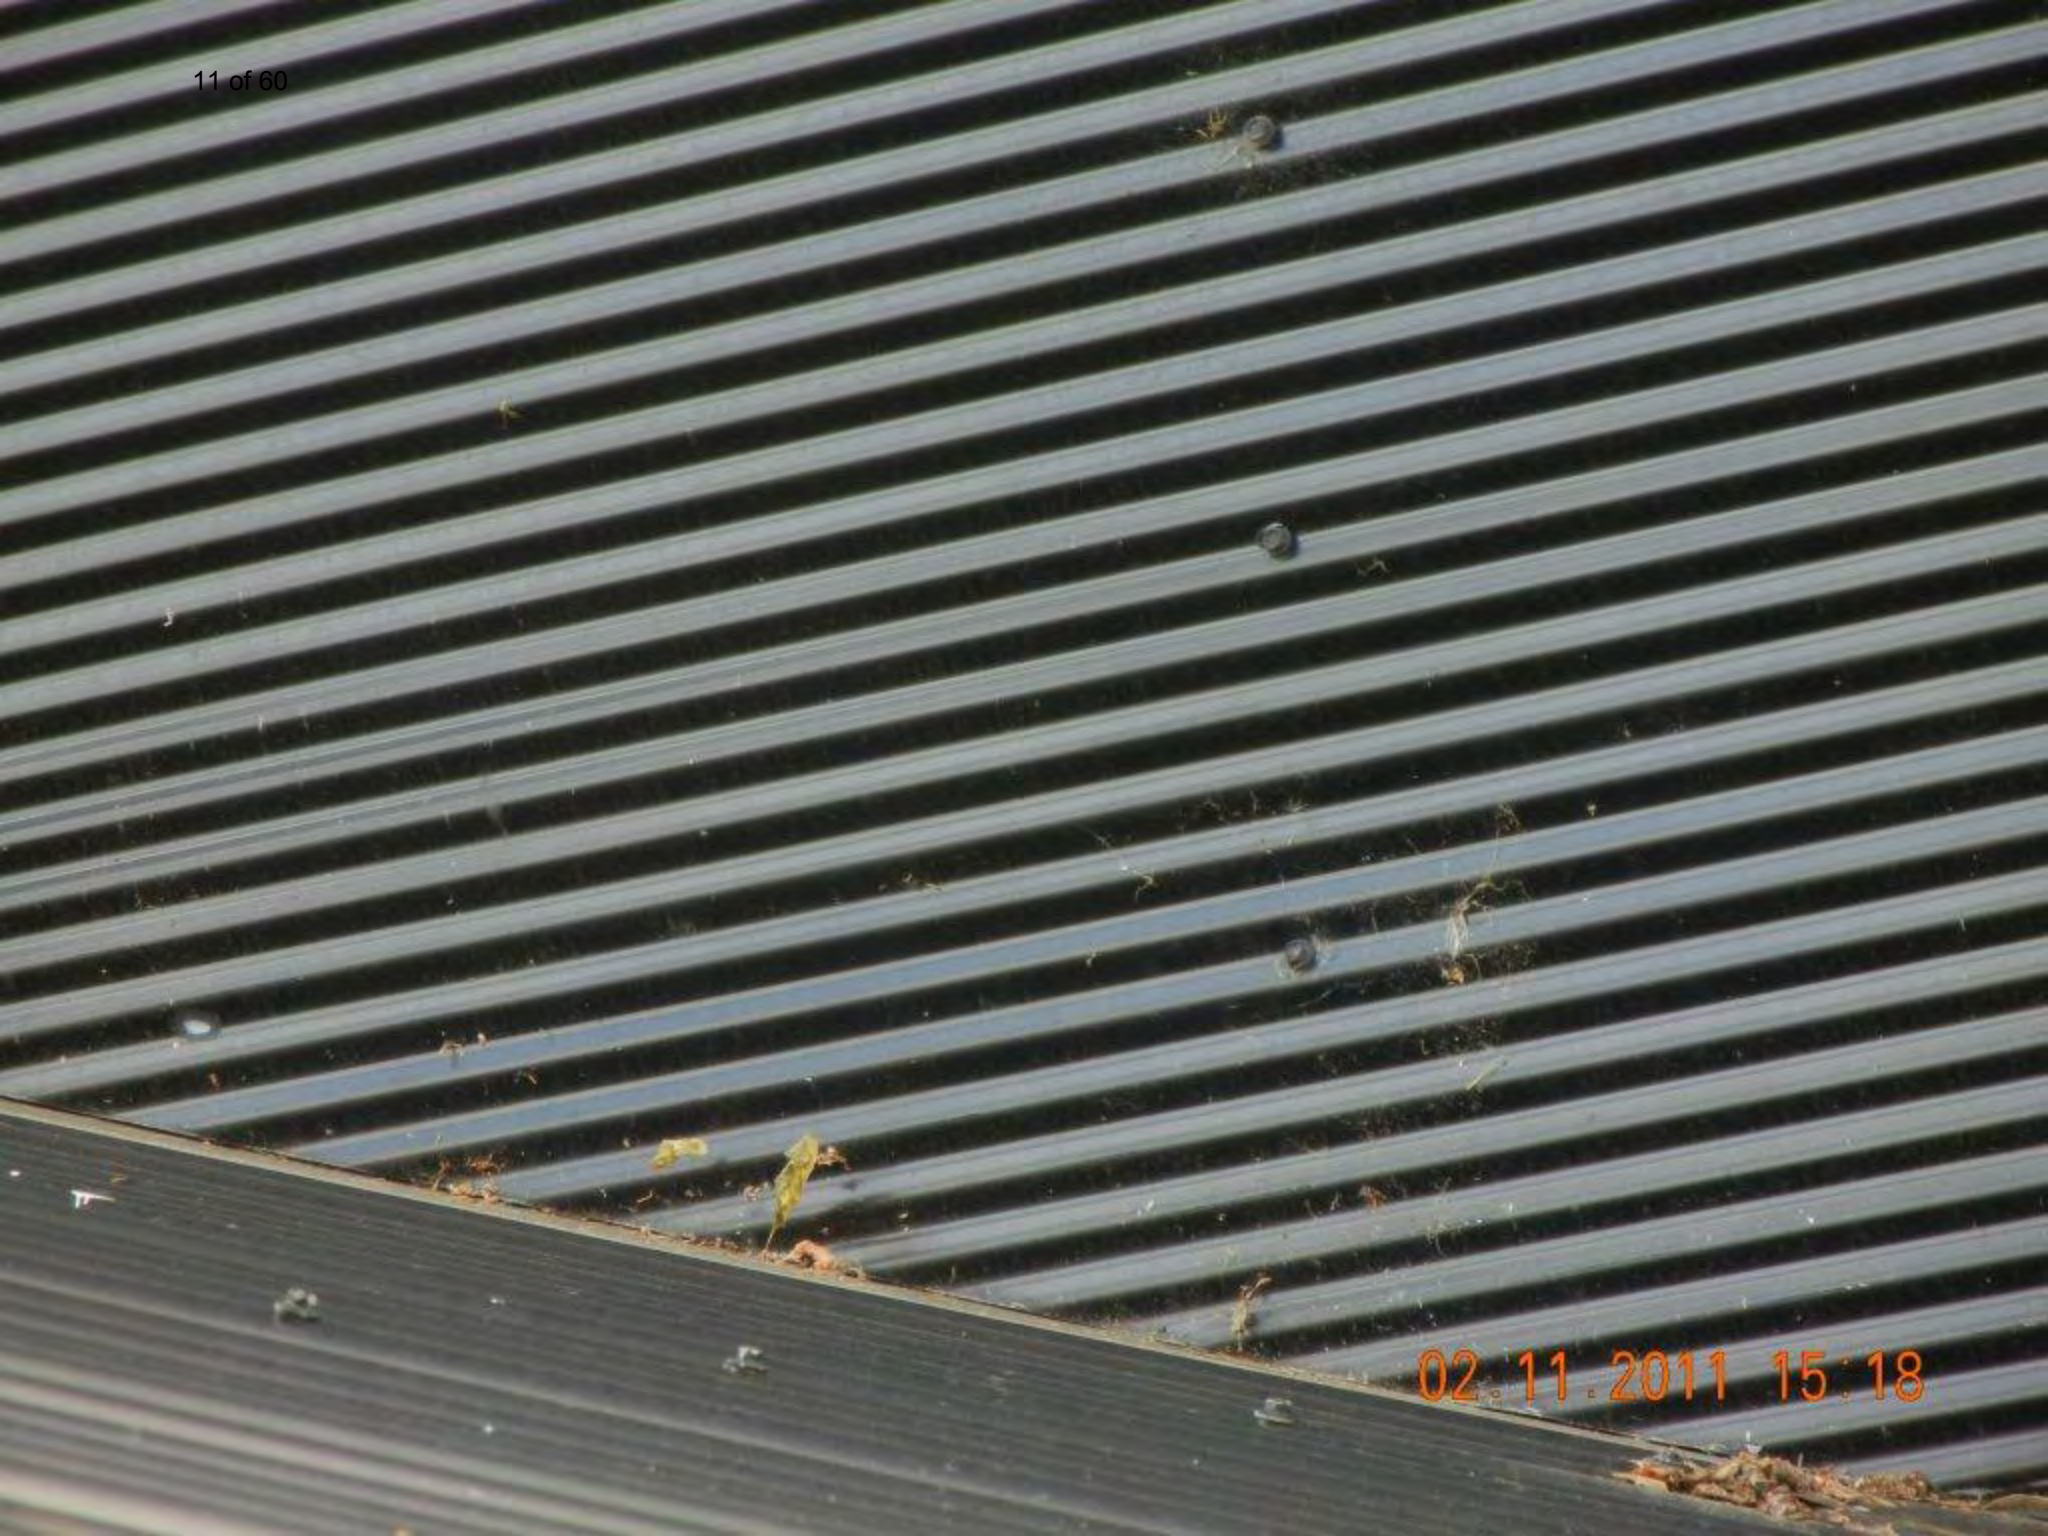
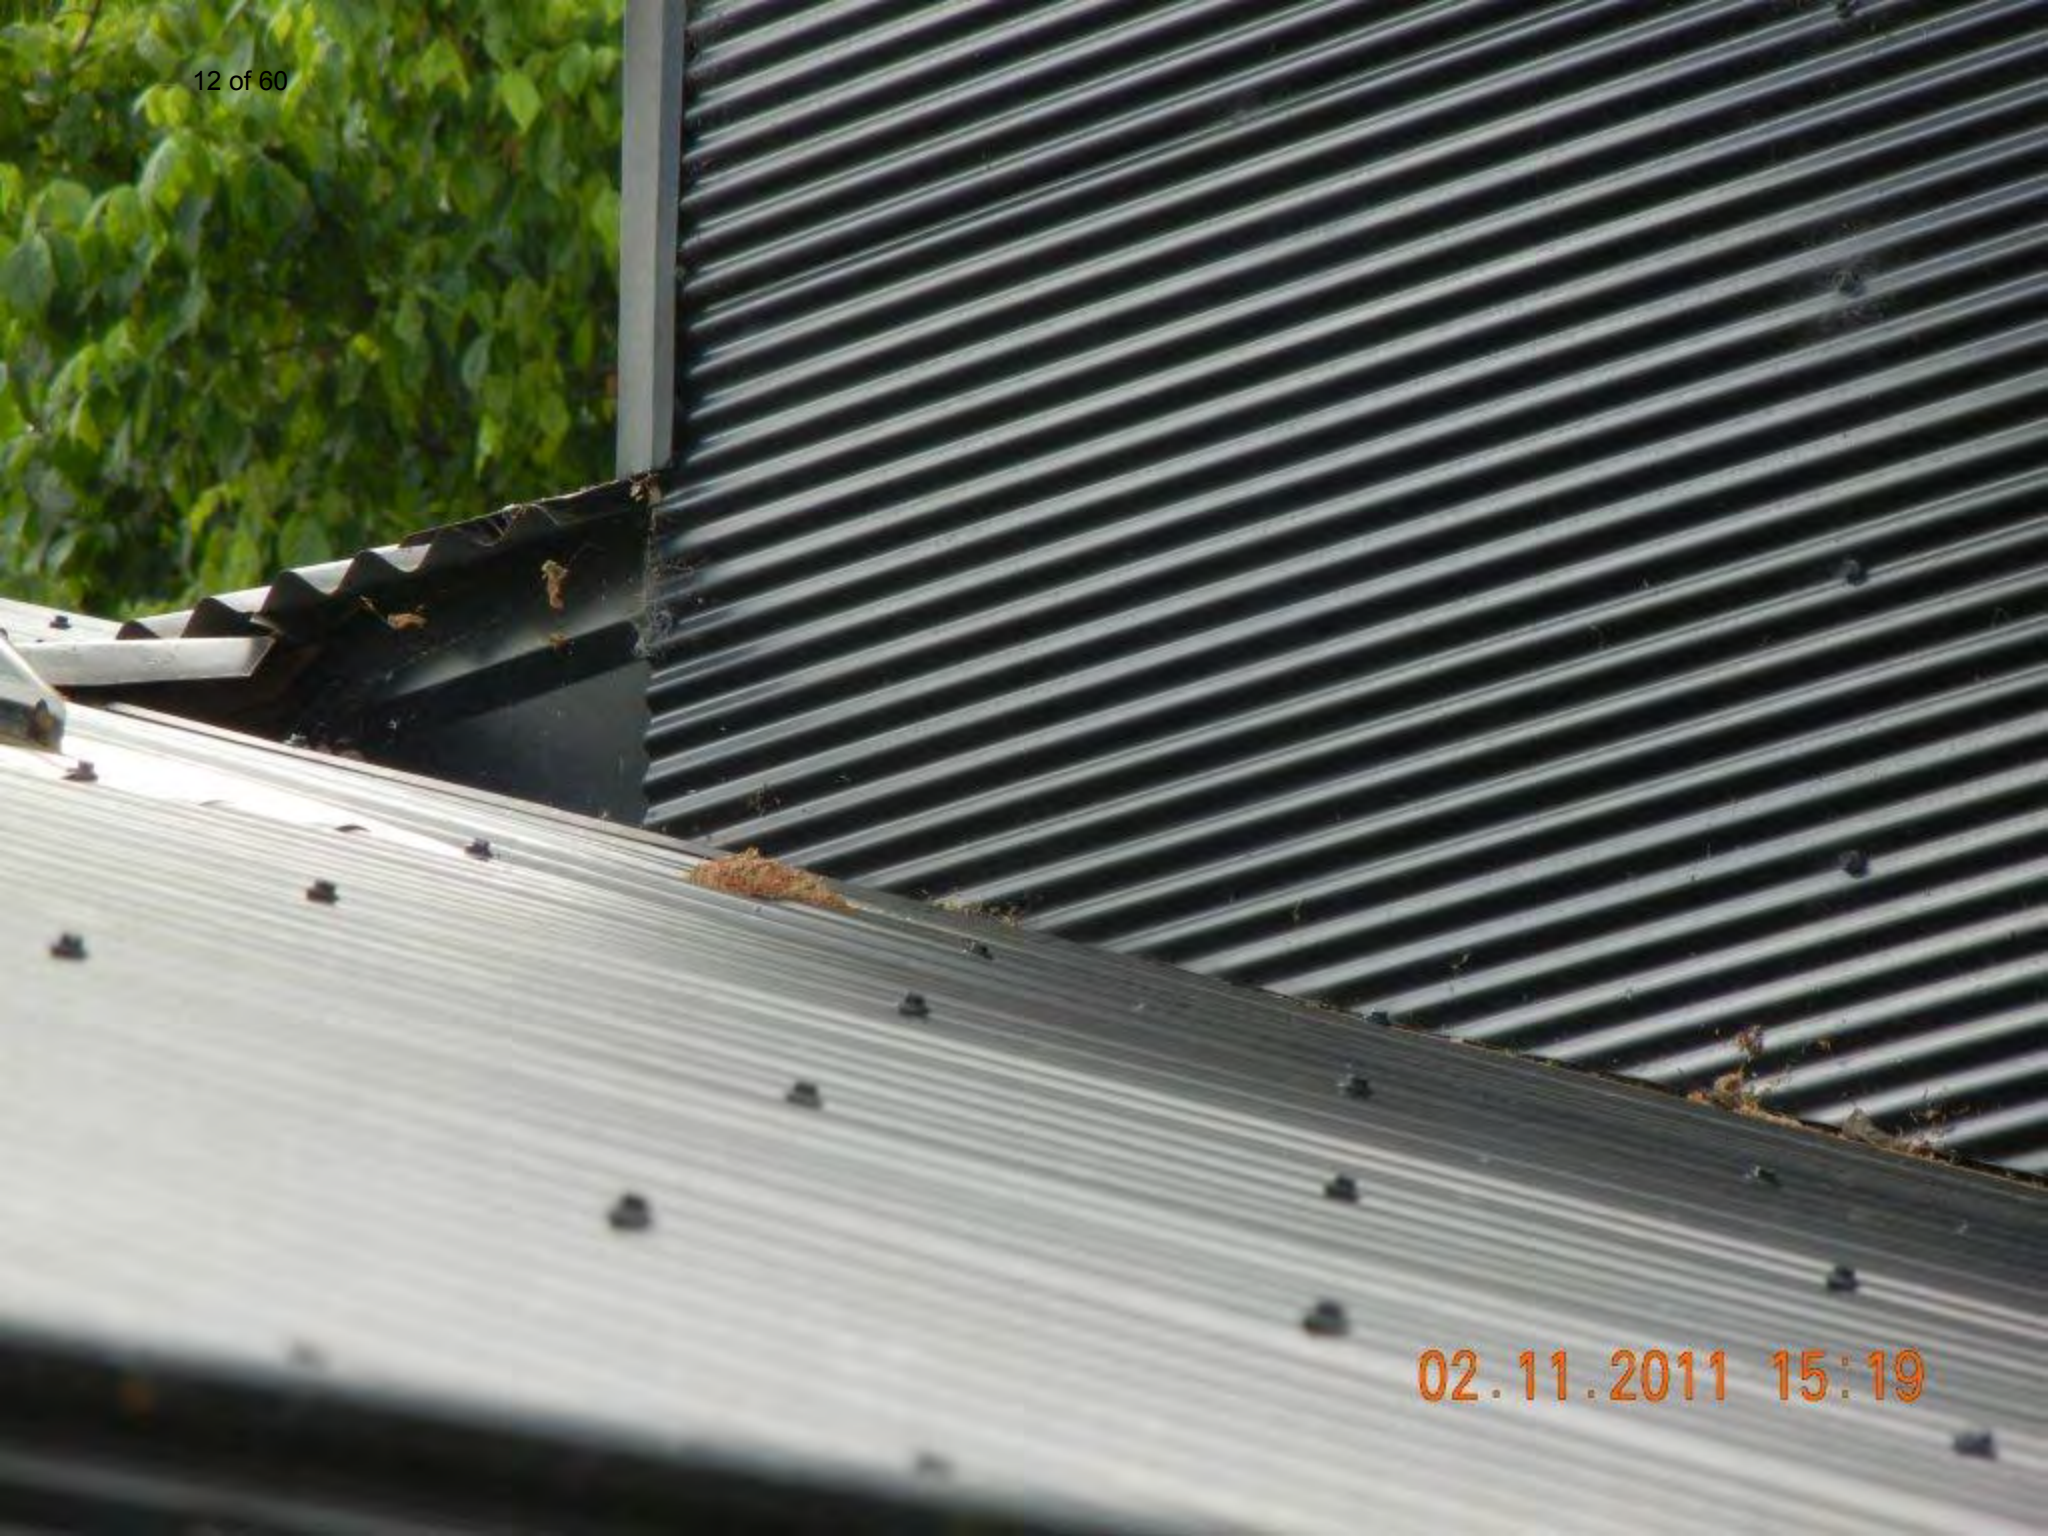
Photo No.	Photo Name	Taken From
1	Contextual photograph of area with leaks	Driveway
2	Valley / join between extension and single storey roof	Driveway
3	Close up of valley / join	Driveway
4	Top area of valley / join and overhanging section of colour bond roofing	Driveway

However, even from the driveway it was apparent that the overhanging section of roofing may be causing a problem. The guttering was not full of rubbish or detritus but there was some vegetation debris on the roof line.
