## Controlled Activity/Construction Occupations Complaint Form

### Record of Inspection

**Block:** 17    **Section:** 17    **Division:** MACQUARIE    **Unit:**

### NOTICE OF INTENTION TO MAKE RECTIFICATION

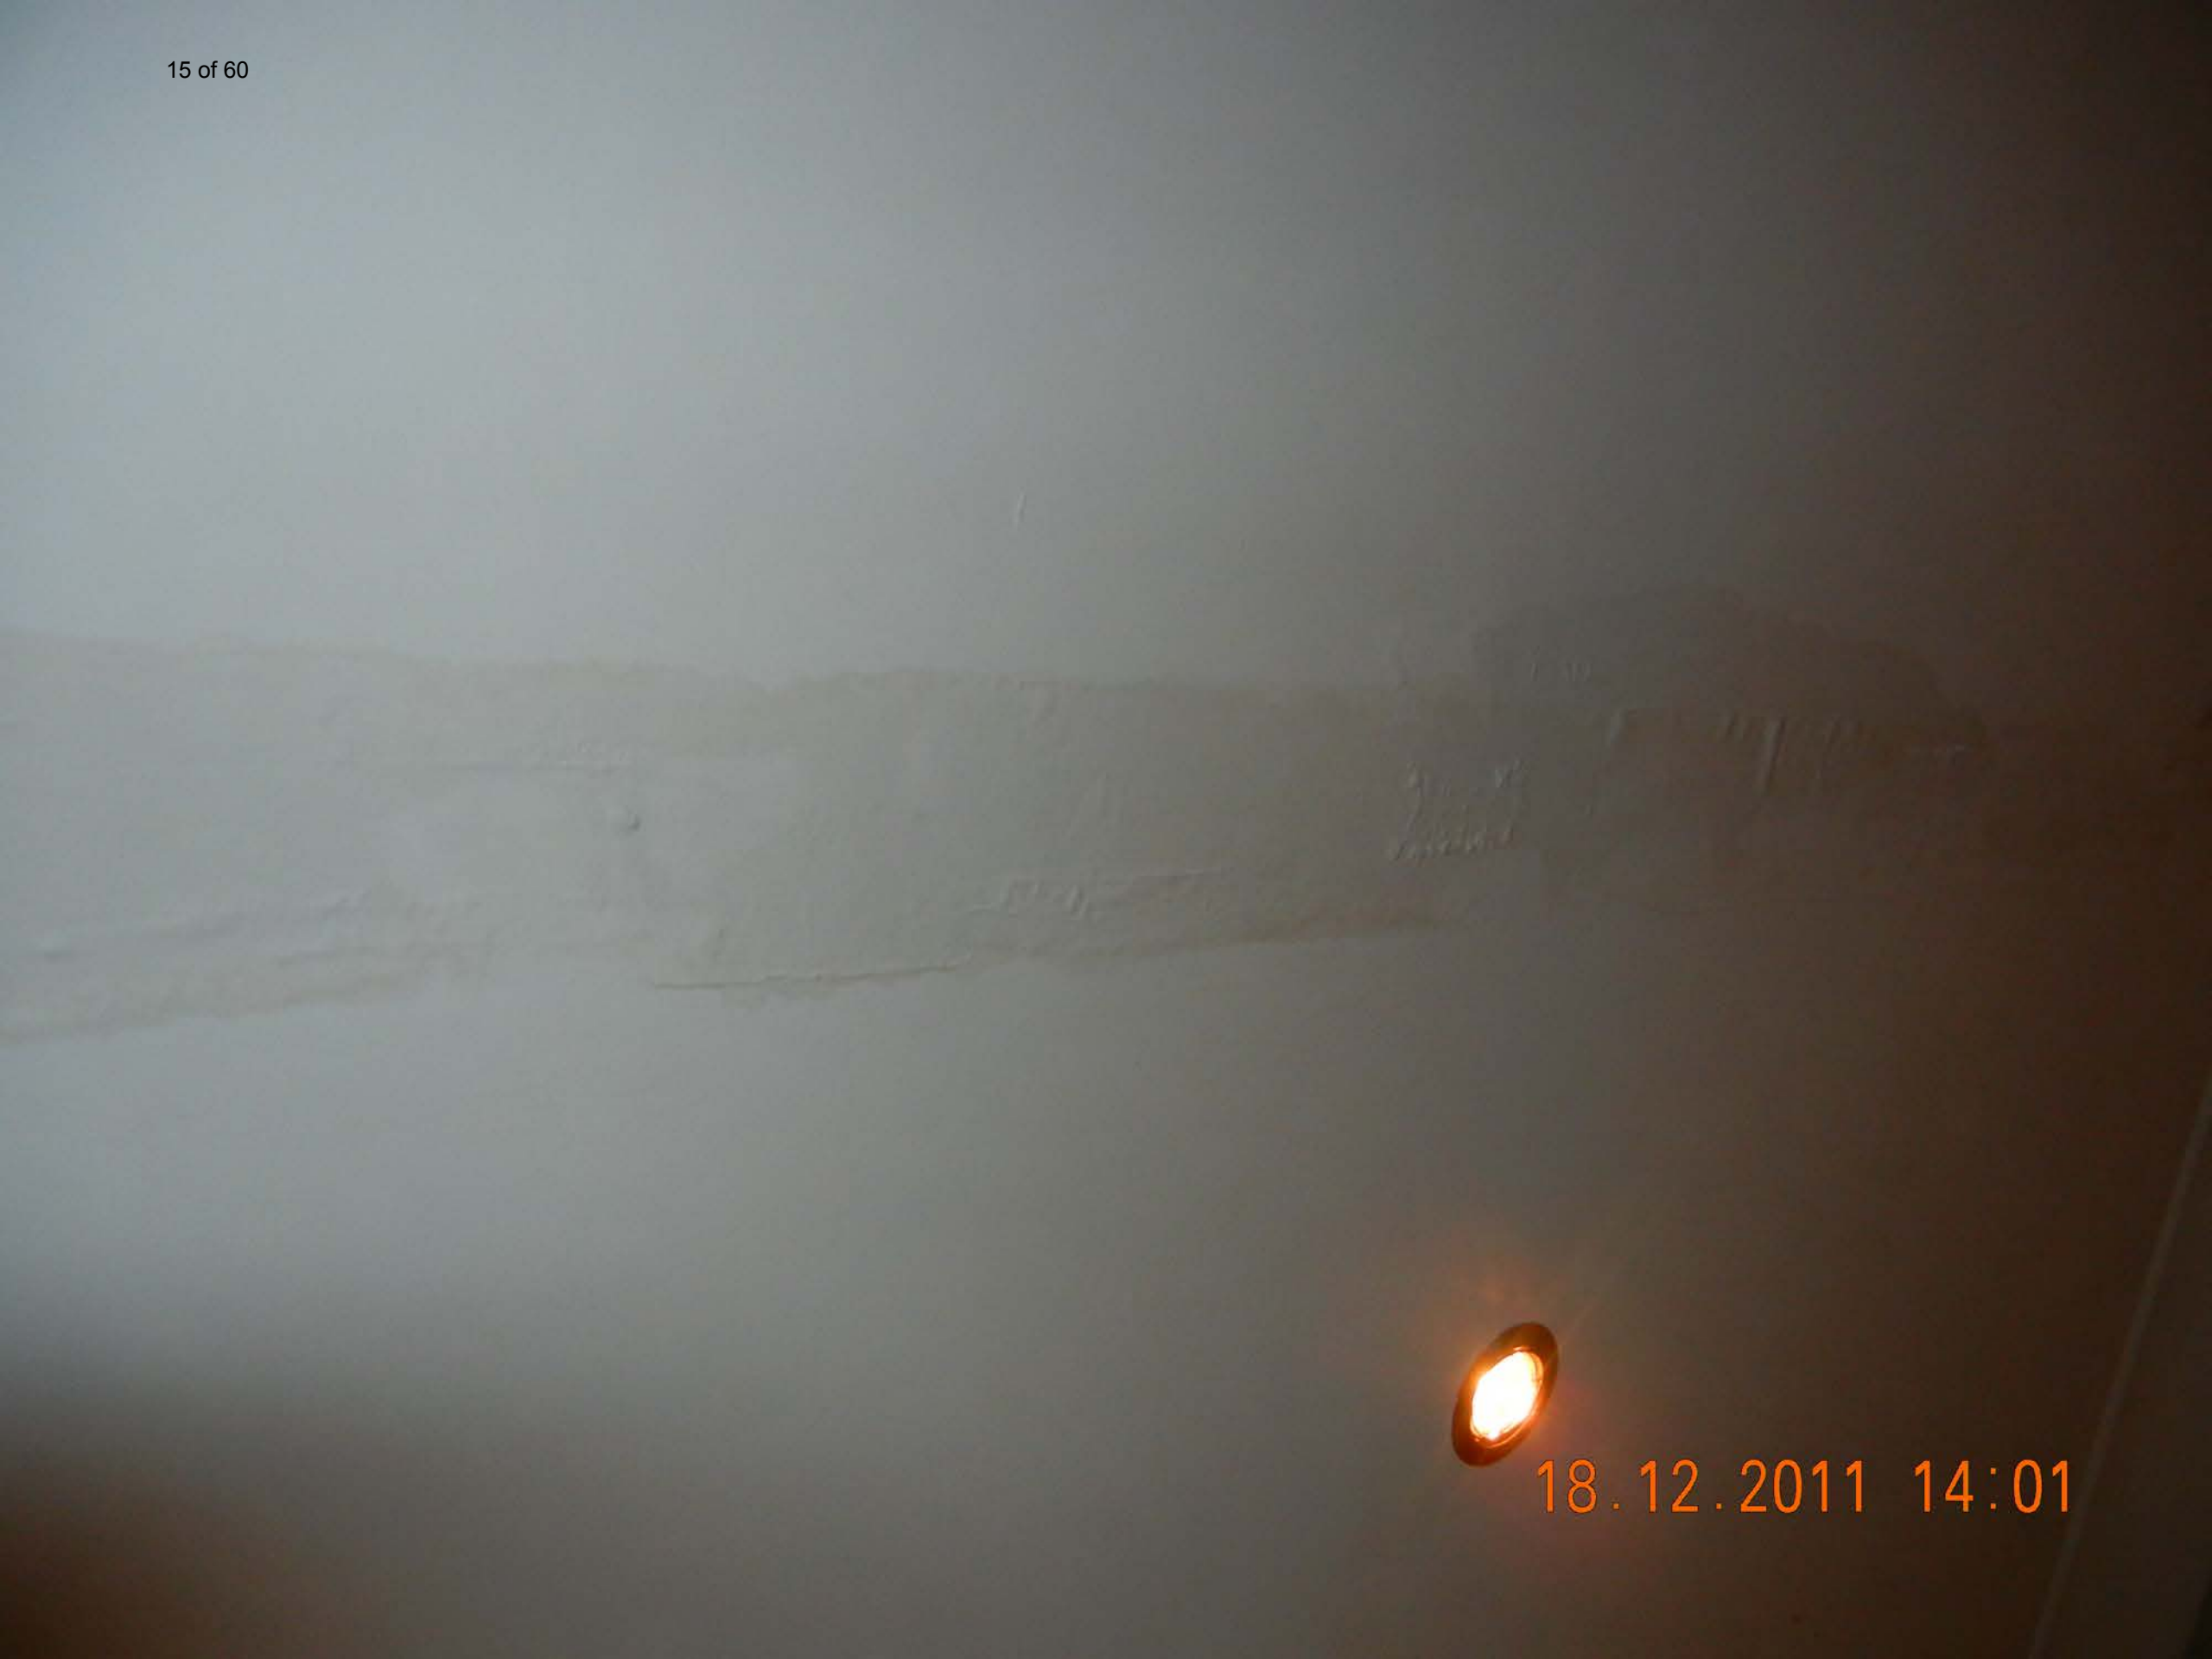
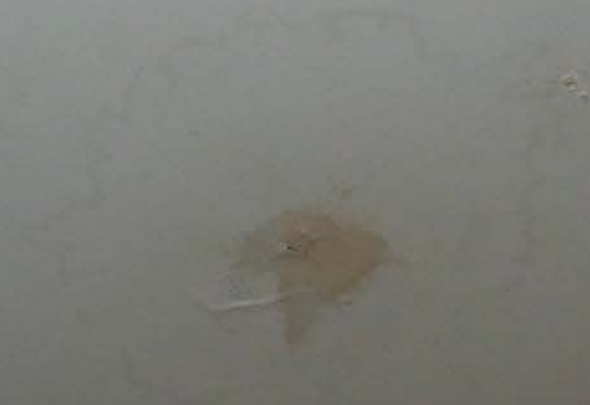
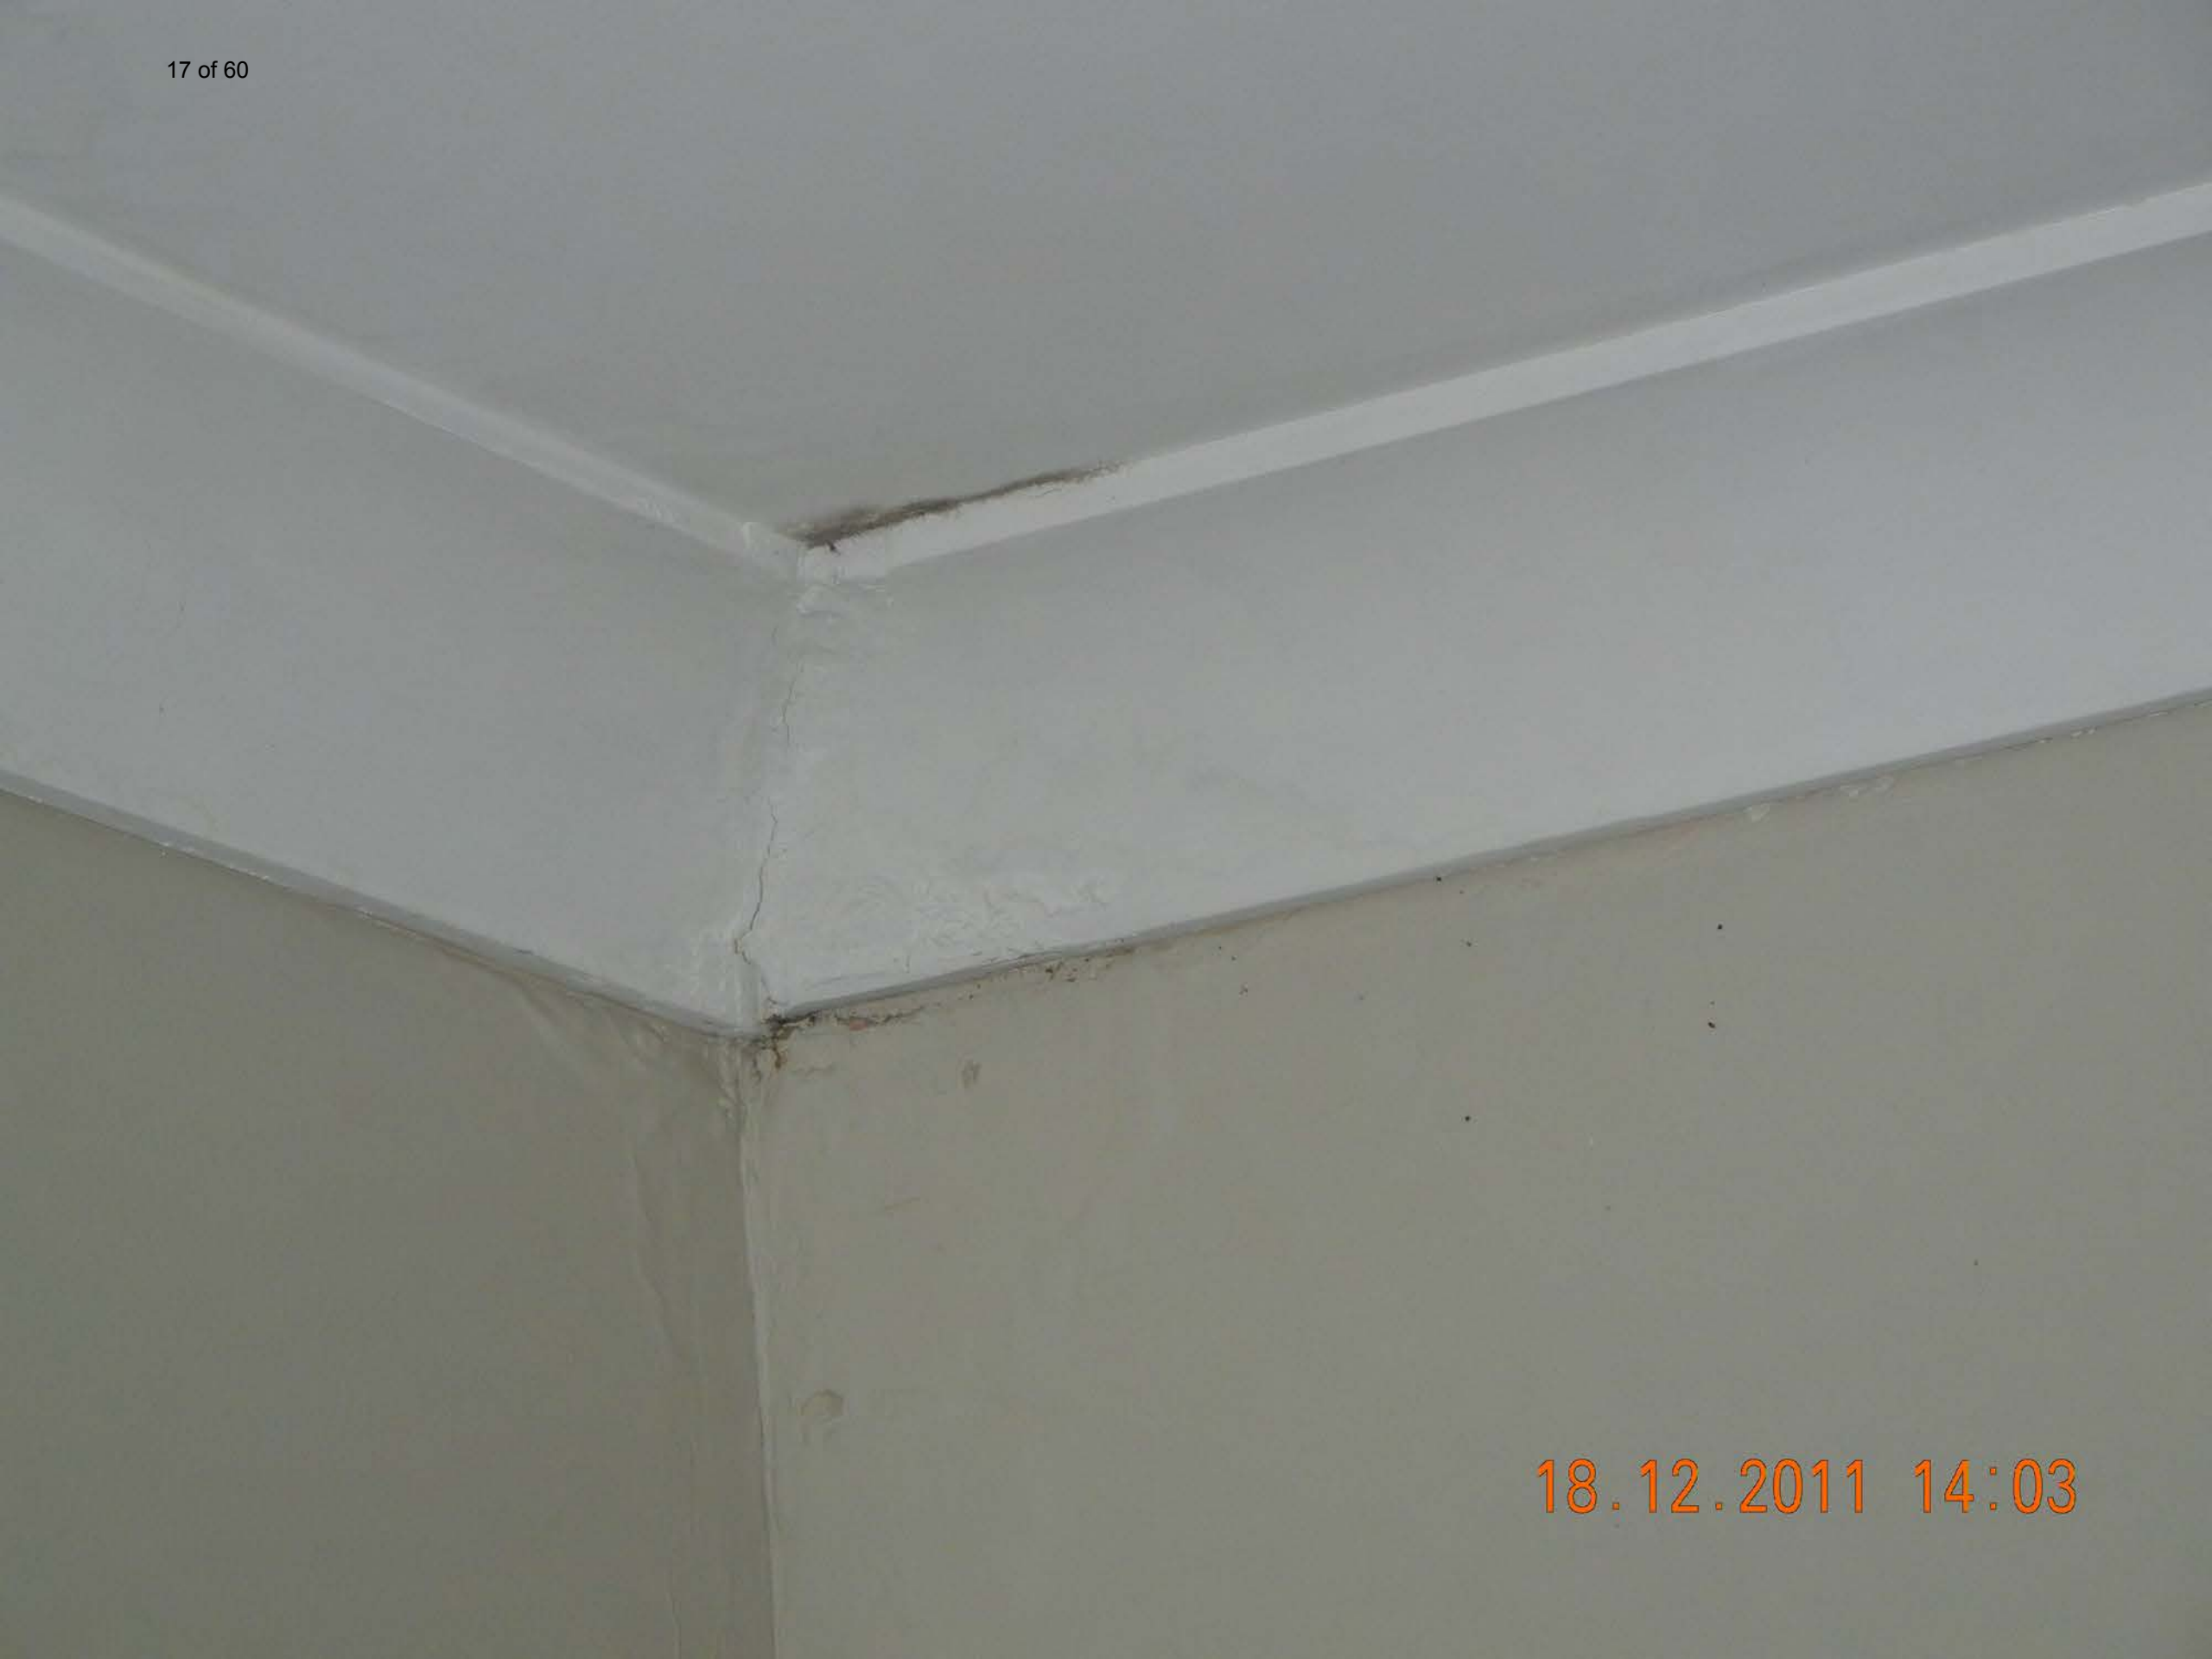
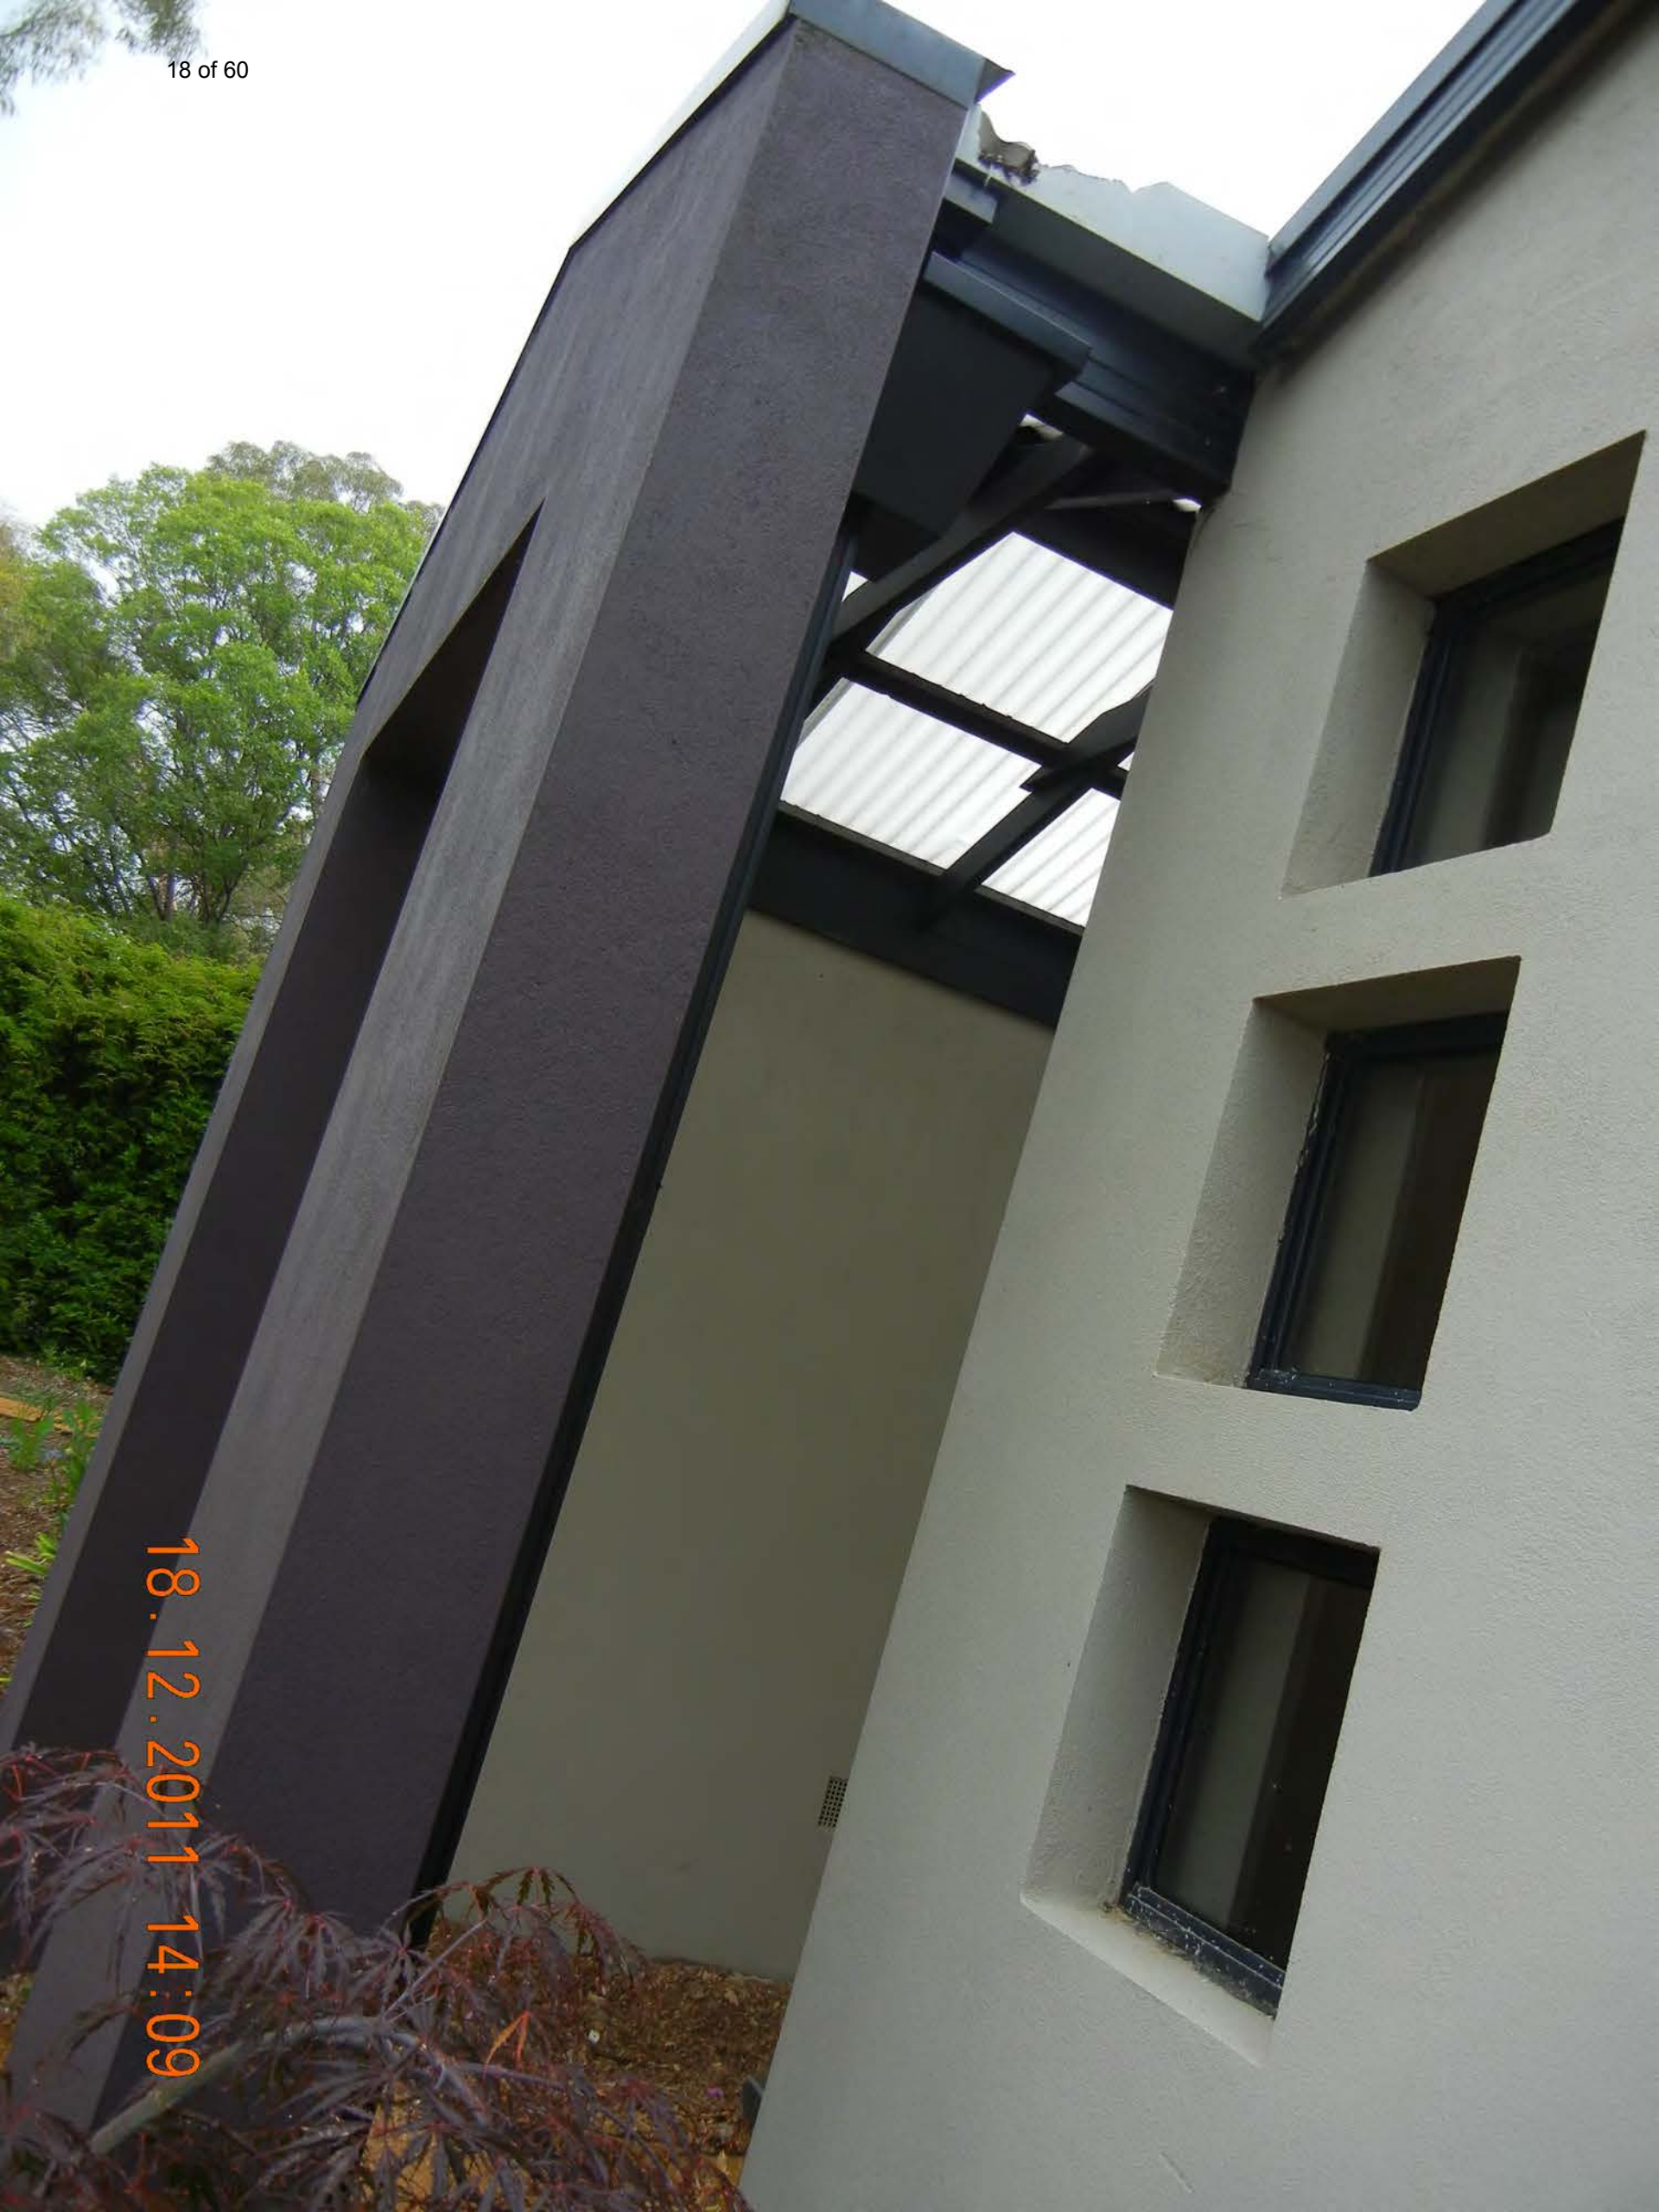
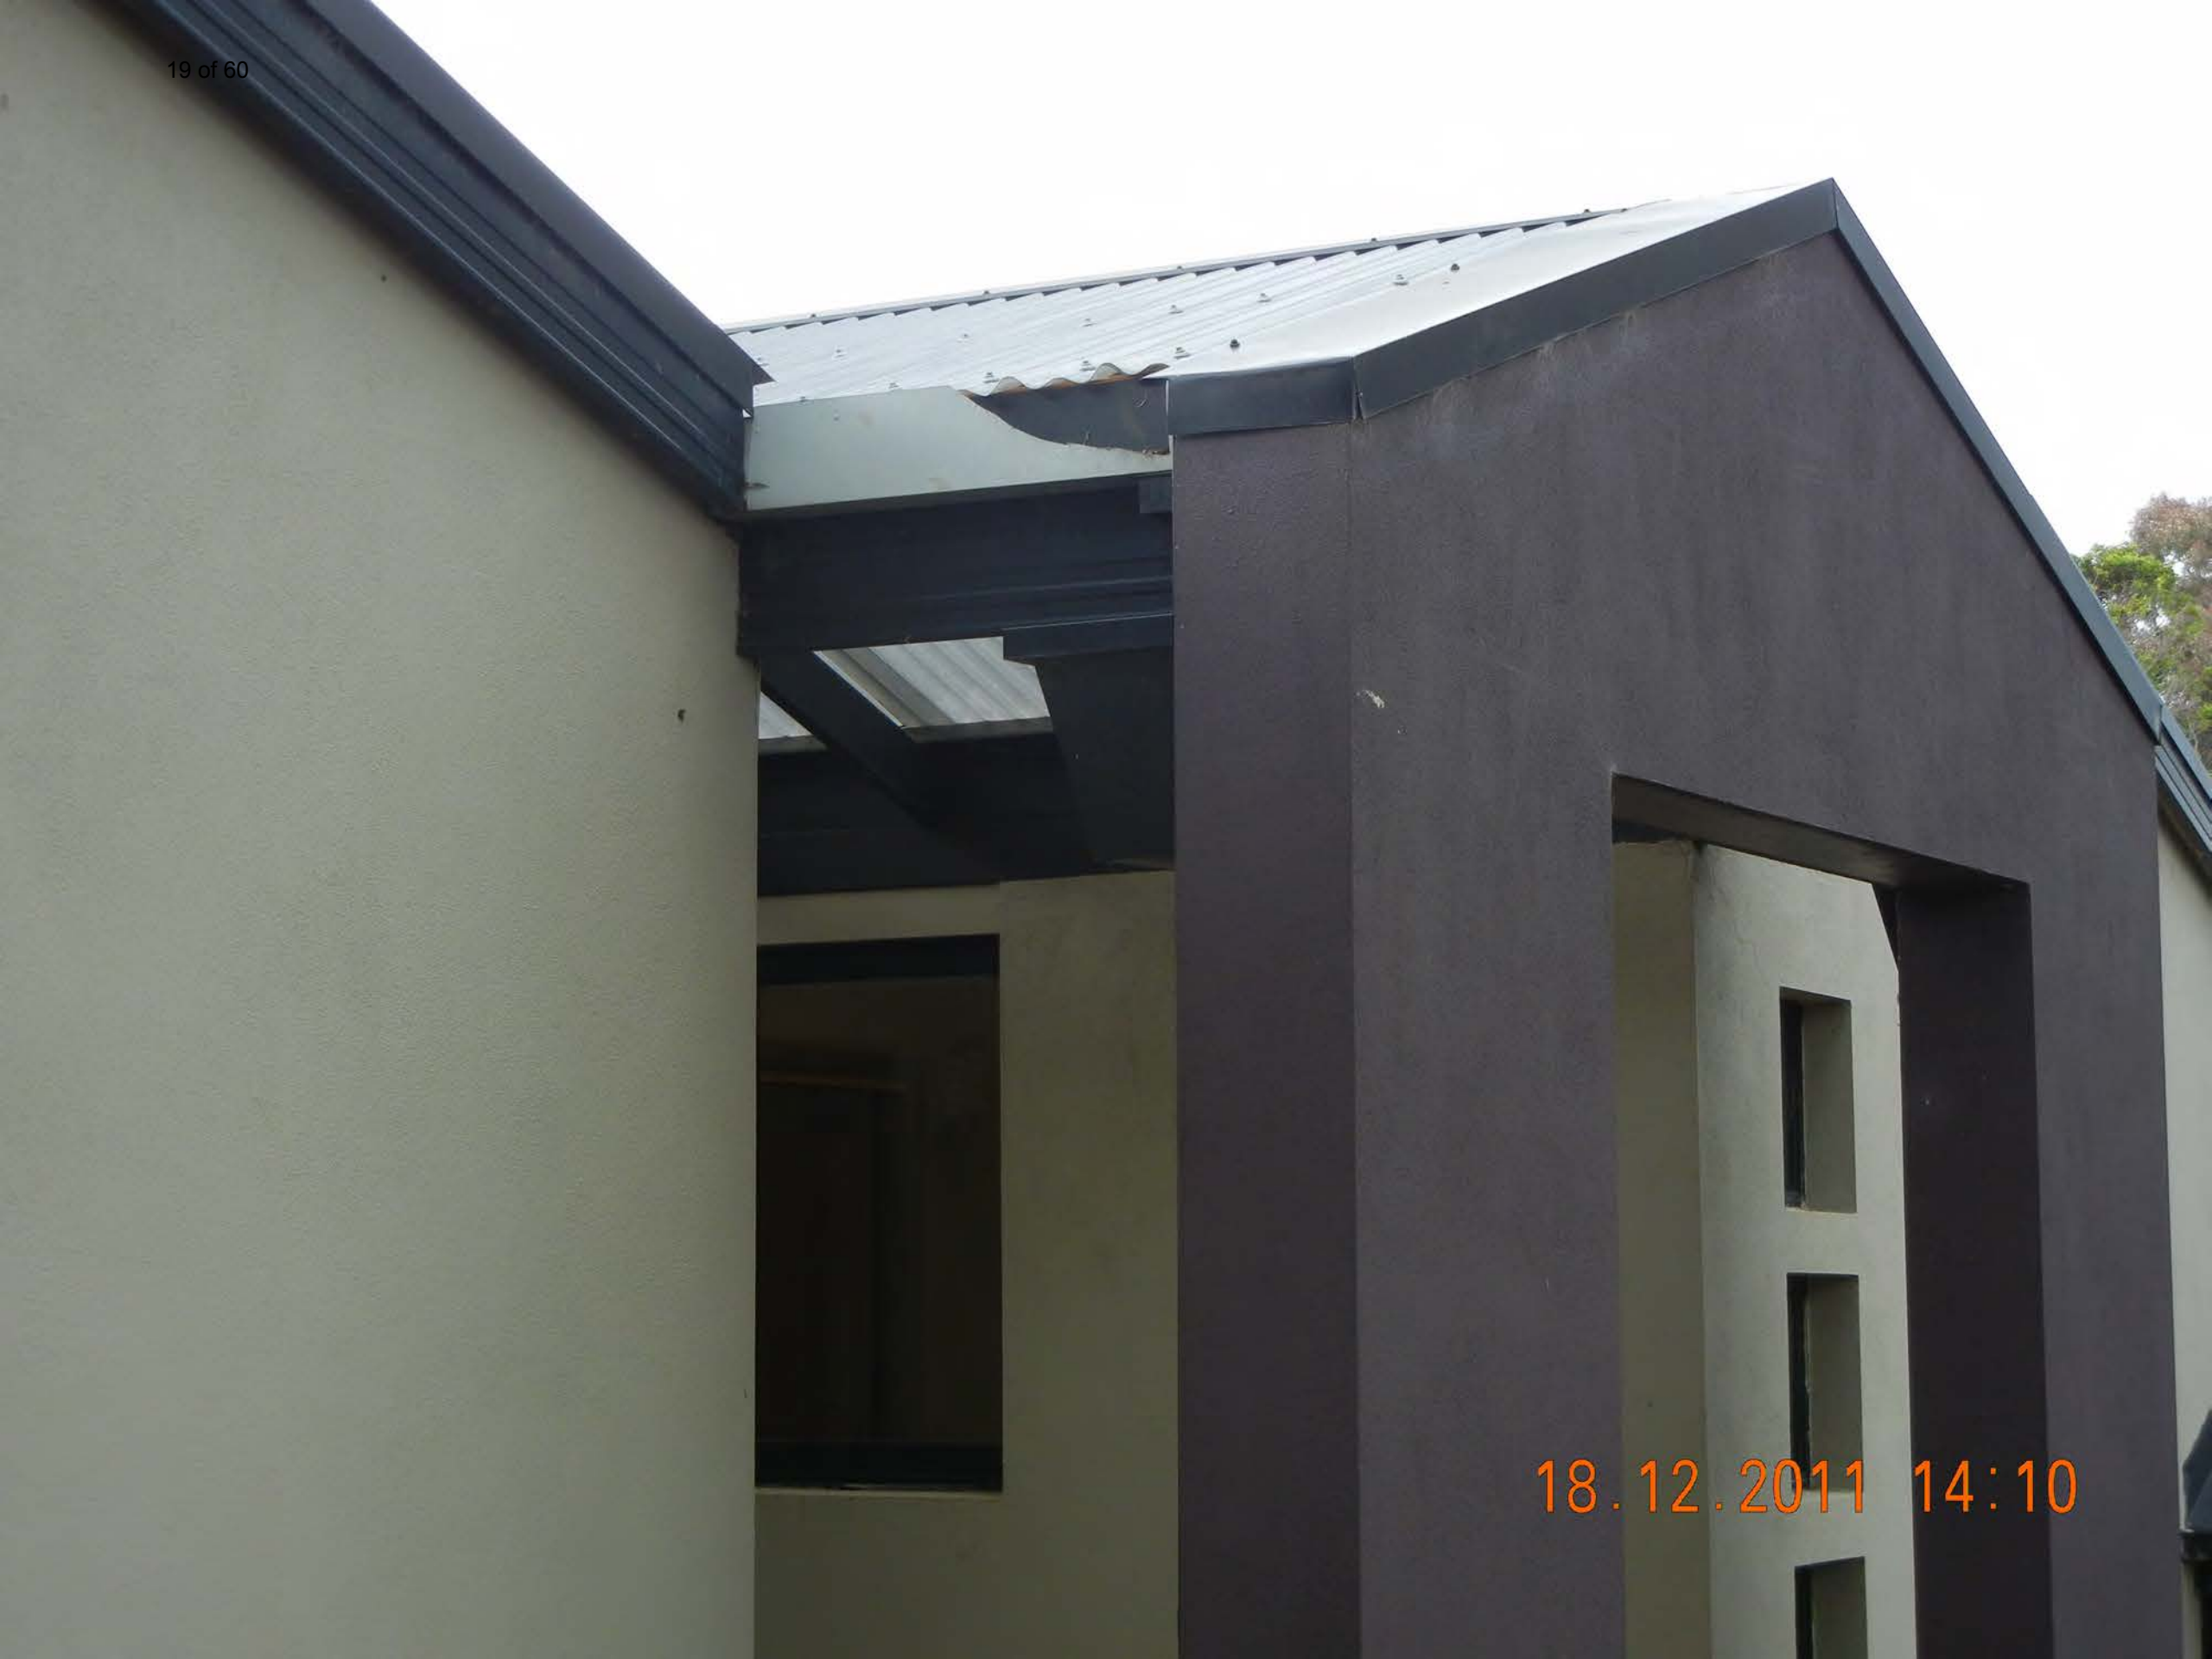
Photo No.	Photo Name	Taken From
1	Damage to ceiling	Entrance
2	Damage to ceiling	Entrance
3	Damage to ceiling, cornice and wall, mould growth	Entrance
4	DIY modification to box gutter over rain heads	Front of building
5	DIY modification to box gutter over rain heads	Front of building
6	Water pooled in gutter; debris at front of box gutter	Top of ladder, front of building
7	Box gutter showing debris and DIY modification	Top of ladder, front of building
8	Valley above leak full of debris, flashing over box gutter	Roof
9	Intact flashing adjacent to box gutter	Roof
10	Debris in valley over leak	Roof
11	Gutter full of leaf matter	Roof
12	DIY silicon under roof edge	Roof
13	DIY silicon in valley	Roof
14	Sealant at edge of sky light	Roof
15	Debris removed from valley / box gutters; intact flashing	Roof

16	Water test / water into box gutter	Roof
----	------------------------------------	------

Water damage inside the house was observed in the entrance area. During an inspection of the roof it was observed that DIY modifications had been made to the box gutter and silicon had been squirted under sections of colourbond. Some debris, including decomposed leaf matter was removed from some of the box gutters and valleys. The flashing was observed to be intact.

A water test was conducted using a hose during light rain, and no leaking was observed into the structure. It was agreed that the owner would clean the roof and gutters thoroughly and call us if the leak persisted.
