## Controlled Activity/Construction Occupations Complaint Form

### Record of Inspection

**Block:** 17    **Section:** 17    **Division:** MACQUARIE    **Unit:**

### NOTICE OF INTENTION TO MAKE RECTIFICATION

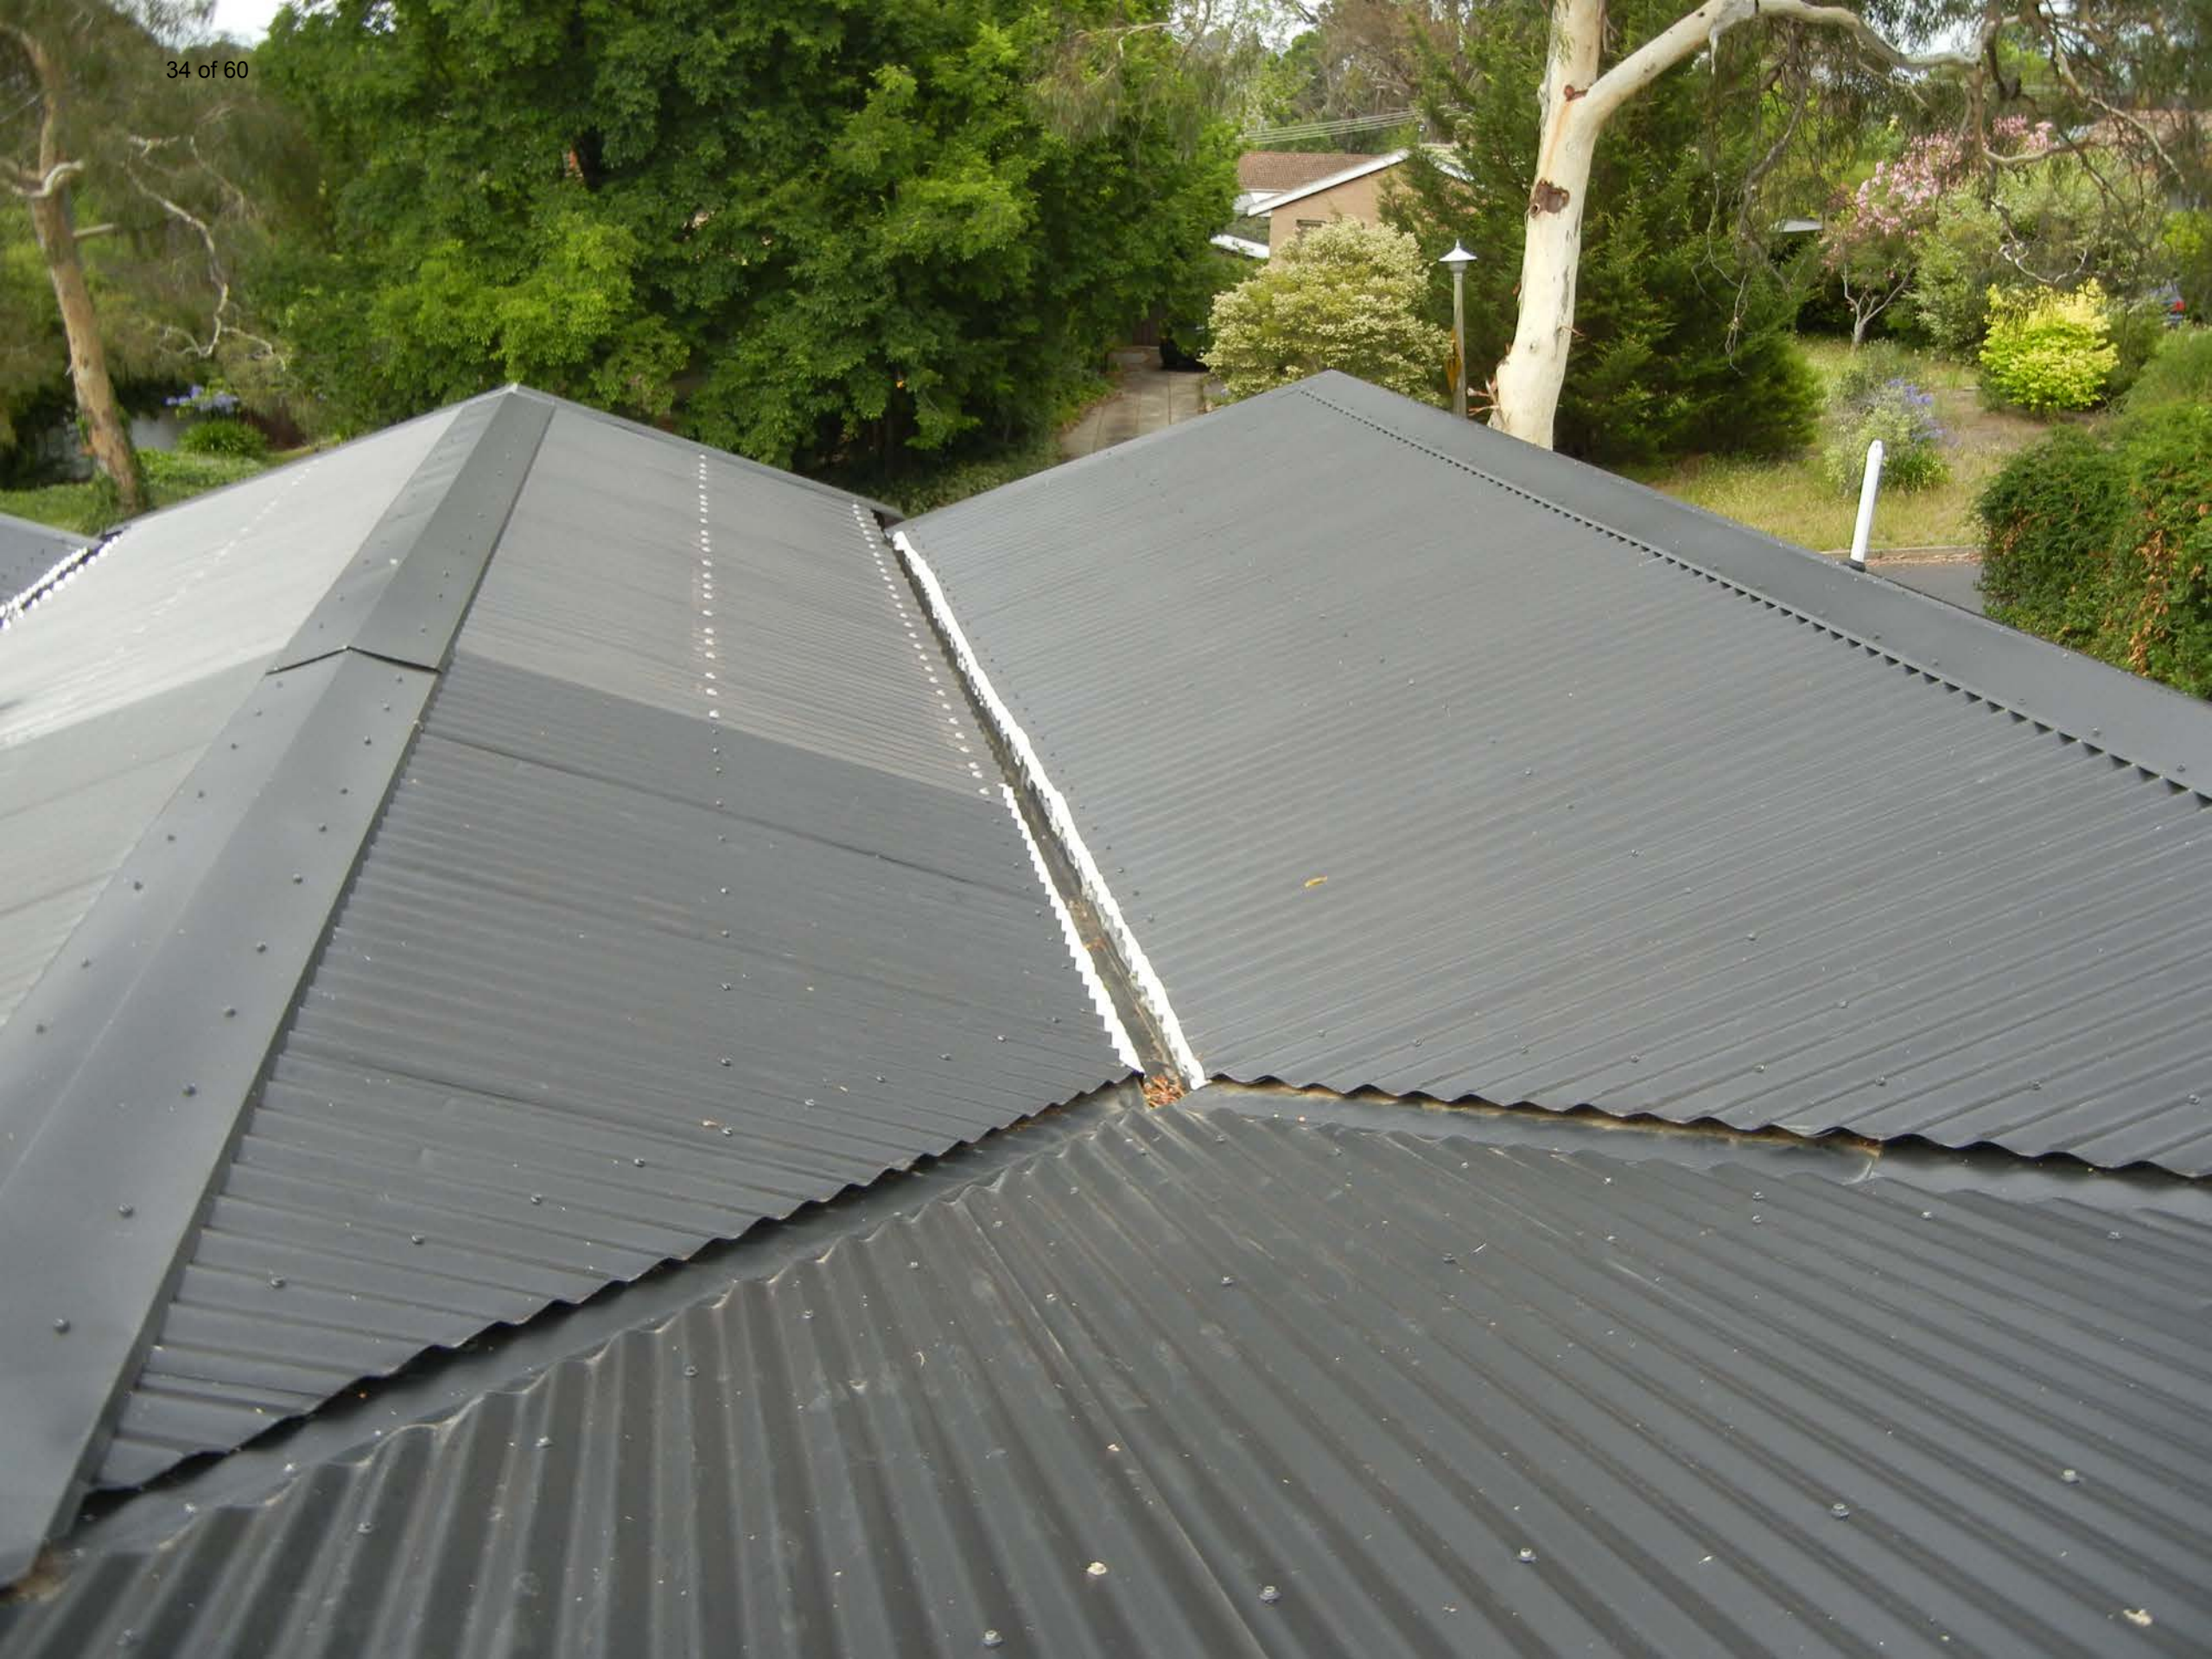
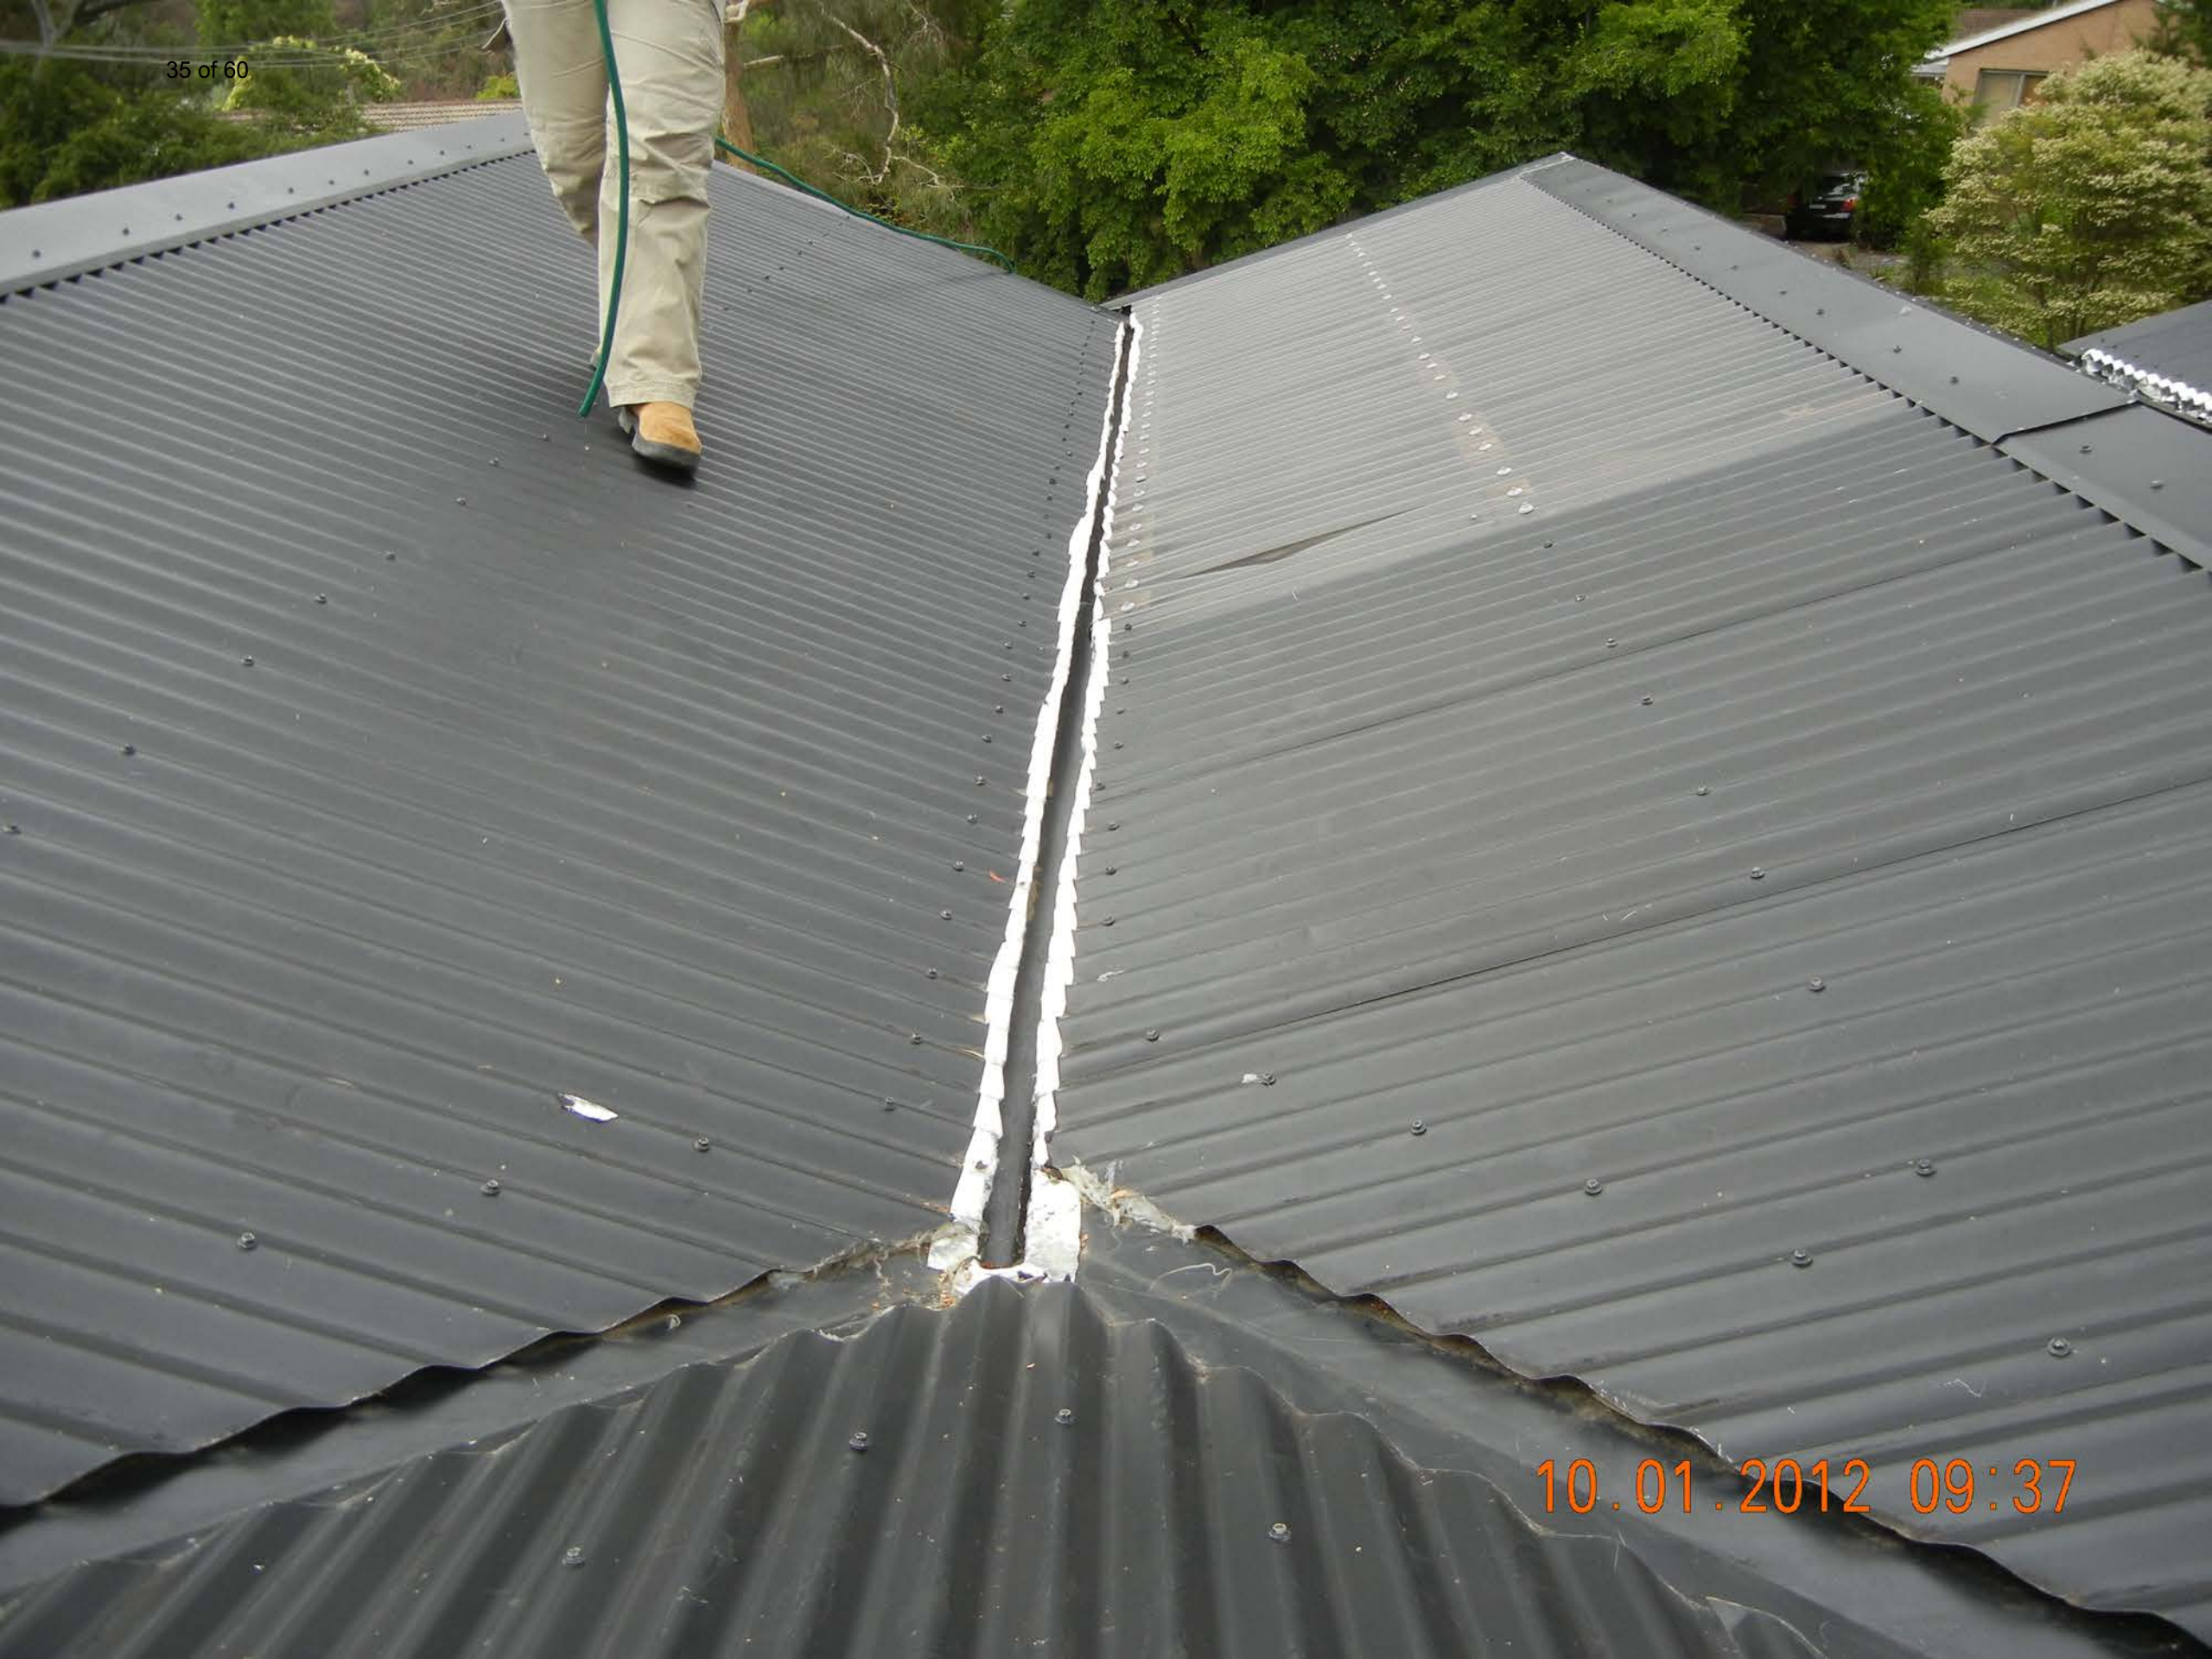
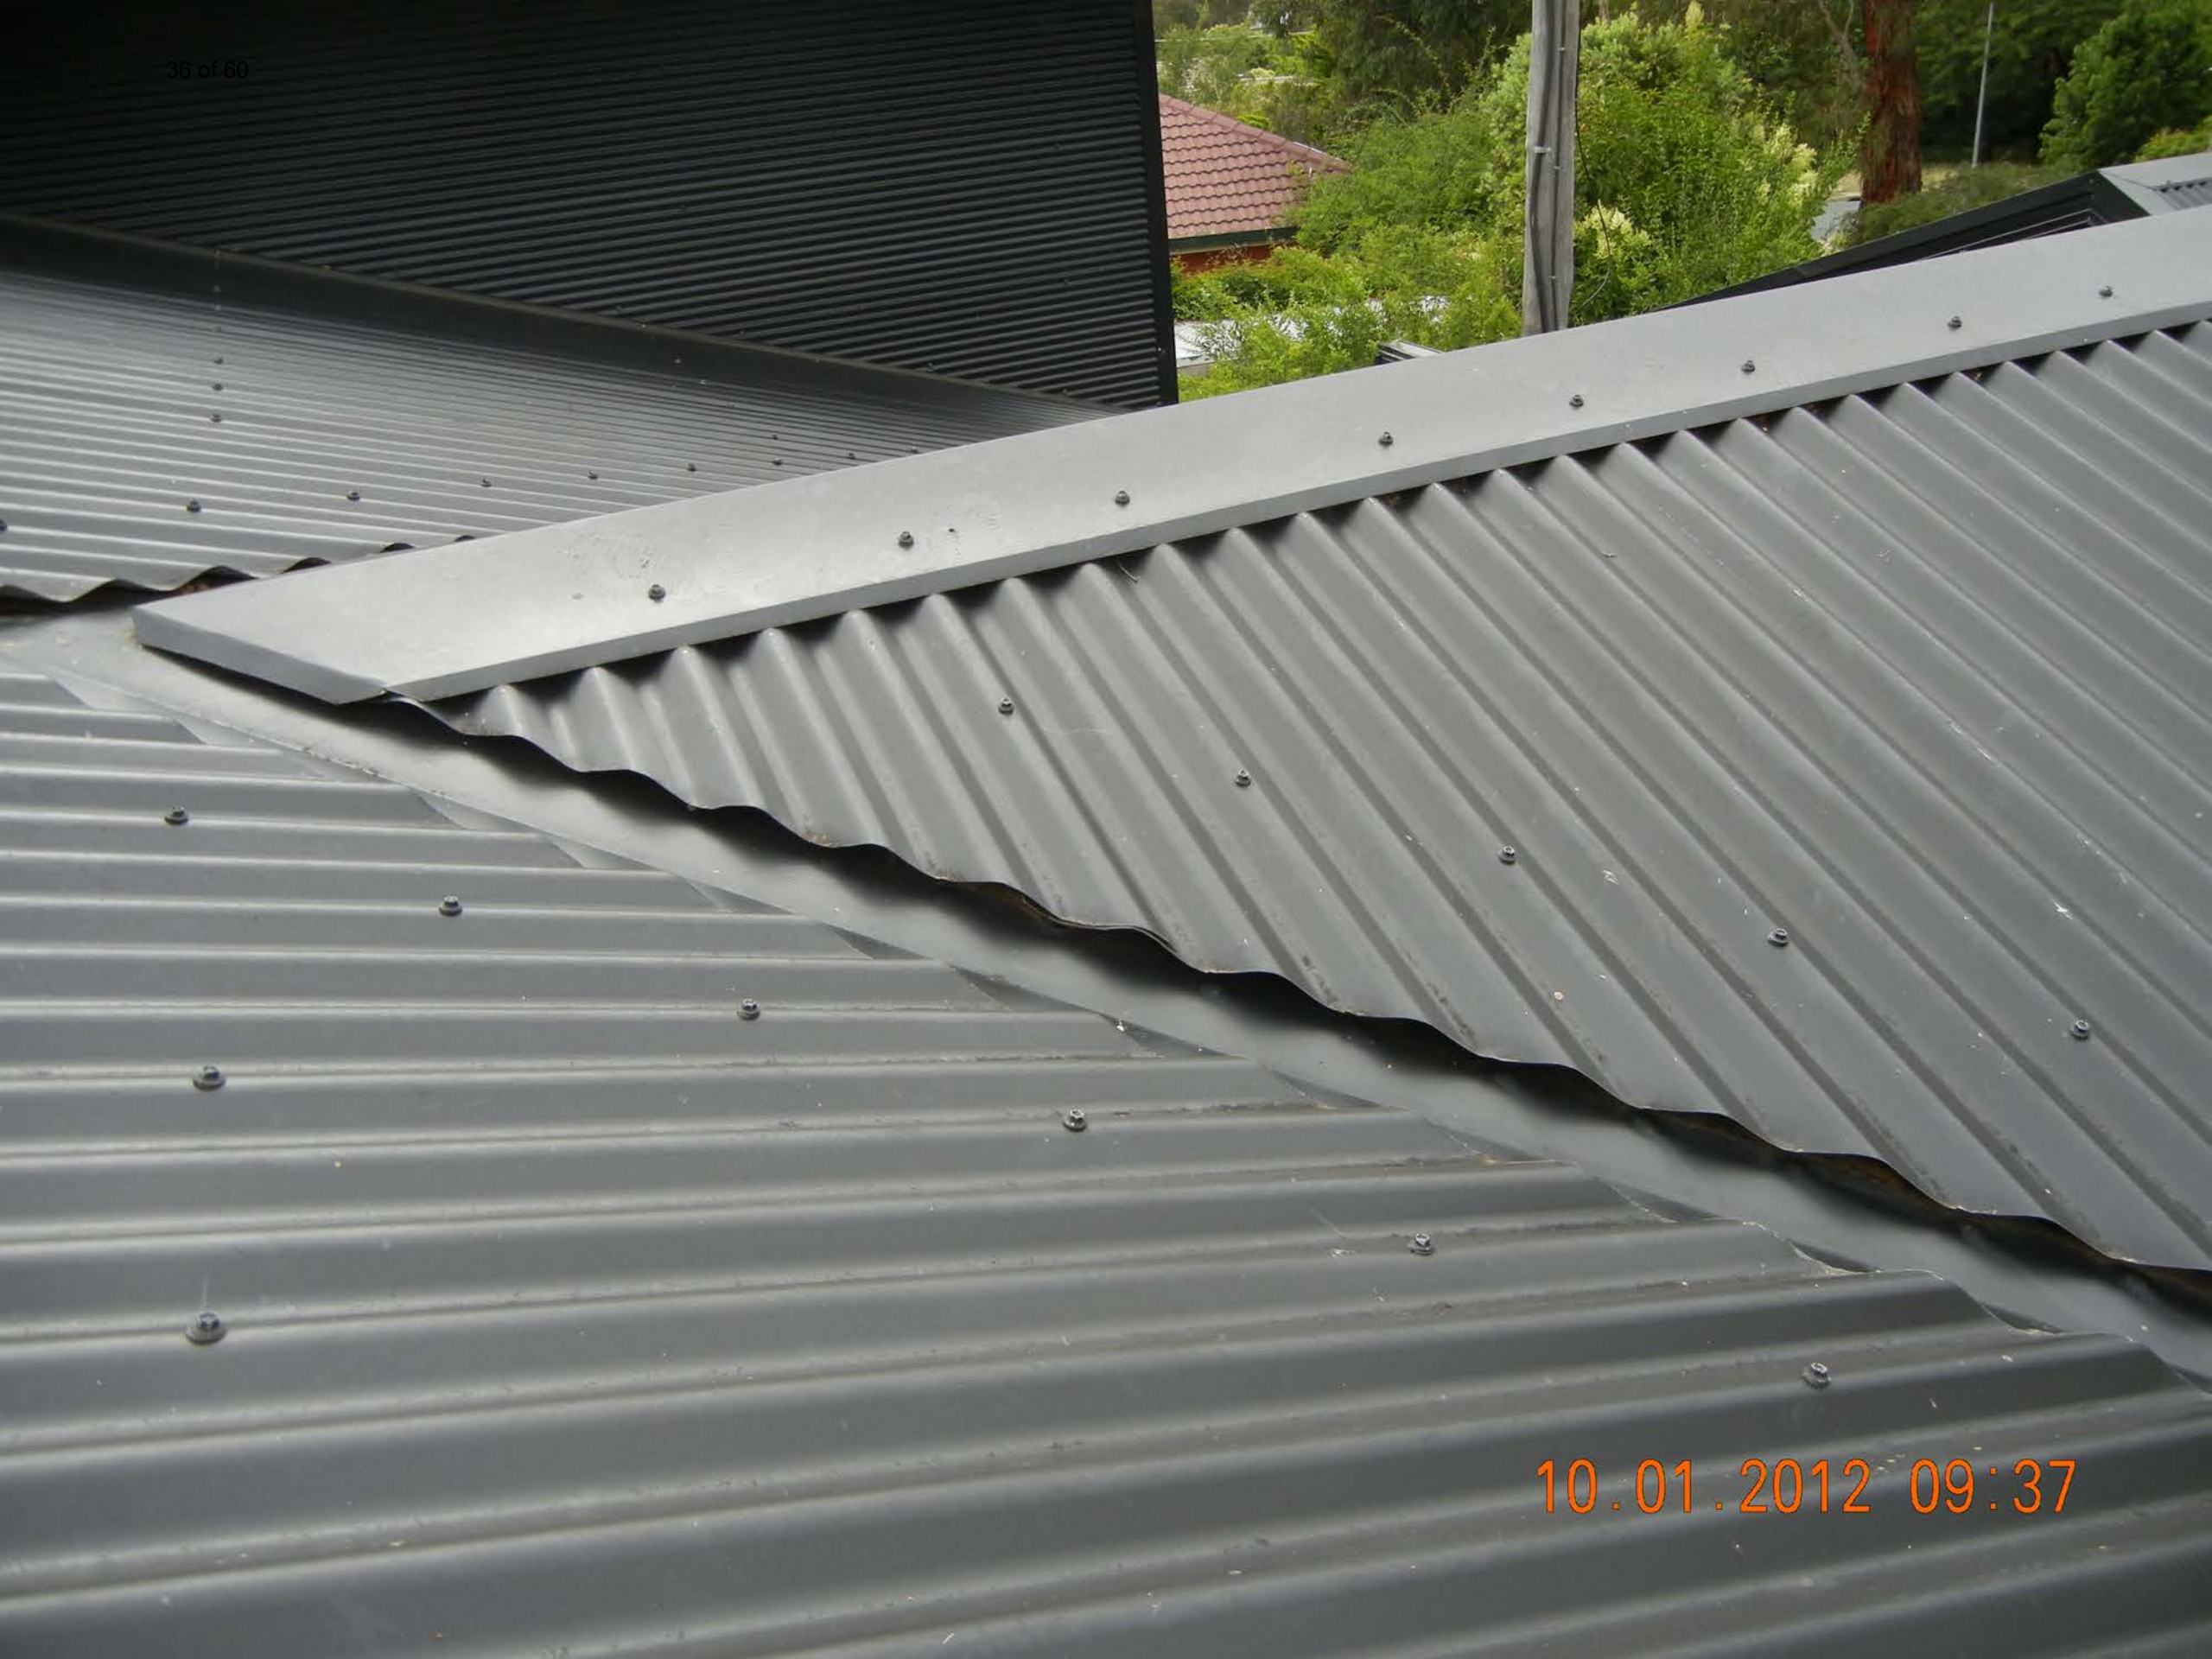
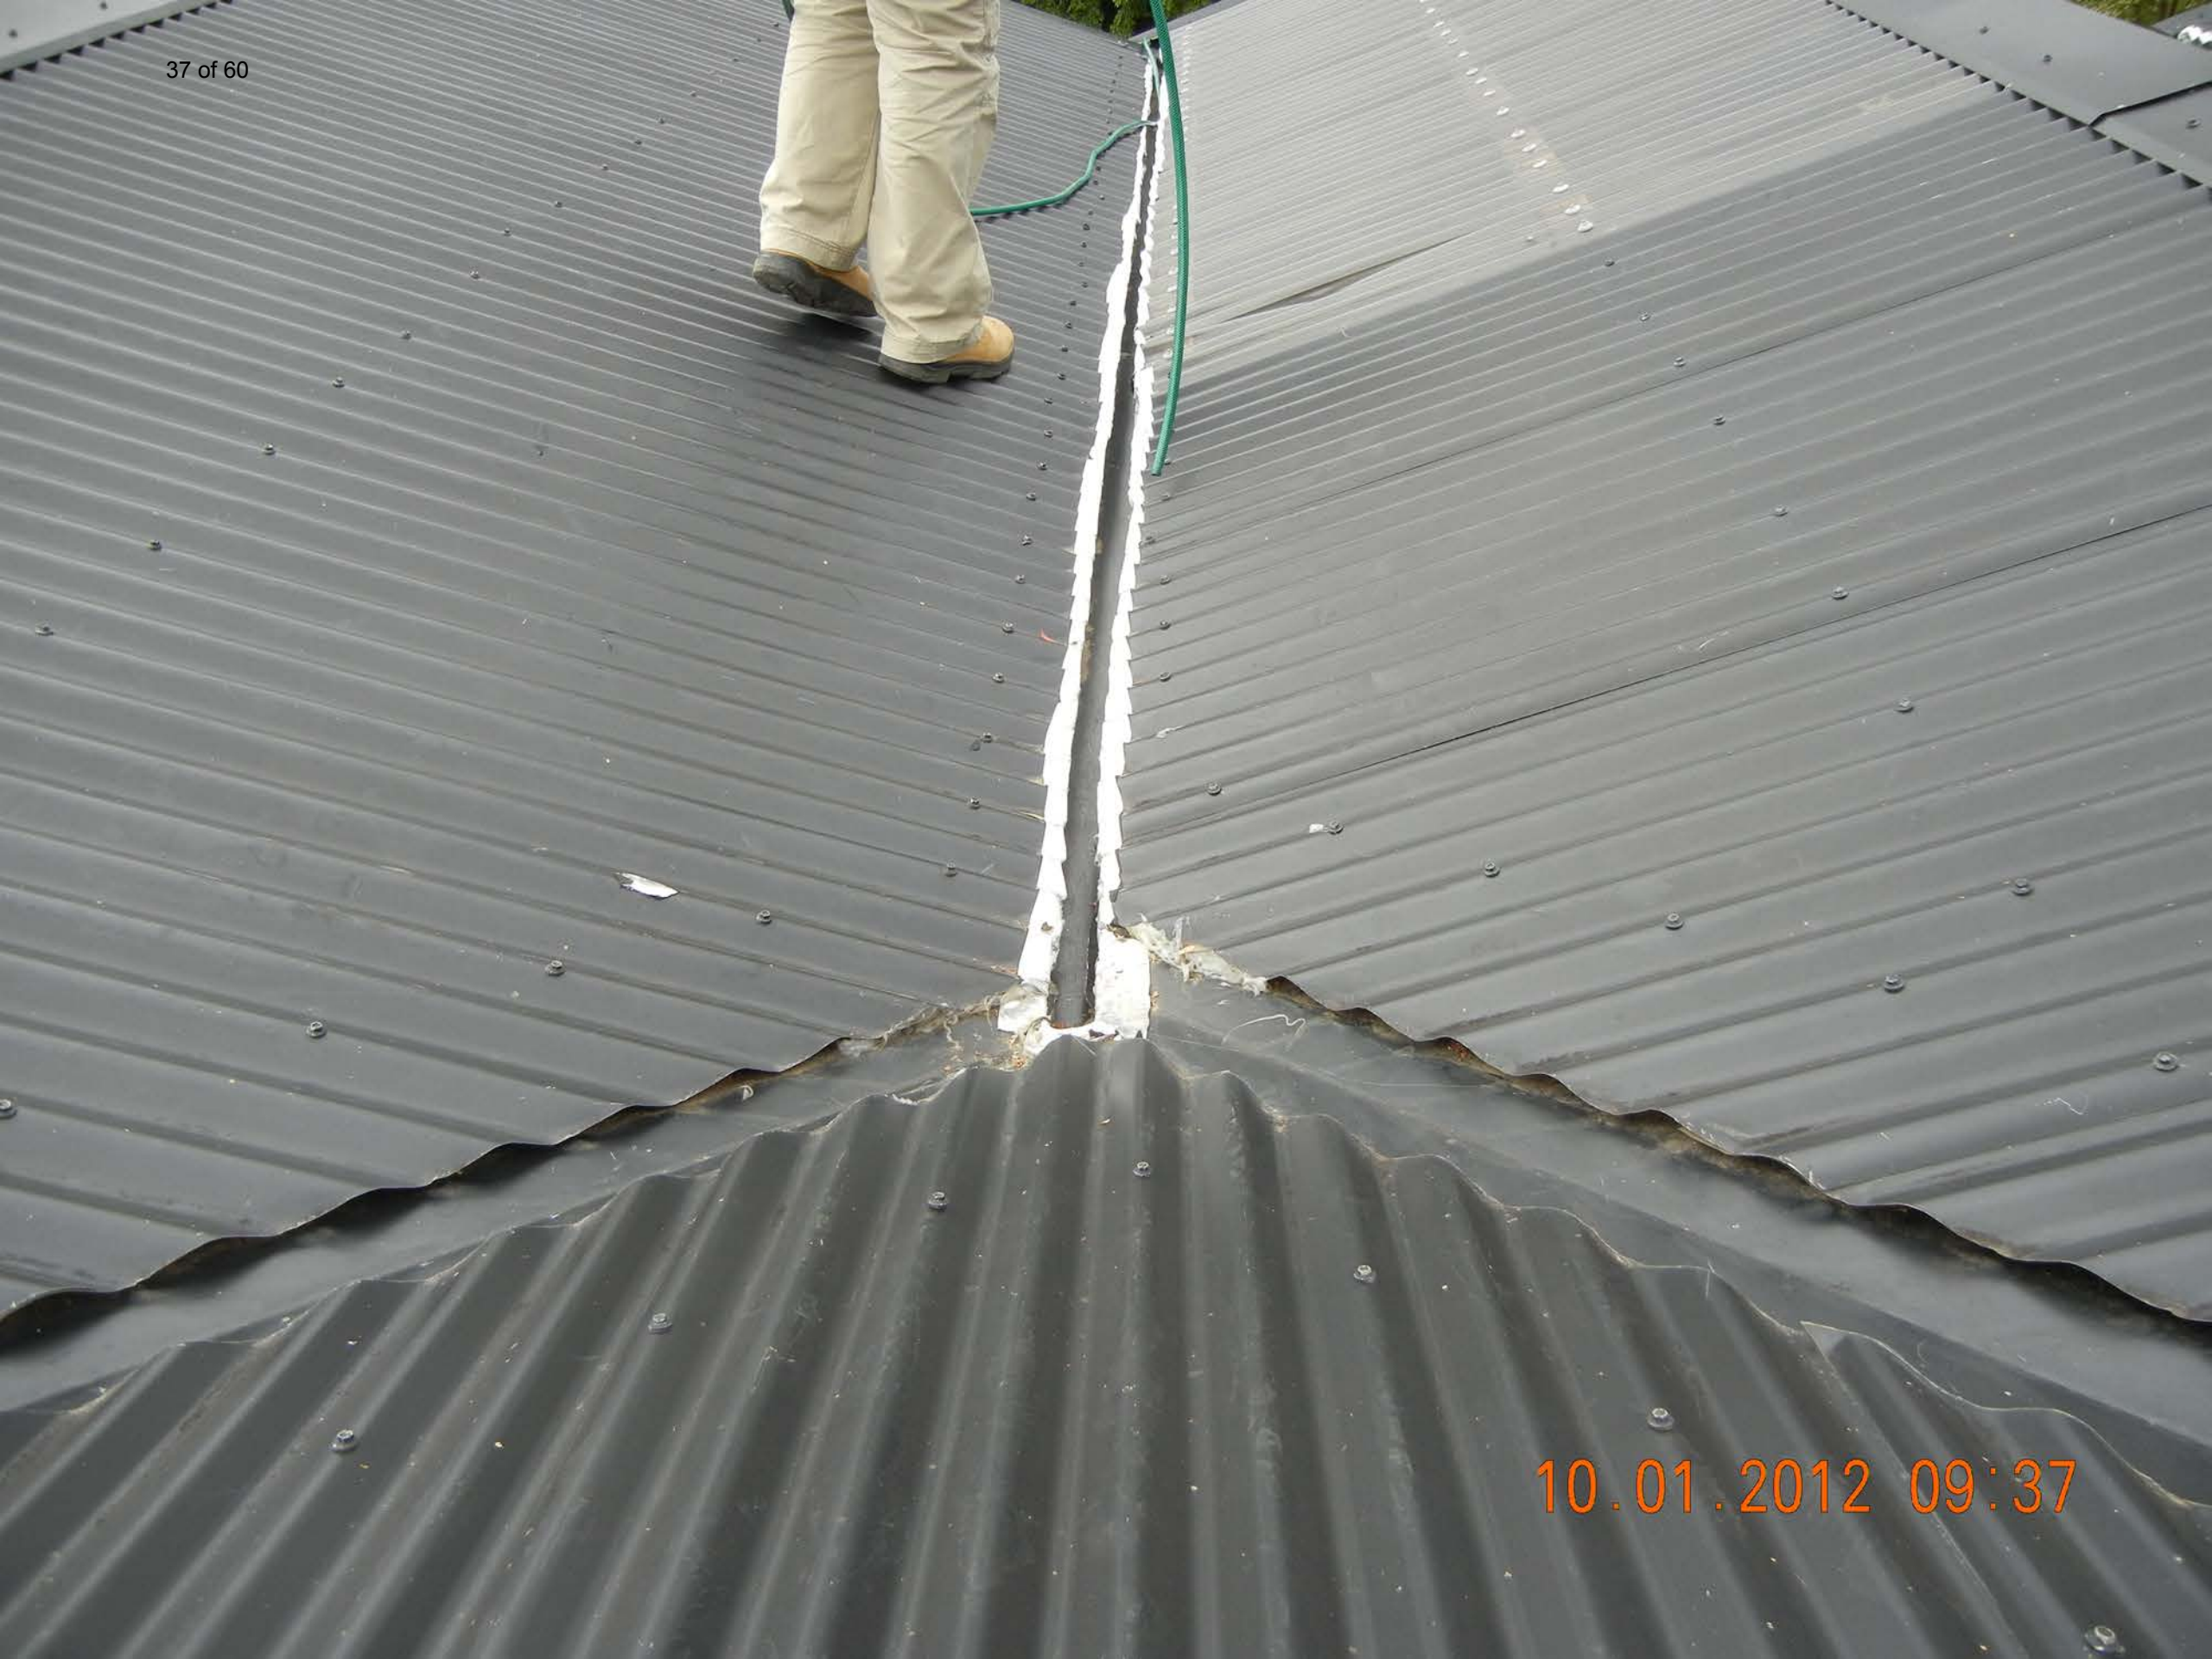
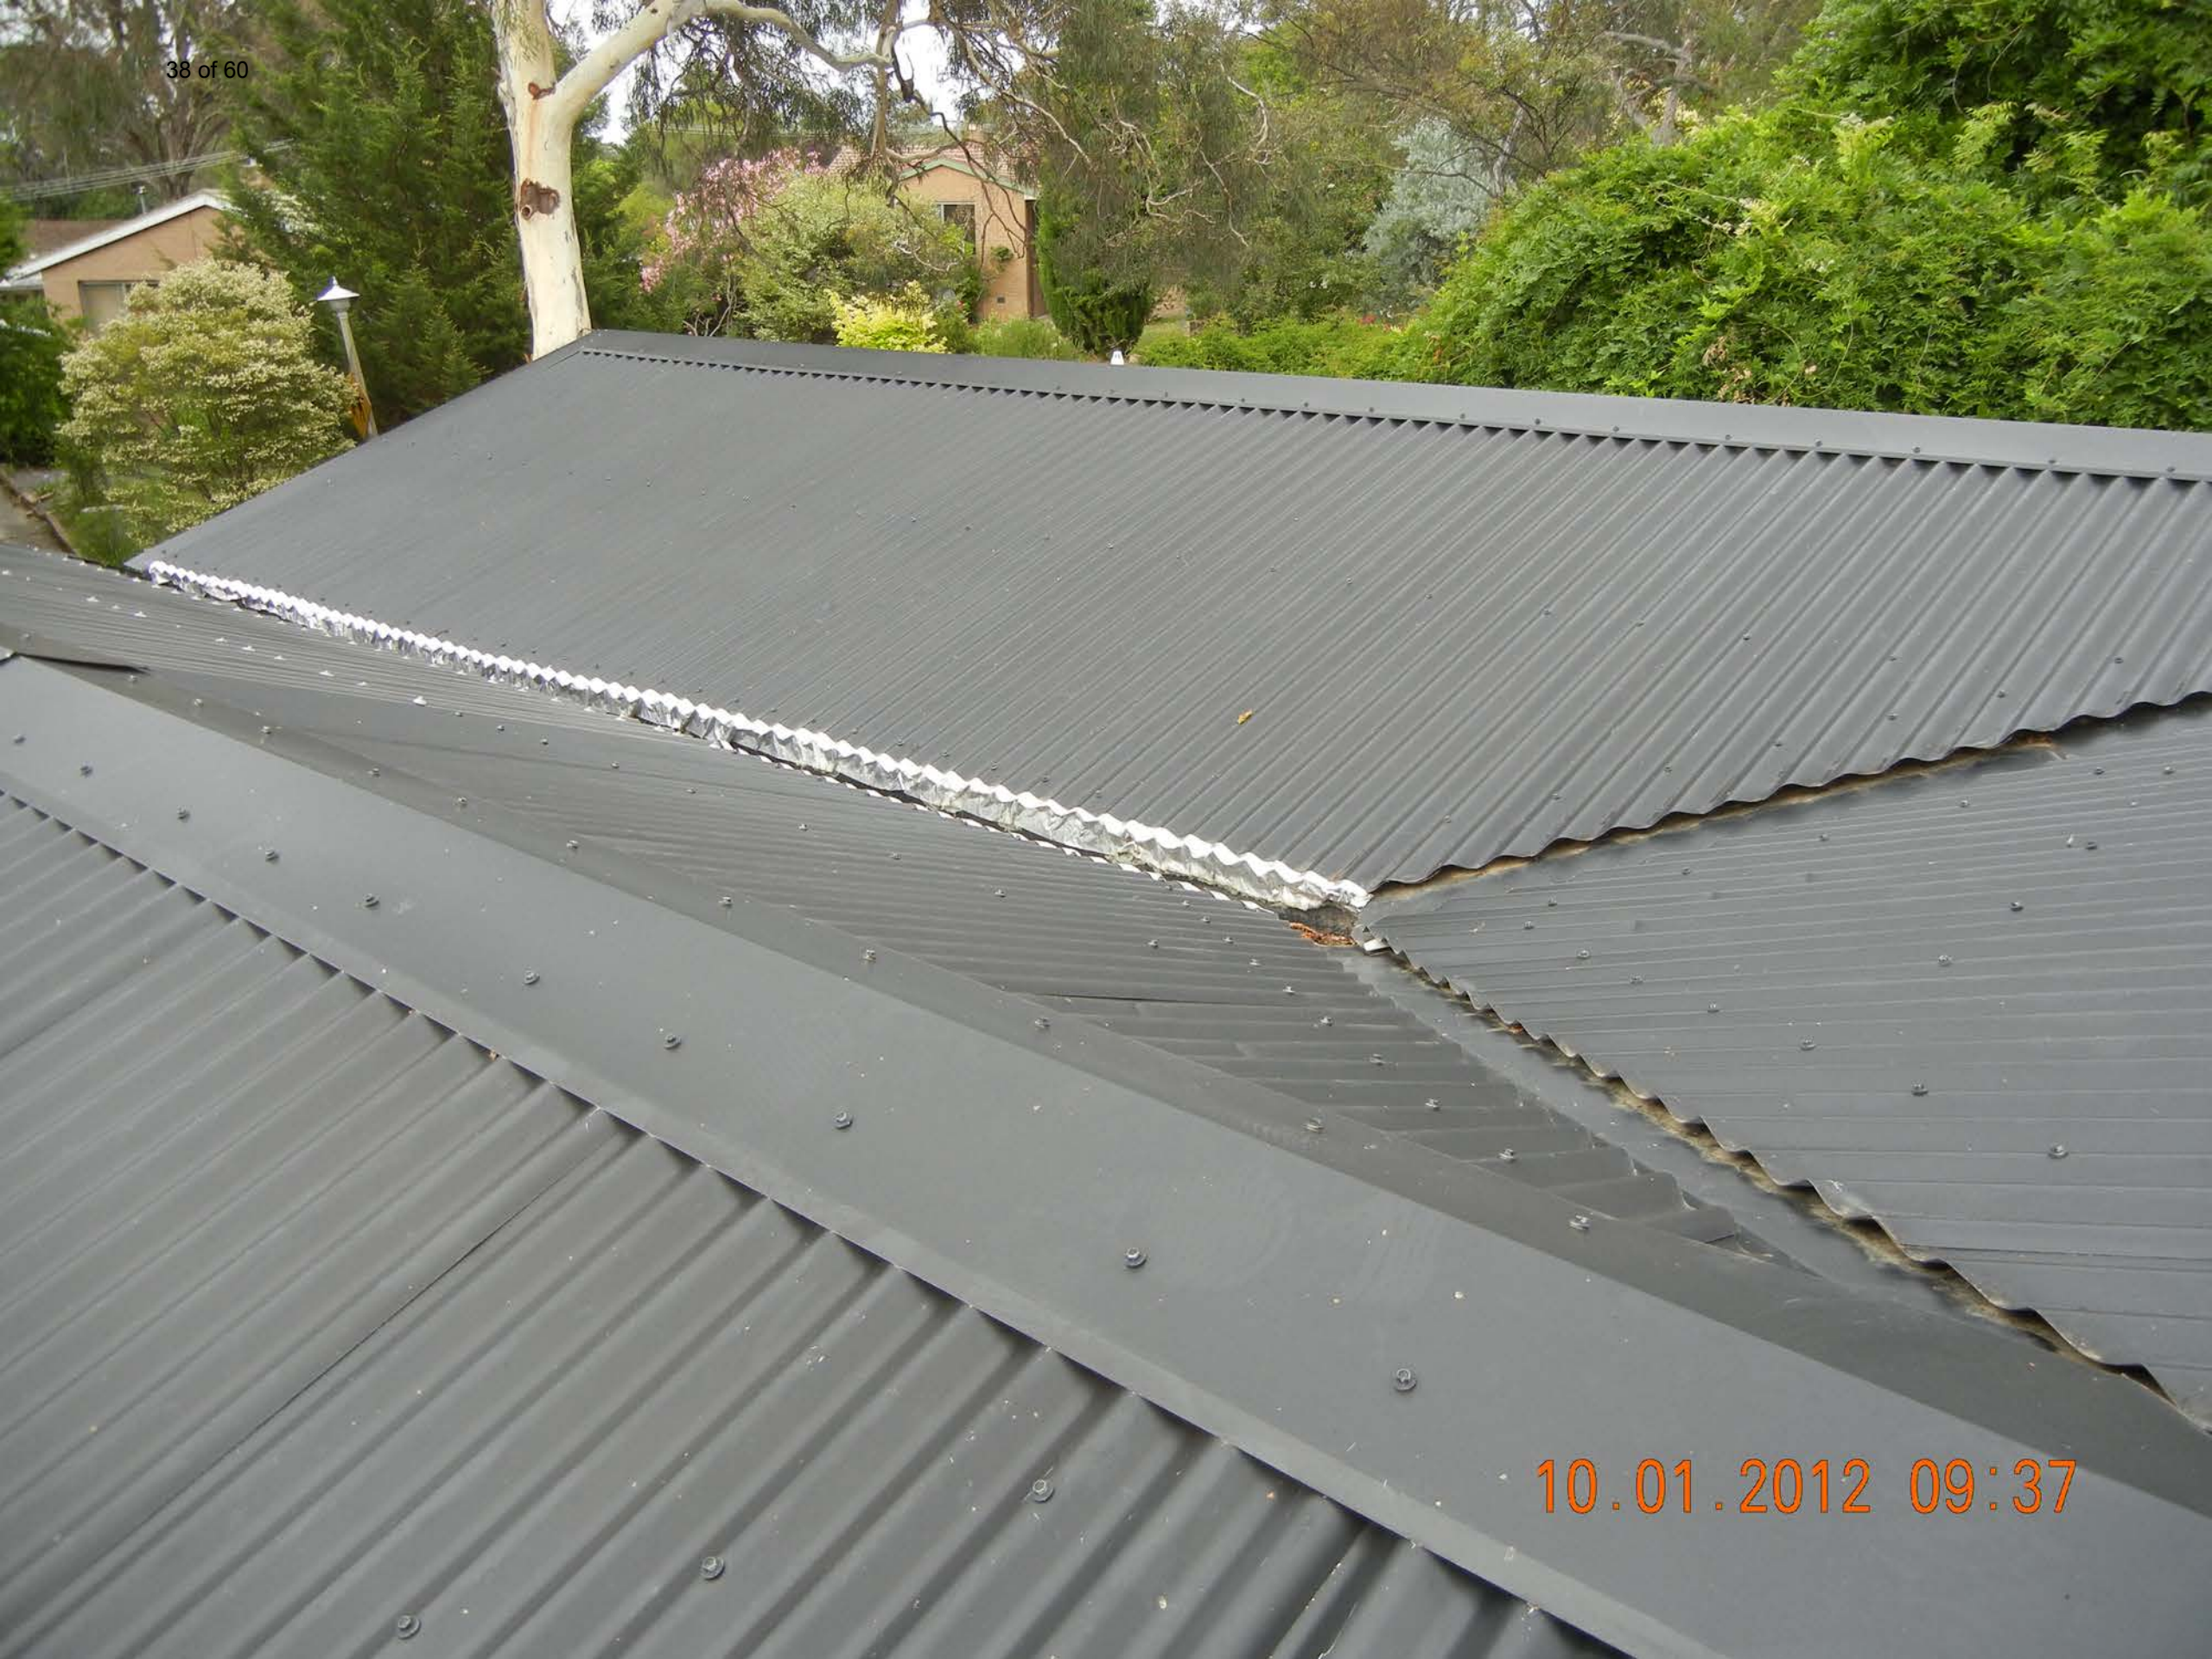
Photo No.	Photo Name	Taken From
1	Roof area clear of vegetation	Roof
2	Water test in valley over leak	Roof
3	Valley clear of vegetation	Roof
4	Roof area	Roof
5	Roof area	Roof
6	Join in box gutter	Roof
7	Join in box gutter	Roof
8	Water test underway	Roof
9	Water test underway	Roof
10	Water test underway	Roof
11	Water test underway	Roof
12	Water running inside house from leak	Inside house
13	Water running inside house from leak	Inside house
14	Bucket catching leak from roof	Inside house

The inspection determined that the roof was clear of vegetation and debris. A joint was observed in the box gutter sections. A water test was carried out on a dry day using two hoses and a leak was observed inside the house. The lessee said that since clearing the roof the leak was less severe.

1. Determine the point or points of water ingress into the building structure from the roof and / or box guttering.
2. Replace any defective components or carry out a permanent repair that will ensure that the roof, gutter and downpipe system operates as effectively as when initially built.
