## Refitting Imris Operating Table.

**From:** Cotterill, James  
**Sent:** Wednesday, 17 August 2011 11:17 AM  
**To:** [REDACTED]  
**Subject:** Manufacturing defect IMRIS MRI table

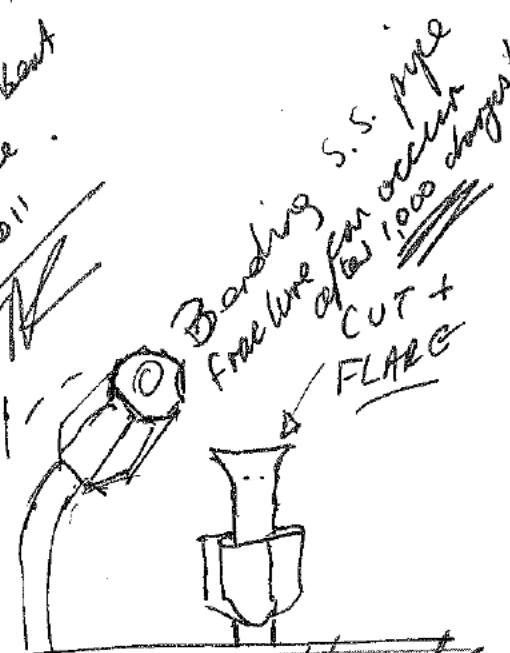
FLOOR

Note  
HK also suggested that the floor pipes be cut below the elbow and new fittings made so that pipes are not bent when IMRIS is not in use.  
December 2011

the need of a safety valve in ??? very low pressure  
The actual length of air can be checked on the reservoir
