CAPITAL METRO – TREE SELECTION MEMORANDUM

This memorandum outlines the process undertaken by the Advisory Team for selecting the replacement tree for the *Eucalyptus elata* (River Peppermint) trees in the Northbourne Avenue median, and how the Advisory Team arrived at the initial selection of the *Eucalyptus rossii* tree species.

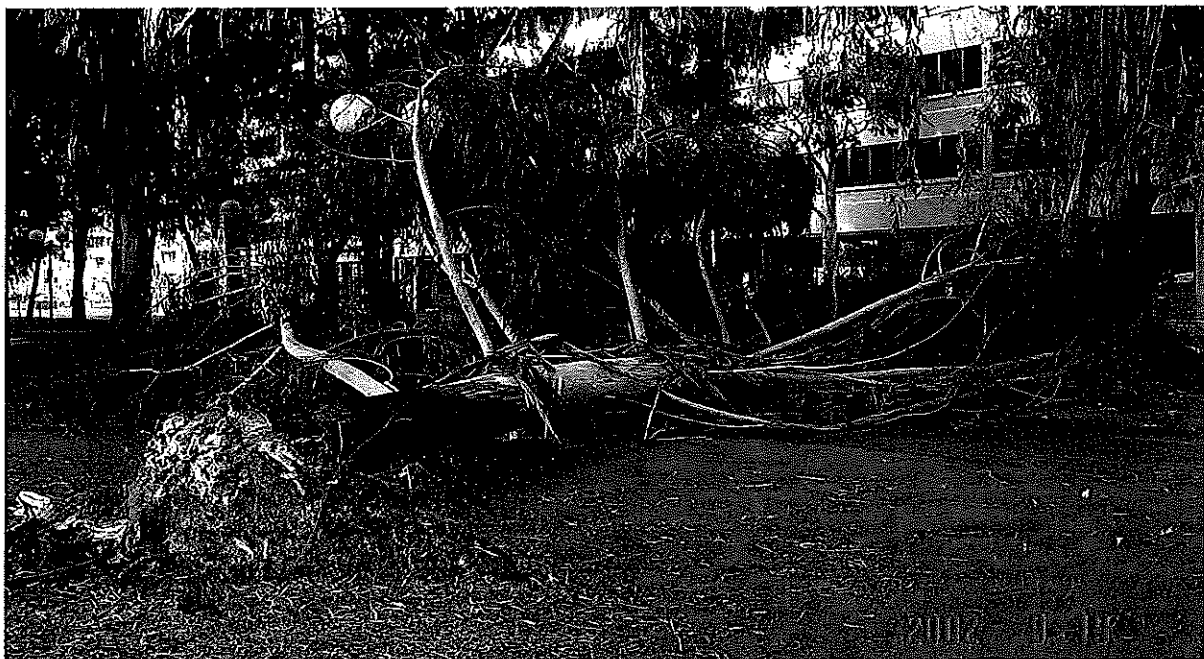
Figure 2: Showing an *E. elata* tree with critical root failure thrown by wind on Northbourne Avenue

Another factor affecting the growth of the *E. elata* trees in the median is a result of the prevailing winds in Canberra coming from the northwest. The tree root systems generally have a bias towards northwest, so there is likely a greater proportion of their root system on the north western side. This means that disturbance to trees along the eastern side of the median may have a greater effect than it would to trees on the western side, as it may be compromising the tree roots that provide structural support which extend towards the construction zone.

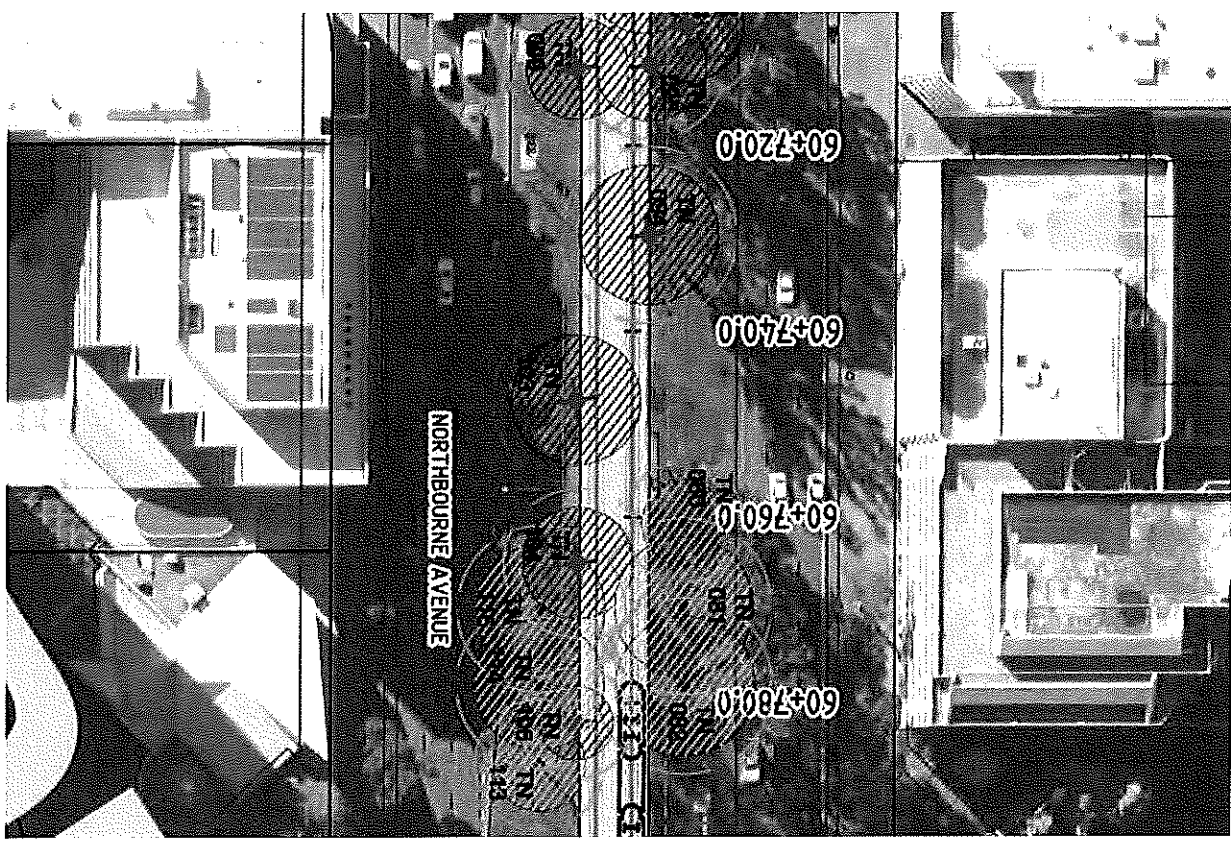
Figure 5: Showing tracks (grey), construction zone offset (orange line) and TPZs (blue circles)

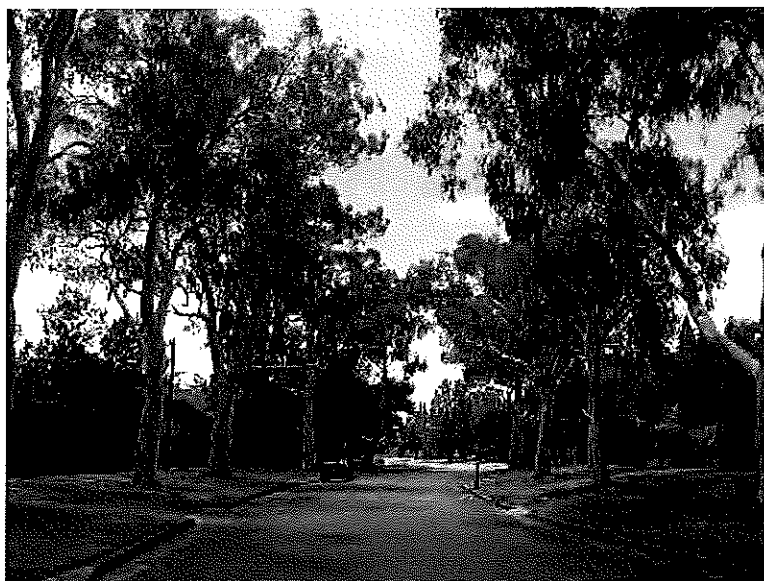
Eucalyptus mannifera – Red spotted gum

Typically the species is found growing on rather poor soils, especially those which contain large amounts of clay, but extends both to lighter podsolics and to shallow and rocky soils.
