## Freedom of Information Publication Coversheet

The [REDACTED] request all editions of the light and noise management plans for Manuka Oval from 2000 including any draft plans under consideration.

This plan replaces the Interim Light Management Plan. Its purpose is to provide an overview of the timing and operations of the sports lights at Manuka Oval and mitigation measures proposed to minimise any adverse effects on residents living in the surrounding area. The plan addresses impacts on the surrounding area and is not concerned with light levels within the venue.

Subject Manuka Oval – Site Lighting Measurements

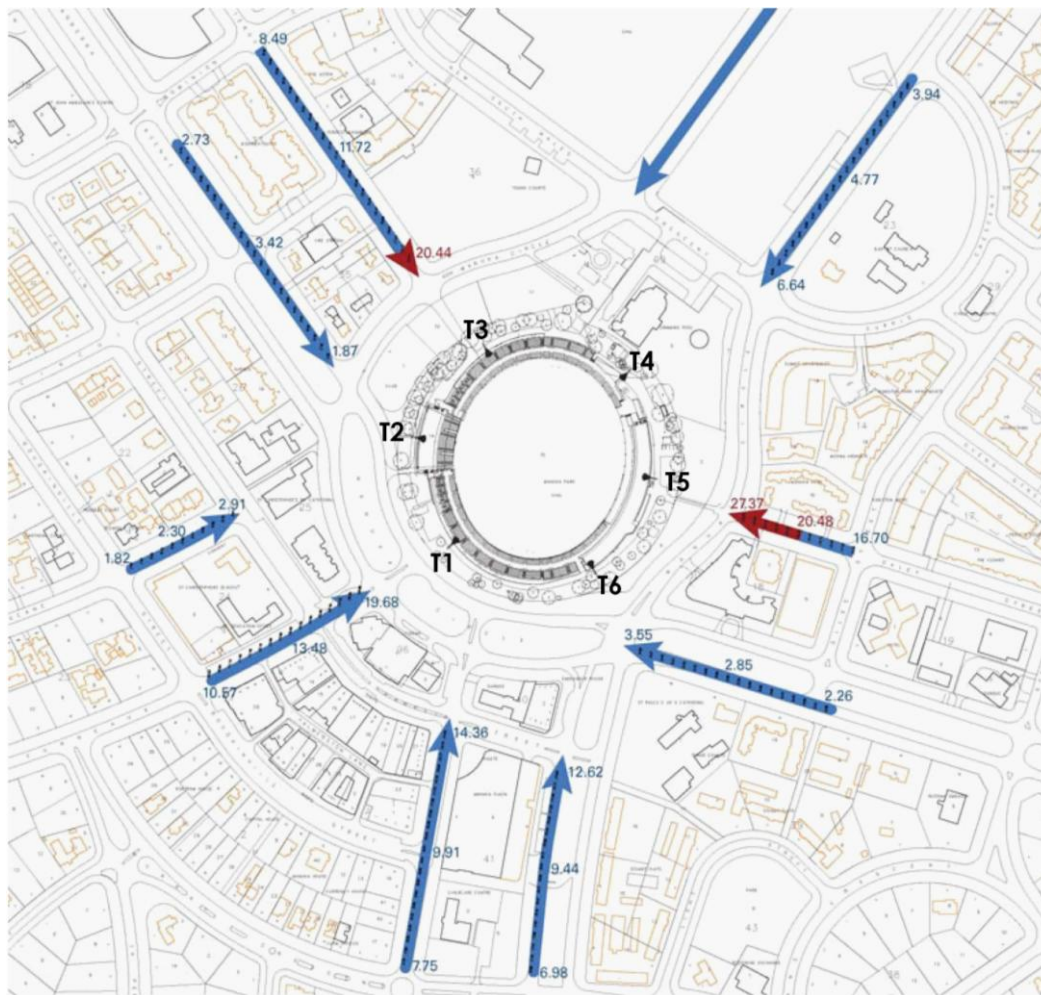
**Figure 1: Glare Levels on Roads Surrounding Manuka Oval**

The assessment of glare when the lights were in broadcast mode identified two locations where glare exceeded the 20% threshold: the intersection of Manuka Circle and Fitzroy Street and the intersection of Manuka Circle and Oxley Street. Glare exceeds the 20% threshold increment along the western part of Oxley Street between Manuka Circle and Giles Street (Figure 1). Other roads surrounding the Oval are not affected by glare when the lights are in broadcast mode.

The glare at the Oxley Street intersection is caused by light from the tower at the rear of the Bradman Stand. A deciduous tree (small tree immediately adjacent to the southern side of the entry to Manuka Circle) screens the lights most of the year (when the tree has leaves). It is estimated that the tree would lower the threshold increment reading below 20% along the extent of Oxley Street shown in red on Figure 1. Therefore glare is unlikely to be an issue in summer.

Based on the above results it is proposed to introduce measures to mitigate the potential effects of glare. Consideration should be given to planting a new evergreen tree near the east gate to shield the intersection. Until such time as a tree has sufficient height to screen the light, it is proposed to close Oxley Street to all but local traffic during winter night-time broadcast games. This traffic management measure is included in the mitigation measures below and has been agreed with RoadsACT. Traffic management measures have already been introduced at along Manuka Circle in the vicinity of Fitzroy Street. These measures will mitigate any effects at this intersection.

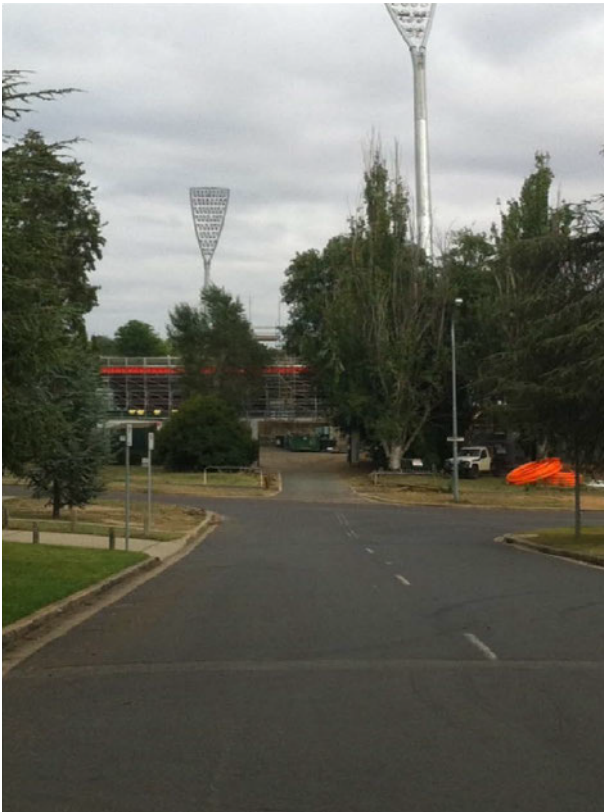
**Figure 9 – View of tower T2 from halfway up Oxley St (near East Hotel)**

Noting that it is not possible to make a site assessment of threshold increment to compare with the recommendations set out in Table 5, informal assessment of potential glare to road users was completed on Oxley St, approaching Manuka Oval's east gate. Cars moving down Oxley St toward the oval have a direct view of tower T2. This could appear glary in the driver's view and impede visibility of the intersection they are approaching (Oxley St and Manuka Circle).

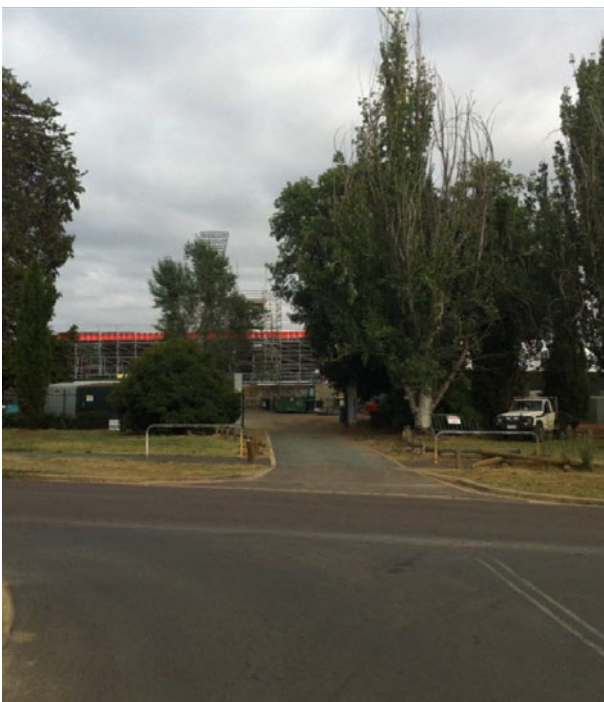
**Figure 10 – Partly obscured view of tower T2 at intersection of Oxley St and Manuka Circle**

Figure 13 shows a view of the tree within Manuka Oval's east gate. This is the same tree as is shown in Figure 10 that provides partial blockage of the tower T2 headframe as seen from the intersection of Manuka Circle and Oxley St. This tree clearly loses its leaves in the winter, reducing the obscuration discussed above regarding glare for drivers on Oxley St. If a new mature tree was to be planted in this area, as was recommended above, it is recommended that this tree should be evergreen to provide year-round protection from glare.

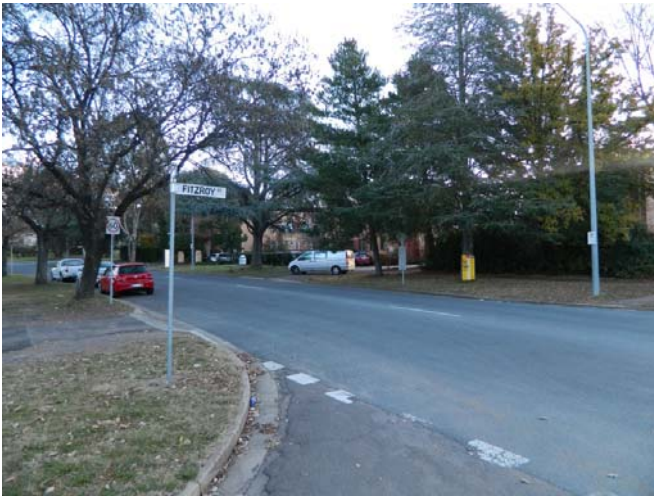
**Figure 11 – Winter tree foliage outside 23-27 Manuka Circle (west of Manuka Oval)**

Figure 11 shows the residences to the west of Manuka Oval, at 23-27 Manuka Circle. Significant foliage is still present on the trees in this area. This indicates that the trees will provide protection from light spill to these properties both in summer and in winter.

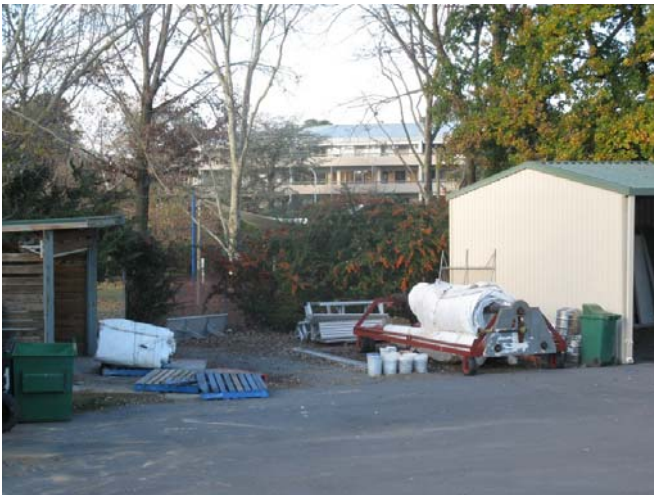
**Figure 12 – Winter tree foliage outside 2 Currie Cres (east of Manuka Oval)**

Figure 12 shows the residences to the east of Manuka Oval, at 2 Currie Cres, as seen from within Manuka Oval near to the scoreboard. This indicates a mixture of foliage, with some trees significantly lacking in leaves, and others in full foliage. Reduced protection from light spill can be expected to these properties in winter, but still some significant protection will be provided. Measurements completed in winter indicate that trees on the east side of Manuka Circle still provide significant shading in the winter.

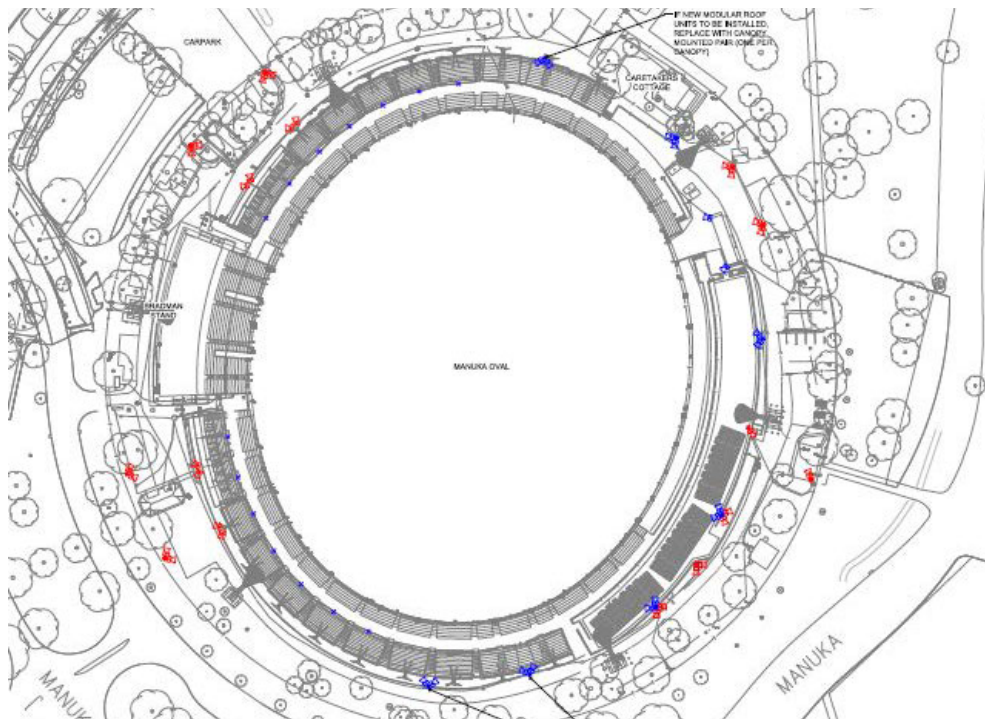
**Figure 2.1** PA system installation [from plans submitted for DA]

The proposed PA system is reproduced in Figure 2.1. There are two separated systems – one to service the seating areas and the other the concourse around the perimeter.

The installation plan is based on the loudspeakers to service the seating areas being located on the underside of the canopies over the seating bays or on poles along the rear row of seats. The distribution of a number of loudspeakers around the oval will ensure good coverage of the seating areas without excessive volume at each loudspeaker. All these loudspeakers are to be selected and positioned so that the sound is focussed onto the seating area with minimal spread outside the target area. The PA should be adjusted so that the sound level at the seating area does not exceed 75 dBA. The set up of the full system to achieve this should be clearly documented and the same procedure followed during the sound checks for all events.

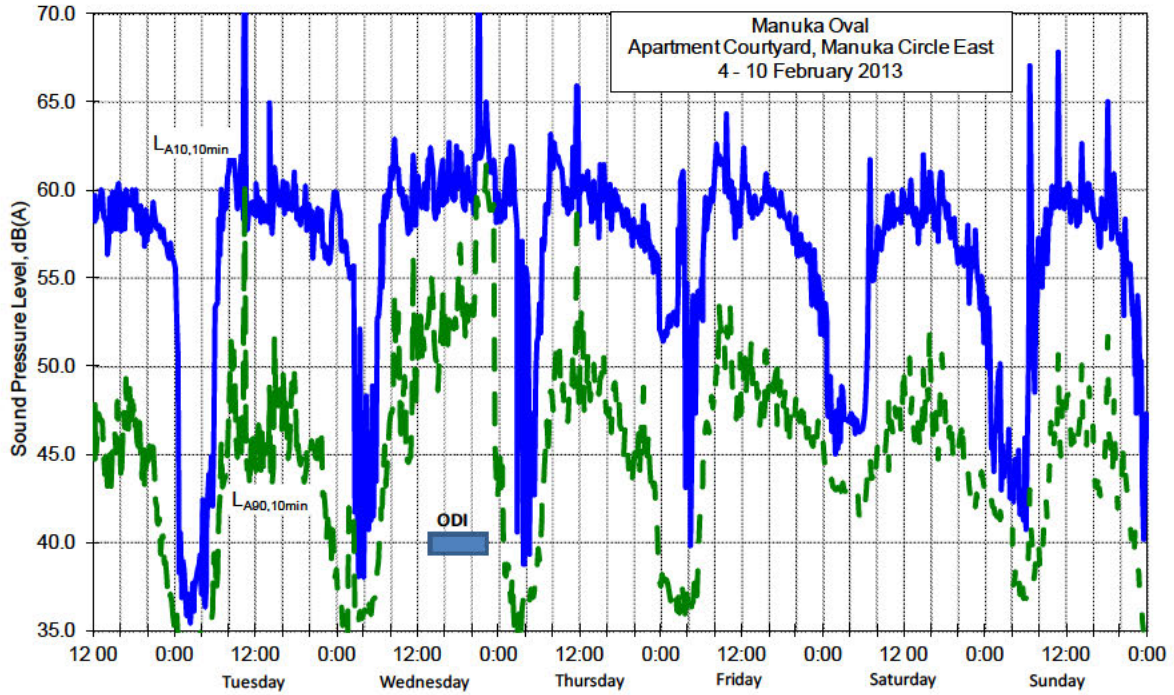
**Figure A2.1** Noise level data at the monitoring location over the week - the ODI was on Wednesday.

In addition to attended monitoring during the ODI, an environmental noise logger was left in location for a week in the residential area to obtain data on the typical noise levels in the area for comparison with the noise levels during the ODI and with the noise zone standards. Figure A2.1 presents the data over the week in terms of the  $L_{A10,10min}$  level exceeded for 10% of each 10 minutes of the placement. This data shows that the  $L_{A10,10min}$  is typically above 60 dBA ( $L_{A10}$ ) till 1800 hrs. Between 1800 and 2200 hours the levels drop to approximately 58 dBA. Thus the noise levels along the eastern boundary are normally more than 10 dB above the noise zone standard of 45 dBA to 2200 hrs.

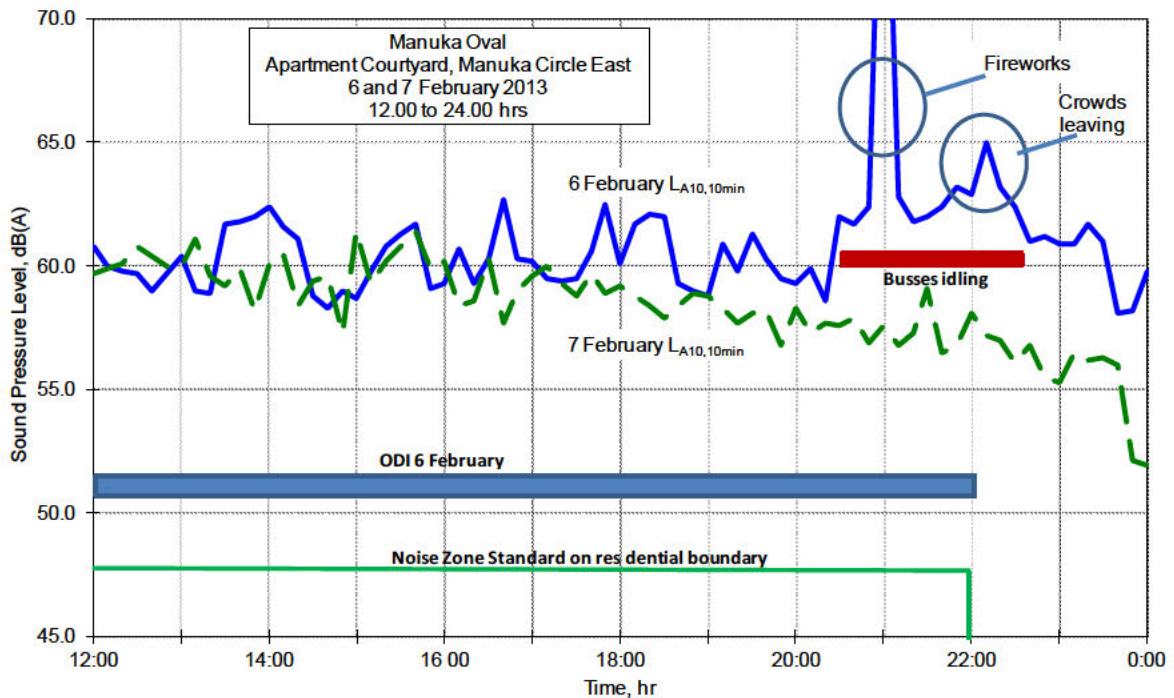
**Figure A2.2** Comparison of the noise level at the monitoring location on the day of the ODI and on the following day.

The effect of the ODI on the noise levels in the area can be more clearly seen in Figure A2.2 which presents a comparison of a 12 hour period of the day of the ODI (6 February) and the day following (7 February). This shows that, except during the time of the fireworks, when the buses were lined up and the crowds leaving, the increase in noise level due to the activity within the venue was less than 5 dB.

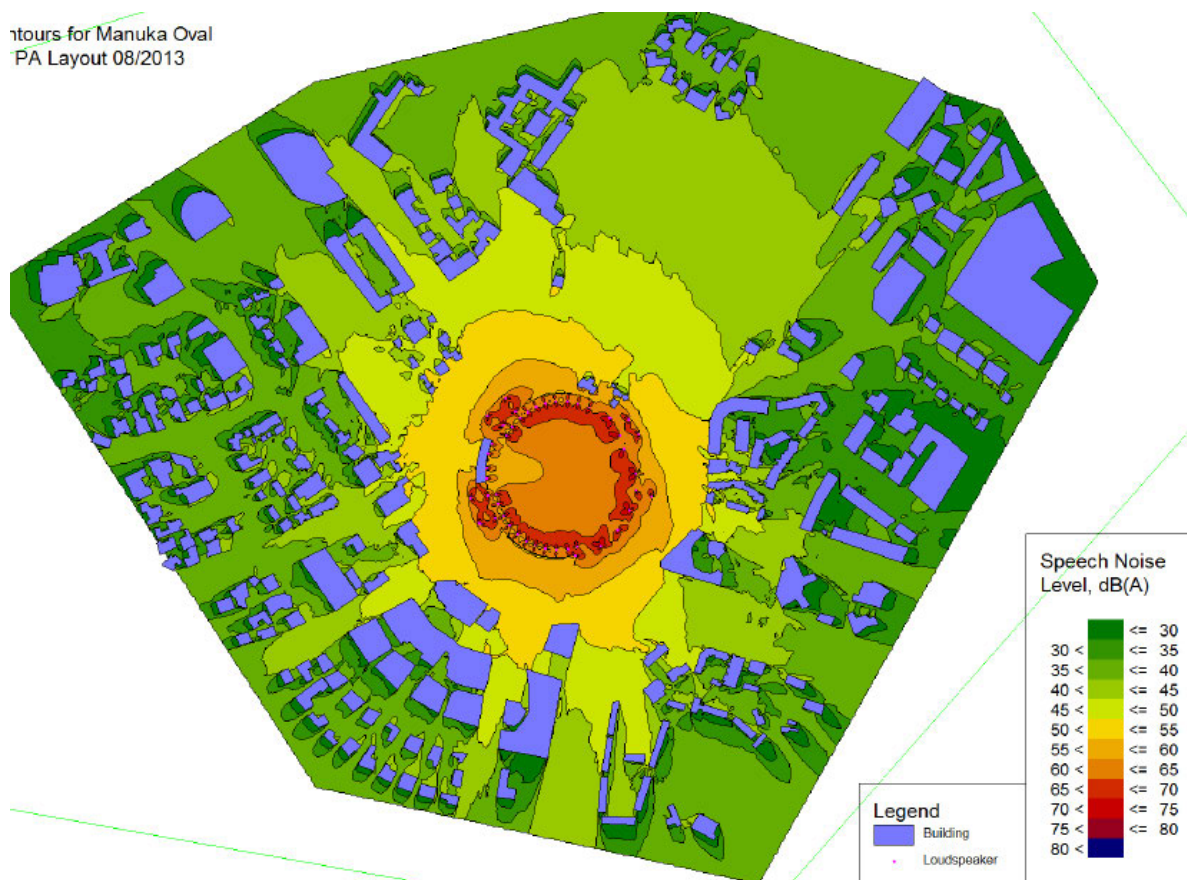
**Figure A2.3** Extract from “Planning Report Statement Against Criteria” of the model of the sound distribution from an indicative layout of the sound system provided by Arup.

As part of the DA 201324118 for further works including a replacement of the Public Address (PA) system, modelling of the sound distribution from the proposed new sound system was undertaken by Arup based on an indicative layout of the new system. Figure A2.3 is an extract from the “Planning Report Statement Against Criteria, August 2013” submitted as part of the DA. This image shows that for noise levels in the vicinity of the new loudspeakers, noise levels of approximately 75 dBA will be less than 60 dBA at the boundary of the residential area to the east of the venue.
