Black Spot Feasibility Study
ACT Department of Territory and
Municipal Services
26 August 2011
Document No. 60216866_RPTRA002_3

Coppins Crossing Road / William Hovell Drive Intersection

Black Spot Feasibility Study
Black Spot Feasibility Study - Coppins Crossing Road / William Hovell Drive
Intersection

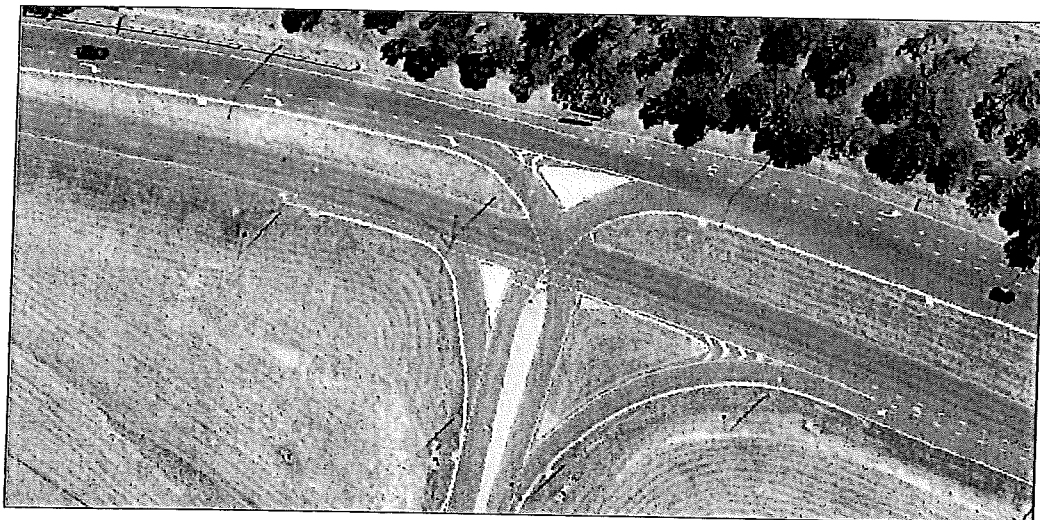
Figure 1 Coppins Crossing Road / William Hovell Drive Intersection

This report is one of twelve studies and presents the findings and recommendations for the intersection of Coppins Crossing Road and William Hovell Drive in Belconnen. The intersection is shown in Figure 1.

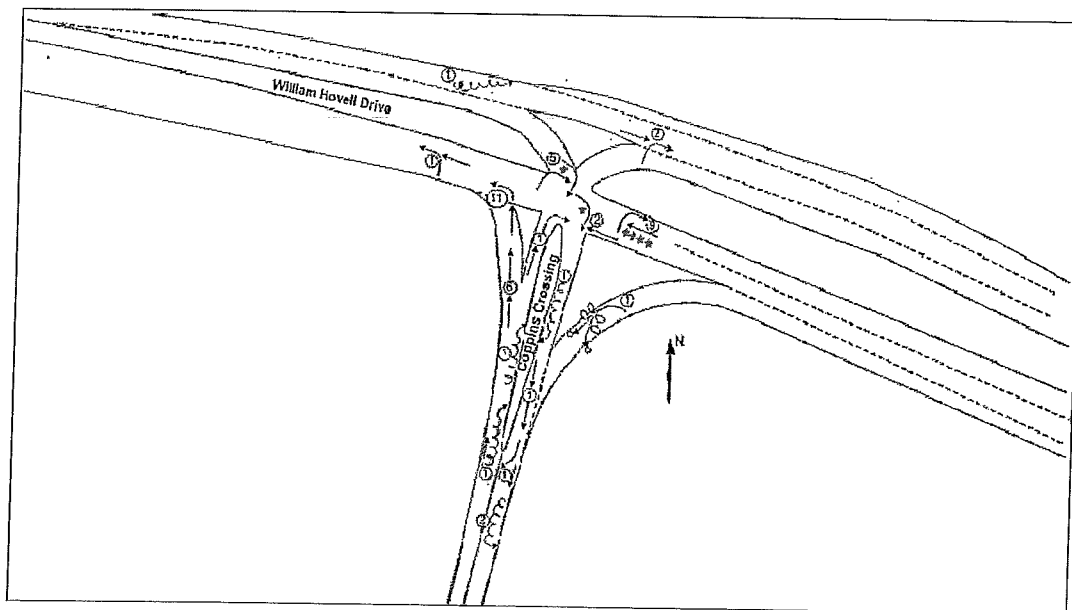
Figure 2 Crash Diagram

A crash diagram has been prepared for the intersection and is shown below in Figure 2.

★: Number of injury crashes

Analysis of the crash diagram reveals the following:

- The majority of adjacent approach (right angle) crashes involved right turn movements out of Coppins Crossing Road.
- All rear end crashes (19) occurred on Coppins Crossing Road.
- Most of single vehicle crashes occurred on Coppins Crossing Road.
- On southbound Coppins Crossing Road there were a number of crashes involving single vehicles out of control, rear end and overtaking crashes. This indicates that there may be an issue with merging lane on this approach.

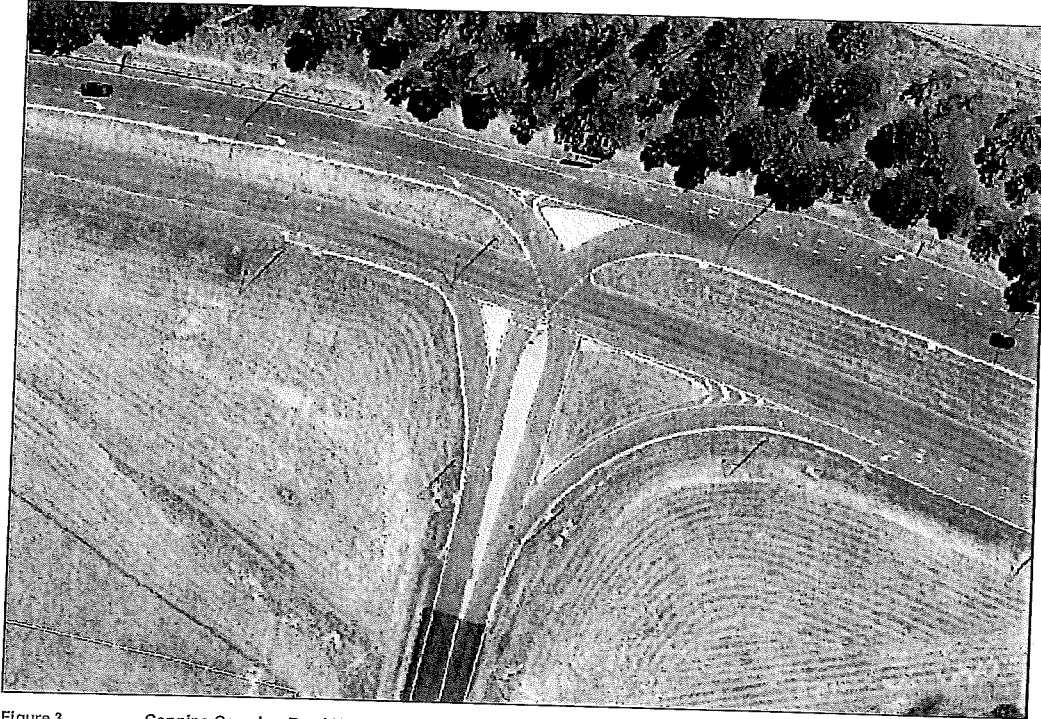
Figure 3 Coppins Crossing Road / William Hovell Drive Intersection

The intersection is a typical rural t-intersection with raised concrete median and raised traffic islands on the terminating Coppins Crossing Road leg. This treatment is called a seagull arrangement. There has been considerable benching to improve sight distance for traffic exiting Coppins Crossing Road.

The road geometry on William Hovell Drive is appropriate for an arterial road carrying heavy volumes. The geometry on Coppins Crossing Road is consistent with a lower order road. It has some curves with advisory speeds indicating a lower design standard. It will need to be upgraded to meet the increased demand as the new town of Molonglo is developed.

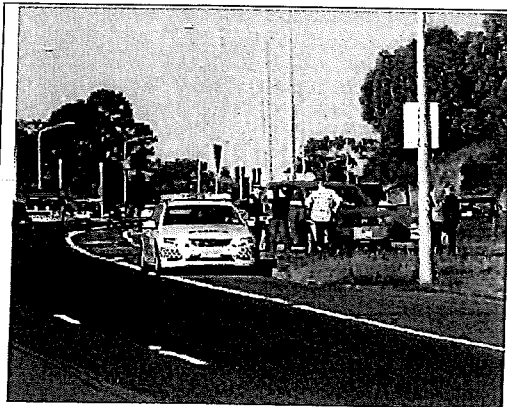
A right angle crash involving a right turn out of Coppins Crossing Road and through movement on William Hovell Drive occurred immediately prior to the site visit.

One option would be to reduce the speed limit on William Hovell Drive from the current 90 km/h to 80 km/h. Slowing oncoming traffic would give turning drivers more time to cross, once they have identified gaps in through traffic, and reduce braking distance and the force encountered during right-angle crashes. This may not be popular with users as the road is considered to be performing a peripheral freeway function.

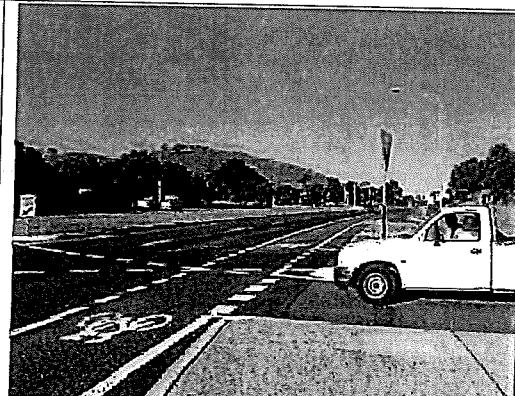
Sight distance is adequate at the intersection; however the drivers may misjudge the gap due to frustration caused by difficulty finding a safe gap.

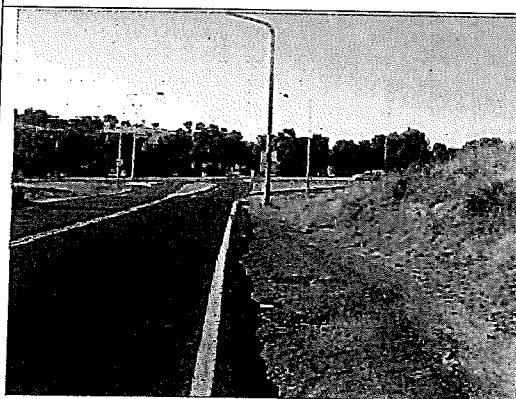
The road shoulder pavement on Coppins Crossing Road has eroded and needs to be reconstructed.

- The wind eroded shoulder on Coppins Crossing Road should be repaired
- The damaged sump on Coppins Crossing Road should be repaired

• Replace speed limit signs on William Hovell Drive	\$20,000
• Repair wind eroded shoulder on Coppins Crossing Road	\$15,000
• Repair damaged sump on Coppins Crossing Road	\$5,000

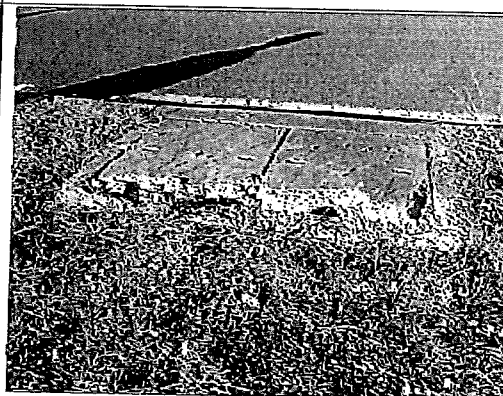
Trucks and other vehicles turning left out of Coppins Crossing Road may have jumped the kerb due to frustration caused by delays.

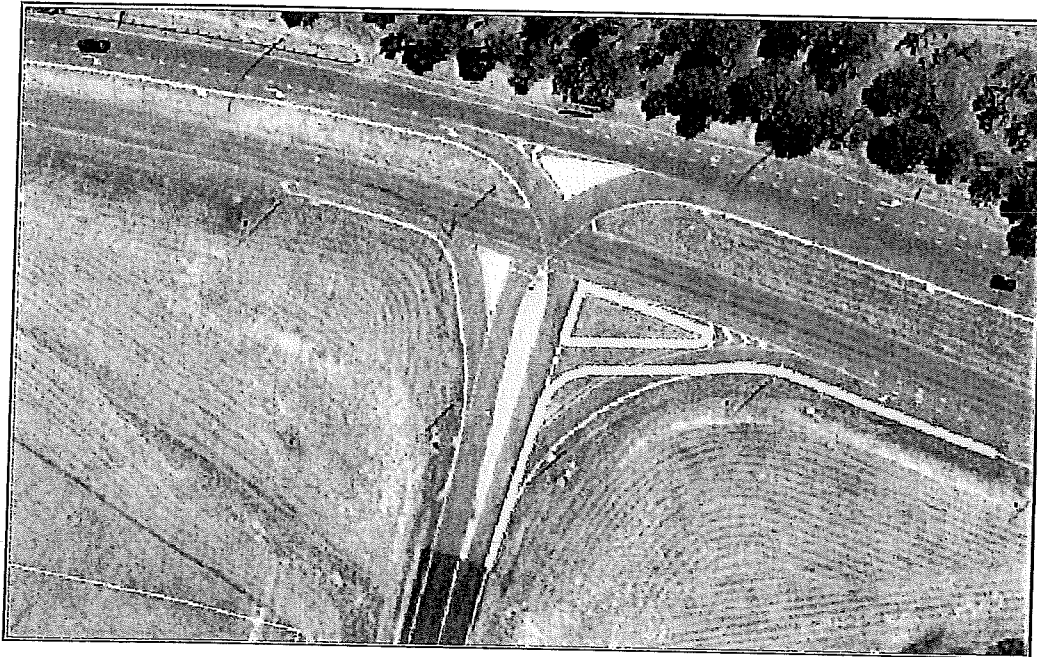
Figure 4 Option 2 – Modify Left Turn Lane from Wm Hovell Drive to 70°

Option 2 is the modification of the sweeping left hand curve to the more current design with a 70° approach angle. This arrangement allows a driver to view the approaching movement safely from the hold line.

The current geometry of the left turn from William Hovell Drive westbound to Coppins crossing Road is a very generous smooth sweeping curve of approximately 45 metres radius. This has the potential to increase speed and not provide for a good right hand view of the traffic into which this movement must merge. It was designed for a merge on entry which can work well especially with low traffic volumes.

This measure will slow the left turn traffic from westbound William Hovell Drive and improve their ability to recognise a potential conflict with the right turn traffic from eastbound William Hovell Drive, and is expected to have the following impact on crash frequency:

- This option should reduce rear-end crashes (crash codes 301-304) by 50%², and should also reduce merging (codes 305-307) and single-vehicle crashes (701-805) on southbound Coppins Crossing Road by 50%.

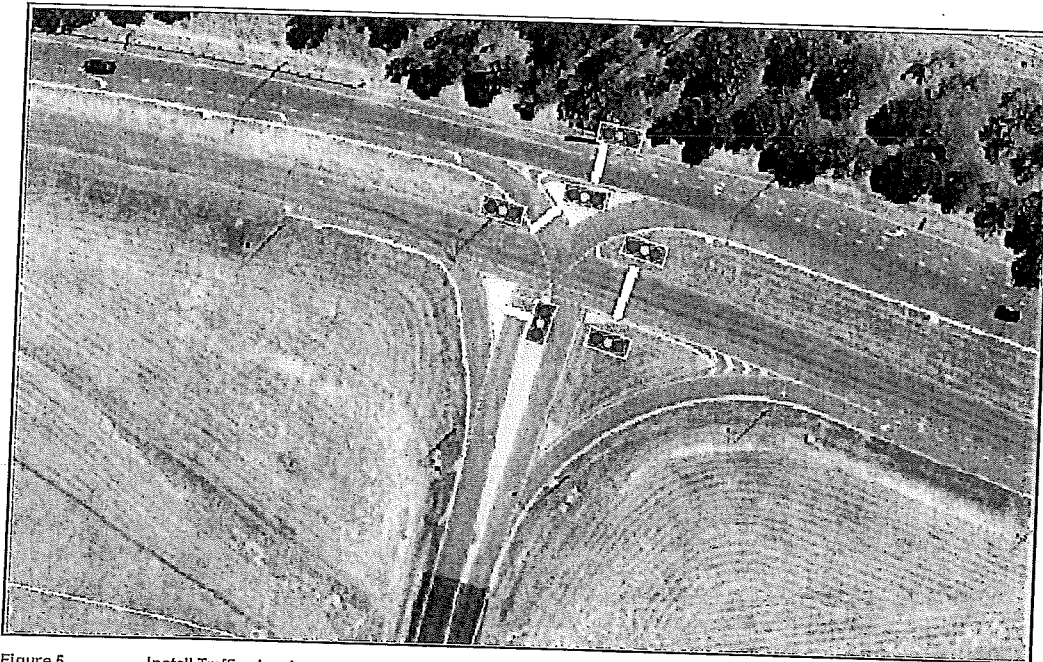
Figure 5 Install Traffic signals

Option 3 is the installation of traffic signals. Due to the closeness of the adjacent signals at Coulter Drive, these two signals would need to be permanently linked. It is not envisaged that there is a need to significantly alter the current kerb layout.

The installation of traffic signals will control most of the movements and will reduce the number of right angle crashes. The installation of traffic signals will typically increase the number of rear end crashes on the approaches controlled by the signals.

Because this intersection is so close to the signalised intersection of Coulter Drive and William Hovell Drive, they both need to be co-ordinated. This has the potential to increase delays on the existing signalised intersection.
