# Canberra Brickworks and Environs Planning Strategy

## SUMMARY REPORT

Prepared by:  
**Elton Consulting**

Prepared for:  
**ACT Land Development Agency**

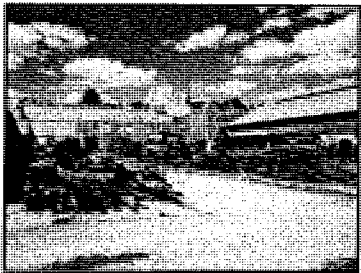
There is a mixture of areas with concrete flooring located between the kilns and sheds. Again, some of these areas are on different levels.

The gravel area situated on the south western perimeter of the building is generally level in contour.

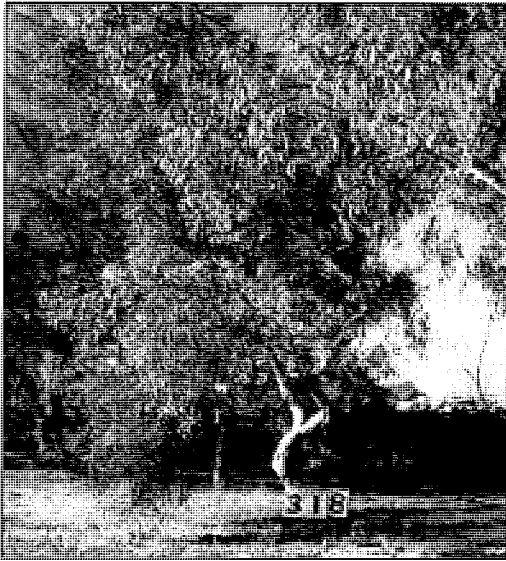
<b>TREE NUMBER</b>	<b>318</b>
--------------------	------------

<b>QUALITY CLASSIFICATION</b>	
Regulated Tree	N
Arboricultural Assessment	M
Urban Amenity Assessment	M
<b>Recommendation:</b>	
Retain and Manage	x
Remove

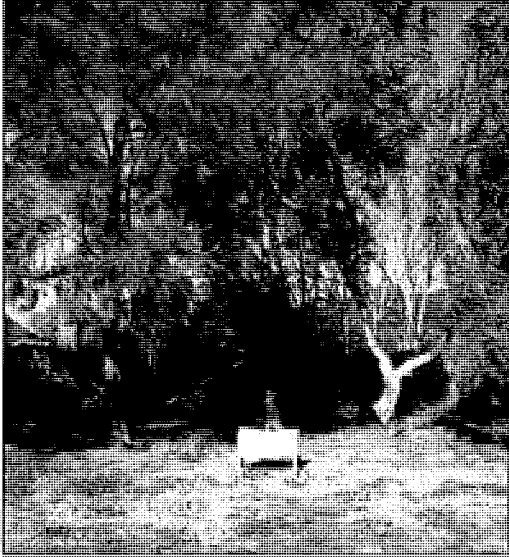
<b>TREE NUMBER</b>	<b>319</b>
--------------------	------------

<b>QUALITY CLASSIFICATION</b>	
Regulated Tree	N
Arboricultural Assessment	M
Urban Amenity Assessment	M
<b>Recommendation:</b>	
Retain and Manage	X
Remove

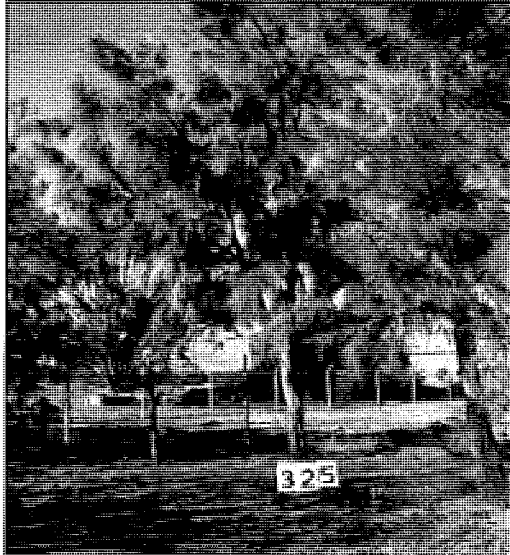
<b>TREE NUMBER</b>	<b>325</b>
--------------------	------------

<b>QUALITY CLASSIFICATION</b>	
Regulated Tree	N
Arboricultural Assessment	M
Urban Amenity Assessment	M
<b>Recommendation:</b>	
Retain and Manage	X
Remove

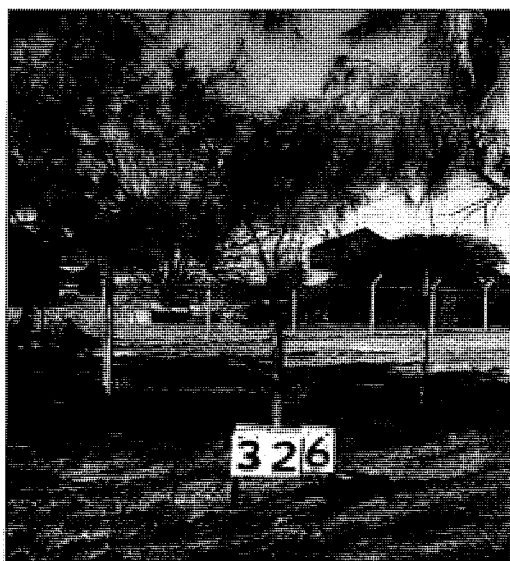
DATA	
Assessment Date:	12/07/10
Assessor:	HS
Tree Location: Old Canberra Brick Works	
E:	N
Species: Casuarina Cunninghiana	
Height:	5
Canopy Spread:	3
Trunk Circumference:	300
Number of Trunks:	1

TREE PROTECTION / MANAGEMENT	
Tree Protection Zone	1
Potential to Reduce Risk	1
Potential to Improve Amenity Value	1

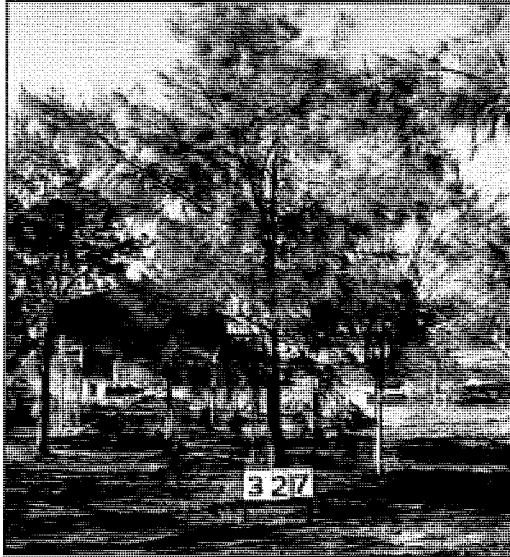
<b>TREE NUMBER</b>	<b>327</b>
--------------------	------------

<b>QUALITY CLASSIFICATION</b>	
Regulated Tree	N
Arboricultural Assessment	M
Urban Amenity Assessment	M
<b>Recommendation:</b>	
Retain and Manage	X
Remove

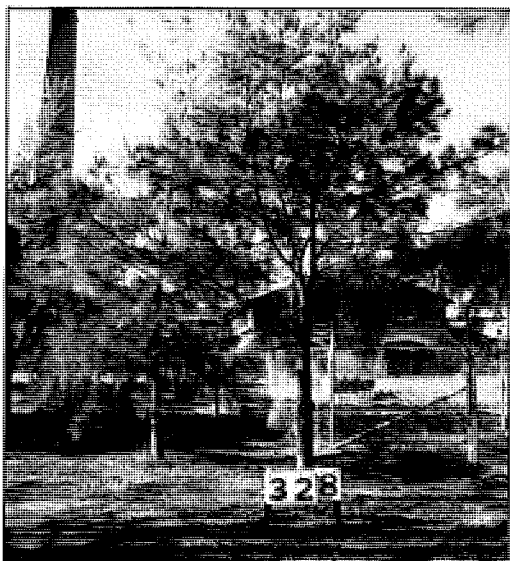
<b>TREE NUMBER</b>	<b>328</b>
--------------------	------------

<b>QUALITY CLASSIFICATION</b>	
Regulated Tree	N
Arboricultural Assessment	M
Urban Amenity Assessment	M
<b>Recommendation:</b>	
Retain and Manage	X
Remove

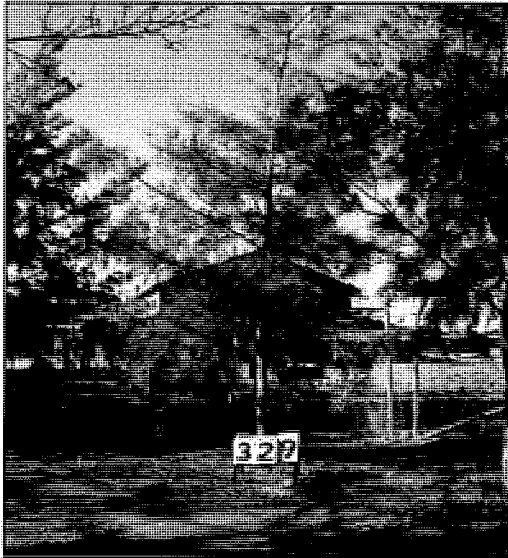
<b>TREE NUMBER</b>	<b>329</b>
--------------------	------------

<b>QUALITY CLASSIFICATION</b>	
Regulated Tree	N
Arboricultural Assessment	M
Urban Amenity Assessment	M
<b>Recommendation:</b>	
Retain and Manage	X
Remove

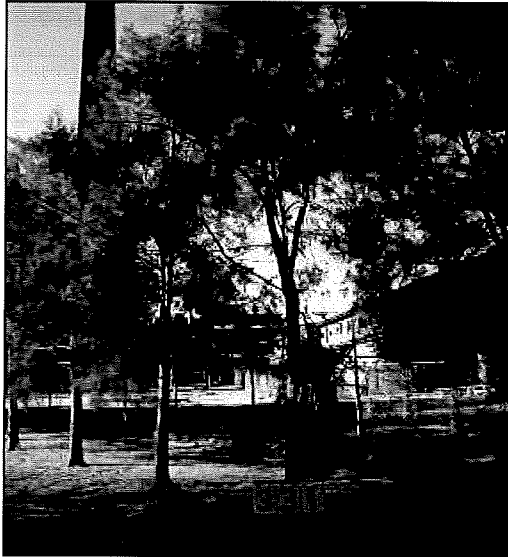
<b>TREE NUMBER</b>	<b>331</b>
--------------------	------------

<b>QUALITY CLASSIFICATION</b>	
Regulated Tree	N
Arboricultural Assessment	M
Urban Amenity Assessment	M
<b>Recommendation:</b>	
Retain and Manage	X
Remove

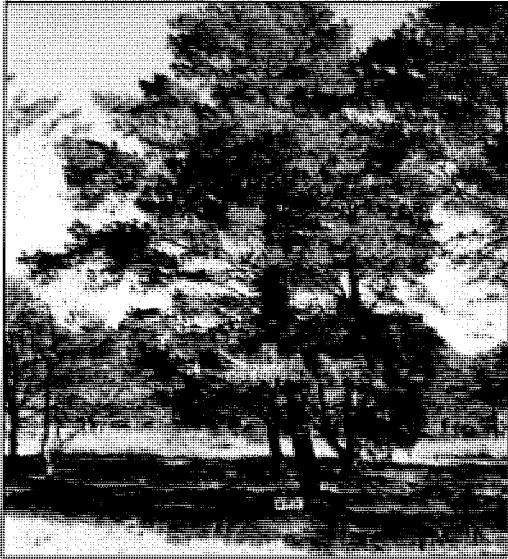
DATA	
Assessment Date:	12/07/10
Assessor:	HS
Tree Location: Old Canberra Brick Works	
E:	N
Species: Pinus radiata	
Height:	23
Canopy Spread:	14
Trunk Circumference:	2200
Number of Trunks:	1

TREE PROTECTION / MANAGEMENT	
Tree Protection Zone	1
Potential to Reduce Risk	2
Potential to Improve Amenity Value	2

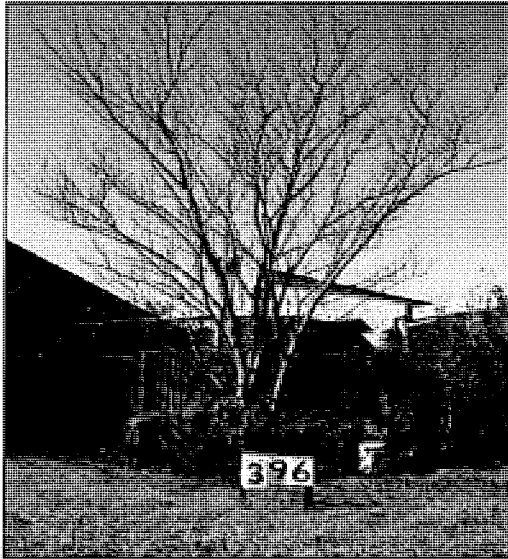
<b>TREE NUMBER</b>	<b>396</b>
--------------------	------------

<b>QUALITY CLASSIFICATION</b>	
Regulated Tree	Y
Arboricultural Assessment	M
Urban Amenity Assessment	M
<b>Recommendation:</b>	
Retain and Manage	X
Remove

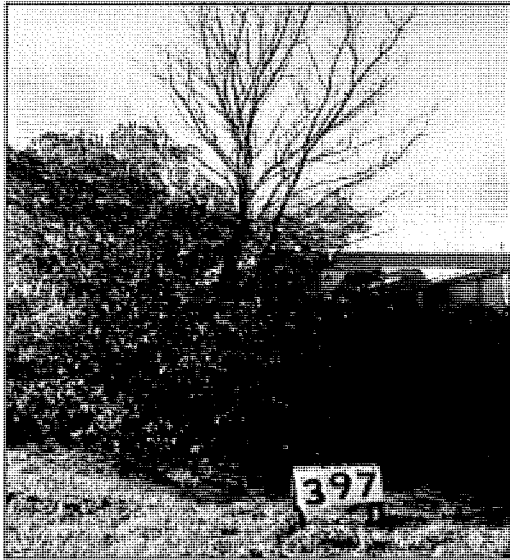
<b>TREE NUMBER</b>	<b>397</b>
--------------------	------------

<b>QUALITY CLASSIFICATION</b>	
Regulated Tree	N
Arboricultural Assessment	M
Urban Amenity Assessment	M
<b>Recommendation:</b>	
Retain and Manage	X
Remove

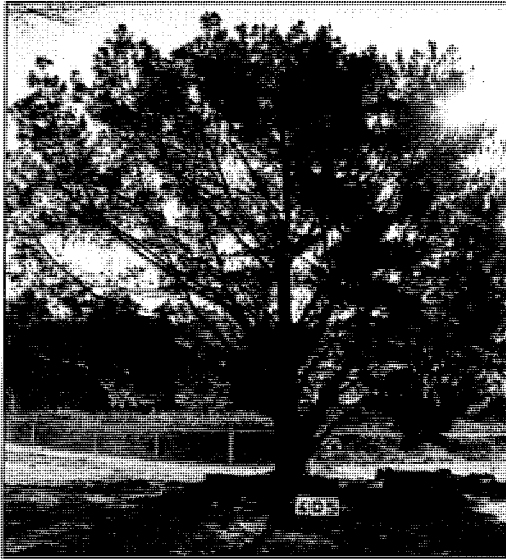
DATA	
Assessment Date:	12/07/10
Assessor:	HS
Tree Location: South of Brick Works	
E:	N
Species: Pinus radiata	
Height:	16.5
Canopy Spread:	14
Trunk Circumference:	3100
Number of Trunks:	1

TREE PROTECTION / MANAGEMENT	
Tree Protection Zone	1
Potential to Reduce Risk	2
Potential to Improve Amenity Value	2

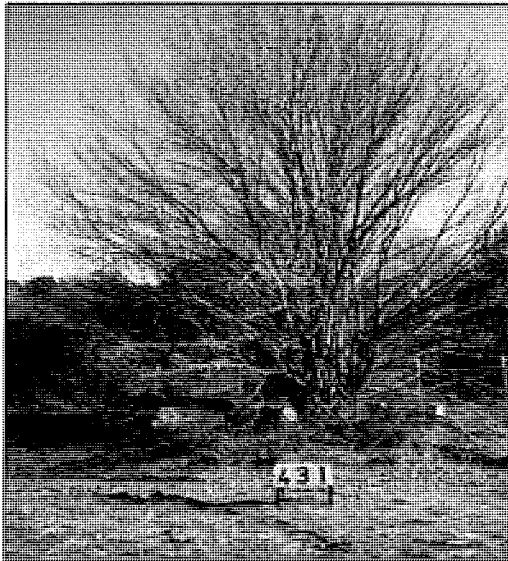
<b>TREE NUMBER</b>	<b>431</b>
--------------------	------------

<b>QUALITY CLASSIFICATION</b>	
Regulated Tree	Y
Arboricultural Assessment	P
Urban Amenity Assessment	M
<b>Recommendation:</b>	
<b>Retain and Manage</b>	
<b>Remove</b>	X

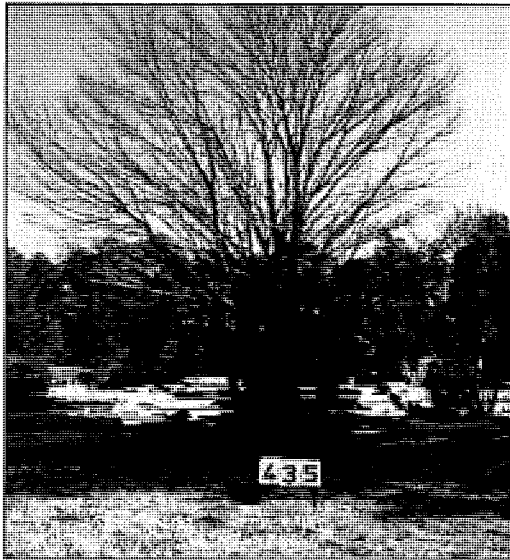
<b>TREE NUMBER</b>	<b>435</b>
--------------------	------------

<b>QUALITY CLASSIFICATION</b>	
Regulated Tree	Y
Arboricultural Assessment	M
Urban Amenity Assessment	M
<b>Recommendation:</b>	
Retain and Manage	X
Remove

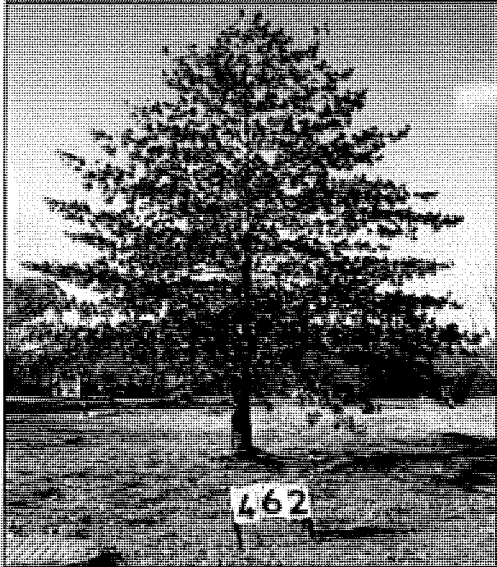
<b>TREE NUMBER</b>	<b>462</b>
--------------------	------------

<b>QUALITY CLASSIFICATION</b>	
Regulated Tree	N
Arboricultural Assessment	H
Urban Amenity Assessment	H
<b>Recommendation:</b>	
Retain and Manage	X
Remove

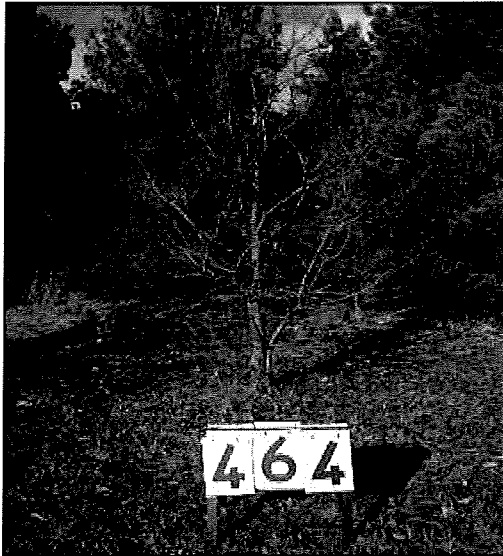
<b>TREE NUMBER</b>	<b>464</b>
--------------------	------------

<b>QUALITY CLASSIFICATION</b>	
Regulated Tree	N
Arboricultural Assessment	H
Urban Amenity Assessment	H
<b>Recommendation:</b>	
Retain and Manage	X
Remove

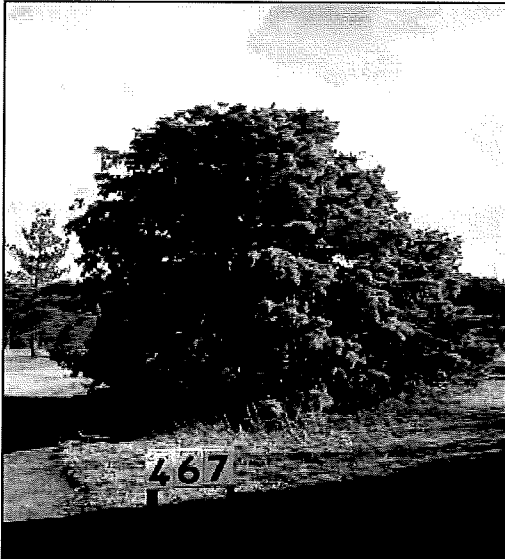
<b>TREE NUMBER</b>	<b>467</b>
--------------------	------------

<b>QUALITY CLASSIFICATION</b>	
Regulated Tree	Y
Arboricultural Assessment	H
Urban Amenity Assessment	M
<b>Recommendation:</b>	
Retain and Manage	X
Remove

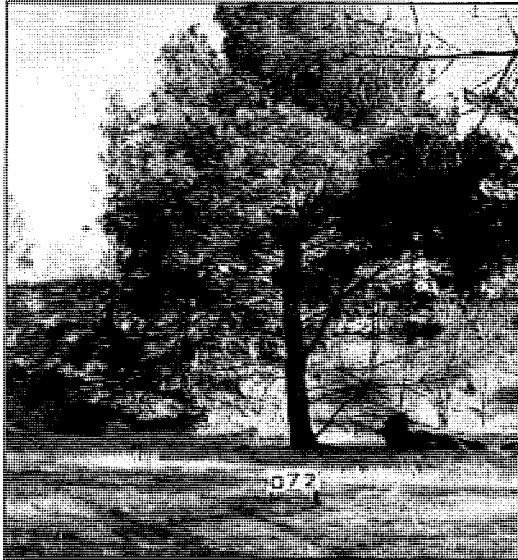
<b>TREE NUMBER</b>	<b>72</b>
--------------------	-----------

<b>QUALITY CLASSIFICATION</b>	
Regulated Tree	Y
Arboricultural Assessment	M
Urban Amenity Assessment	H
<b>Recommendation:</b>	
Retain and Manage	X
Remove

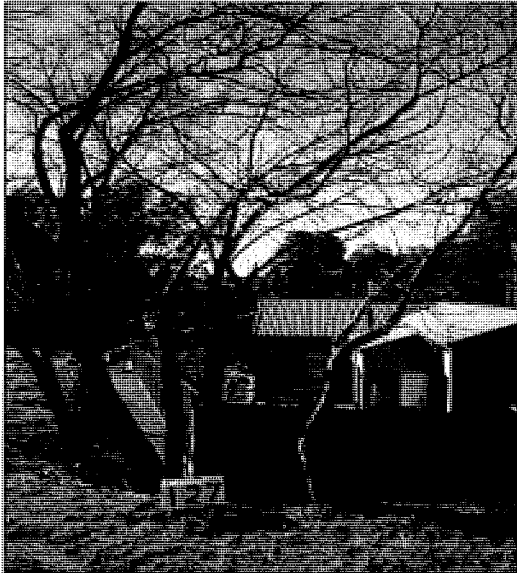
<b>TREE NUMBER</b>	<b>127</b>
--------------------	------------

<b>QUALITY CLASSIFICATION</b>	
Regulated Tree	N
Arboricultural Assessment	P
Urban Amenity Assessment	P
<b>Recommendation:</b>	
<b>Retain and Manage</b>	
<b>Remove</b>	x

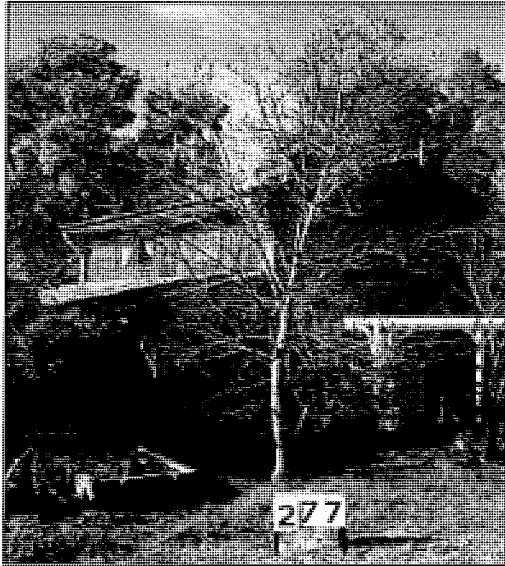
<b>TREE NUMBER</b>	<b>277</b>
--------------------	------------

<b>QUALITY CLASSIFICATION</b>	
Regulated Tree	N
Arboricultural Assessment	H
Urban Amenity Assessment	M
<b>Recommendation:</b>	
Retain and Manage	X
Remove

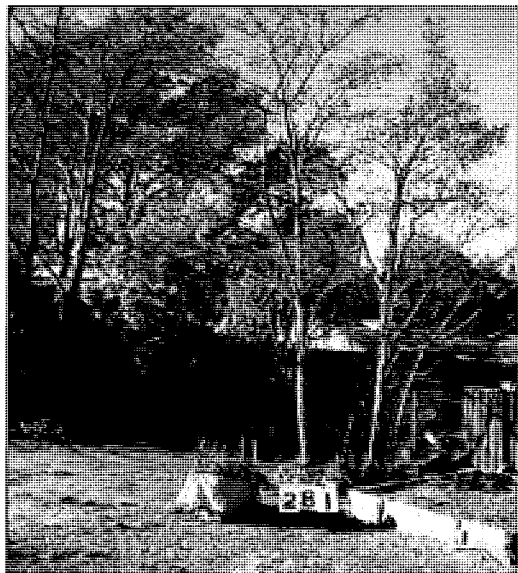
<b>TREE NUMBER</b>	<b>281</b>
--------------------	------------

<b>QUALITY CLASSIFICATION</b>	
Regulated Tree	N
Arboricultural Assessment	M
Urban Amenity Assessment	M
<b>Recommendation:</b>	
Retain and Manage	X
Remove

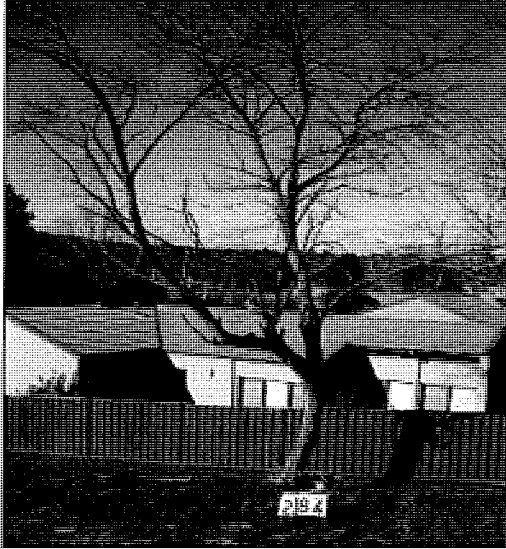
<b>TREE NUMBER</b>	<b>284</b>
--------------------	------------

<b>QUALITY CLASSIFICATION</b>	
Regulated Tree	Y
Arboricultural Assessment	M
Urban Amenity Assessment	M
<b>Recommendation:</b>	
Retain and Manage	
Remove	x

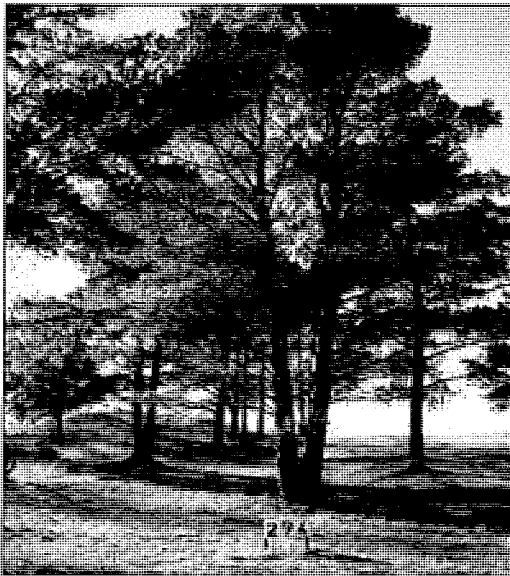
DATA	
Assessment Date:	12/07/10
Assessor:	HS
Tree Location: Brick Works Quarry	
E:	N
Species: Pinus radiata	
Height:	17.5
Canopy Spread:	13
Trunk Circumference:	1300
Number of Trunks:	2

TREE PROTECTION / MANAGEMENT	
Tree Protection Zone	1
Potential to Reduce Risk	3
Potential to Improve Amenity Value	3

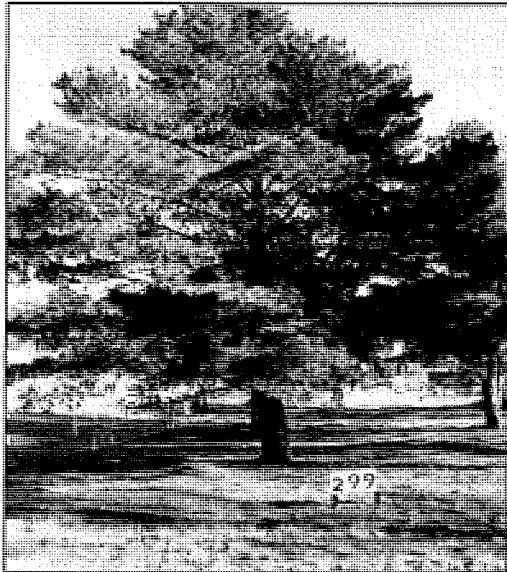
<b>TREE NUMBER</b>	<b>299</b>
--------------------	------------

<b>QUALITY CLASSIFICATION</b>	
Regulated Tree	Y
Arboricultural Assessment	H
Urban Amenity Assessment	H
<b>Recommendation:</b>	
Retain and Manage	X
Remove

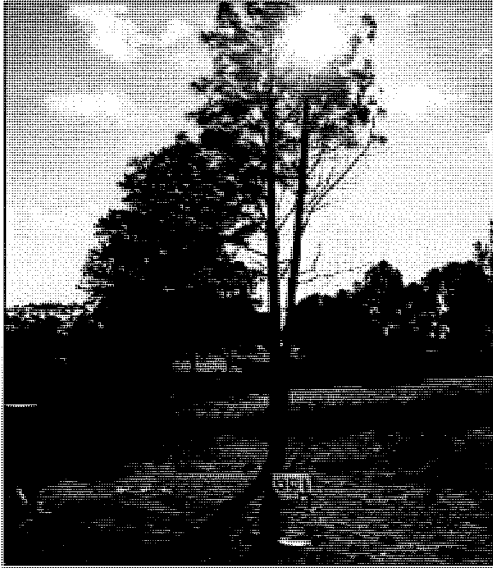
<b>TREE NUMBER</b>	<b>556</b>
--------------------	------------

<b>QUALITY CLASSIFICATION</b>	
Regulated Tree	Y
Arboricultural Assessment	P
Urban Amenity Assessment	P
<b>Recommendation:</b>	
Retain and Manage	
Remove	X

<b>ARBORICULTURAL CHARACTERISTICS</b>	
Canopy Density	2
Canopy Dead Wood	3
Insect Occurrence	3
Disease	3
Epicormic Growth	3
Mistletoe	3
Form	2
Age	2
Habitat Value	3
Disturbance Tolerance	2
Risk Potential	2
Health / Condition	2

<b>ARBORICULTURAL NOTES</b>
Tree was missing on original assessment hence the 001 TREE 556 Badly formed tree removal recommended

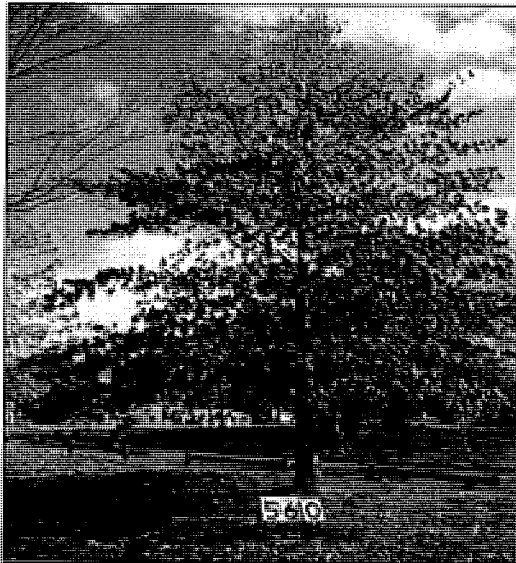
<b>TREE NUMBER</b>	<b>560</b>
--------------------	------------

<b>QUALITY CLASSIFICATION</b>	
Regulated Tree	N
Arboricultural Assessment	H
Urban Amenity Assessment	E
<b>Recommendation:</b>	
Retain and Manage	X
Remove

<b>ARBORICULTURAL CHARACTERISTICS</b>	
Canopy Density	3
Canopy Dead Wood	3
Insect Occurrence	3
Disease	3
Epicormic Growth	3
Mistletoe	3
Form	4
Age	2
Habitat Value	3
Disturbance Tolerance	2
Risk Potential	3
Health / Condition	4

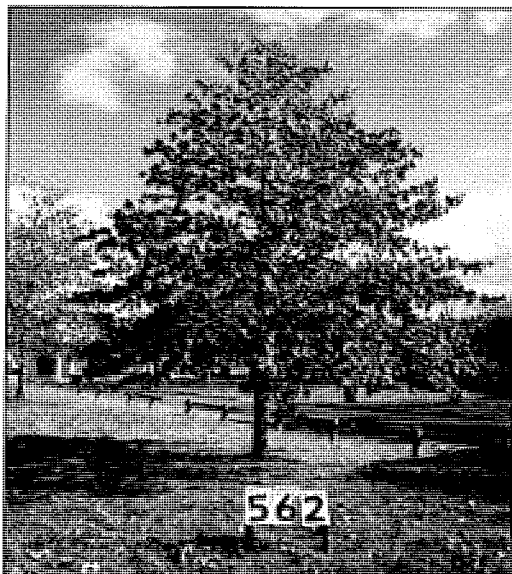
<b>TREE NUMBER</b>	<b>562</b>
--------------------	------------

<b>QUALITY CLASSIFICATION</b>	
Regulated Tree	N
Arboricultural Assessment	H
Urban Amenity Assessment	E
<b>Recommendation:</b>	
Retain and Manage	X
Remove

<b>ARBORICULTURAL CHARACTERISTICS</b>	
Canopy Density	3
Canopy Dead Wood	3
Insect Occurrence	3
Disease	3
Epicormic Growth	3
Mistletoe	3
Form	4
Age	2
Habitat Value	3
Disturbance Tolerance	2
Risk Potential	3
Health / Condition	4

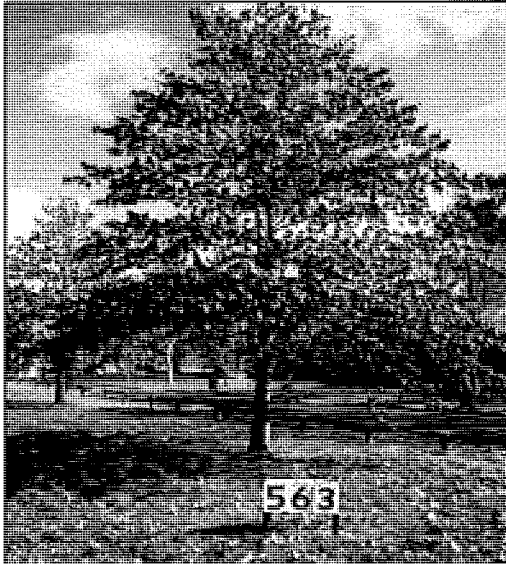
<b>TREE NUMBER</b>	<b>563</b>
--------------------	------------

<b>QUALITY CLASSIFICATION</b>	
Regulated Tree	N
Arboricultural Assessment	H
Urban Amenity Assessment	E
<b>Recommendation:</b>	
Retain and Manage	X
Remove

<b>ARBORICULTURAL CHARACTERISTICS</b>	
Canopy Density	3
Canopy Dead Wood	3
Insect Occurrence	3
Disease	3
Epicormic Growth	3
Mistletoe	3
Form	4
Age	2
Habitat Value	3
Disturbance Tolerance	2
Risk Potential	3
Health / Condition	4

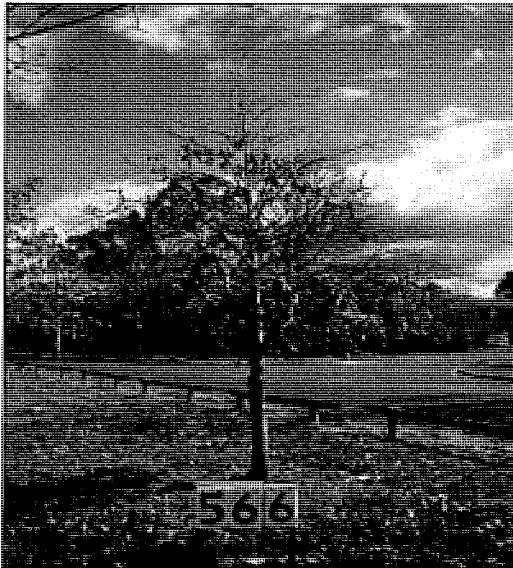
<b>TREE NUMBER</b>	<b>566</b>
--------------------	------------

<b>QUALITY CLASSIFICATION</b>	
Regulated Tree	N
Arboricultural Assessment	M
Urban Amenity Assessment	E
<b>Recommendation:</b>	
Retain and Manage	X
Remove

<b>ARBORICULTURAL CHARACTERISTICS</b>	
Canopy Density	3
Canopy Dead Wood	3
Insect Occurrence	3
Disease	3
Epicormic Growth	3
Mistletoe	3
Form	3
Age	2
Habitat Value	3
Disturbance Tolerance	2
Risk Potential	3
Health / Condition	2

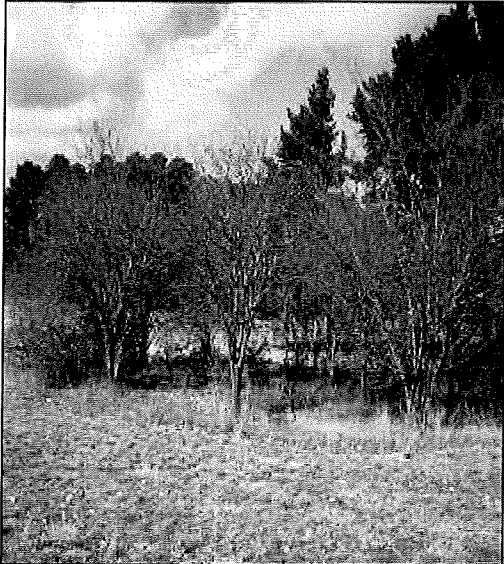
Opposite 18-20 Denman St  
Yarralumla

Assessment Date:	23/07/10
Assessor:	HS
Tree Location: Dudley St West	
E:	N
Species: Prunus cerasifera "nigra"	
Height:	5-8
Canopy Spread:	3-6
Trunk Circumference:	400-1000
Number of Trunks:	Multiple

Canopy Density	3
Canopy Dead Wood	3
Insect Occurrence	3
Disease	3
Epicormic Growth	3
Mistletoe	3
Form	4
Age	2
Habitat Value	3
Disturbance Tolerance	1
Risk Potential	3
Health / Condition	3

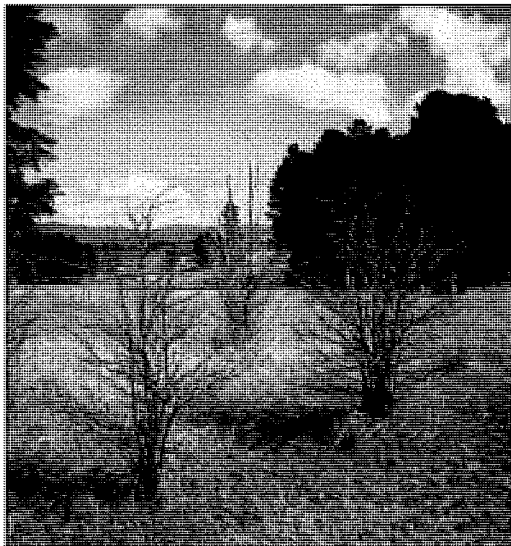
Opposite 12 Denman St Yarralumla

DATA	
Assessment Date:	23/07/10
Assessor:	HS
Tree Location: Dudley St West	
E:	N
Species: Crataegus smithiana	
Height:	1.5-2
Canopy Spread:	1-3
Trunk Circumference:	200-600
Number of Trunks:	Multiple

QUALITY CLASSIFICATION	
Regulated Tree	N
Arboricultural Assessment	P
Urban Amenity Assessment	P
Recommendation:	
Retain and Manage	
Remove	X

ARBORICULTURAL CHARACTERISTICS	
Canopy Density	3
Canopy Dead Wood	3
Insect Occurrence	3
Disease	3
Epicormic Growth	2
Mistletoe	3
Form	3
Age	2
Habitat Value	3
Disturbance Tolerance	1
Risk Potential	3
Health / Condition	1

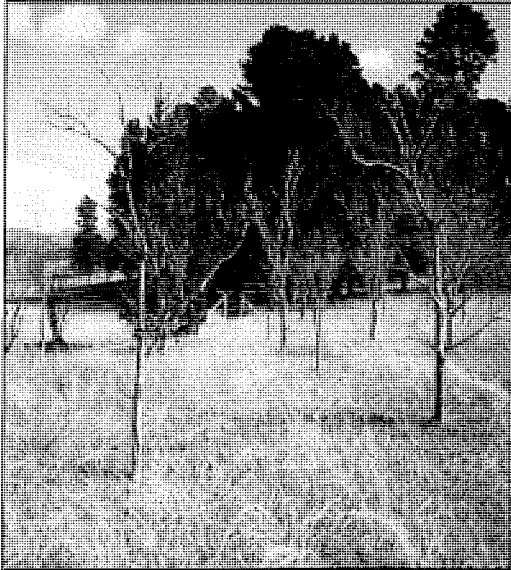
Opposite 14-16 Denman St

QUALITY CLASSIFICATION	
Regulated Tree	N
Arboricultural Assessment	P
Urban Amenity Assessment	P
<b>Recommendation:</b>	
Retain and Manage	
Remove	x

ARBORICULTURAL CHARACTERISTICS	
Canopy Density	1
Canopy Dead Wood	2
Insect Occurrence	2
Disease	2
Epicormic Growth	3
Mistletoe	3
Form	3
Age	1
Habitat Value	3
Disturbance Tolerance	1
Risk Potential	3
Health / Condition	1

ARBORICULTURAL NOTES
Poor health, replacement trees recommended.

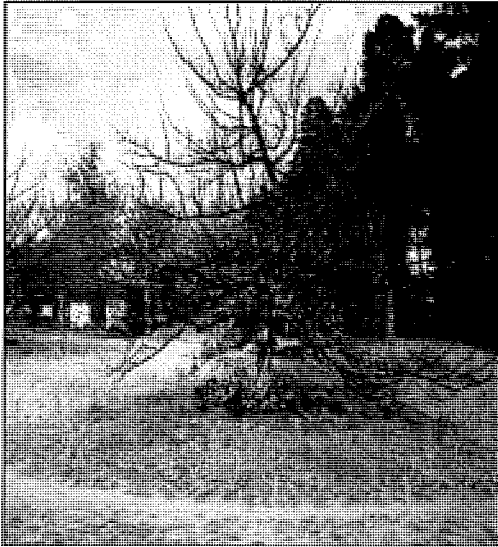
Adjacent to Abbott St Yarralumla

DATA	
Assessment Date:	23/07/10
Assessor:	HS
Tree Location: Dudley St	
E:	N
Species: Quercus robur	
Height:	8-12
Canopy Spread:	6-10
Trunk Circumference:	600-1000
Number of Trunks:	1

QUALITY CLASSIFICATION	
Regulated Tree	Y
Arboricultural Assessment	M
Urban Amenity Assessment	M
Recommendation:	
Retain and Manage	X
Remove

ARBORICULTURAL CHARACTERISTICS	
Canopy Density	2
Canopy Dead Wood	3
Insect Occurrence	3
Disease	2
Epicomic Growth	3
Mistletoe	3
Form	3
Age	2
Habitat Value	2
Disturbance Tolerance	2
Risk Potential	3
Health / Condition	2

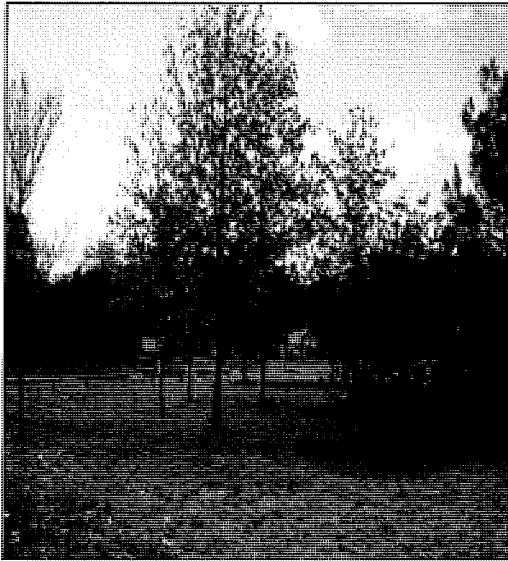
## Kintore Street Quercus Palustris

QUALITY CLASSIFICATION	
Regulated Tree	N
Arboricultural Assessment	H
Urban Amenity Assessment	E
<b>Recommendation:</b>	
Retain and Manage	X
Remove

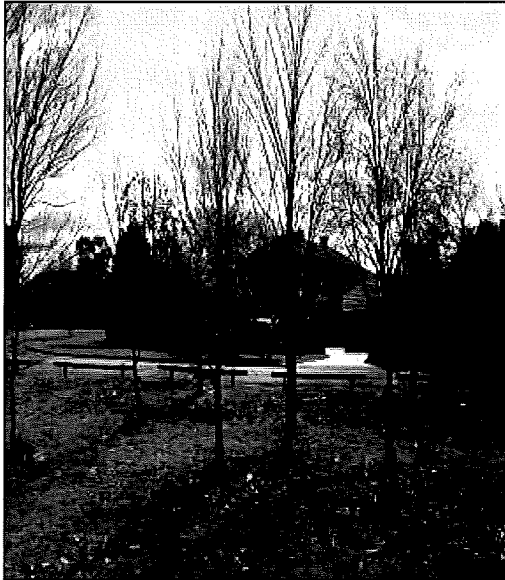
## Kintore Street Ulmus procera

DATA	
Assessment Date:	23/07/10
Assessor:	HS
Tree Location: Kintore St East	
E:	N
Species: Ulmus procera	
Height:	5-8
Canopy Spread:	3-4
Trunk Circumference:	300-600
Number of Trunks:	1

TREE PROTECTION / MANAGEMENT	
Tree Protection Zone	2
Potential to Reduce Risk	1
Potential to Improve Amenity Value	1

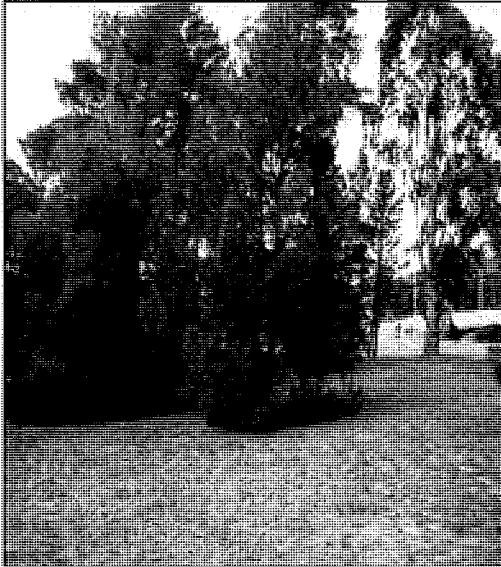
## Pinus patula Group 2

DATA	
Assessment Date:	23/07/10
Assessor:	HS
Tree Location: Dudley St East	
E:	N
Species: Pinus patula	
Height:	6-12
Canopy Spread:	600-900
Trunk Circumference:	5-8
Number of Trunks:	1

TREE PROTECTION / MANAGEMENT	
Tree Protection Zone	2
Potential to Reduce Risk	1
Potential to Improve Amenity Value	1

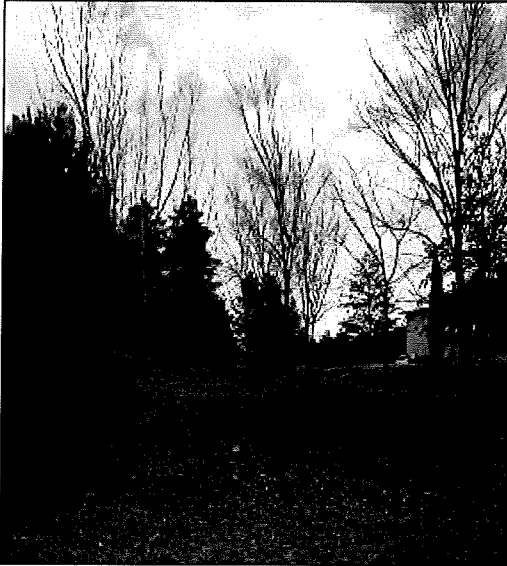
## Ulmus procera Group 2

DATA	
Assessment Date:	23/07/10
Assessor:	HS
Tree Location: Dudley St East	
E:	N
Species: Ulmus procera	
Height:	4-6
Canopy Spread:	2-5
Trunk Circumference:	300-600
Number of Trunks:	1

TREE PROTECTION / MANAGEMENT	
Tree Protection Zone	2
Potential to Reduce Risk	2
Potential to Improve Amenity Value	1

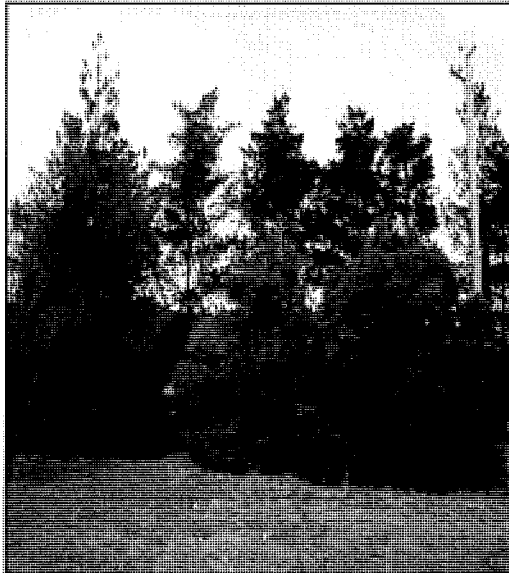
## Pinus patula Group 3

QUALITY CLASSIFICATION	
Regulated Tree	N
Arboricultural Assessment	H
Urban Amenity Assessment	E
<b>Recommendation:</b>	
Retain and Manage	X
Remove

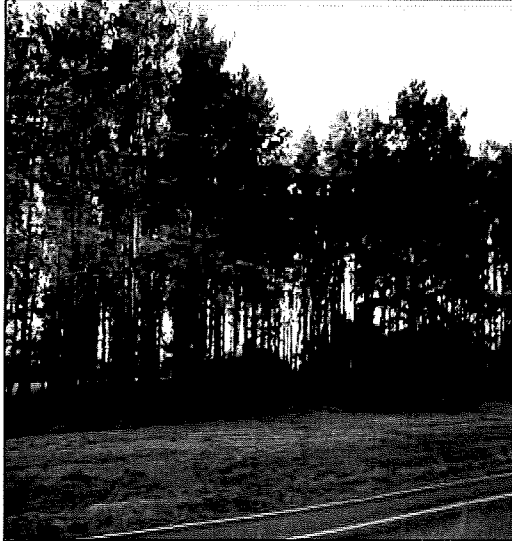
## Dudley Street East Area E

DATA	
Assessment Date:	23/07/10
Assessor:	HS
Tree Location: Dudley St East	
E:	N
Species: Pinus radiata	
Height:	16-25
Canopy Spread:	4-15
Trunk Circumference:	60-2400
Number of Trunks:	1

TREE PROTECTION / MANAGEMENT	
Tree Protection Zone	2
Potential to Reduce Risk	2
Potential to Improve Amenity Value	2

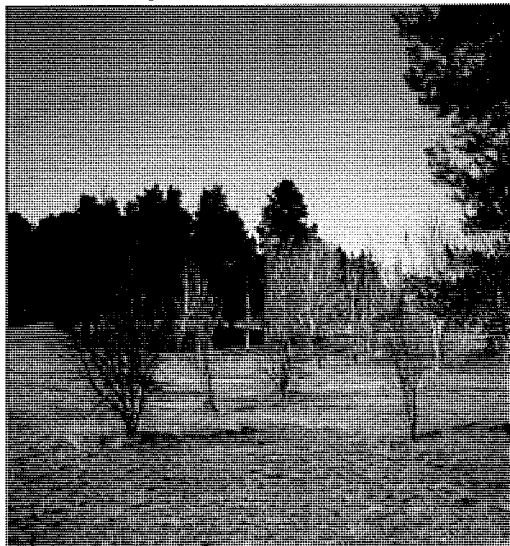
Photo 1: Burnt pines from December 2005 fire

On 29 December 2005 a fire started at the rear of the brickworks buildings, burning 9.6ha of land under a moderate westerly wind, destroying one house and severely damaging another two houses.

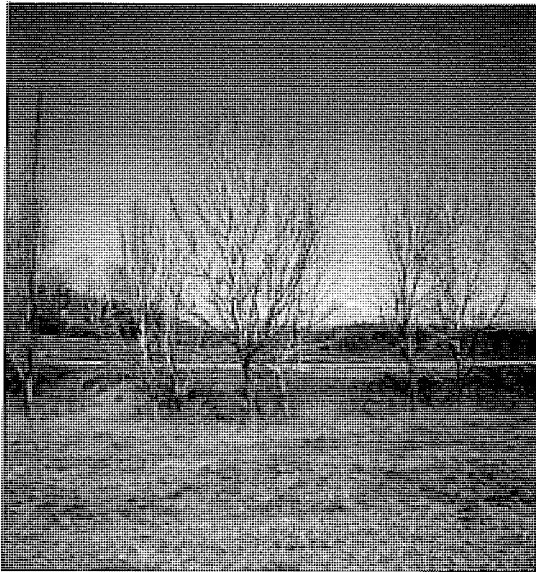
Cotter Road verge (north side)

QUALITY CLASSIFICATION	
Regulated Tree	Y
Arboricultural Assessment	M
Urban Amenity Assessment	M
Recommendation:	
Retain and Manage	X
Remove

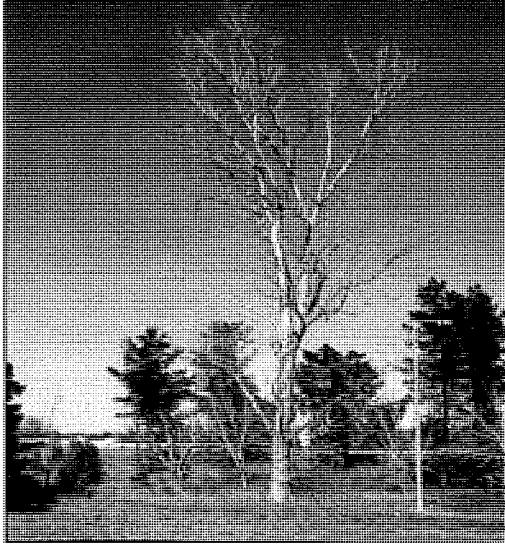
<b>TREE NUMBER</b>	<b>592</b>
--------------------	------------

<b>QUALITY CLASSIFICATION</b>	
Regulated Tree	Y
Arboricultural Assessment	M
Urban Amenity Assessment	M
<b>Recommendation:</b>	
Retain and Manage	X
Remove

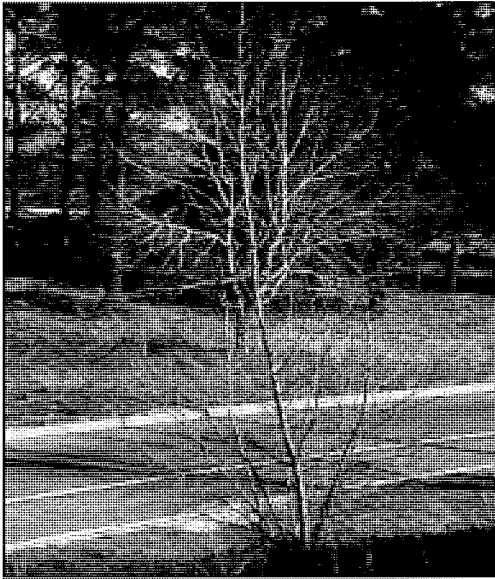
<b>TREE NUMBER</b>	<b>591</b>
--------------------	------------

<b>QUALITY CLASSIFICATION</b>	
Regulated Tree	N
Arboricultural Assessment	P
Urban Amenity Assessment	P
<b>Recommendation:</b>	
Retain and Manage	
Remove	X

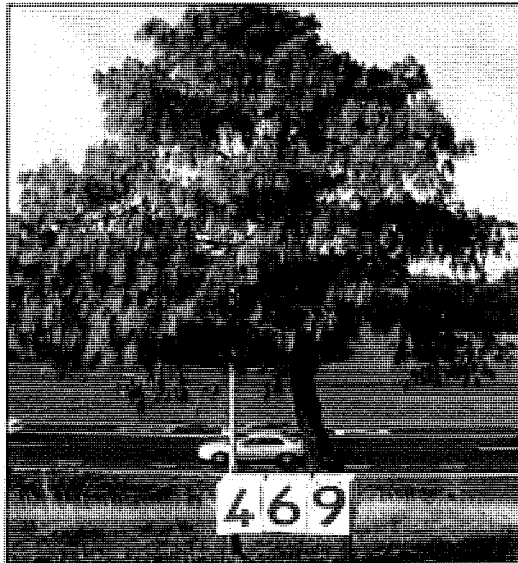
<b>TREE NUMBER</b>	<b>469</b>
--------------------	------------

<b>QUALITY CLASSIFICATION</b>	
Regulated Tree	N
Arboricultural Assessment	M
Urban Amenity Assessment	M
<b>Recommendation:</b>	
Retain and Manage	X
Remove

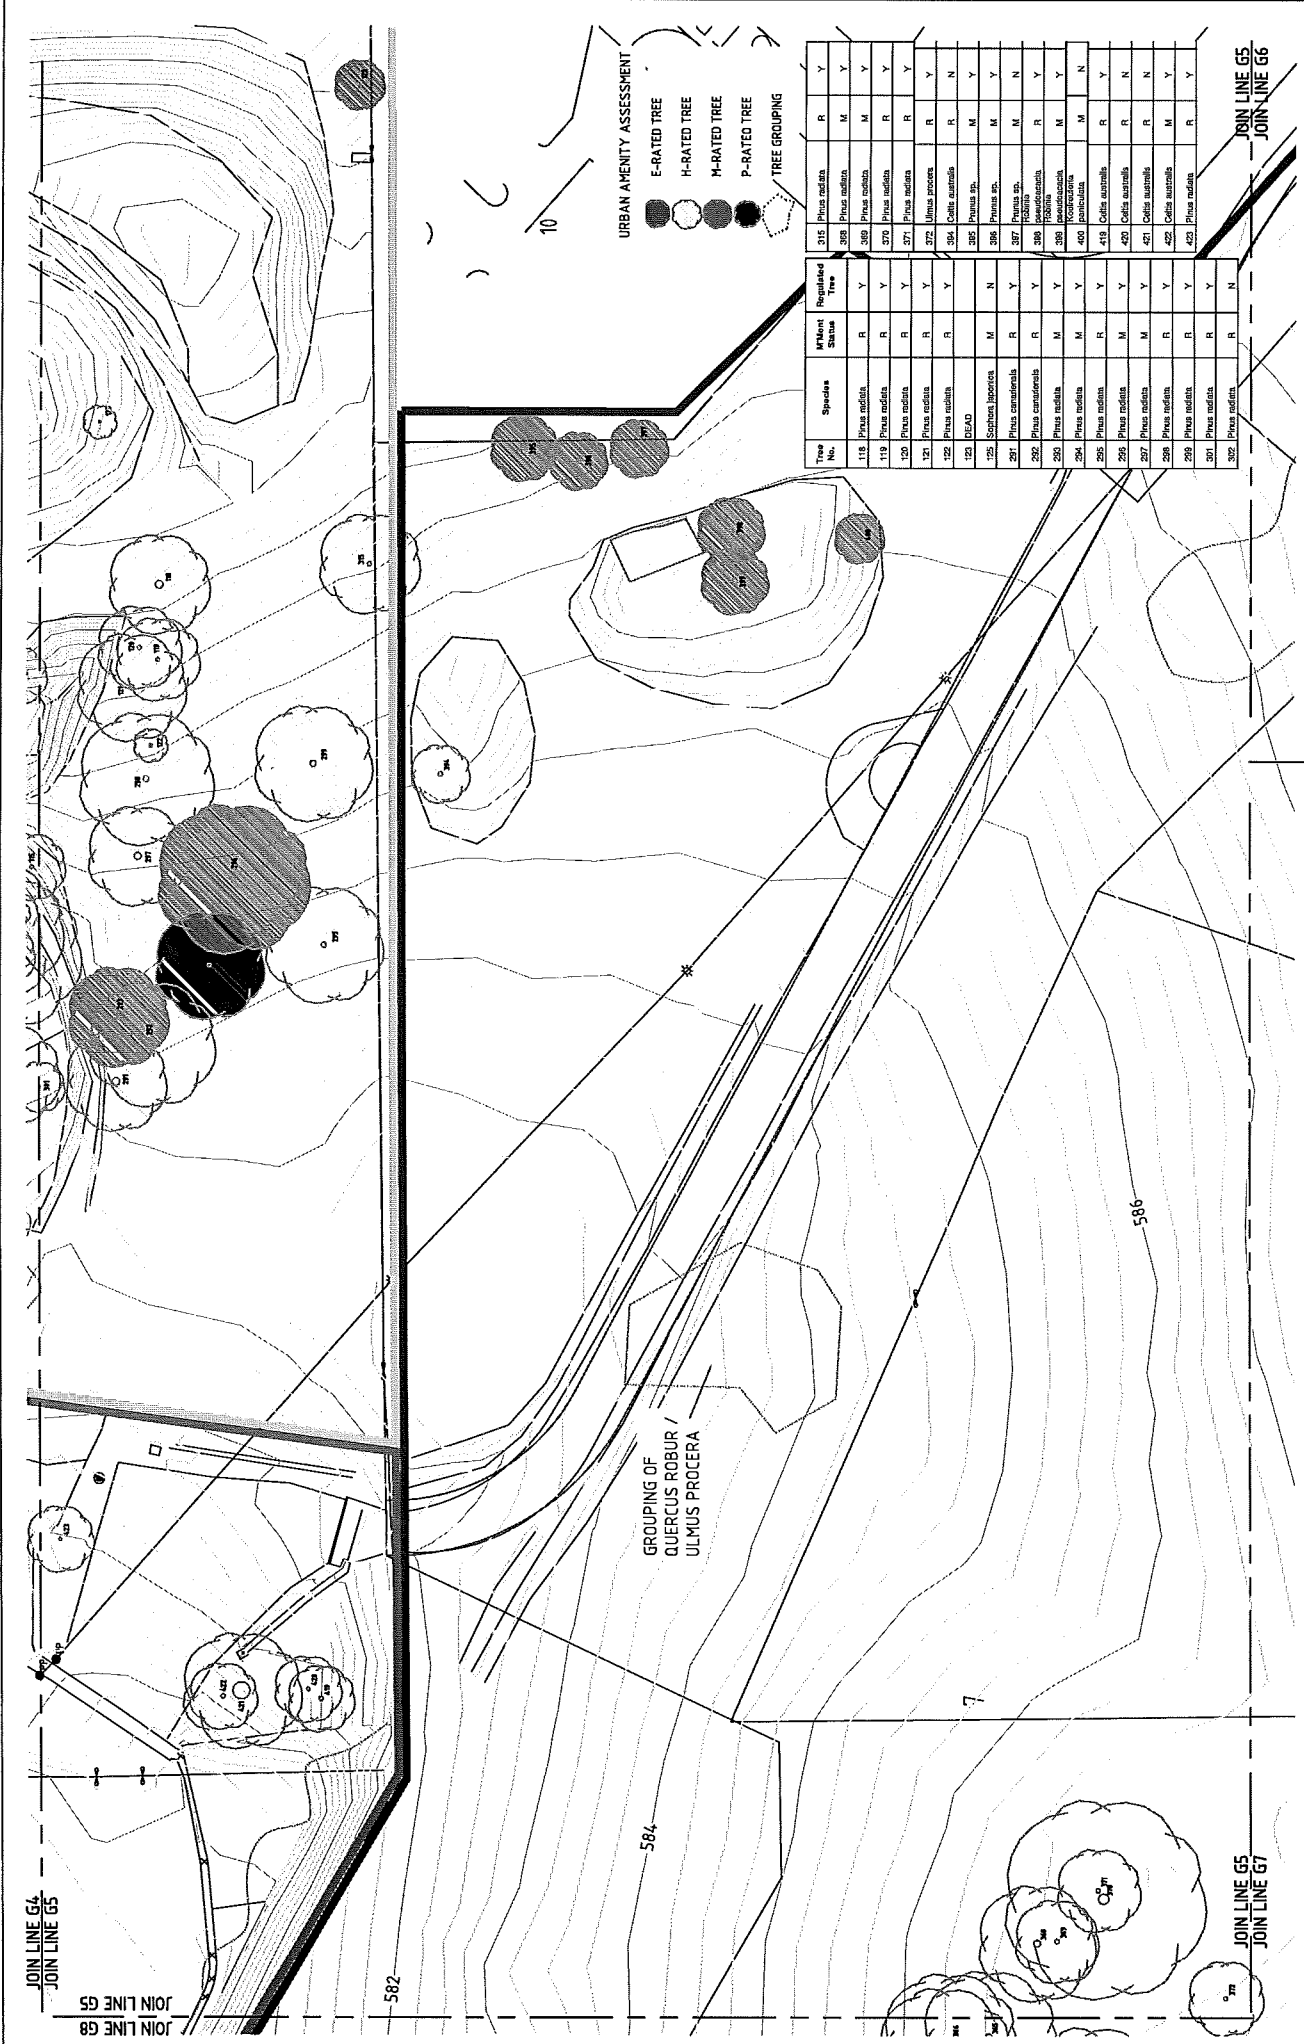
Project OLD CANBERRA BRICKWORKS	Drawing Title TREE ASSESSMENT PLAN	Sheet No. 2393-G4-C
	Client LAND DEVELOPMENT AGENCY		
	dslb LANDSCAPE ARCHITECTS	Drawing No. 2393-G4-C	Date 23/02/2016
	Land Development Agency	Drawing No. 2393-G4-C	Date 23/02/2016

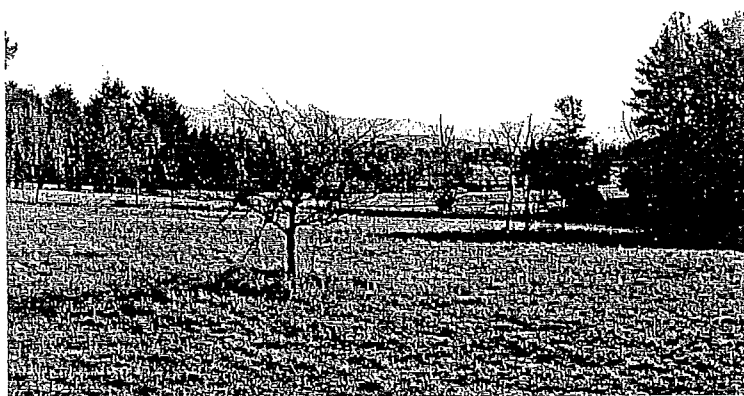
**Photo 2**  
Break in plantings west of  
Denman Street provide  
glimpses of Cotter Road,  
Dudley Street and  
Brindabellas. Note  
remnant Danthonia  
grassland with deciduous  
trees doing poorly due to  
sketal soils.

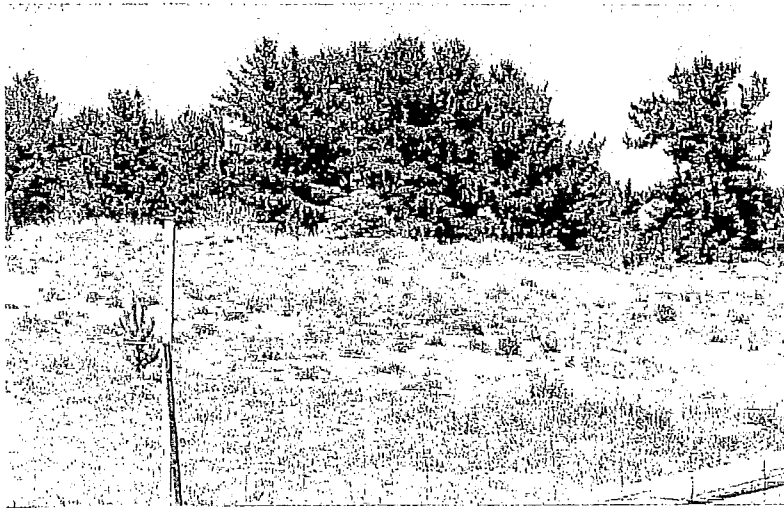
Photo 3  
Former road works depot site with pines at rear screening views from/to Curtin and Cotter Road.

Adjacent to the Brickworks and the west of the access track entry, is the fenced off former roadworks materials depot. This area was used by the road builders as a site to store bulk materials such as gravel. This use occurred from the 1950's through to 1980's. It has remained unrestored as can be seen in the photo below.

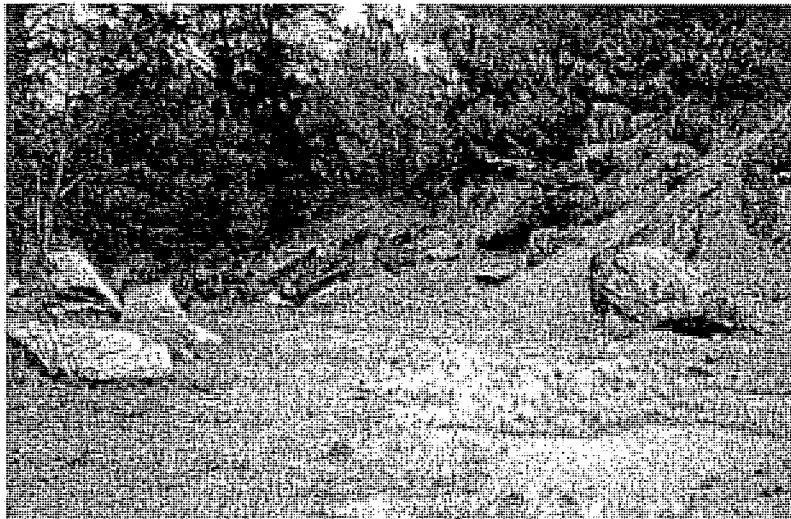
Photo 4  
Brickworks quarry showing scree slope and pine colonisation.

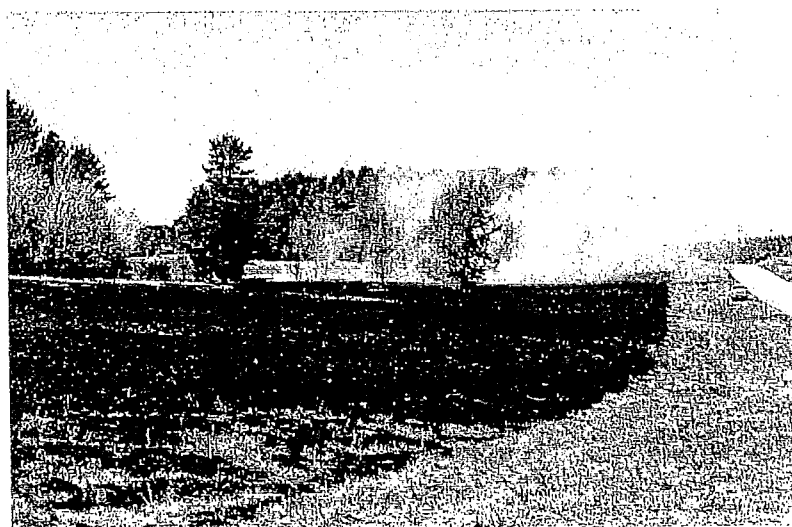
Photo-14  
Control burning of  
wet Themeda  
grassland beside  
Dudley Street.

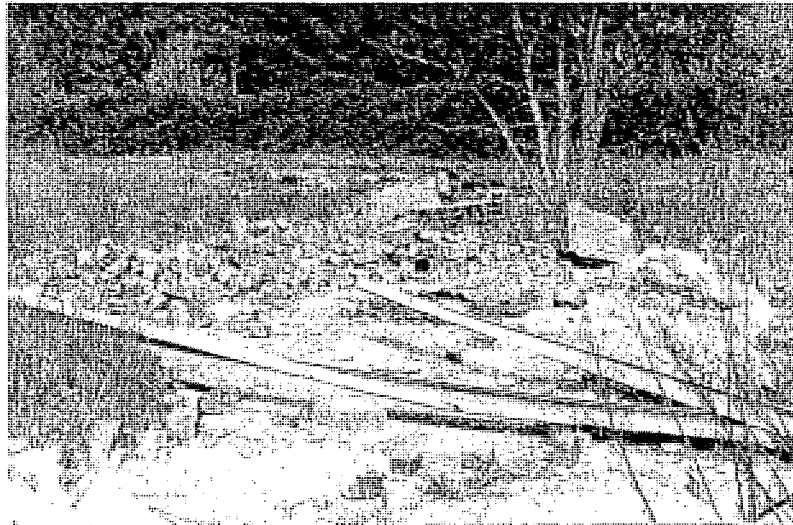
Photo 15  
Site of former  
shed with  
underground oil  
tank. Note  
'hedge' of  
blackberry and  
seedling 'weed'  
trees.

One of the weed issues to be addressed is invasion by suckers and seedlings. Where parent trees are to be retained, for example the Pines of Westbourne Woods and Elms beside Dunrossil Drive, the quantity of seedlings and suckers is endangering the intended landscape and the health of the parent trees. The suckers and seedlings are controlled on all adjacent lands other than this site.

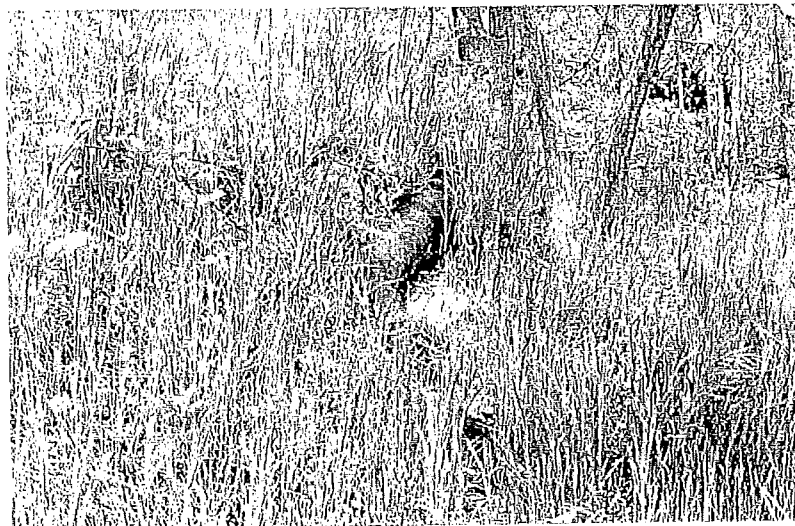
Photo 16  
Remains of  
workmen's camp  
exposed among  
tree thicket.

Of lesser significance, but an important part of the history of the site and the social heritage of the burgeoning city of Canberra, is the workmen's camp to the west of the kiln complex outside the fenced area. The camp area can be identified by the ruins of the building foundations and from the trees and domestic garden plants introduced that still persist (see photo below).

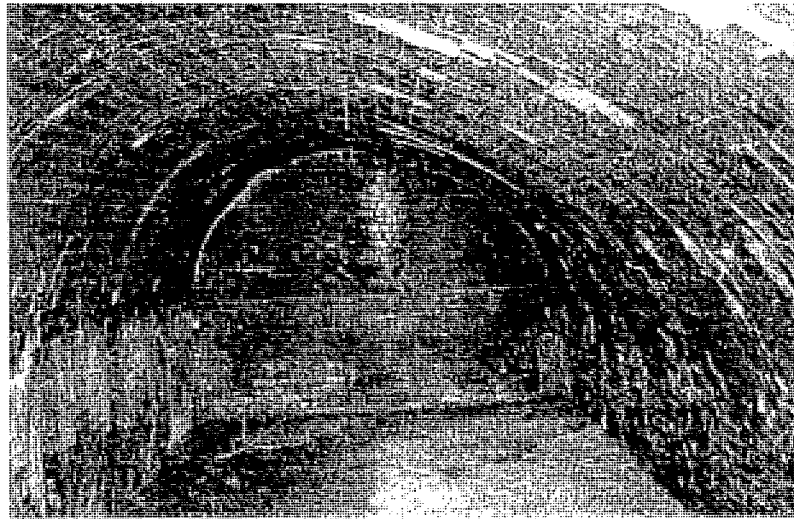
Photo 17  
View of kiln showing  
sagging of arch.

This investigation found that there is one kiln that is not safe or able to be considered suitable for reuse due to structural instability.
