6. PEDESTRIAN AND CYCLIST ASSESSMENT

It is understood that the north-eastern corner of Rural Block 1218, Weston Creek will be subject to future redevelopment most likely consisting of commercial land use. Site investigation was carried out to provide limited information on subsurface conditions with preliminary comments given on site classification, site preparation measures, excavation conditions, the performance of suitable foundation systems, likely bearing pressures and pavement design parameters.

INFRASTRUCTURE UPGRADE DESIGN SUBMISSION REPORT V2.0

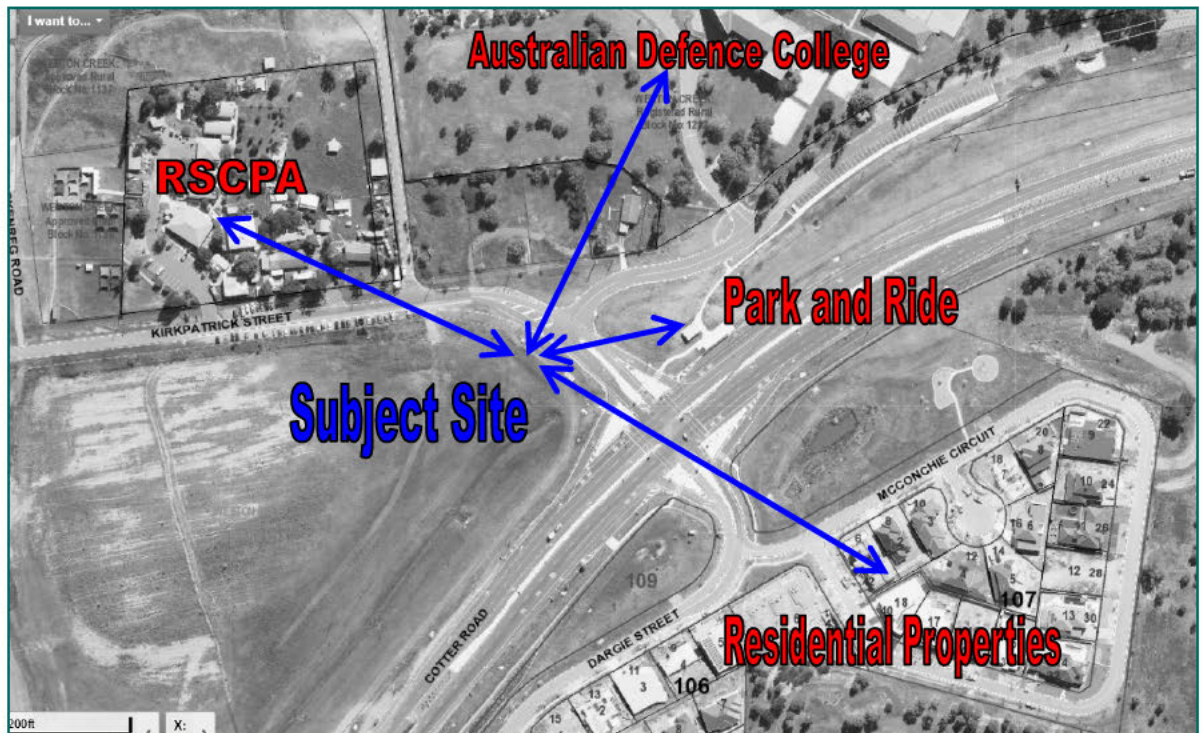
Figure 13: Likely Pedestrian Desire Lines

Figure 13 below presents a summary of the likely pedestrian desire lines associated with these locations.

The likely pedestrian desire lines for the residential properties generally occurs along the route of existing pedestrian facilities including a footpath on the northern side of Dargie Street and the pedestrian crosswalks at the Cotter Street / Kirkpatrick Street / Dargie Street intersection. In the final section of the route between the Cotter Street intersection and the subject site there is no footpath, which should be provided between the intersection and the subject site.

uncontrolled pedestrian crossings should be avoided. It is recommended that pedestrians along these desire lines are guided to utilise the existing pedestrian crosswalk on the north-western leg of the Cotter Street signals. This approach may require the installation of pedestrian fencing to encourage movements to utilise the existing formal crossing.

- The proposed development is likely to generate pedestrian demands for the local area including from the park and ride facility, the Australian Defence College, the RSPCA facility and the existing residential properties. To cater for the likely pedestrian demand footpaths in the vicinity of the subject site should be provided to improve the quality of the pedestrian conditions. Furthermore, it is recommended that pedestrian movements are guided to utilise the existing pedestrian crosswalk on the north-western leg of the Cotter Street signals. This approach may require the installation of pedestrian fencing to encourage movements to utilise the existing formal crossing.

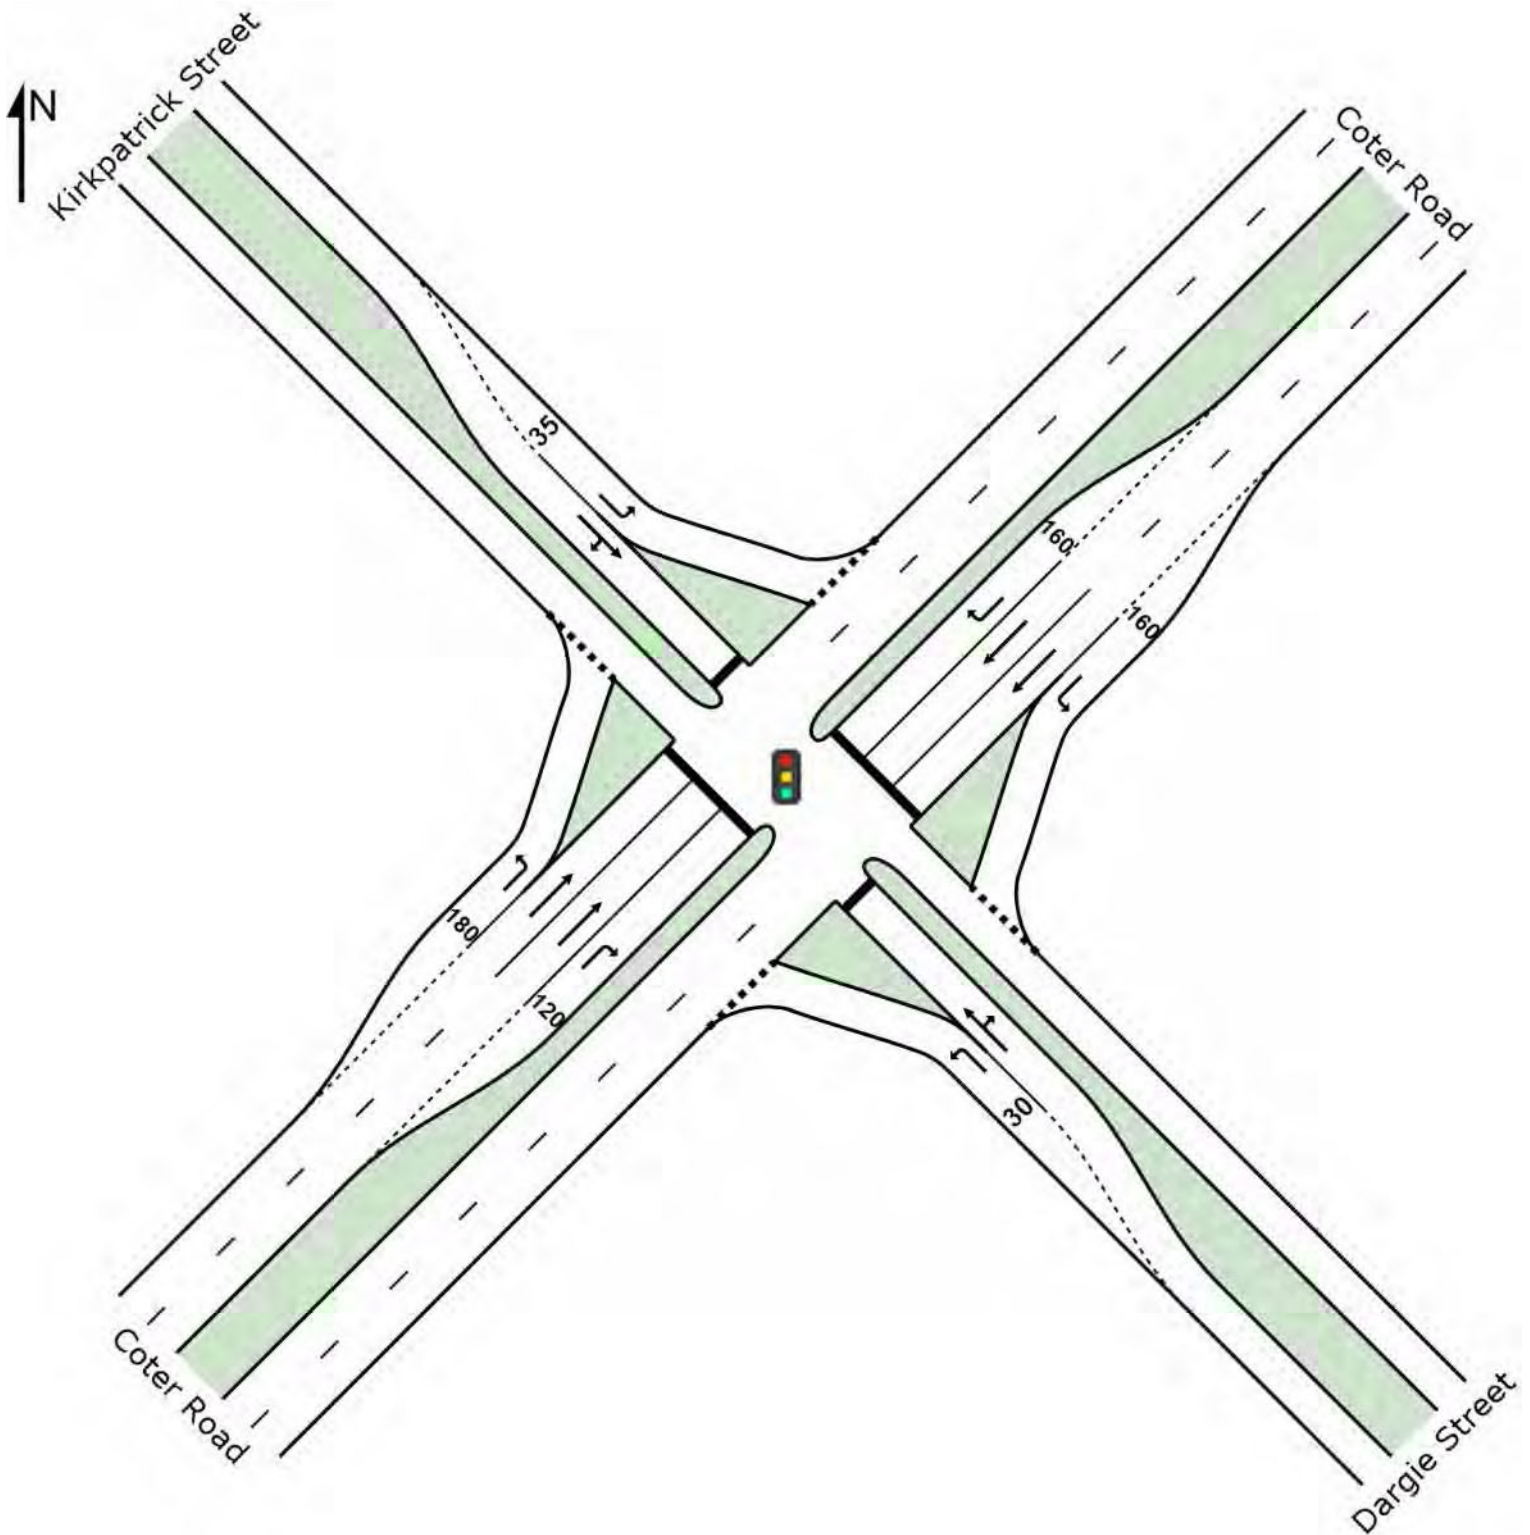
Coter Road / Kirkpatrick Street / Dargie Street
Signals - Fixed Time

Site: Existing AM

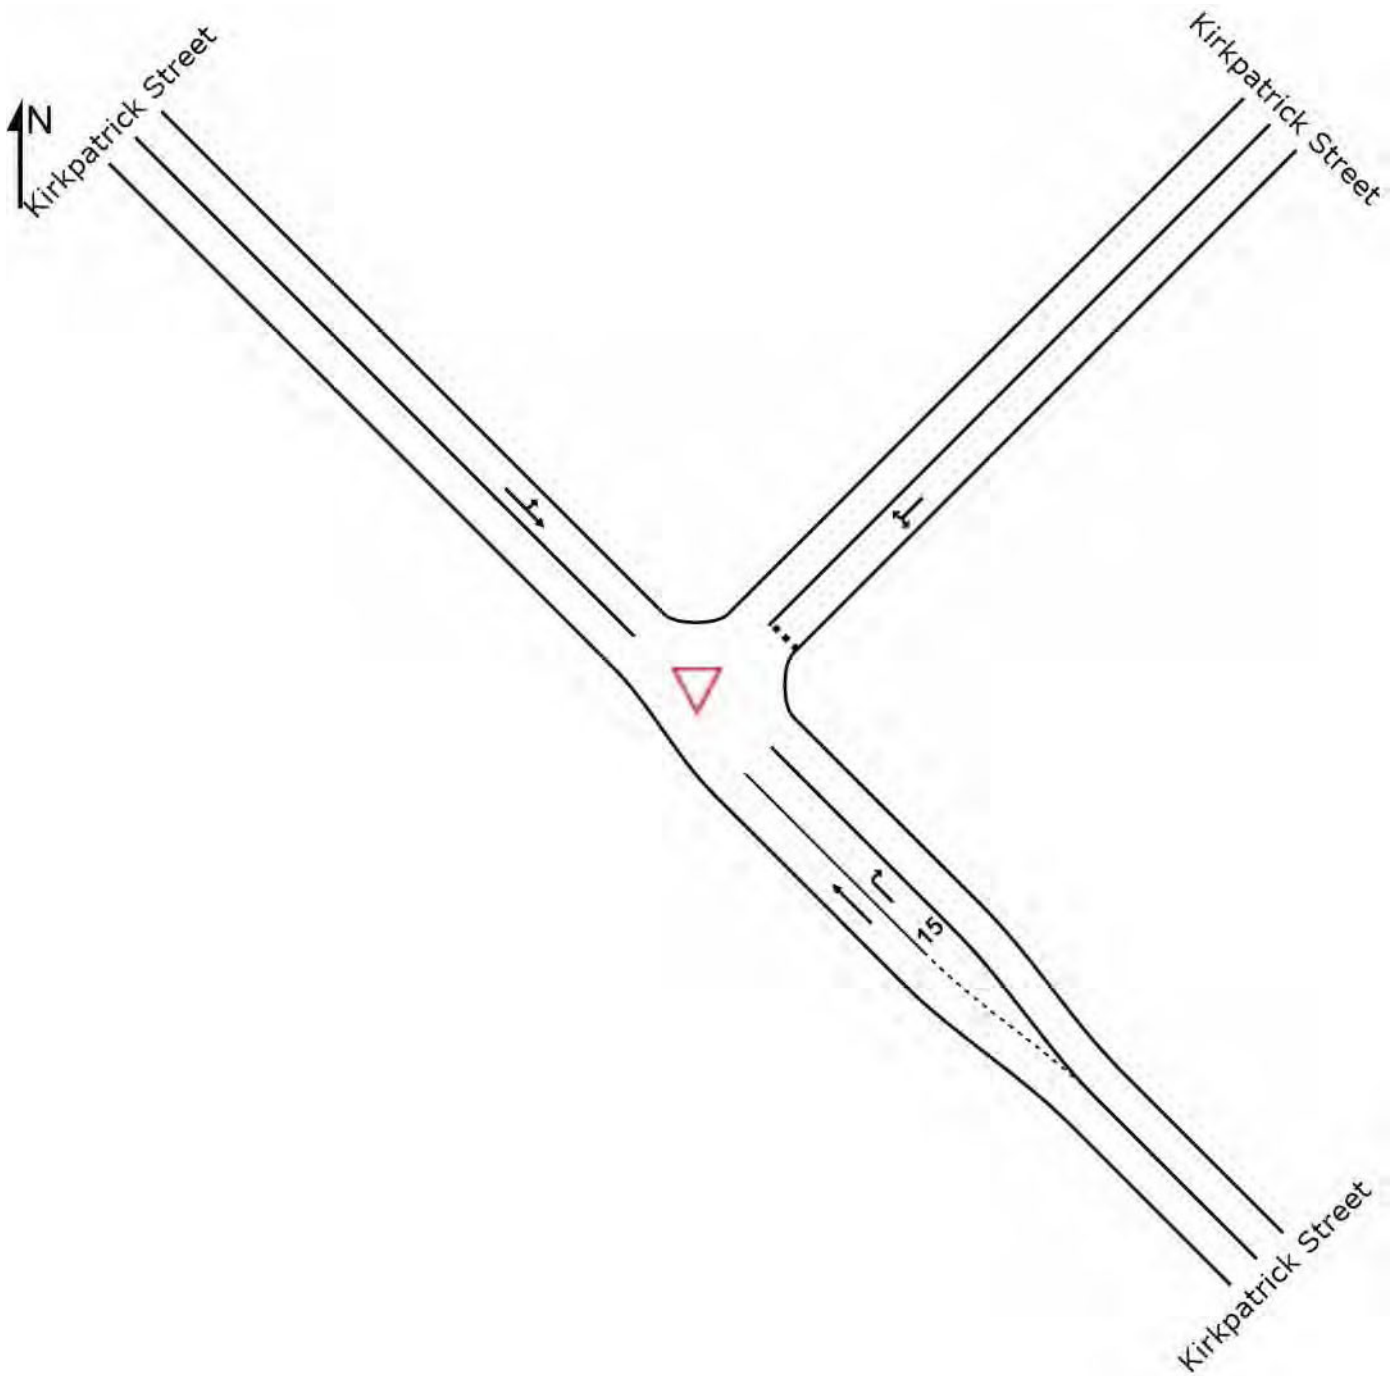
Kirkpatrick Street / Kirkpatrick Street
Giveaway / Yield (Two-Way)

▽ Site: Existing AM

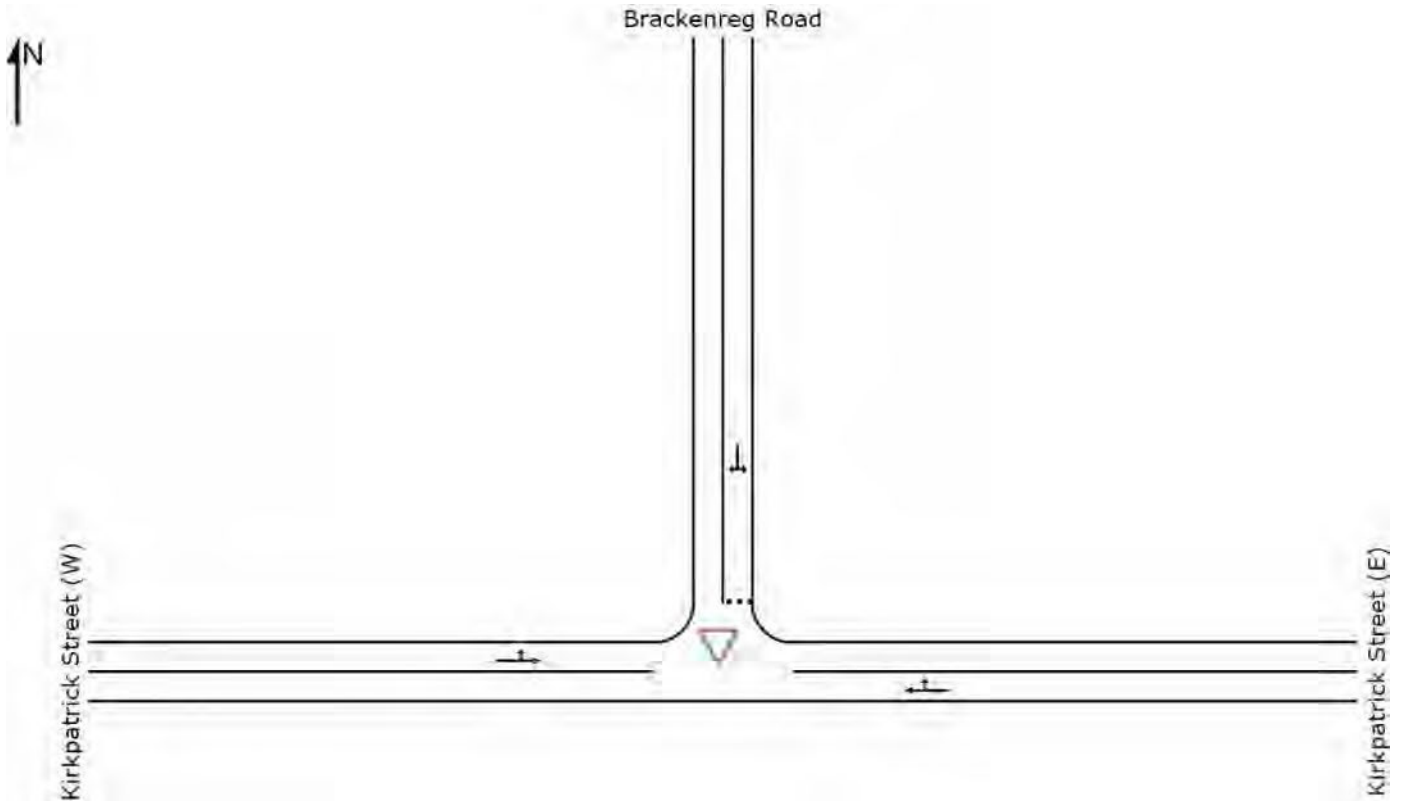
Kirkpatrick Street - Brackenreg Road
Giveaway / Yield (Two-Way)

▽ Site: Existing AM

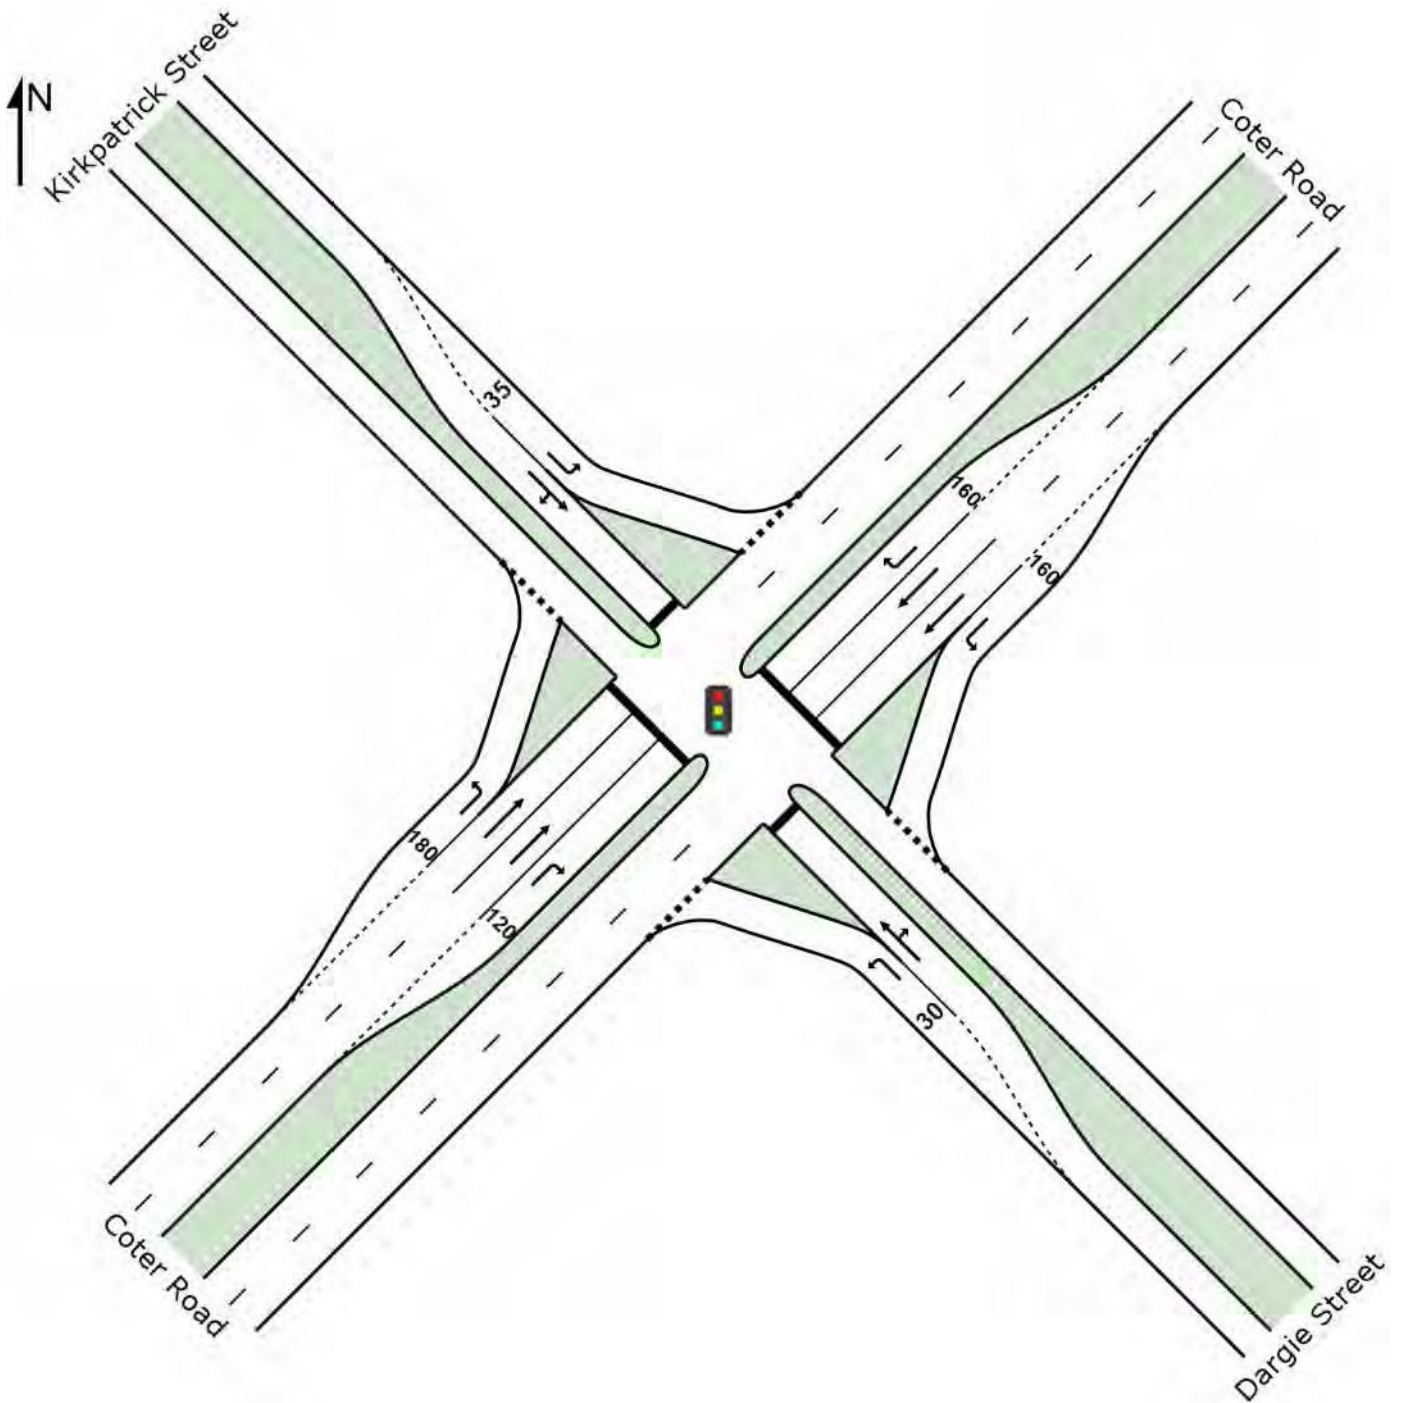
Coter Road / Kirkpatrick Street / Dargie Street
Signals - Fixed Time

**Site: Post Development PM**

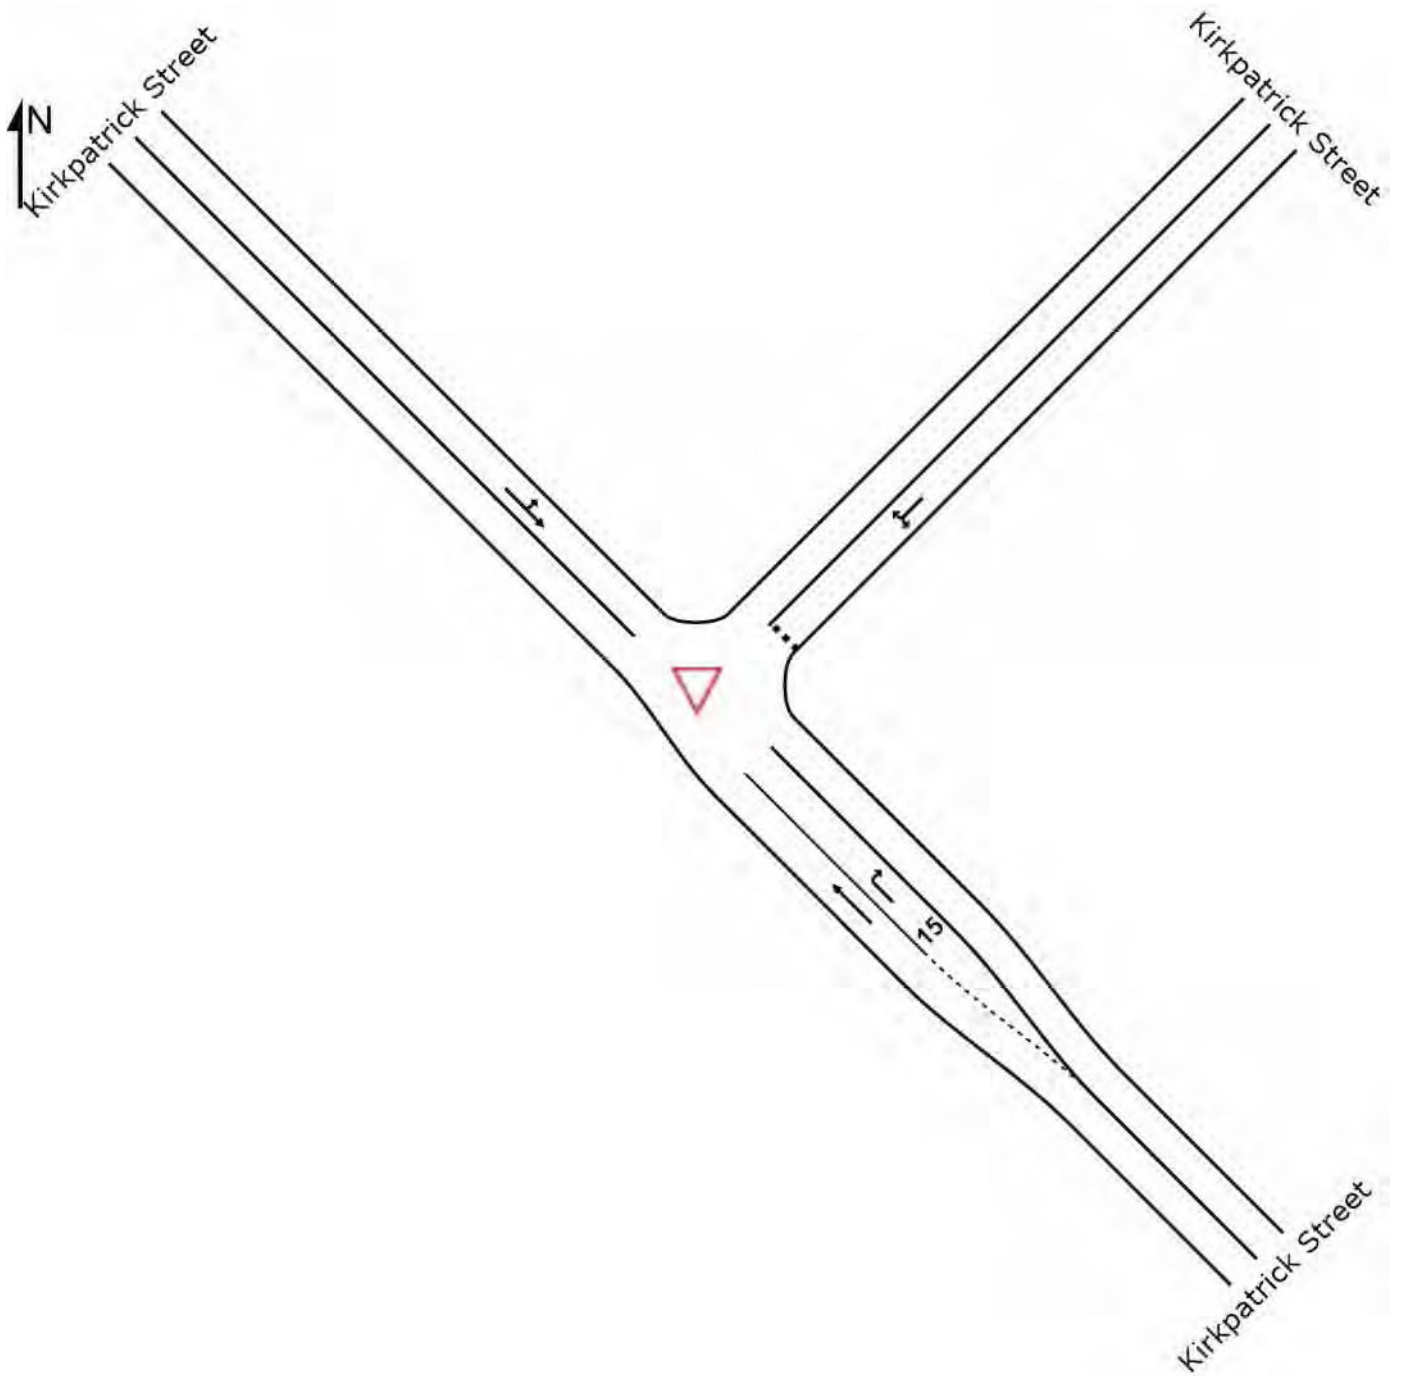
Kirkpatrick Street / Kirkpatrick Street
Giveaway / Yield (Two-Way)

▽ Site: Post Development PM

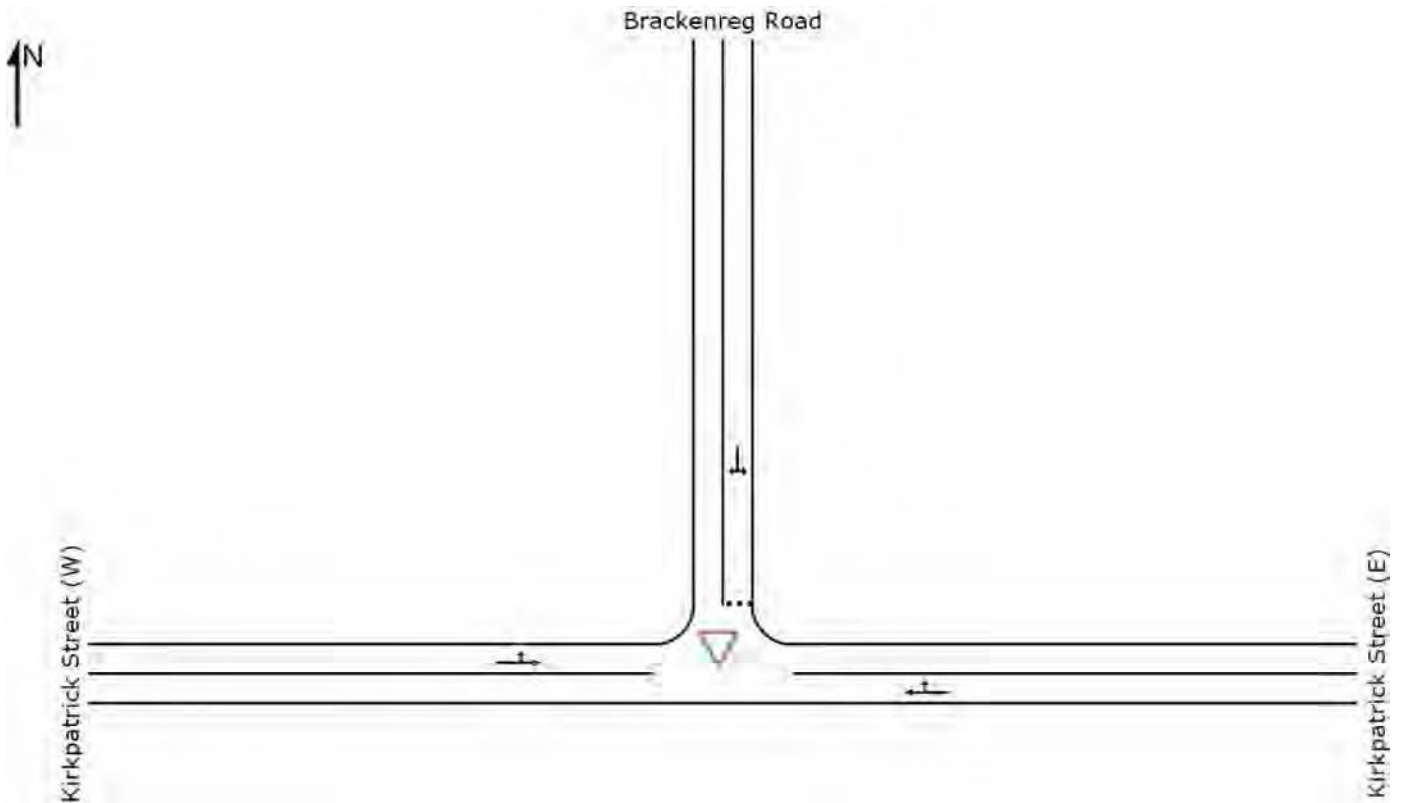
Kirkpatrick Street - Brackenreg Road
Giveaway / Yield (Two-Way)

▽ Site: Post Dev PM

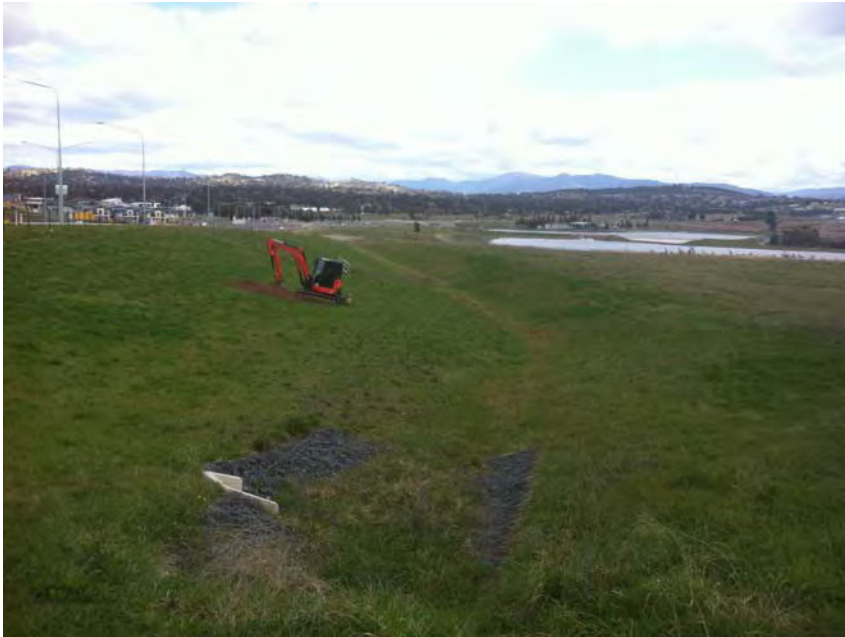
Site levels fall in a south westerly direction generally at approximate grades from 1 in 5 to 1 in 25 (vertical in horizontal). A swale was observed within the south eastern part of the site, following a north east to south west path (parallel to Cotter Road), with a concrete culvert and wire meshed covered ballast rock adjacent to it at the northern end (where the swale starts) and another one just south of site boundary (for groundwater flow below Cotter Road). The site is grass vegetated with some weeds up to approximately 0.3 m. Current access to the site is unrestricted (refer Drawing 1, Appendix B). Figure 1 below shows the condition of the site at the time of the investigation.

Figure 1: View looking south-west from the eastern part of the site with Cotter Road to the left and swale drain mid-photo.

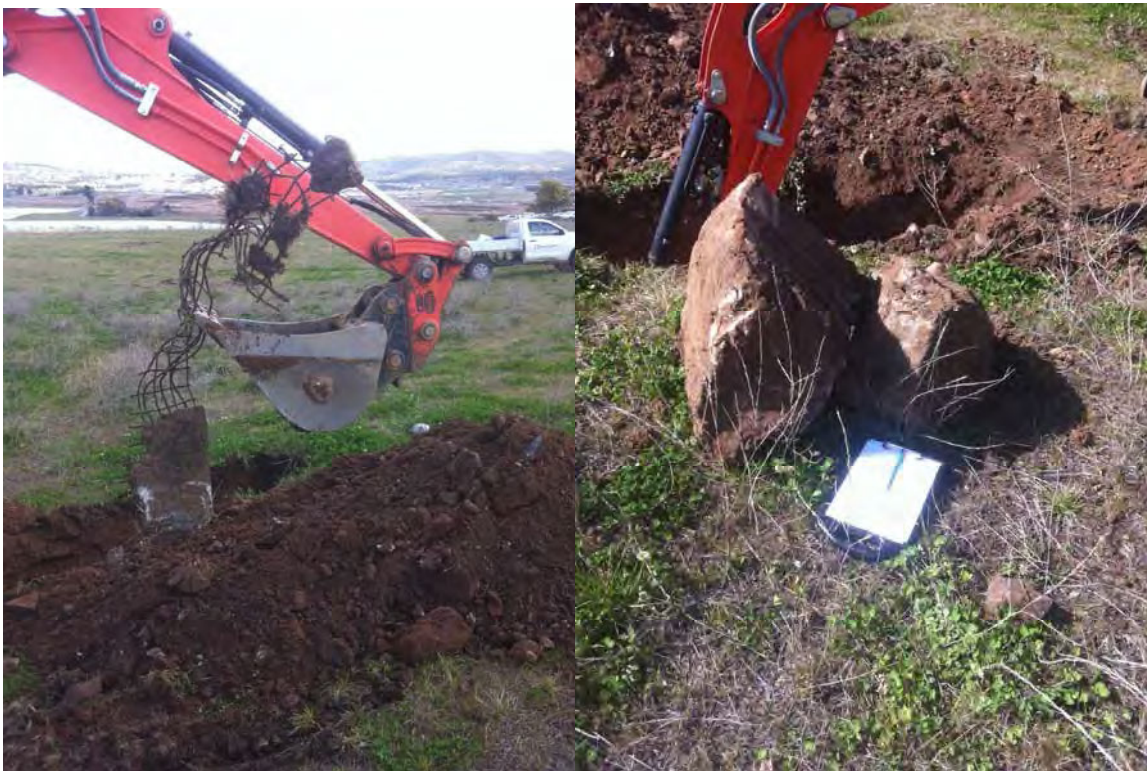
- **FILLING (UNCONTROLLED):** Moderately compacted, moist mixture of silt, clay and sand filling in Pits 1, 4 and 7 to depths of 0.6 m, 0.3 m and 1.8 m. Some minor debris (asphalt fragments, wire and grass clumps) were noted in Pits 1 and 4. Extensive debris (wire, metal pipes and ceramics) and over-sized boulders (up to 700 mm by 500 mm by 400 mm) were observed in Pit 7 from 0.7 – 1.8 m depth. Figures 2 and 3 below show the conditions encountered in Pit 7.

Figures 2 & 3: Wire and concrete (left) and oversize boulders (right) excavated from Pit 7.

Based on the results of the investigation, it is expected the topsoil stripping depth will be around 0.1 – 0.3 m. If the development area includes the northern and eastern boundaries of the site, stripping of the uncontrolled filling material would likely be an additional 0.3 – 0.4 m along the northern boundary and up to 1.7 m on the eastern boundary, depending on the proposed development. It is noted that a capping layer thickness of 0.7 m of well compacted filling overlaid the debris encountered in Pit 7

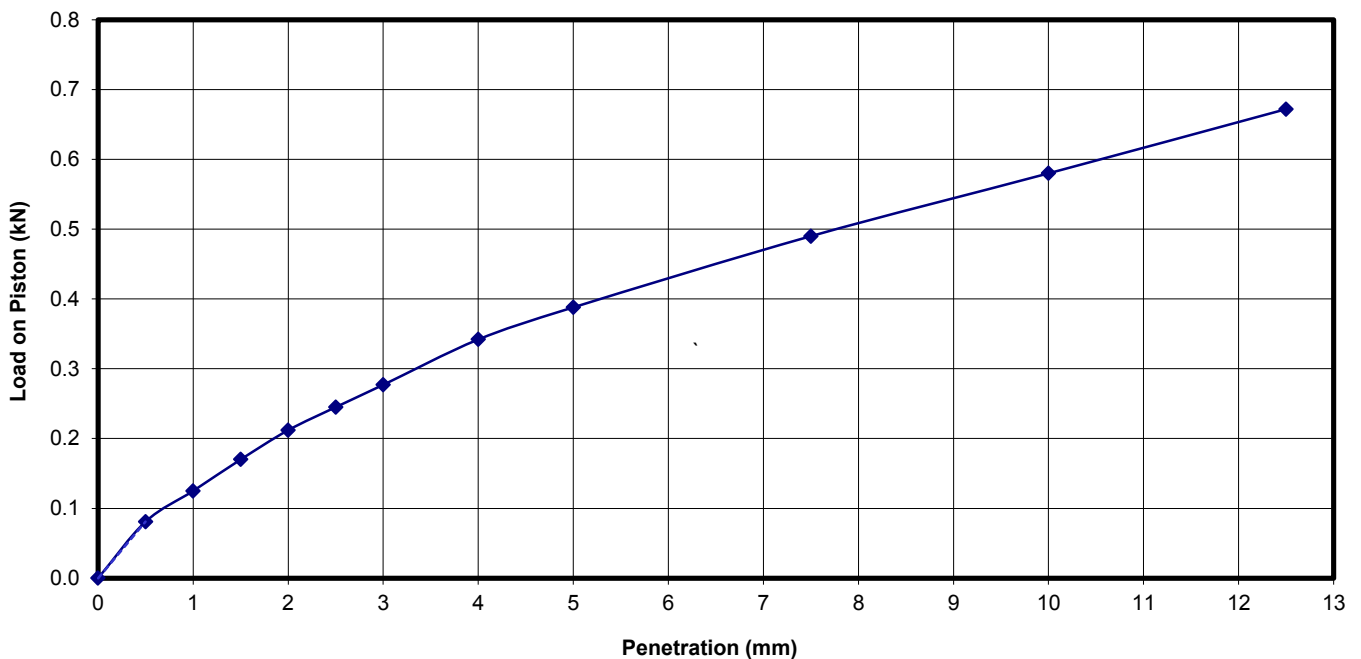
Result of California Bearing Ratio Test

The sample tested for CBR was compacted to about 95% modified dry density ratio at about optimum moisture content and soaked for four days under a surcharge loading of 4.5 kg. The measured CBR value was quite low, at 2.0 %.

Description: Silty Sandy Clay **Test Method(s):** AS 1289.6.1.1, AS 1289.2.1.1
