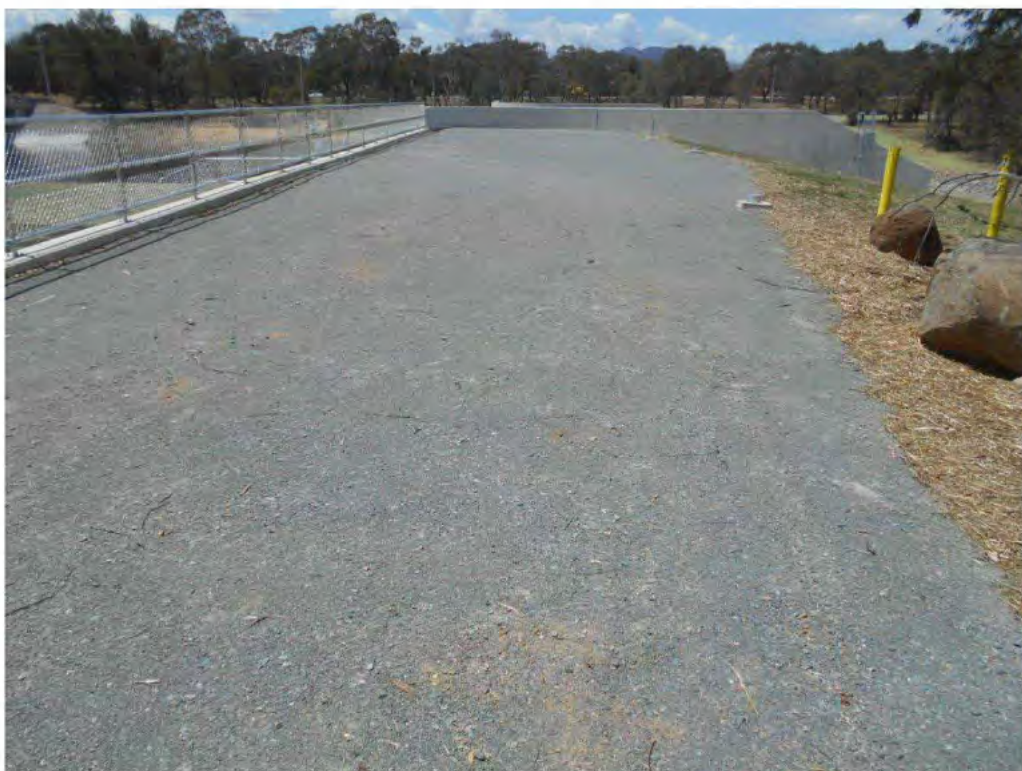
Crest	<p>Good crest capping material with no evidence of breakdown or disintegration (<i>Photograph 8</i>).</p> <p>There was no evidence of settlement, depressions, low spots, sinkholes, wheel rutting or cracking.</p> <p>Overall in good condition.</p>	
Downstream face	<p>There was no evidence of depressions, settlements or cracking (<i>Photograph 9</i>).</p> <p>Seeding has been completed. Once the grass cover is established, the condition of the grass, including the existence of bare patches should be assessed.</p> <p>Overall in good condition.</p>	
RHS Training wall	In good condition with no evidence of displacements, tilt, cracking, spalling, AAR or deterioration (<i>Photograph 7</i>).	
RHS abutment Wall	In good condition with no evidence of displacements, tilt, cracking, spalling, AAR or deterioration.	
RHS Wing wall	In good condition with no evidence of displacements, tilt, cracking, spalling, AAR or deterioration (<i>Photograph 9</i> and <i>Photograph 13</i>).

Photograph 8 – General view of the crest of the RHS embankment.

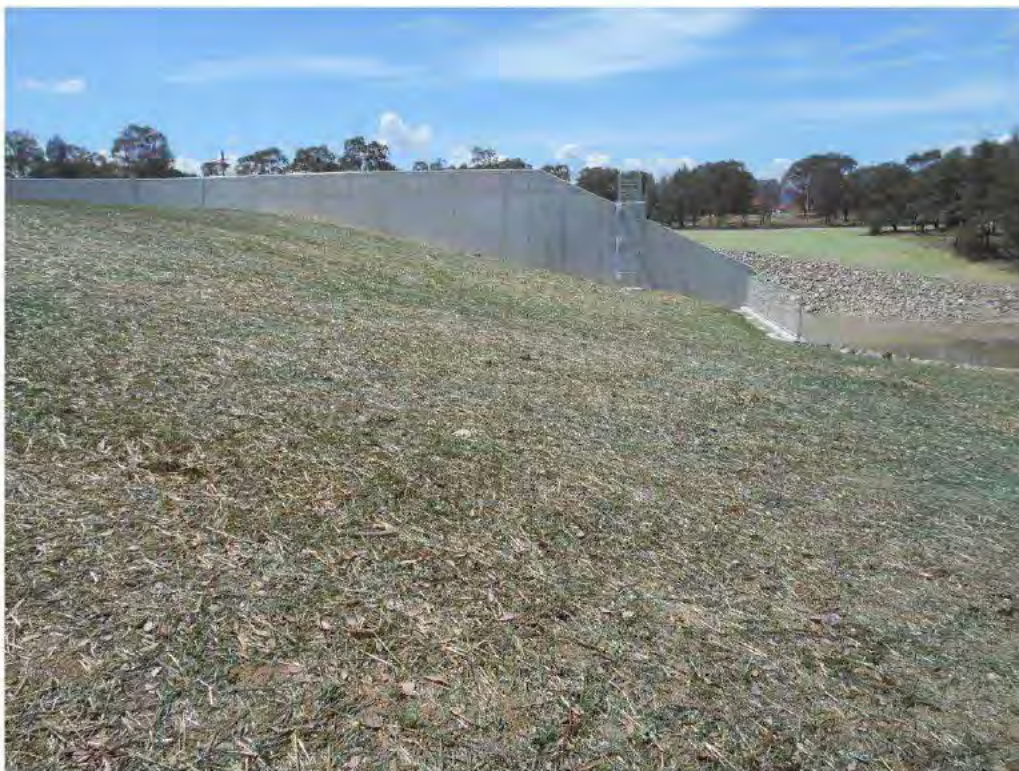
Photograph 9 – Downstream face of the RHS embankment.

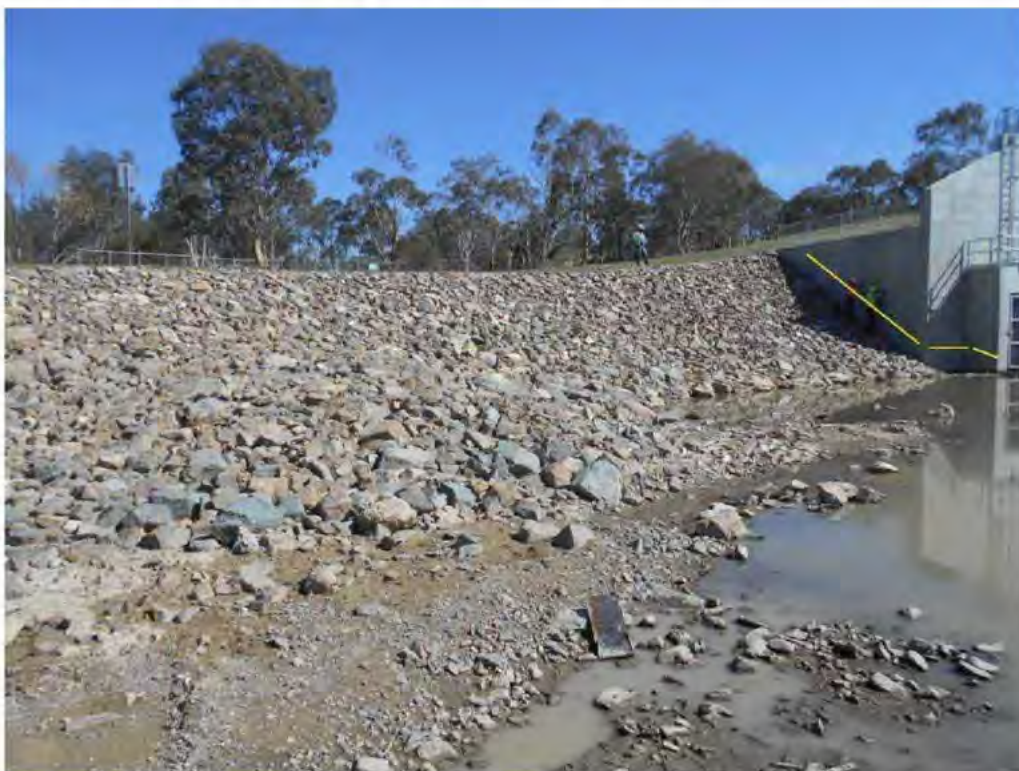
RHS batter downstream of the weir	<p>In good condition with no evidence of slope instability (<i>Photograph 10</i>).</p> <p>There are several areas where small size rip-rap and lumps of soil are present (<i>Photograph 11</i> and <i>Photograph 12</i>). There is a risk of displacement of smaller size rip-rap and washing away of soil, resulting in inadequate erosion protection.</p> <p>Consideration should be given to monitoring the condition of the rip-rap protection following major floods.</p>	
Instrumentation	Survey Monitoring Points on LHS and RHS embankment dams	In good condition with no evidence of damage.
	Survey Monitoring Pins on concrete walls.	In good condition with no evidence of damage.
	Gauge Board	In good condition (<i>Photograph 7</i>). There are no elevation markers such as EL 573 AHD and EL 574 AHD.
	Standpipe piezometers	In good condition with no evidence of damage.
Outlet Works	Valve Chamber	Concrete in good condition with no evidence of cracking, spalling, AAR or deterioration.

*Photograph 10 – View of the RHS batter immediately downstream of the weir.
There is no safe access to the downstream apron area from right abutment. Therefore, consideration should be given to providing a hand rail as shown in yellow, or similar acceptable arrangement.*

Work, Health & Safety issues noted	Safe access for inspection of the downstream face of the concrete walls of Labyrinth weir	There is no safe access (Photograph 10 and Photograph 31). Therefore, consideration should be given to installing handrails on both LHS and RHS wingwalls as shown in above photographs.
	Ladder access to operate outlet valves	The existing arrangement of ladders and installation of the "recovery system" should be reviewed.
	Ladder on the outside face of the RHS wall	There are several sharp edges the risk of injury to personnel. Consideration should be given to grinding those sharp edges to eliminate this risk (Photograph 14).
	The hatch of the outlet valve chamber	The gate latch for the outlet valve chamber is heavy, jammed and hard to open (Photograph 15).
General issues	Illumination during night	There are no flood lights or similar for inspection of the weir during the night, in case of an emergency.

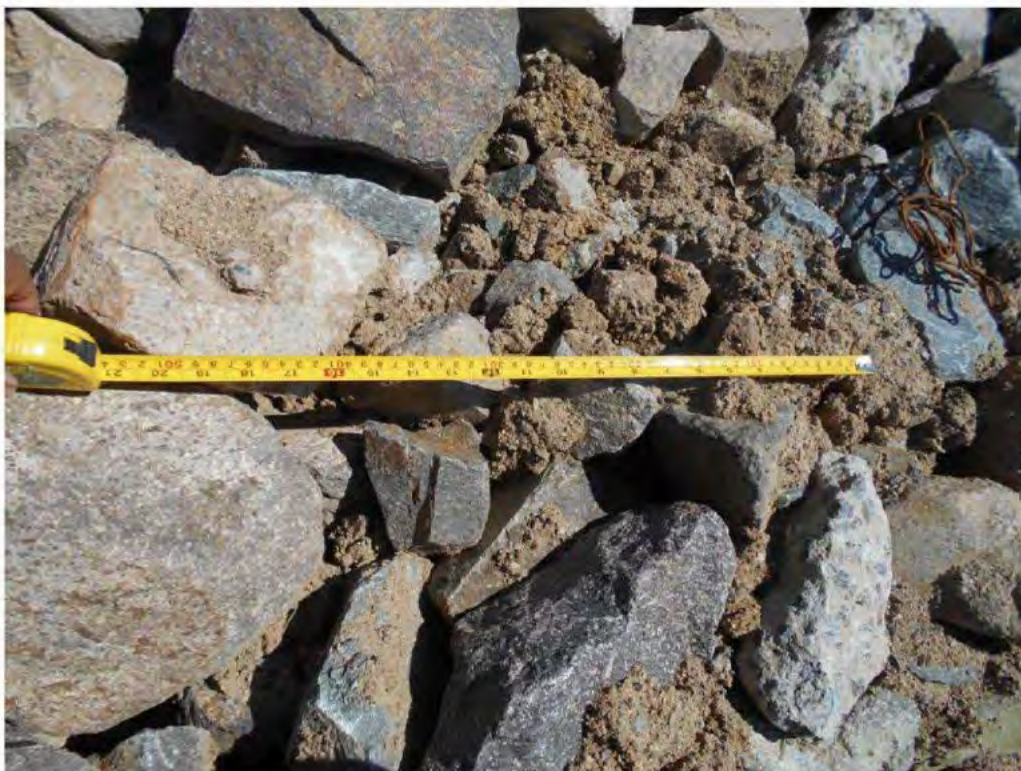
Photograph 11 – A close-up view of the tip-rap protection of the RHS batter referred to in Photograph 10. Note sand-like materials within the rip-rap protection which could be washed away during flood discharge.

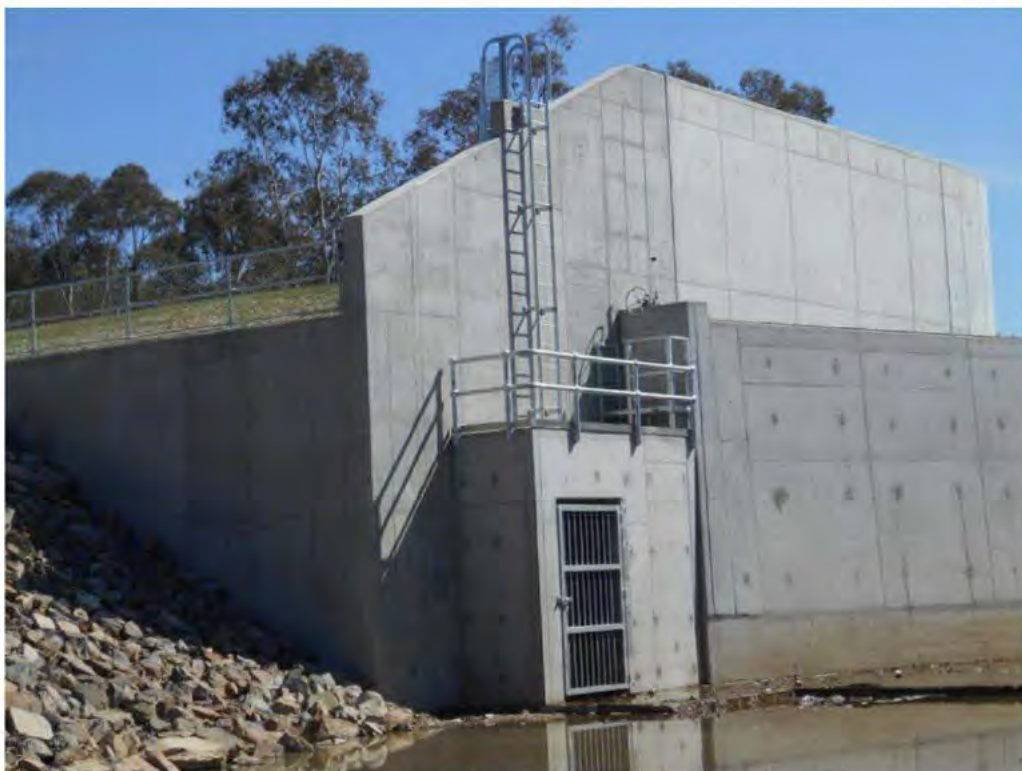
Photograph 13 – General view of the outlet valve chamber, valve operating platforms and access ladders. Note the ladder and bracket for the Devitt arm of the recovery system.

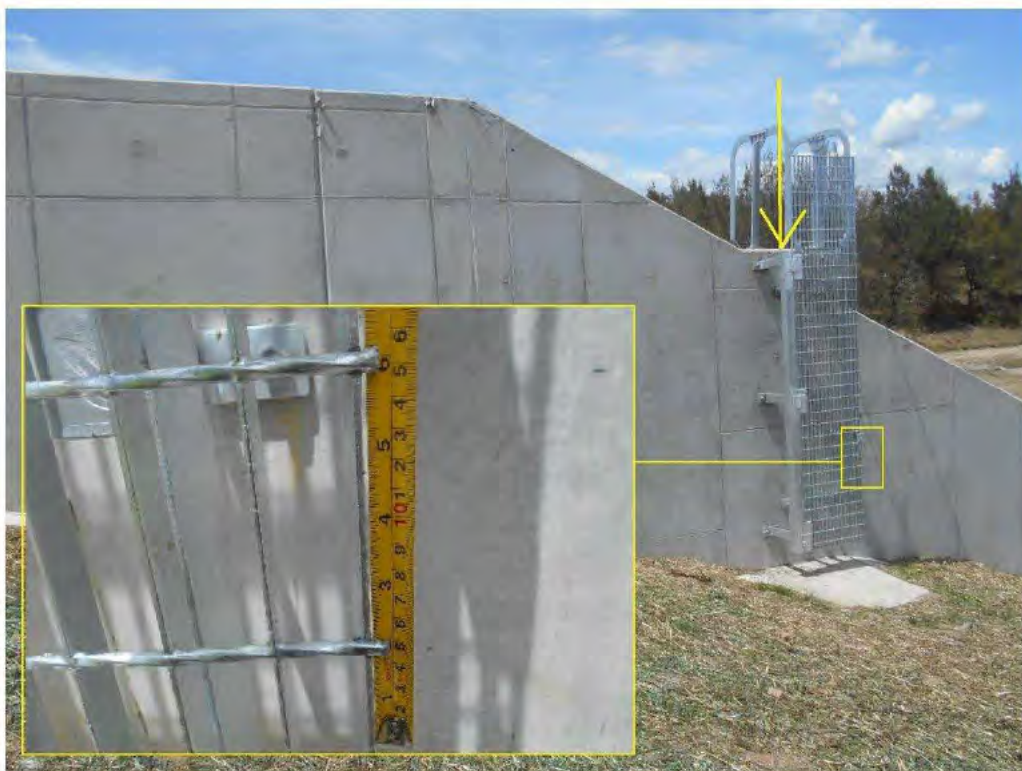
<p>and then the second rung ladder is from top of the concrete wall down to the operating floor at EL 573.20m.</p> <p>A bracket for a portable recovery system (davit arm) is provided at the top of the ladders. The practicality of installation of the safety davit is yet to be proven. It is considered as not required for normal operation and exercise works. However, for high risk works, the safety davit should be installed.</p> <p>A heavy-duty handrail (Including kick board) is provided at the valve operating platform.</p> <p>Access down to the valve chamber can be via another rung ladder from the operating platform through a Gatic cover (filled with concrete). However, if the tail water level is low, access can be through the security gate at the floor level at EL 569.50m.</p> <p>It is noted that the gate locking bolt and lug may not be properly aligned. The bolt pin has been bent, resulting the locking operation being difficult (Photograph 36).</p> <p>The ladder was in good condition. However, there are several sharp edges which introduce the risk of injury (Photograph 14).</p>

Photograph 14 – View of the ladder installed on the external face of the RHS abutment wall of the weir. There are several sharp edges (See inset). The bracket for installation of the “Recovery System” is shown in yellow arrow.

3.3	There are several sharp edges in the ladder (outside of the RHS wall) provided for access to valve operation which can cause injury to personnel.	Clean the sharp edges and repaint with zinc rich paint.	Priority B

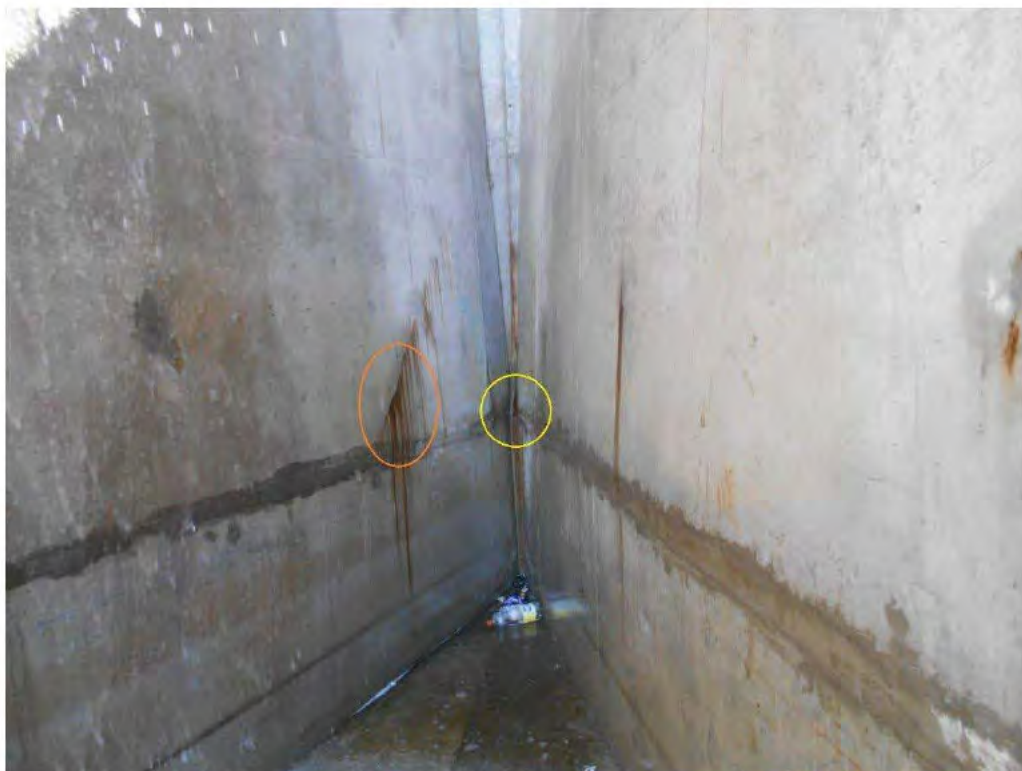
Photograph 17 – General view at the corner of LHS and RHS walls of the Bay 5. Close-up views of defects circled in orange and yellow are shown in Photograph 17 and Photograph 18.

Item	Observations / Issues / Concerns	Recommended Action (by whom)	Status (Priority)
1	Civil Works		
1.1	Cracking and defects of concrete in walls of the labyrinth weir where there was evidence of seepage and brown colour stains.	Request the contractor to provide a method statement outlining the procedure for sealing for approval.	Priority A - 3

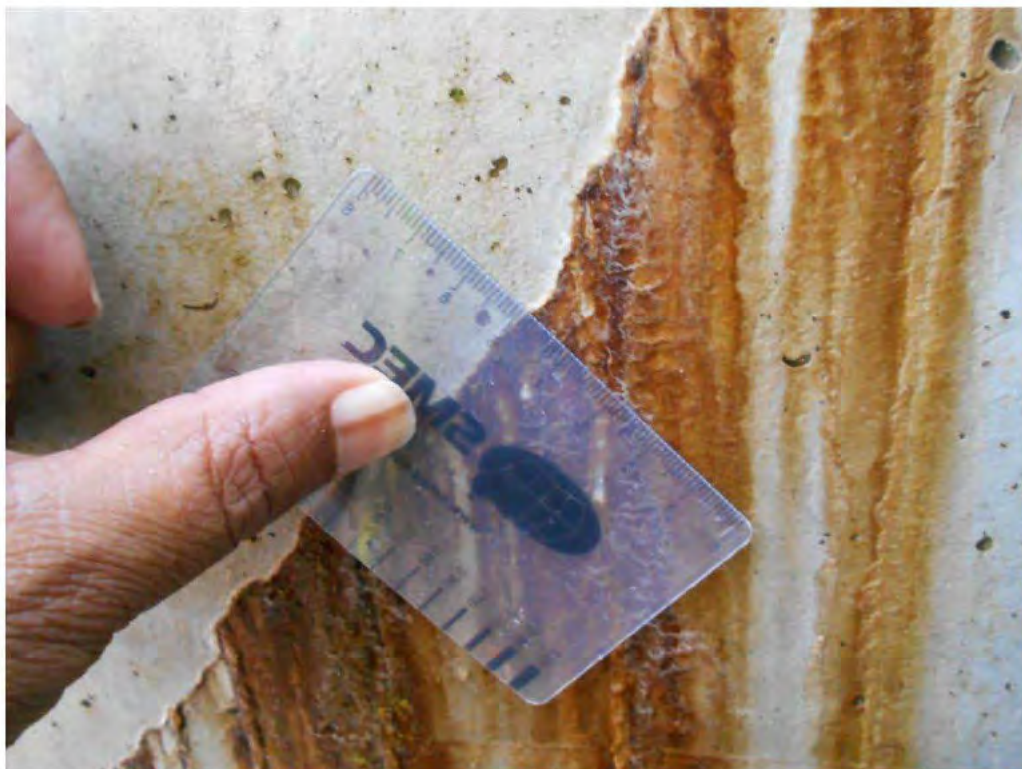
Photograph 18 – A close-up view of a defect on the RHS wall of the Bay 5 (Circled in orange in Photograph 17).

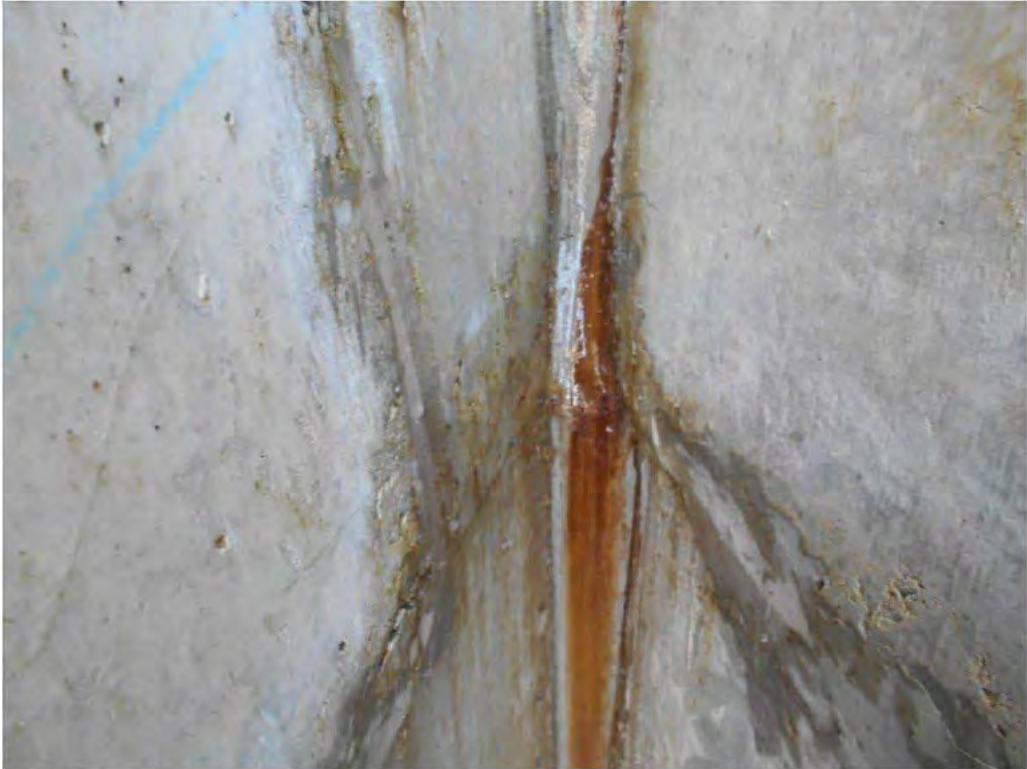
Photograph 19 – A close-up view of a defect on the RHS wall of the Bay 5 (Circled in yellow in Photograph 17).

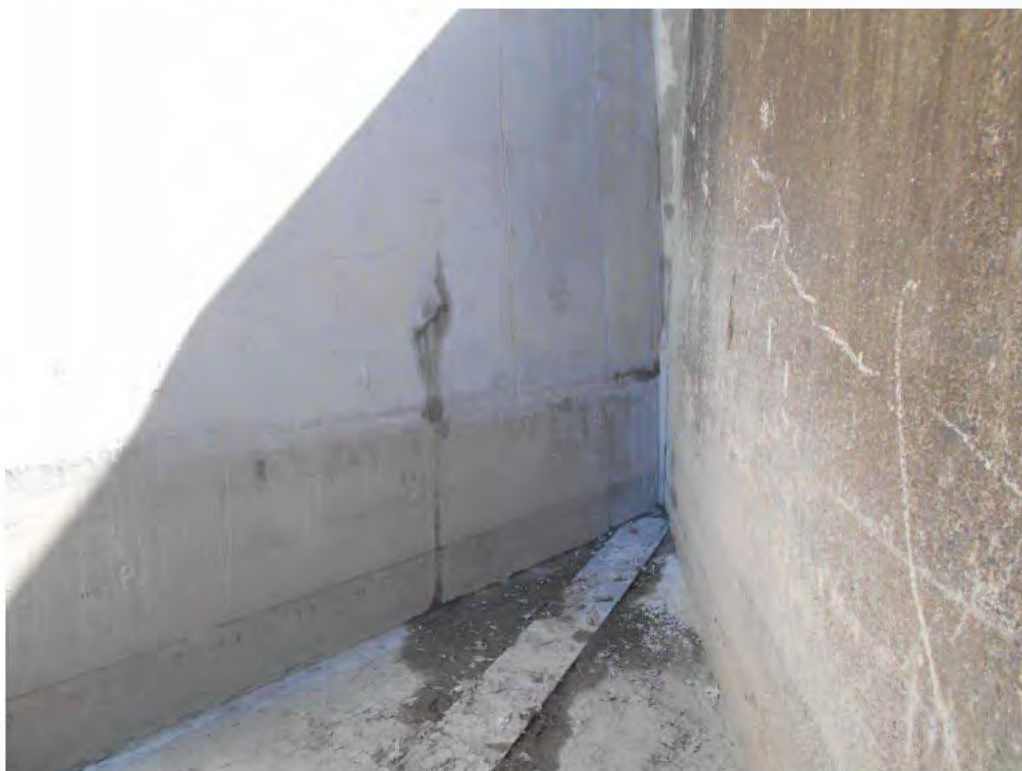
*Photograph 22 – General view at the corner of LHS and RHS walls of the Bay 4.
Note defects where minor seepage was evident.*

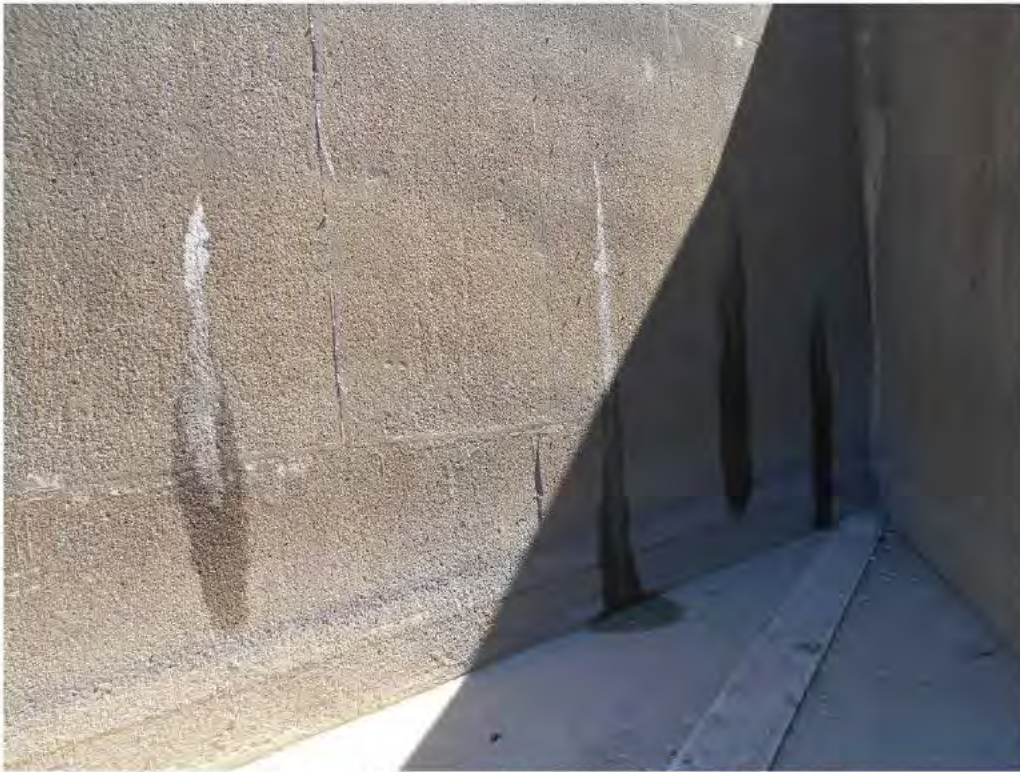
*Photograph 23 – General view at the corner of LHS and RHS walls of the Bay 3.
Note defects where minor seepage was evident.*

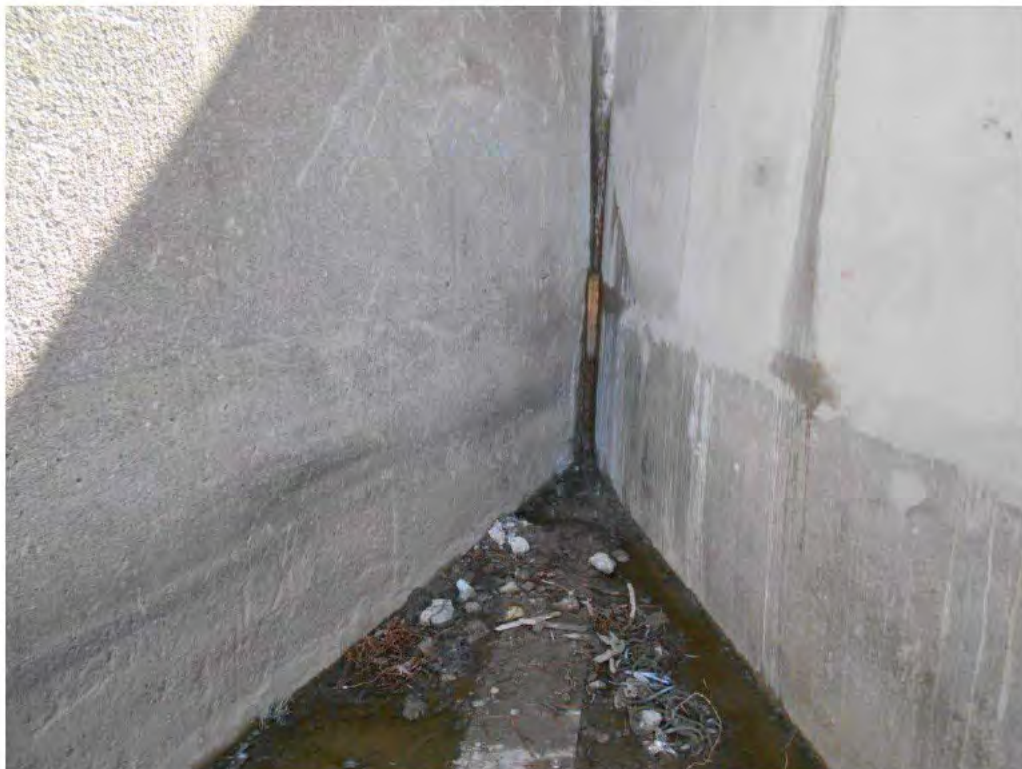
Photograph 25 – General view at the corner of LHS and RHS walls of the Bay 2. Note defects where seepage was evident.

1.3	A substantial water flow was evident through a defect at the upstream corner of walls in Labyrinth Weir Bay No 2.	Request the contractor to provide a method statement outlining the procedure for sealing for approval.	Priority A - 3

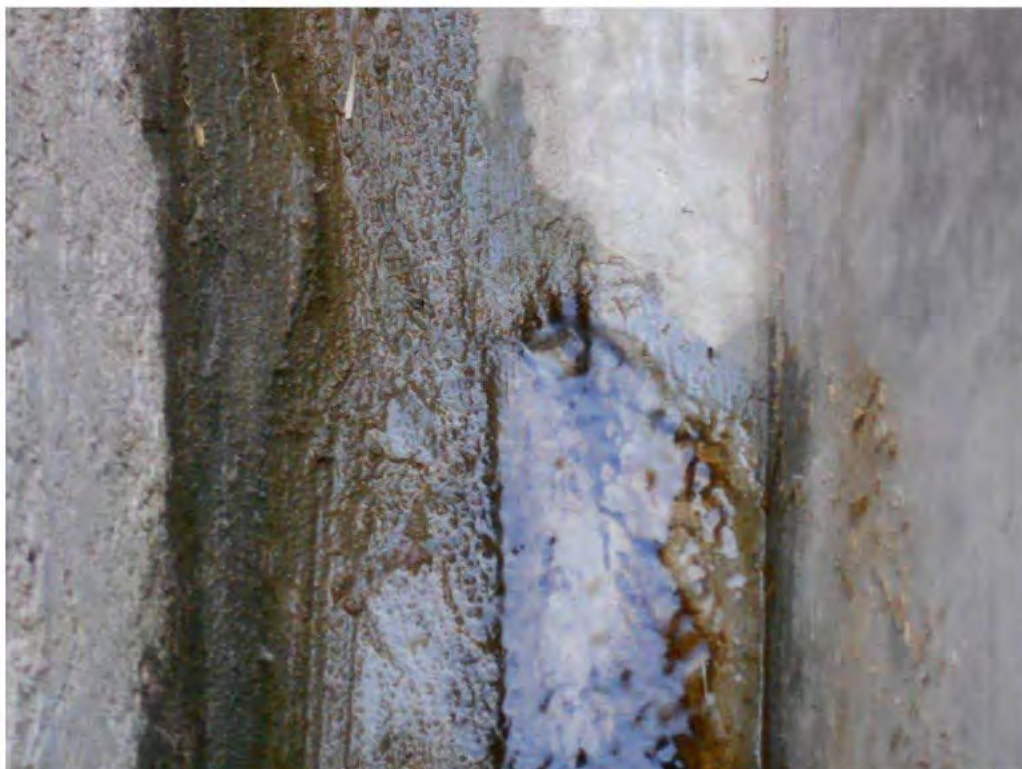
Photograph 26 – A close-up view of the defect at the corner of LHS and RHS walls of the Bay 2 and referred to in Photograph 25.

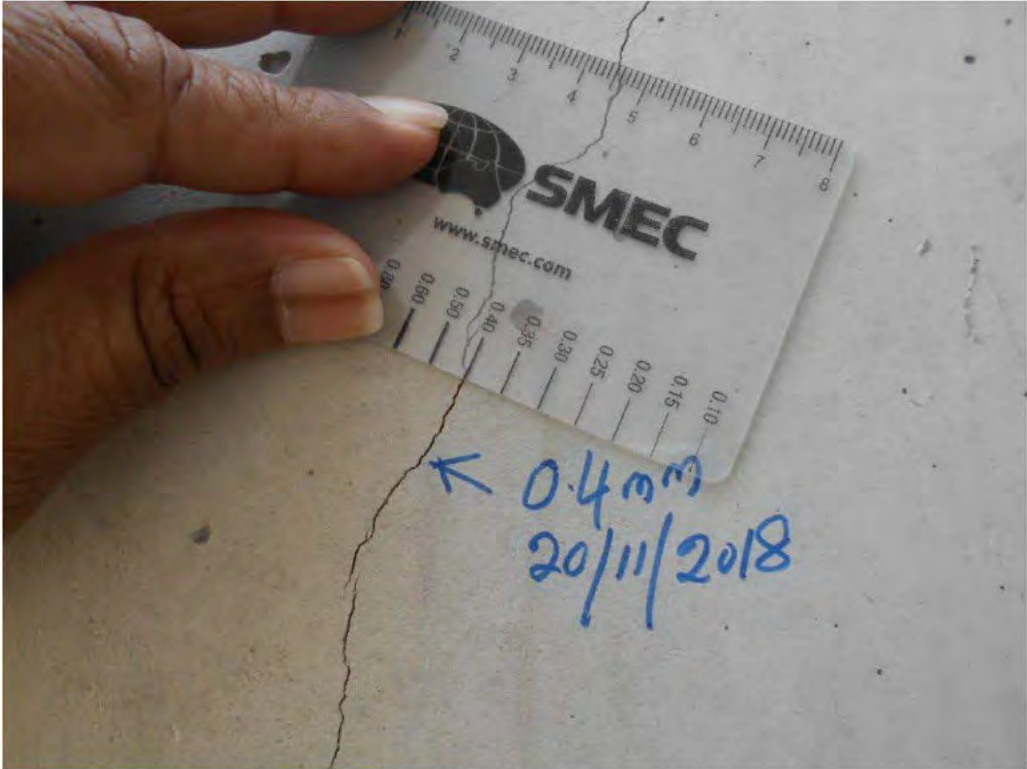
Photograph 29 – A close-up view of a typical crack on the RHS wall of the Bay 1.

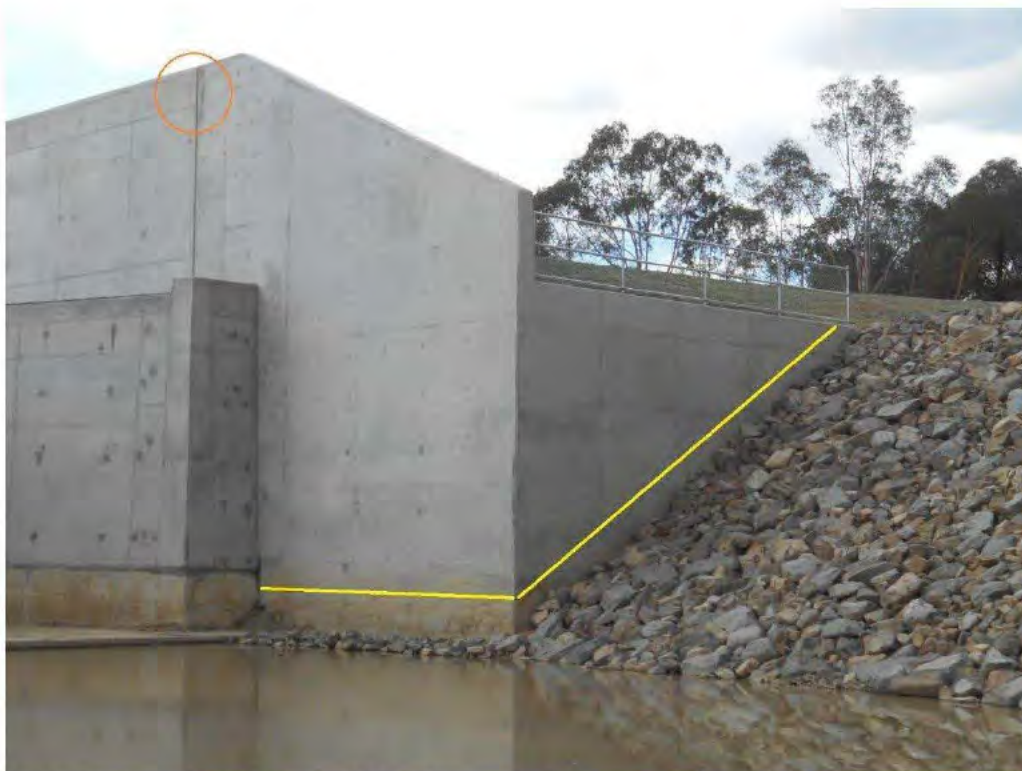
Photograph 31 – General view of the LHS wing wall.

There is no safe access to the downstream apron area from left abutment. Therefore, consideration should be given in providing a hand rail as shown in yellow, or similar acceptable arrangement. A close-up view of the defect repaired during the construction stage (Circled in orange) is shown in Photograph 32.

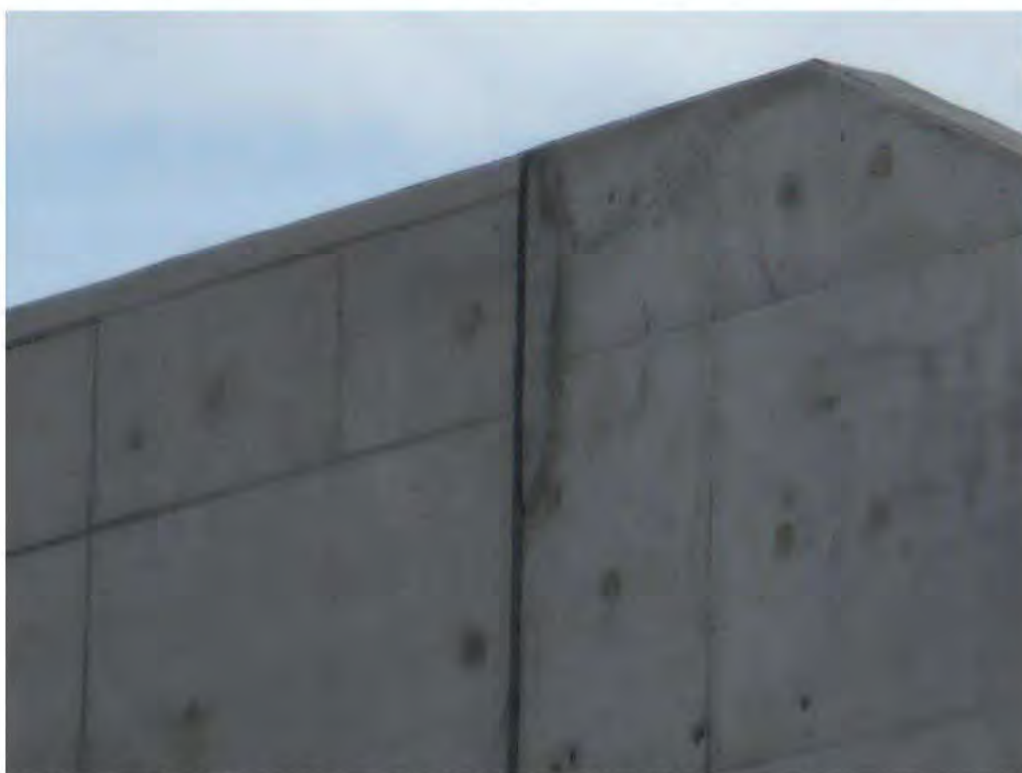
Photograph 32 – A close-up view of the defect referred to in Photograph 31.

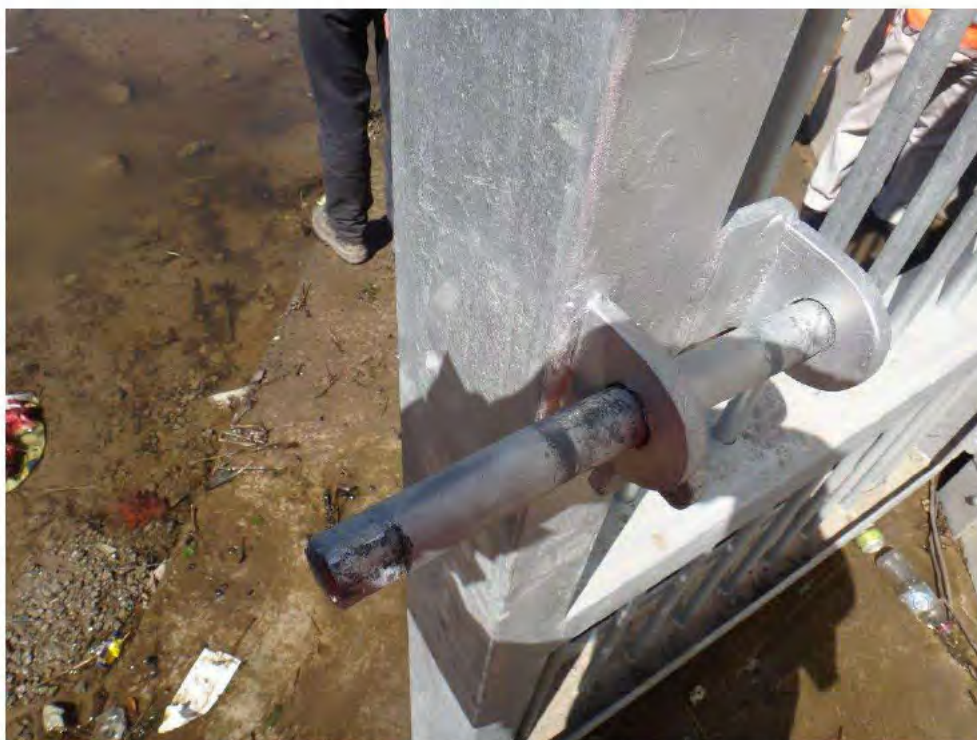
Photograph 36 – View of the locking bolt of the outlet valve chamber with evidence of wear and rubbing due to improper installation.

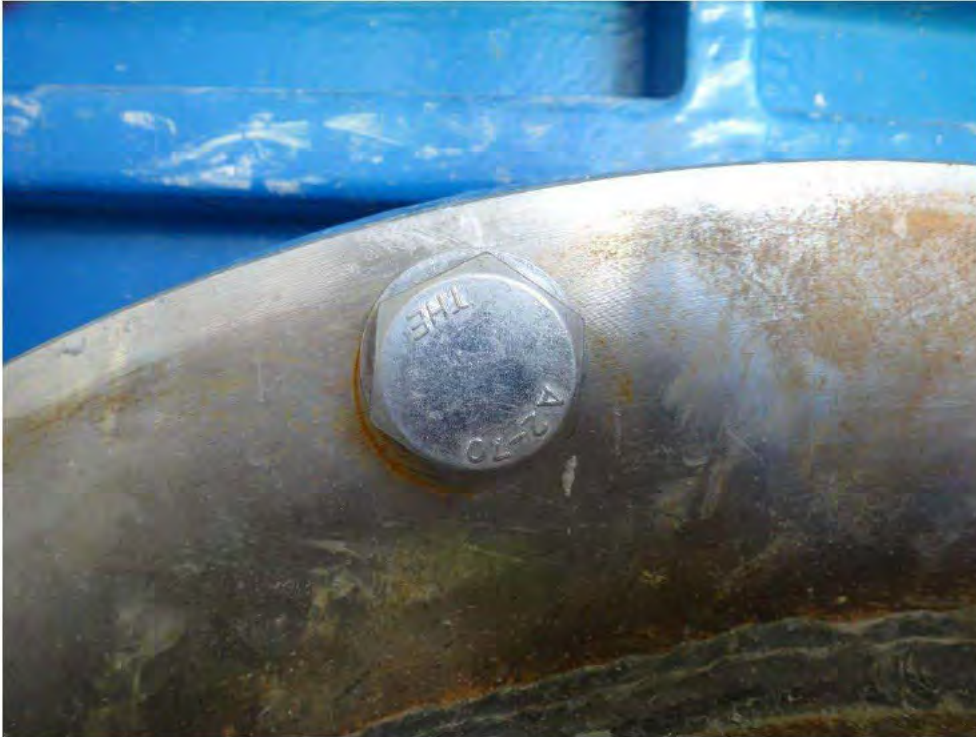
Photograph 37 - Close-up view of gate valve flange showing stained surface from carbon steel contamination.

2.1	One missing bolt and one loose bolt on the gate valve flange.	Tighten the loose bolt and replace the missing bolt.	Priority A-1
2.2	Stainless steel pipe and flanges seems to be contaminated and corrosion has started.	Clean and re-passivate these components.	Priority A-1

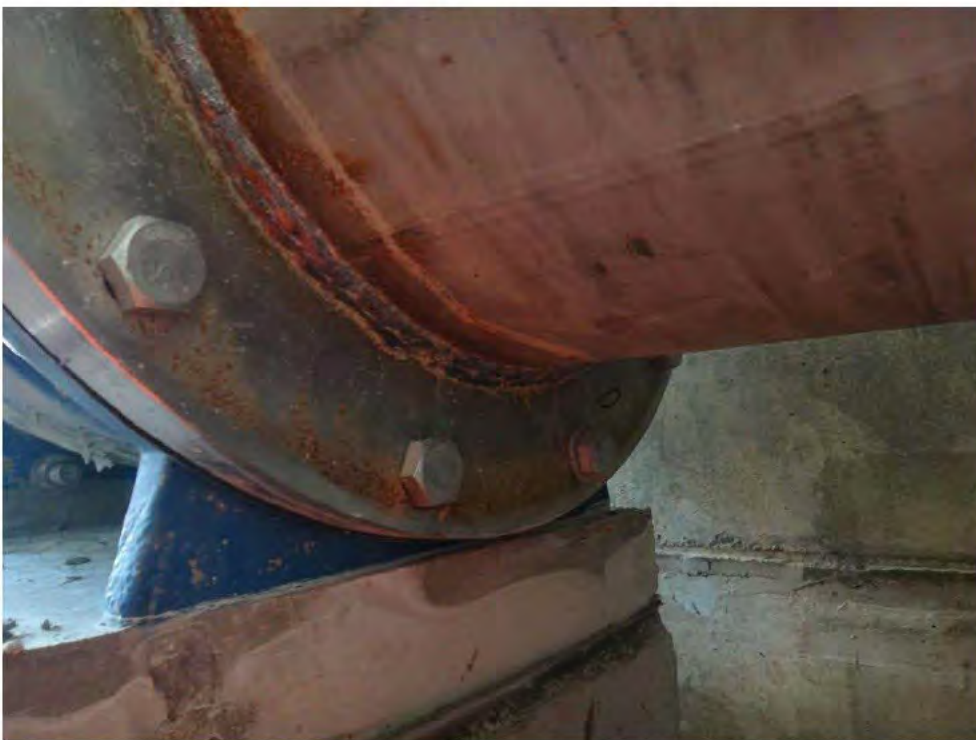
Photograph 38 – View of the underside of the stainless-steel pipework and flange showing improper preparation of works on stainless steel. There was evidence of surface corrosion. The bolt seen LHS of the photograph was found to be in loose state.

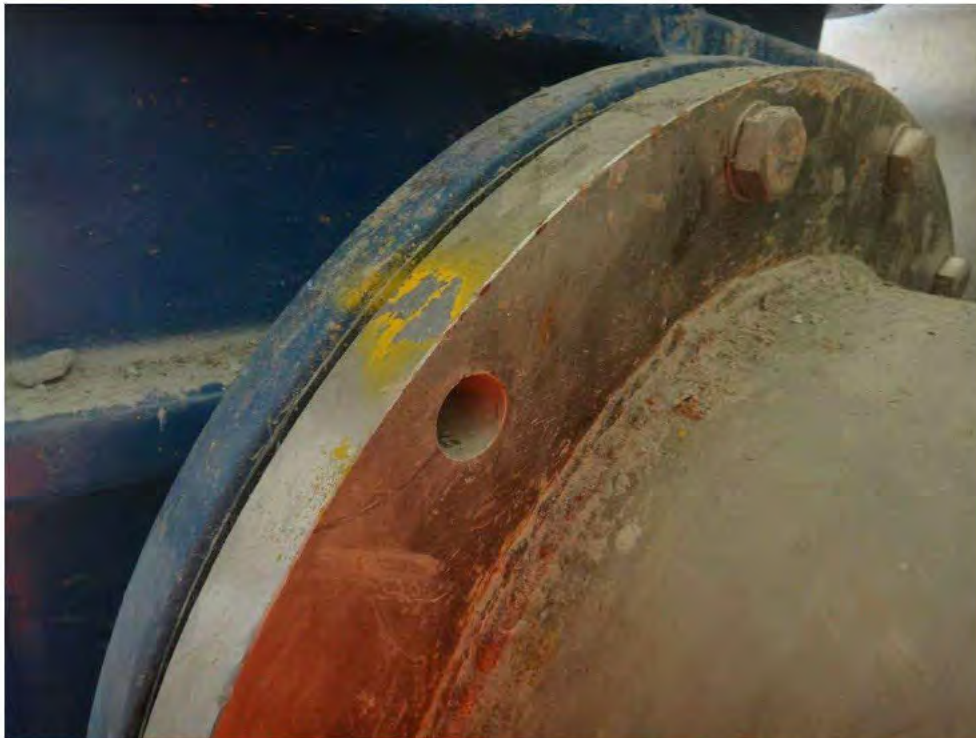
Photograph 39 – View of the upstream flange of the gate valve where one bolt was missing.

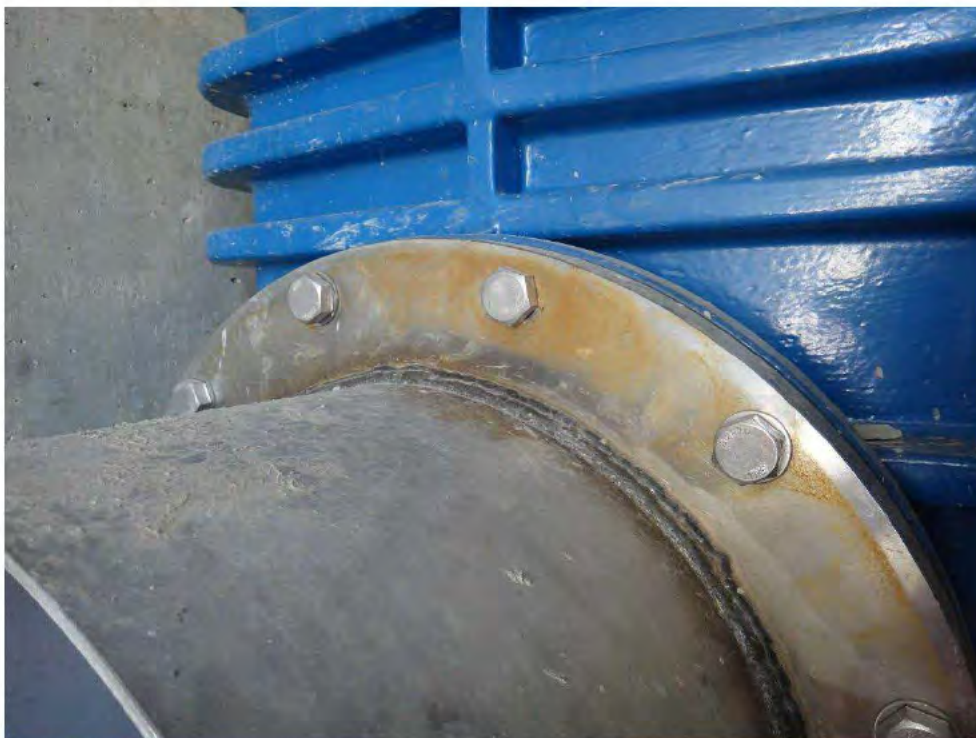
Photograph 40 – A Close-up view of the flange of the gate valve where there is evidence of stains from carbon steel contamination.

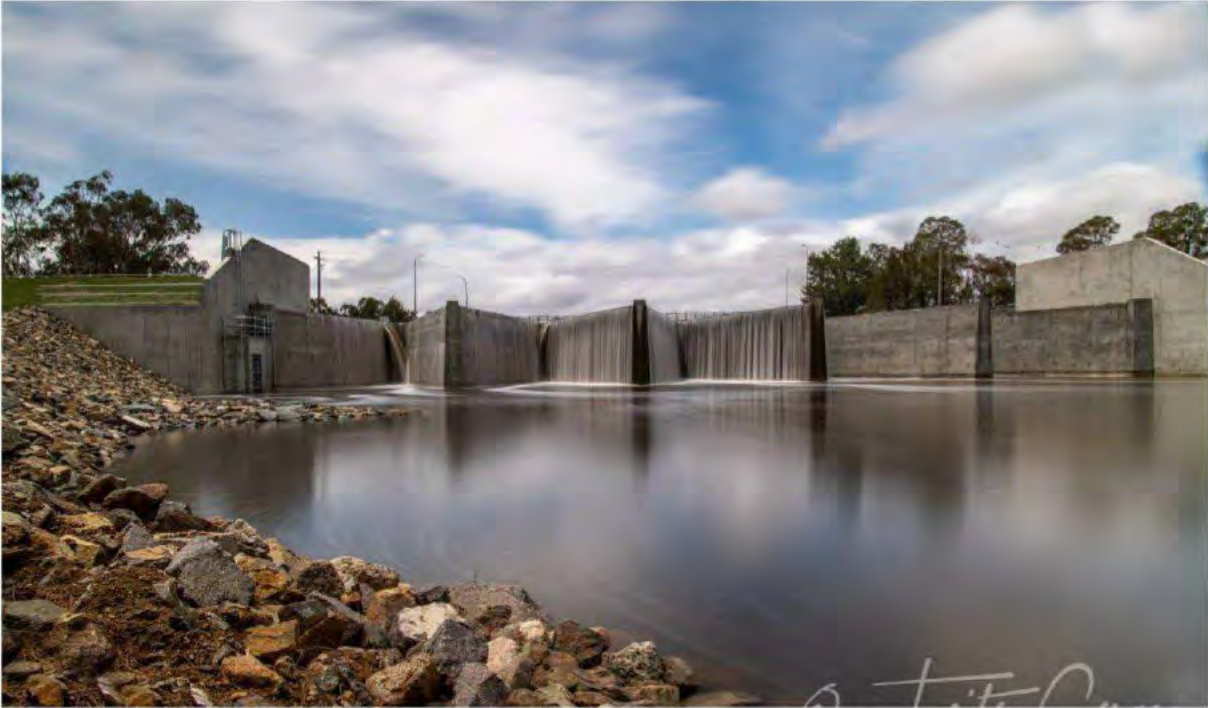
*Photograph 43 (19 December 2019) – Downstream view of the weir.
Spilling was not observed in Bays 1 (LHS end) and 2.*

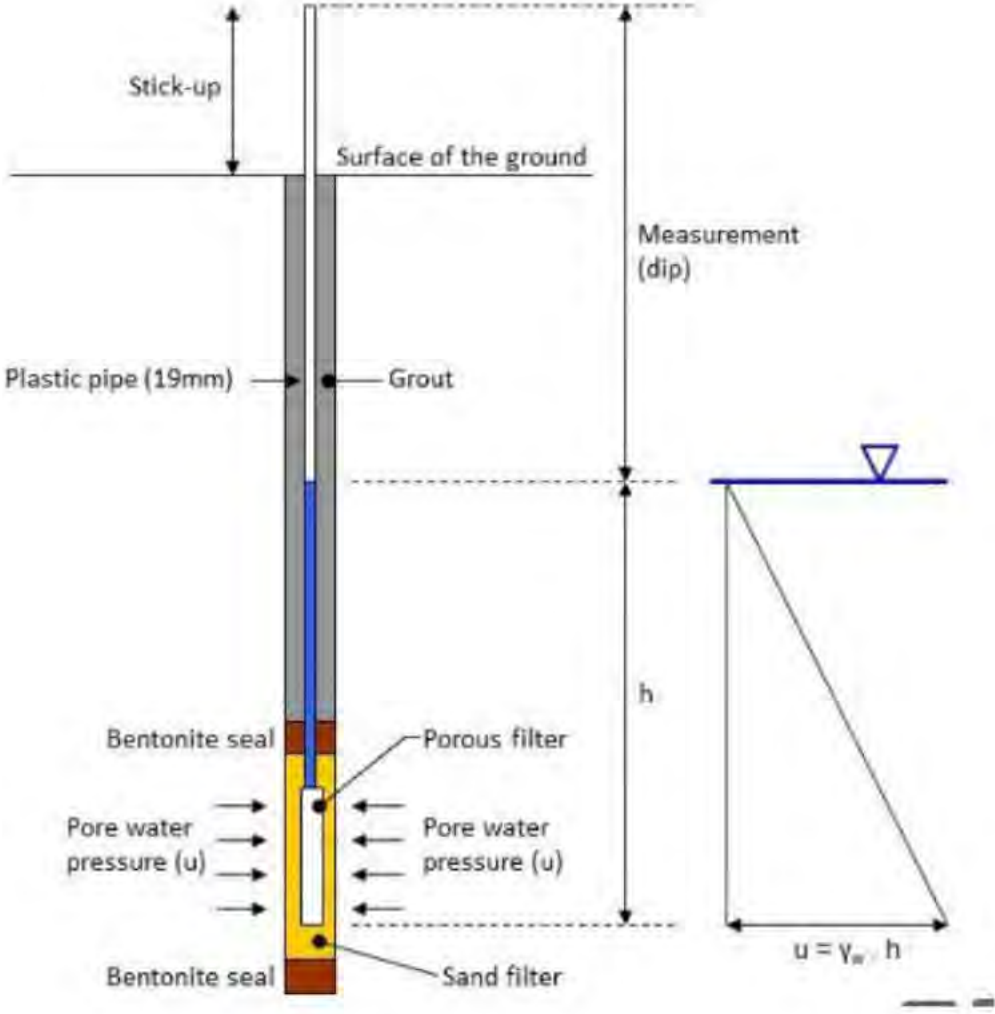
ISABELLA WEIR
Standard Casagrande Type Piezometer Standpipe detail provided by client

Water-level observation boreholes IW-PEI-001 and IW-PEI-002 at Isabella Weir are Casagrande type standpipe piezometers, and were installed within the abutting earth embankment foundations, on either side of the concrete weir structure. The 150mm diameter holes were bored by a mini excavator with an auger attachment on 10 September 2018 to 5.93m and 7.18m depth below crest surface level for piezometers IW-PEI-001 and IW-PEI-002 respectively. 100mm Diameter PVC pipes, slotted in the lower "pick-up" section, were installed for the full depth, and the "pick-up" zone sealed top and bottom by a bentonite layer within the annulus of the 150mm dia auger-hole. A cement/bentonite swelling grout was then poured into the annulus to the surface. A 1m long, . square-section steel outer casing pipe with lockable cap was then embedded at the surface during pouring of the concrete plinths on 10 September 2018. The typical installation arrangement is shown in Figure 3. The installation of the piezometers was in accordance with Guideline specifications.

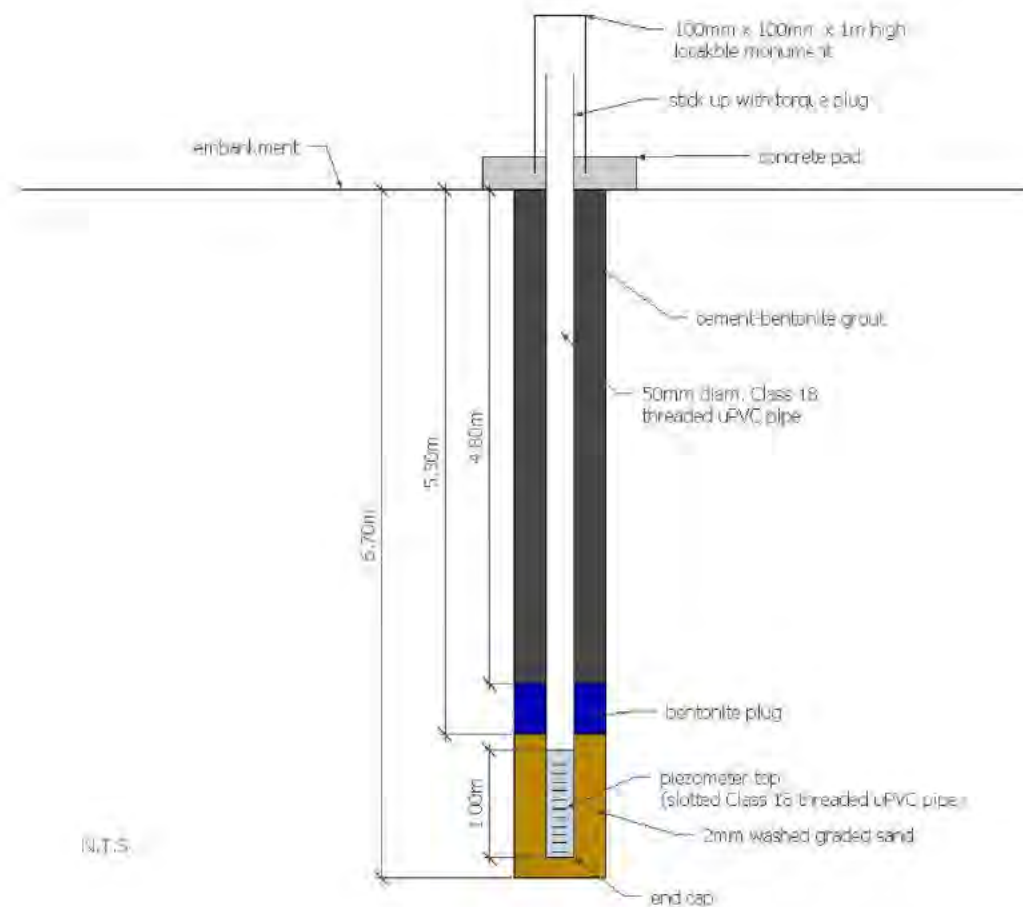
ISABELLA WEIR
Standpipe Piezometer Installation Field Sketch – left abutment

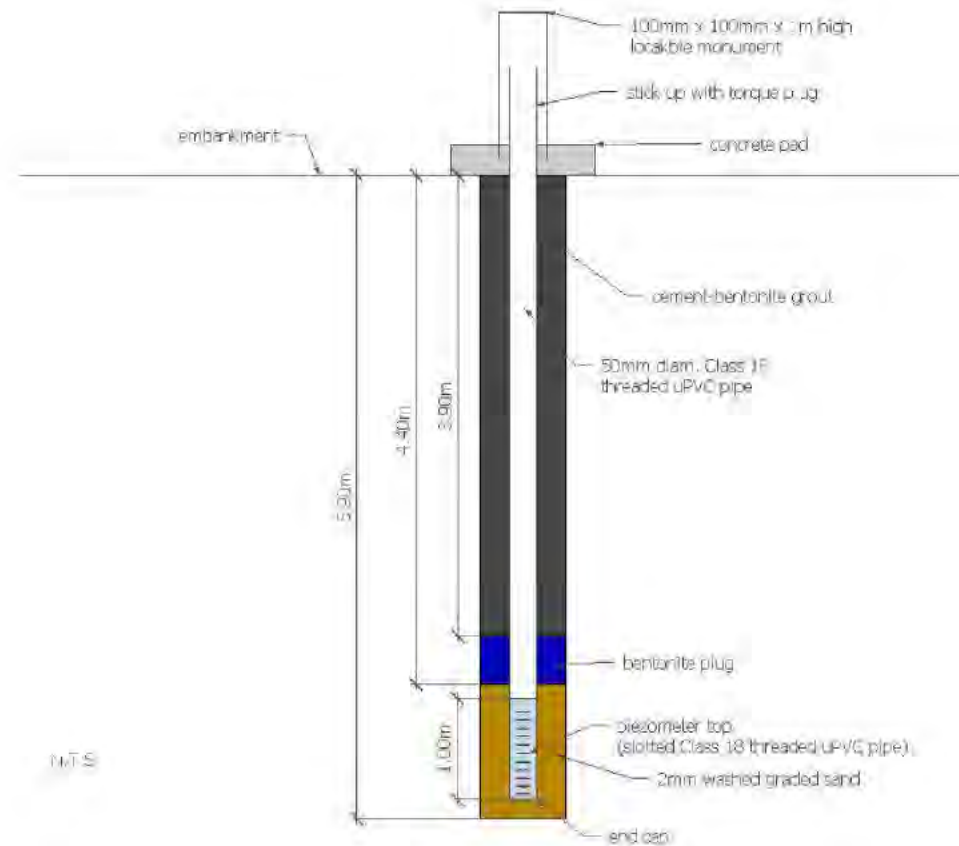
ISABELLA WEIR
Standpipe Piezometer Installation Field Sketch – right abutment
