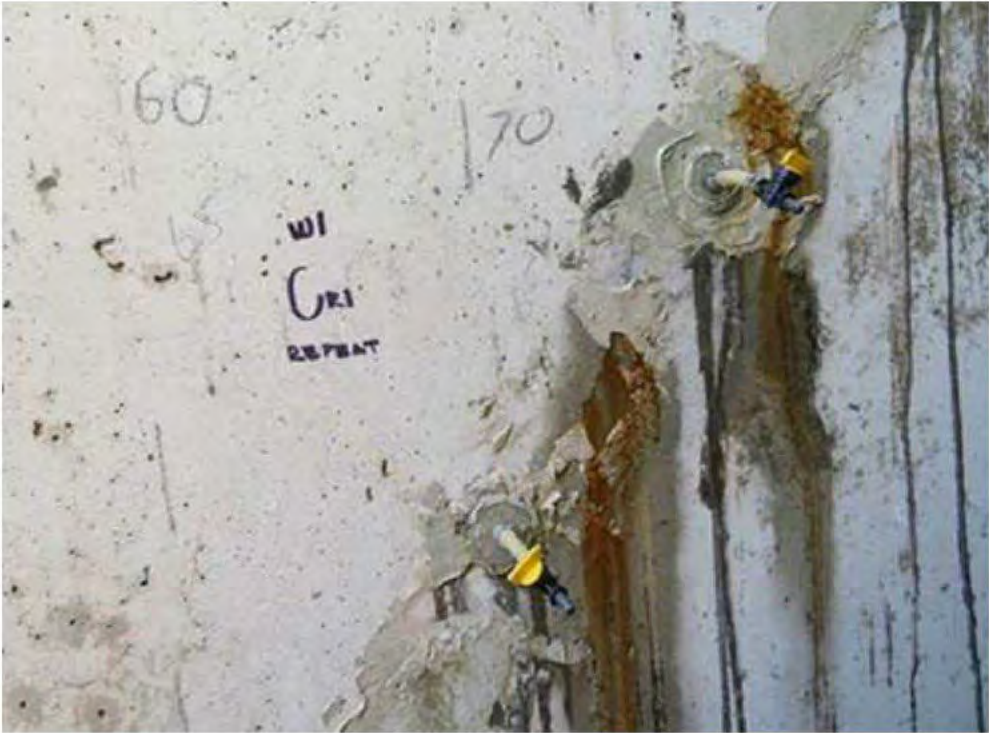
1. Cracks injection to seal the cracks were failed.

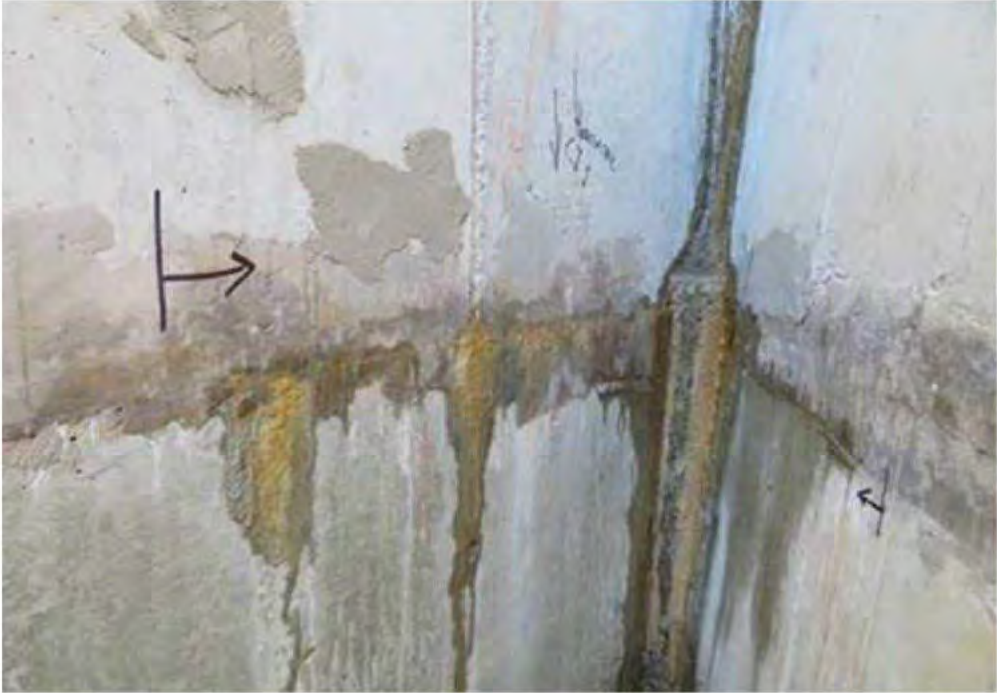
2. Water seeping through construction joint near contraction joint 5

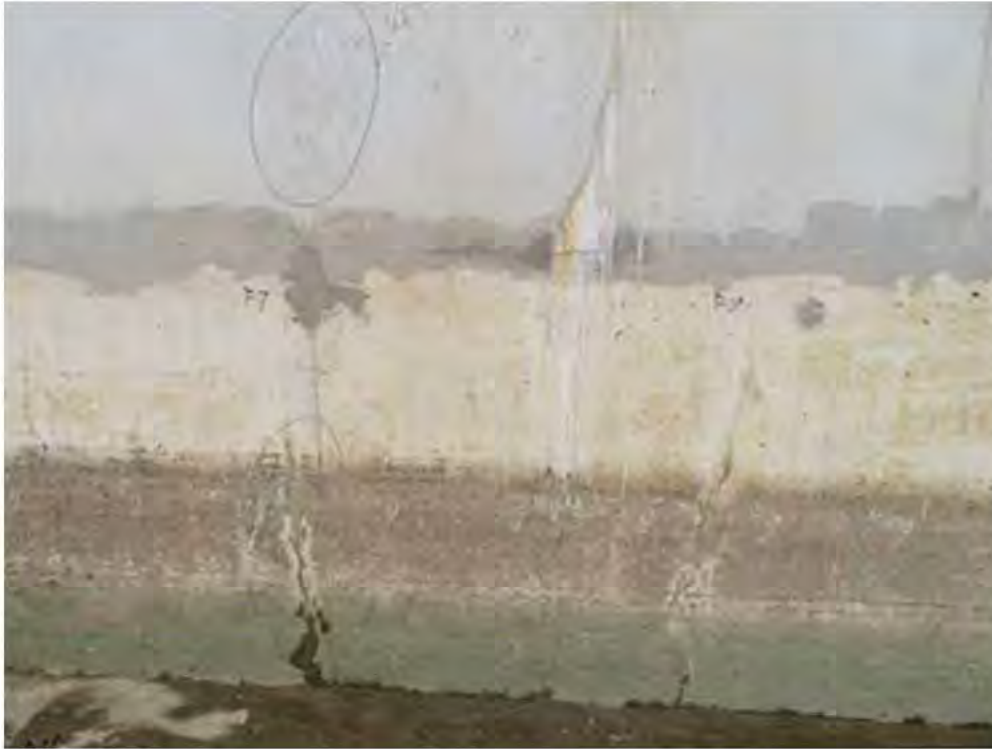
3. Water seeping through cracks on foundation slab (this is mainly on wall 9 and 10). Photograph is referring to wall 10, cracks 7 and 8 only.
