ACT
Government

Territory and Municipal Services

Cycle Separation Trial

**Final Draft Report
2015**

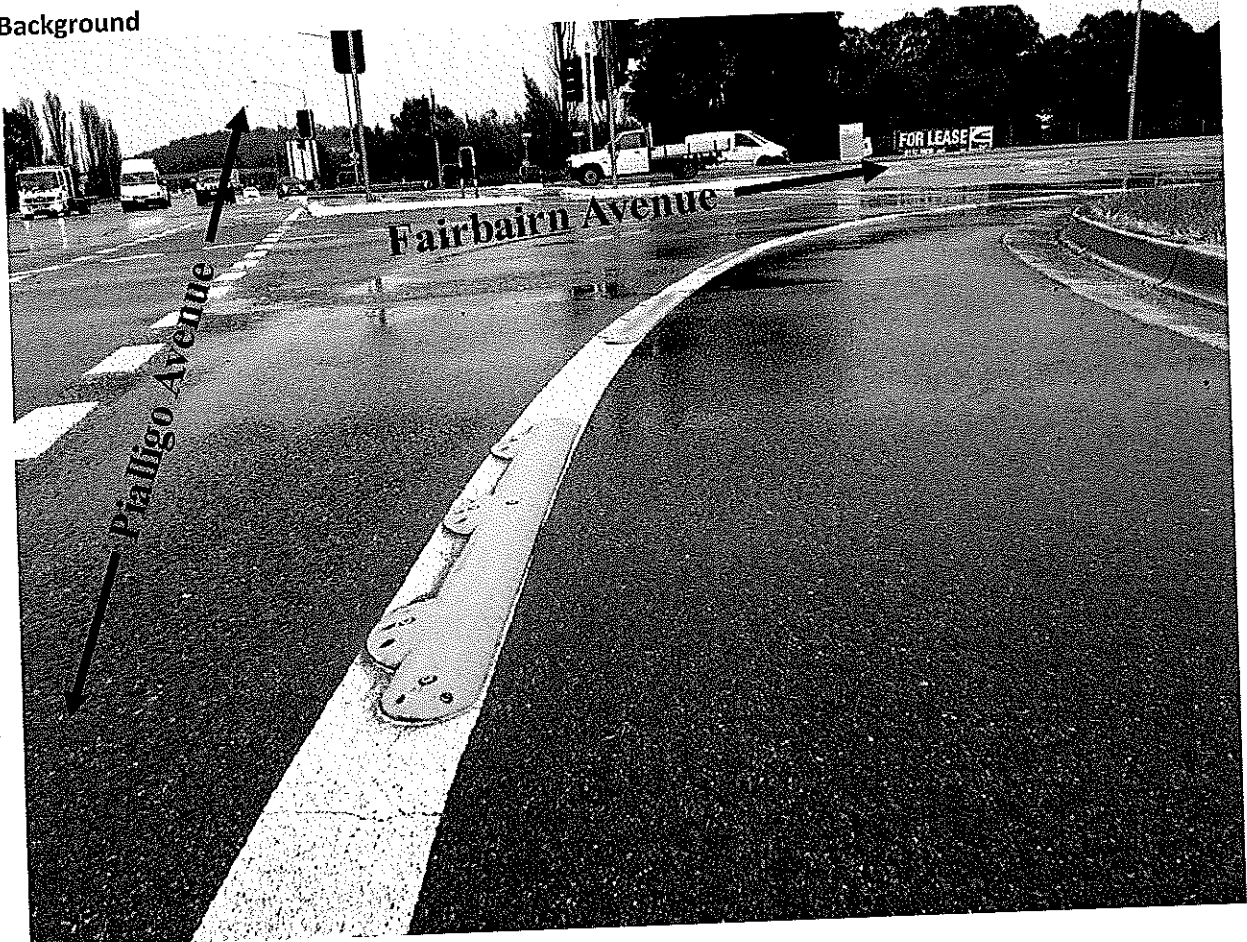
Figure 4. 12 months after installation

Riley kerb was trialled at this location due to the high proportion of motorists encroaching onto the cycle lane as they make a left turn from Fairbairn Avenue to Pialligo Avenue, and due to a large proportion of these vehicles being heavy vehicles.

During the 12 months that the devices were monitored, noticeable discolouration due to rubber markings from vehicle tyres was apparent.

During the 12 month period in which the riley kerb device was monitored, a significant proportion of heavy vehicles encroached onto the on road cycle lane. This is due to the tight turning circle as motorists make a left turn from Fairbairn Avenue to Pialligo Avenue. But, this device was effective in deterring passenger vehicles away from the on road cycle lane, whilst informing heavy vehicles of the on road cycle lane. An insignificant portion of passenger vehicles were observed hitting the device, during the inspections conducted.

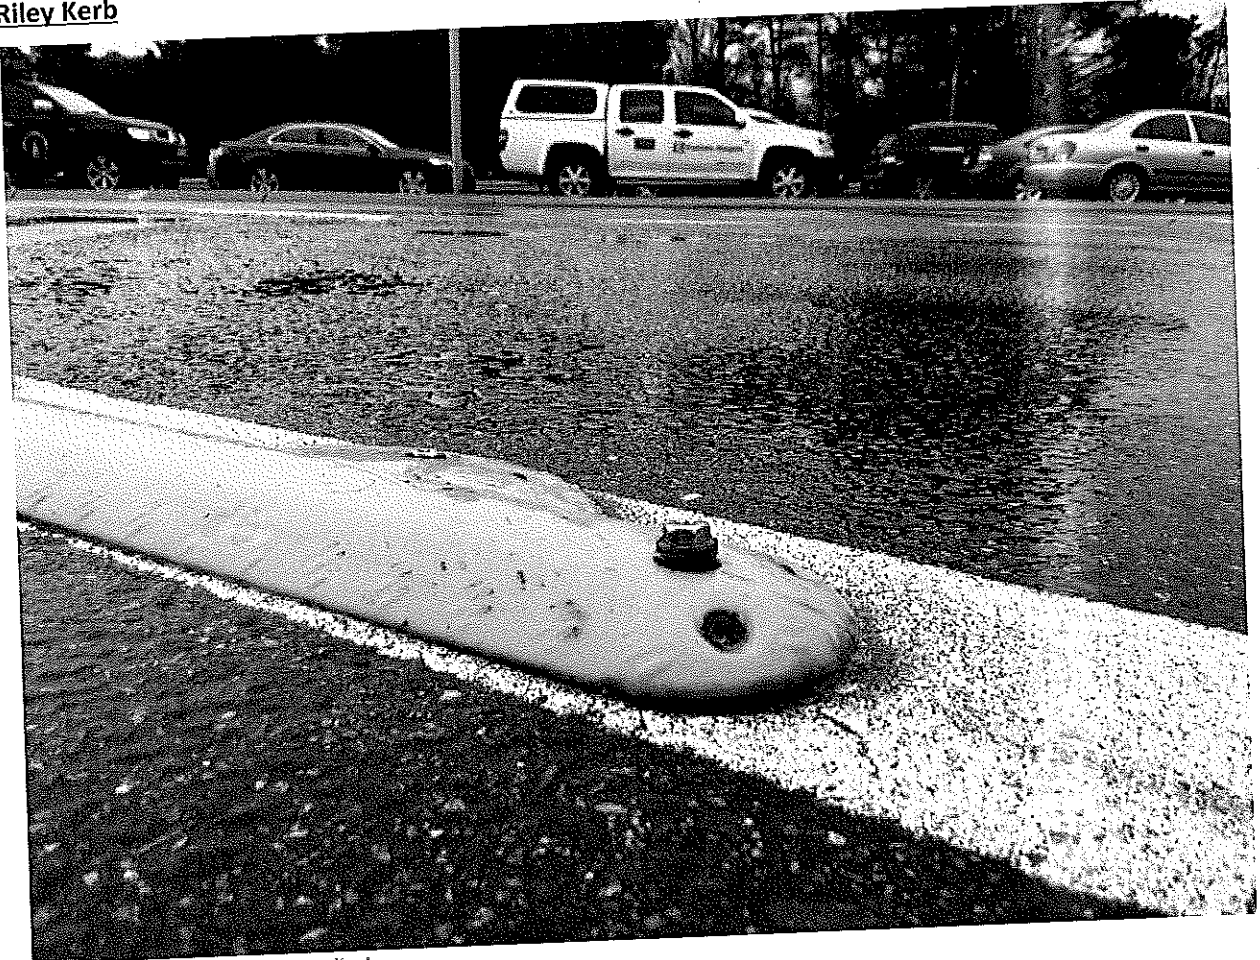
Figure 5. 12 months after installation

There were not any significant damages to the device, apart from some experiencing loose bolts. This could be due to the high proportion of heavy vehicles encroaching onto the cycle lane when making a left turn onto Pialligo Avenue, driving over the devices.

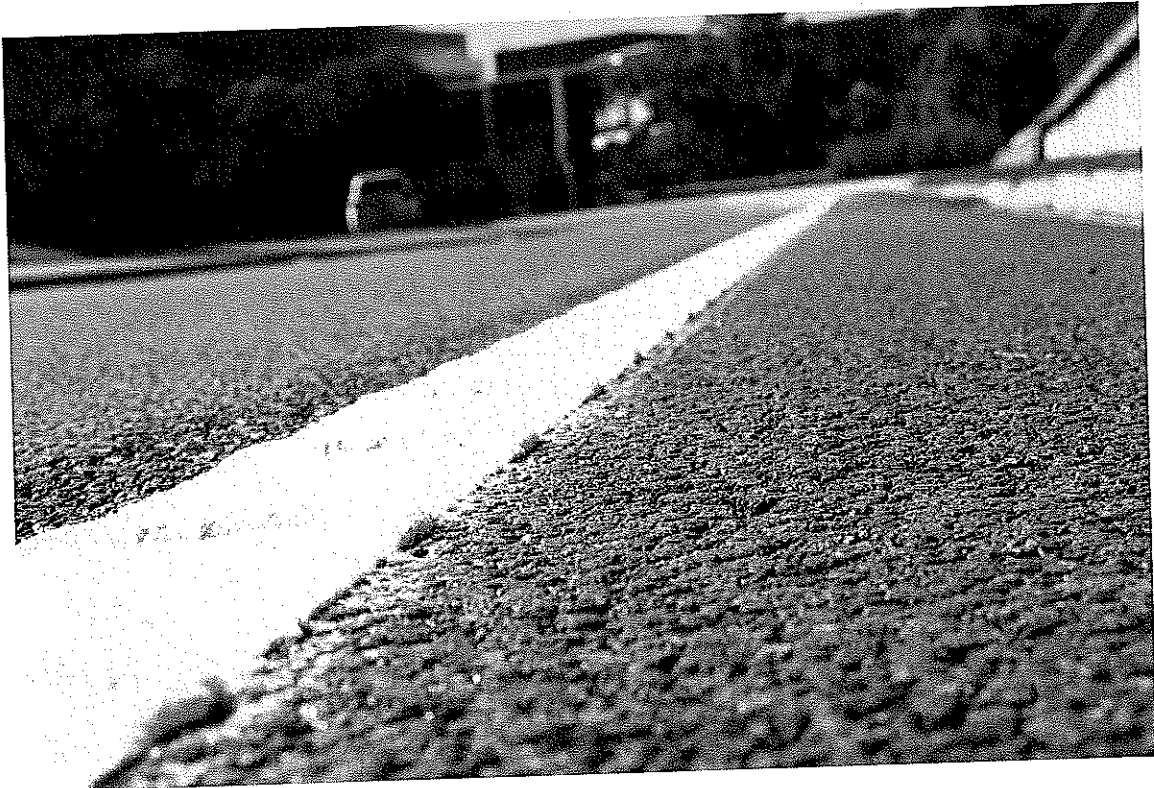
Figure 6. ATLM

Screed applied audio tactile thermo plastic line marking commonly referred to as “rumble strips” - is used to provide an audible and vibratory alert to motorists. Similar to rumble strips used on highways to target driver fatigue, these devices alert the driver if they encroach onto the adjacent cycle lane. The line marking consists of a 2mm thick continual base and an intermittent 8-10mm raised profile. Unlike other devices, rumble strips do not use any additional road space, as it is applied over the existing line marking. This profile allows cyclists to enter and exit the lane as they please, whilst allowing water to flow over as designed. Rumble strips contain glass beads in the thermoplastic for added reflectivity across the line marking for delineation at night.

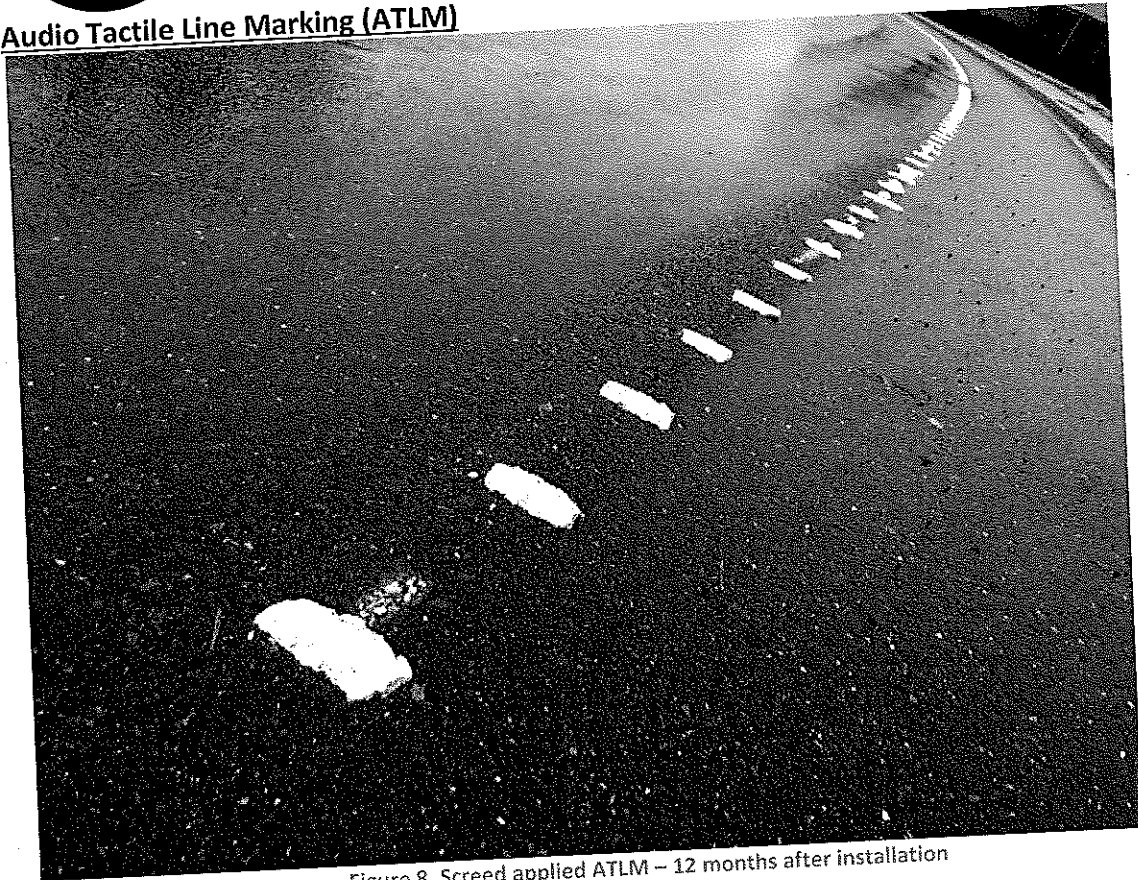
Figure 8. Screed applied ATLM – 12 months after installation

ATLM was the most susceptible to damage out of the 3 devices trialled.

Initially the ATLM was screed applied at all locations mentioned above. But, preformed ATLM layers were applied a month after the initial installation to areas that experienced high levels of delamination.

As shown in Figure 8, durability of ATLM decreased at screed applied thermoplastic areas compared to preformed thermoplastic. However, the costs associated with preformed were significantly greater than screed applied.

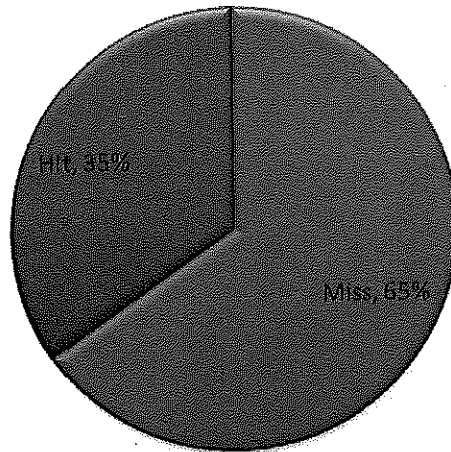
Figure 12. Total vehicles - 6 months after installation

Total vehicles - 6 Months After Installation									
	Total	Avoided	% avoided	Encroached	% encroached	Not reacted	% not reacted	Reacted	% reacted
Small vehicles	869	588	68%	281	32%	158	56%	123	44%
Heavy vehicles	53	14	26%	39	74%	33	85%	6	15%
Total vehicles	922	602	65%	320	35%	191	60%	129	40%

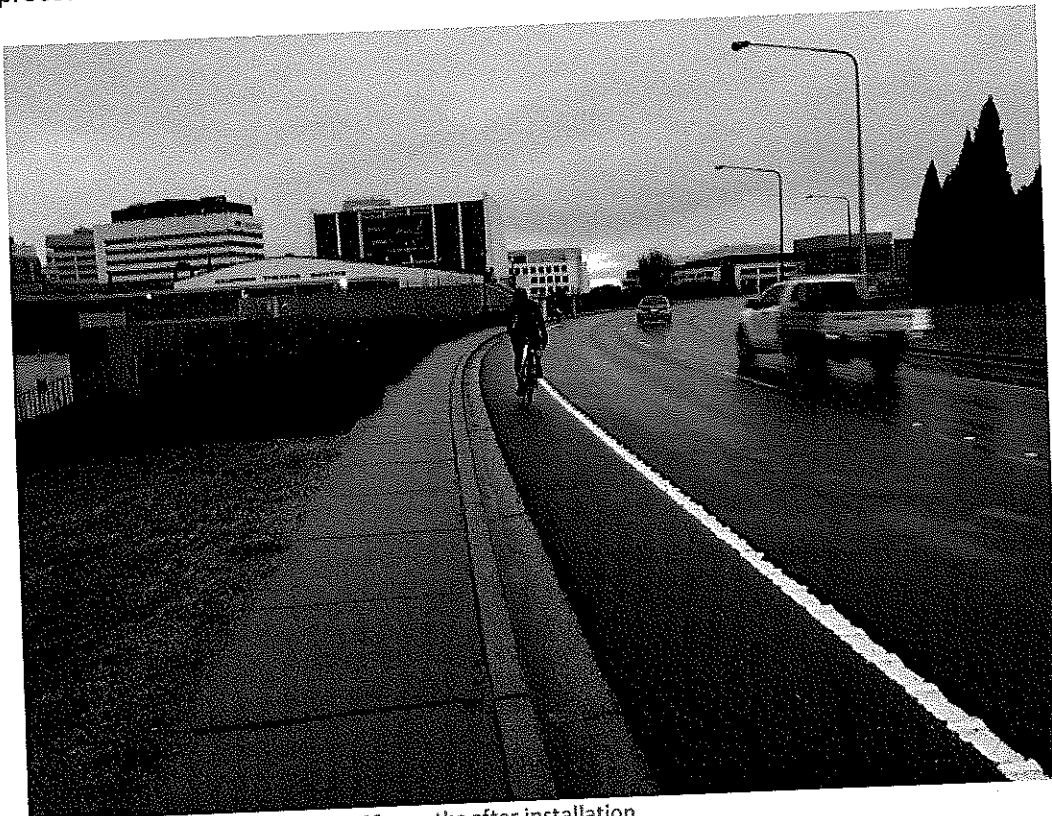
Figure 14. Screed applied ATLM – 12 months after installation

Audio Tactile Line Marking separation devices do not require additional road space, as it is typically applied over the existing edge line line marking. If ATLM is to be screed applied, particular attention must be given to the installation (i.e. road surface conditions/temperature, application of line marking, etc) of the product. Not all screed applied sections experienced deterioration to the same extent as shown in Figure 8. However the durability of these varied, depending on the quality of the installation process.

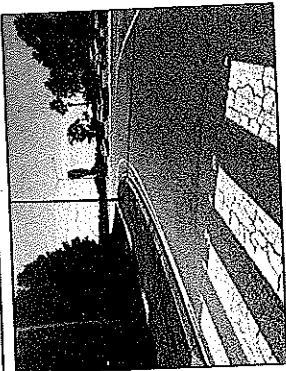
PROPOSED SITE AT
NORTHBOURNE AVE-BARTON HWY

EXISTING LINEMARKING, SIGNS, KERBS AND CONCRETE.
	APPLY TACTILE LINEMARKING
	APPLY NEW LINEMARKING
	EXISTING KERB/LINEMARKING
	EXISTING SIGN W/CODE

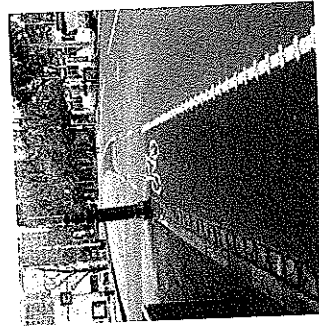
AUDIO TACTILE LINEMARKING
AS APPLIED IN MELBOURNE

AUDIO TACTILE LINEMARKING PROFILE
