FOI Reference: CMTEDDFOI 2020-144

Subject  
**Request for Information - Contamination Assessments and Environmental Audit Reports - Block 14 Section 38 Fyshwick and Block 11 Section 47 Fyshwick**

Client: Indec Consulting  
Project: UST Removal and Excavation Validation  
Location: Kingston, ACT

URS Summary Review

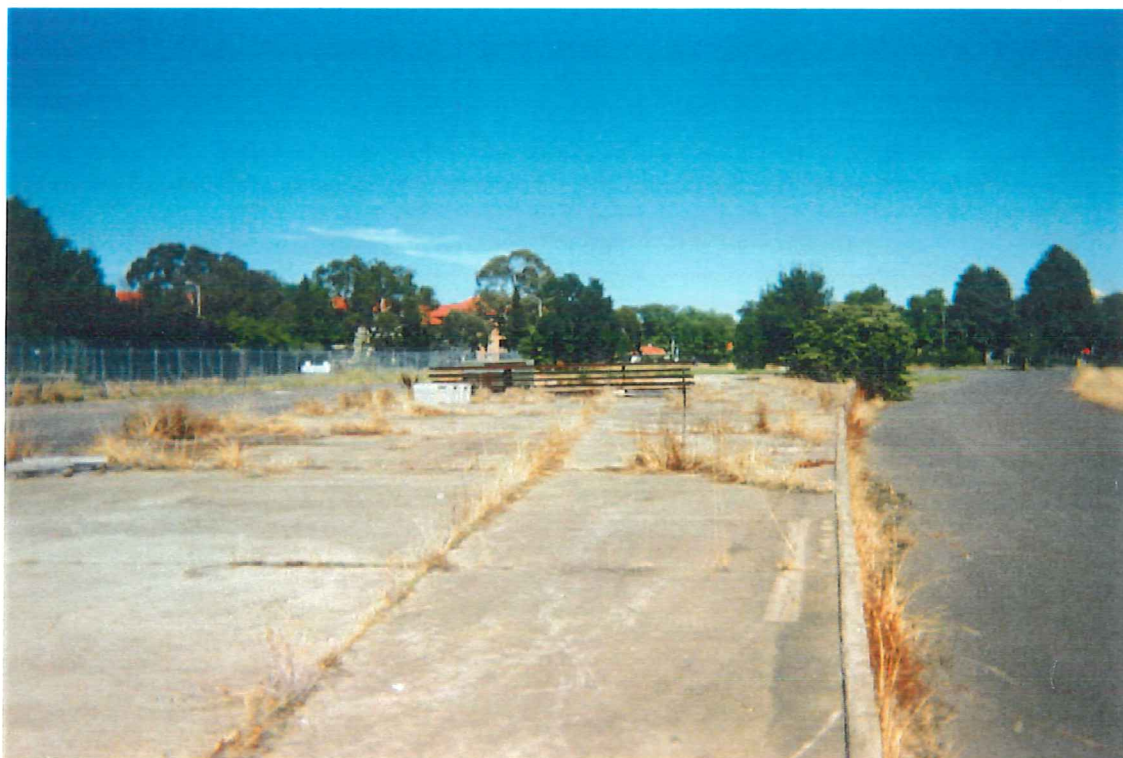
**Photo 1: No evidence of asbestos sheeting on surface soils or slabs.**

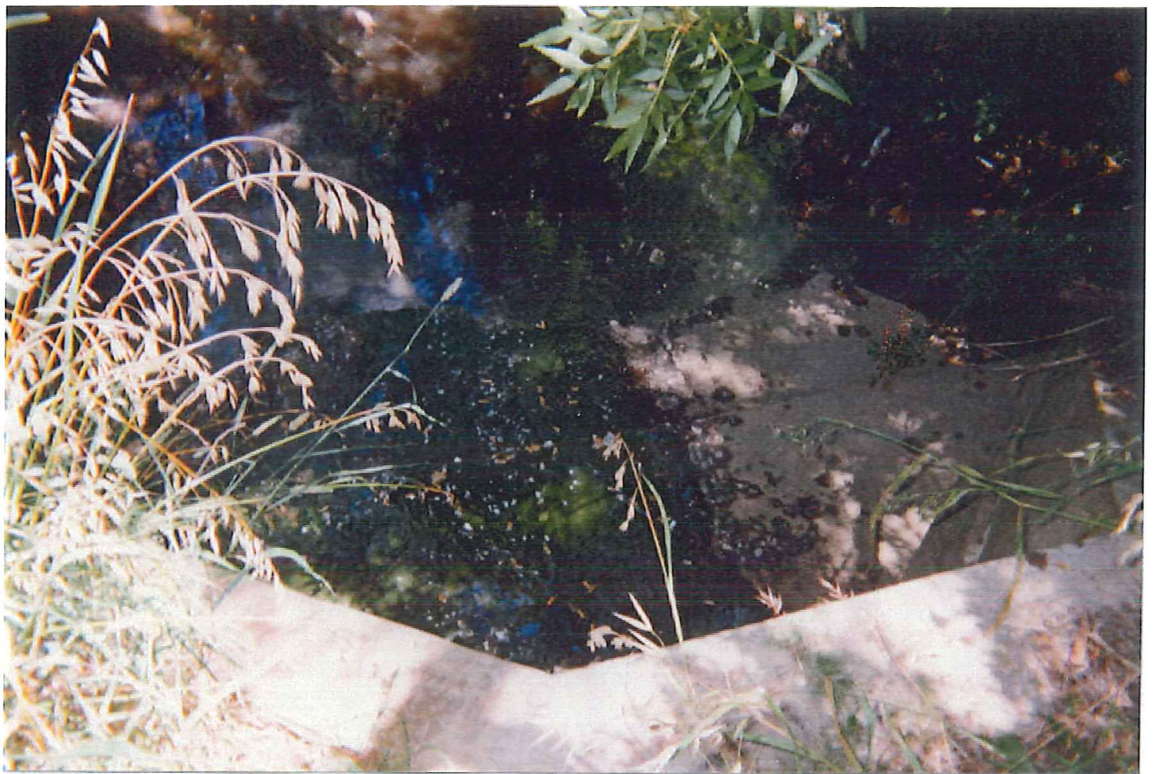
**Photo 2: Stormwater drain – no evidence of oil or oil staining.**

Site inspection on 20 December 2000 confirmed the areas previously identified as potential disposal drains for oily water showed no visual evidence of oil stain or residue (see Photographs Appendix C).

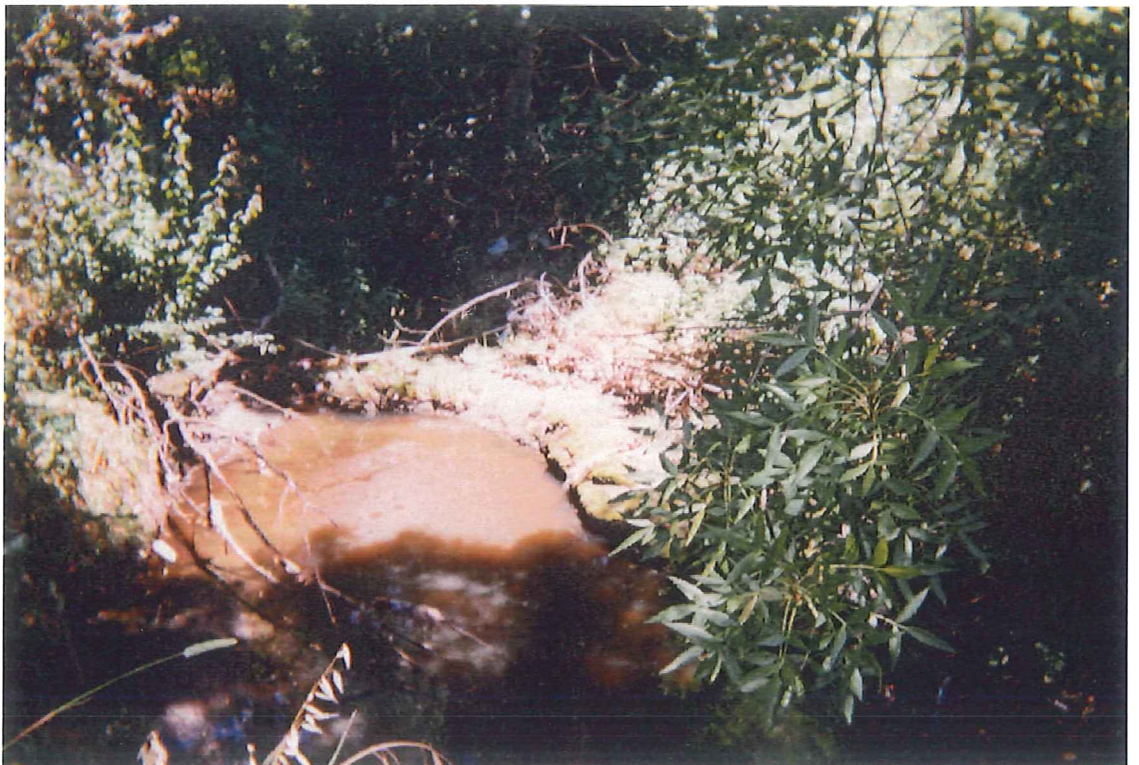
**Photo 3: Stormwater drain – no evidence of oil or oil staining.**

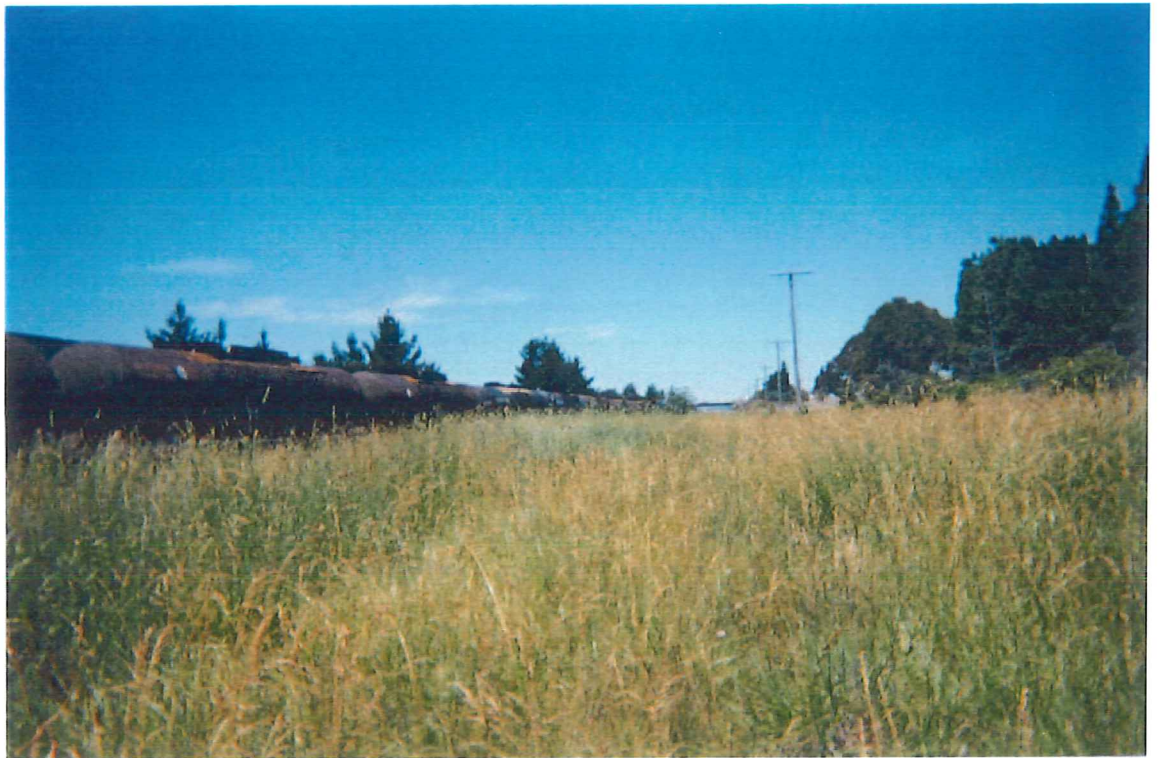
**Photo 4: Revegetated areas adjacent to fuel depot sidings. No visual evidence of staining.**

Previously reported oil staining, both along the fuel depot sidings and adjacent to the Shell depot, was reinspected as part of an overall site review in December 2000.

Staining was no longer in evidence along the fuel depot sidings (see Photographs in Appendix C) and significant growth of grass and other vegetation is now in evidence.

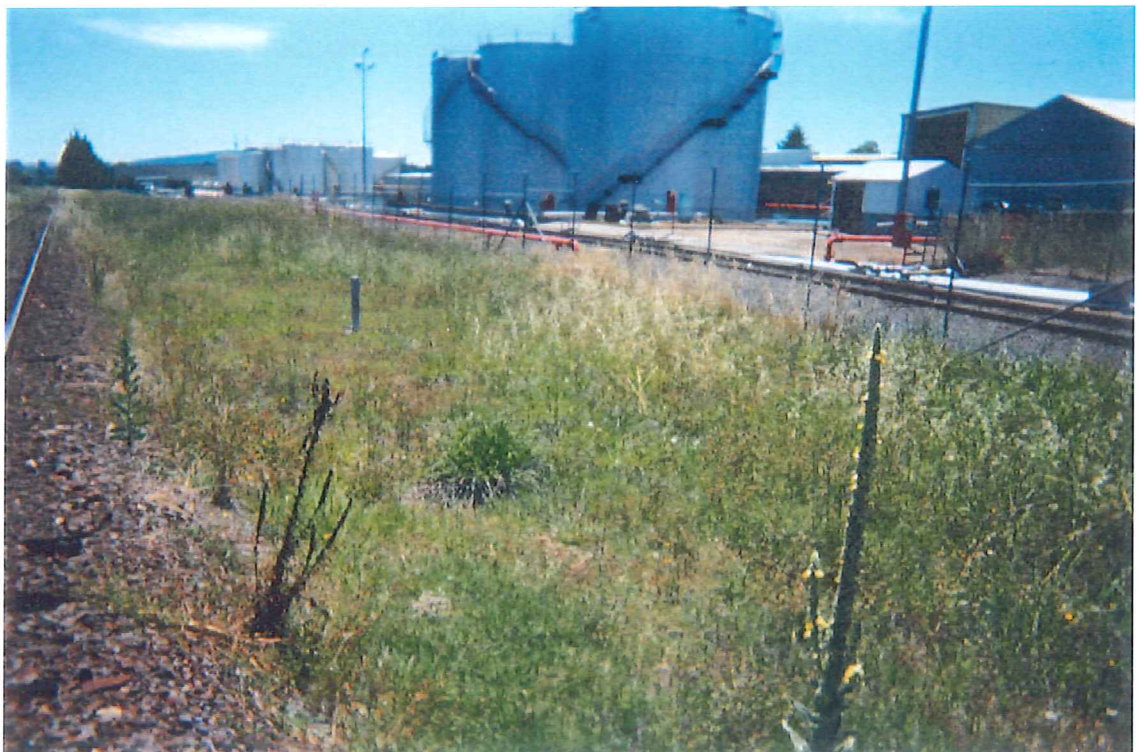
**Photo 5: Revegetated areas adjacent to fuel depot sidings. No visual evidence of staining.**

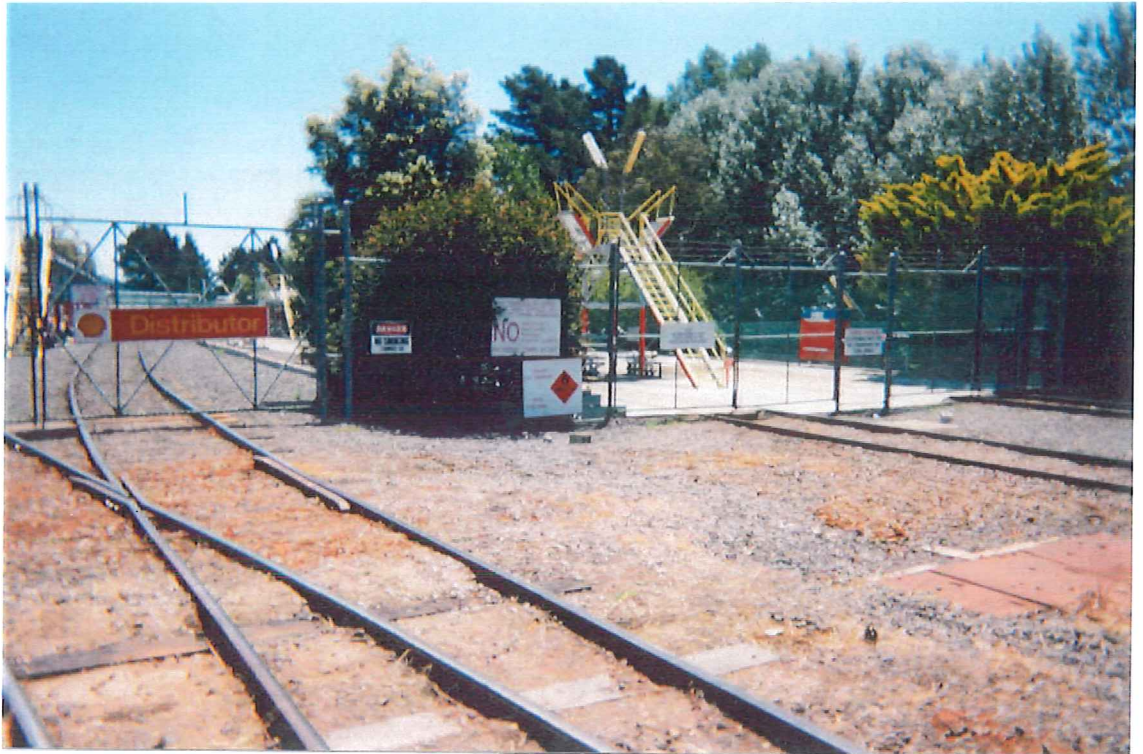
**Photo 6: Shell Depot – no evidence of staining.**

Staining associated with the Shell depot is considered a matter for Shell and outside the scope of this report.

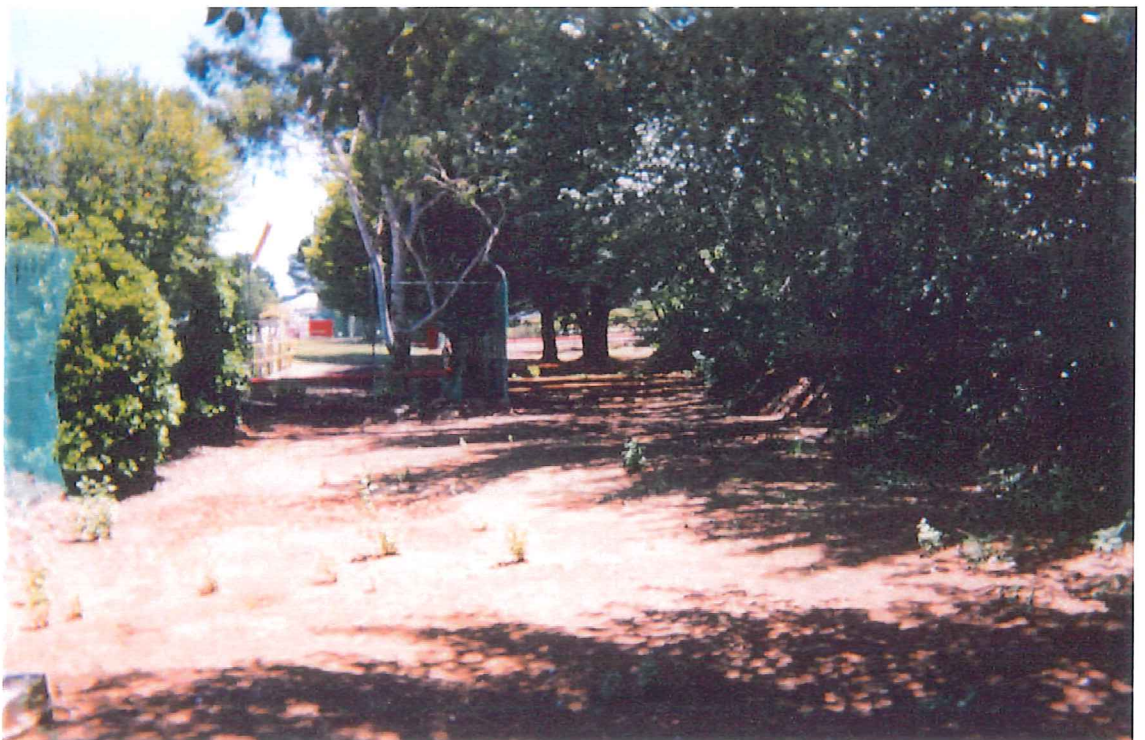
**Photo 7: Shell Depot – no evidence of staining.**

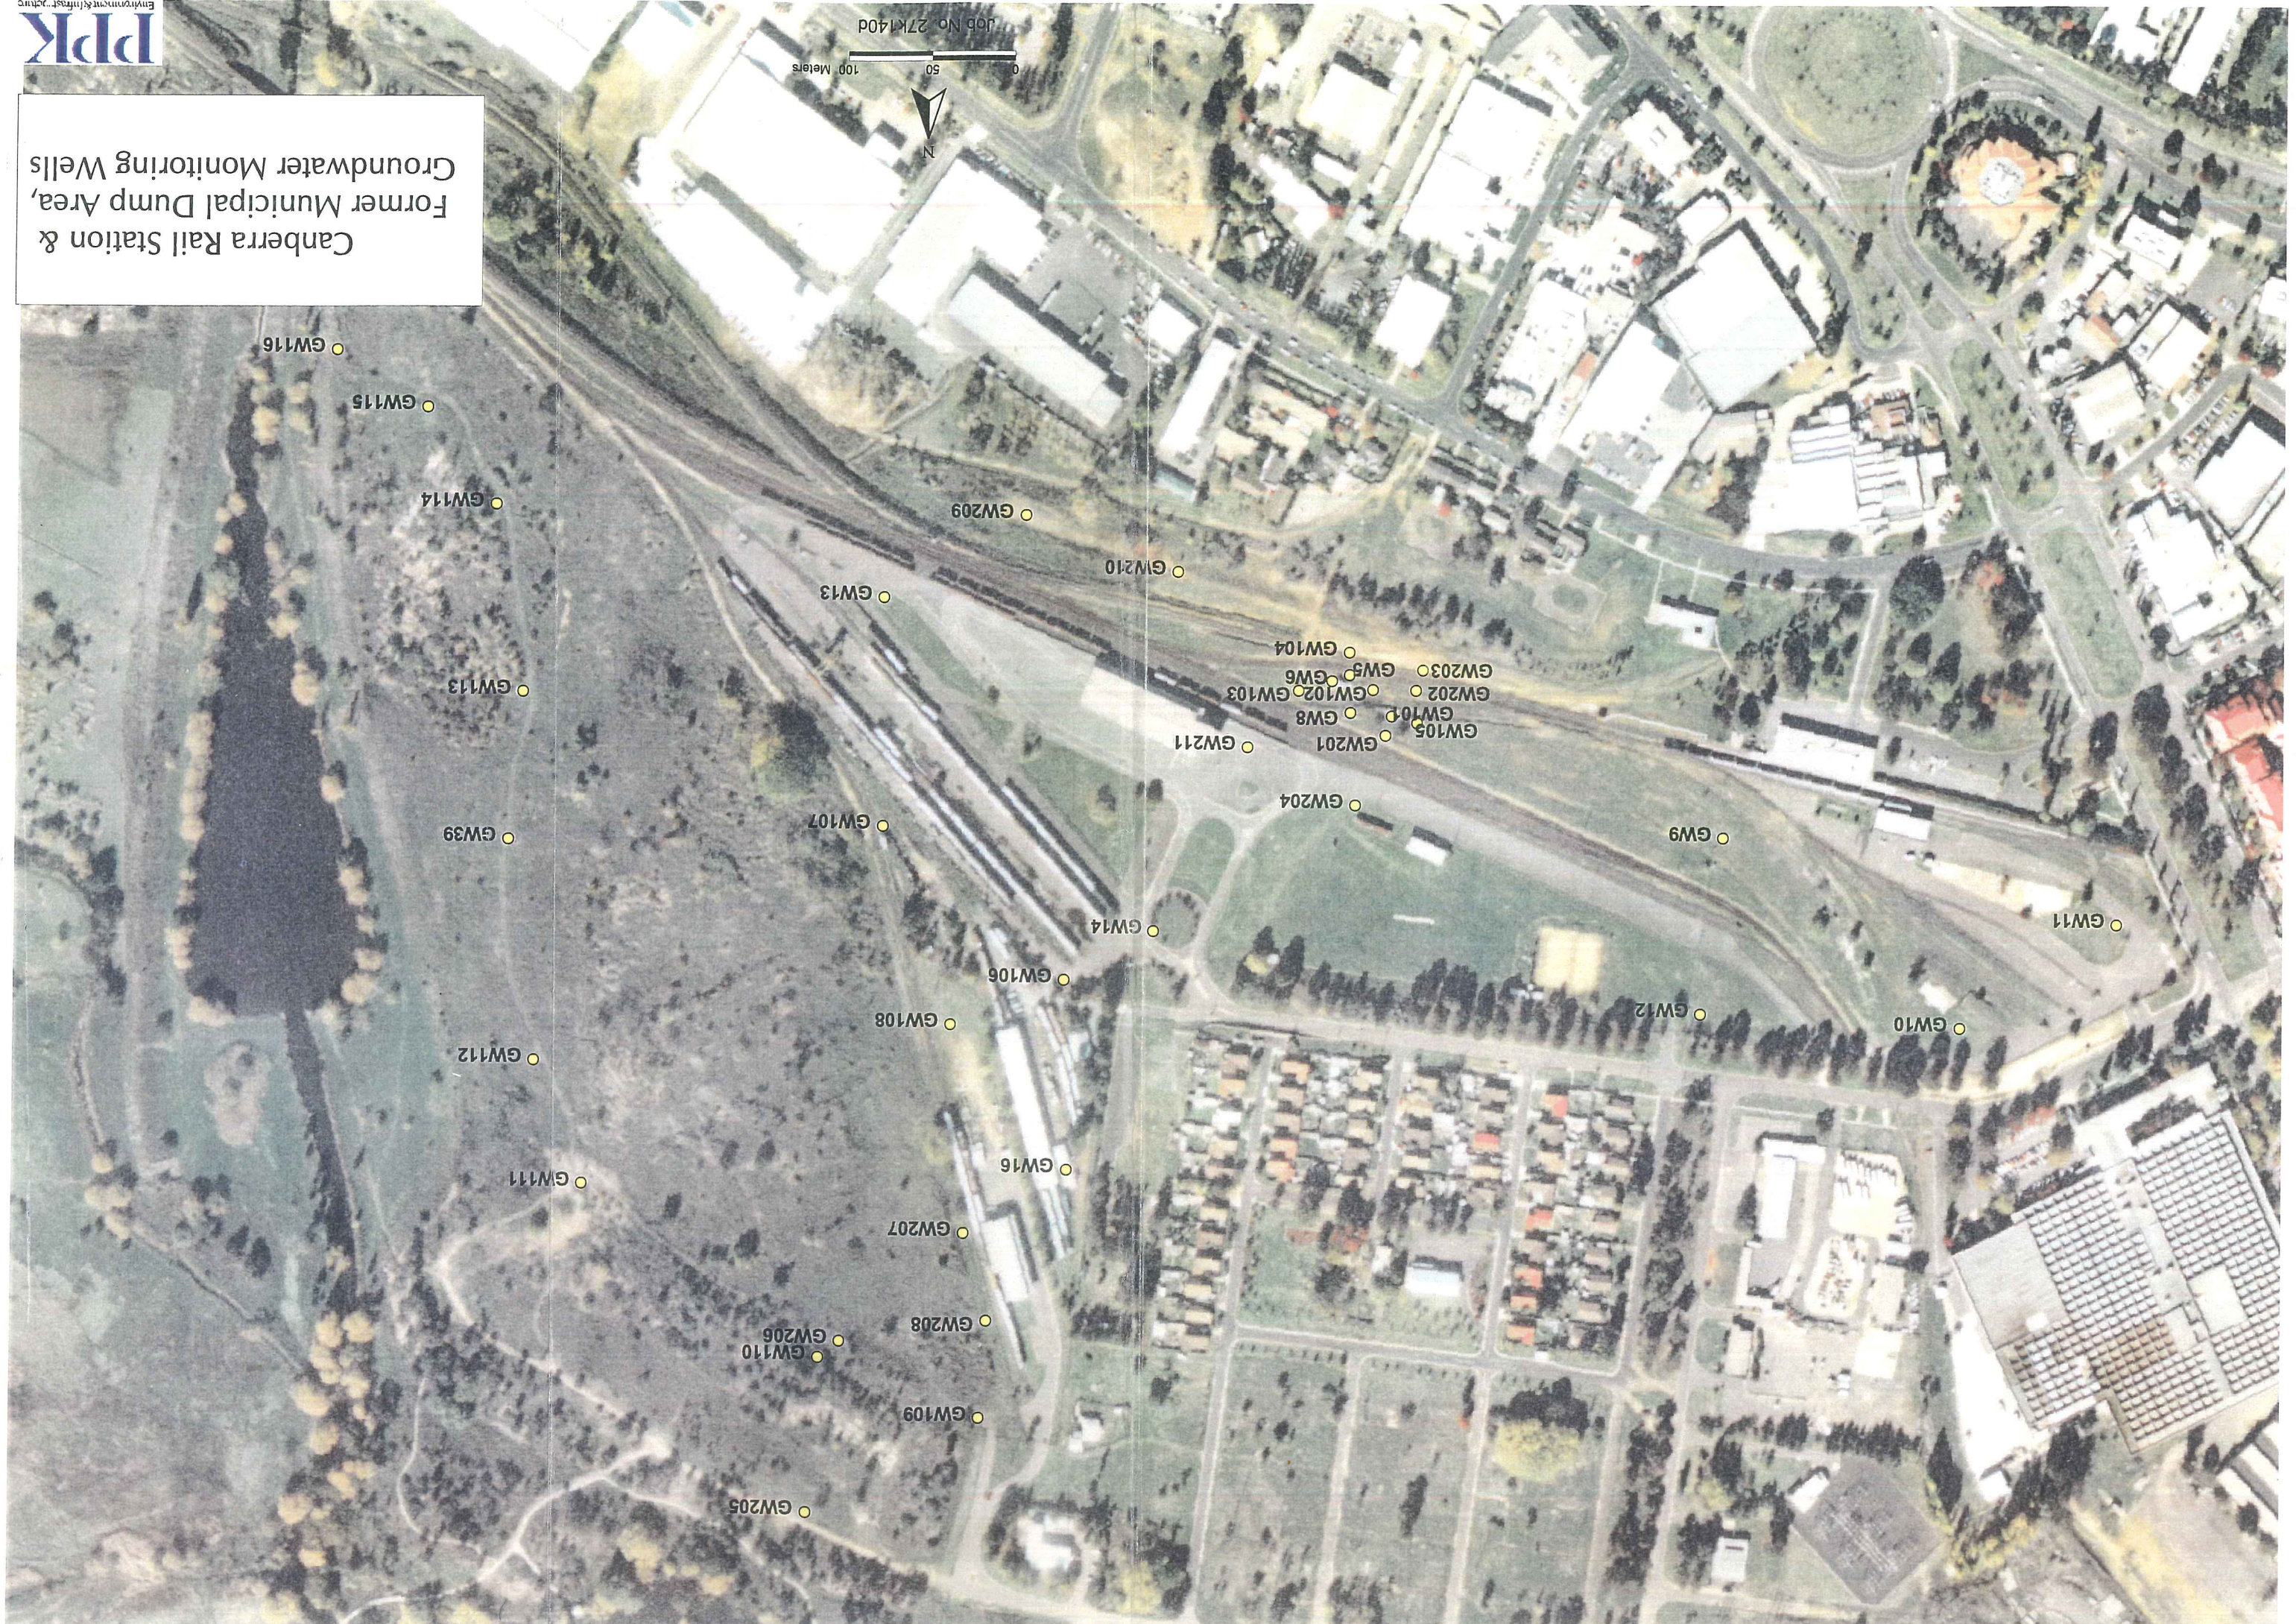
Canberra Rail Station &  
Former Municipal Dump Area,  
Groundwater Monitoring Wells

A review of PPK's findings undertaken by URS noted that additional objective data, in the form of groundwater monitoring results, would be of benefit to confirm the model predictions. This was specifically in relation to two potential areas, namely the former refuelling depot and vacant dump site.
