Environmental Audit of the Australian National Facilities

Canberra Railway Station Yards and Rail Corridor

Australian National

**PPK Environment &
Infrastructure Pty Ltd**

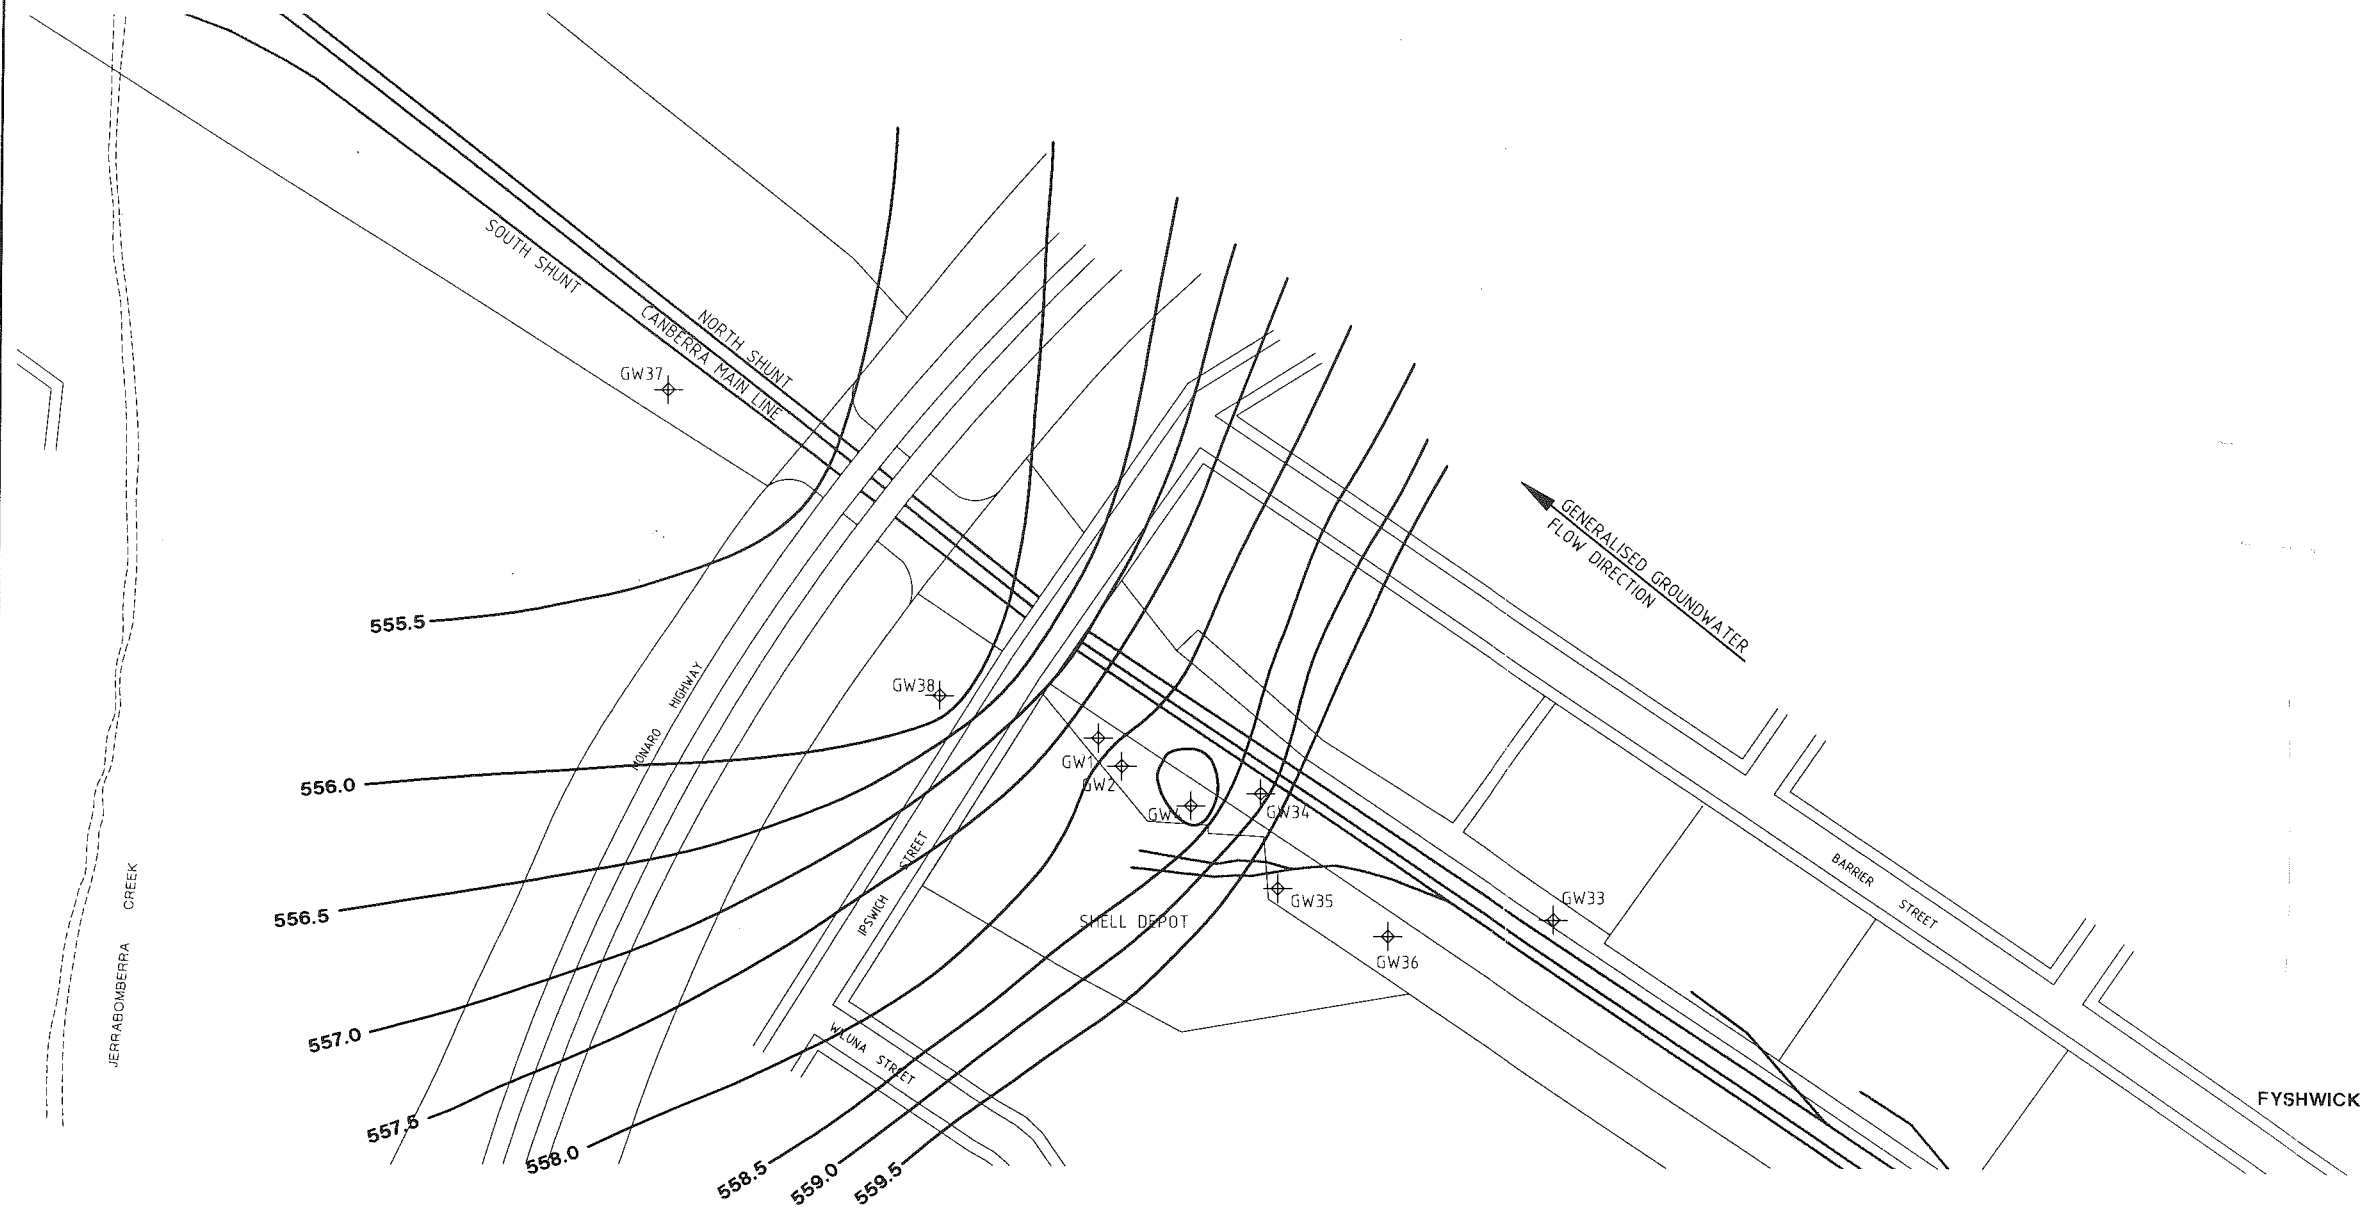
DESIGNED	DATE	SCALE
		A1 1:2000, A3 1:4000
DESIGN CHECK		CAD REFERENCE 27K140A
DRAWN BJB	19.10.98	PROJECT APPROVAL
DRAWING CHECK JCR	19.10.98	CLIENT APPROVAL
DRAWING NO 27K140A/10		ISSUE

TITLE
**PHASE 2 INVESTIGATION
GROUNDWATER CONTOURS
SHEET 10 OF 11**

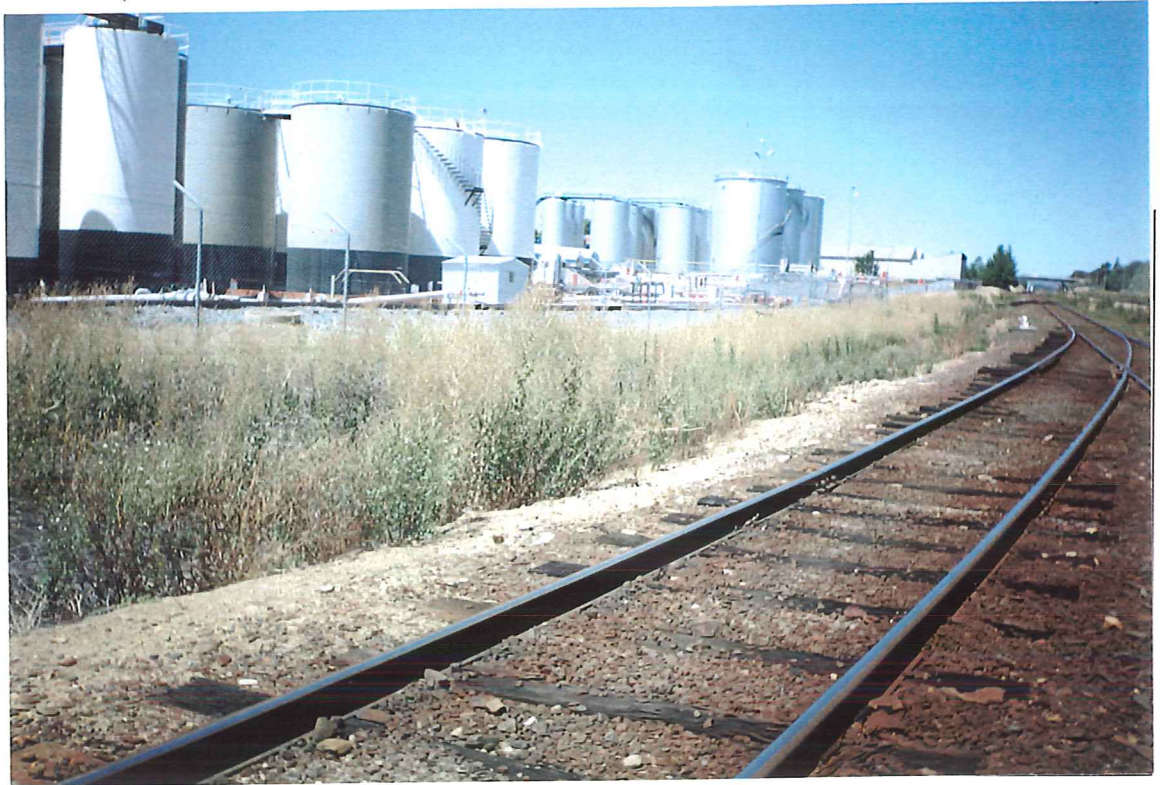
Photo 1: Fuel Depots North of Main Railway Line

- Hydrocarbon odours and staining of soil and ballast adjacent to the fuel depot sidings between Ipswich and Newcastle Streets.
- Oil spillage in the open stormwater drain adjacent to the Shell fuel siding east of Ipswich Street and South of the railway line.

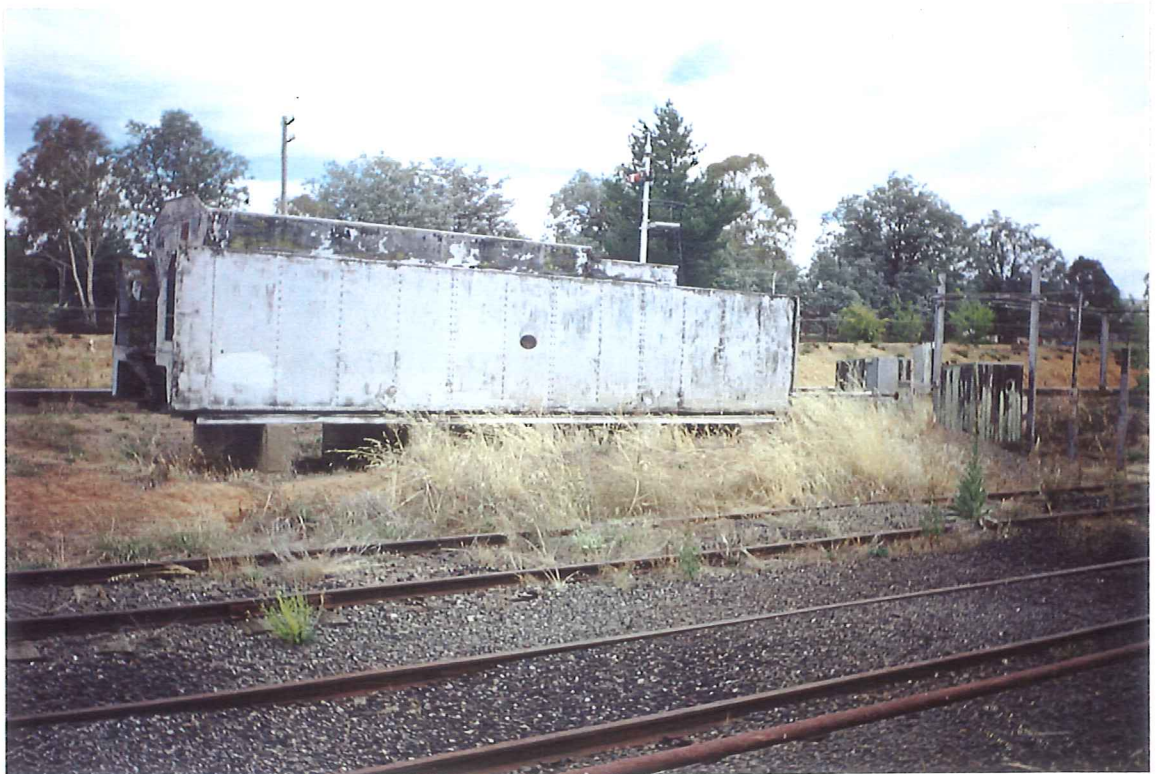
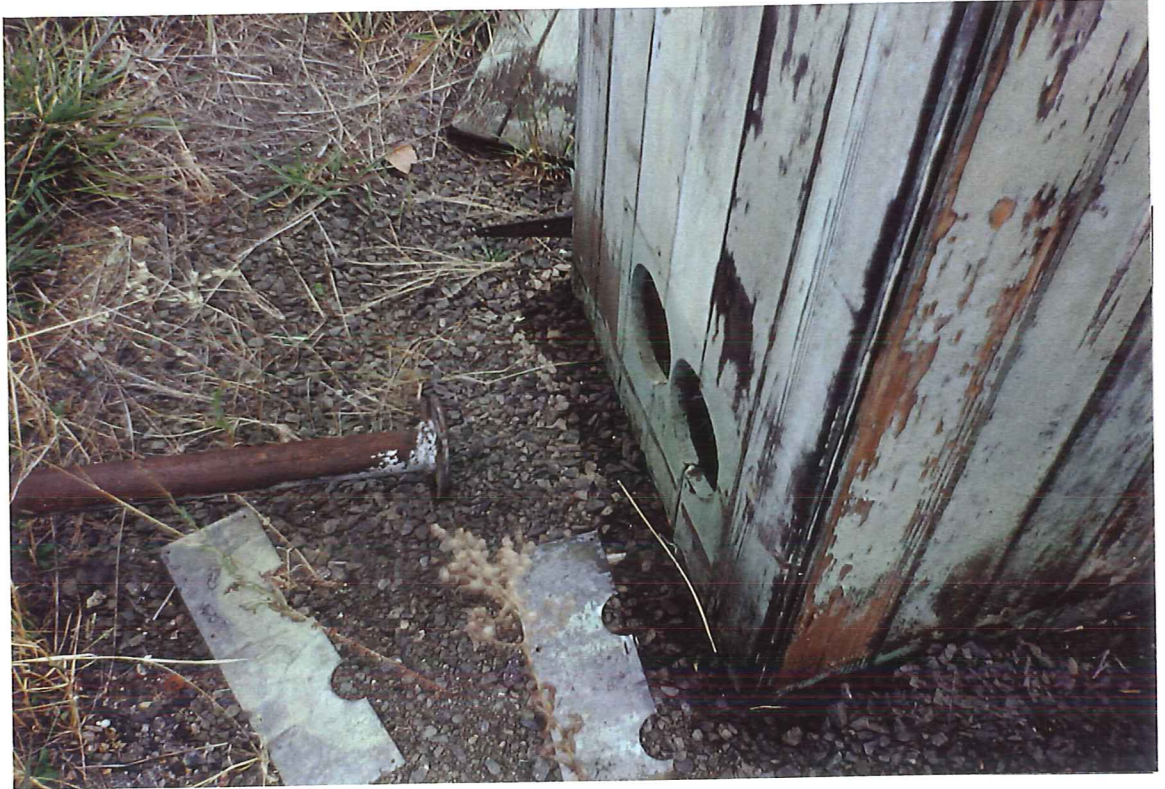
Photo 6: Old Fuel Storage Tank in Canberra Yard

- An old refuelling depot within the railyards may have experienced fuel leakages or spillages in the past resulting in localised soil and groundwater contamination (refer to Photos 6 and 7).

To the eastern end of the railyards an old refuelling area was observed which was just south west of the former goods shed. This refuelling area was reported to be disused and out of operation since the mid 1980's. The fuel tank was a modified tender tank from a steam locomotive, and pipework ran underground to empty pump sheds and then on to a refuelling point.

The tank was located over a concrete pad which had earthen walls partially lined with concrete. There was no clear evidence of major hydrocarbon spillage in the form of staining in this area although a slight hydrocarbon odour was detected. The two timber pump sheds had concrete flooring, however there was evidence of past spillage both in and around these sheds.

- Areas of the railway yards which are bare may indicate residual weedicides present in soil over the site.
- Minor soil staining and hydrocarbon odours around the old diesel refuelling area and storage tank.

Old Refuelling Depot	Past	Past spillages and leakages of fuel onto ground	'000s litres	ACT Environmental Legislation - Water Pollution/ Environment Protection Act 1997	uncertain without testing	2	Soil and groundwater testing adjacent to the old fuelling point	2k
Landfill Area	Past	Potentially contaminating materials in filled area	uncertain	ACT Environmental Legislation - Water Pollution/ Environment Protection Act 1997	uncertain without testing	3	Soil and groundwater testing along site boundary adjoining the fill area	5k
Ash and Cinders filling of the western railyards	Past	Filling with power station ash may have contaminated soil or groundwater	uncertain	ACT Environmental Legislation - Water Pollution/ Environment Protection Act 1997	uncertain without testing	3	Soil testing in the western yard area	3k
Minor oil/solvent storage	Normal	Flammables and oils stored inappropriately	'00s litres	ACT Environmental Legislation - Water Pollution/ Environment Protection Act 1997 and AS 1940	non compliance	2	Ensure storage of all flammables and combustible liquids in accordance with AS 1940	5k

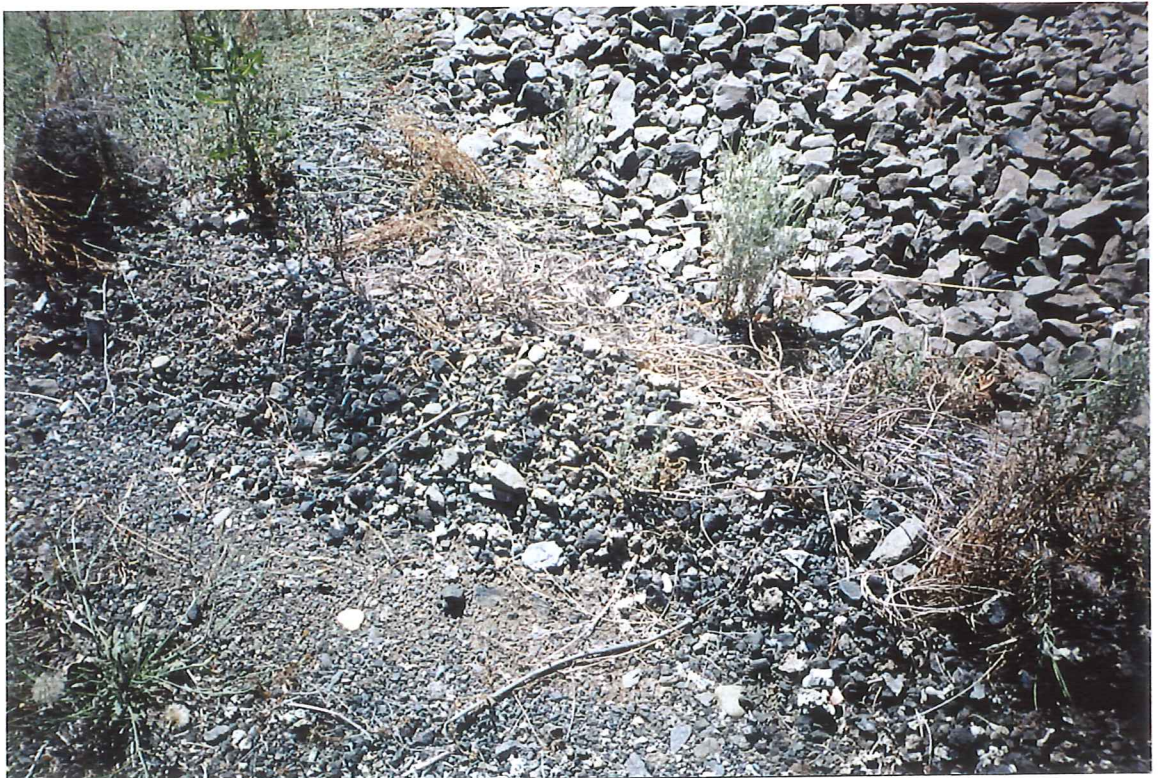
Photo 8: Ash and Cinders in Railyards

Ash and cinders and coal residues were observed scattered over large areas of the site in the western yard area, and it was reported that power station ash had also been disposed of in this area.

- Ash and cinders from steam locomotives disposed of over the railyards and along the railway formation.
- Heavy oil staining along railway lines in front of the railway station building.

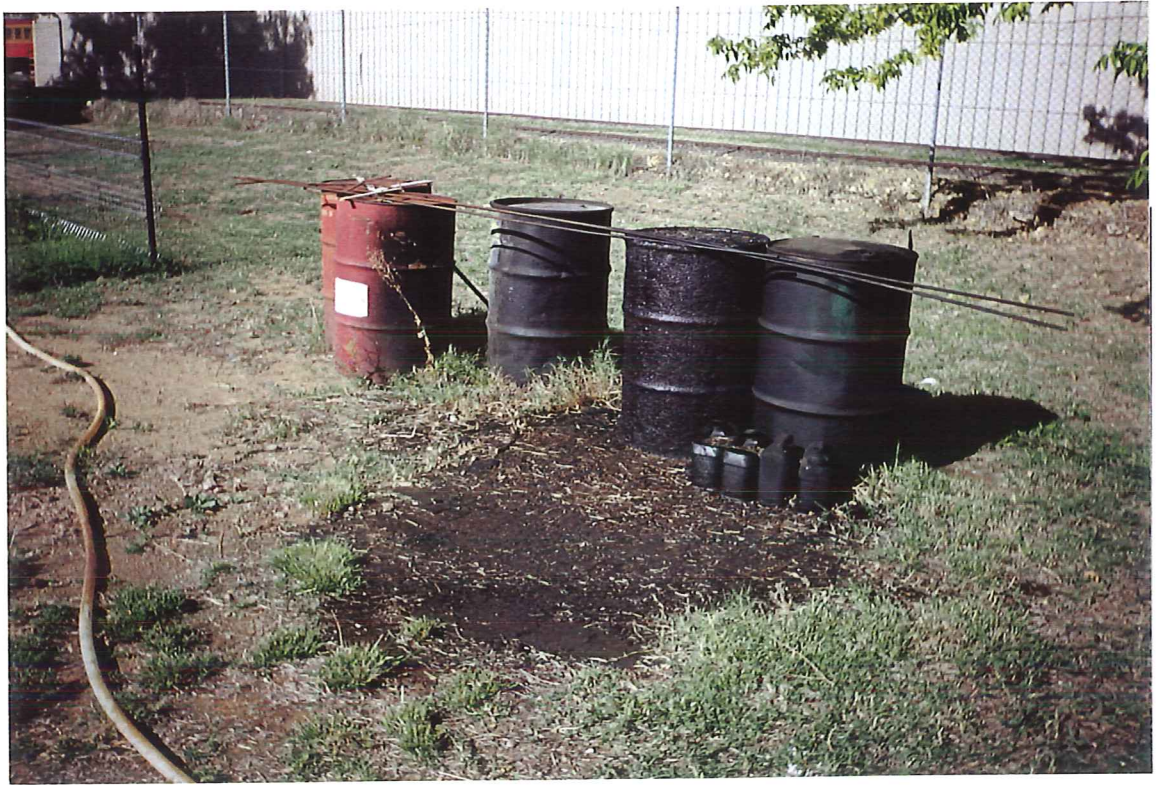
Photo 9: Waste Oil Drums in William Edmunds Area

- Storage of waste oils in the William Edmunds site has been identified as inadequate as there is no spillage containment provided and substantial leakage has occurred which has impacted on localised soils (refer to Photo 9).

Various plumbing components and scrap was observed to be stored over the site and one drum of flammable solvent was noted stored outside on the ground. Furthermore four 205 litre drums of waste oils were observed stored in the compound with substantial staining underneath due to spillage.

- General rubbish disposed of south of the railway line adjacent to the scrap metal yard.
- Soil staining from waste oil drum spillage in the William Edmunds yard area.

Soil staining	Past	Hydrocarbons in soil	moderate	ACT Environmental Legislation - Environment Protection Act 1997	non compliance	3	Soil testing and clean up	2k
Waste oil drums	Normal	Hydrocarbons in soil	minor	ACT Environmental Legislation - Environment Protection Act 1997 and AS 1940	non compliance	3	Store waste oils in bunded and covered areas in accordance with AS 1940	2k

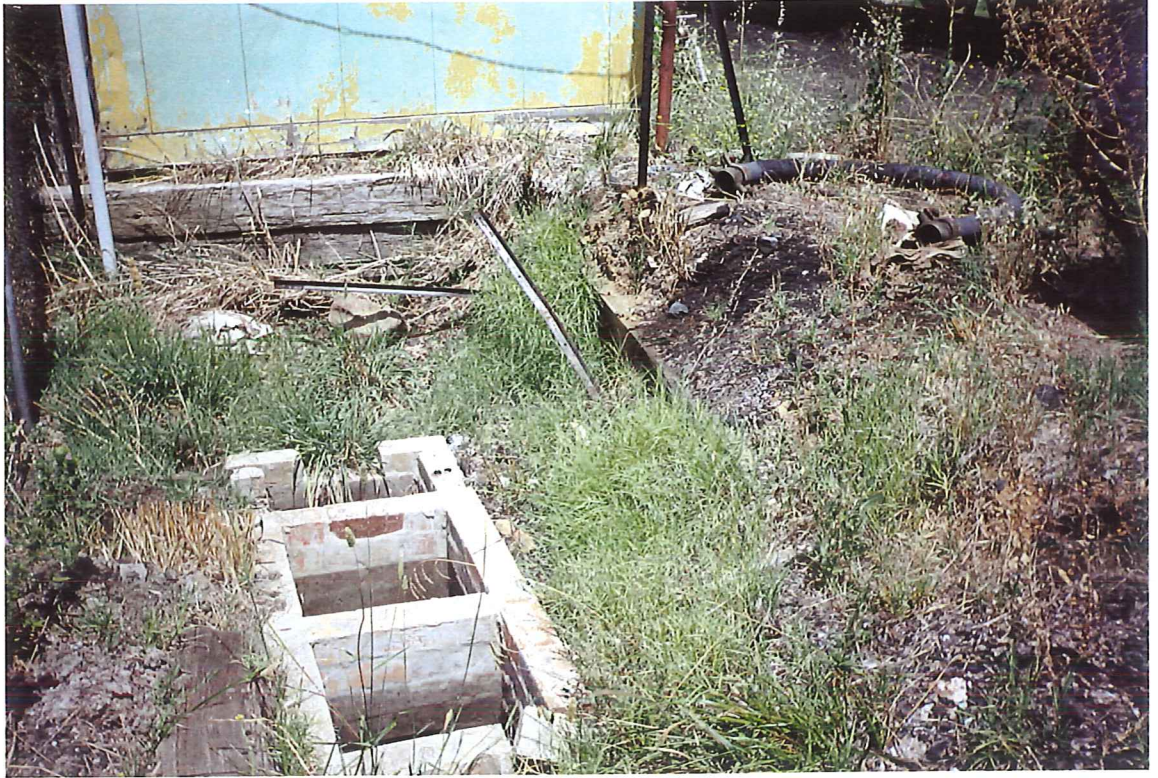
Photo 11: Stormwater Drain in ARHS Area

- Oil staining of soil within the Australian Railways Historical Society (ARHS) yard area.
- Discolouration of soil within the open stormwater drain along the northern boundary of the ARHS yards.

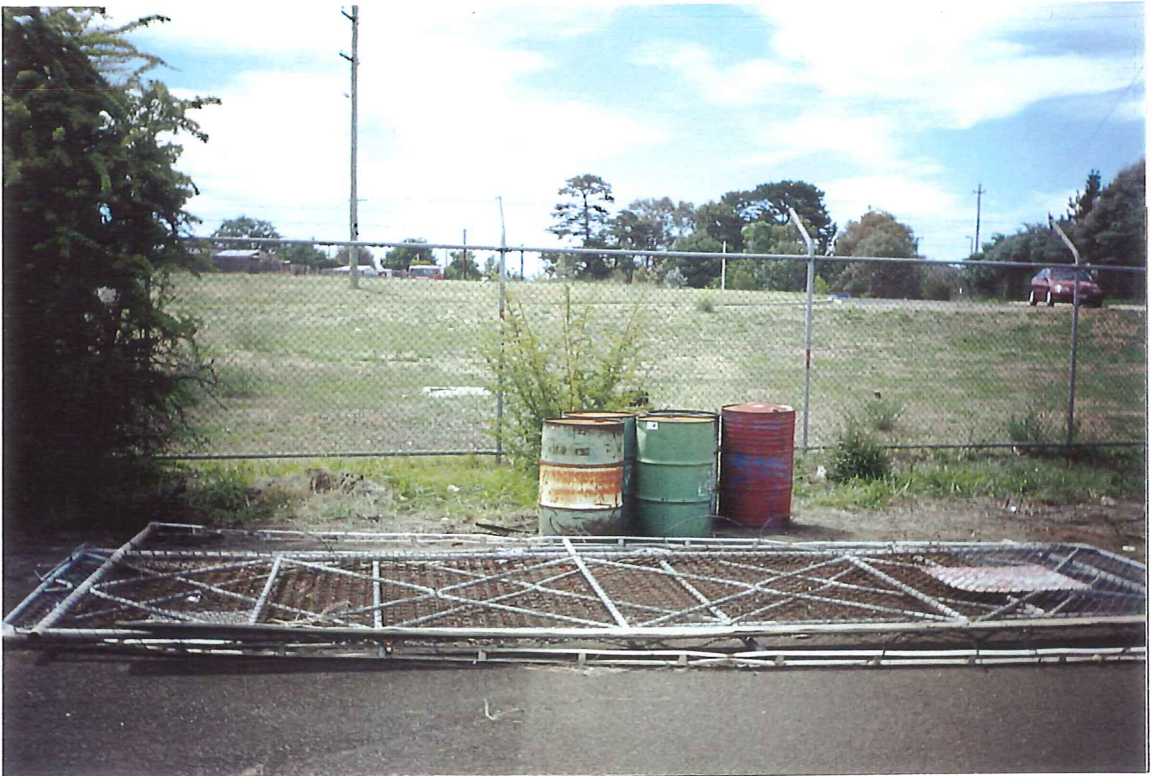
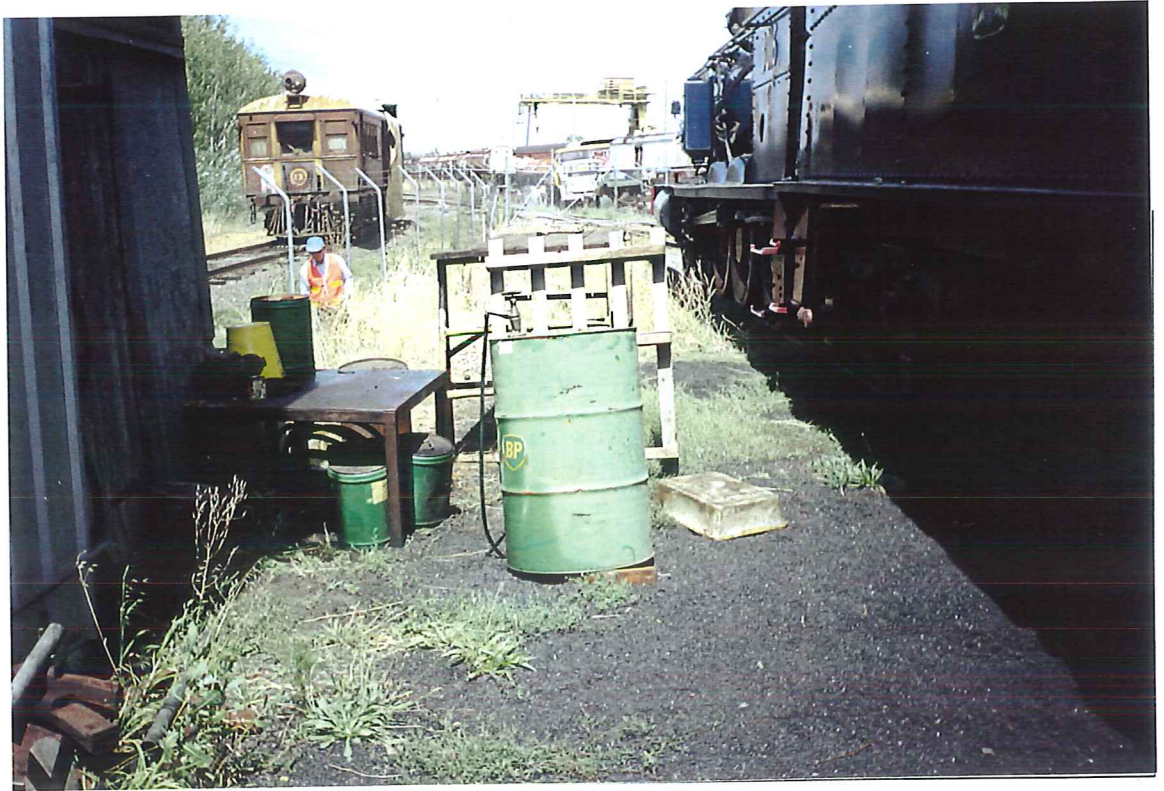
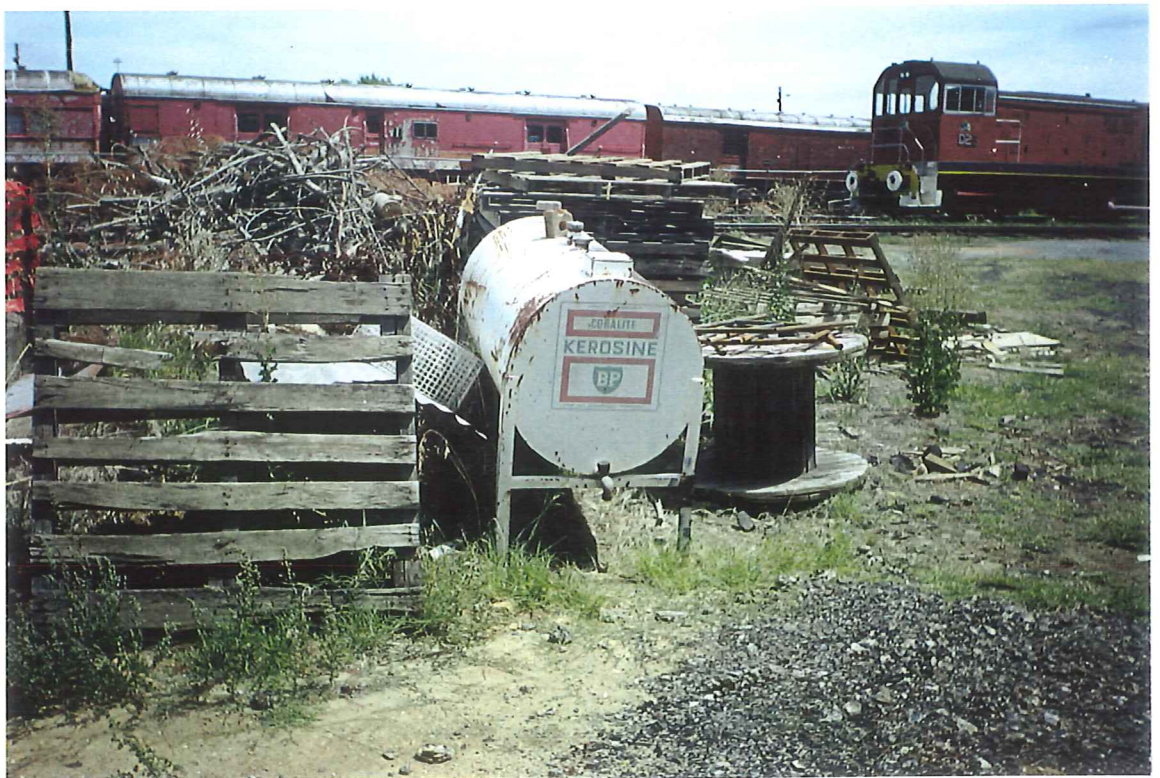
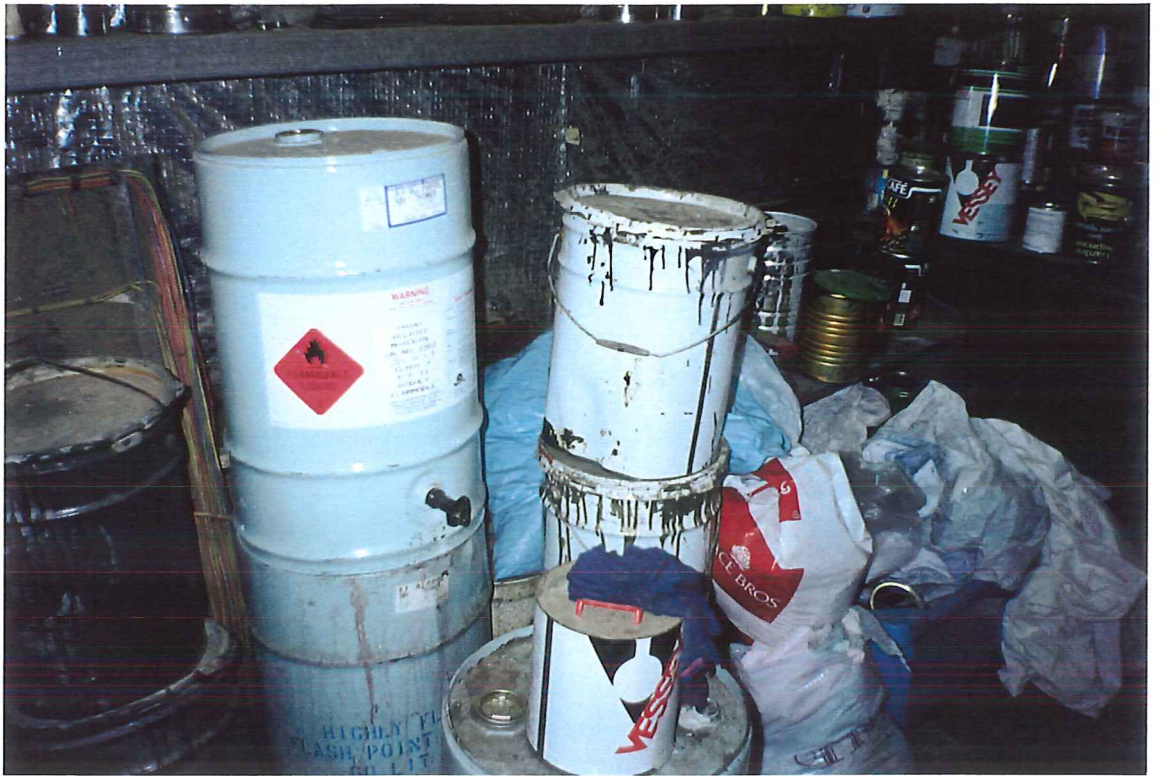
Photo 12: ARHS Oil Drums

- Drums of waste oils and flammable degreasers and paints were observed in several areas of the site unbanded and stored inappropriately (refer to Photos 12-15).

Within this workshop and also in an adjacent shed storage of flammable solvents and paints were observed without adequate spill containment or labelling. There were also additional paints and solvents observed stored outside on unsealed ground.

Waste oils were reported to be generated from the operations on the site, however these consisted only of approximately 400 litres per year. These were disposed of to a recycling depot according to site personnel. Waste oil drums were observed stored outside on unsealed ground without labelling.

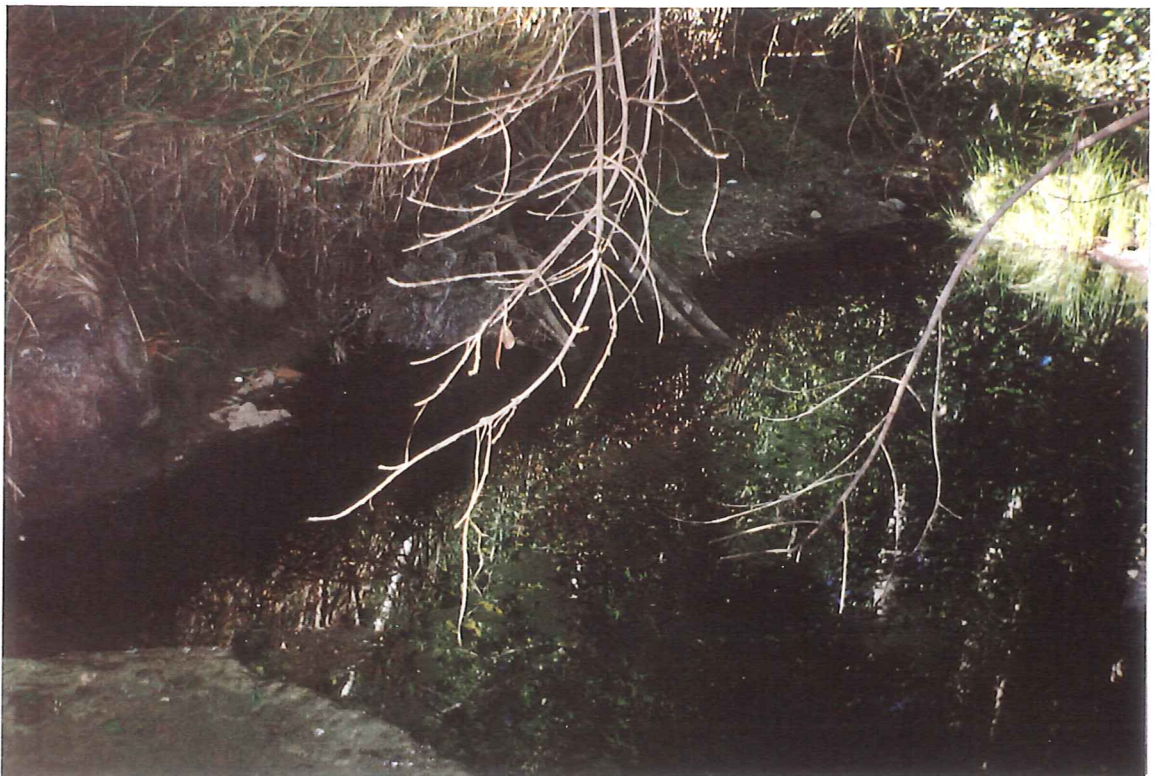
Photo 16: Oil Spillage in Stormwater Drain

- A significant quantity of oil was observed disposed of into a stormwater drain next to Ipswich Street and the Shell depot. This oil was sourced off site and steps should be taken to prevent recurrence (refer to Photo 16).

A motor wrecking yard was observed west of the BP siding and north of the Shell siding on the northern side of the main line. No issues were observed sourced from the wreckers yard impacting on the railway property. An open earthen stormwater drain was inspected adjacent to the Shell Depot and was filled with a substantial volume of black waste oil. The oil was coming from the stormwater drain which ran north into the Fyshwick industrial area and the source of this oil contamination could not be identified. Several industrial sites are located in their area as well as automotive workshops and the nature of the oil appeared consistent with automotive maintenance activities.

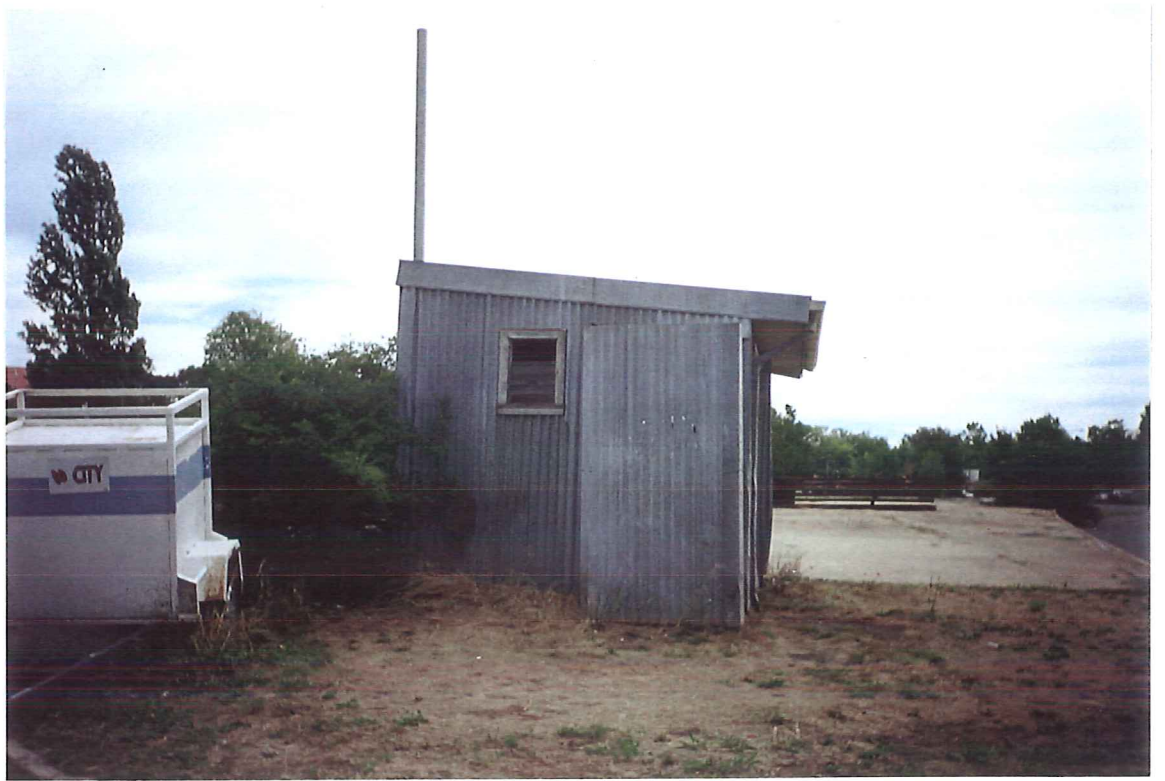
Photo 17: Toilet Shed with Asbestos Cement Debris Inside

- Broken asbestos cement sheeting was identified in the corrugated toilet shed located north of the station platform and car club garage (refer to Photo 17).

A corrugated iron toilet building located behind the garage situated opposite the railway station platform was internally inspected and found to have damaged fibrous cement lining. This material was sampled to assess it for asbestos content.

Asbestos samples were analysed using stereo microscopy by PPK, and only sample A3 taken from the debris in the William Edmunds yard was found to be free of asbestos. Both samples A1 and A2 from Robbo's Pet Barn and the old toilet shed respectively, contained chrysotile and amosite asbestos fibres.

Environmental Effect Source	Circumstances (eg emergency)	Potential Effect	Magnitude of Effect	Legal/Other Obligation	Compliance Status	Action Priority	Recommendations	Indicative Cost (\$)
Abattoir USTs	Past	Hydrocarbons in soil and groundwater	uncertain	ACT Environmental Legislation - Water Pollution/ Environment Protection Act 1997	uncertain without testing	3	Soil and groundwater testing along boundary of abattoir	5k
Asbestos Cement Debris	Past	Public Health	minor	ACT Worksafe Code	non compliance	3	Remove asbestos cement debris and damaged materials	1k

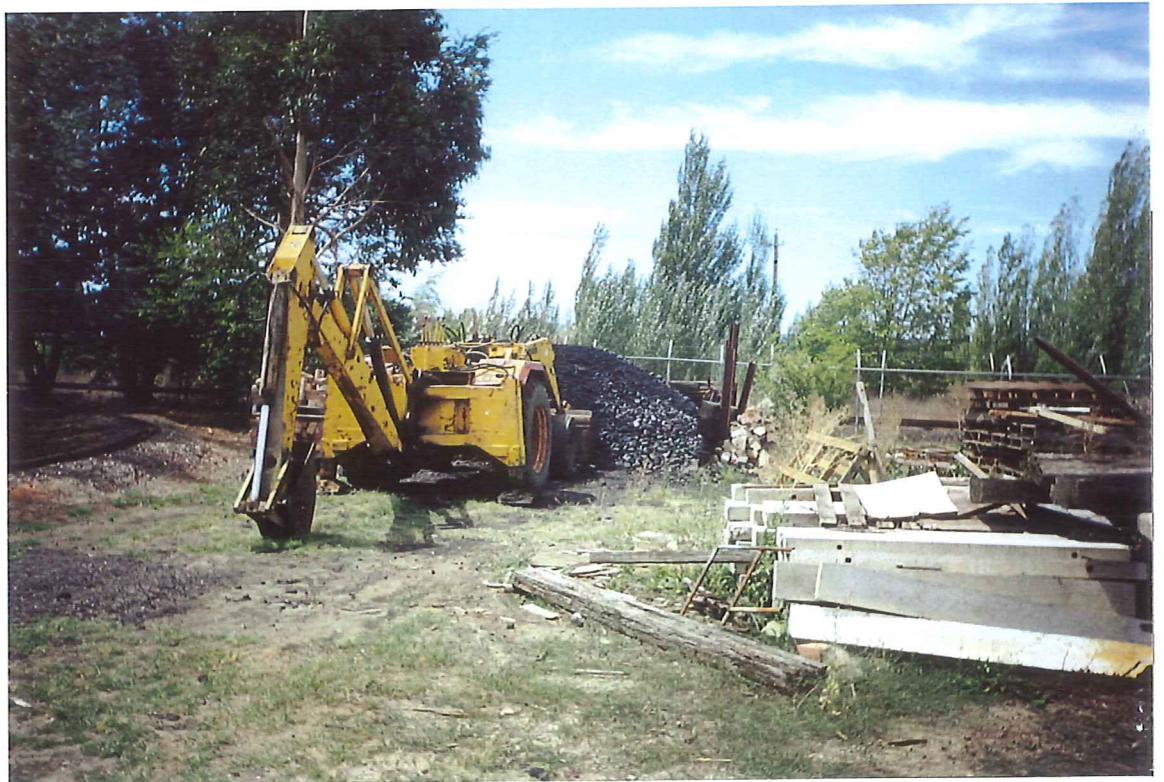
Photo 18: Coal Stockpile on ARHS Site

Adjacent and north of the ash pit a coal stockpile was observed mounded on the ground and was reported to be used by the ARHS when old steam locomotives were operated as part of their tourism activities.

A coal stockpile was observed along the northern area of the yard with a front end loader parked alongside. This coal was reported to be used for the firing of the historical steam locomotives owned and operated by the ARHS.

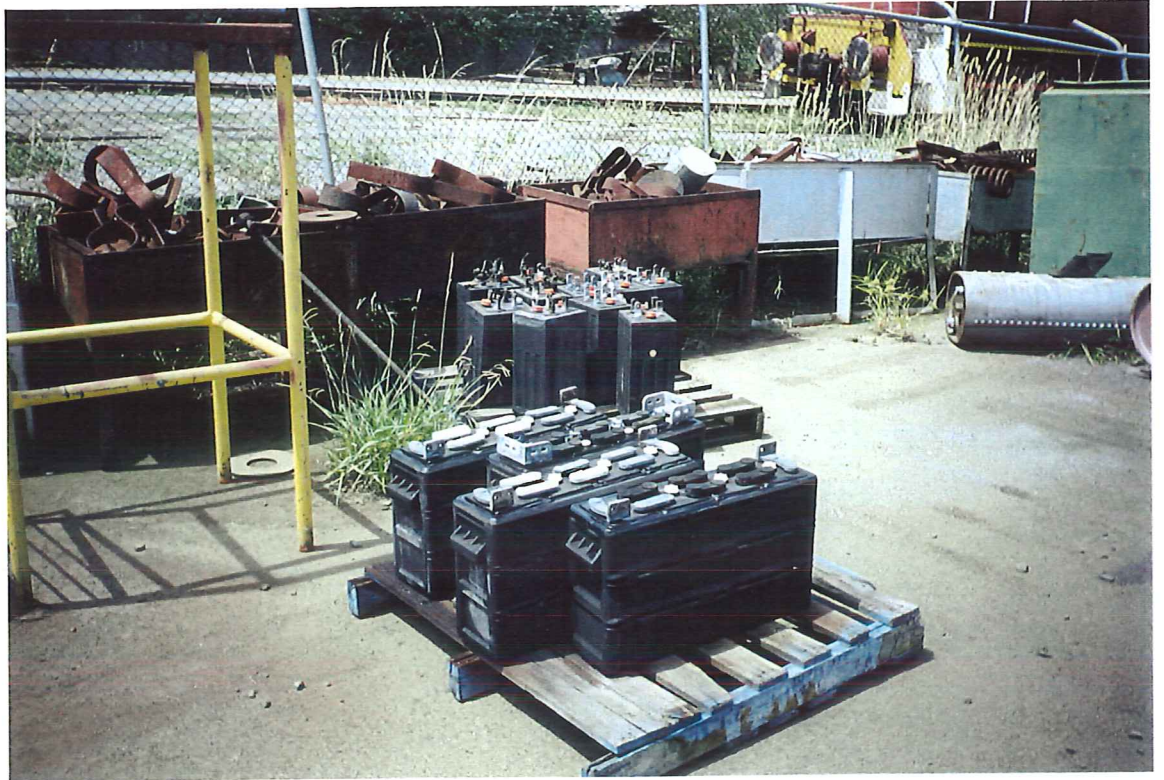
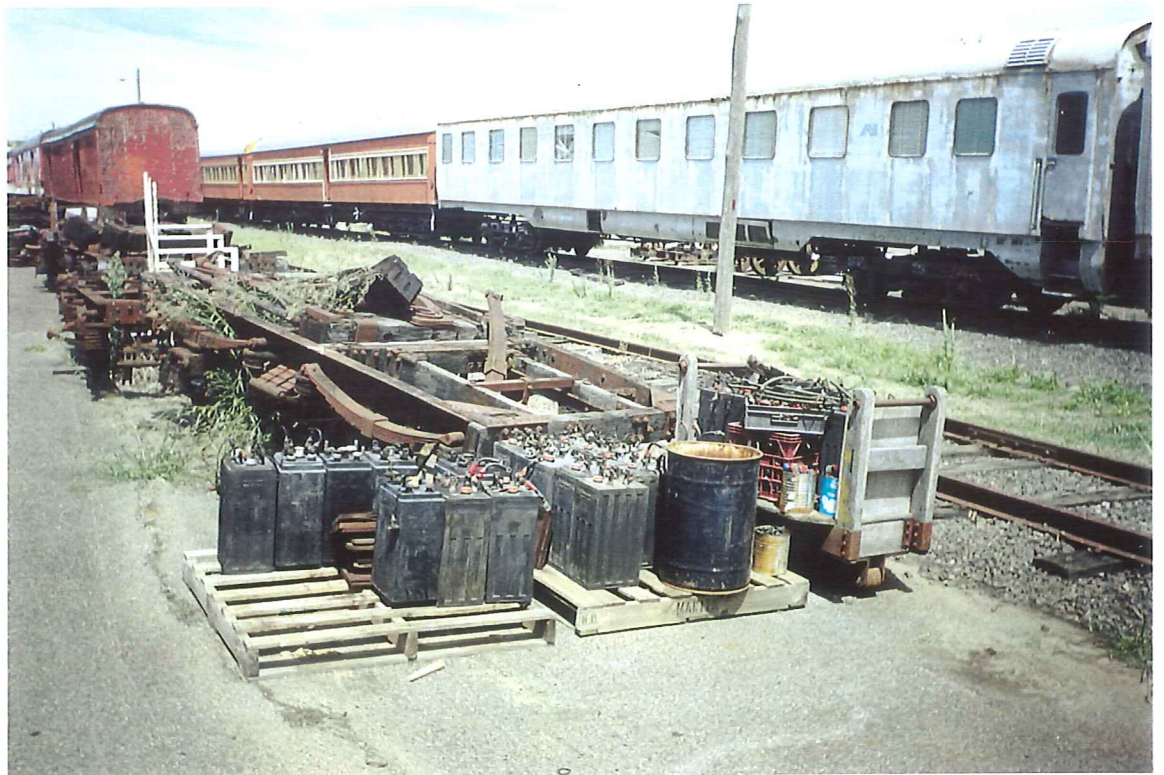
Photo 19: Lead Acid Battery Storage on ARHS Site

- Lead acid batteries were observed stored outside in the open and without spillage containment in the ARHS leased area. Although these were located over bituminised ground spillage or leakages would impact on stormwater runoff from the area (refer to Photos 19 and 20).

To the south of the main operational and workshop area a bituminised area was devoted to storage of rolling stock and components. Most of the componentry consisted of metallic railway parts, however approximately 20 - 30 lead acid batteries of various sizes were observed stored on pallets in the open in a few areas. A single unsealed 5 litre can of oil was also observed in this area.

Environmental Effect Source	Circumstances (eg emergency)	Potential Effect	Magnitude of Effect	Legal/Other Obligation	Compliance Status	Action Priority	Recommendations	Indicative Cost (\$)
Fuel Depots/Sidings	Abnormal	Spillage or leakages of fuels	'000s litres	ACT Environmental Legislation - Environment Protection Act 1997	uncertain without testing	2	Soil and groundwater testing adjacent fuel depots/sidings	10k
Spillage of oil into stormwater drains	Normal	Hydrocarbon contamination of surface waters and soils	'00s litres	ACT Environmental Legislation - Water Pollution/ Environment Protection Act 1997	non compliance	1	Cease disposal of oily wastes into stormwater drain on ARHS site, and find sources of oil contamination in Ipswich St Drain	2k
Lead acid battery storage (ARHS site)	Normal	Acid and metals into drains and surface waters	litres	ACT Environmental Legislation - Water Pollution/ Environment Protection Act 1997	non compliance	3	Remove and store batteries in a bunded and covered area	1k

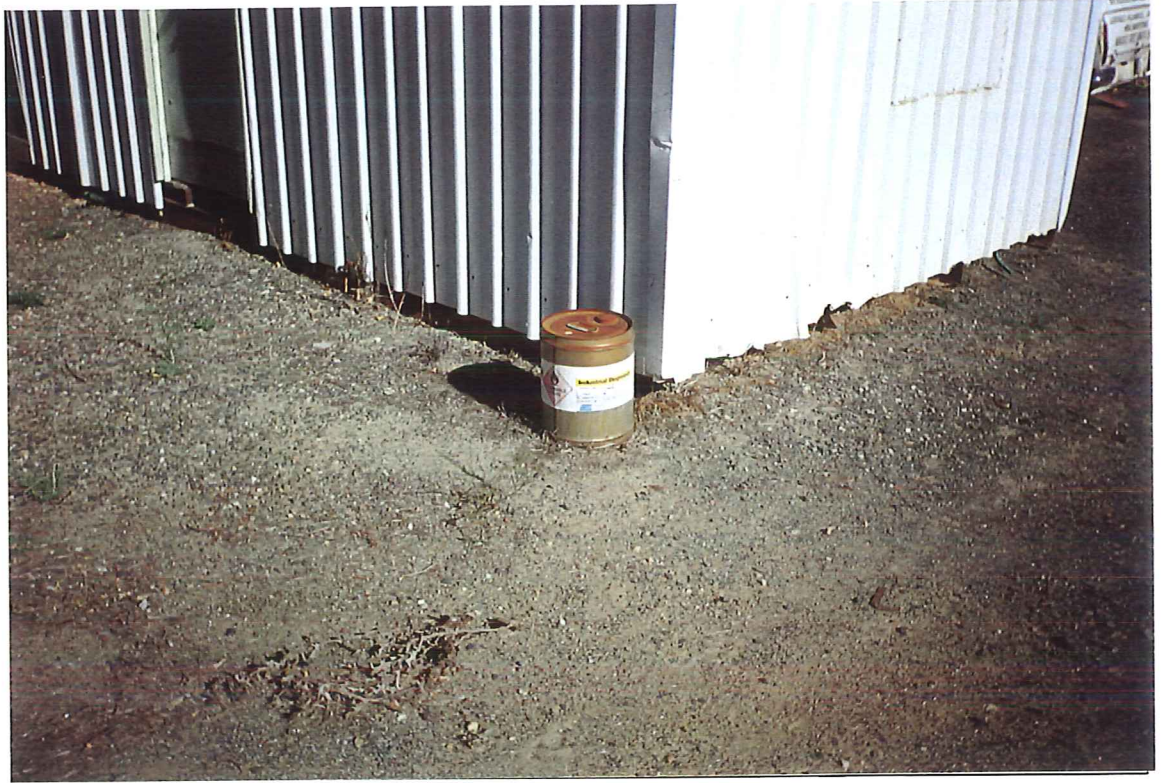
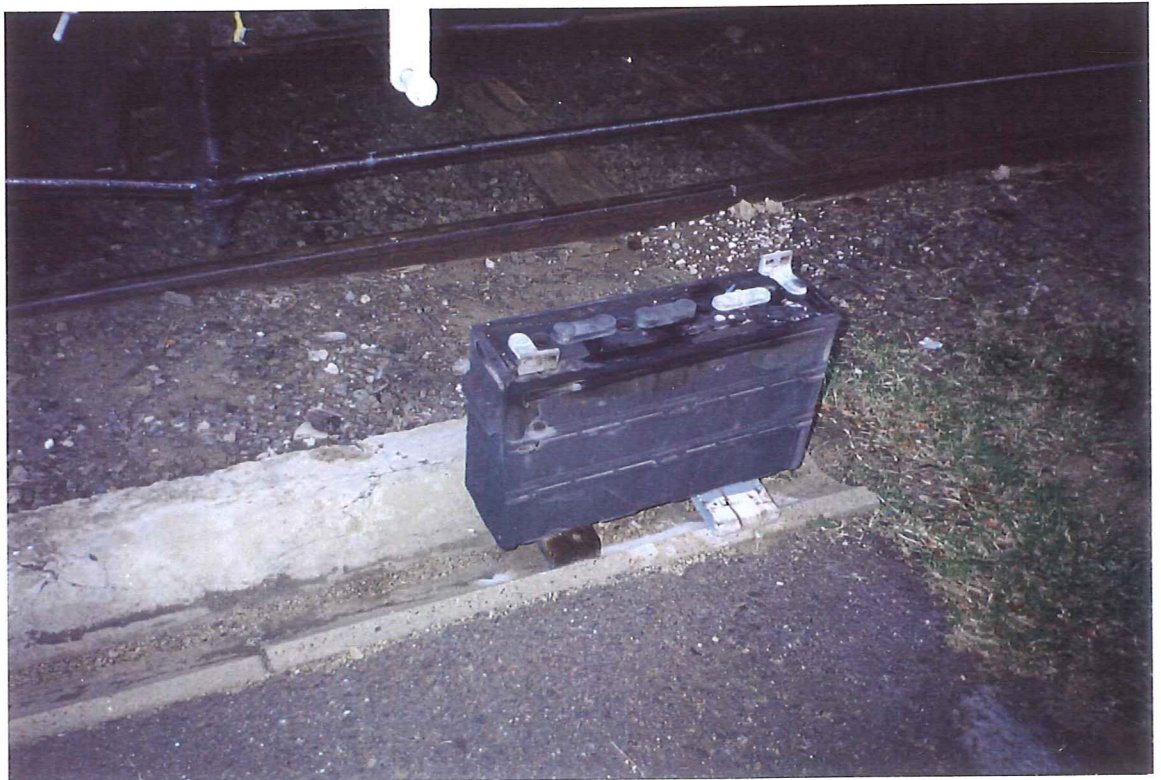
Photo 21: Oil Drum Storage on William Edmunds Site

- Minor volumes of oils and a single lead acid battery were observed stored outside on the William Edmunds site and have potential to cause localised contamination if spillages or leakage occurs (refer to Photo 21 and 22).

A single damaged lead acid battery was located over a stormwater drain.
