Environmental Audit of the Australian National Facilities

Canberra Railway Station Yards and Rail Corridor

Australian National

**PPK Environment &
Infrastructure Pty Ltd**

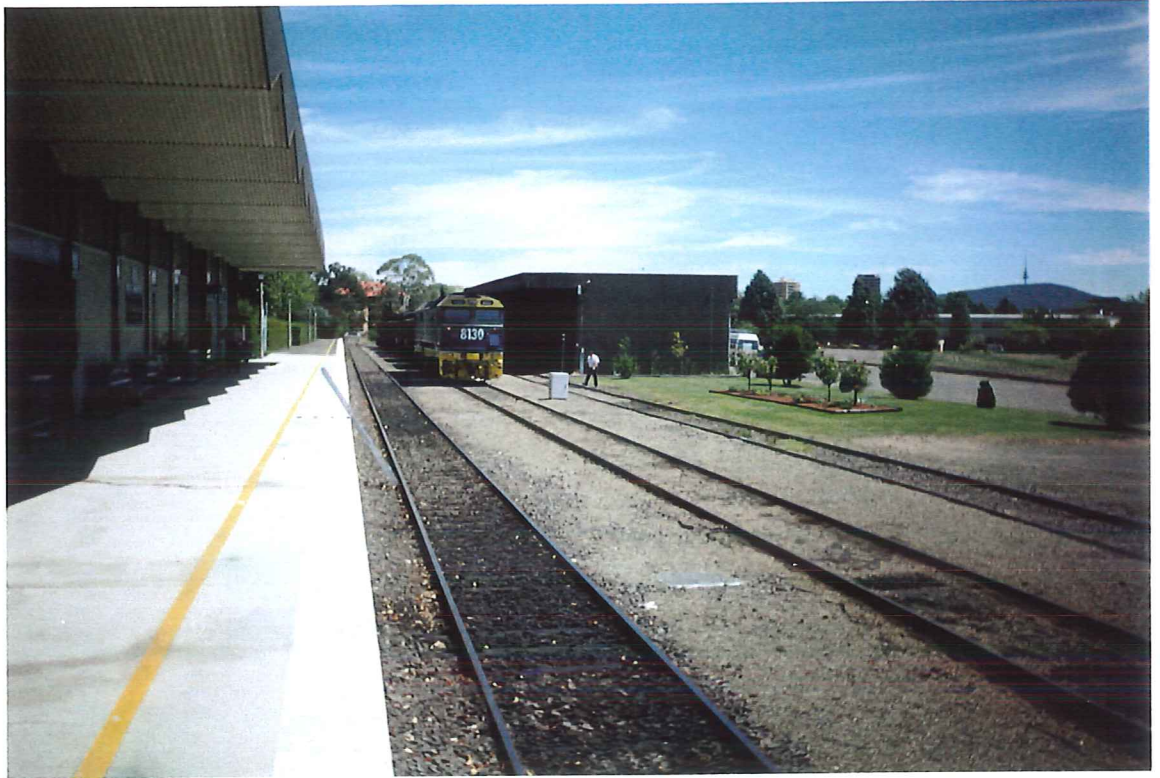
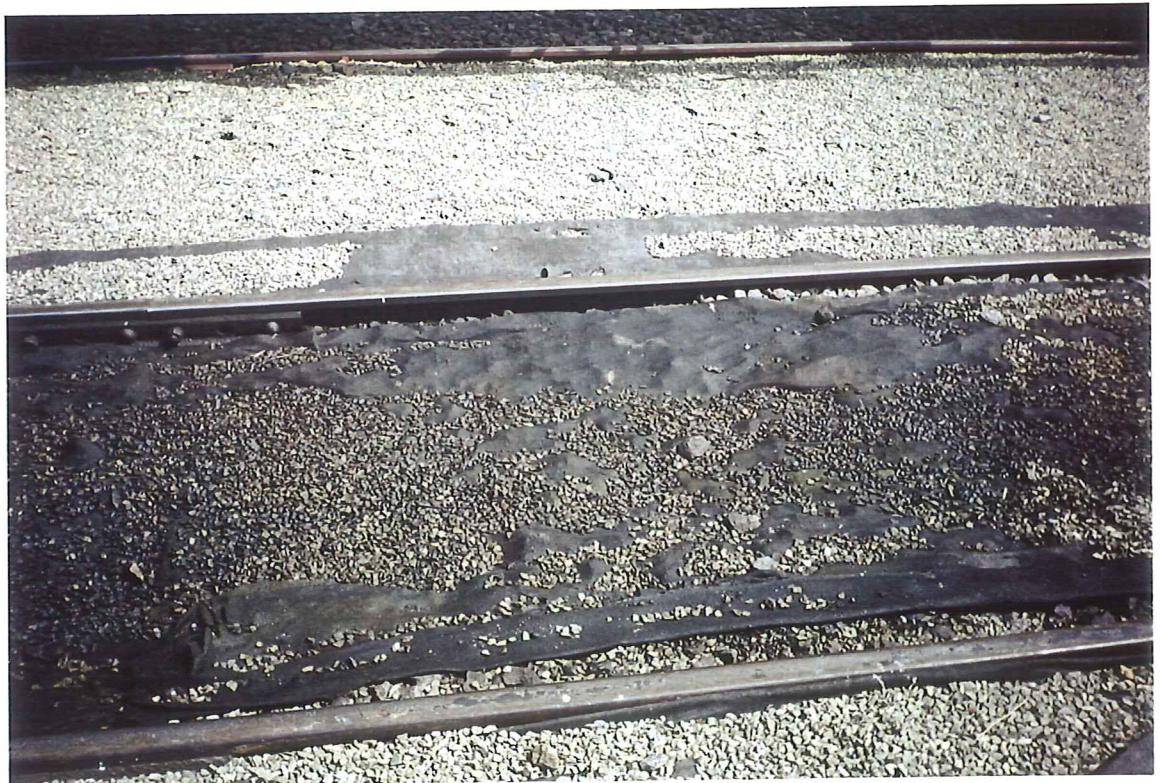
Photo 23: Hydrocarbon Staining Next to Platform

- Significant hydrocarbon staining was observed in the railway yard adjacent to the platform, however it was reported that this had been cleaned up in the past and a hydrocarbon resistant fabric now underlies this area (refer to Photos 23 and 24).

There was significant oil staining observed in front of the railway station building the NSW Country Link Trains stopped to pick up and drop off passengers. Much of this area had been lined with an oil resistant fabric which was designed to prevent oil contamination of underlying soil.

Furthermore, emergency oil and chemical spill response equipment was observed stored in the garage building adjacent to the station. A hydrocarbon resistant membrane was observed being used in the station yard to collect oil spillage onto the railway line.

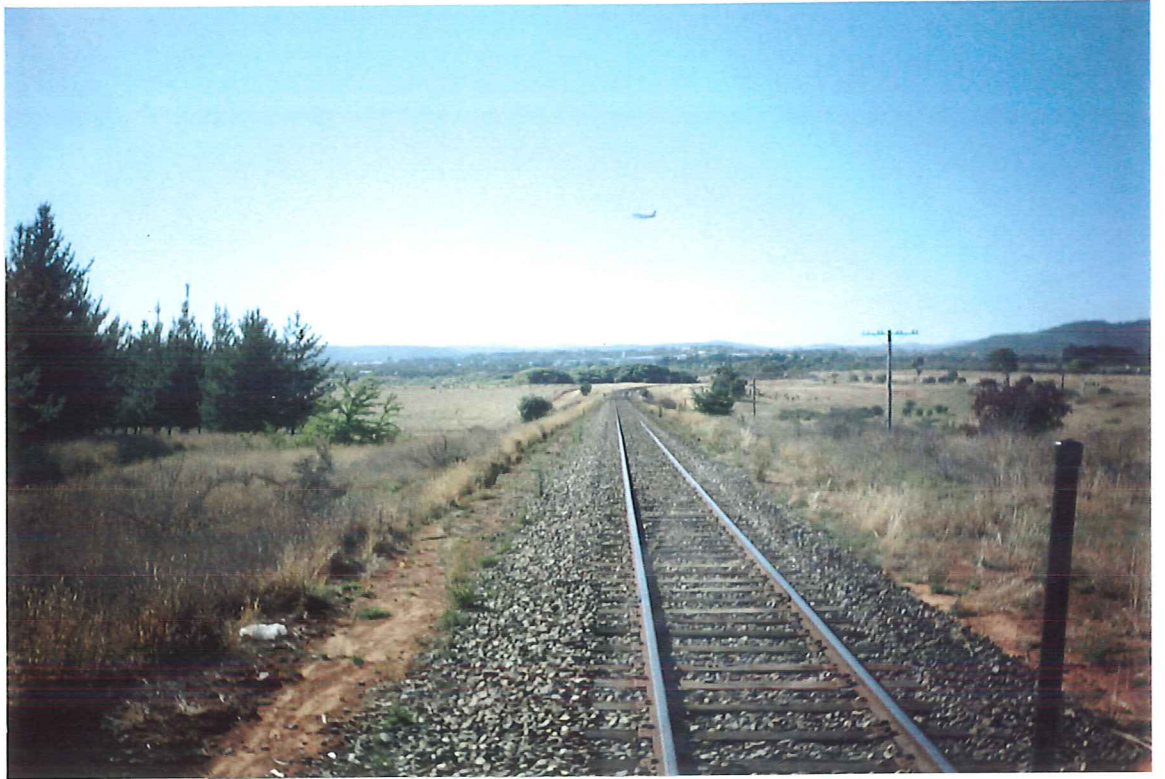
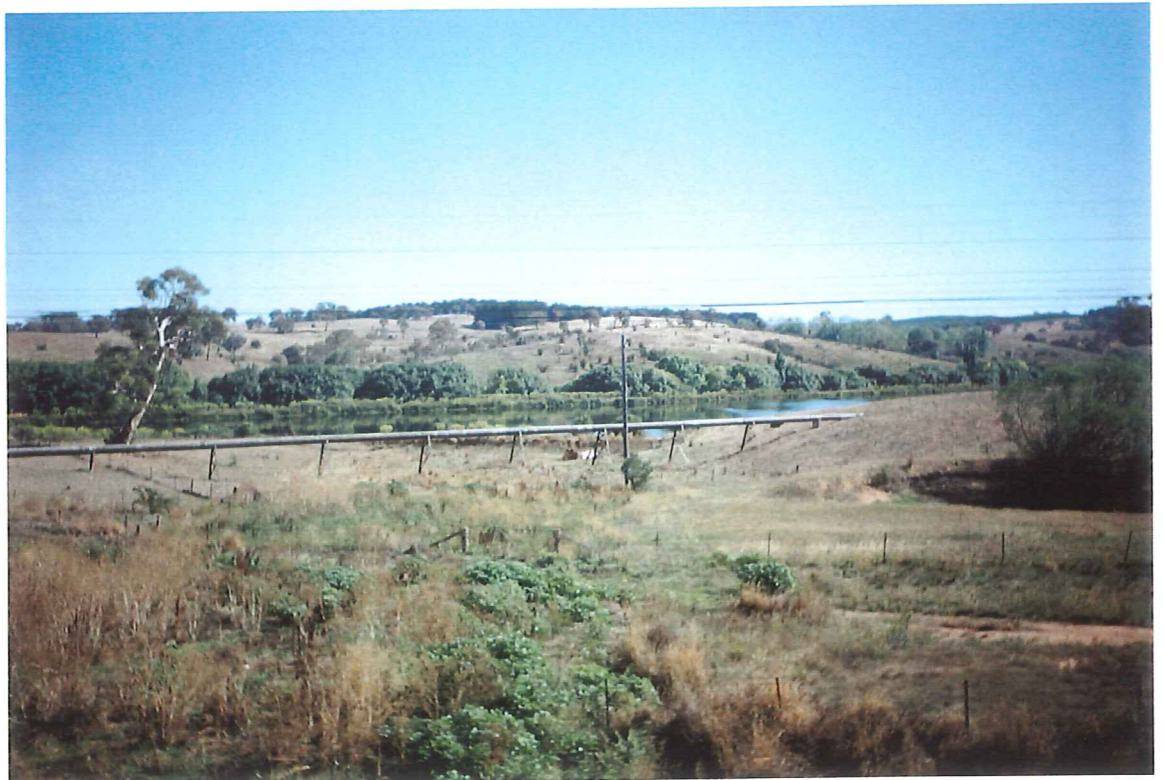
Photo 25: Rail Corridor East of Fyshwick

- The railway corridor east of Fyshwick was not observed to have any adjacent major environmental issues and was surrounded by predominantly rural land use (refer to Photos 25 and 26).

The rail corridor east of Newcastle Street was traversed and no environmental issues were identified from the railway line. The land use along the corridor is predominantly rural with an old abattoir site and small modern tannery facility located south of the line near Queanbeyan. It was reported by Environment ACT that two underground fuel storage tanks were removed from the abattoir site without appropriate testing and notification. If these have leaked then there is potential for hydrocarbon impacts onto railway land.
