CANBERRA BRICKWORKS

Name	Primary Crusher House (Crusher House III)	Reference No	20
Construction	Corrugated galvanised steel over steel frame, retaining wall of concrete	Survey Date	3 December 2009
Historical Phase	Post-war phase, 1944-1976	Date	c. 1955

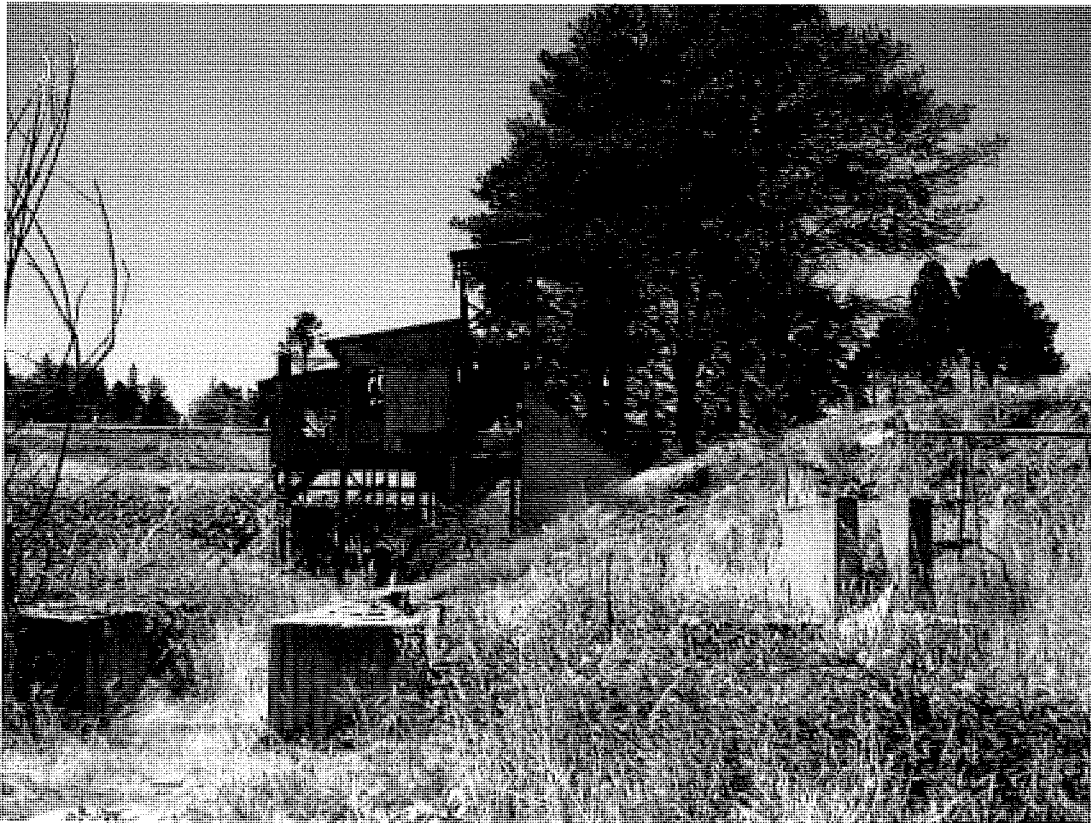
Figure 130 The Primary Crusher House viewed from the west. The concrete footings in the foreground supported the now demolished conveyor which transported crushed material to the Red Pan Room (also demolished) for further refining.

The structure is in a ruinous state. Parts of the crushing machinery and conveyor are still in evidence. The timber decking within the structure is in a hazardous condition. The building is impacted by a copse of pine trees which appear to have self-seeded in front of the chute.

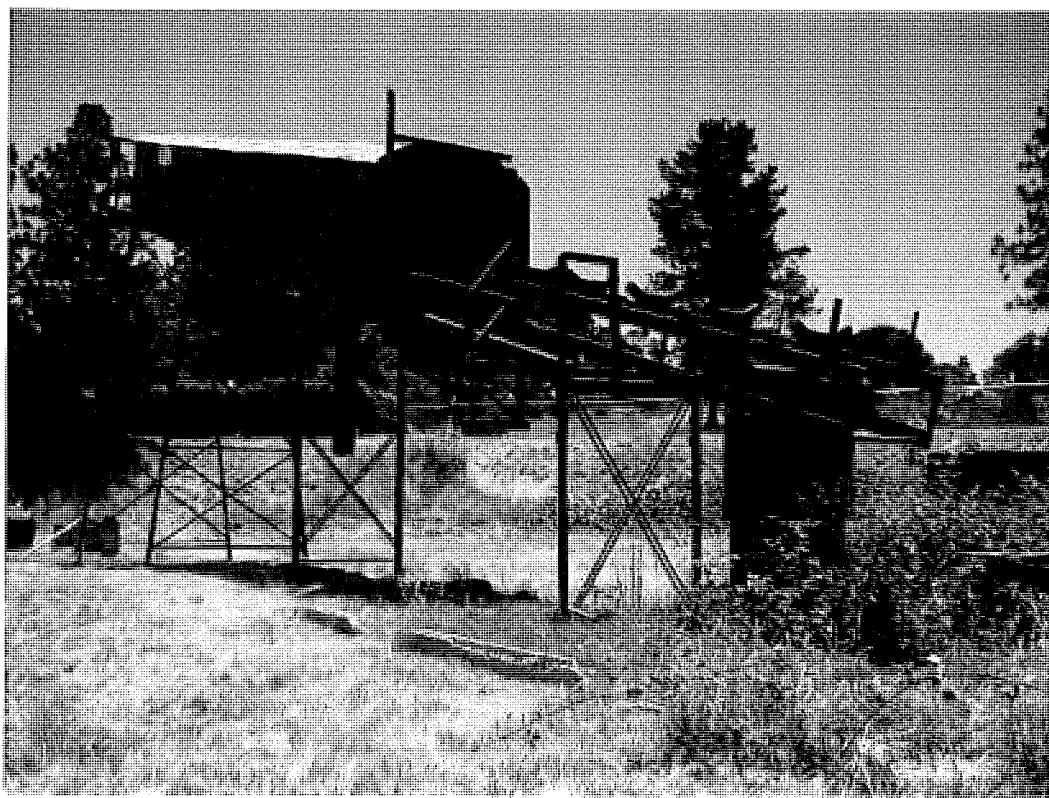
Figure 132 Extant section of the elevator/conveyor looking north-east.

The Conveyor is in poor condition. The section linking the demolished pan house to the distribution hopper is only partly intact and the section linking the pan house to the crusher has been demolished. The adjoining distribution hopper structure has also been demolished.

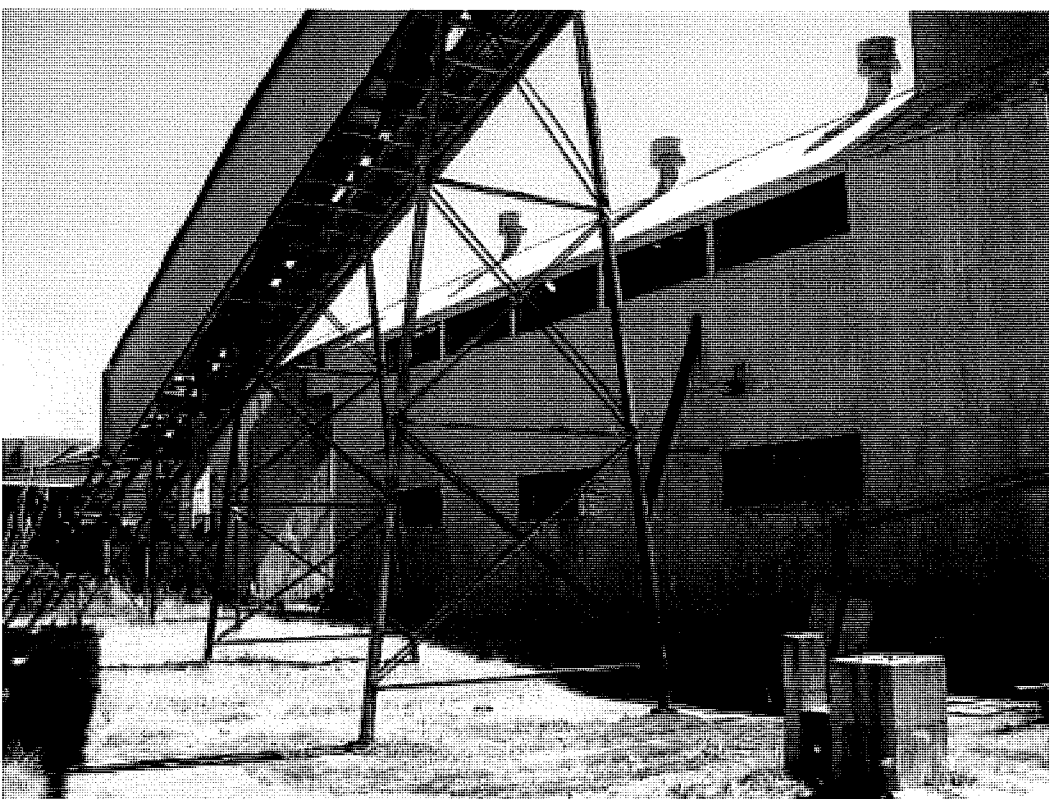
Figure 133 Looking south-west. Machine Bay III (Building 16) is in the background.

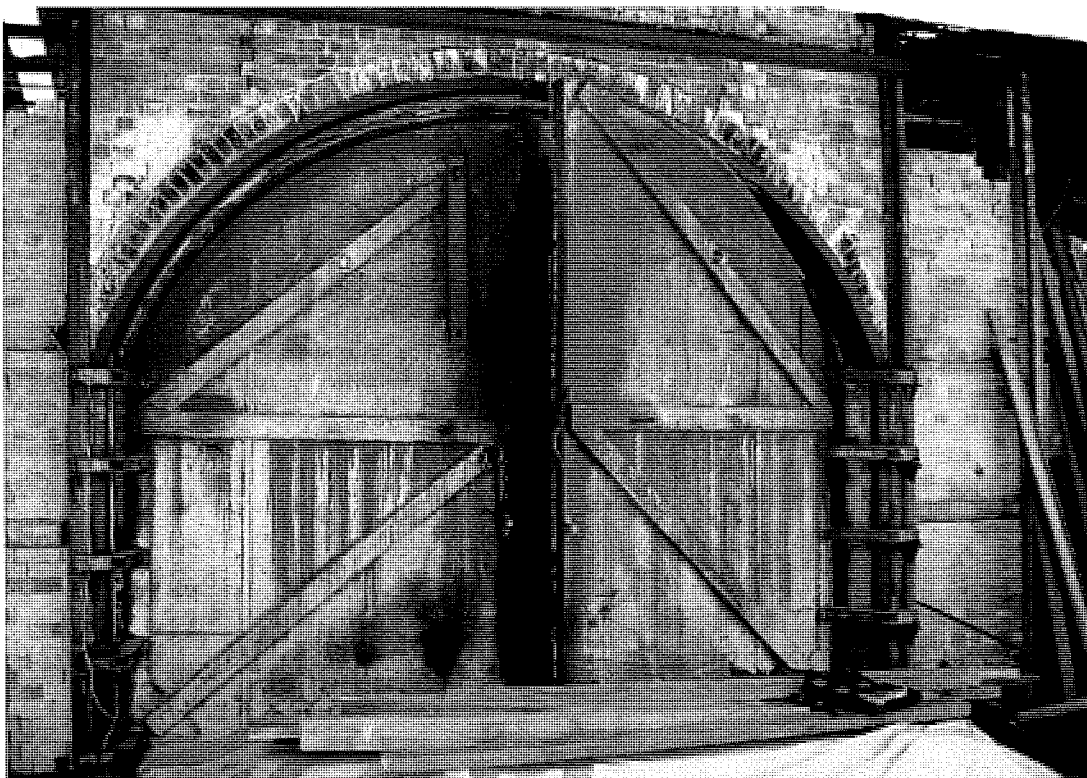
Figure 137 Kiln entry showing stepped side wall.

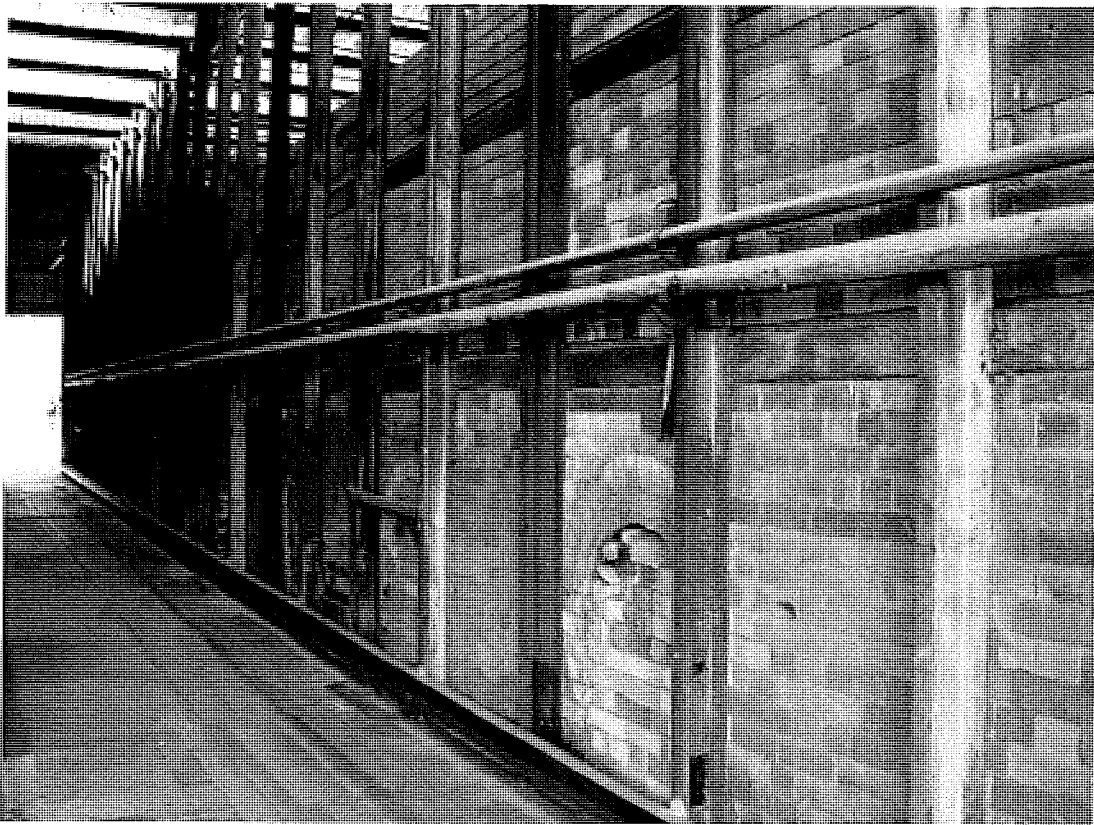
Figure 138 Side elevation showing steel framing and fireholes.

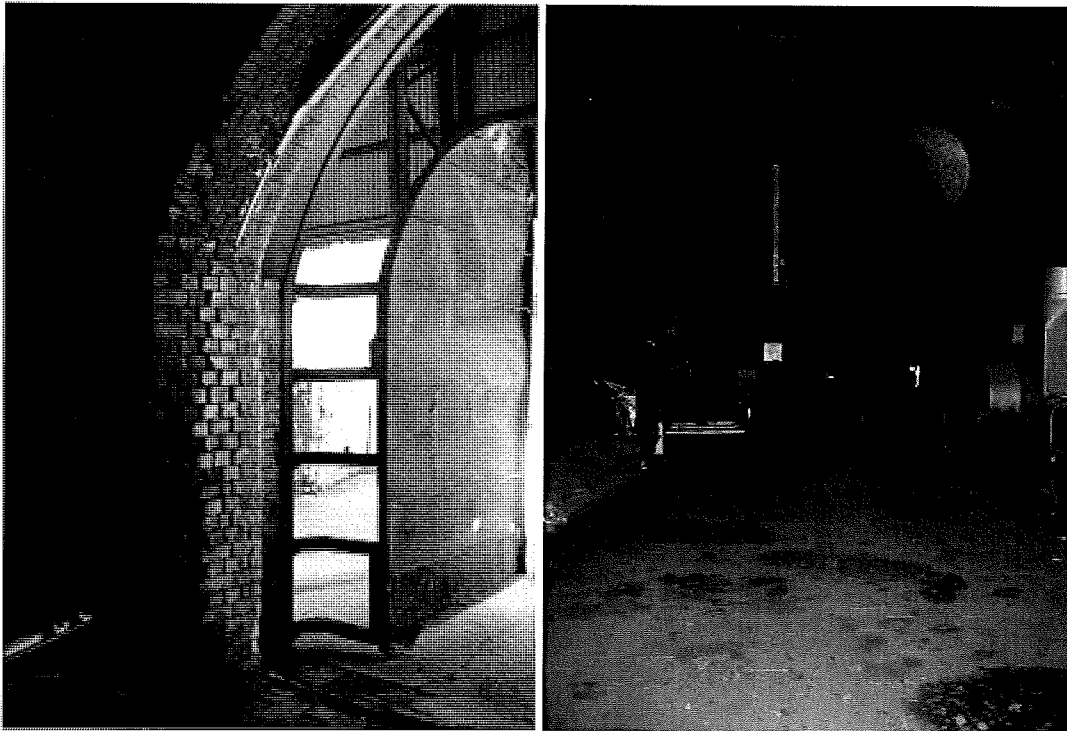
Figure 139 From left: interior of kiln showing entry and deteriorating fire bricks; interior of kiln showing later cement paving.

Internally, the kilns are designed to be accessed via metal doors to either end. None of the three kilns are accessible from the north end. With the exception of Kiln 1, the doors to the south end comprise metal cladding to the exterior face and a wall of firebricks, held in place to the surface of the metal door by a heavy duty metal mesh. These are in reasonable condition albeit some of the brick is friable and deteriorating. The doors to Kiln 1 are of metal without the firebrick lining. The doors are fitted with easy clean hinges, enabling them to be folded fully back flat against the kiln wall to permit access to the interior. Internally the north doors are either bricked over or, as for Kiln 1, a false stud wall with plaster has been installed.

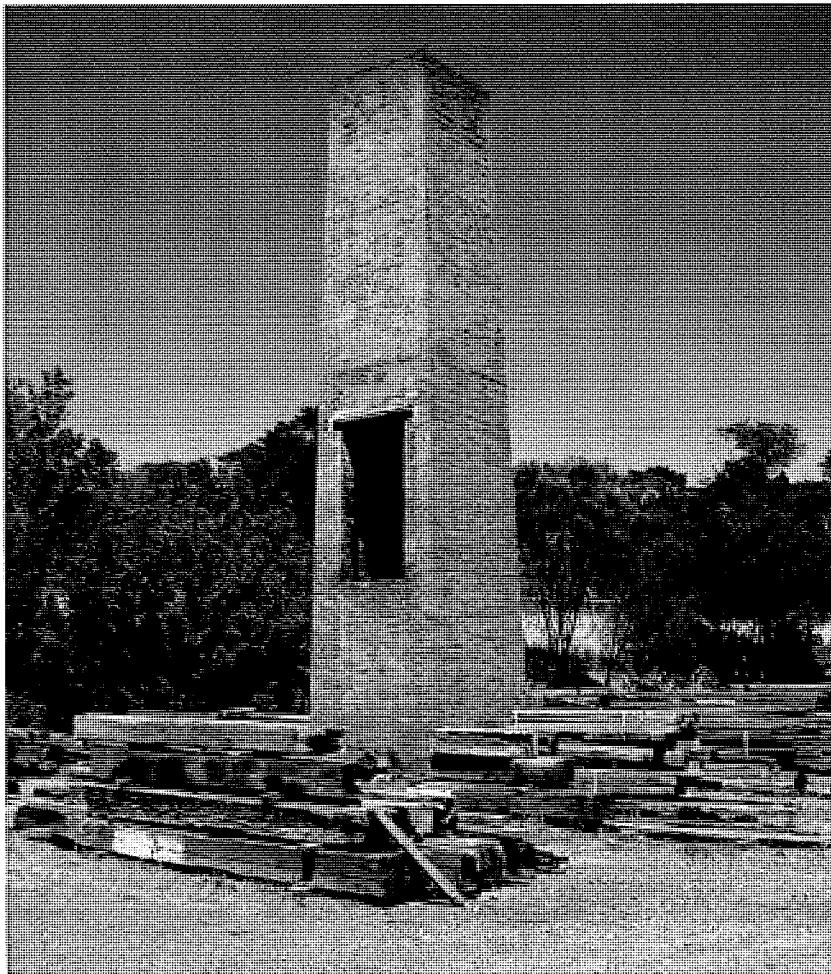
Figure 141 Chimney stack viewed from the north-west.

There is evidence of brickwork spalling, particularly to the west and north faces. There is a large oblong opening approximately three metres above the ground in the north face, indicating where a duct channelled spent fuel and heat to the stack for dispersal. There is an opening at low level in the south face, set within a steel door surround – the door is missing.

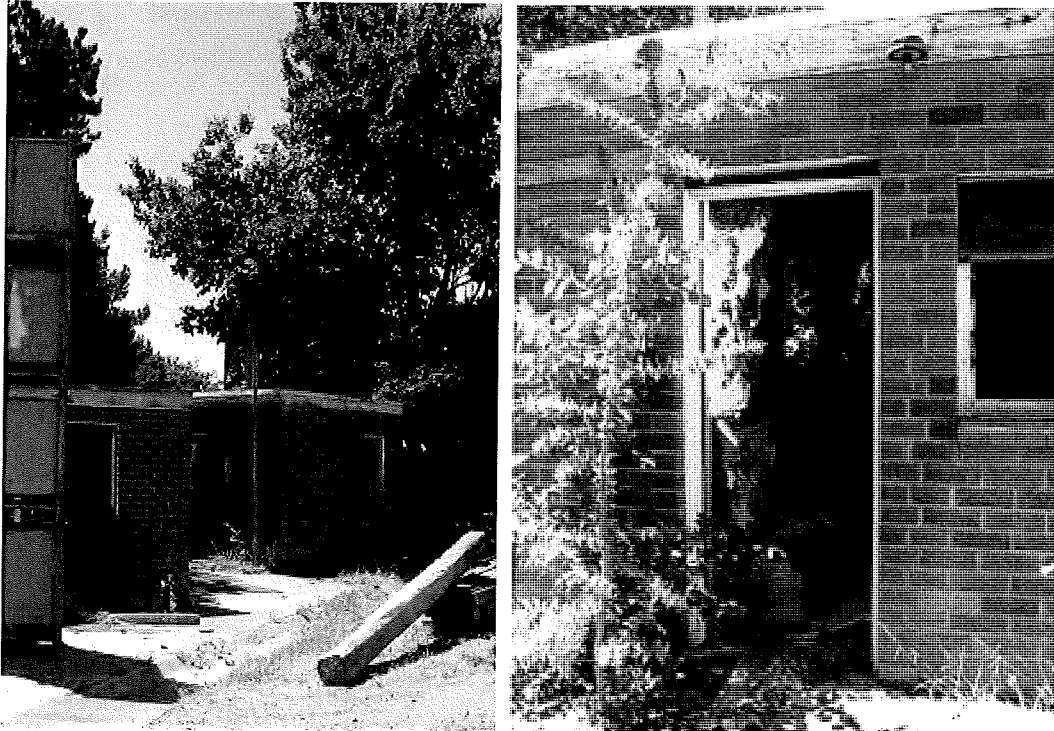
Figure 143 From left: the amenities block is the small red brick building at right; entry.

The amenities block is of vari-coloured brickwork, and has a skillion roof of metal roof decking. Internally it has a concrete floor and there are window openings to the north, east and south. The entry is from the south. The interior has been heavily vandalised with all fittings and finishes in poor condition.

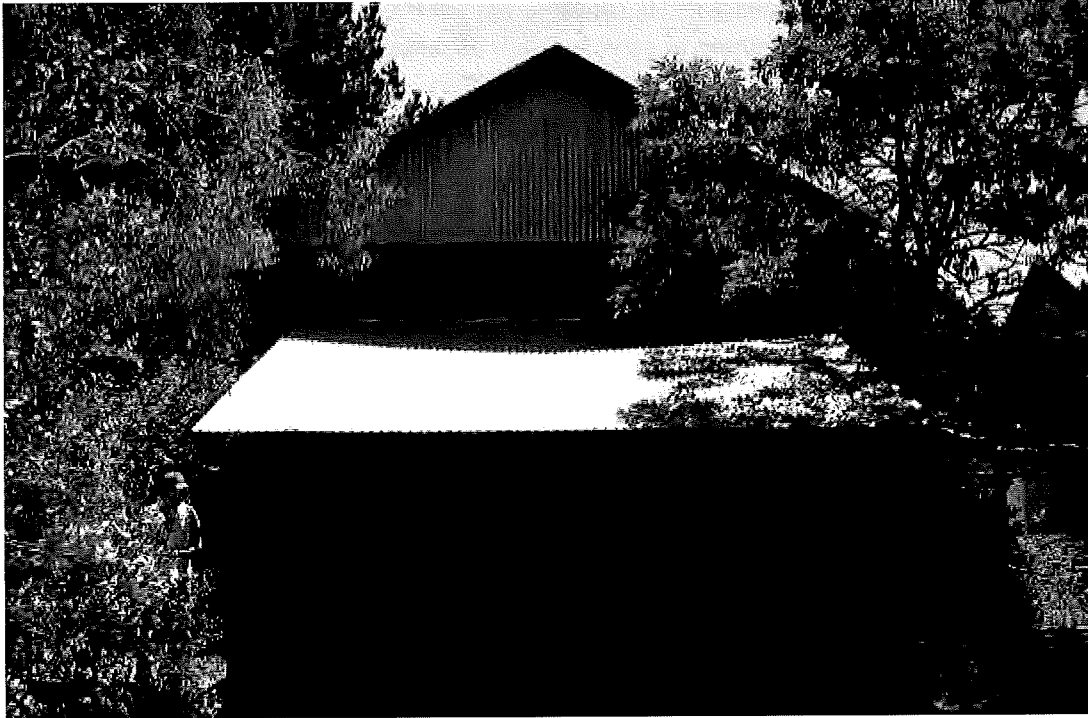
Figure 146 Former boiler house building showing east entry and later verandah addition.

The building is in good condition, apart from the impacts of minor vandalism, including the breaking of windows.

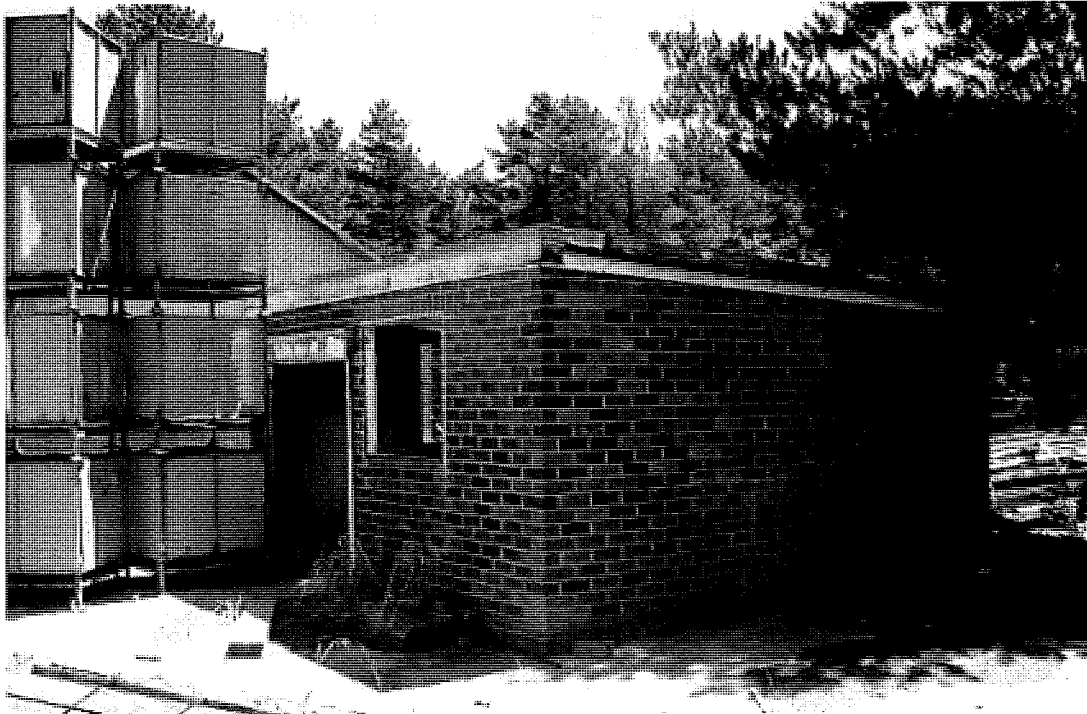
Figure 148 The storage building, adjoining the site of the brick extrusion plant site.

The building is vacant and in poor condition.

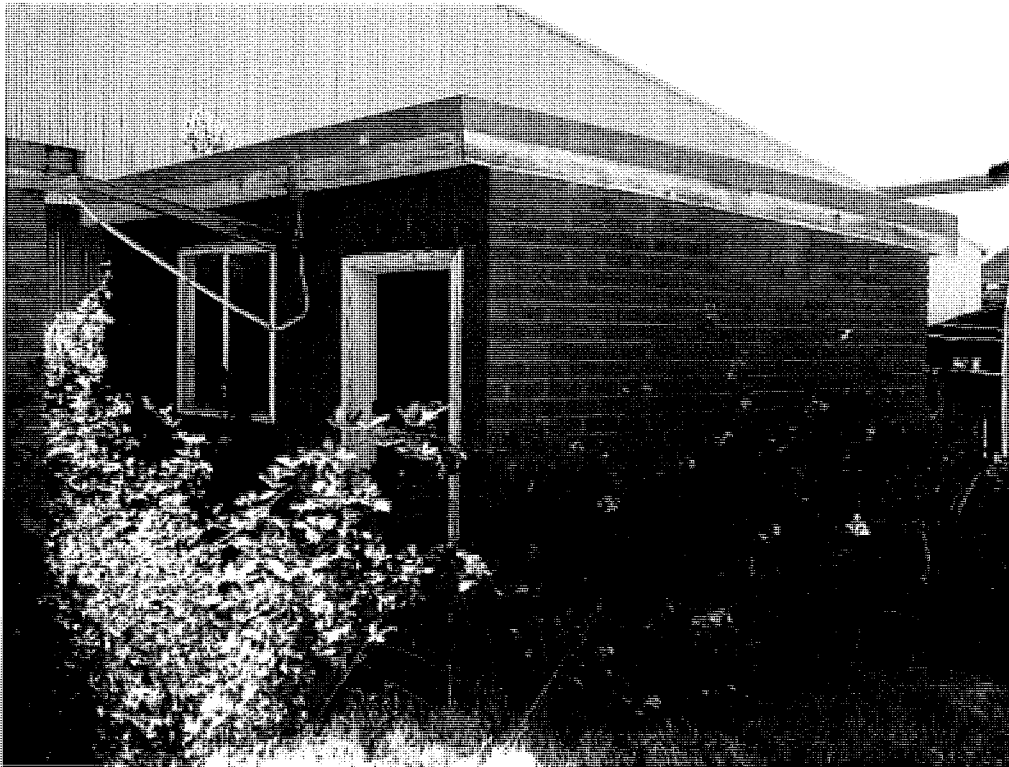
Figure 151 The ancillary storage building is sited behind the former offices (Building 7).

The structure is of orange face brick with a timber framed door and window to the south elevation. It has a skillion roof of metal roof decking. The interior walls are lined and part-fitted with shelving unit brackets. The building is unsecured, vandalized and in poor condition.

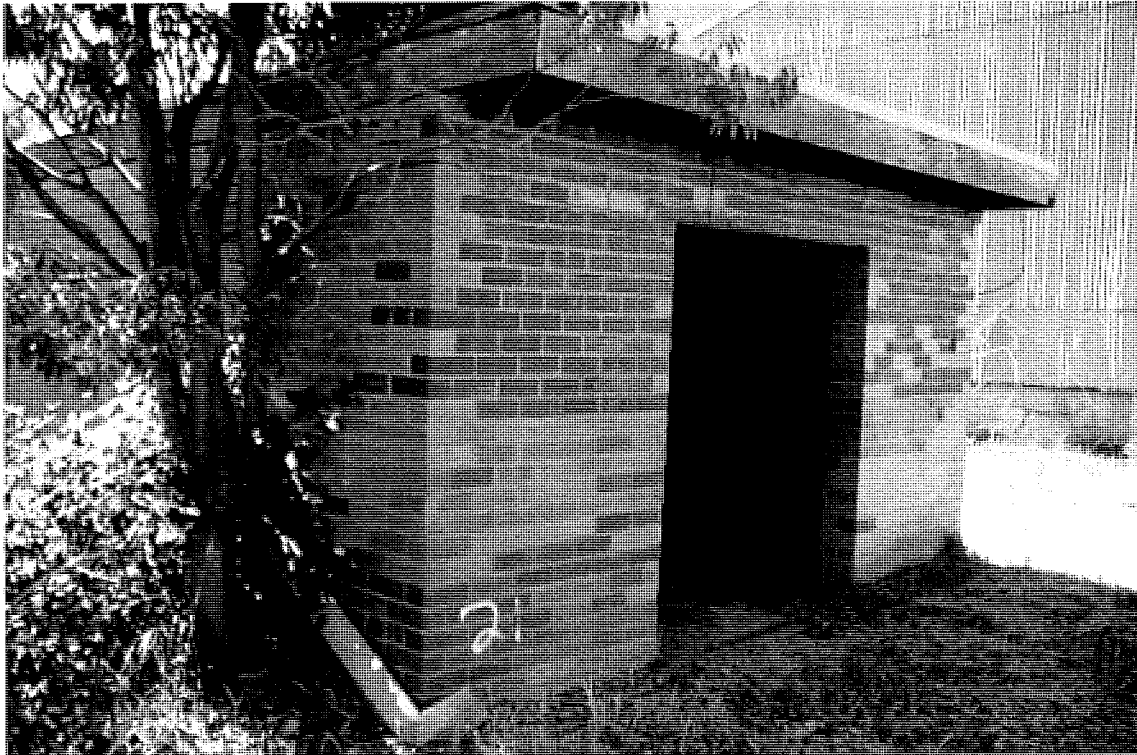
Figure 152 Storage shed.

The shed is of vari-coloured brickwork, and has a skillion roof of metal roof decking. Internally it has a concrete floor and the timber door to the large opening on its north face is stored within the building. The walls are not lined internally and the reflective insulation has been damaged by vandals. The shed is vacant and in fair condition.
