Carnall, J and the Australian Institute of Architects (ACT Chapter), 2010, 'Heritage Nomination of Kingston Bus Depot (Kingston Transport Depot), Wentworth Avenue, Kingston, ACT'.

STATEMENT OF HERITAGE EFFECTS

1.2 The site

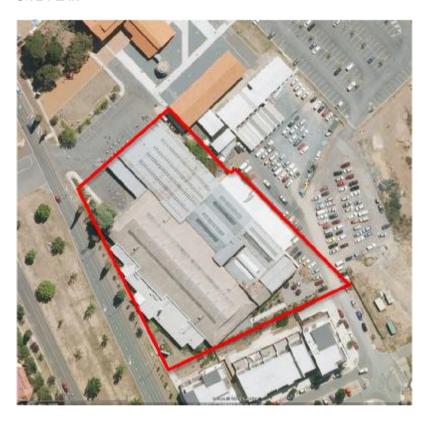
SITE PLAN

The site boundary is indicated by red lines on the above plan – the eastern boundary includes the orientation of the building parallel to the railway siding and the western aligns with the block boundary on Wentworth Avenue. Northern and southern boundaries align with the former Transport Depot building footings.

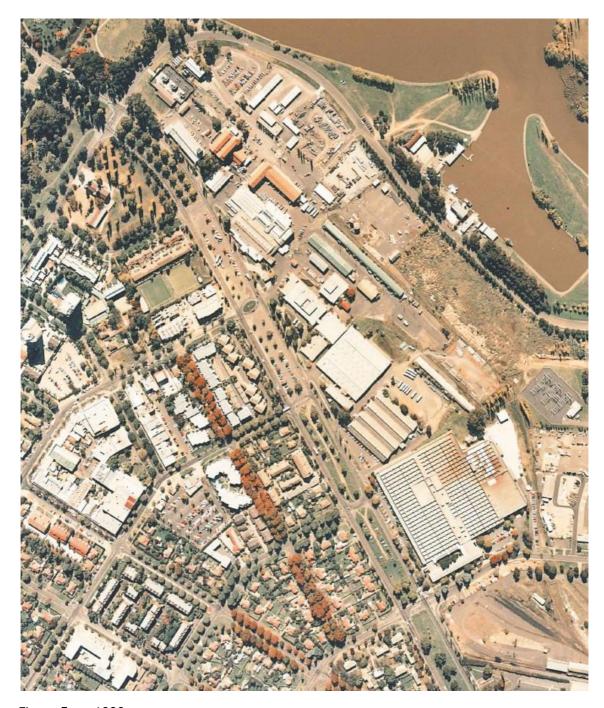
Figure 5 1990 Source: ACTPLA.

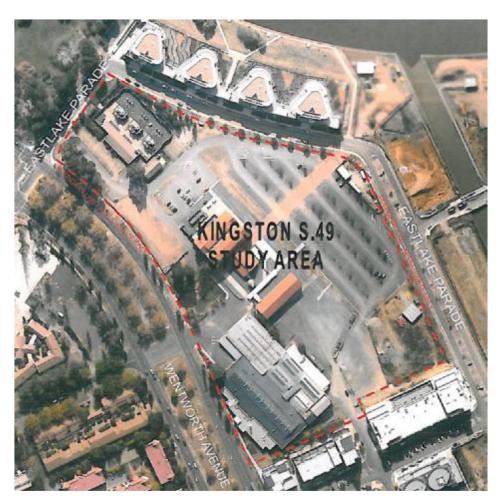
Figure 2 Recent aerial view of Section 49 (indicated by the red dotted line). Source: Land Development Agency.

Kingston Section 49 is located approximately two kilometres east of Capital Hill, and immediately south of Lake Burley Griffin in central Canberra (Figure 1). The site covers an area of approximately 5.4ha and is bounded to the north and east by Eastlake Parade, to the south by new development on Giles Street and to the west by Wentworth Avenue (Figure 2).

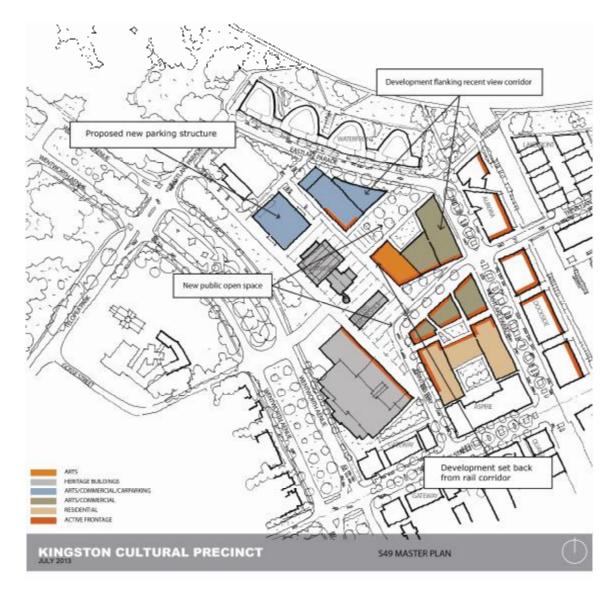
Figure 3 Kingston Section 49 masterplan. Source: 'Kingston S49 Masterplan' (July 2013), p. 10.

As noted, development is anticipated for this area. Much of this area is outside the zone of heritage sensitivity, as identified in the Heritage Strategy (Lovell Chen, 2013). However, the Master Plan is responsive to the heritage context, providing for development no higher than the underside of the Power House eaves at the interface with the Power House, and stepping up to the north-east, and a 20m-wide linear open space between the Power House and the new development. The view line extending from the Power House to the lake is also maintained.

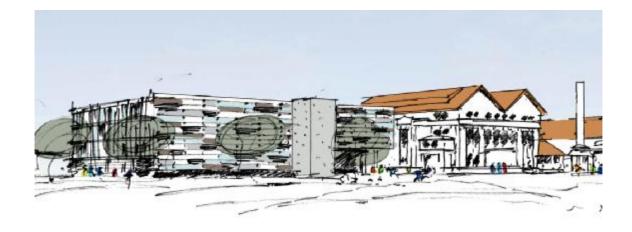
Figure 4 Concept sketch of the proposed parking structure, viewed from the south-west.

The site is contained by the rail siding alignments, and the Heritage Strategy recommends a setback of 15m from the north-west elevation of the Power House. The parking structure requires the demolition of the '1948 Switch Room'.

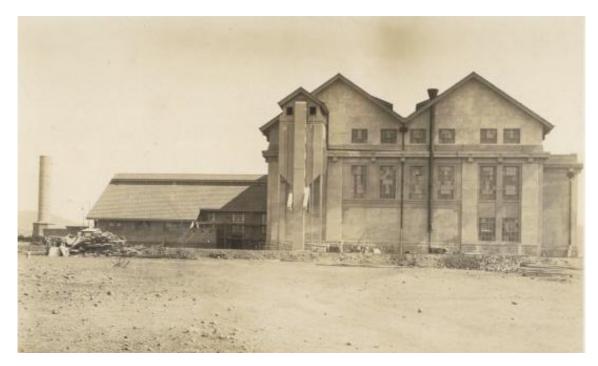
Figure 6 North-east elevation of the Power House c. 1915. Source: National Library of Australia.

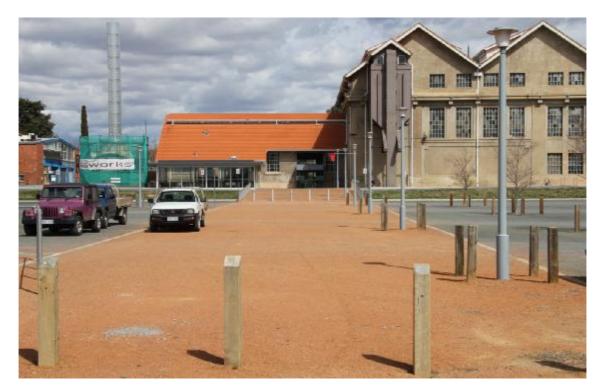
Figure 7 North-east elevation of the Power House 2012.

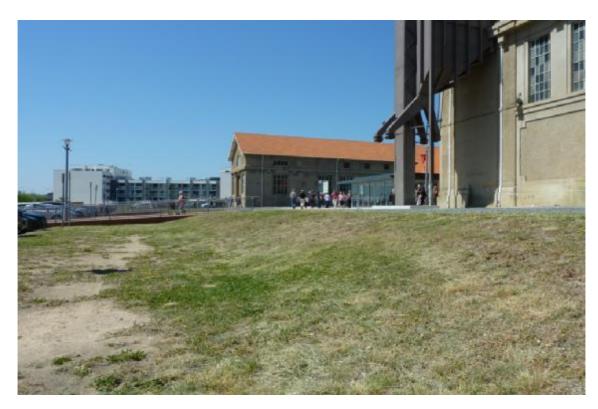
Figure 8 View looking south along the embankment, 2012.

In 2002-03 a 3m-deep and 4m-wide trench for 132kV electrical cables was introduced adjacent to the embankment, approximately 16m from the main building line of the Power House. The works are likely to have resulted in physical impacts (re-grading) to the embankment (compare Figure 6 with Figure 7 and Figure 8). The gradient of the embankment to the south of the Power House has clearly been modified for the pedestrian paths and ramps that extend from Wentworth Avenue to Eastlake Parade.

Archaeological testing conducted in June, July and September 2006 exposed sections of the two original rail lines closest to the Power House. The archaeologists (Navin Officer) concluded that, 'There is significant historical and archaeological evidence ... to indicate that there are further remains of at least three sets of railway lines aligned in a northeast/southwest orientation, and a built-up railways embankment, in the area to the immediate northeast of the Power House and the Bulk Store [Fitters' Workshop]'. 10

It is recommended that a section of the embankment to the immediate north-east of the Power House should be incorporated into the landscape plan for the new public open space. Prior to works being commenced, archaeological test trenches should be conducted to establish what remains of the original tracks and sleepers. It would also be desirable to establish the original height of the embankment.

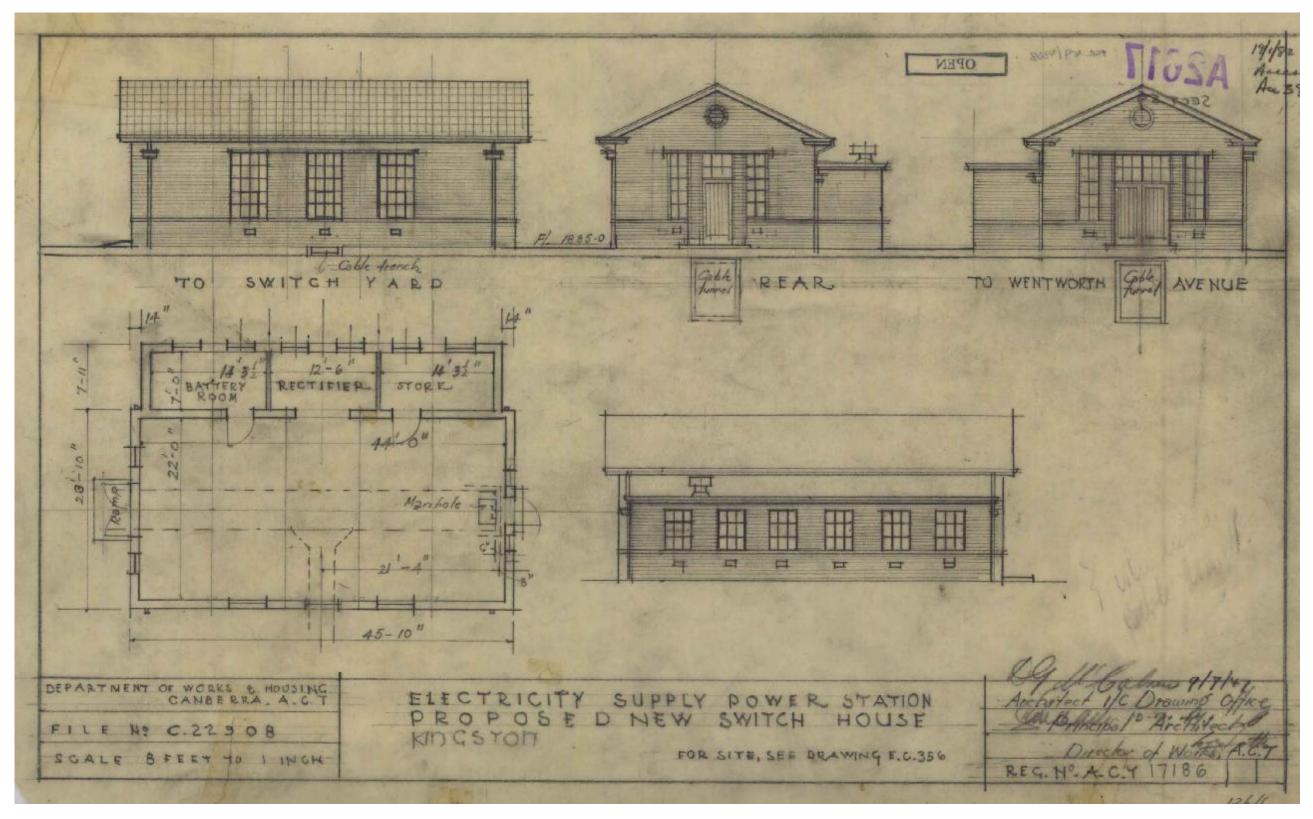
Figure 1 'Electricity Supply Power Station, Proposed New Switch House, Kingston,' prepared by the Director of Works, ACT, 9 July 1947. Source: National Archives of Australia.

Albeit constructed in 1948, it is understood that the Switch Room was not used as such until 1960, when the 11kv switchgear was designed and installed. The Switch Room handled power generated remotely from the site. The Power House had ceased operating for the final time in 1957. The building was later extended to accommodate additional switchgear. It has subsequently been modified on at least two further occasions, including an extension to the south-west in the mid-1980s for its adaptation to office use. These works may also have resulted in the replacement of the original terra cotta tiles, and the removal of the switchgear. The most recent works – a fit-out to residential use – were carried out in 2008.

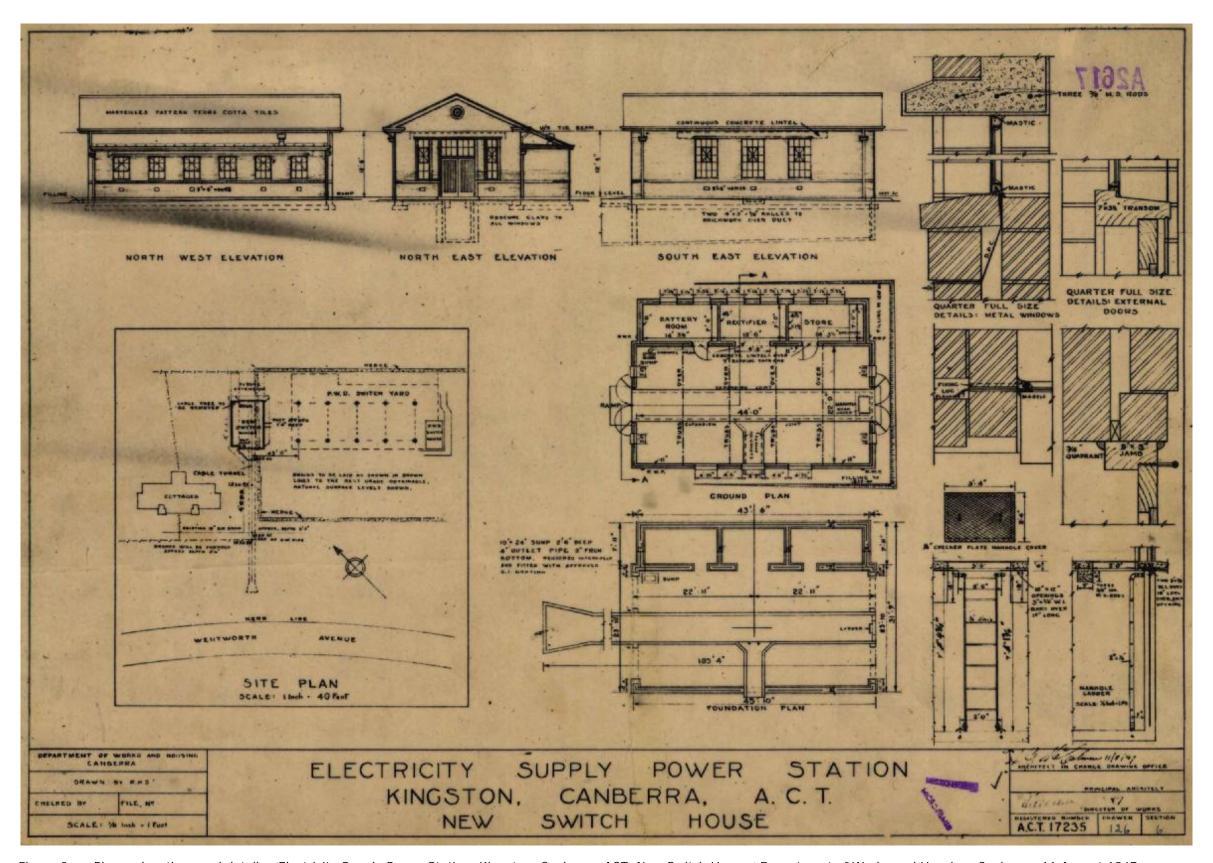
Figure 2 Plans, elevations and details: 'Electricity Supply Power Station, Kingston, Canberra, ACT, New Switch House,' Department of Works and Housing, Canberra, 11 August 1947. Source: National Archives of Australia.

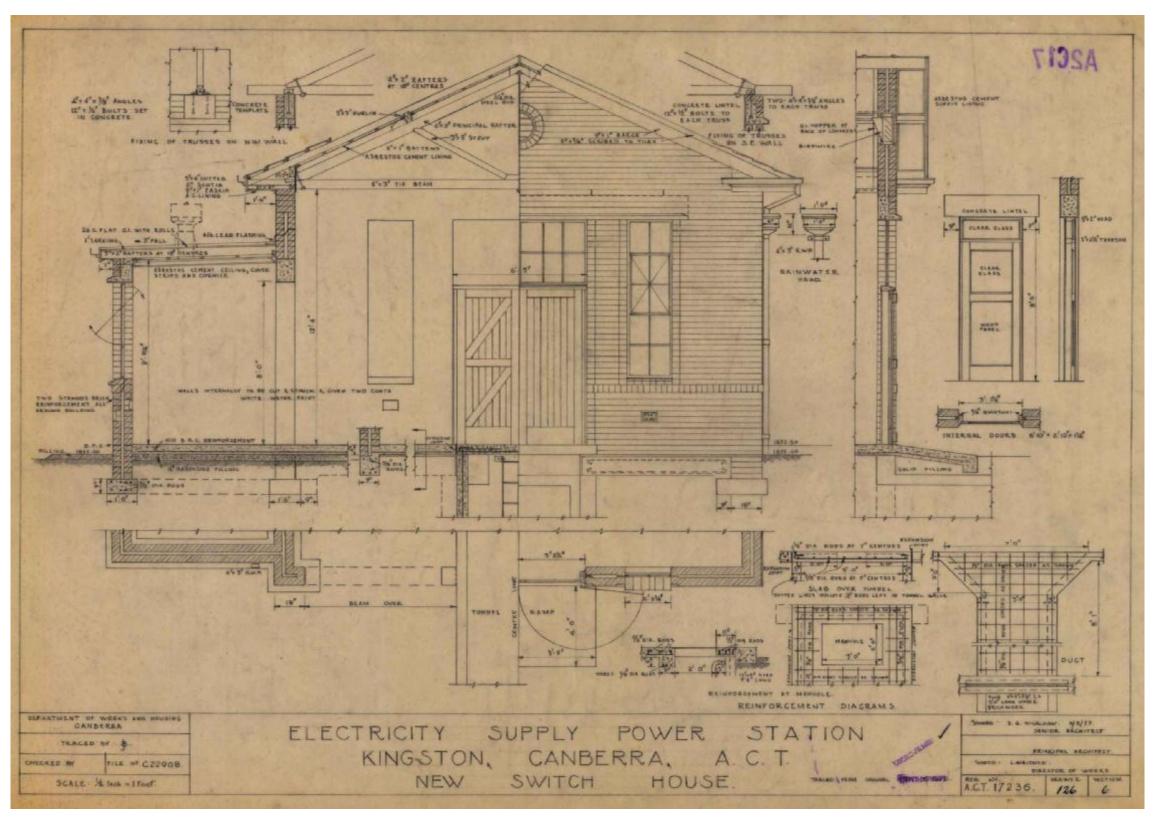
Figure 3 Details: 'Electricity Supply Power Station, Kingston, Canberra, ACT, New Switch House,' Department of Works and Housing, Canberra, 11 August 1947. Source: National Archives of Australia.

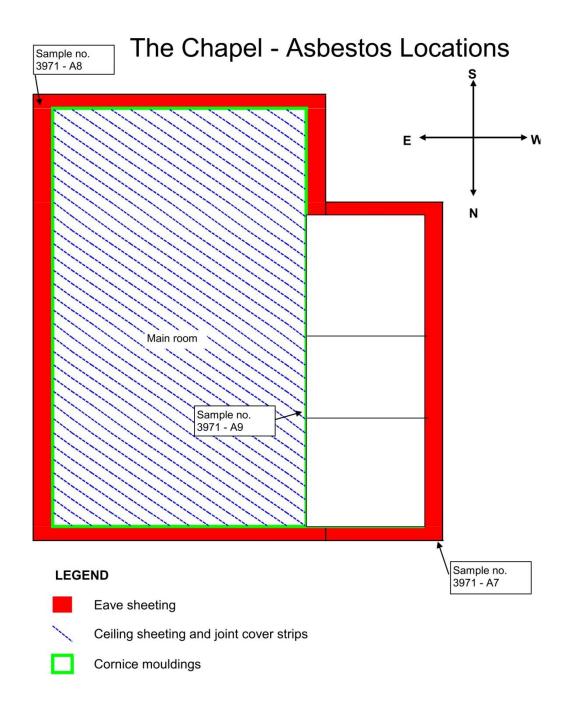
10.2 APPENDIX B - Plans

Refer to Section 1.4 - Table 1B for presumed ACMs and Section 2.2 for exclusions
