Preliminary Geotechnical Site Investigation for the Canberra Brickworks

For: Land Development Agency

8 November 2013

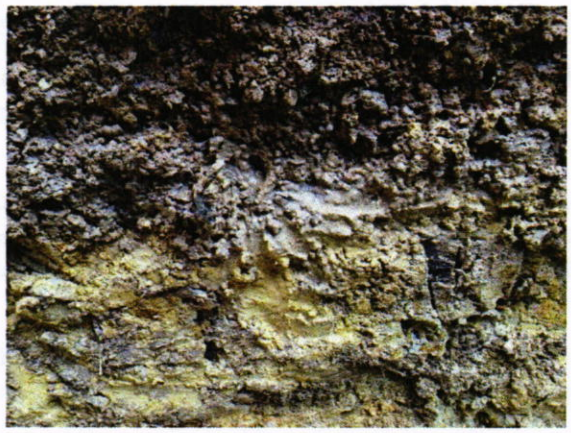
Alluvium was encountered in TP16 and TP3. Alluvium is associated with water courses, and TP3 was targeted to intersect the bed of a creek noted in historical photographs. TP3 is in fact still a drainage point for the surrounding northern hills, and is adjacent to a culvert underneath Adelaide Avenue. Alluvial gravels in TP3 were noted to be wet.

Unit 3 consists of a medium plasticity, stiff, grey mottled orange gravelly clay. Gravels were well graded and sub-rounded, indicating an alluvial origin.

Photograph 6: Saturated gravelly clay, TP3

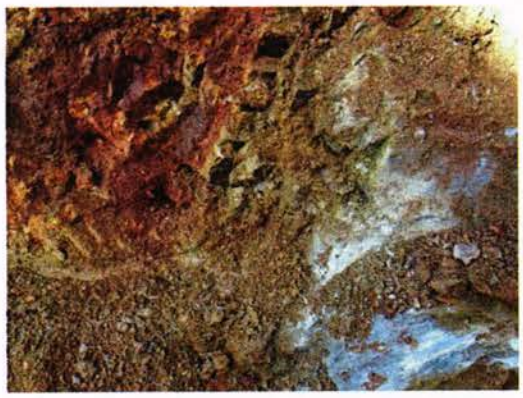
Medium strength siltstone occurred from depths around 0.85-1.1 m. In TP17 corestones were observed. Large blocks of fresh grey high strength siltstone occurred in the midst of moderately weathered orange low strength siltstone, as displayed in Photograph 8 below.

Photograph 8: Corestone of fresh high strength siltstone (bottom right) surrounded by highly weathered, low strength siltstone. TP17

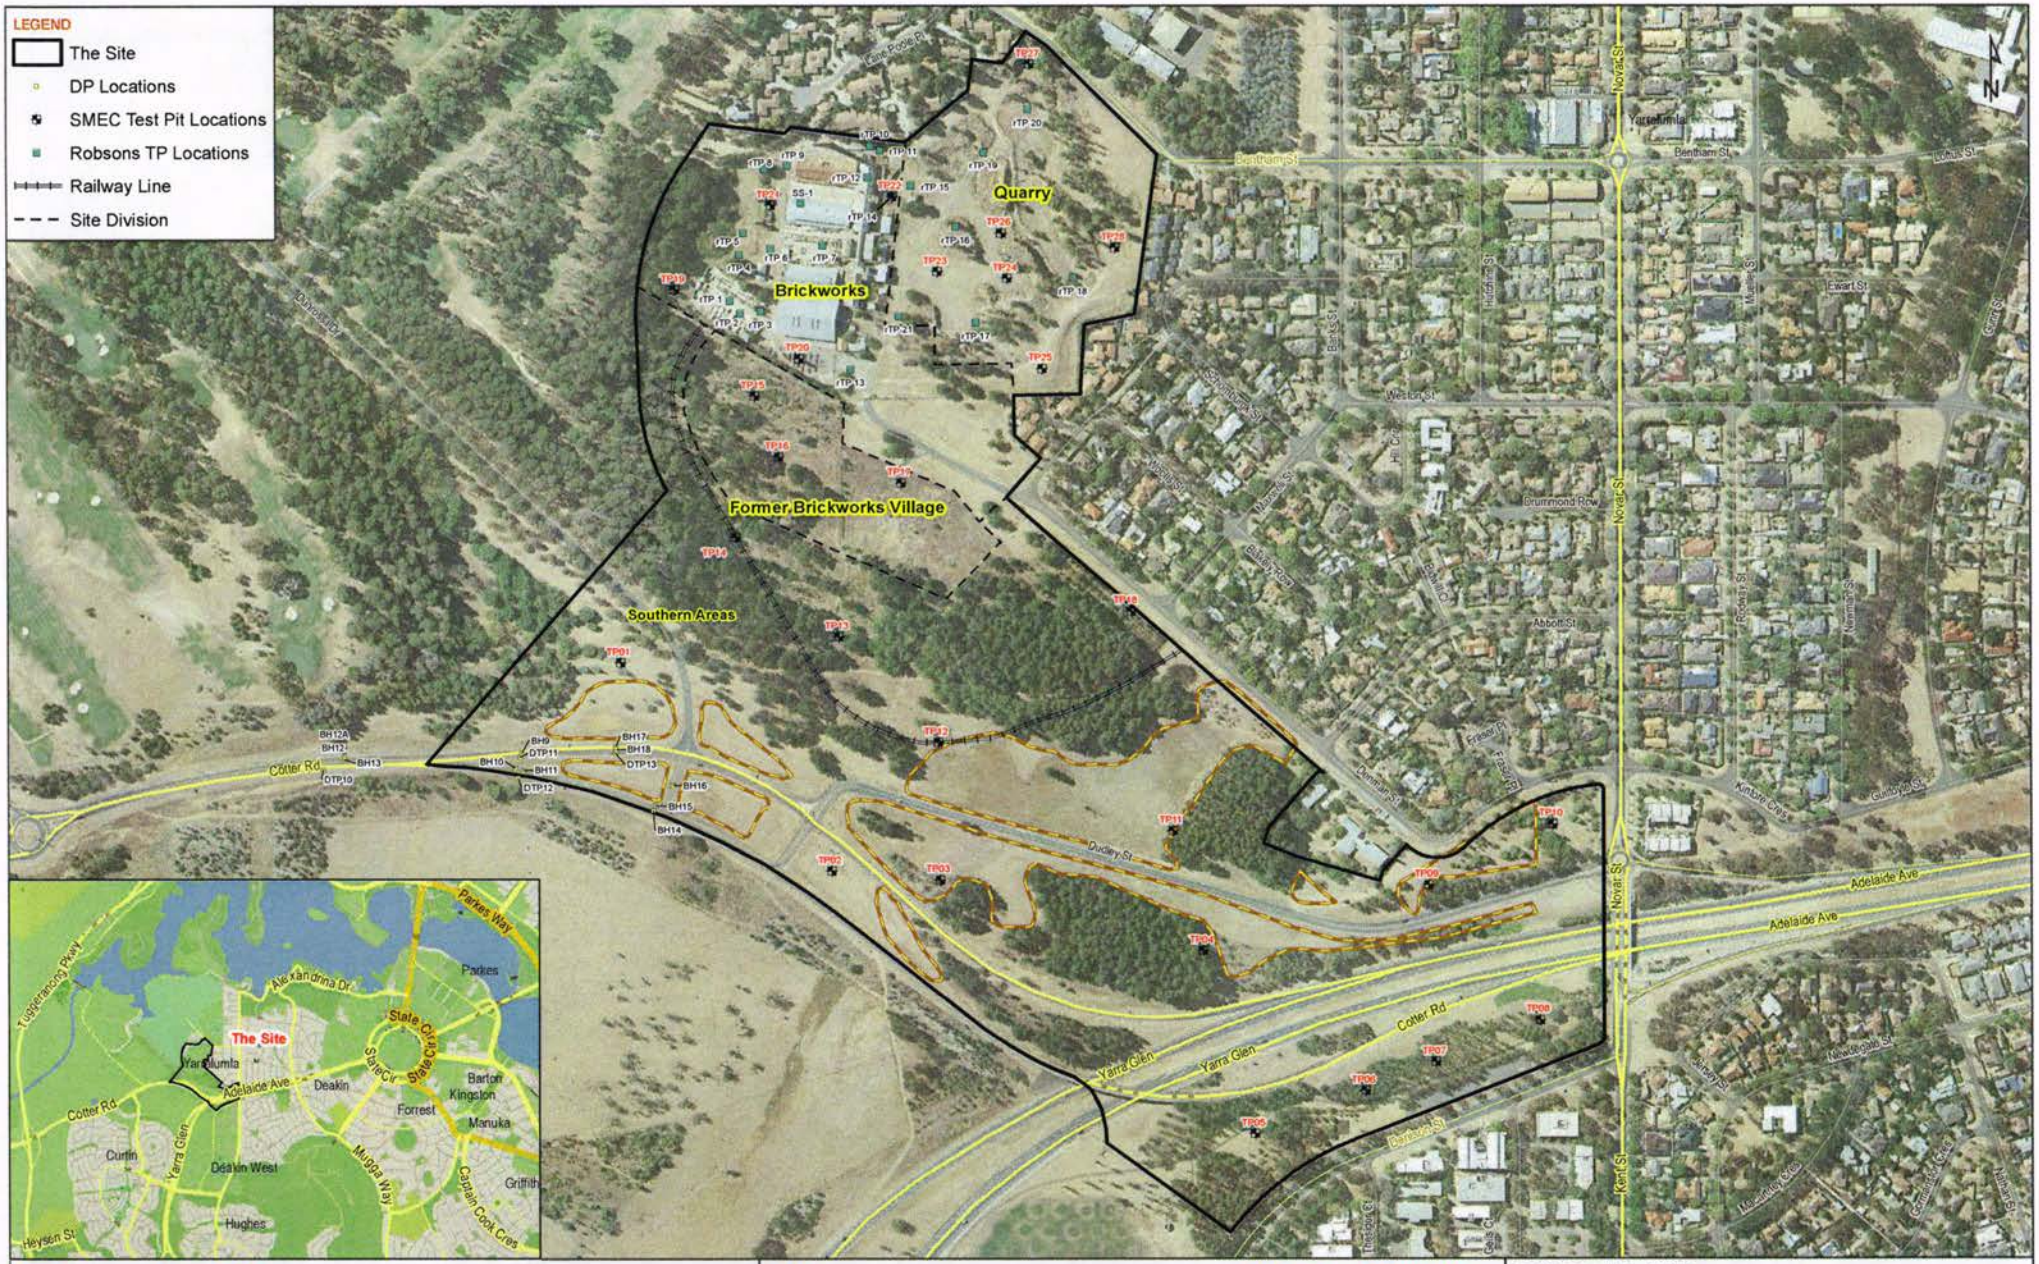
FIG NO. 2	**FIGURE TITLE** Borehole Locations (all investigations)	**DATE** 30/10/2013	0 50 100 200 Meters 1:4,500	**PAGE SIZE** A3	**COORDINATE SYSTEM** ACT Grid 1966
PROJECT NO. 3002369	**PROJECT TITLE** Canberra Brickworks Preliminary Site Investigation	**CREATED BY** J. Seng	**SOURCES** Imagery © Roadnet, Imagery © Stromlo

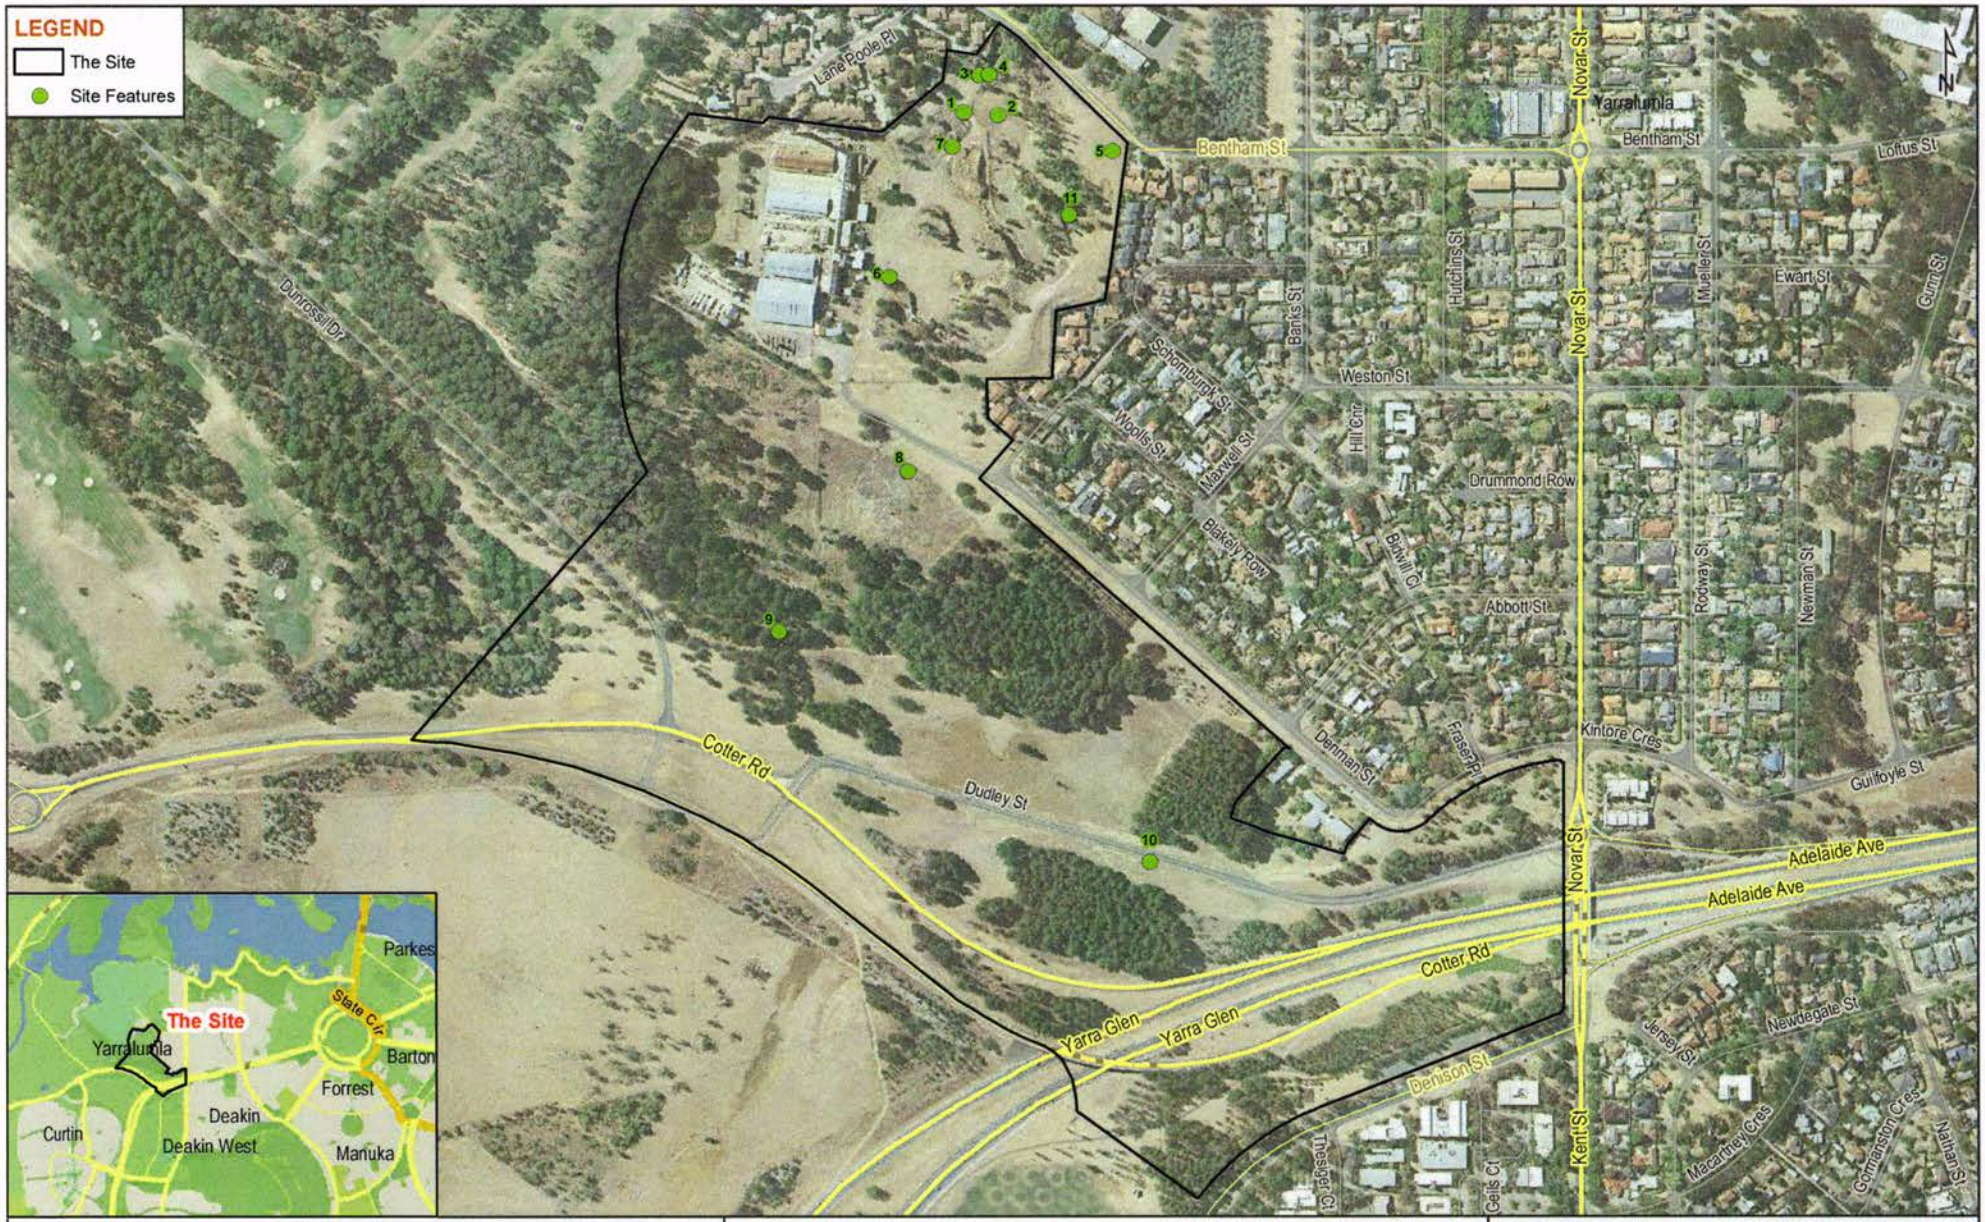
The disused quarry presents several opportunities to identify rock strata and other geological features without additional excavation. Geomorphological mapping was undertaken across the site and several features were noted, including geological structures, rock outcrops, fossils and tuffaceous units. Significant features are displayed in **Figure 3, Appendix A**, and are detailed in Table 4.2.

FIG NO. 3	FIGURE TITLE Outcrops and Observations	DATE 31/10/2013	0 40 80 160 Meters 1:6,500	PAGE SIZE A4	COORDINATE SYSTEM ACT Grid 1966
PROJECT NO. 3002369	PROJECT TITLE Canberra Brickworks Preliminary Site Investigation	CREATED BY J. Seng	SOURCES Imagery © roadnet, Imagery © Stromlo

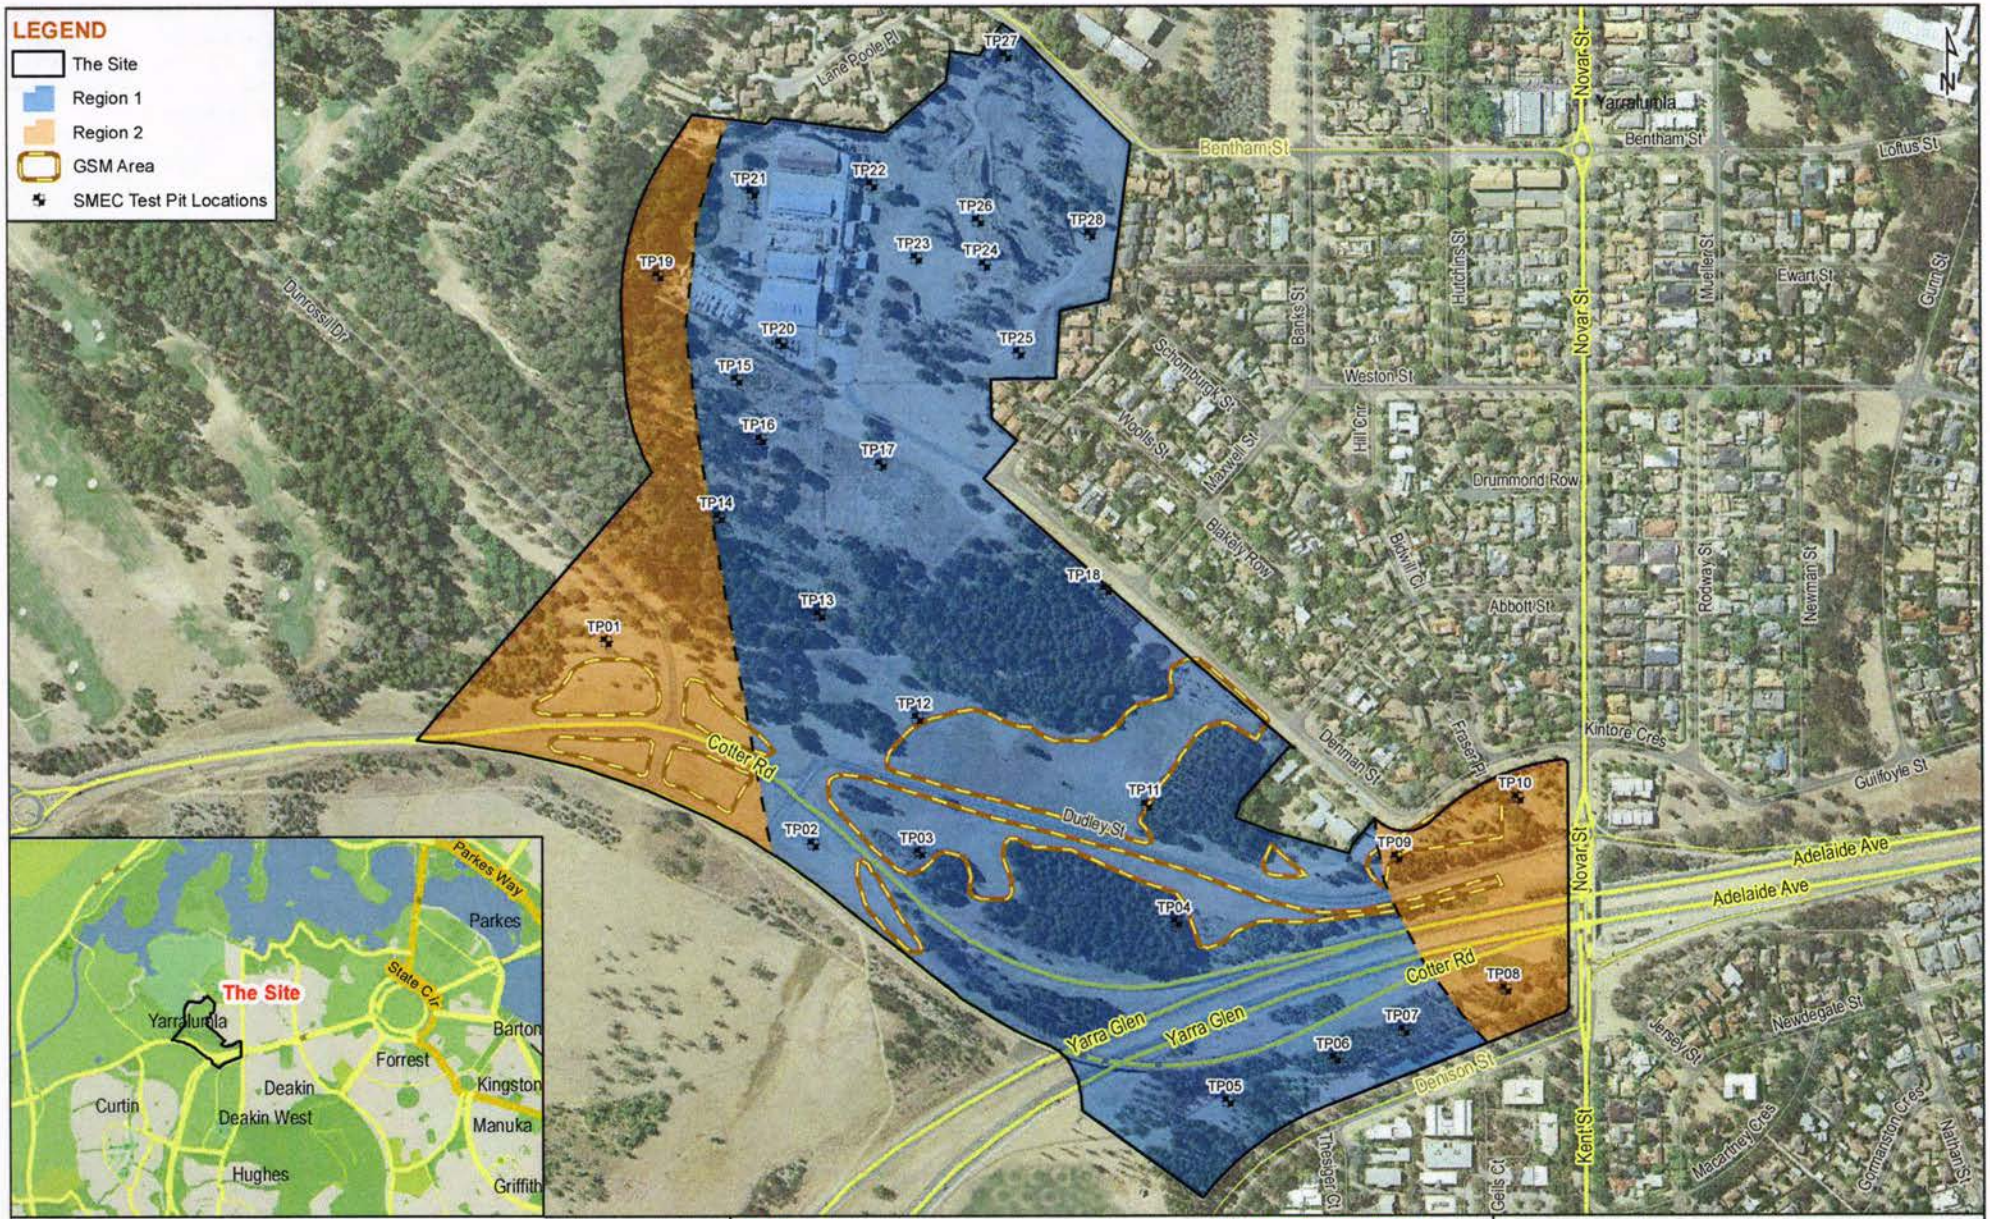
FIG NO. 4	**FIGURE TITLE** Geological Regions	**DATE** 30/10/2013	0 40 80 160 Meters 1:6,500	**PAGE SIZE** A4	**COORDINATE SYSTEM** ACT Grid 1966
PROJECT NO. 3002369	**PROJECT TITLE** Canberra Brickworks Preliminary Site Investigation	**CREATED BY** J. Seng	**SOURCES** Imagery © Roadnet, Imagery © Stromlo
