ENVIRONMENT ACT

OLD CANBERRA BRICKWORKS
YARRALUMLA

*Condition report to formalise
handover from Environment ACT to
Infrastructure and Asset Management*

4 February 2000

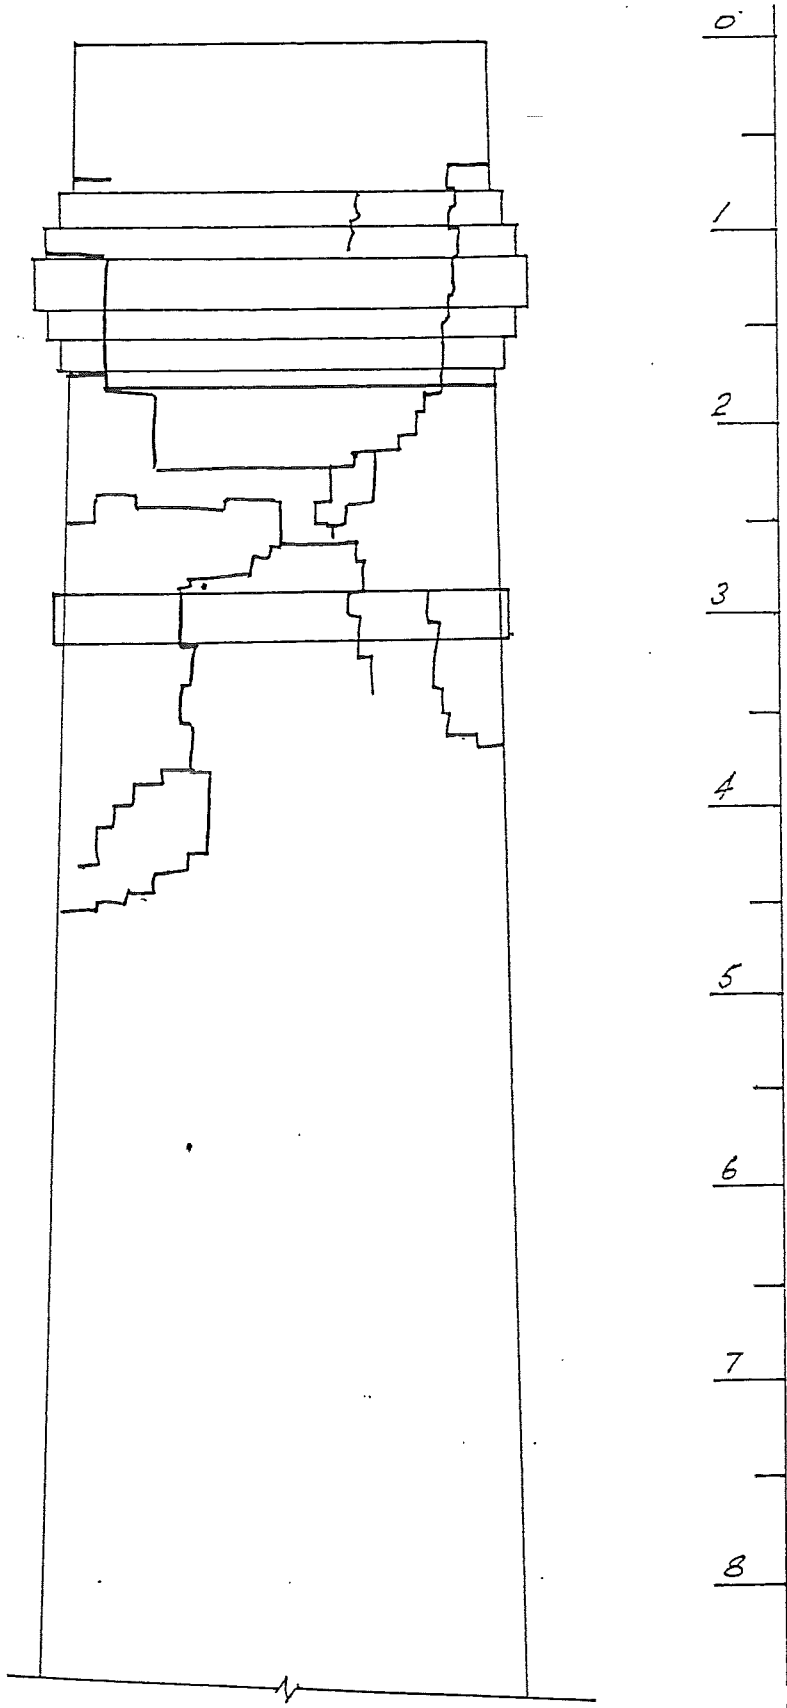
FIGURE 2

The chimney is extensively cracked in its top section as shown in the photographs and Figures 2 to 5.

YARRALUMLA BRICKWORKS
CHIMNEY S3
INSPECTION - MAY 1998
NORTH FACE CRACKING

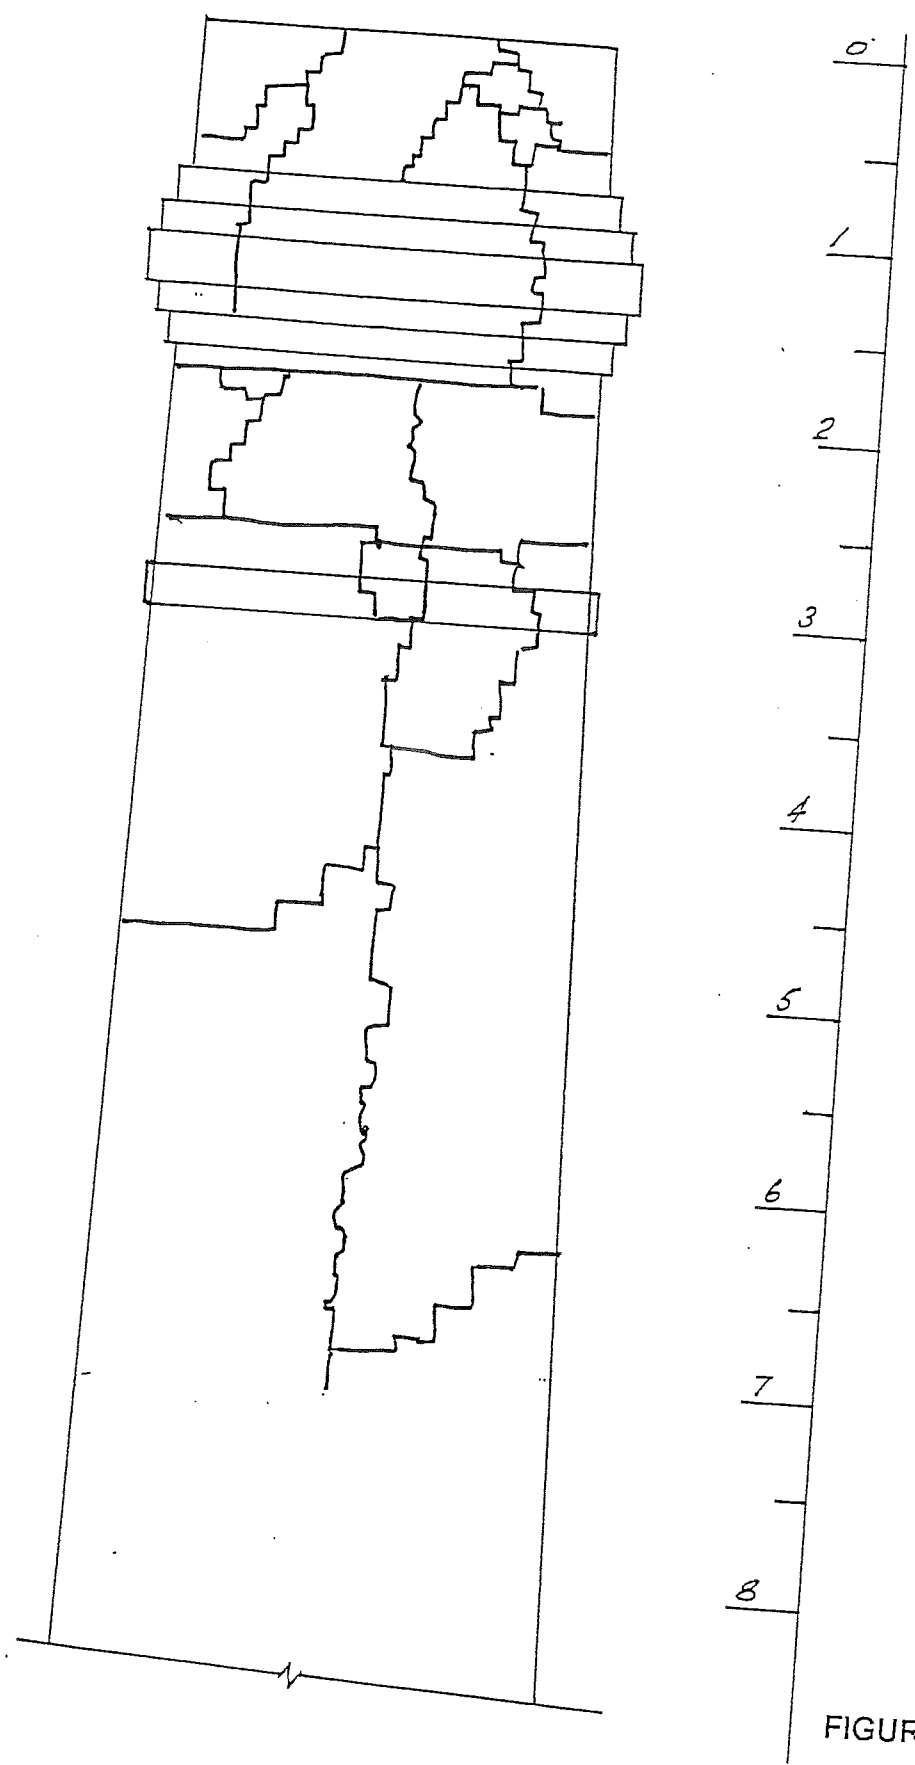
FIGURE 4

YARRALUMLA BRICKWORKS
CHIMNEY S3
INSPECTION - MAY 1999

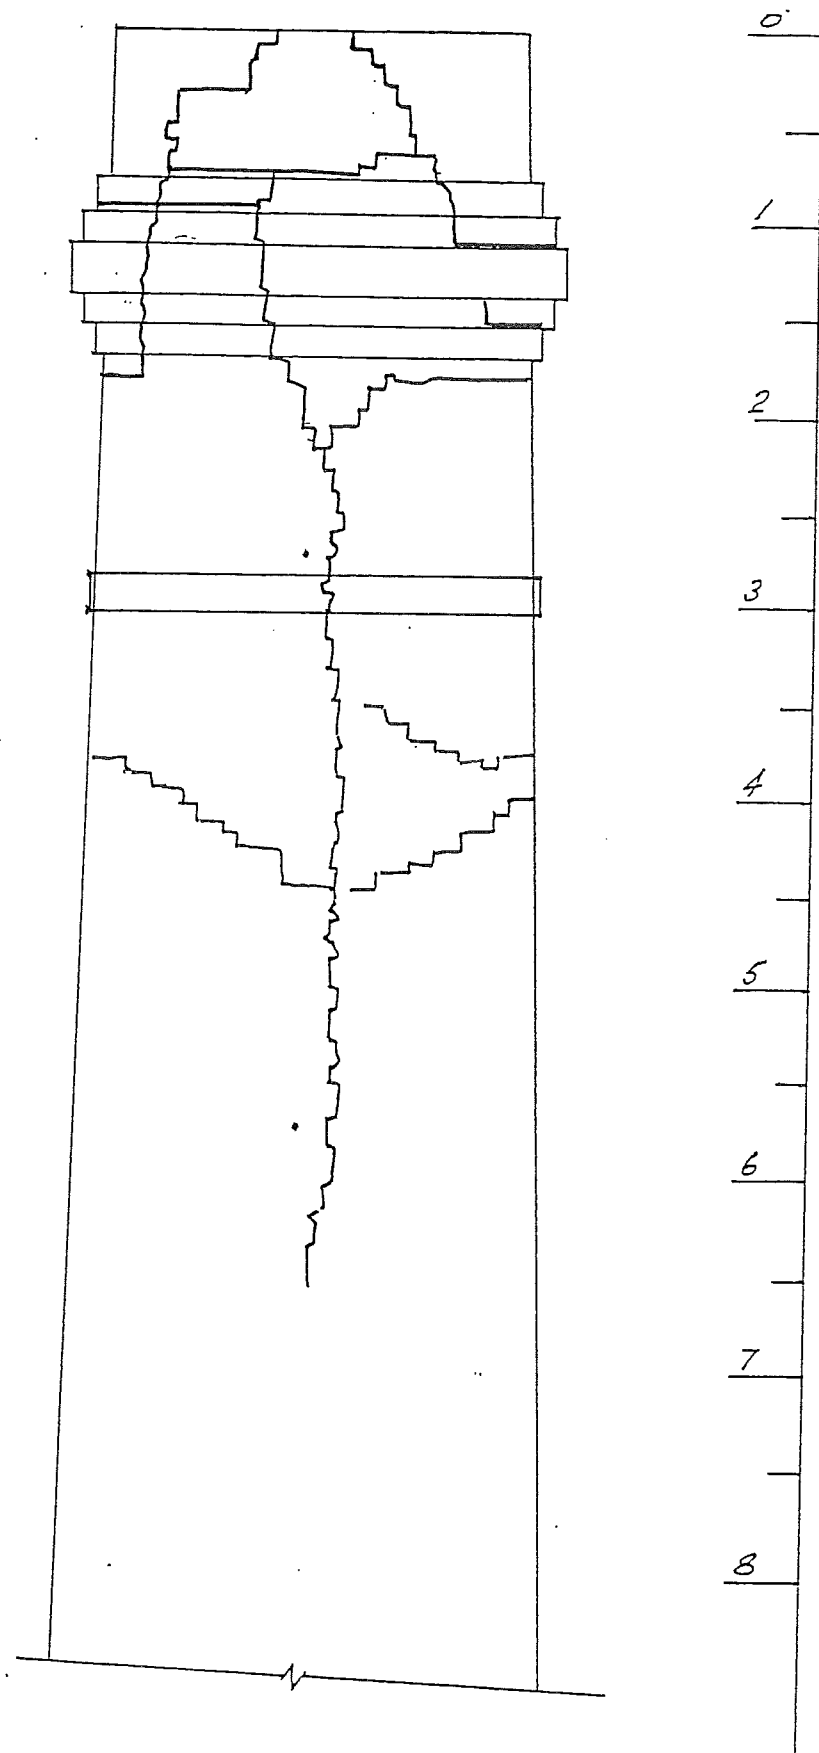
FIGURE 5

YARRALUMLA BRICKWORKS
CHIMNEY S3
INSPECTION - MAY 1998

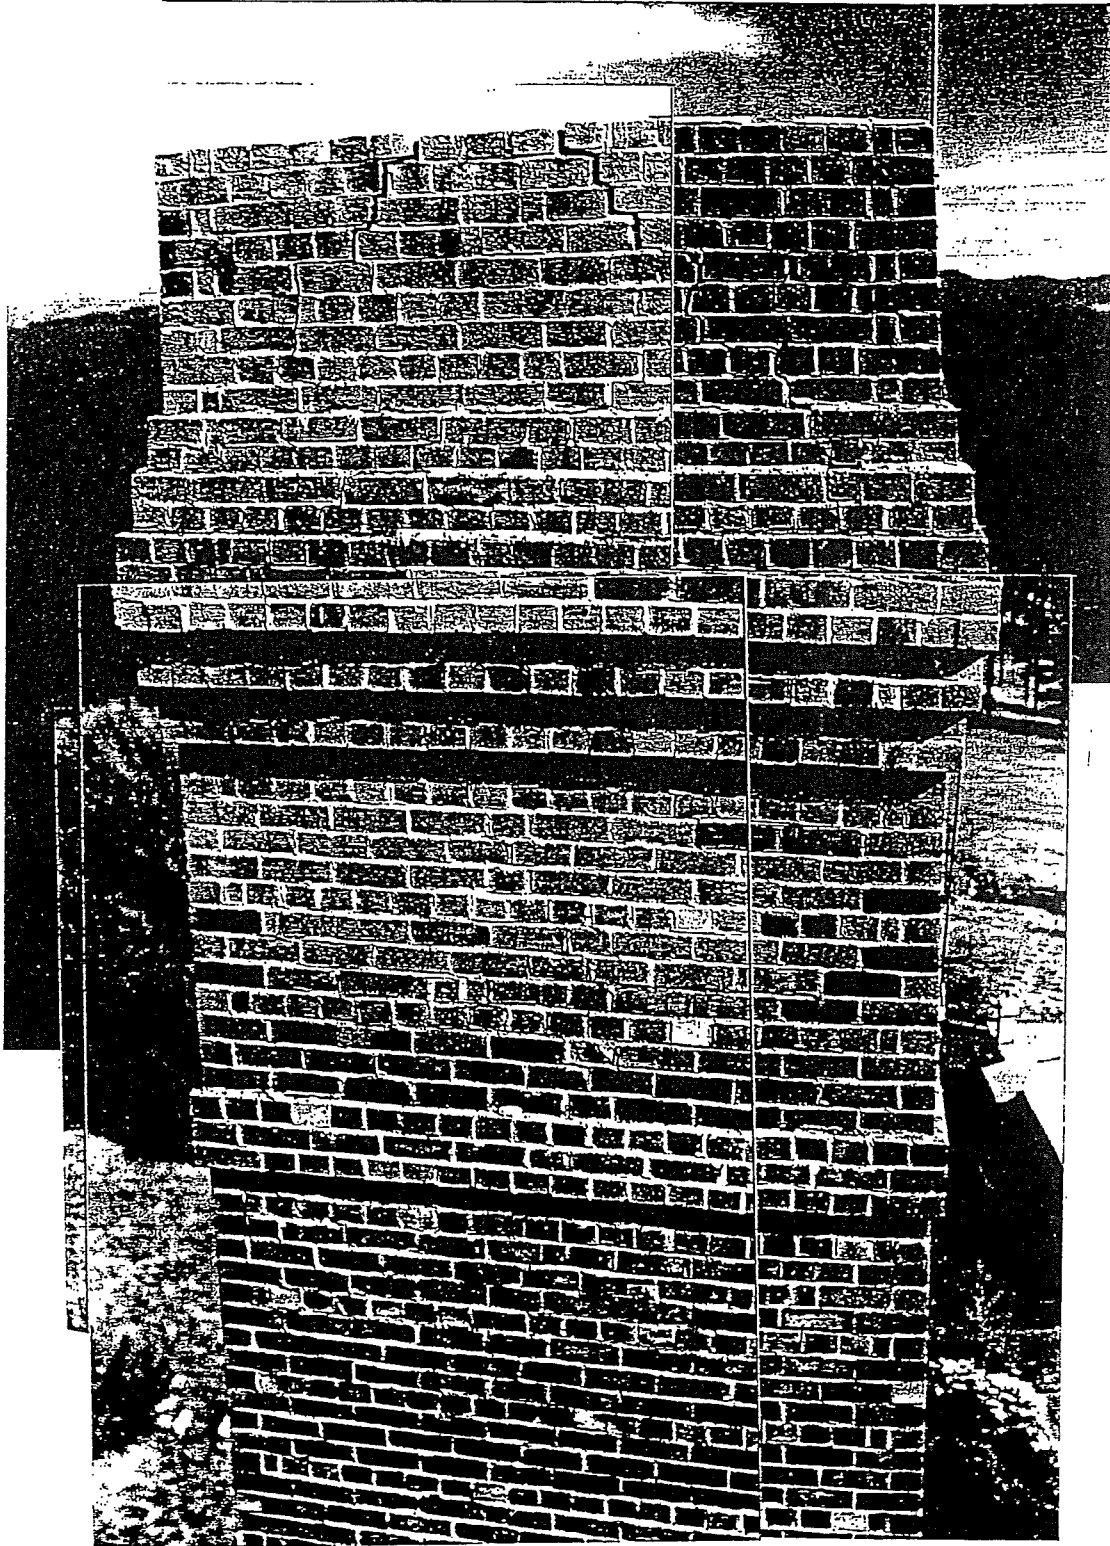
Photograph 4. Detail top east face.

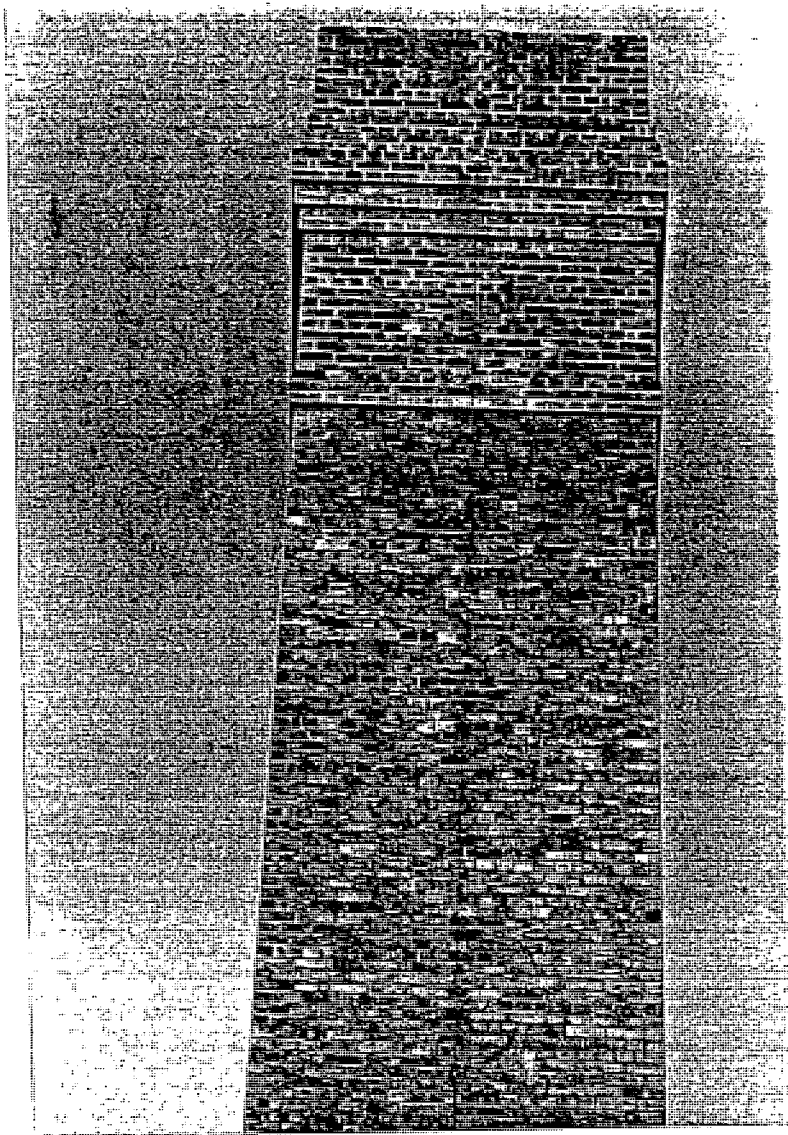
Photograph 5.
View of north face.

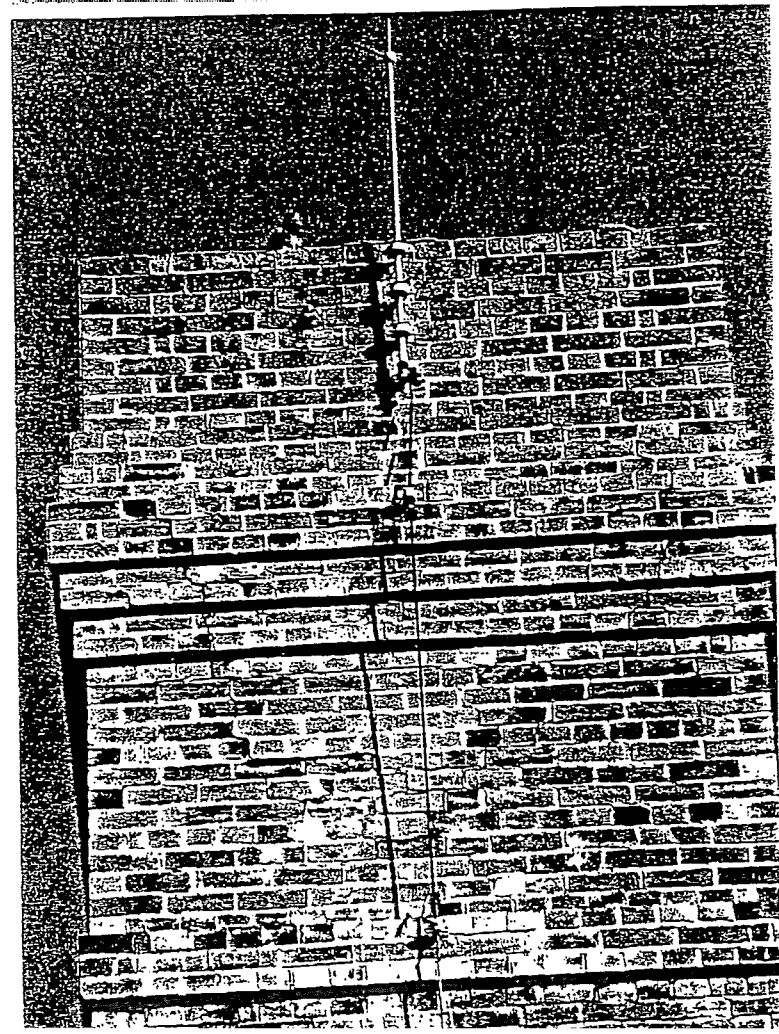
Photograph 6.
Detail of Photograph 5.

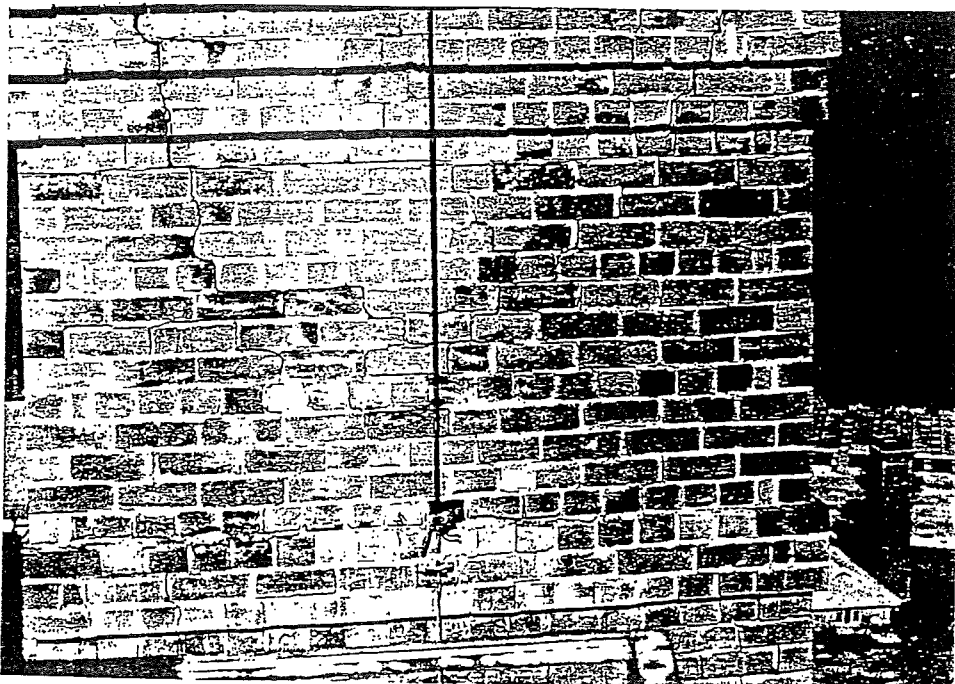
Photograph 14. Detail Photograph 13.

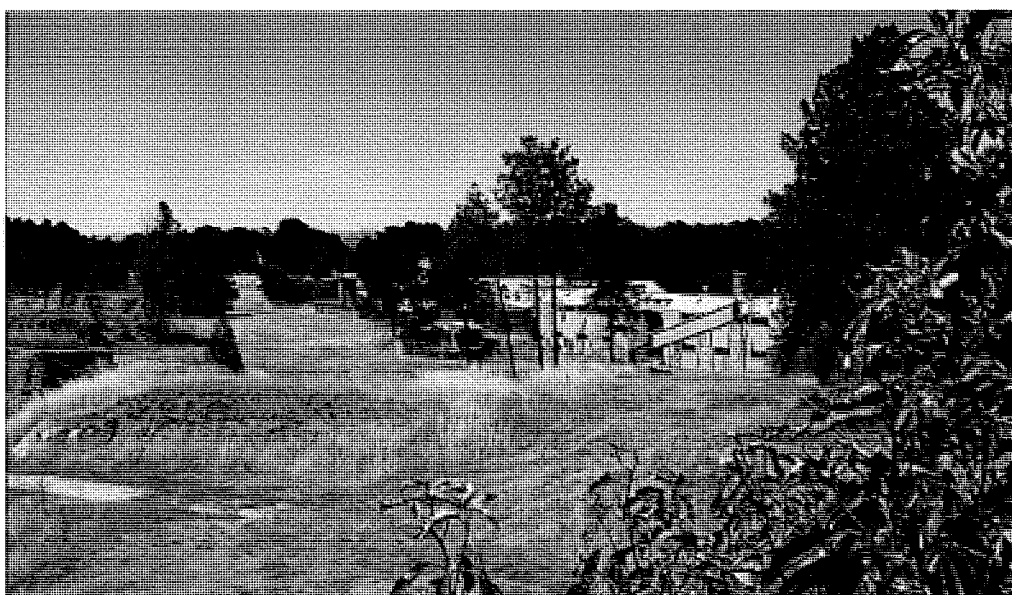
Figure 40 View of the Quarry looking south-west from adjacent to the site boundary to Bentham Street.

The quarry is secured by a cyclone wire fence, due to safety concerns regarding the eroding quarry face, though access is available to residents whose properties back onto it.

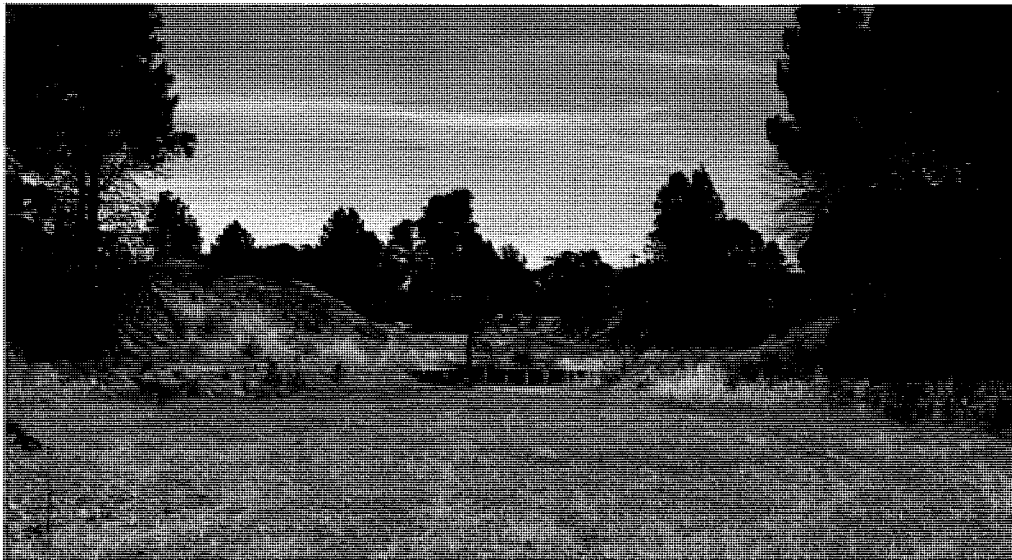
Figure 41 Looking north across the quarry floor, the site of the reflection pool, developed as part of the A R Marr Pty Ltd proposal. The dividing wall in the centre of the image marks the location of a walkway which traversed the pool.

After the closure of the Brickworks, the site development proposal prepared by A R Marr Pty Ltd proposed the construction of a narrow gauge railway and a 'reflection pool' in the former quarry (see Figure 39, and Figure 41). However, the pool failed to retain water and was frequently dry.

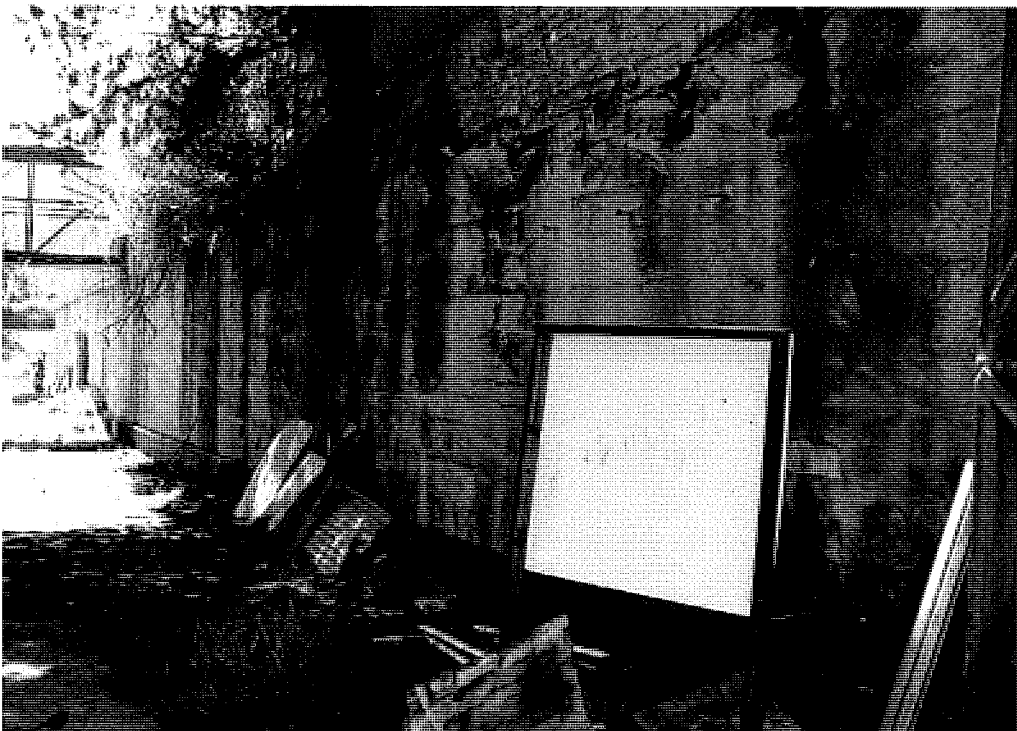
Figure 45 Retaining wall to the rear of the Workshop (Building 17).

The cast in-situ off-form concrete wall is approximately three metres high. Its depth has not been established. The original extent of the wall remains legible, although the former Coal Stage has been demolished. The crusher houses (Buildings 18 and 19) and the east and north brick walls of the model railway workshop (Building 33) are built on top of the wall. It also carries the pedestrian bridge that provides access to the firing floor of the first Hardy patent kiln (Building 8), see Figure 46.

Notwithstanding some deterioration at the top, and the impacts of buildings 18, 19 and 33, the wall is generally in sound condition.

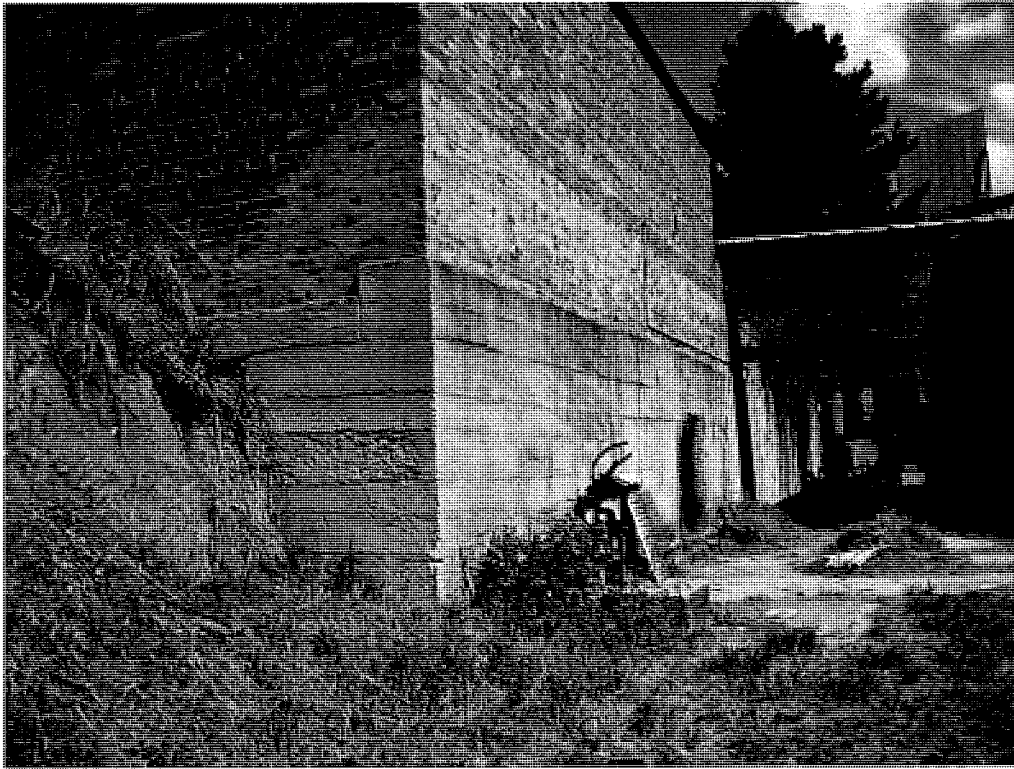
Figure 46 The north end of the concrete wall.

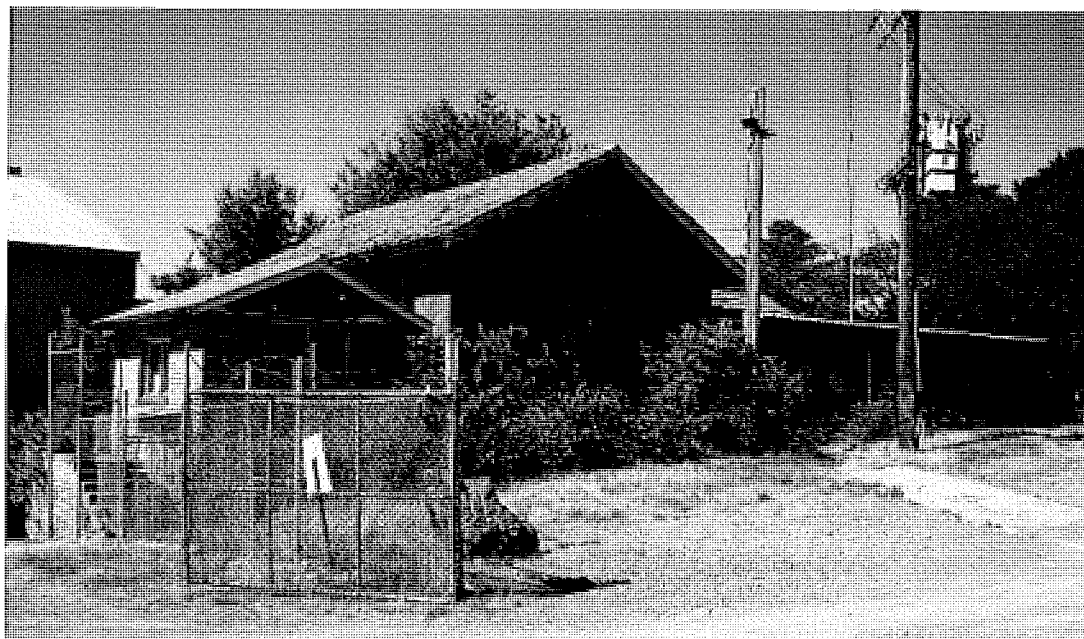
Figure 47 The Power House is the tile roofed building in the centre of the image. The office building (Building 7) adjoins it to the right and the small cream brick structure is the Downdraught kiln control room (Building 23).

The building is in fair condition. Efforts to secure the building against illegal entry and vandalism have had a detrimental impact on its physical condition and presentation. The terracotta roof tiling and the soffit are both in poor condition. The entry doors are damaged with some of the boards removed and the highlight windows above are broken and sheeted over. Graffiti is also evident.

The extension of the adjoining office block to the east and the siting of the small service building to the immediate west have had an adverse impact on the presentation of the building.

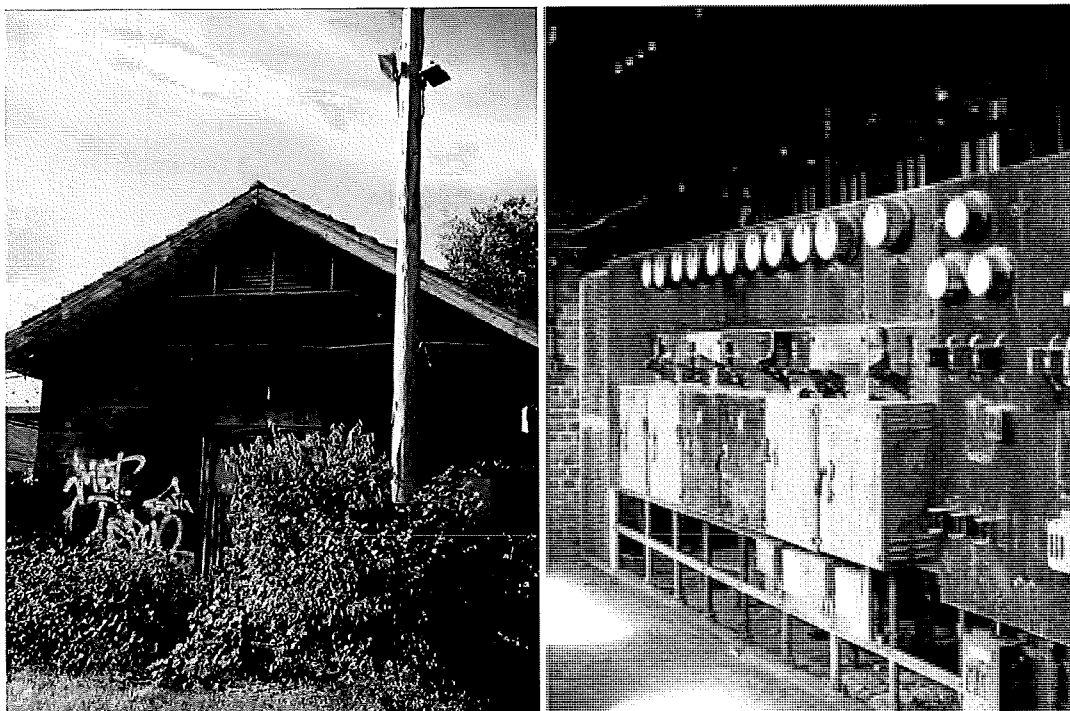
Figure 48 From left: South elevation and entry; interior showing retained plant.

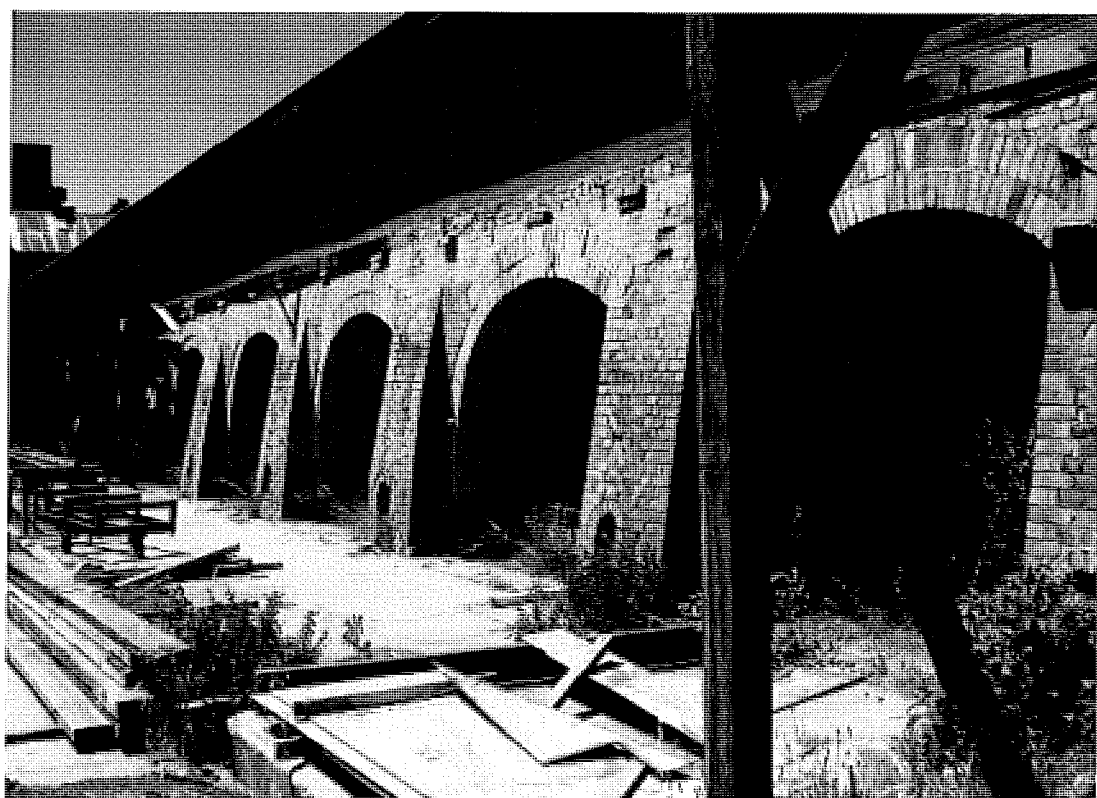
Figure 54 North elevation showing modified kiln entrances.

openings. To the south elevation, one of the kilns at the eastern end has been infilled with brickwork and a single door opening installed, enabling the space to be secured for storage. The first floor level of the verandah has been demolished and the supporting verandah is only extant in areas to the north, east and west ends, and is in an advanced state of deterioration.

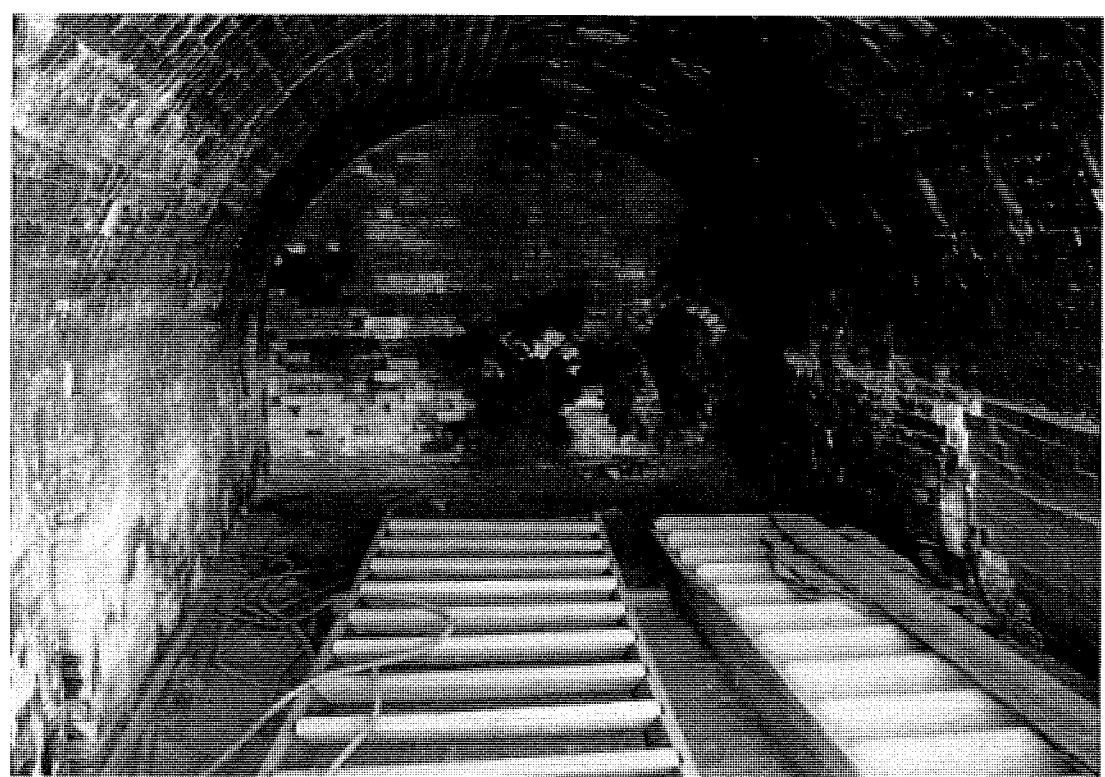
Figure 55 Kiln interior.

Several of the kiln linings are bulging and brickwork is loose in places. The first floor remnant verandah structure is in very poor condition and the former firing floor space is in poor condition.

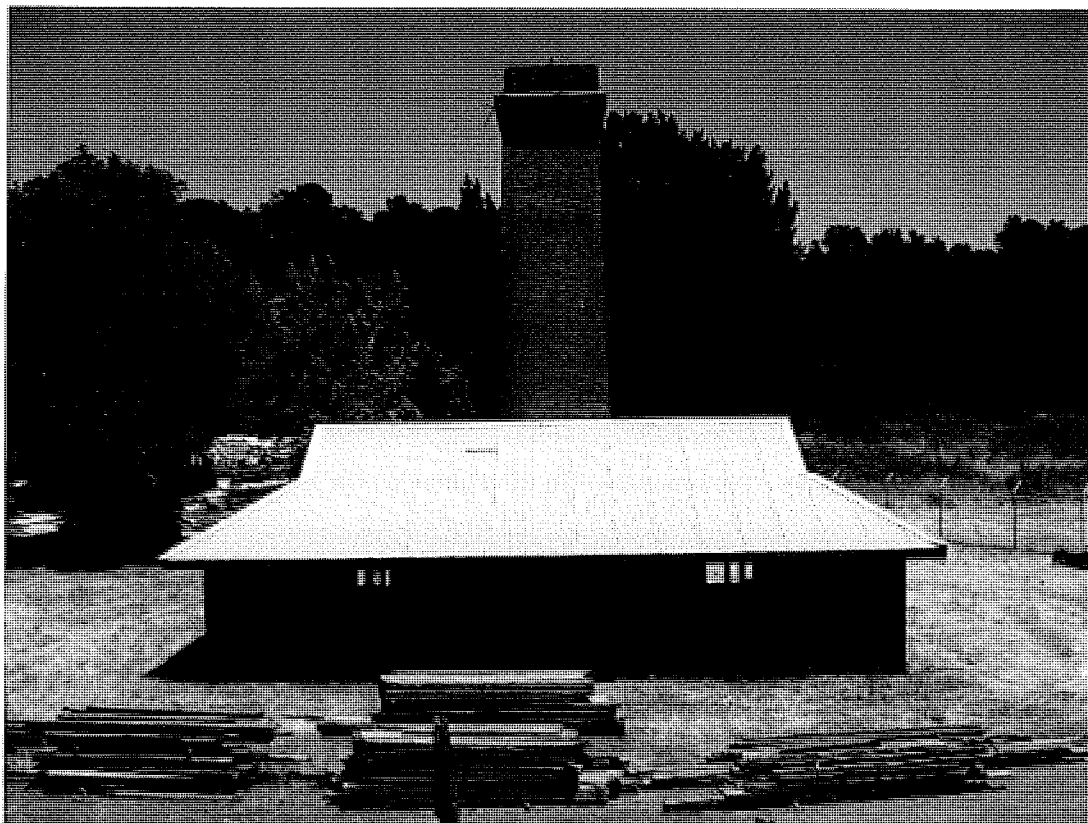
Figure 57 Fan house with stack behind.

The building is unsecured and in poor condition with evidence of the effects of vandalism including broken windows, missing entry doors and graffiti to the exterior brickwork. The replacement of the roof cladding is a positive action which is preventing further deterioration of the interior ceiling lining.

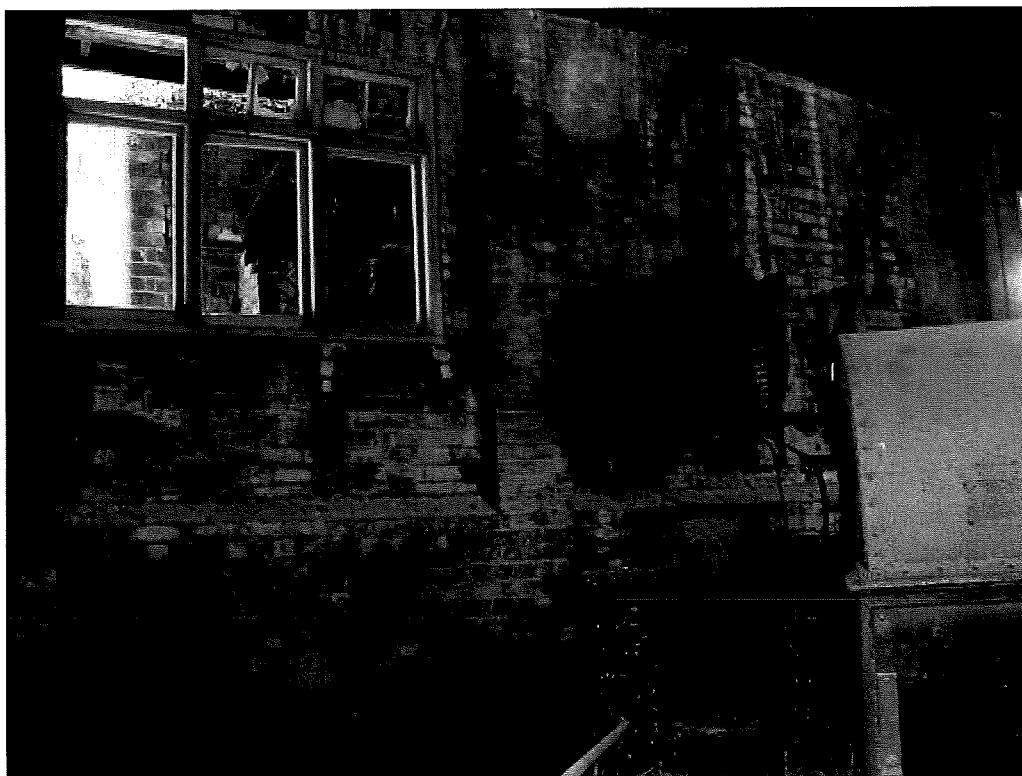
Figure 58 Interior of fan house. The tangential fan is mounted on the rear wall.

Internally the ceiling is lined in beaded painted timber boards, some of which are damaged. The walls are of brickwork, heavily stained by soot. Within the building there is a diamond-shaped concrete apron to the entry with metal ladder from stairs to a lower floor level to either side of the apron. There is a metal guardrail around the apron. The apron sits over the entry to the kiln draught tunnel and the tunnel to the stack. One of two fan motors remains (albeit in a dilapidated state) within the basement area and the concrete engine mounts are also intact. The fan housings are partly intact with the dampers in-situ and one of the tangential fans hanging on the rear wall. The ductwork which carries the exhaust to the stack is carried below ground.

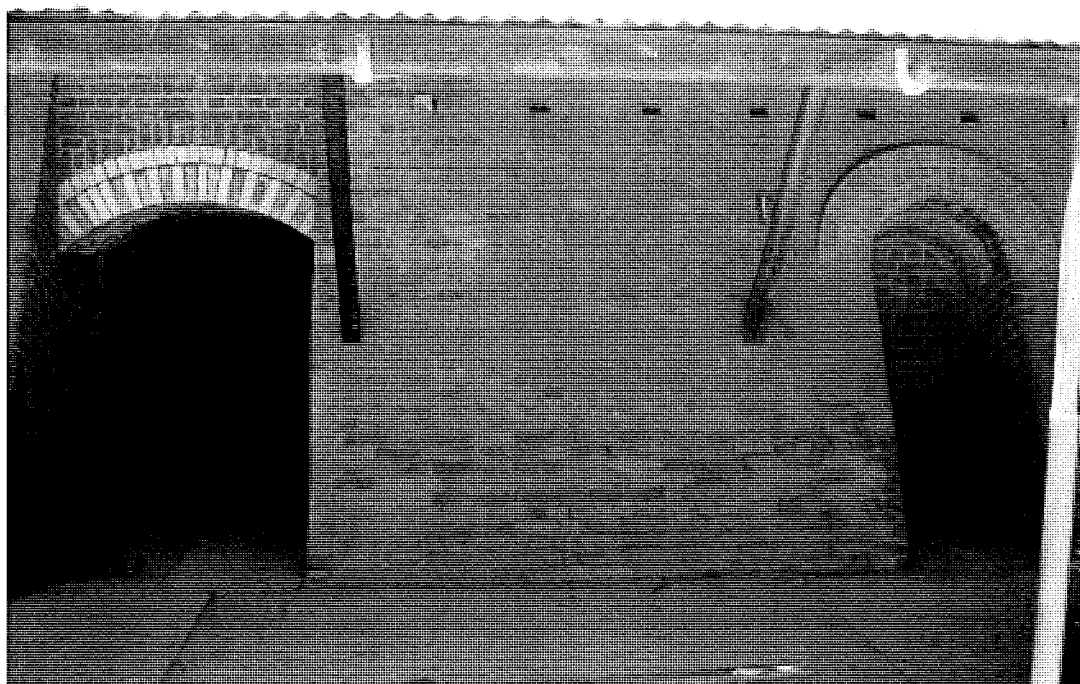
Figure 86 Kiln wickets – the opening at left has been altered to enable forklift access and the bricked-up the opening at right is as originally built.

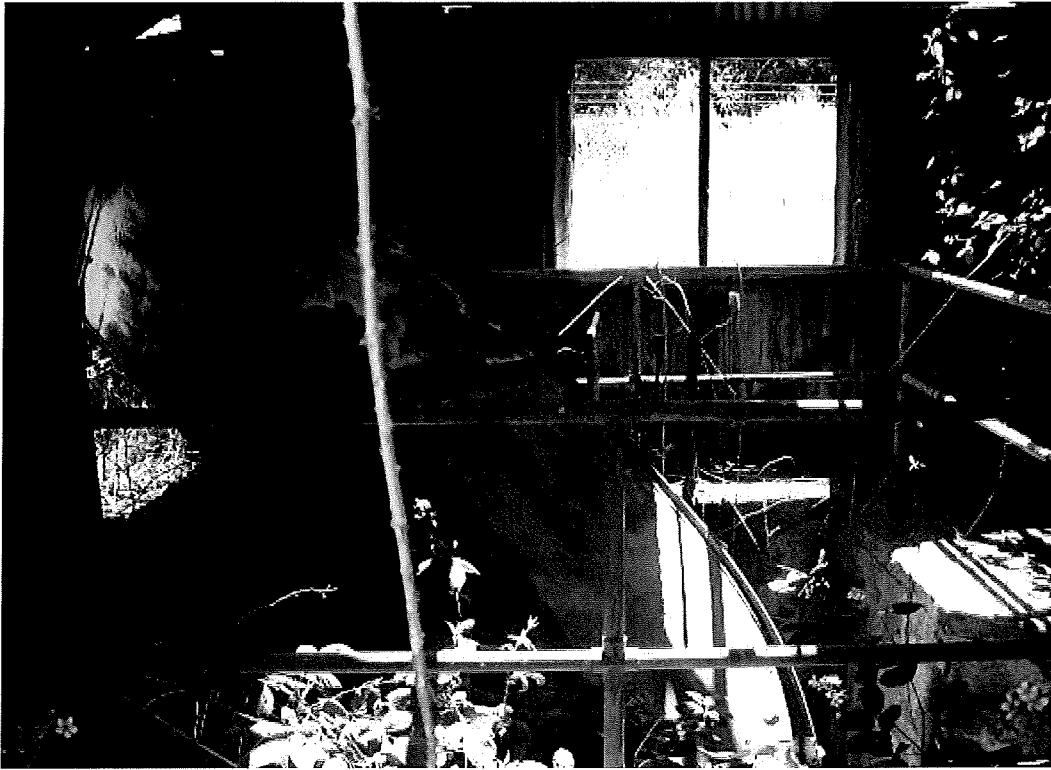
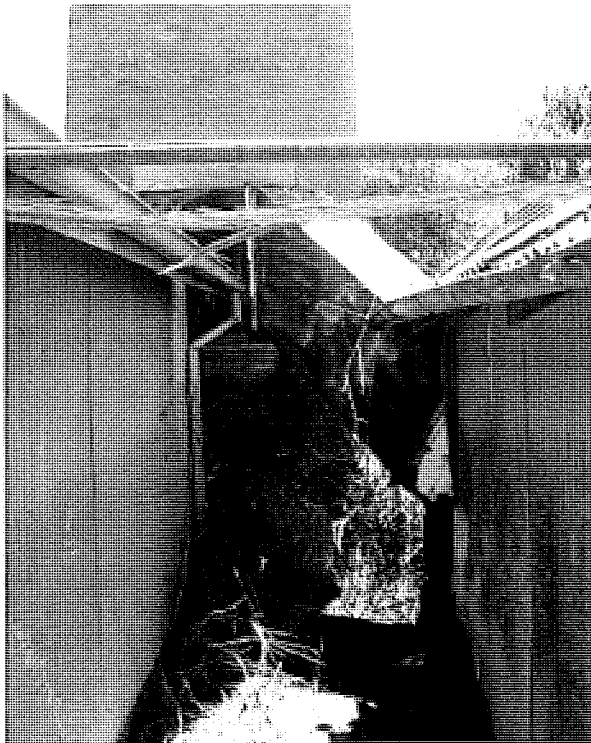
Figure 90 Interior of the 1927 fan house.

Figure 91 Ducts connect through to the chimney stack.

The fan house comprises two timber-framed sheds, with gabled roofs, clad and roofed in corrugated steel. There is an entry to the east elevation and windows in the rear and outer walls. Part of the wall cladding has been removed, and the glazing has also been broken and many of the glazing bars are missing. The entry doors have also been removed.

Internally, similar to the Staffordshire kiln fan house, the floor is below ground level and there is an entry apron with metal handrail. Evidence remains of the now removed fan machinery, the location of which is discernible by the pedestal mount of the fan machinery. The ducts connecting the fan house with the stack are *in-situ*, and unlike the Staffordshire kiln fan house, these are visible rising out of the rear wall of the fan houses and connecting to the east elevation of the stack at a height of approximately two metres (Figure 91).

The fan house is in an advanced state of disrepair and the c. 1926 structure is severely impacted upon by unchecked growth of blackberries.

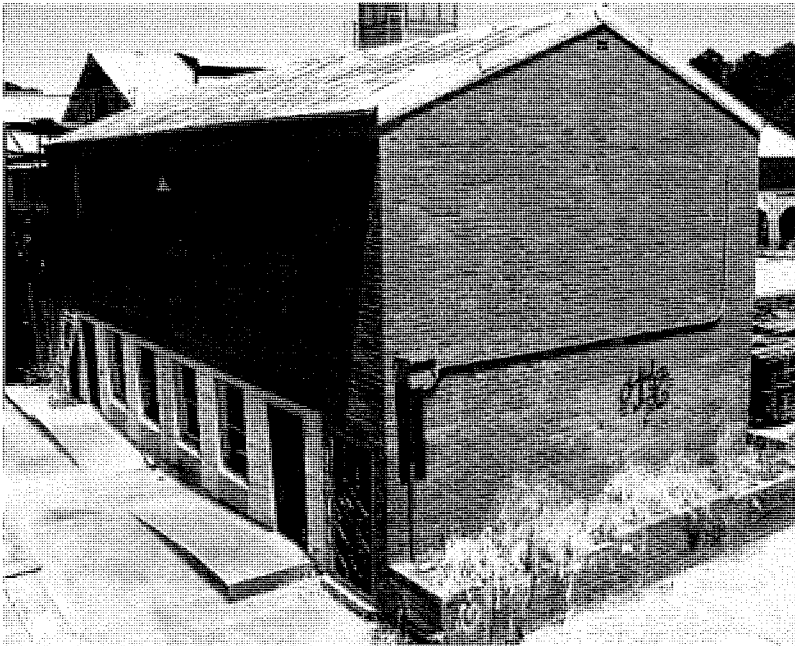
Figure 101 The Amenities Block viewed from the west.

The building is in a badly vandalized state with only a few toilets and basins intact and operable. Most of the glazing has been broken and the exterior of the building spray-painted with graffiti. Access to the first floor space was not obtained with one of the stairs secured by a metal grille and the door off the stair landing to the south end nailed shut internally.

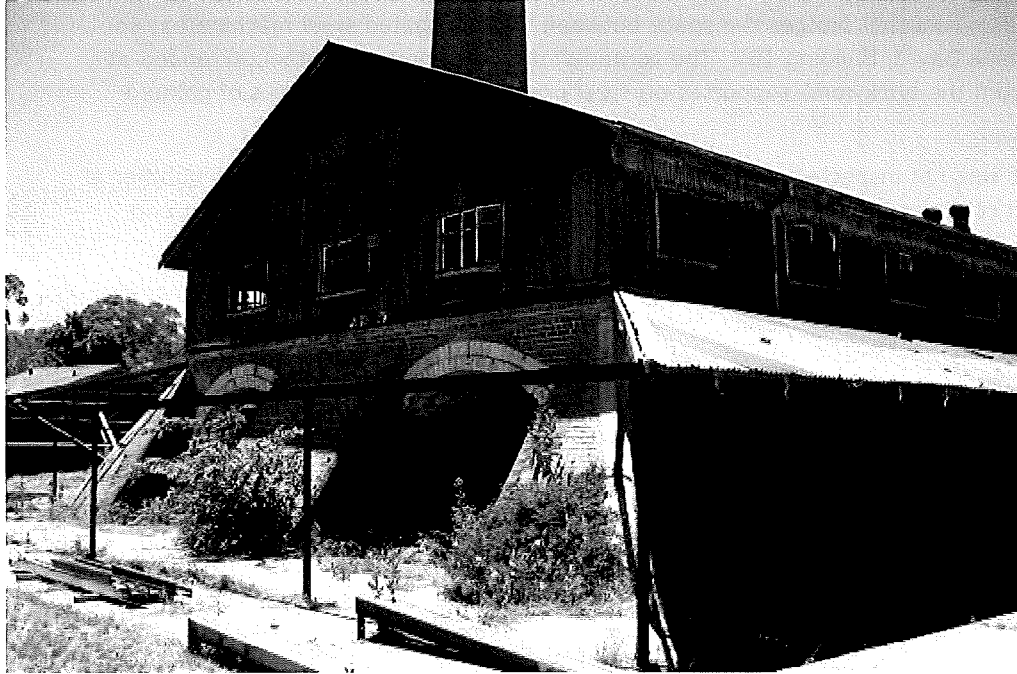
Figure 103 The Hardy patent kiln, showing the west end and part of the south elevation. Note the verandah cladding has been removed and the kiln wall part removed, presumably for improved access to the kiln interior.

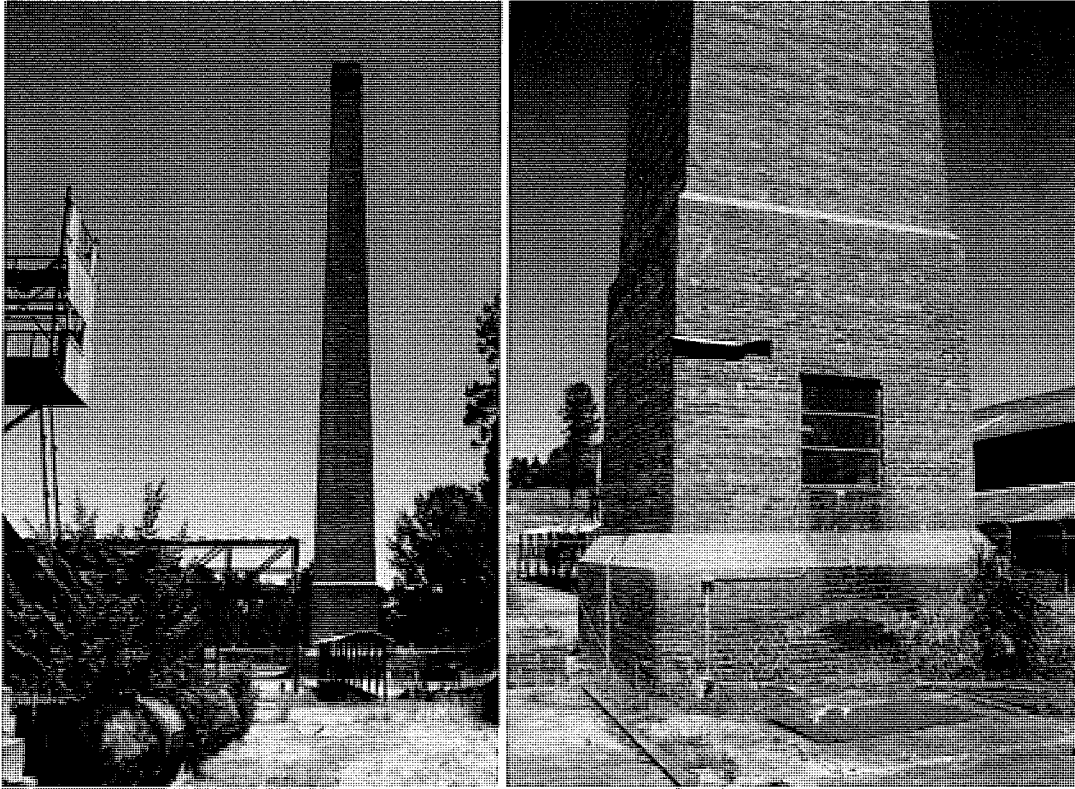
Figure 104 Left: view from east. Right: West elevation, base of stack.

Internally the tunnel connection to the kiln is visible and there is a steel frame and timber work platforms installed within the stack. These were installed as part of the c. 2005 building works, which stabilized the structure, and repaired significant cracking and damage to the top of the structure.

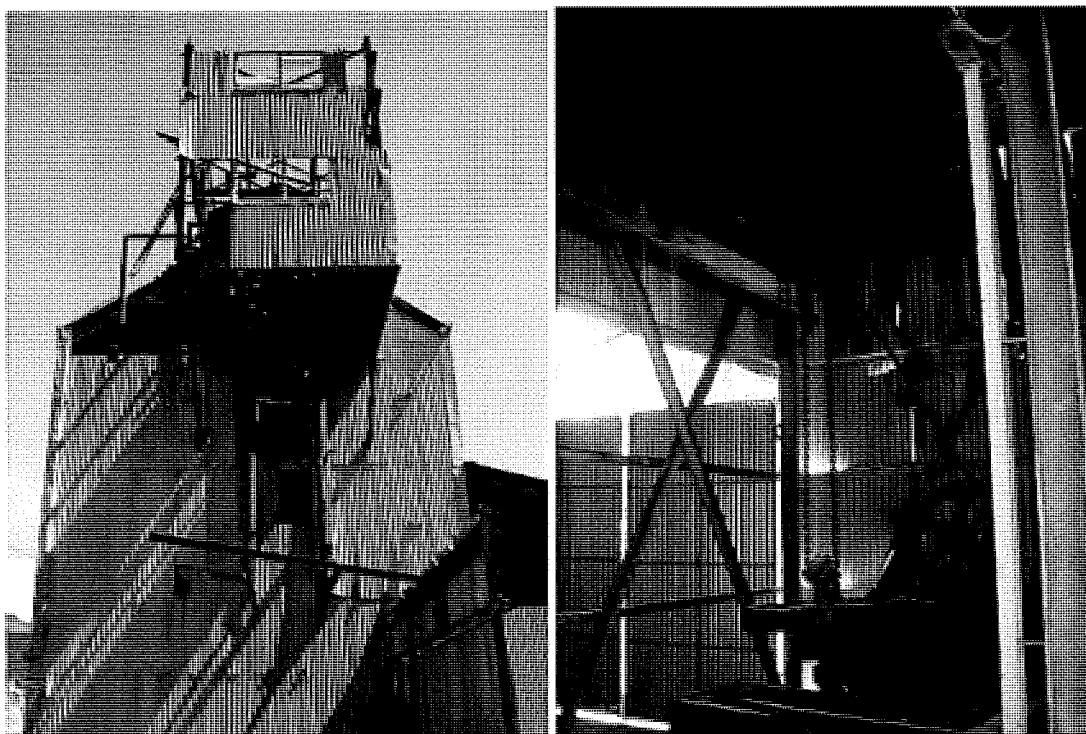
Figure 117 From left: north end Machine Bay III showing remains of headgear housing for the loft conveyor; interior with remnants of the Anderson brick machinery at north end.
