ENVIRONMENT ACT

OLD CANBERRA BRICKWORKS
YARRALUMLA

*Condition report to formalise
handover from Environment ACT to
Infrastructure and Asset Management*

4 February 2000

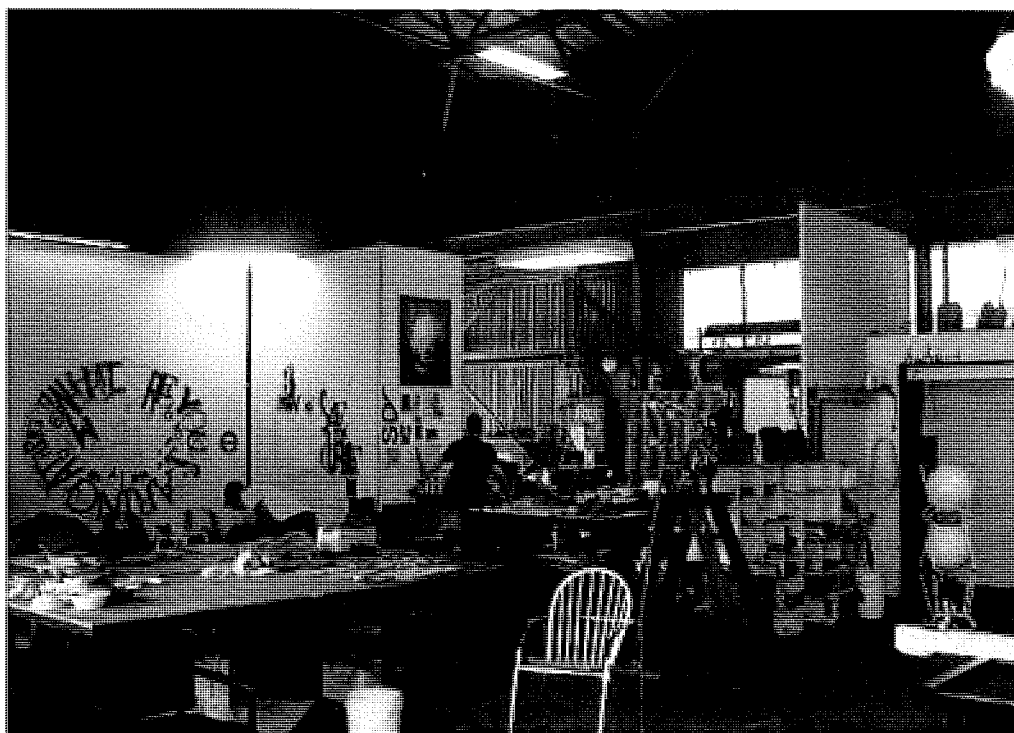
Figure 121 Interior of Workshop

Internally the building has a concrete floor and the walls are unlined. Since 1991, the former workshop has been used as an artist's studio. The tenant has installed some internal partitioning and has also been responsible for the maintenance of the building – at the time of inspection the building appeared to be in reasonable condition.

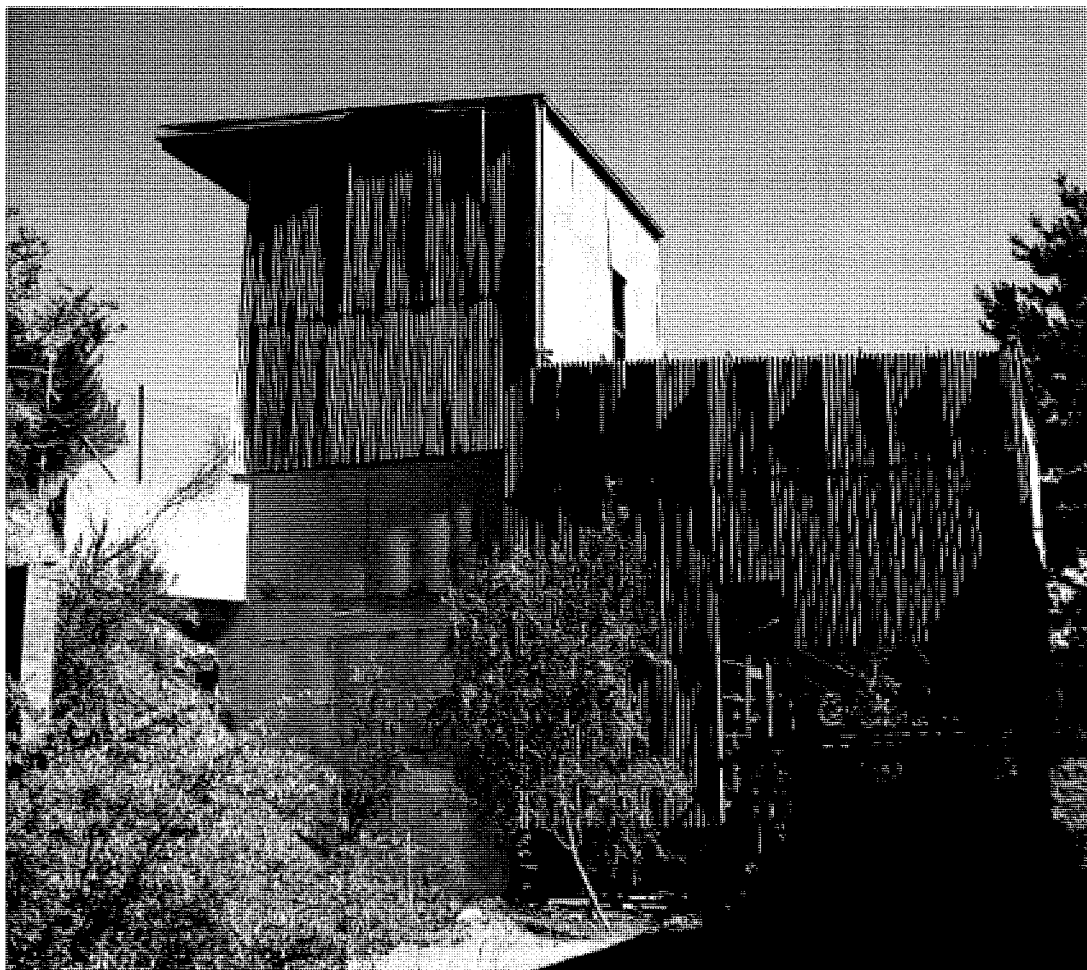
Figure 124 Small Crusher House viewed from the north.

The Small Crusher House is in poor condition and its connection to the White Pan Room removed.

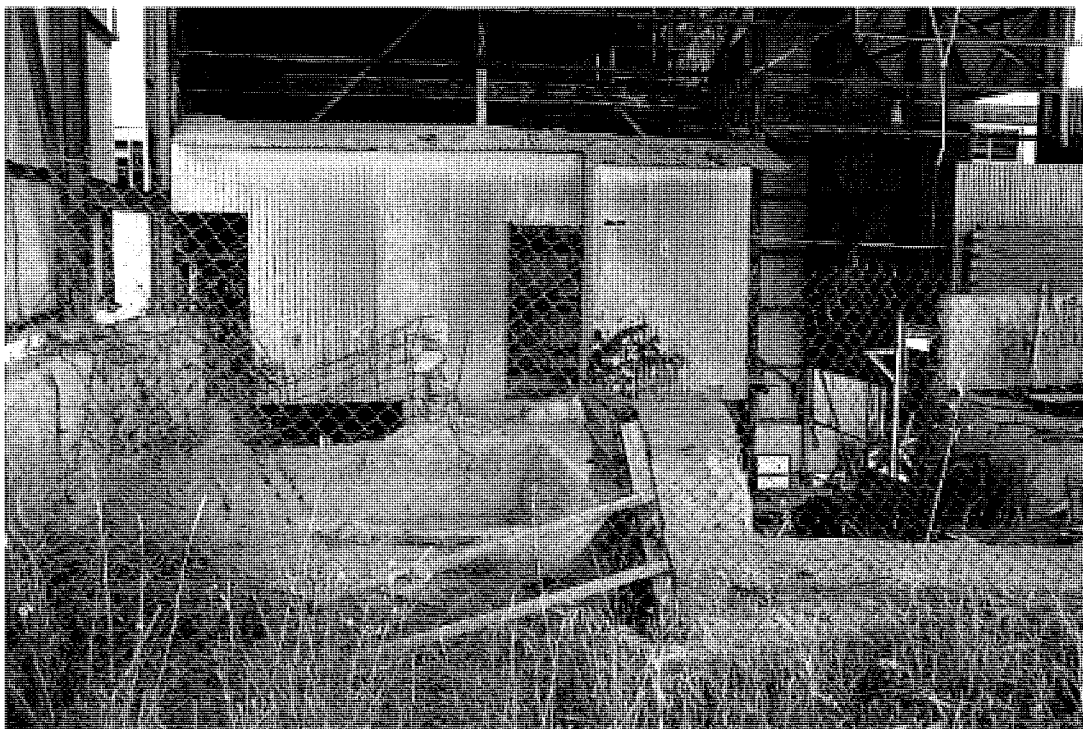
Figure 127 Interior of the White Pan Room looking west. The site of the now-removed hoppers is in the foreground.
