Environmental Investigation – Audit Report

**Yarralumla Brickworks
Sandford Street Complex
Block 1 Section 102 Yarralumla
Canberra Central ACT**

**Yarralumla Brickworks
Denman St.
Yarralumla
ACT 2600**

Title: Hazardous Materials Survey
Yarralumla Brickworks
Denman St.
Yarralumla, ACT 2600

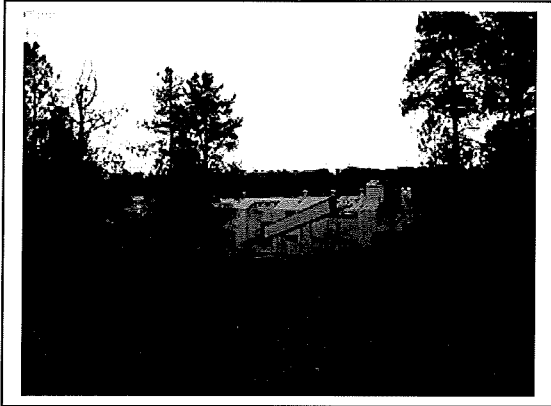
Photograph 1: West view of crusher area.

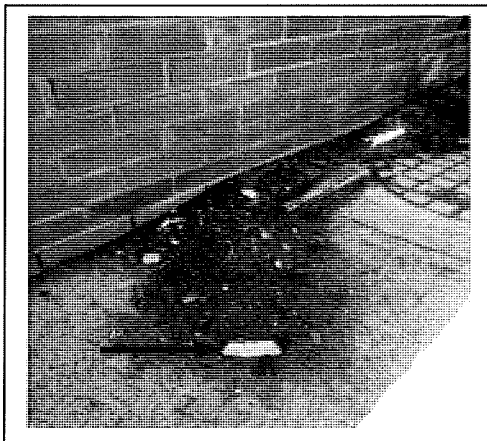
Photograph 13:
Scattered sheeting debris**
(in various locations)
Refer Sample: 2810 - 40 - A14

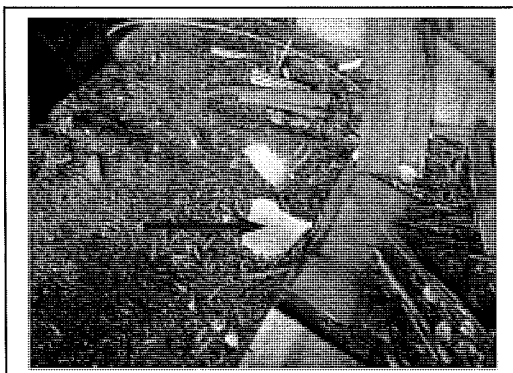
Photograph 15:
Debris to small chimney at entrance
Sheet
Refer Sample: 3617 - 103 - A2

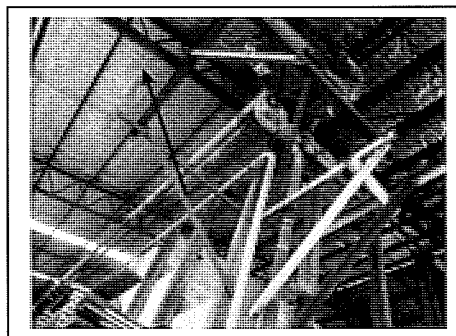
Photograph 24:
To underside of roofs throughout
Refer Sample: 3617 – 103 – S2

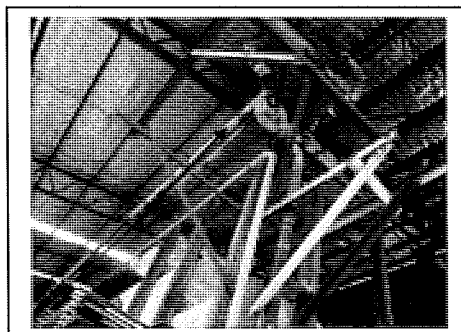
Photograph 25:
SMF as insulation to Pipes throughout
Refer Sample: 3617 – 103 – S3

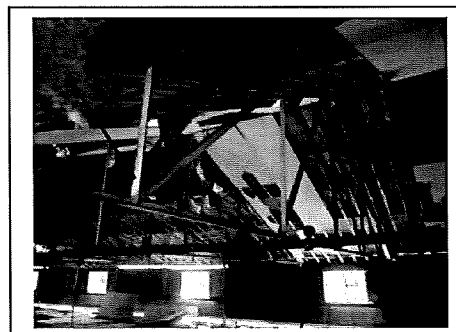
Photograph 26:
SMF as insulating batts to various ceiling spaces
Refer Sample: 3617 – 103 – S4

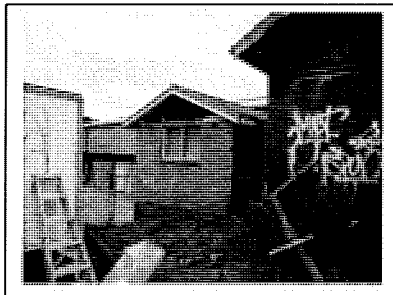
Photograph 1: Building prior to commencement of asbestos removal.

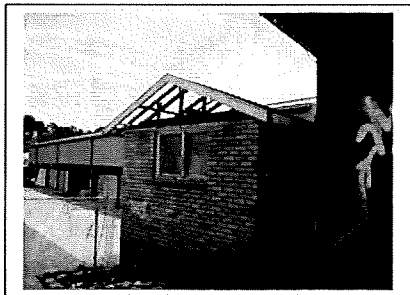
Photograph 2: Building at the completion of asbestos removal works.

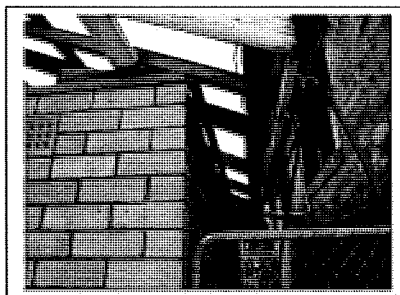
Photograph 4: Building at the completion of asbestos removal works.

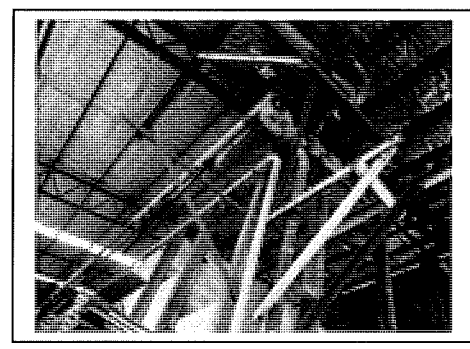
Photograph 26:
SMF as insulation to
Pipes throughout
Refer Sample: 3617 – 103 – S3

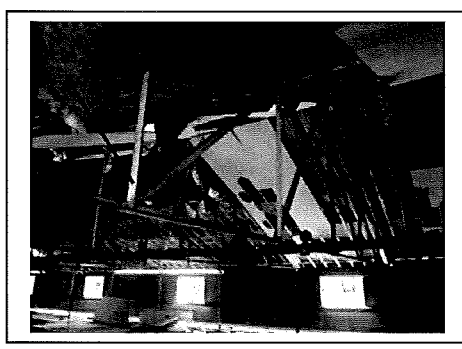
Photograph 27:
SMF as insulating batts to
various ceiling spaces
Refer Sample: 3617 – 103 – S4

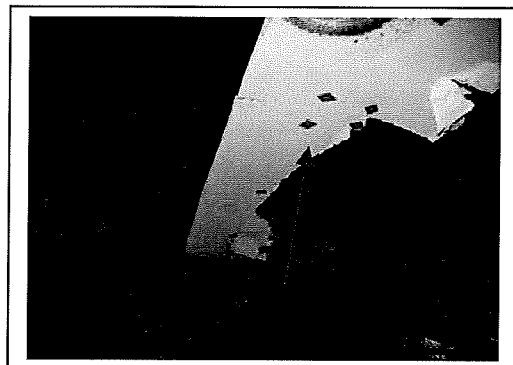
Photograph 2. Insulation top floor Kiln 2.

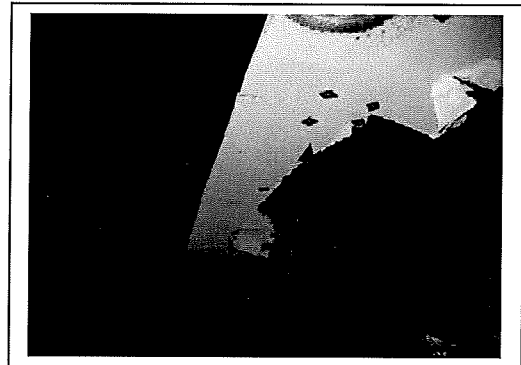
Photograph 2. Insulation top floor Kiln 2.
