**Rivett Block 13
Section 28**

Rivett Section 28 Block 13

Site Investigation Report

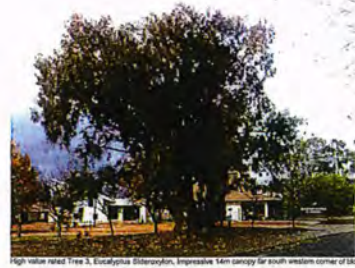
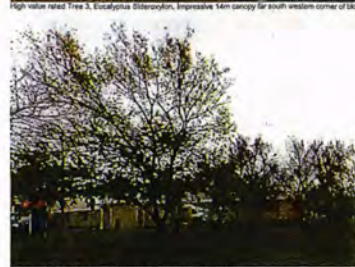
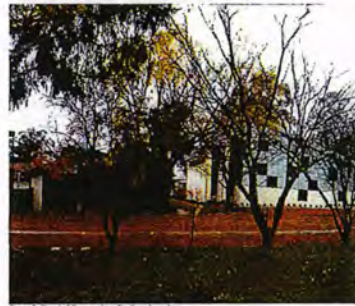
MATURE MEDIUM & HIGH QUALITY RATED *Eucalyptus mannifera* & *E. sideroxylon* 'Rosea' TREES 3 & 5 APPEAR TO BE GROWING & ARE IN GOOD HEALTH.

GROUP 1 TREES ARE SEMI - MATURE *Ulmus parvifolia*. THESE TREES HAVE BEEN PLANTED AS A STAND WITHIN A RELATIVELY TIGHT PLANTING ARRANGEMENT. AS SUCH, SOME TREES WITHIN THE STAND ARE SUPPRESSED & OR HAVE LEANING / UNDER DEVELOPED CANOPIES.

SELECTIVE THINNING MAY BE AN ADVANTAGE TO ALLOW SOME INDIVIDUAL IMPROVED LARGER TREE FORMS
