FOI Reference: CMTEDDFOI 2021-316

Connell Mott MacDonald was engaged by ACT Work Cover to investigate the cause of collapse of a partially constructed aircraft hangar building structure for the Special Purpose Aircraft Facility (SPAF) located at RAAF Fairburn, Canberra. The SPAF was being constructed by Construction Control with the design, erection methodology and construction of the hangar superstructure subcontracted to Strarch International (Strarch International 2003a p9).

This final report describes the analytical work undertaken by Connell Mott MacDonald and the component testing conducted by the University of Western Sydney in an effort to ascertain the cause of the structure collapse. The report is arranged in several parts as follows:

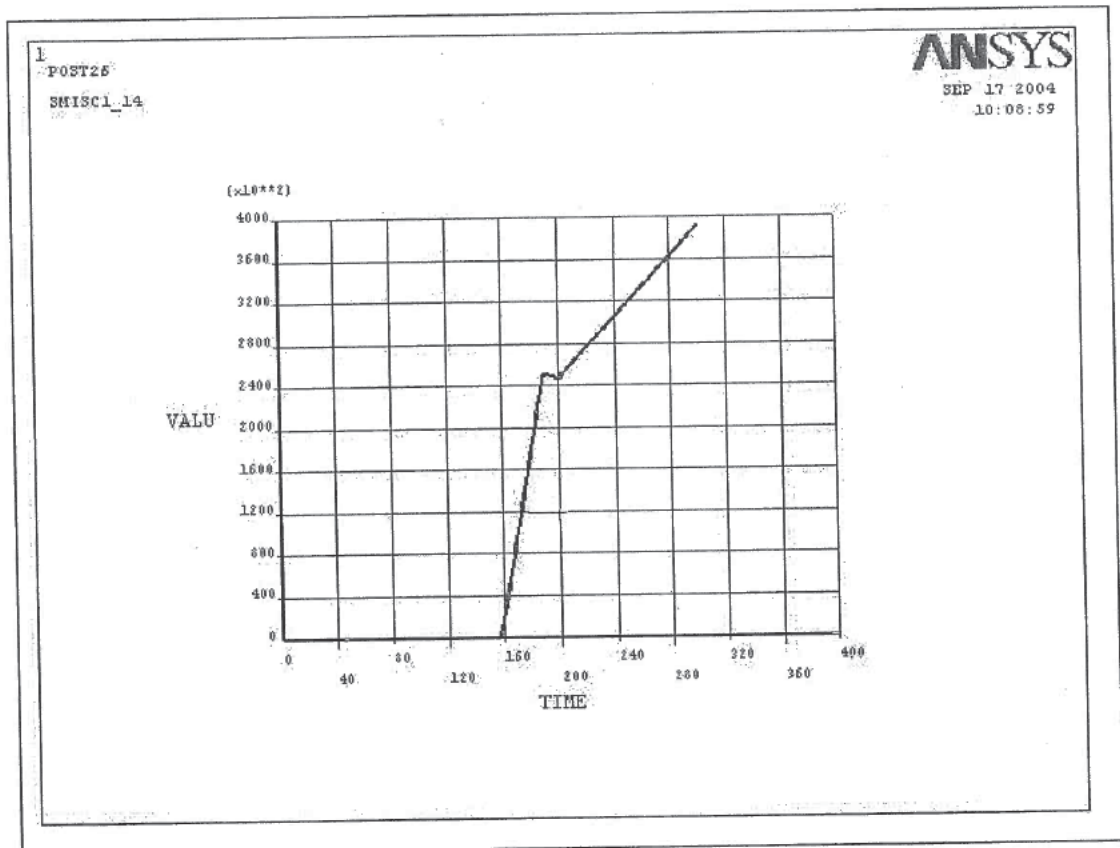
Figure 9: Load in centre gap lock throughout the analysis.

The gap lock at the centre of the structure was the most highly loaded. The time history of load on this gap lock throughout the analysis is shown in Figure 9. As explained earlier, "time" is merely a proxy value for the ramped application of loads throughout the analysis. At the lift off stage (t=190s) the calculated load in the gap lock was 251 kN. At the end of the analysis, with all roof-sheeting loads applied, the load in the gap lock was 392 kN. For comparison the results with lower bound applied secondary steelwork loads gave a load of approximately 350 kN on the same gap lock.

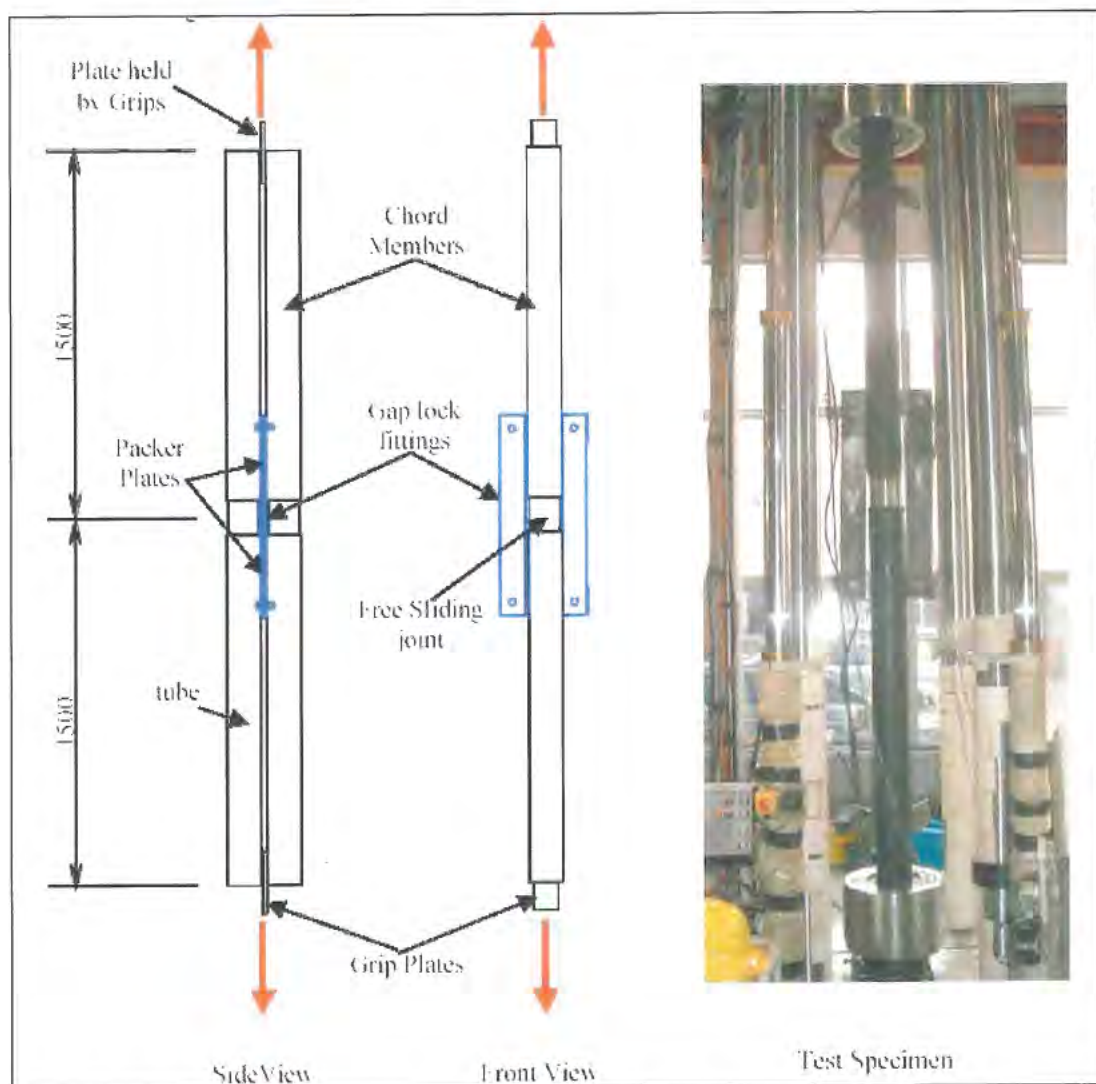
Figure 12: The test rig used for testing the gap locks (Wheeler 2004).

The testing involved a total of nine gap lock components, supplied from the failed structure by ACT Work Cover. These gap locks were tested in a range of configurations using a test rig (Figure 12) to simulate the lower chord members adjacent to the gap lock. The parameters varied between tests included the width of the gap lock end plate, the length of bolts used and the geometric relationship between the gap lock and the adjacent lower chord members.

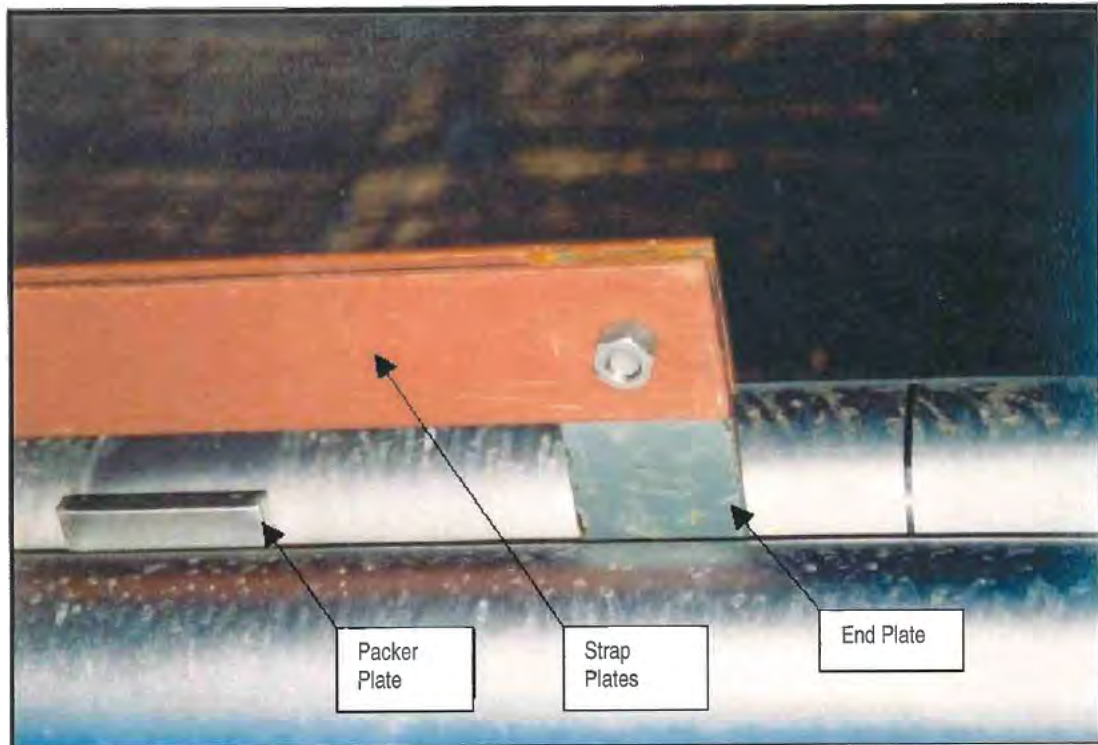
Figure 13: Part view of a gap lock together with the naming convention used for the gap lock parts.

The width of the end plate on the gap lock was found to be either 100 mm or 110 mm from examination of the gap locks recovered from the failed structure. Gap locks with both these dimensions were included in the test programme. The nomenclature used for the plates forming the gap locks is indicated in Figure 13. Four M20 bolts were used to assemble each gap lock.

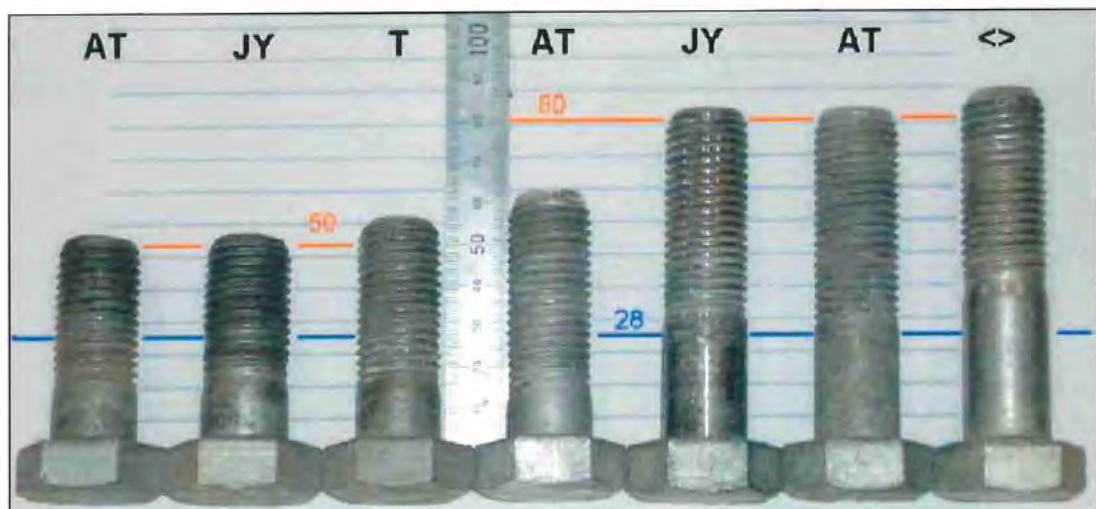
Figure 14: Examples of the bolt types used in testing (Wheeler 2004).

From a functional point of view two different bolt lengths were included in the test programme (Wheeler 2004). What will be referred to as “short” bolts had the first shear plane, between the first strap plate and the end plate, located in the shank of the bolt. The second shear plane, between the second strap plate and the end plate was located at the threaded section of the bolt. The other bolt type, referred to as “long” bolts had both shear planes located in the shank section of the bolt. Figure 14 provides examples of the two bolt types described (Wheeler 2004). The blue line indicated at 28 mm coincides with the position of the second shear plane (when washers are not used). The four shorter bolts on the left fit into the short bolt category described above. The three longer bolts on the right fit into the long bolt category.

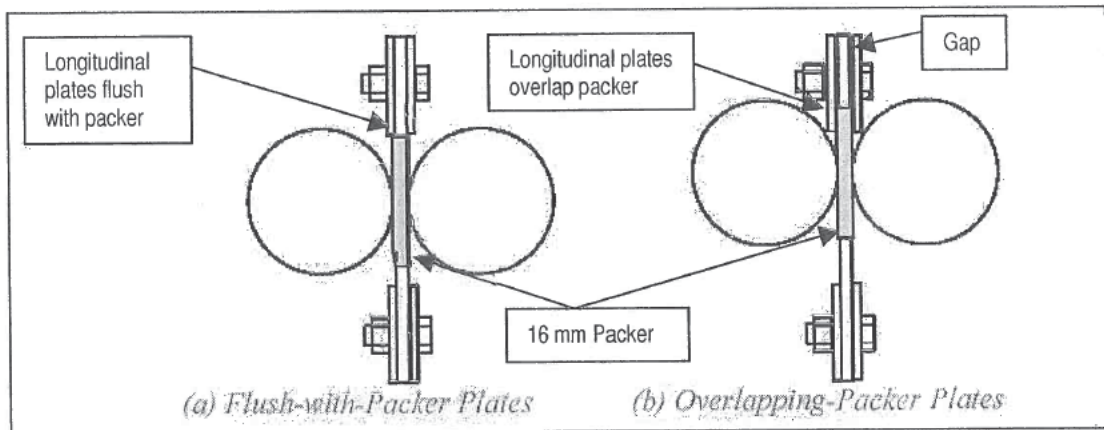
Figure 15: Two gap lock configurations tested (Wheeler 2004).

The geometric relationship relates to the degree of eccentricity with which the gap lock component is loaded. Two configurations were considered. The first (type A) had the bolts firmly tightened such that the top strap plates of the gap lock rest on the top of the packer plate between the lower chord members. The second configuration (type B) required the bolts to be sufficiently loose (4 mm) so that the top strap plates could drop down outside the packer plate resulting in greater preferential loading of the top plates during testing. These two configurations are indicated in Figure 15.

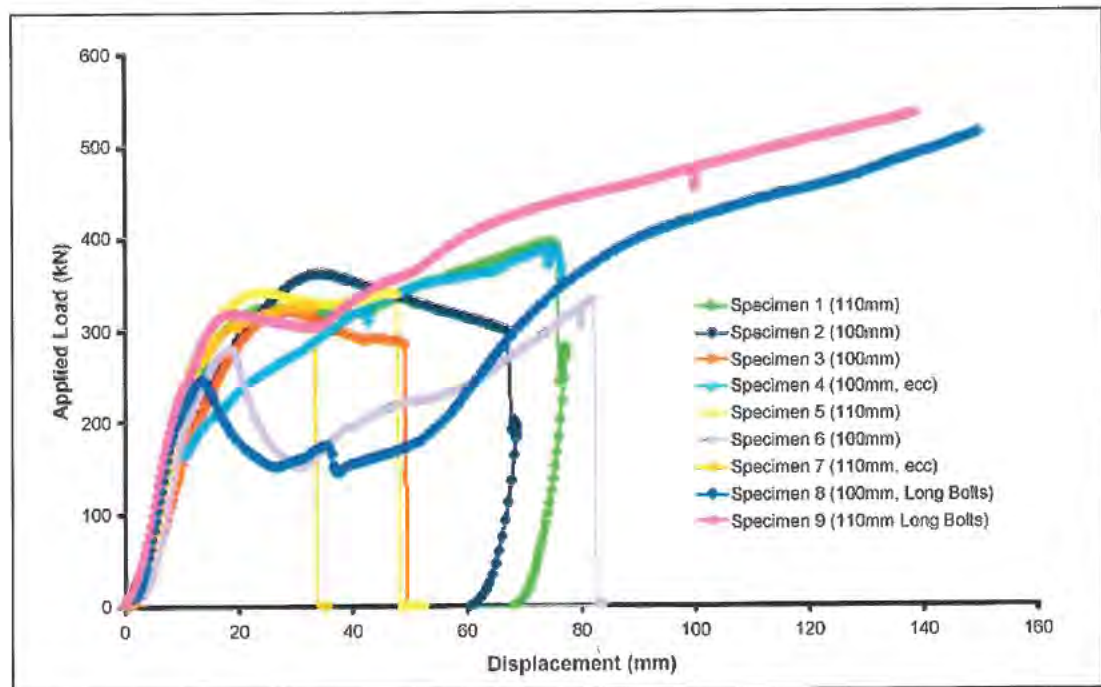
Figure 16: Total load (kN) versus cross head displacement (mm) curves for the nine gap lock specimens tested.

Figure 16 provides a summary of the load versus displacement curves generated from the tests. Figure 16 and Table 2 both indicate a clear split in the results where the specimens with long bolts reaching much higher load levels before failure compared with specimens with shorter bolts. Specimen 4 appears to be an exception to this until the premature mode of failure is taken into account. This is a plate tear-out failure mode with no bolts failing in shear. This failure mode was not observed in any of the gap lock assemblies in the collapsed hangar structure.

The specimens with short bolts failed at a single shear plane in the threaded section of one of the bolts. The failed bolts were located on the preferentially loaded side of the gap lock in each instance.

Figure 16 shows that most specimens exhibited an initial yield. After this yield the load dipped prior to increasing again and then failing. The magnitude of this "dip" in the load profile generally increased for the later specimens. This was because the test rig tubes adjacent to the end plate became progressively distorted as testing progressed. This occurred as the yielding of the end plate (at the initial yield point) resulted in the gap lock bearing upon the adjacent tubes. The amount of restraint provided by the adjacent tubes decreased for later tests (due to distortion of the tubes). As the end plate distorts, once the adjacent tubes provide sufficient restraint the load displacement curve trends upwards again. This effect resulted in a larger dip in the load displacement curve for later specimens.

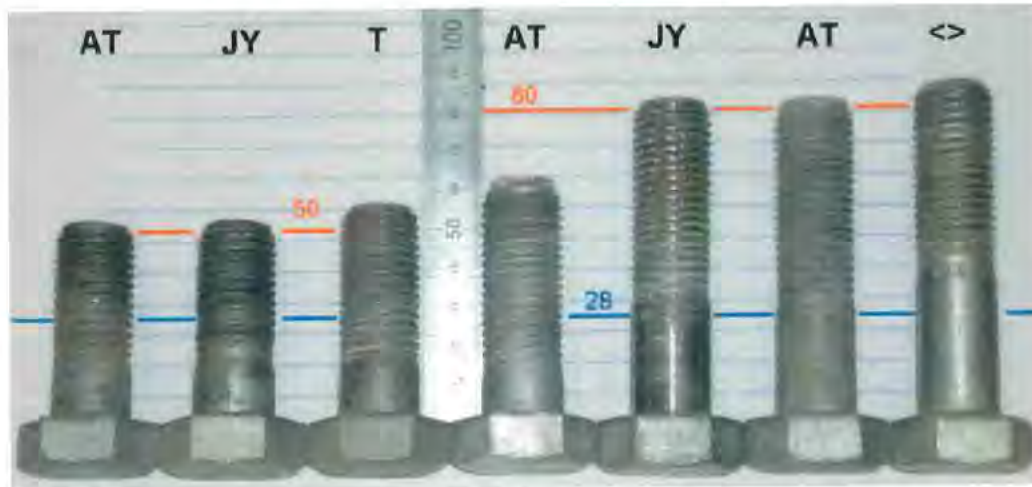
**Figure 2 – Varying Bolt lengths and Markings**

All bolts were M20 and marked with three radial lines and an 8.8 indicating structural grade 8.8 bolts. The various lengths of bolts are shown in Figure 1. As a reference the 50 mm and 80 mm lengths are shown in the figure. Also presented is the location of the second shear plane assuming a strap plate thickness of 12 mm and an end-plate thickness of 16 mm. The manufacturers markings found on the bolt heads are also presented above each of the bolts.

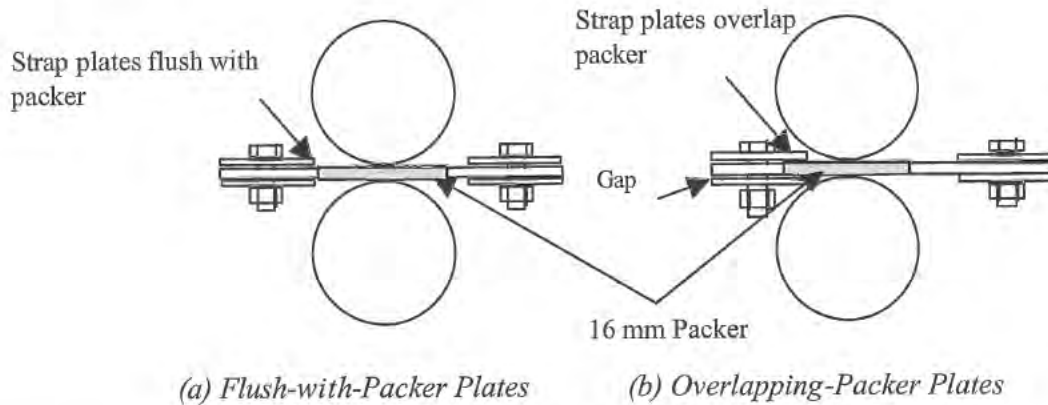
**Figure 5 – Test Configurations**

The first configuration, Type A, shown in Figure 5(a) modelled the gap-lock fittings with the strap plates held flush with the end plate. The longitudinal plates on one side of the specimen beared against the packer as shown in Figure 5(a).

The second configuration, Type B, shown in Figure 5(b) modelled the gap-lock fittings with the bolts loose, allowing the strap plates to overlap both sides of the packer plate. To ensure a consistent gap, a 16 mm plate was placed between the longitudinal plates in the vicinity of the bolts, the bolts were then tightened and the 16 mm plate removed.

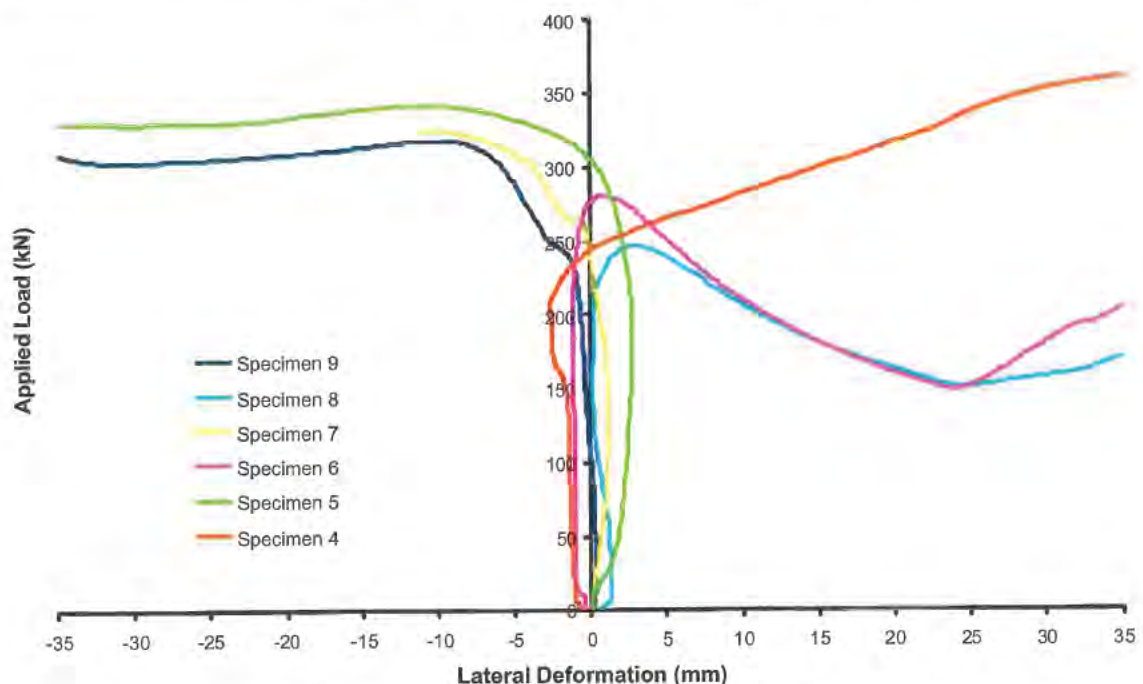
Figure 6 – Typical Lateral Displacements

In all the tests, significant lateral deflections of the end plate were observed. Typical lateral deflection curves for the last six tests are shown in Figure 6. The figure demonstrates that the lateral deflection was relatively small (less than 5mm) until the end plate began to yield.

The significant lateral deflections as shown in Figure 6 were observed in all the tests. In addition to this lateral deflection the end plates were also deformed significantly in the direction of the applied load as shown in Figure 7(b). Also demonstrated in the figure is that this plastic deformation resulted in the end plates twisting out of plane. This twisting action of the end plate resulted in some bending in the strap plates. This bending is shown in Figure 7(c), with a straight line superimposed to highlight the bending of the strap plates. Photographs of all the end plates when removed from the test specimen showing the deformations are found in Appendix A.

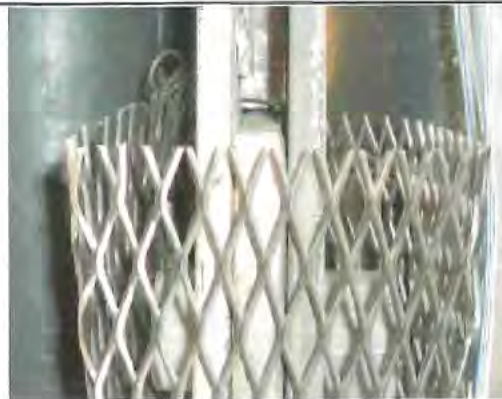
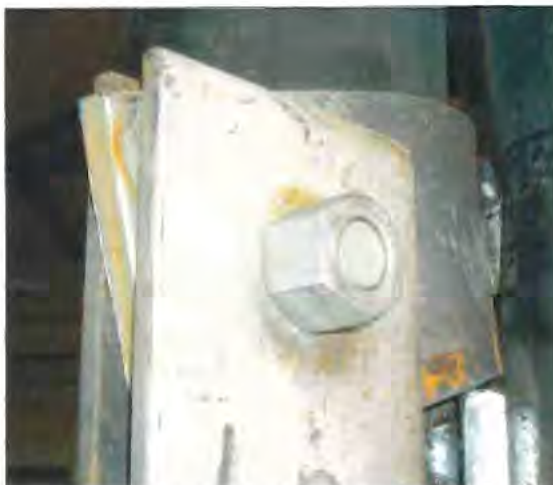
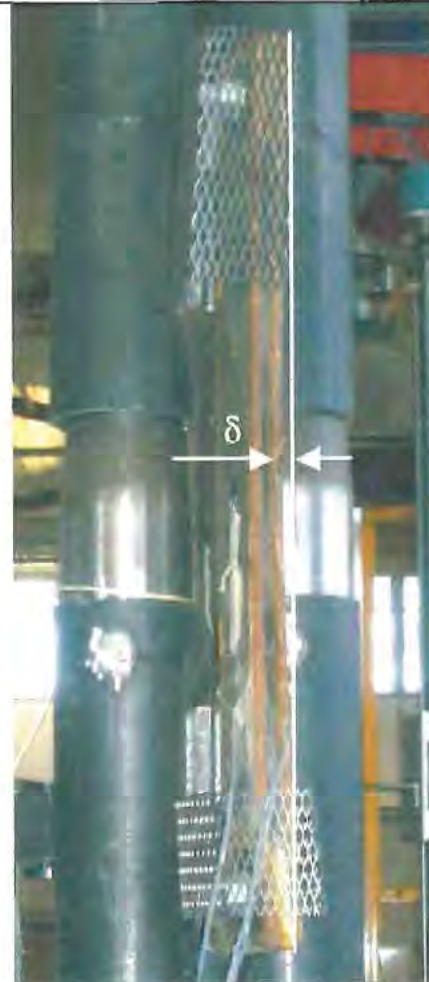
**Figure 7 – Seating and Rotations of End Plates**

(a) Bearing of End Plate

(b) Typical Deflections of the End Plates

(c) bowing of the strap Plates

It was also noted that during the manufacturing process, some weld was placed on the contact surface of the packer/end-plate interface. This weld material preventing an ideal bearing surface to form, and contributes to eccentric loading and thus twisting. Furthermore, it was noted that for most specimens the inside edge of the end plate that bears on the packer plate was not square (see Figure 7(a)) thus increasing the difficulty to obtain an ideal bearing surface.

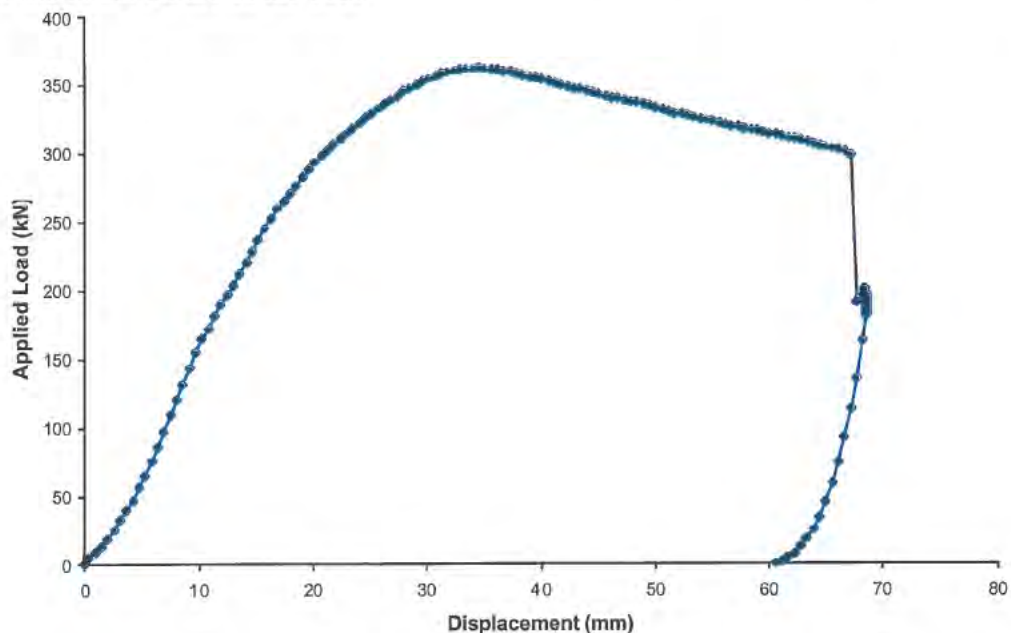
Figure 8 - Specimen 2 - Load vs Cross-Head Displacement Curve

Specimen 2 had an end-plate width of 100 mm, tested using configuration Type A. In this test only one peak load prior to failure of the gap-lock fitting was observed. This peak load of 361 kN occurred at a crosshead displacement of 34 mm. A further 33 mm of displacement was observed prior to failure at 297 kN. The failure mode for specimen 2 was a shear failure of the top left-hand bolt through one shear plane located in the threaded section of the bolt. After the failure of the bolt one shear plain remained intact, thus some load was still carried after the initial failure of the bolt.

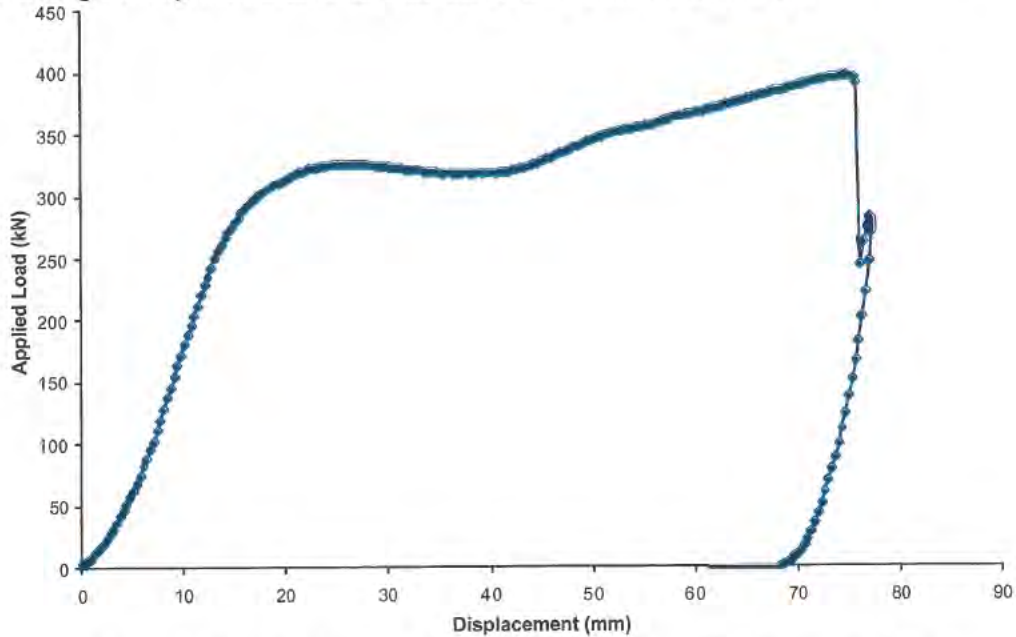
**Figure 16 – Specimen 1 - Load vs Cross-Head Displacement Curve**

Specimen 1 incorporated a 110 mm wide end plate exhibited two peaks in the load crosshead movement curve in Figure 15. The first occurred at a displacement of 25 mm at 325 kN. At this point the load fell off to approximately 318 kN until a deflection of about 40 mm. The load then gradually increased until ultimate failure occurred at 395 kN.

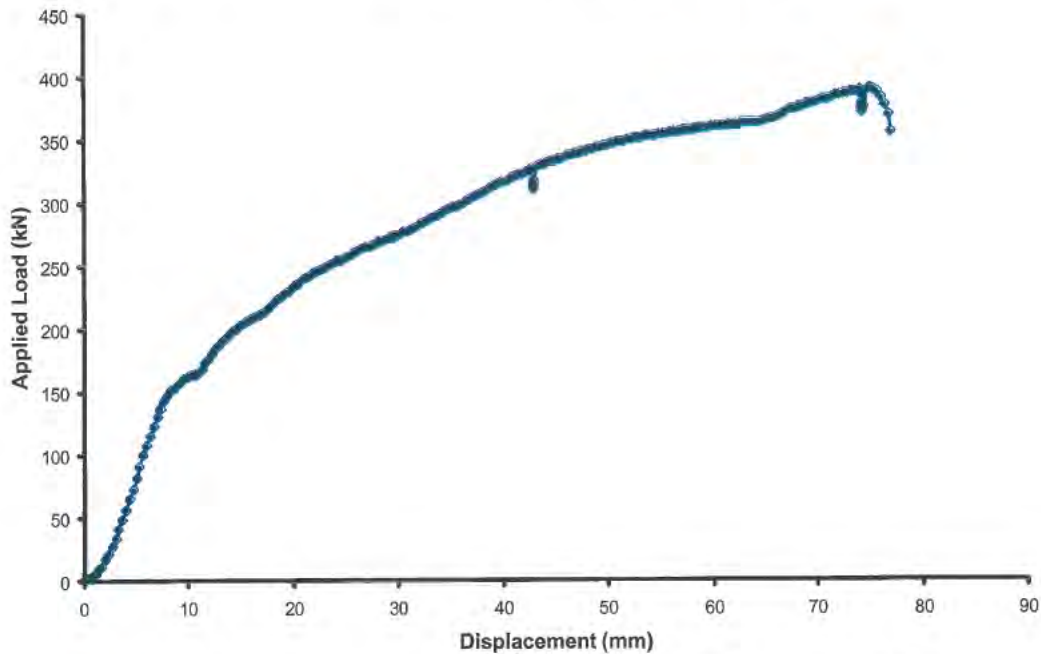
Figure 24 - Specimen 4 - Load vs Cross-Head Displacement Curve

For Specimen 4 the end plate width was 100 mm with a Type B configuration. To enable the connection to be loose longer bolts were used. Significant yielding of the end plate was observed at an earlier stage than for the type A configuration. The failure mode of the specimen was by plate tearing, which occurred at the top left side and is shown in Figure 27. The failure was relatively sudden, and occurred at a load of 389 kN.

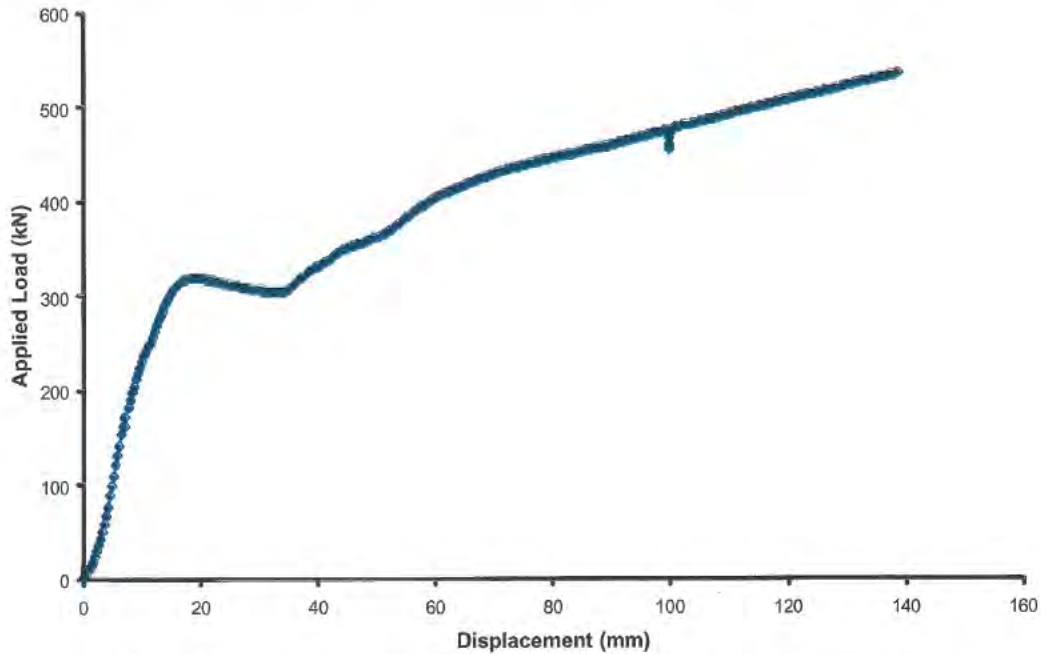
Figure 28 - Specimen 9 - Load vs Cross-Head Displacement Curve

For Specimen 9 the end plate width was 110 mm with a Type A configuration. The long bolts were selected to ensure that the unthreaded section of the bolt shank passed through both shear planes. The specimen had an initial peak load of 318 kN at 20 mm then lost load until approximately 30 mm beyond which the load progressively increased. The test was stopped at 534 kN due to significant lateral deformations being imposed on the assembly.

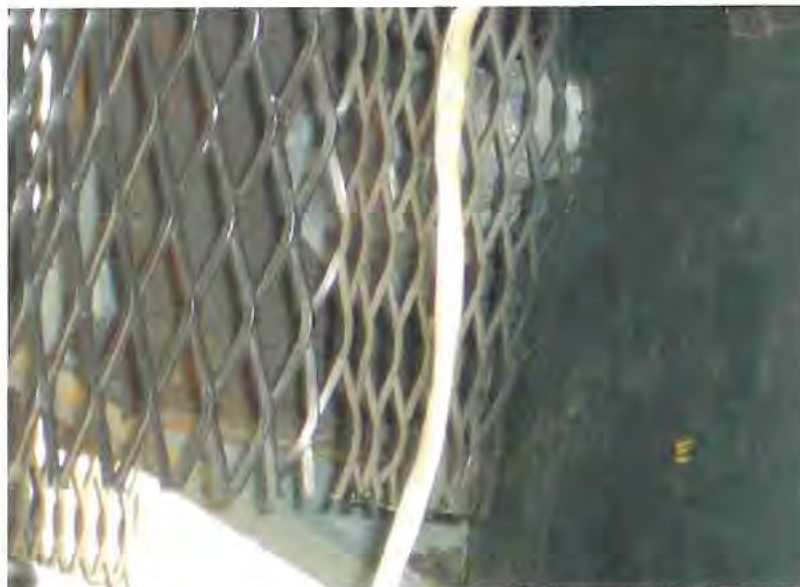
**Figure 31 – Bolt Ends bearing into Chord Member**

The direction of the end plate deflection was forward. As the end plates deformed, the protruding ends of the bolts eventually beared on the chord member as can be seen in Figure 31. As the load increased the deformations of the end plate also increased causing the bolts to pinch the chord members. The test was stopped when these deformations were considered excessive.

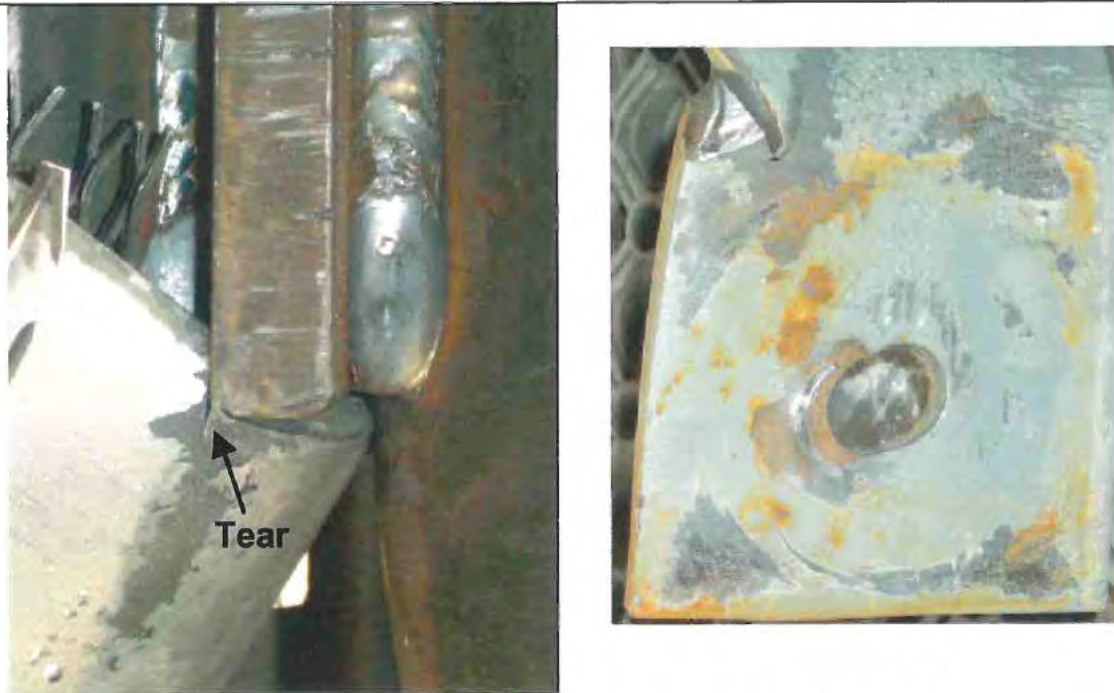
**Figure 32 – Tearing of End Plates and Elongation of Bolt Holes**

Upon completion of the test, close inspection of the end-plates revealed significant yielding and tearing at the interface of the corner of the packer plate with the end plate as seen in Figure 32(a). The boltholes on the left side of the test frame also demonstrated significant elongation as shown in Figure 32(b). At the high loads the rotation of the gap-lock fitting resulted in a significant out-of-straightness of the chord member as shown in Figure 33.

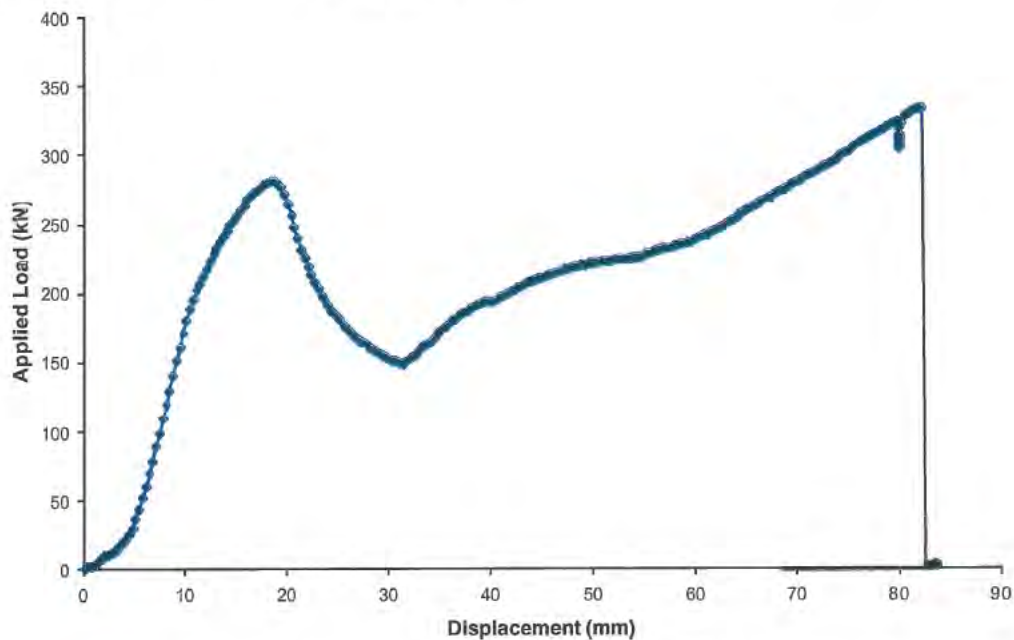
Figure 34 - Specimen 6 - Load vs Cross-Head Displacement Curve

Specimen 6 had an end-plate width of 100 mm, tested using the Type A configuration, and washers under the nuts. Initially a peak load of 280 kN was reached at 18 mm deflection, at this point the end plates began to yield with the load decreasing significantly as the bottom endplate deflected laterally. At this stage on small lateral deflections were observed at the top end plate (see Figure 37(a)). Once the endplate at the bottom came into contact with the chord member the applied loads began to increase until an ultimate load of 334 kN was reached. As the applied load increased the lateral deflections at the top endplate also increased. The failure mode for specimen 6 was a shear failure of the bottom left hand bolt through one shear plane located in the threaded section of the bolt.

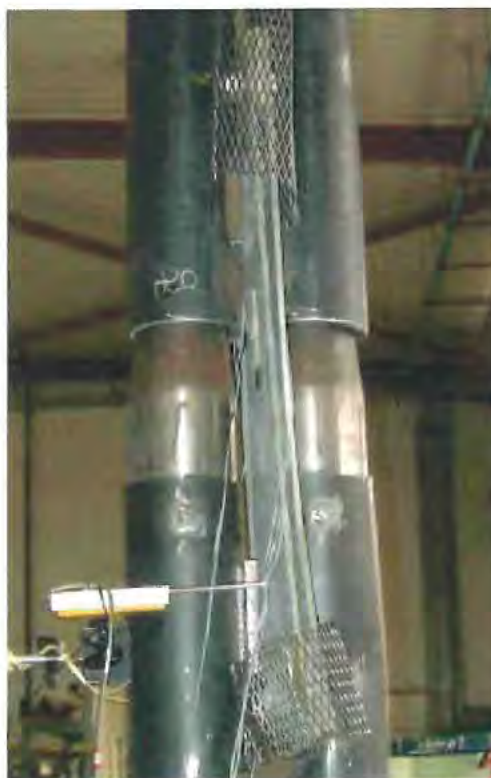
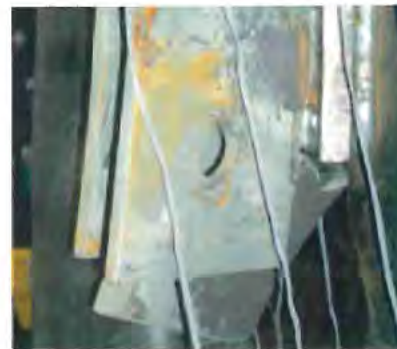
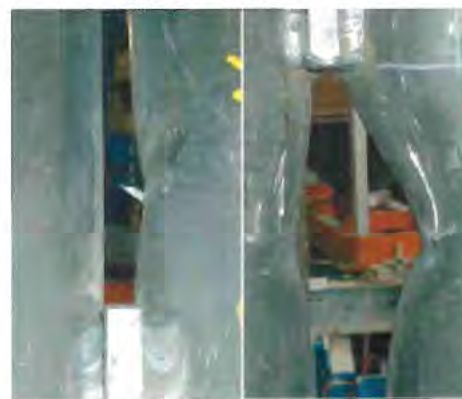
**Figure 37 – Failure Mode Specimen 6**

The mode of failure is clearly shown in Figure 37(b) with the bolt missing from the fitting. The lateral movement of the end plate was towards the rear of the test assembly. The variation in the deformations of the side of the chord members is shown in Figure 37(c).

*(a) Twisting of the bottom End-plate*

*(b) Missing Bolt*

*(c) Chord Member Deformations*

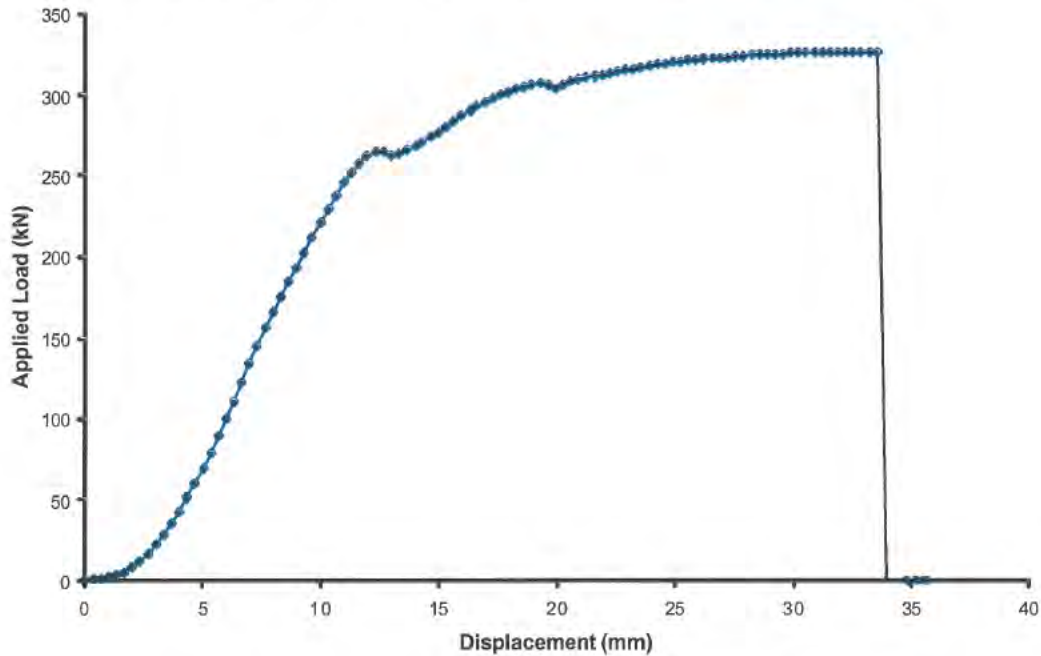
Figure 38 - Specimen 7 - Load vs Cross-Head Displacement Curve

Tested using the Type B configuration, with an end-plate width of 100 mm specimen 7 was a repeat test of specimen 9 with short bolts. For this test the lateral deflection of the end plates was towards the front of the test rig. The plastic deformations on the bottom chord members at the front was significantly less (Figure 37(c)), thus preventing the significant drop in load observed in Specimen 7. The ultimate load was 326 kN, and occurred when the top left-hand bolt failed through a single shear plane through the thread section of the bolt.

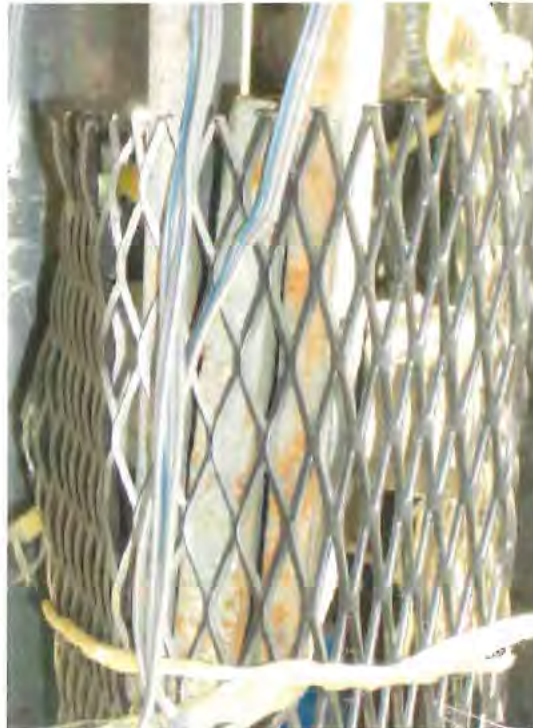
**Figure 41 – Rotation of the End Plate**

The gap in the test configuration Type B allowed for some unrestrained rotation of the end plate under loading see Figure 41, with a gap on the top right and bottom left. It should also be noted that while the bolt length was shorter, 1½ threads still protruded through the nut.

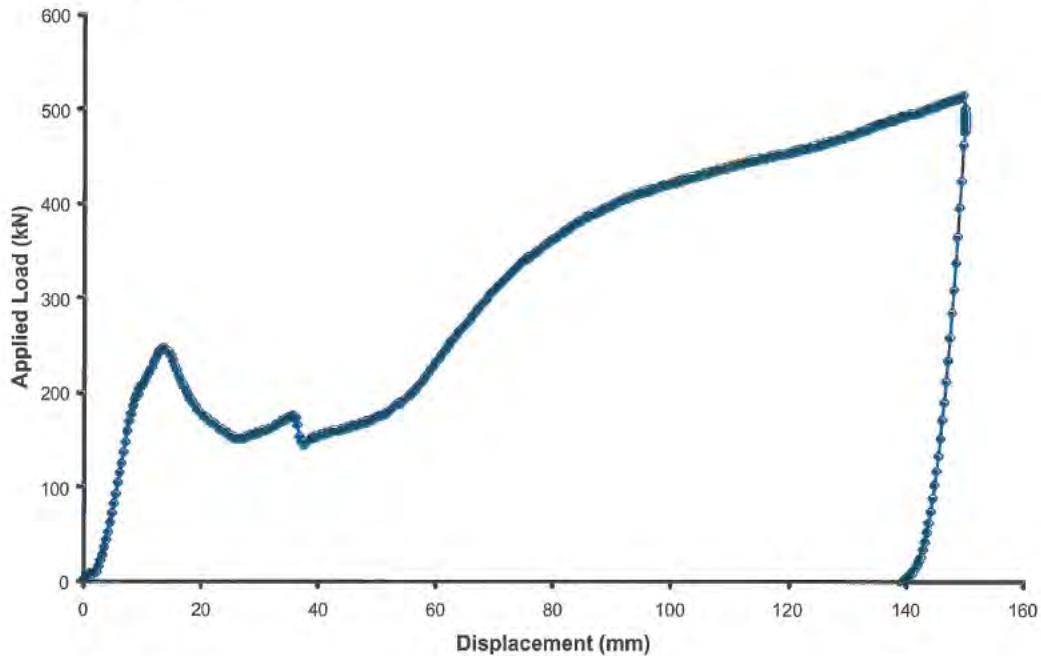
Figure 42 – Specimen 8 - Load vs Cross-Head Displacement Curve

Specimen 8 consisted of a 110 mm end plate, with long bolts positioned in a manner to ensure that both shear plane passed through the shank of the bolt. The Lateral deflections of the end plates was towards the back of the test rig and as observed for specimen 6 the load dropped significantly at yield until the endplate came into contact with the chord member. From this point the load gradually increased until the test was stopped due to excessive deformations at a load of 514 kN.

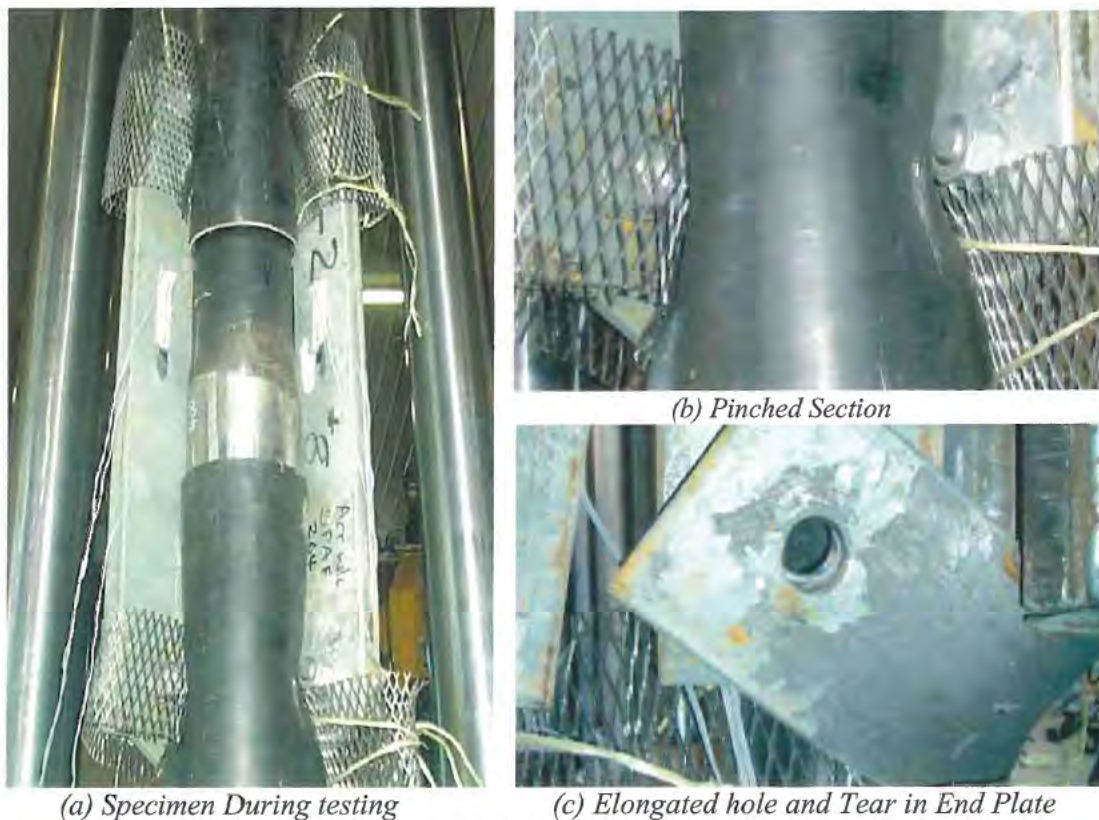
**Figure 45 – Failure of Specimen 8**

To prevent the bolts from bearing into the chord member as experience in Specimen 4 the bolt length was reduced so that 1½ threads protruded out of the nut when fastened. With the bolts shortened the chord member was now pinched by the nuts when the plate had deformed see Figure 45 (b).

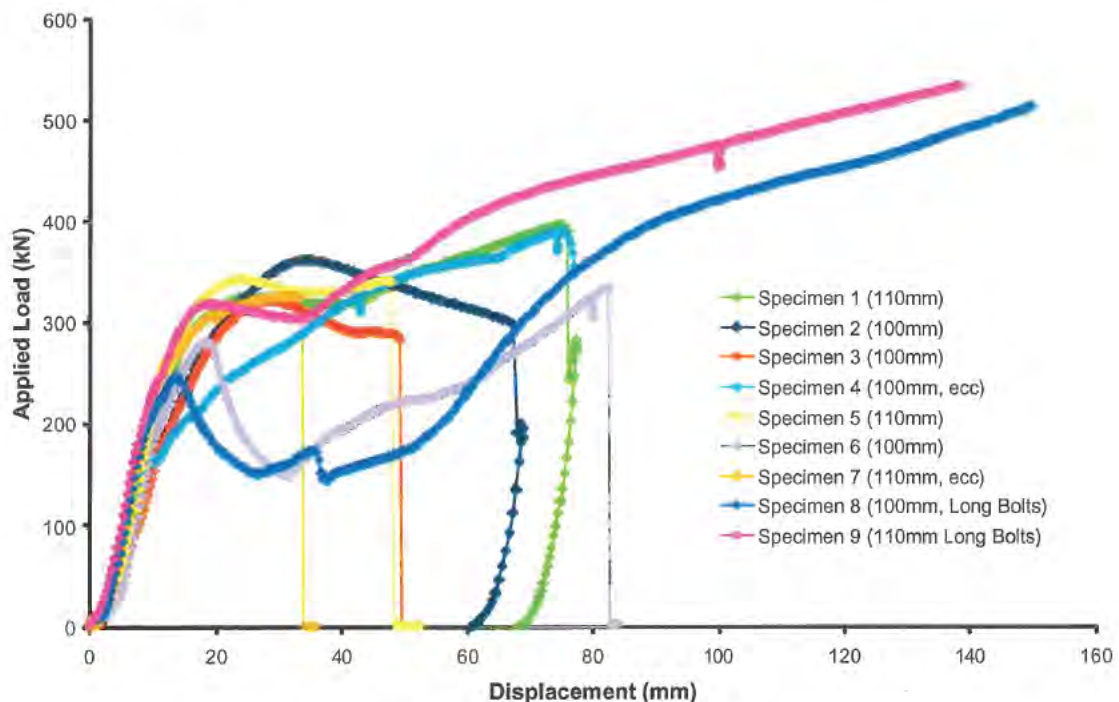
**Figure 46 – All Specimens - Load vs. Cross-Head Displacement Curves**

For a comparison of the behaviour of all the tests Figure 46 gives the load vs. crosshead displacement curves.

For all tests the end plates experienced significant plastic deformations, with the shear failure of the bolts being the dominant failure mode. The shear failure was always through one shear

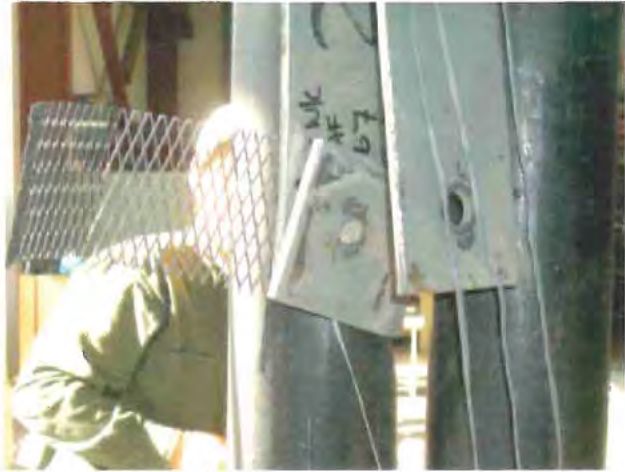
*Specimen at Failure*

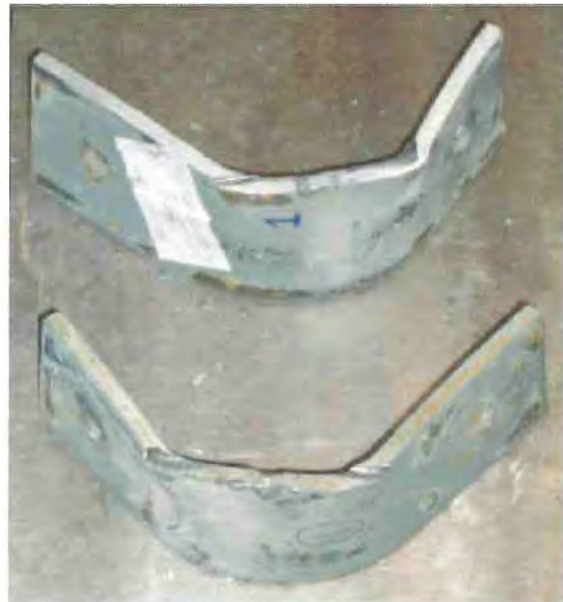
*End plates after testing.*

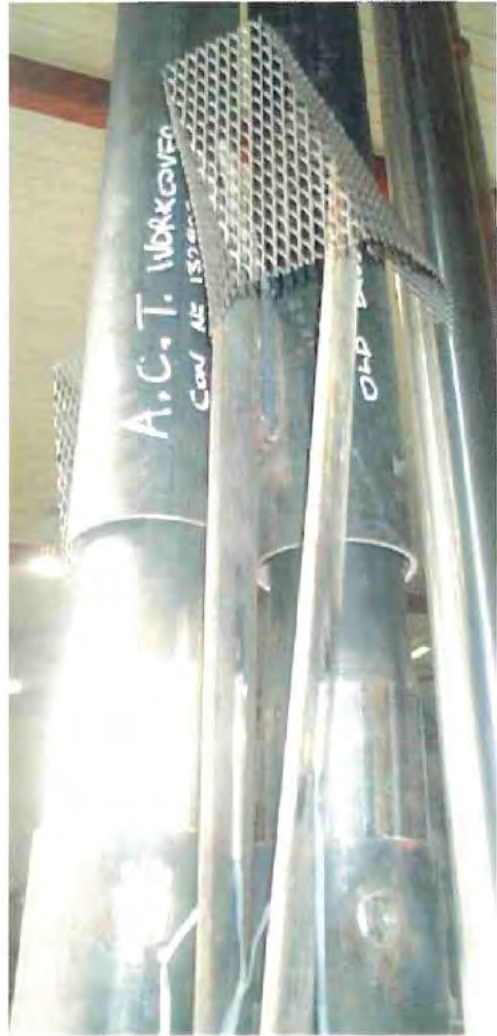
*At failure*

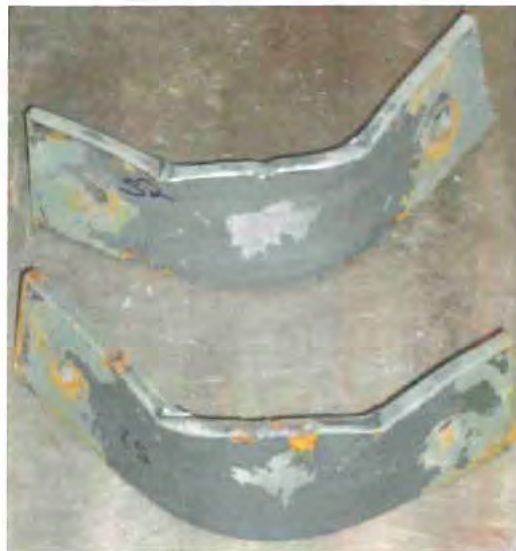
*End plates after testing.*

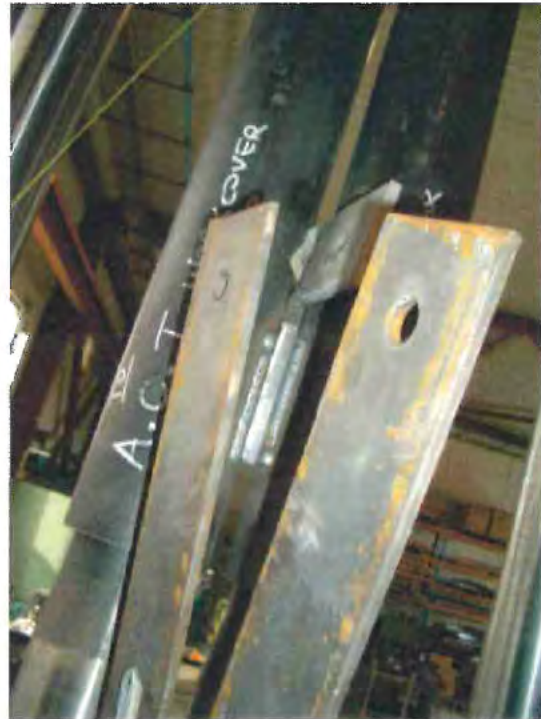
**Figure 15 – Failure Mode of Specimen 3**

*After Failure*

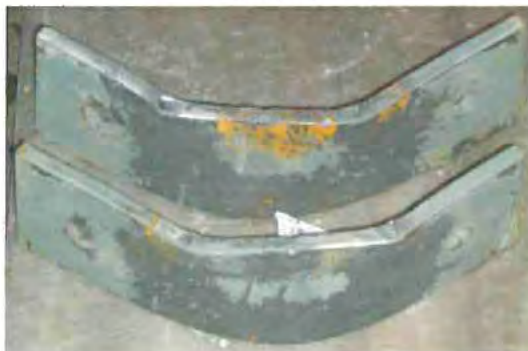
*End plates after testing*

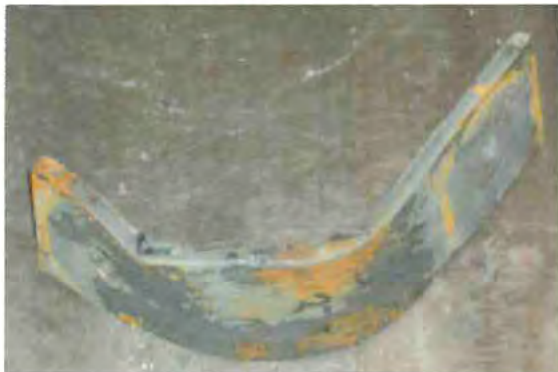
*End plates after test*

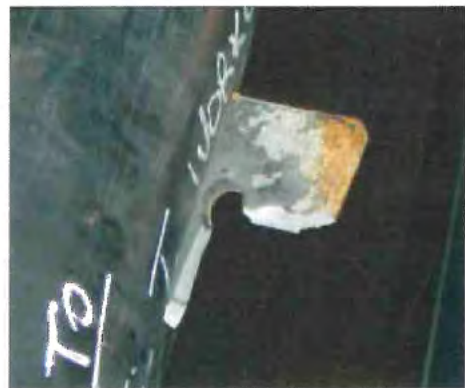
**Figure 27 – Failure Mode of Specimen 4**

*Failed Endplate*

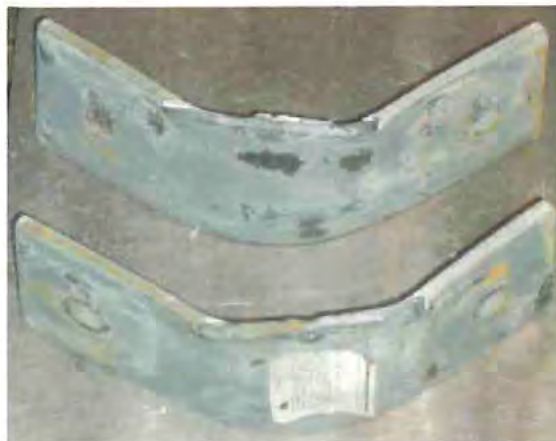
*End plates after test*
