FOI Reference: CMTEDDFOI 2021-316

Connell Mott MacDonald was engaged by ACT Work Cover to investigate the cause of collapse of a partially constructed aircraft hangar building structure for the Special Purpose Aircraft Facility (SPAF) located at RAAF Fairburn, Canberra. The SPAF was being constructed by Construction Control with the design, erection methodology and construction of the hangar superstructure subcontracted to Strarch International (Strarch International 2003a p9).

This final report describes the analytical work undertaken by Connell Mott MacDonald and the component testing conducted by the University of Western Sydney in an effort to ascertain the cause of the structure collapse. The report is arranged in several parts as follows:

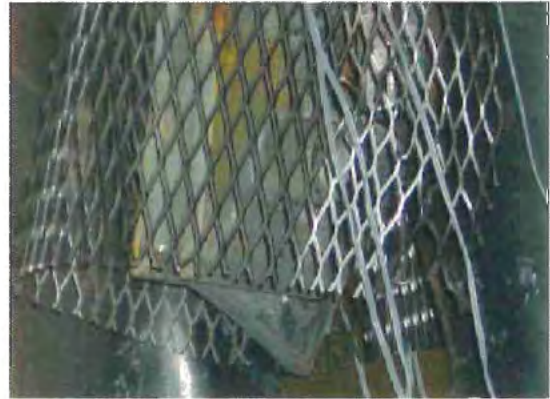
Specimen 6 had an end-plate width of 100 mm, tested using the Type A configuration, and washers under the nuts. Initially a peak load of 280 kN was reached at 18 mm deflection, at this point the end plates began to yield with the load decreasing significantly as the bottom endplate deflected laterally. At this stage on small lateral deflections were observed at the top end plate (see Figure 37(a)). Once the endplate at the bottom came into contact with the chord member the applied loads began to increase until an ultimate load of 334 kN was reached. As the applied load increased the lateral deflections at the top endplate also increased. The failure mode for specimen 6 was a shear failure of the bottom left hand bolt through one shear plane located in the threaded section of the bolt.

*End plate deformations*

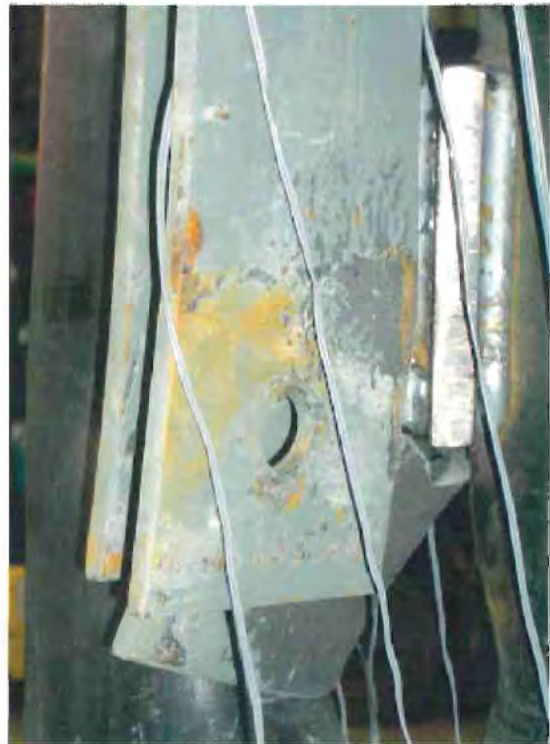
*End plate at failure**End plates after test*

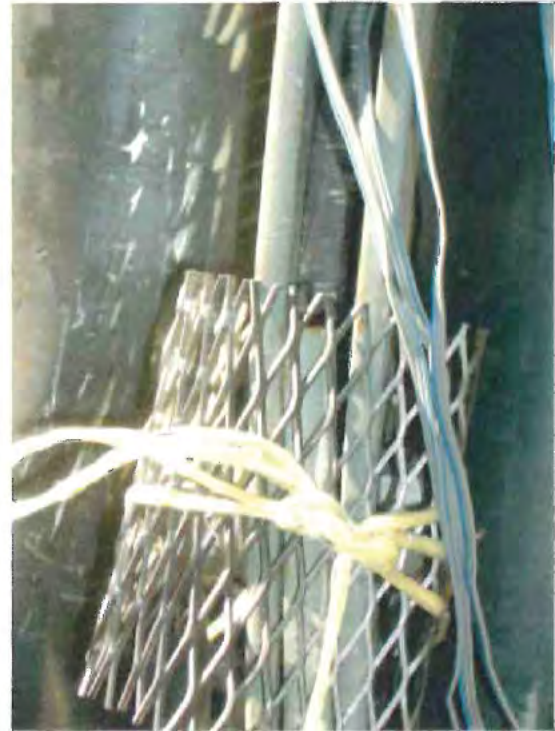
The gap in the test configuration Type B allowed for some unrestrained rotation of the end plate under loading see Figure 41, with a gap on the top right and bottom left. It should also be noted that while the bolt length was shorter, 1½ threads still protruded through the nut.

*Twisting of the end plate*

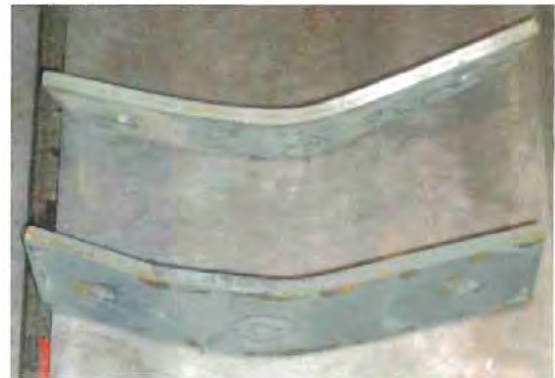
Tested using the Type B configuration, with an end-plate width of 100 mm specimen 7 was a repeat test of specimen 9 with short bolts. For this test the lateral deflection of the end plates was towards the front of the test rig. The plastic deformations on the bottom chord members at the front was significantly less (Figure 37(c)), thus preventing the significant drop in load observed in Specimen 7. The ultimate load was 326 kN, and occurred when the top left-hand bolt failed through a single shear plane through the thread section of the bolt.

*End Plate after test*

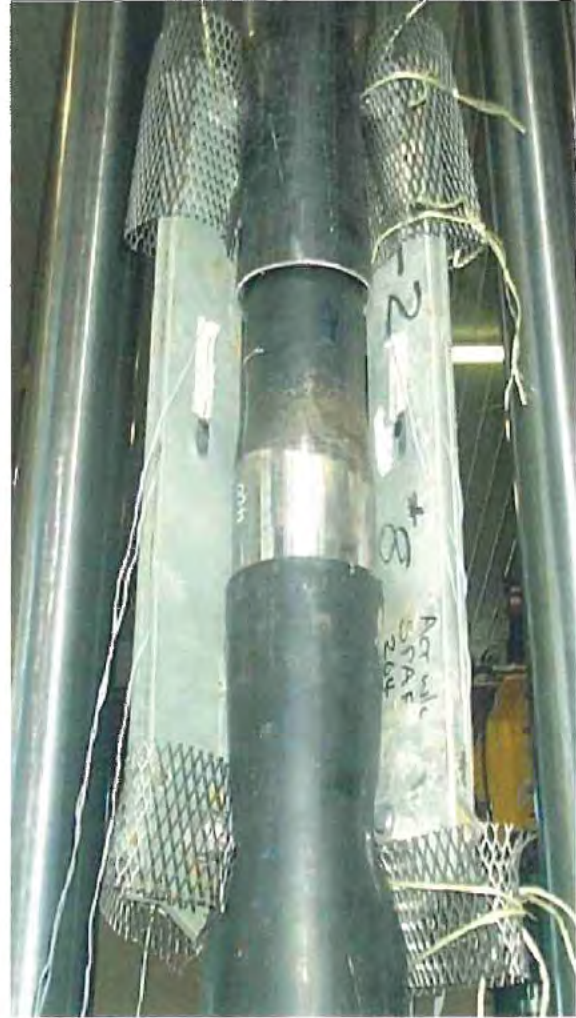
Specimen 8 consisted of a 110 mm end plate, with long bolts positioned in a manner to ensure that both shear plane passed through the shank of the bolt. The Lateral deflections of the end plates was towards the back of the test rig and as observed for specimen 6 the load dropped significantly at yield until the endplate came into contact with the chord member. From this point the load gradually increased until the test was stopped due to excessive deformations at a load of 514 kN.

*Deformations at peak load*

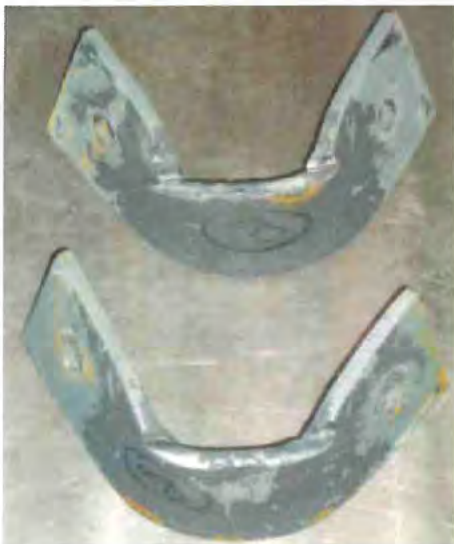
*End plates after test*

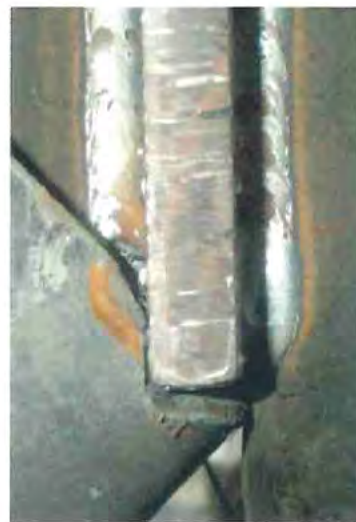
*Tearing of end plate*

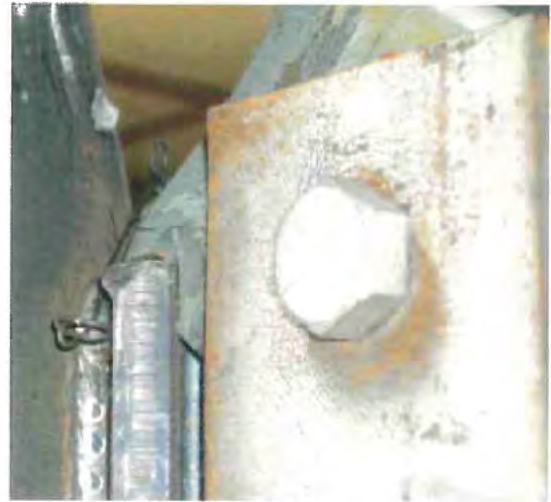
*Endplate at peak load*

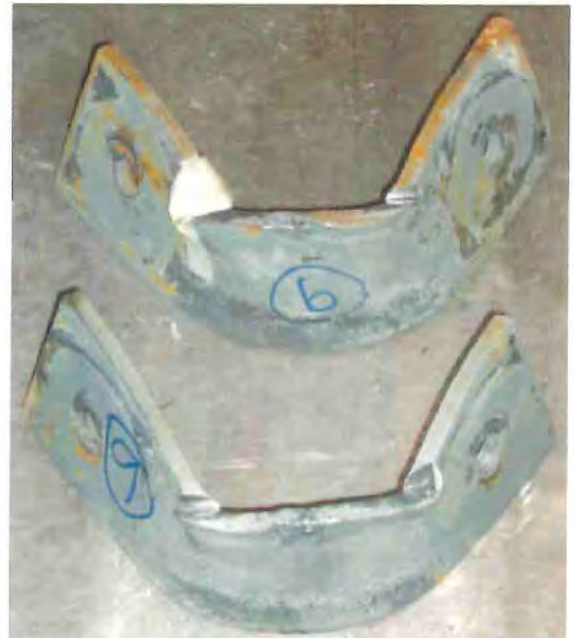
*End plates after test*
