**Bulk Water
Alliance**

Memorandum

SUBJECT ECD – Thermal Analysis – Cracked Section

Interim Incident Report – Cotter Dam flooding during construction – 1 March – 5 March 2012

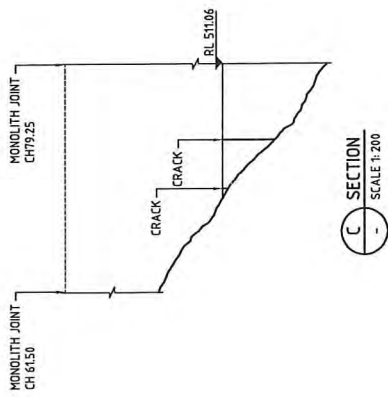
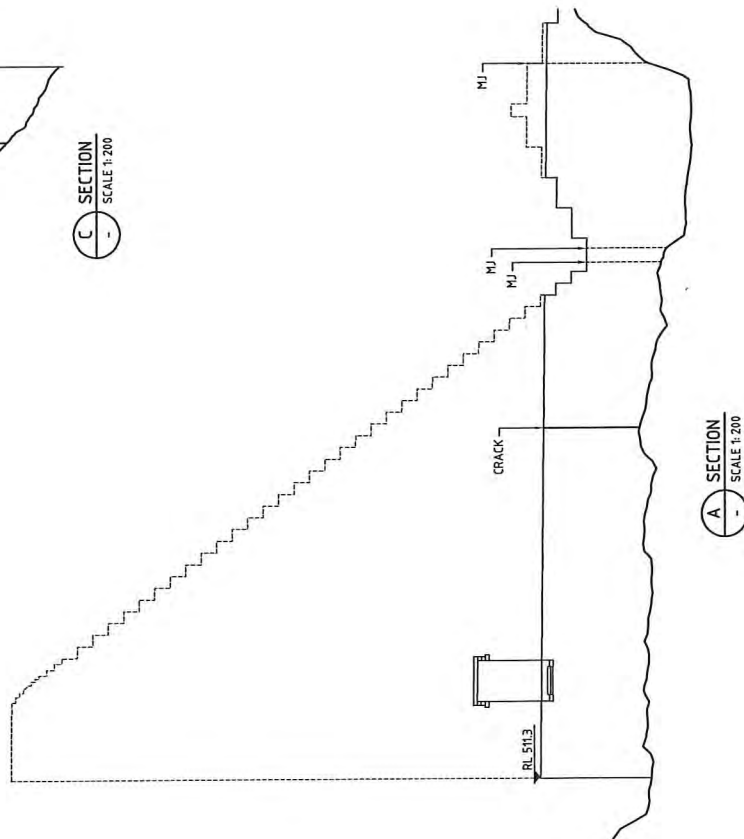
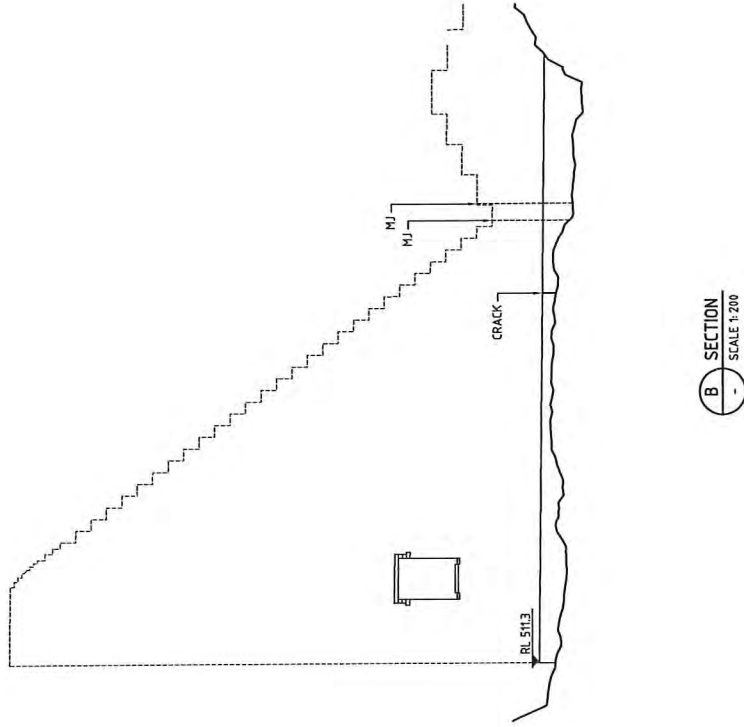
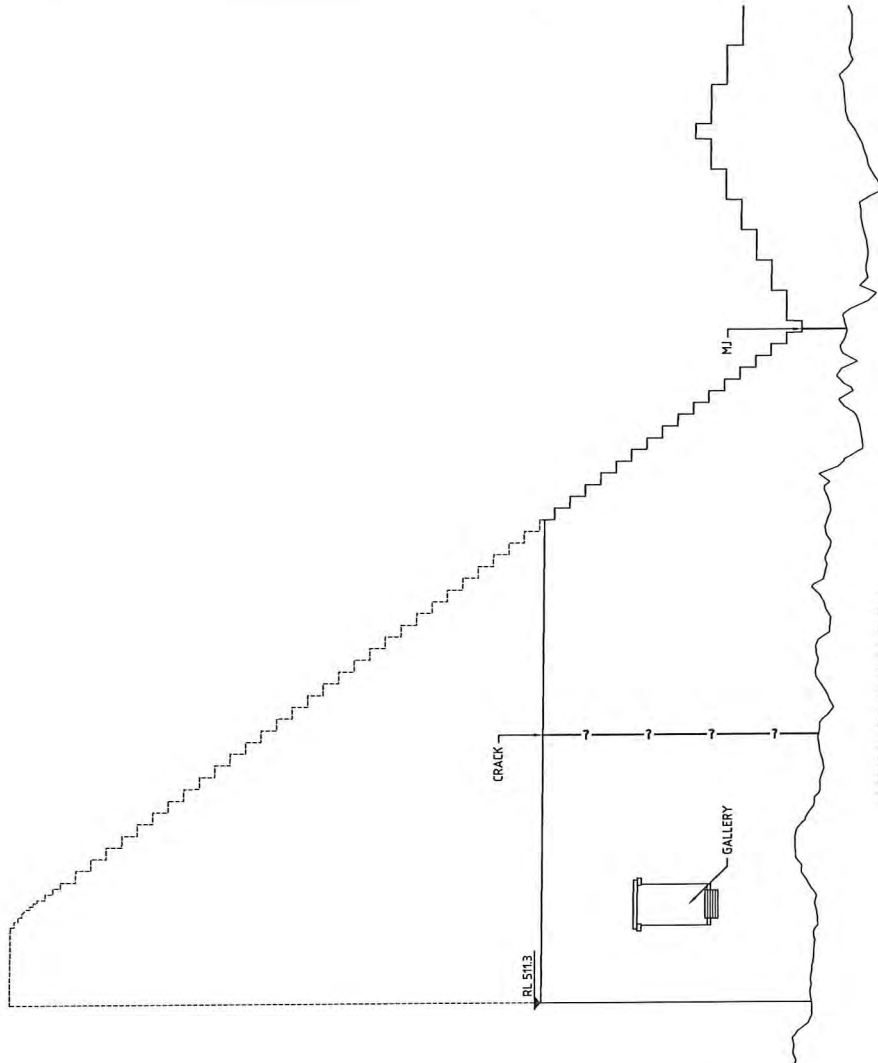
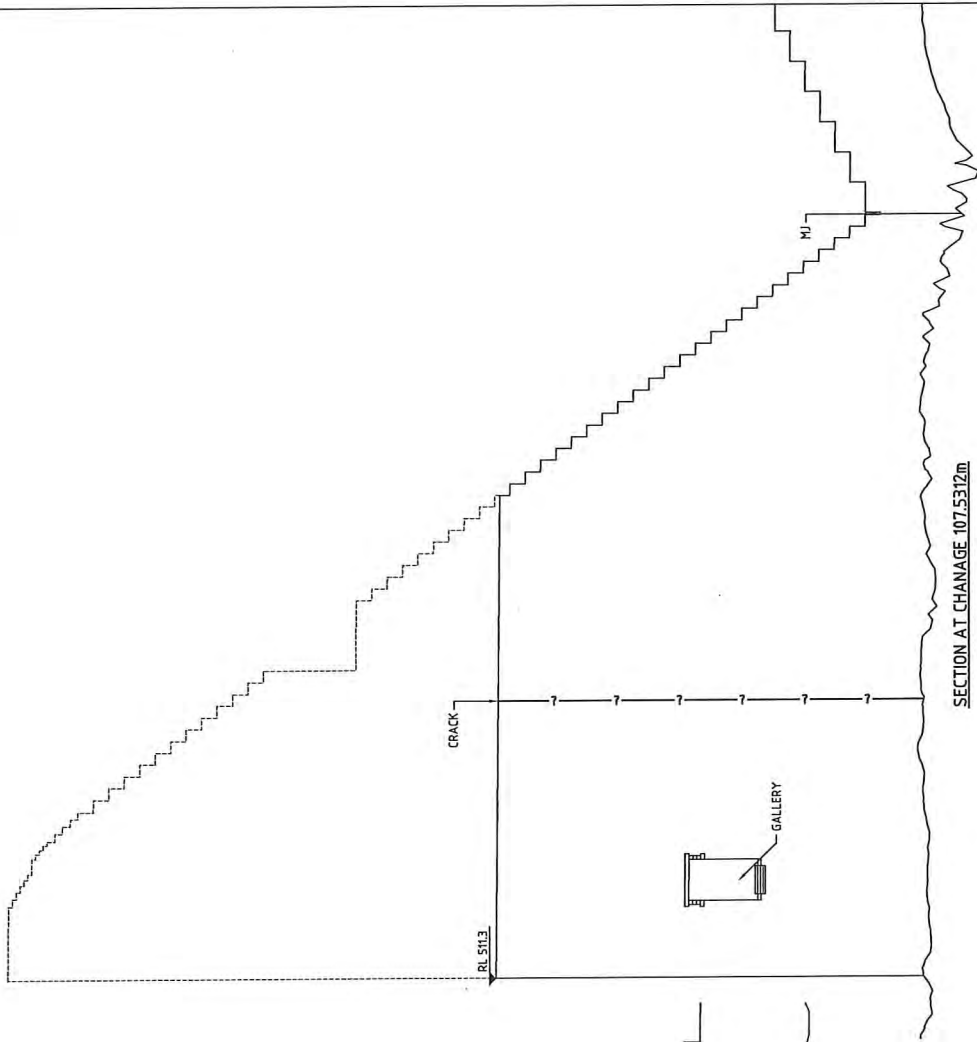
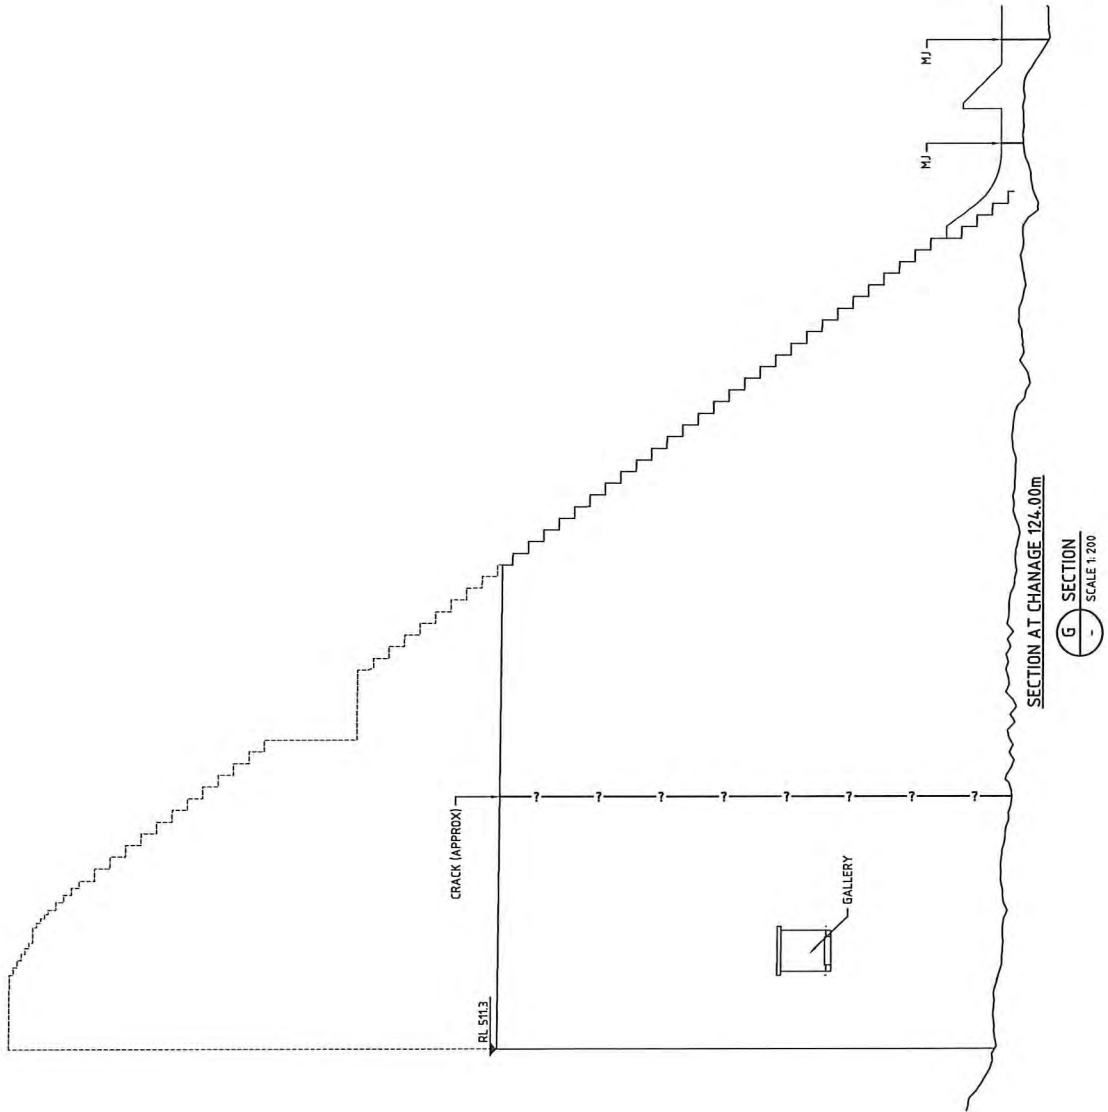
Appendix A
Cracks - Plan and Sections

As the surface clean up continued for the recommencement of placing RCC, additional cracks were identified across adjacent monoliths. The last of these was identified on 3 May where it appears to have terminated about midway through the monolith containing the intake tower. The timing of when these cracks occurred is not known but is suspected that they formed over the Easter weekend or some time thereafter as generally cooler ambient conditions were experienced. The cracks are located at approximately 20 to 25m downstream of the upstream face, or 15 to 20m from the downstream face, (at RL511.3m). The locations of the crack are shown in Appendix A.

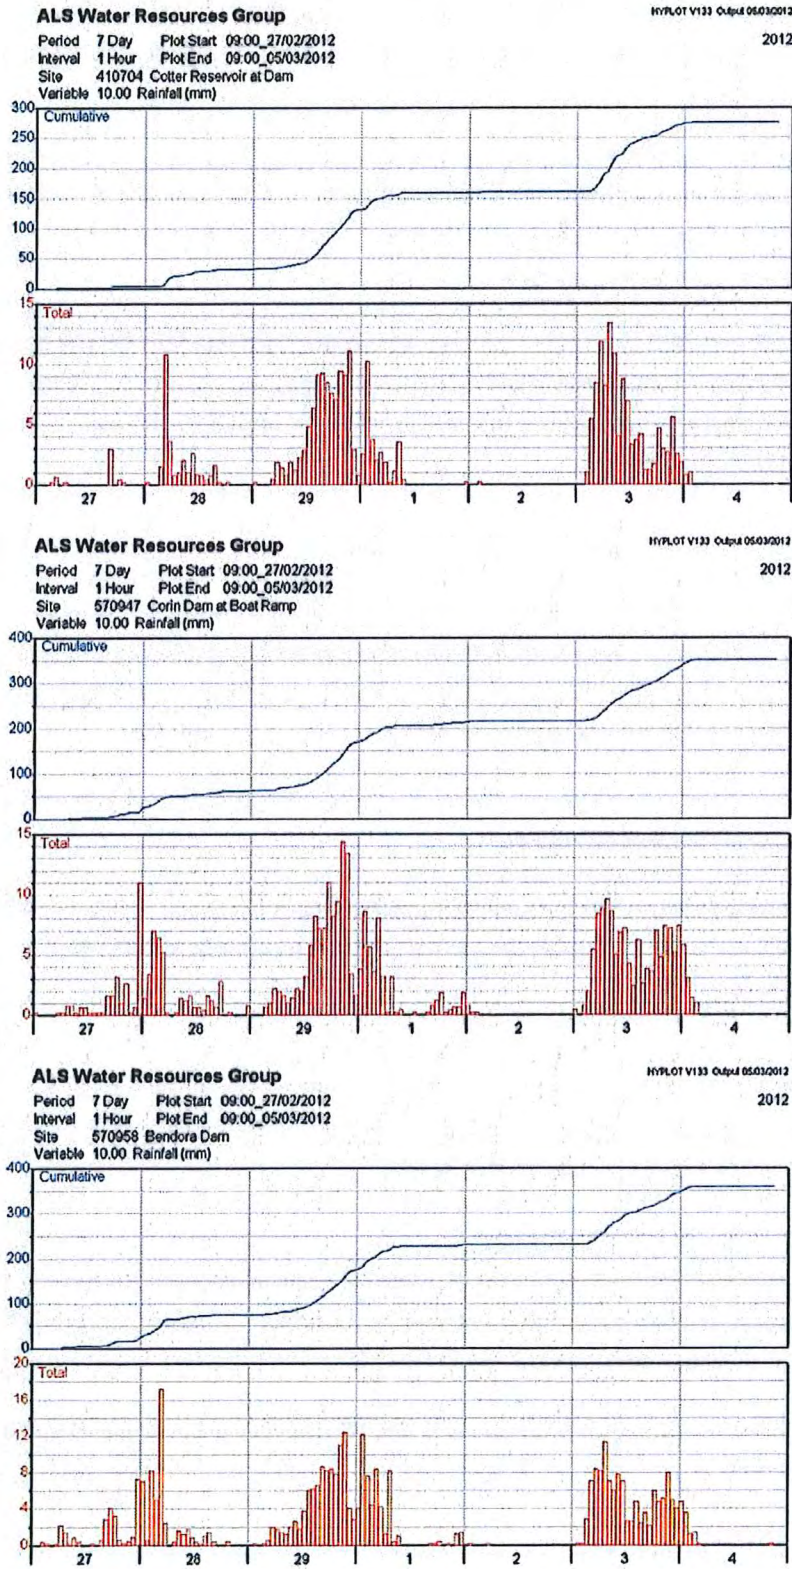
Figure 1 - Rainfall plots for Cotter, Corin and Bendora Dam sites

Over the 7 day period 27 February to 4 March a total of approximately 270 mm of rain was recorded to at the Cotter Dam. Rainfall at upstream dam sites (Corin and Bendora) on the Cotter River exceeded 350 mm over the same period. See Figure 1.

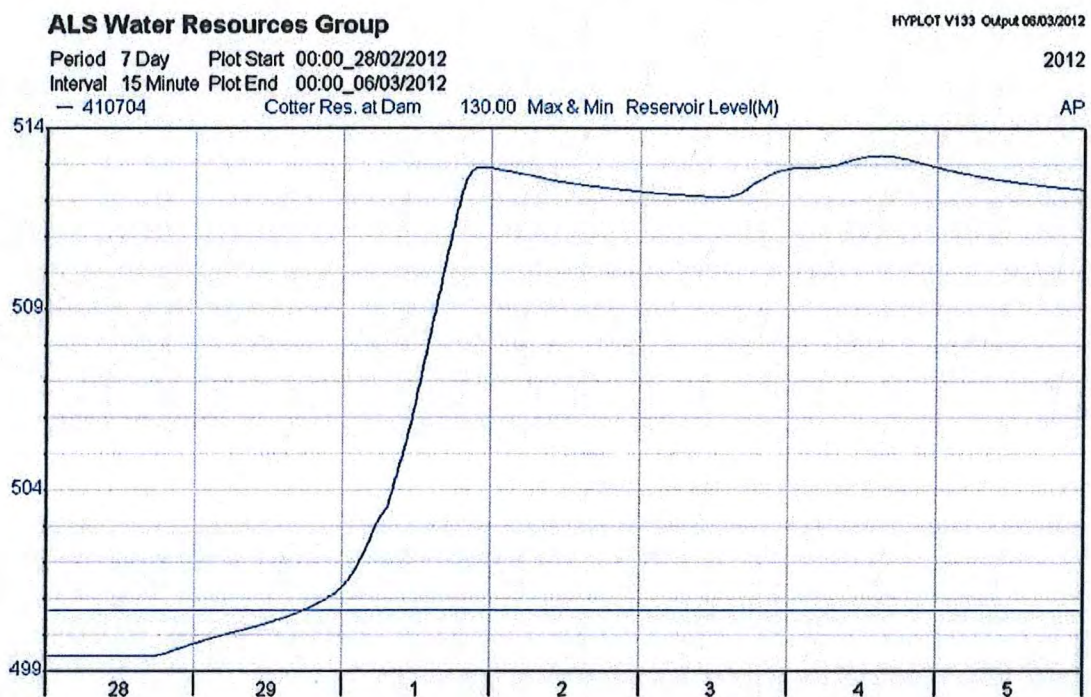
Figure 2 - Upstream water level at Cotter Dam

The reservoir level commenced to rise with the rainfall over the 27-28 February and then rapidly rose on 1 March to an initial peak of RL 512.91. From this point the level fell and reached a low of approximately RL 512.1, then rose again with rainfall on 3 March to a new high of RL 513.24. See Figure 2.

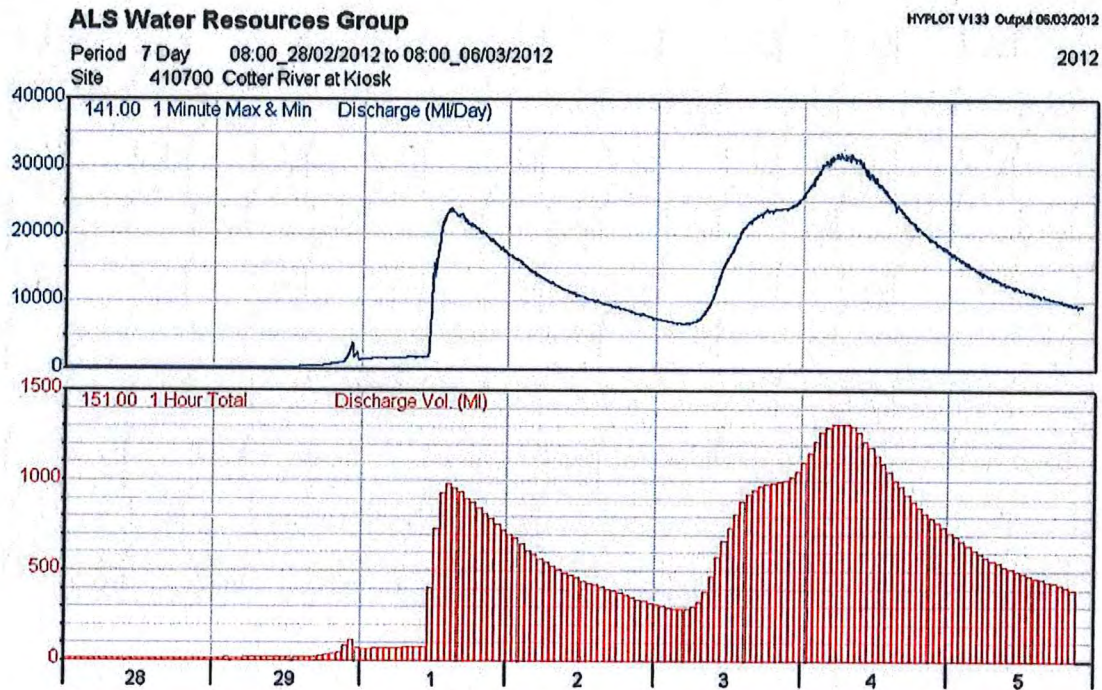
Figure 6 - Downstream flow data – Cotter Kiosk Gauging Station

Approximate peak 15 minute outflows during this event were in the order of 23,500 ML/d (272 m³/s) on 1 March and 31,700 ML/d (367 m³/s) on 4 March. See Figure 6.

Note: This gauging station has maximum gauged height of 1.74m (approximately 15,000 ML/d) and this was significantly exceeded during this event, indicating the accuracy of the reported peak flow rates and volumes is likely to be approximate only.

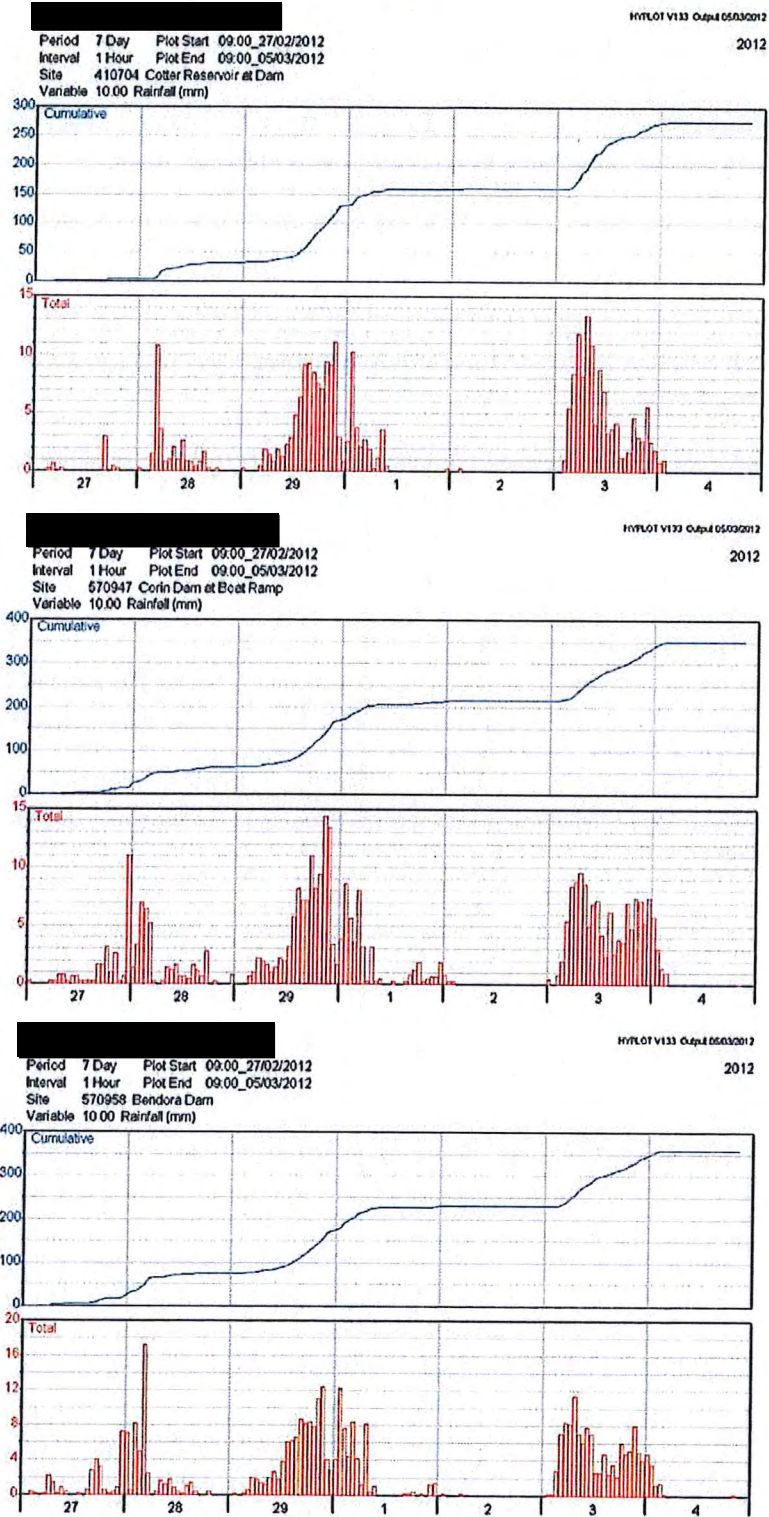
Figure 1 - Rainfall plots for Cotter, Corin and Bendora Dam sites

Over the 7 day period 27 February to 4 March a total of approximately 270 mm of rain was recorded to at the Cotter Dam. Rainfall at the two upstream dam sites (Corin and Bendora) on the Cotter River exceeded 350 mm over the same period. See Figure 1.

The Bureau of Meteorology (BOM) reported that this event was the largest 7 day rainfall for Canberra since 1950.

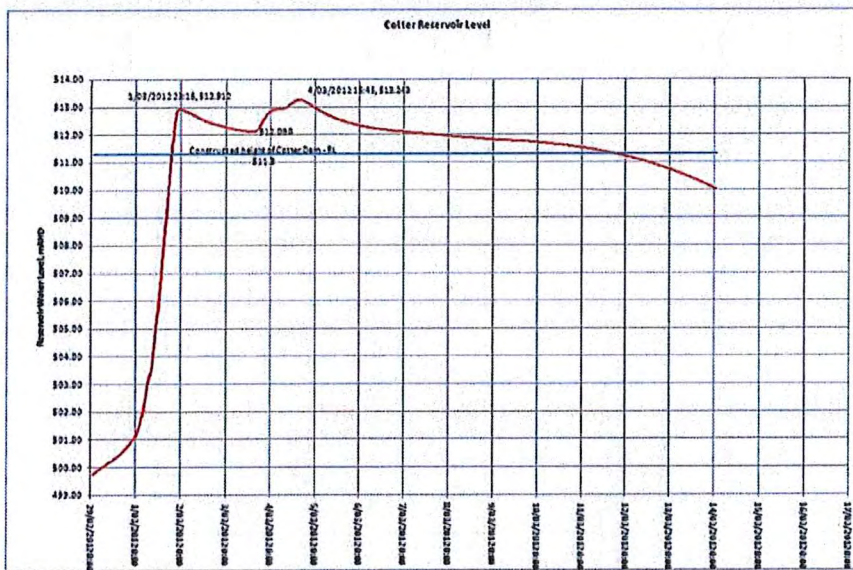
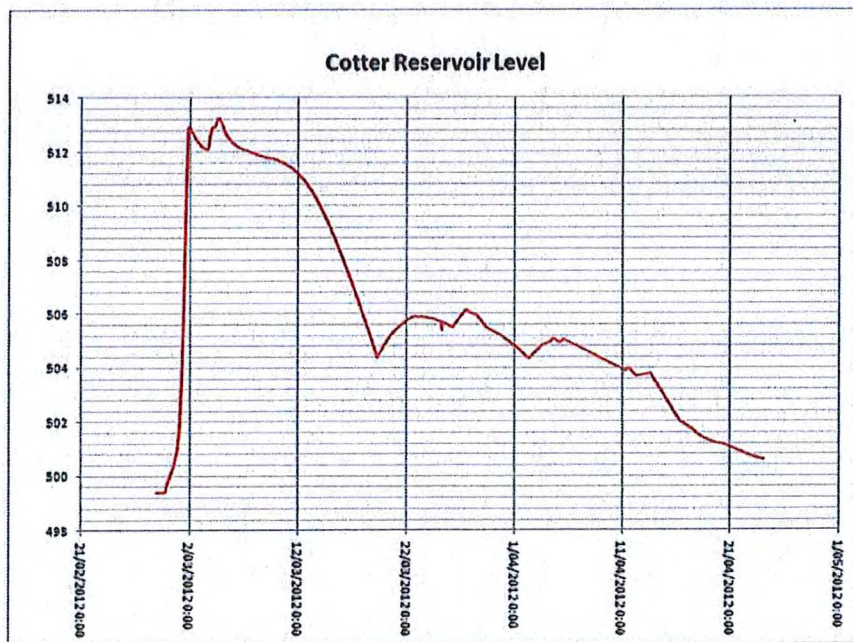
Figure 2 - Upstream water level at Cotter Dam

The reservoir level commenced to rise with the rainfall over the 27-28 February and then rapidly rose on 1 March to an initial peak of RL 512.91. From this point the level fell slightly and reached a low of approximately RL 512.1, then rose again with new rainfall on 3 March to a new high of RL 513.24 at 15:45 hr on 4 March. See Figure 2.

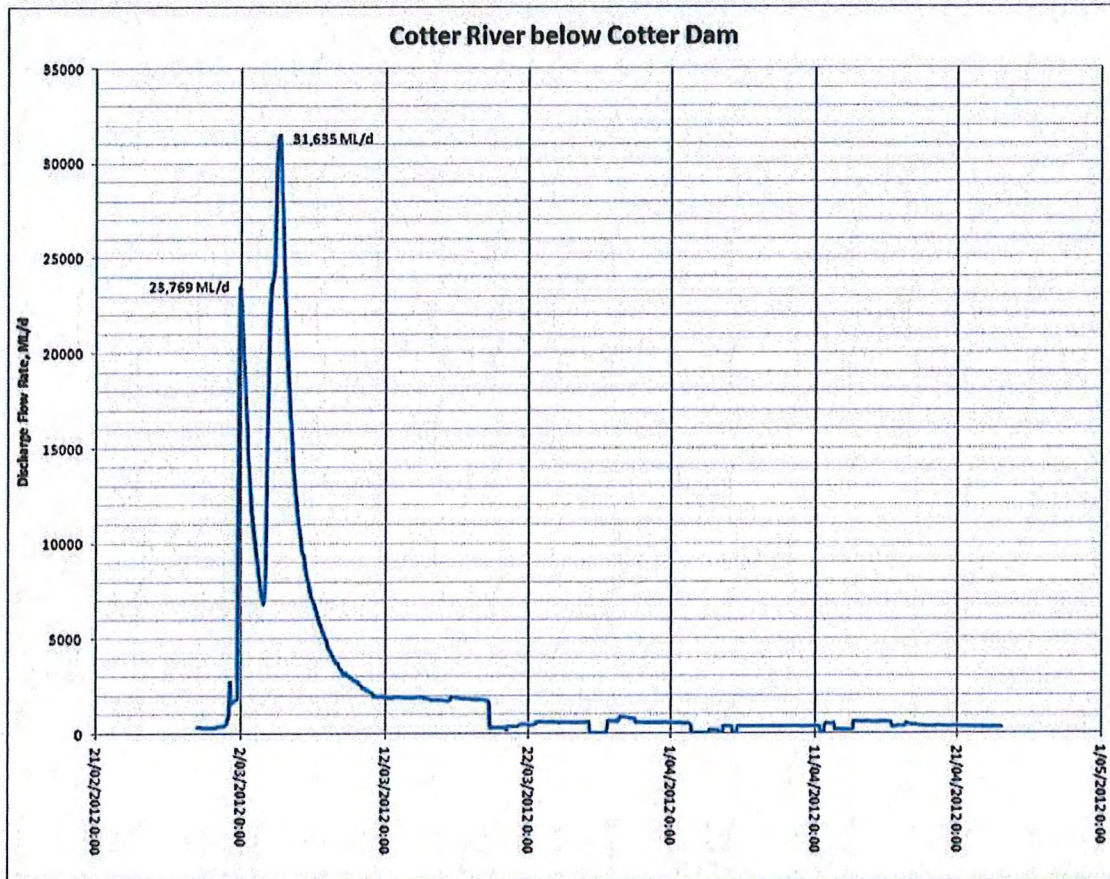
Figure 3 - Downstream flow data – Cotter Kiosk Gauging Station

Approximate peak outflows during this event were in the order of 23,769 ML/d (275 m³/s) on 1 March and 31,635 ML/d (366 m³/s) on 4 March. See Figure 3.

Note: This gauging station has maximum gauged height of 1.74m (approximately 15,000 ML/d) and this was significantly exceeded during this event, indicating the accuracy of the reported peak flow rates and volumes is likely to be approximate only.
