FOI Reference: CMTEDDFOI 2019-184

From: [EPSDFOI](#)
To: [CMTEDD FOI](#)
Subject: Partial Transfer - 72 Printers Way Kingston
Date: Thursday, 8 August 2019 12:16:19 PM

Site Inspection	3
1. Assumptions.....	3
2. Areas Inspected	3
3. Overview / Acceptance Criteria	4
4. Assessment/(Methodology).....	5
5. Inspection Findings	6
Terms and Conditions	50

The purpose of this inspection was to provide a list of defective items that are not in compliance with the relevant building code and other standards.

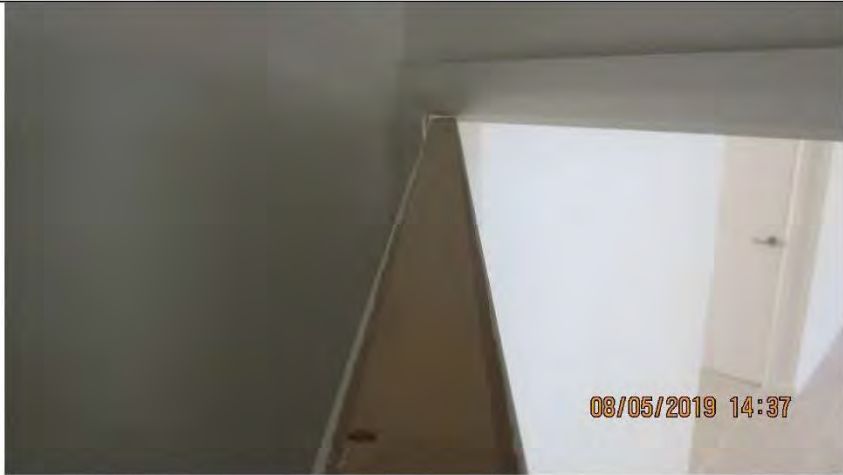
<p>08/05/2019 14:35</p>
2	Bedroom 4 - lower level.	The top and bottom edges of the bedroom door are not sealed.

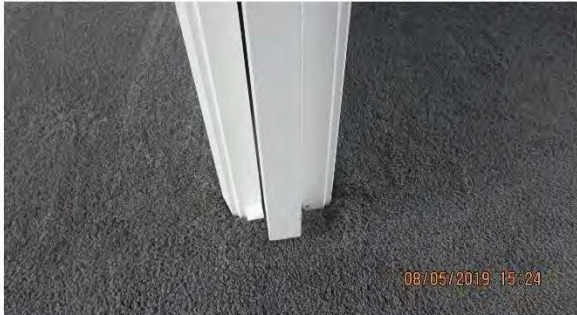
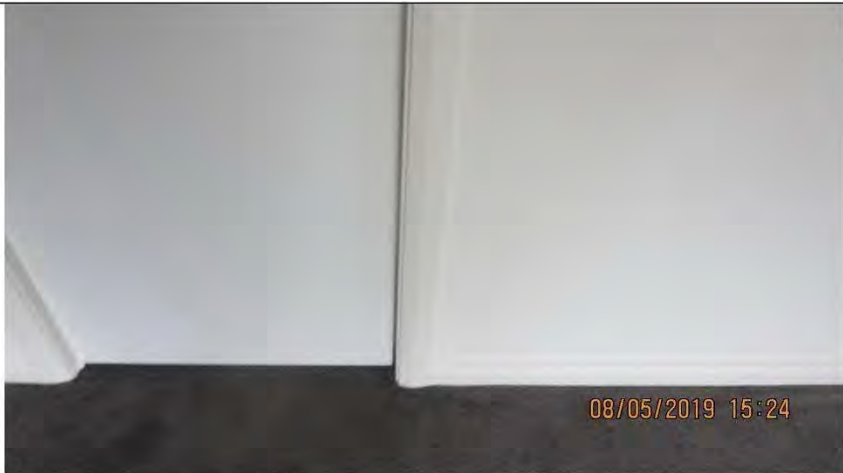
<p>A photograph showing the junction between a light-colored wall and a dark brown tiled floor. The grout is a light, rigid material. A timestamp '08/05/2019 15:20' is visible in the bottom right corner.</p>
18	Bedroom 1 retreat.	<p>Inconsistent door margins are apparent between the sliding door and the door jamb. In addition, there is poorly fitted door guides allowing potential damage to the door surfaces as a result of scratching of the door leaf between the cavity jamb edges.</p>

<p>A photograph showing the bottom of a white sliding door and its jamb. The door is slightly off-level, and the guides appear poorly fitted. A timestamp '08/05/2019 15:24' is visible in the bottom right corner.</p>

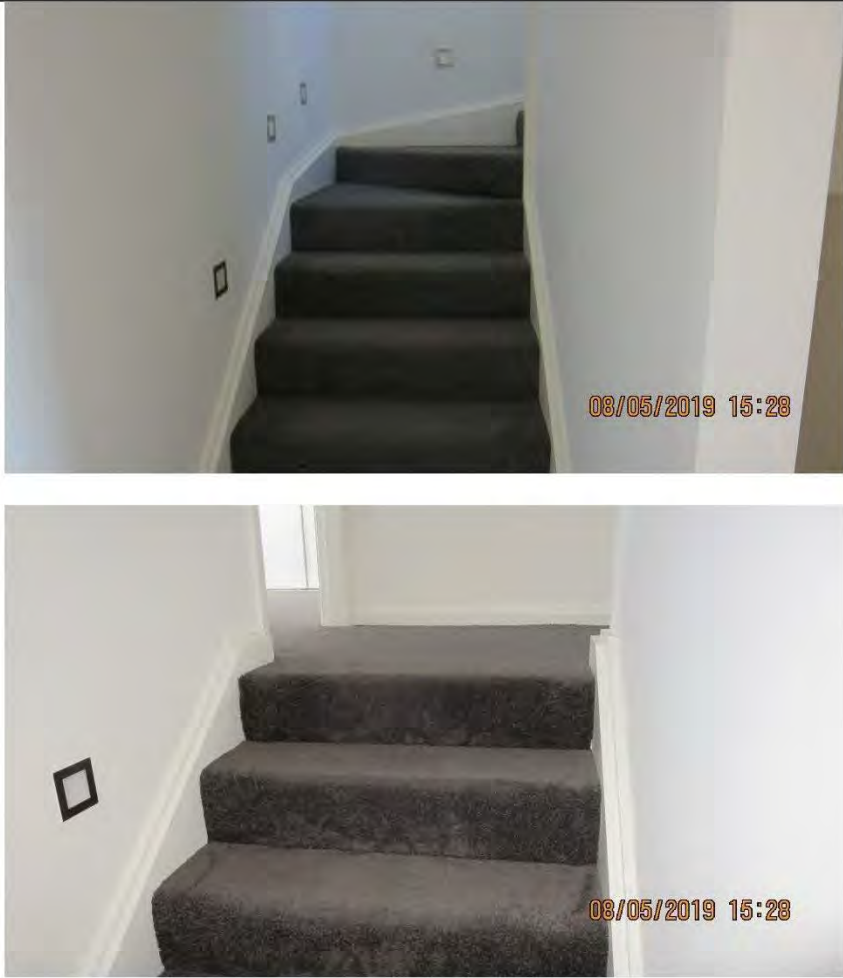
Item No.	Location	Description / Findings	Image Reference
19	Stairwell.	<p>No handrails have been fitted to the stairwell providing access from level 1 to level 2.</p> <p><i>Refer NCC 2016 Vol.2 Part 3.9.2 (Barriers and Handrails)</i></p> <p><i>Part 3.9.2.4 (a)(i) Handrails to a stairway or ramp must – be located along at least one side of the flight or ramp.</i></p>

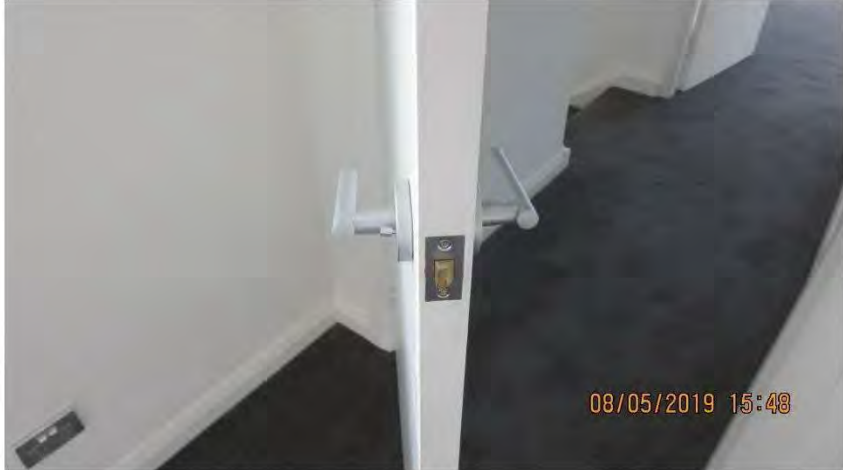
Item No.	Location	Description / Findings	Image Reference
28	Bedroom 2.	<p>The door furniture fitted to the bedroom door is not operating as intended.</p> <p>It is fitted with a snib lock which cannot be operated.</p>

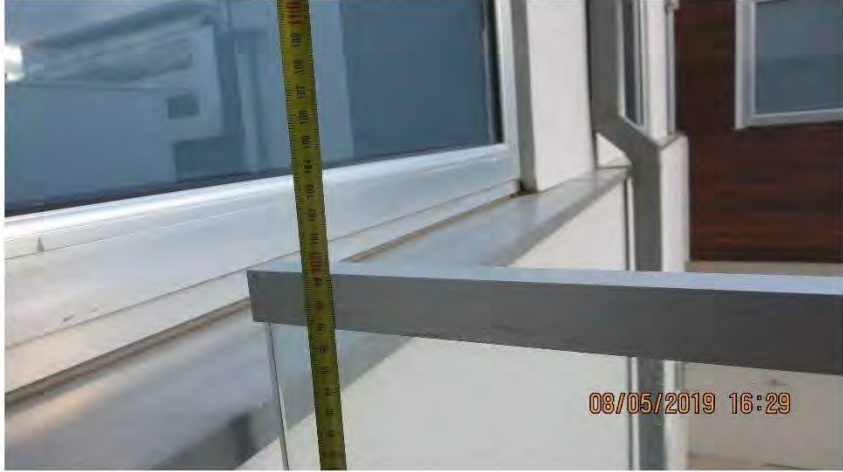
Item No.	Location	Description / Findings	Image Reference
36	Exterior balcony (bedroom 1 retreat)	<p>The handrail fitted to the balcony servicing bedroom one retreat is under height measuring 995mm.</p> <p><i>Refer NCC 2016 Vol.2 Part 3.9.2 (Barriers and Handrails)</i></p> <p><i>Part 3.9.2.3 (ii)(A) The height must be 1 m above any access path, balcony, landing or the like.</i></p>

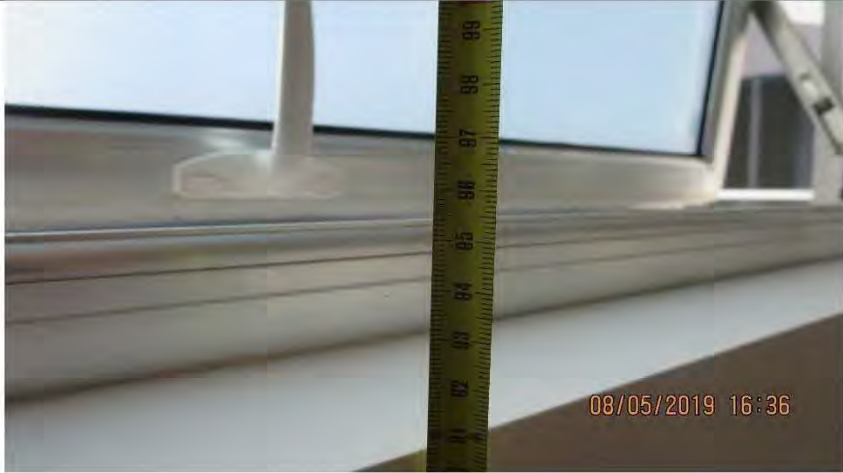
<p>08/05/2019 16:34</p>
Two Bedroom Apartment			
39	Bedroom 1.	<p>The windowsill height within this bedroom was measured to be 955mm. One of the awning windows was able to be opened greater than 125 mm and greater than the required measurement for an upper level opening.</p> <p>The other window collided with the balcony handrail restricting the opening.</p> <p><i>Refer to NCC 2016 Vol.2 Part 3.9.2 (Barriers and Handrails)</i></p> <p><i>Part 3.9.2.5 (a) A window opening must be provided with protection, if the floor below the window in a bedroom is 2m or more above the surface beneath.</i></p>

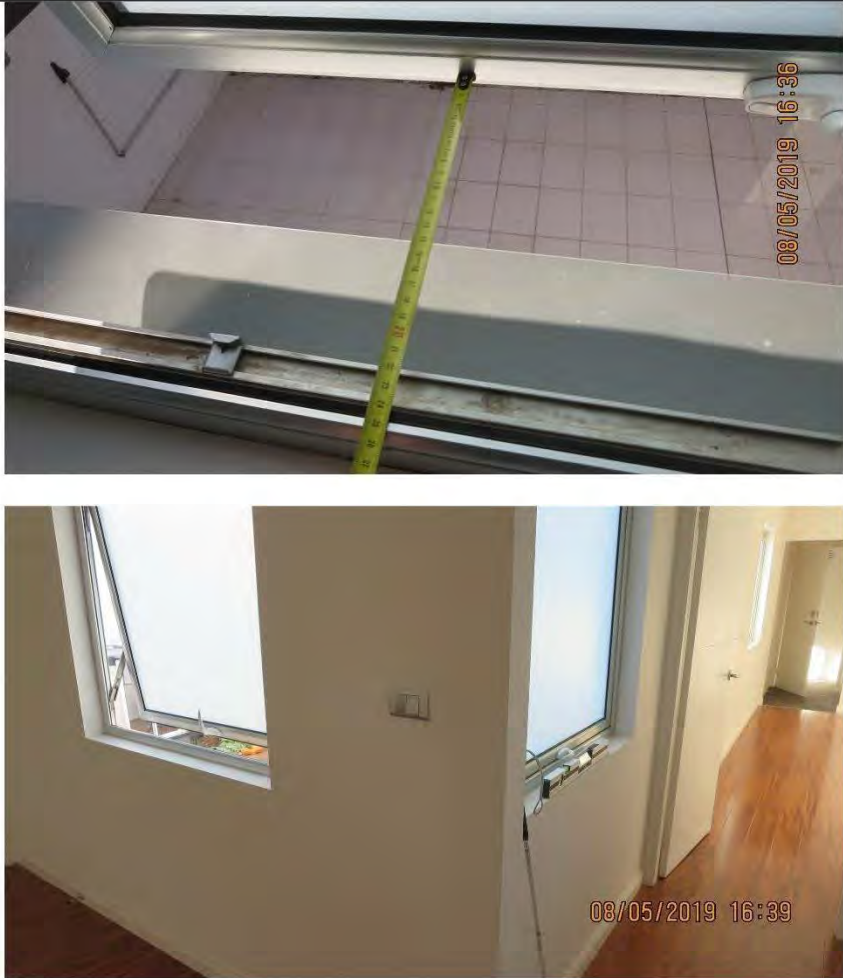
Item No.	Location	Description / Findings	Image Reference
40	Meals area.	<p>The two windowsill heights within this area were measured to be 955mm. The awning window was able to be opened greater than 125 mm and greater than the required measurement for an upper level opening.</p> <p><i>Refer to NCC 2016 Vol.2 Part 3.9.2 (Barriers and Handrails)</i></p> <p><i>Part 3.9.2.5 (b) Where the lowest level of the window opening is less than 1.7 m above the floor, a window opening covered by (a) must comply with the following.</i></p>

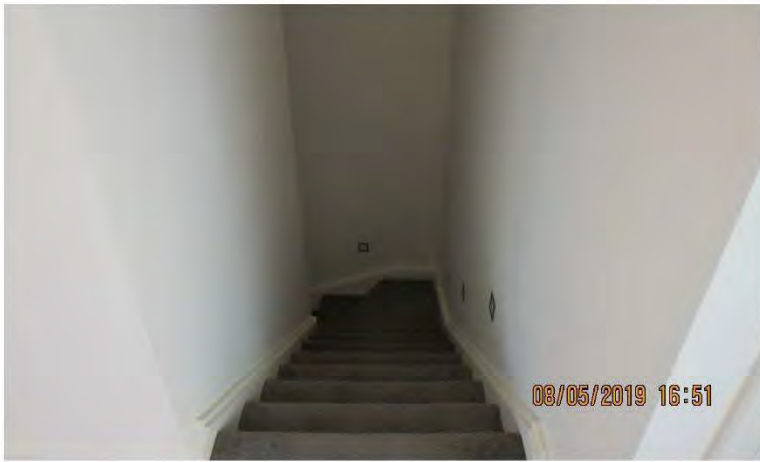
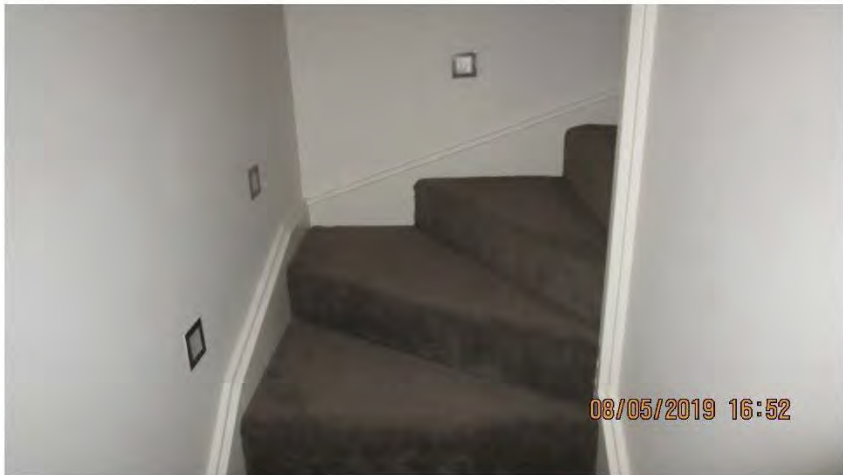
<p>08/05/2019 16:50</p>
47	Stairwell.	<p>No handrails have been fitted to the stairwell.</p>

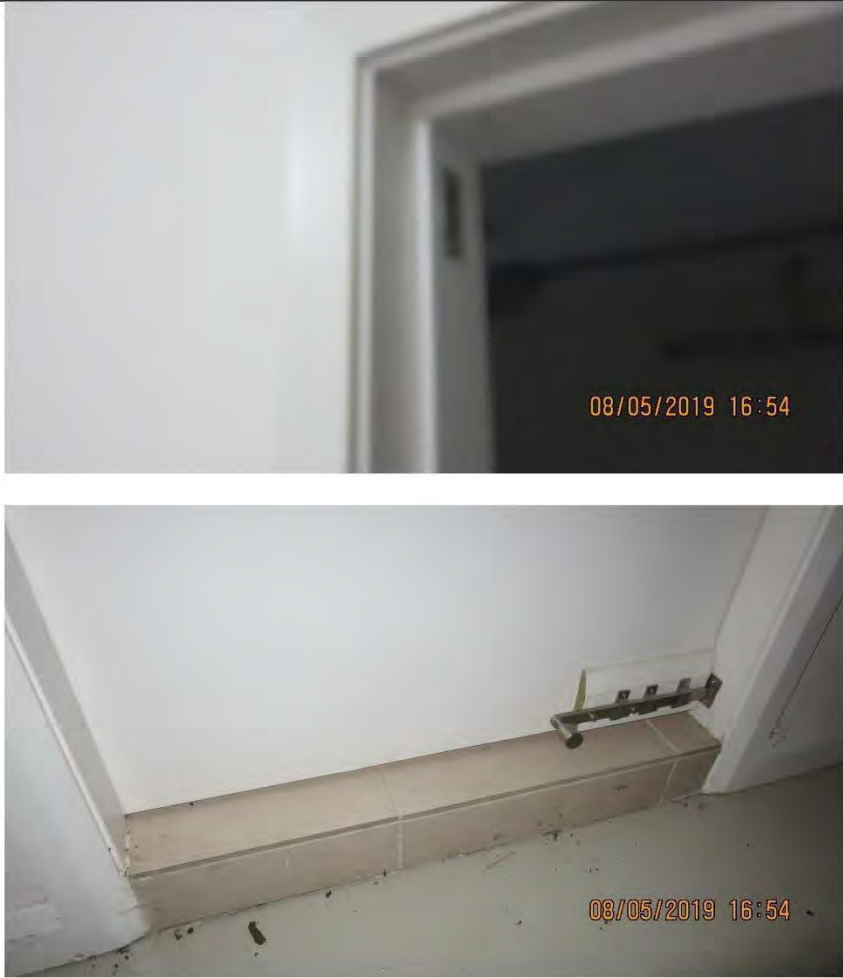
Item No.	Location	Description / Findings	Image Reference
48	Garage.	Door seals have not been fitted to the internal swinging garage door as is required.

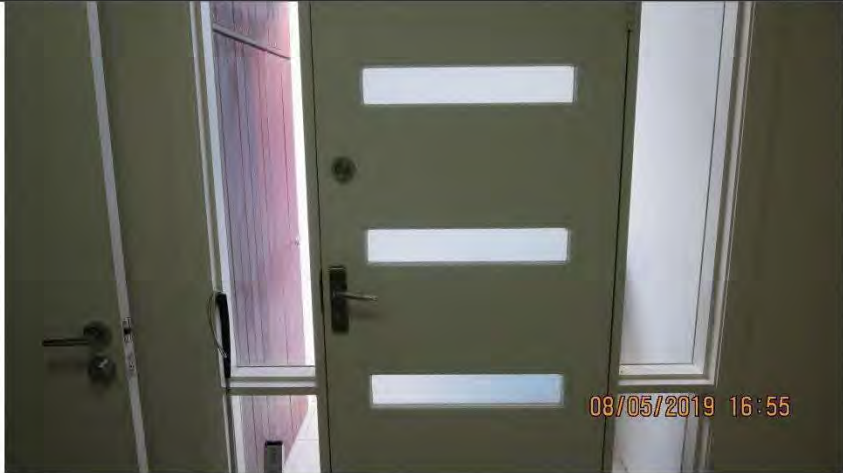
Item No.	Location	Description / Findings	Image Reference
49	Entry.	The entrance door was unable to be opened to check if any door seals have been installed and to evaluate the overall operation of the door itself.

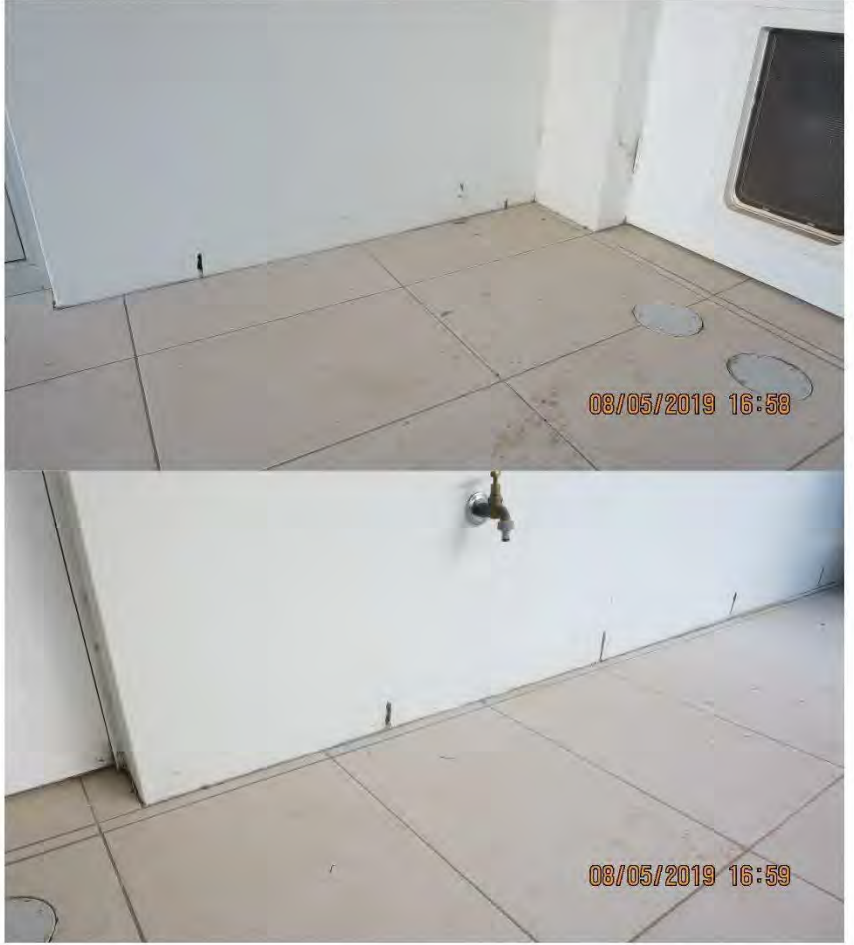
Item No.	Location	Description / Findings	Image Reference
51	Exterior.	<p>The tiled area adjacent to the exterior swinging door of the four-bedroom residence and the exterior courtyard, presents with the weep holes being compromised by the height of the substrate on which the tiles are installed.</p> <p>No clearance to the bottom edge of the weep hole has been provided therefore providing possible entry for water and insects.</p> <p>Depending on the termite protection system used, this breach may void the warranty of the system.</p> <p>Ventilation of the wall cavity is not in reducing and controlling any moisture (condensation) within the wall cavity. In this case, the ventilation is compromised and unable to perform as intended.</p> <p><i>Refer AS 3660.2 2017 Part 2.4 – Where perimeter termite management systems have been installed with a defined inspection zone, no changes to finished ground level, paving, retaining walls, fixtures, vegetation or other contacting items which provide scope for concealed termite passage shall bridge the inspection zone.</i></p>

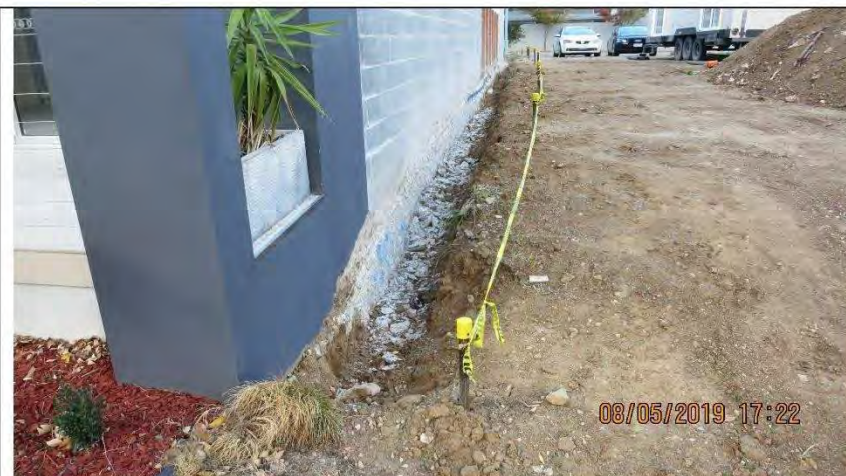
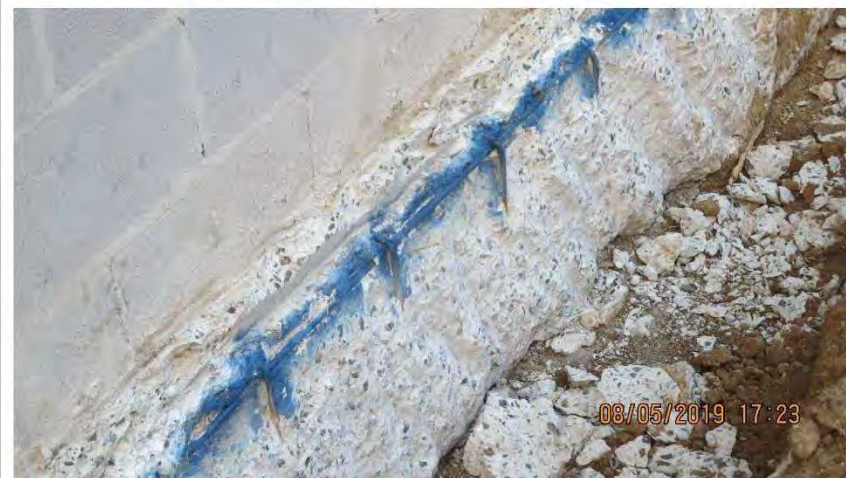
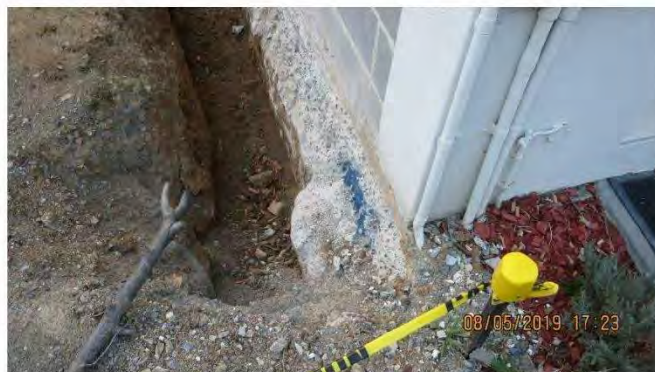
Refer AS 2870 -1996 Part 5.4 (Requirements for pad and strip footings)

Part 5.4.2 (Reinforcement)(b)

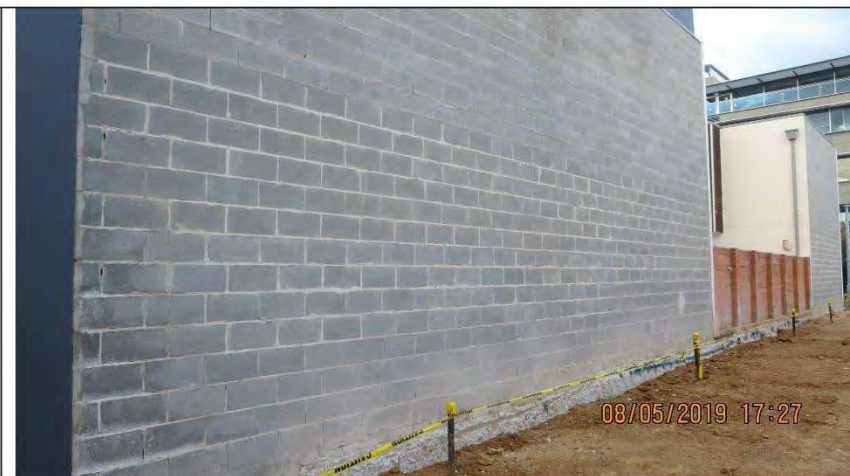
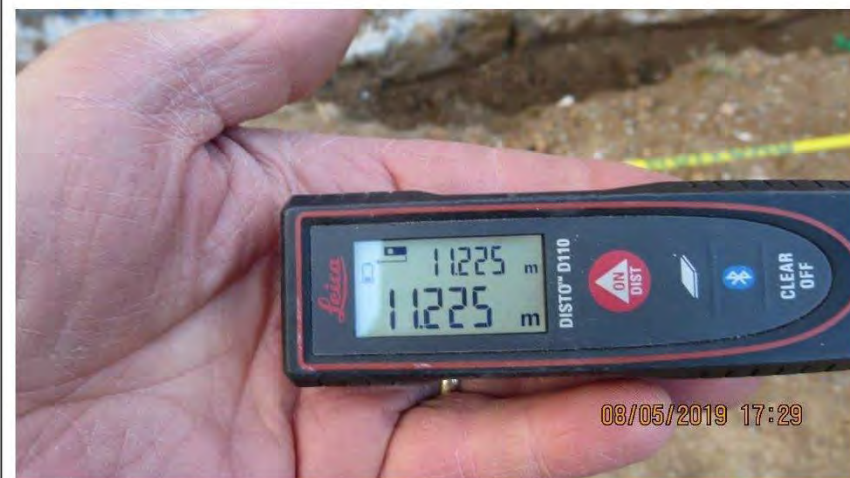
58	Exterior.	<p>The masonry block wall on the northern elevation has been constructed with no articulation joints (control joints) to cater for the normal and expected expansion and contraction of the masonry.</p> <p>A measurement was taken and recorded to be 11.22m. Articulation joints are required at 6m intervals.</p> <p><i>Refer AS 3700 – 2011 (Articulation joints)</i></p> <p><i>Part 4.8.4 Articulation joints as per table 4.3</i></p>
----	-----------	---

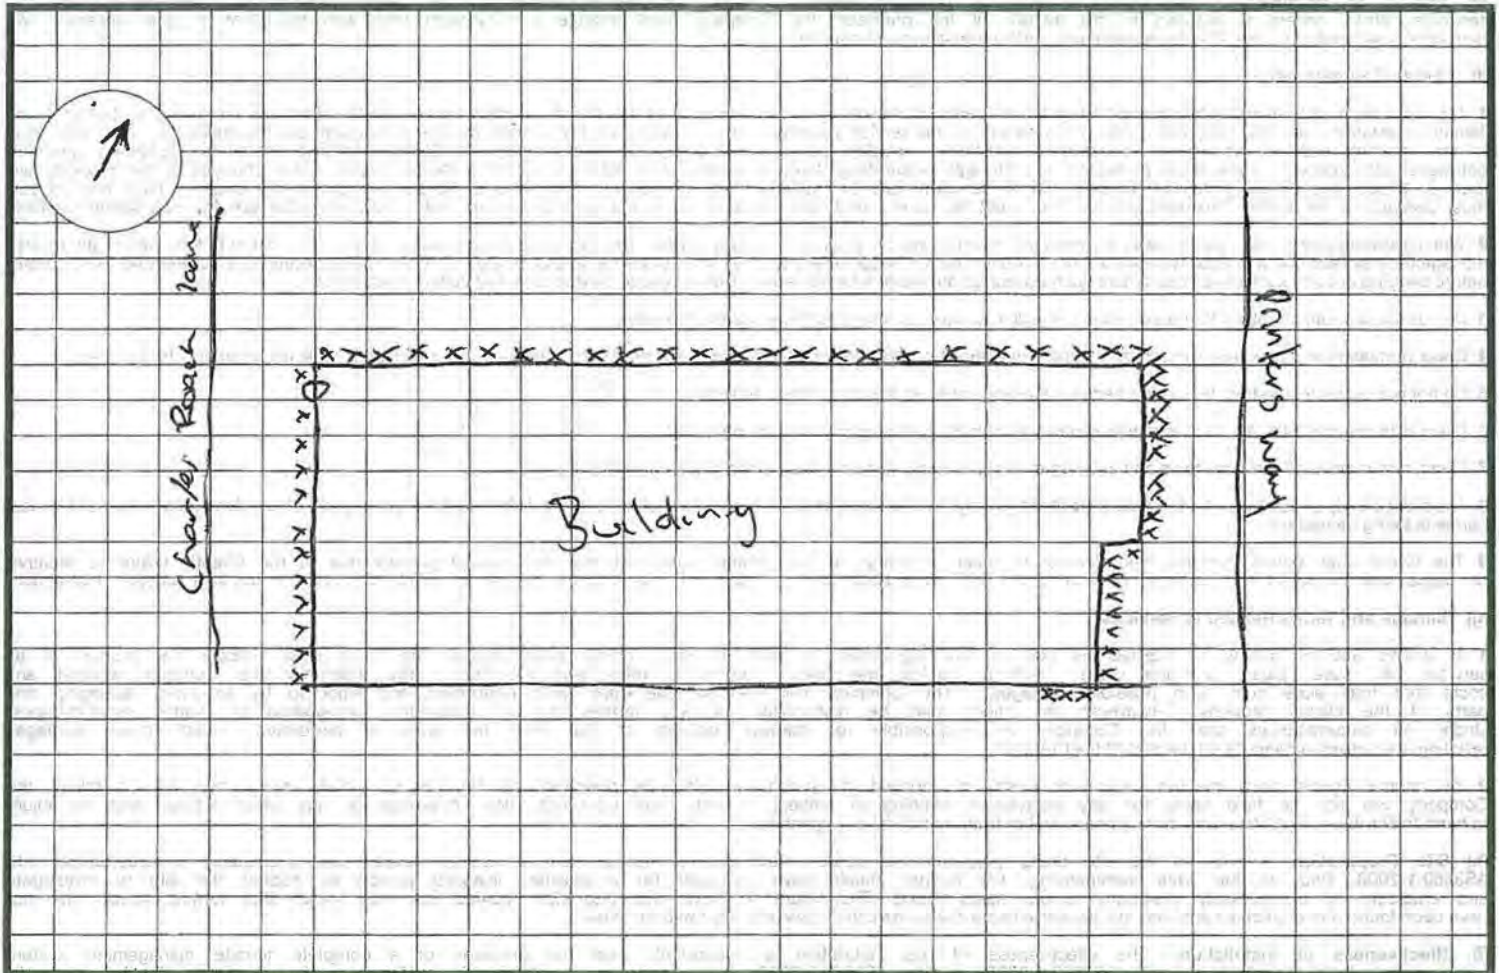
Diagram showing the location of the installed barrier(s). The direction of North is indicated by the ↑ symbol.

Specific Limitations applying to this Installation: *next unit is hard up against this unit and not possible to chemical treat area.*
