# Preliminary (Environmental) Site Investigation

## Canberra Brickworks

For: Land Development Agency

<b>Project Name:</b>	DRAFT Preliminary (Environmental) Site Investigation, Canberra Brickworks
<b>Project Number:</b>	3002369
<b>Report for:</b>	Land Development Agency

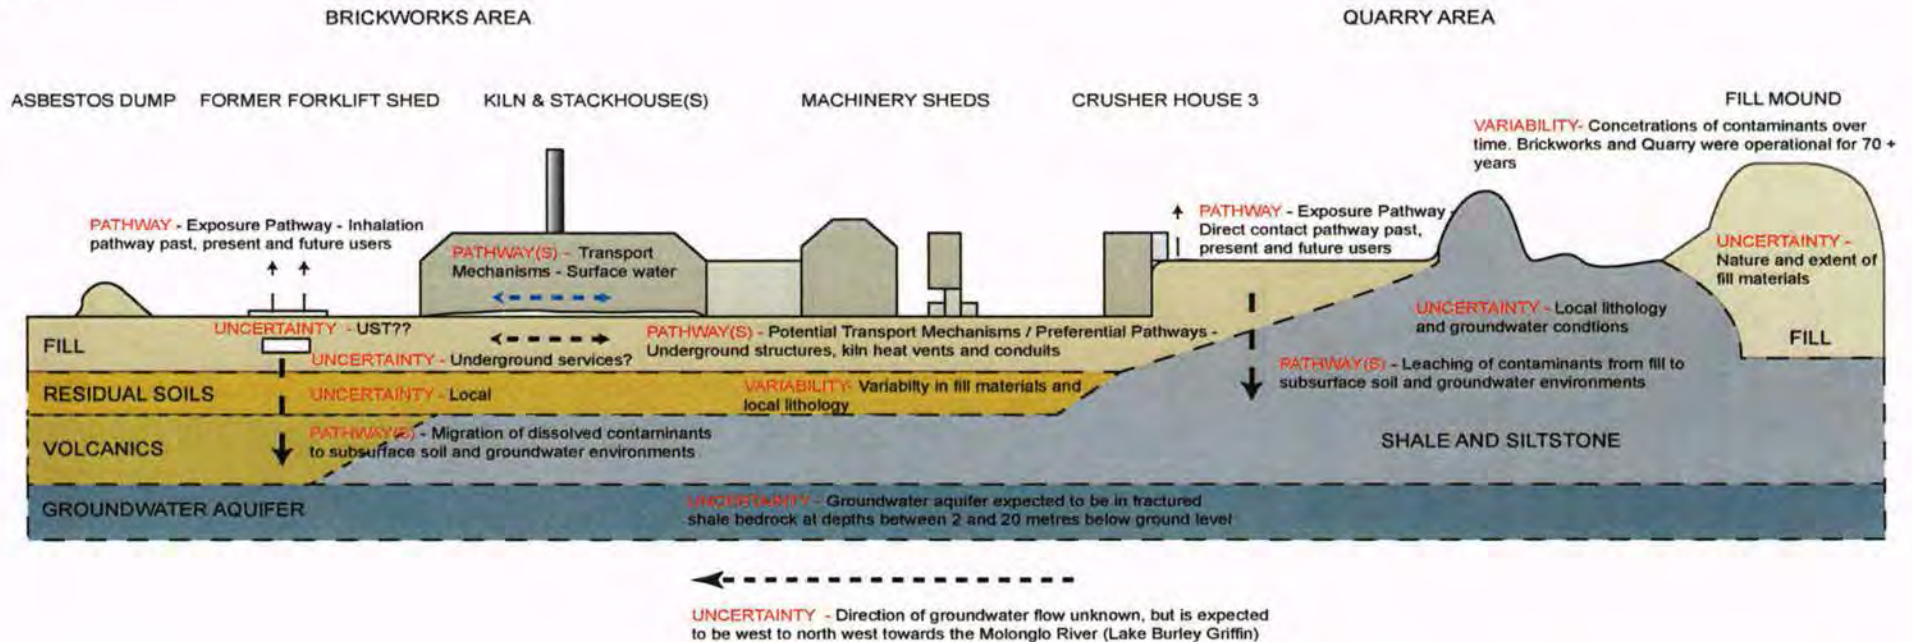
### Conceptual Site Model

N.T.S  
Not To Scale

Subsurface conditions (soil, sediment and groundwater) can be complex and heterogeneous with many unknown geologic interactions that may affect the movement and/or concentrations of potential contaminants. This uncertainty is increased by the lack of sufficient field testing (logging of soil conditions, collection of samples and the evaluation of the concentrations of potential contaminants) to adequately assess the Site. Some of these uncertainties and variability's are identified in the Graphical CSM show above in **Section 4.2**.

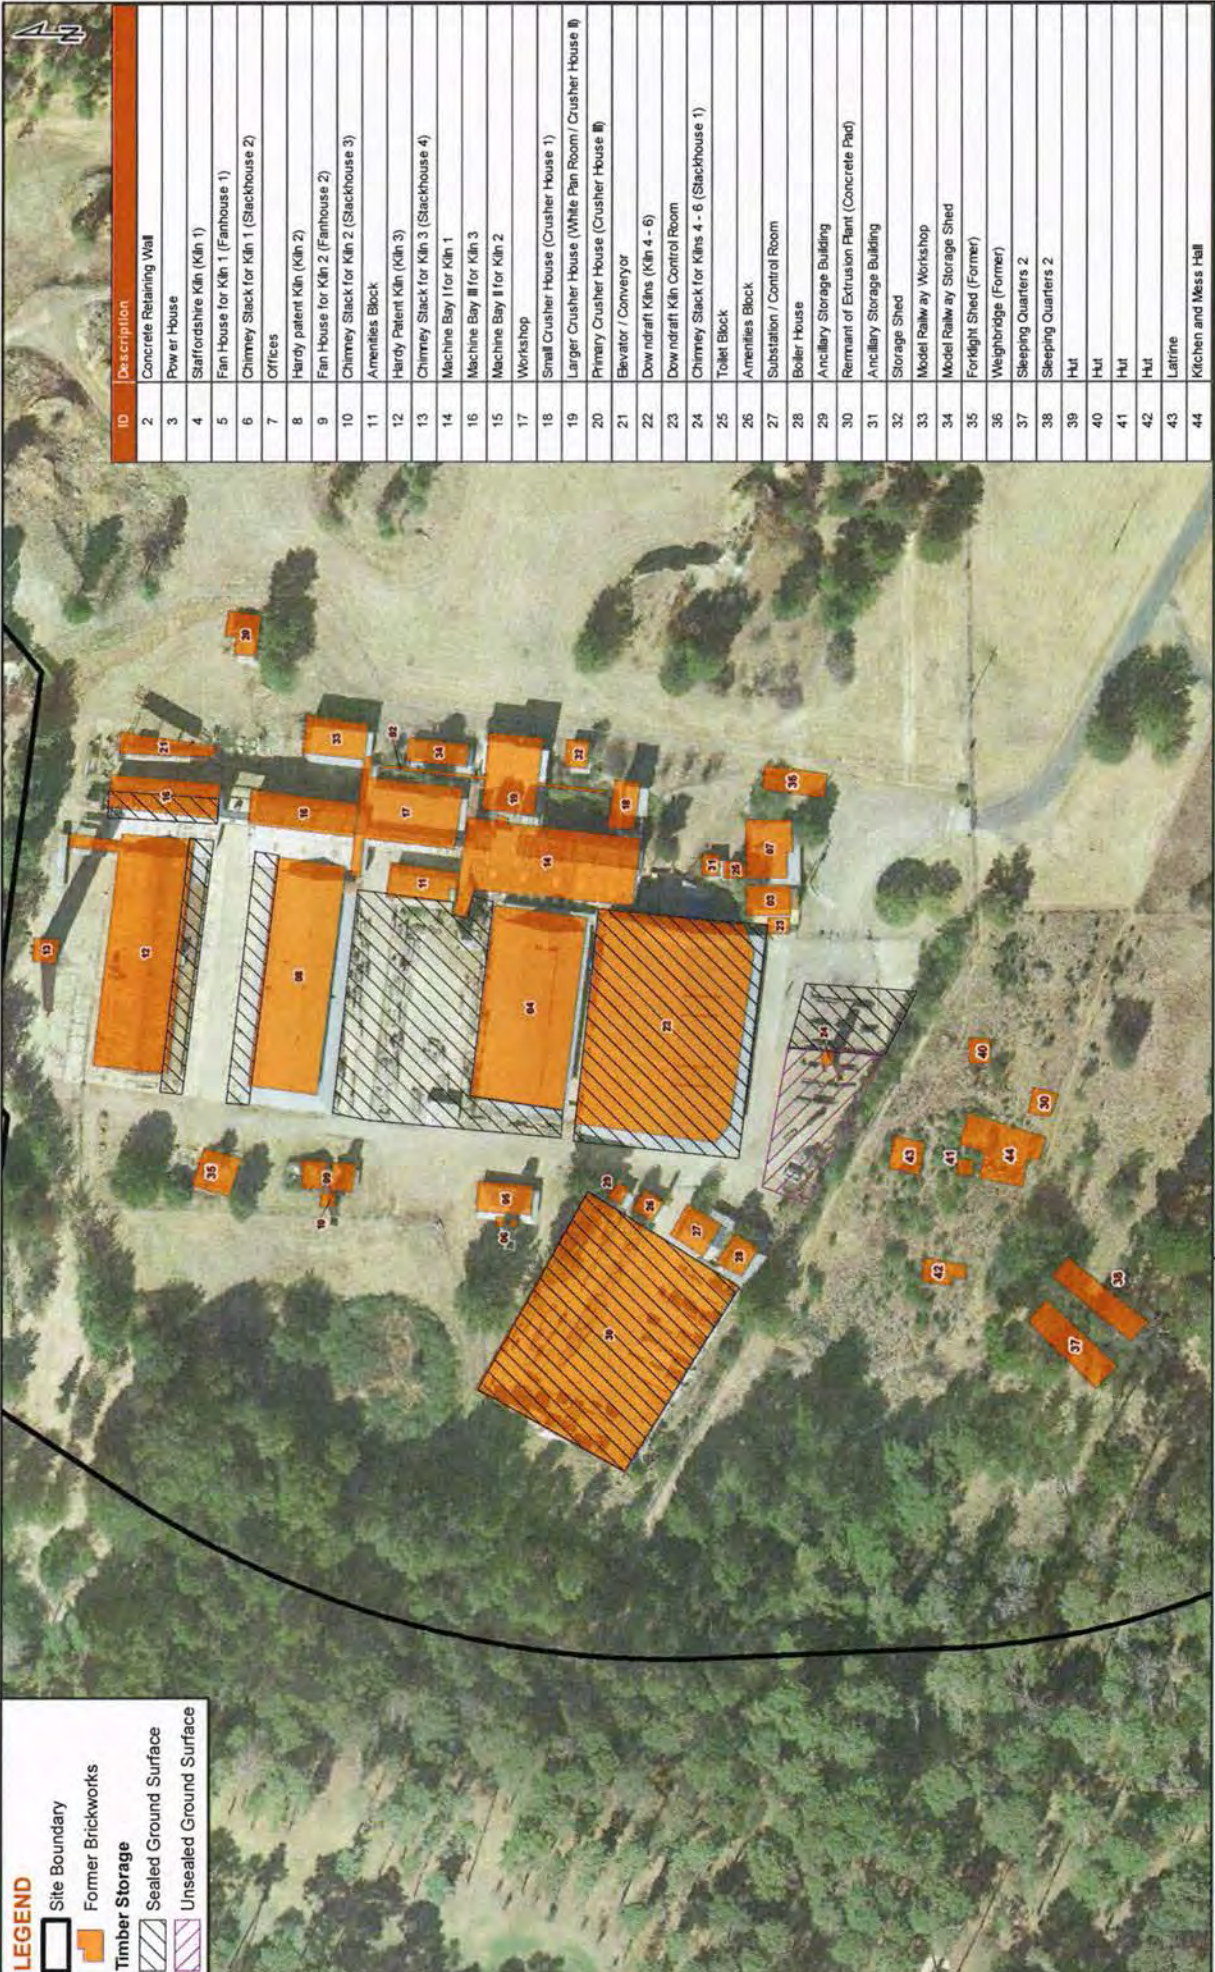
Location: X:\PROJECT\3002369\Canberra Brickworks Site Investigation\DWG\2 Figures and Results\Figure 2b - brickworks features.mxd

ID	Description
2	Concrete Retaining Wall
3	Power House
4	Staffordshire Kiln (Kiln 1)
5	Fan House for Kiln 1 (Fanhouse 1)
6	Chimney Stack for Kiln 1 (Stackhouse 2)
7	Offices
8	Hardy patent Kiln (Kiln 2)
9	Fan House for Kiln 2 (Fanhouse 2)
10	Chimney Stack for Kiln 2 (Stackhouse 3)
11	Amenities Block
12	Hardy Patent Kiln (Kiln 3)
13	Chimney Stack for Kiln 3 (Stackhouse 4)
14	Machine Bay I for Kiln 1
16	Machine Bay III for Kiln 3
15	Machine Bay II for Kiln 2
17	Workshop
18	Small Crusher House (Crusher House 1)
19	Larger Crusher House (White Pan Room / Crusher House II)
20	Primary Crusher House (Crusher House III)
21	Elevator / Conveyor
22	Down draft Kilns (Kiln 4 - 6)
23	Down draft Kiln Control Room
24	Chimney Stack for Kilns 4 - 6 (Stackhouse 1)
25	Toilet Block
26	Amenities Block
27	Substation / Control Room
28	Boiler House
29	Ancillary Storage Building
30	Remnant of Extrusion Plant (Concrete Pad)
31	Ancillary Storage Building

32	Storage Shed
33	Model Railway Workshop
34	Model Railway Storage Shed
35	Forklift Shed (Former)
36	Weightbridge (Former)
37	Sleeping Quarters 2
38	Sleeping Quarters 2
39	Hut
40	Hut
41	Hut
42	Hut
43	Latrine
44	Kitchen and Mess Hall

The historical aerial photographs are presented in Figure 3a to 3k, **Appendix A**. Remnant features still visible today are presented in Figures 2 and 2a, **Appendix A**.

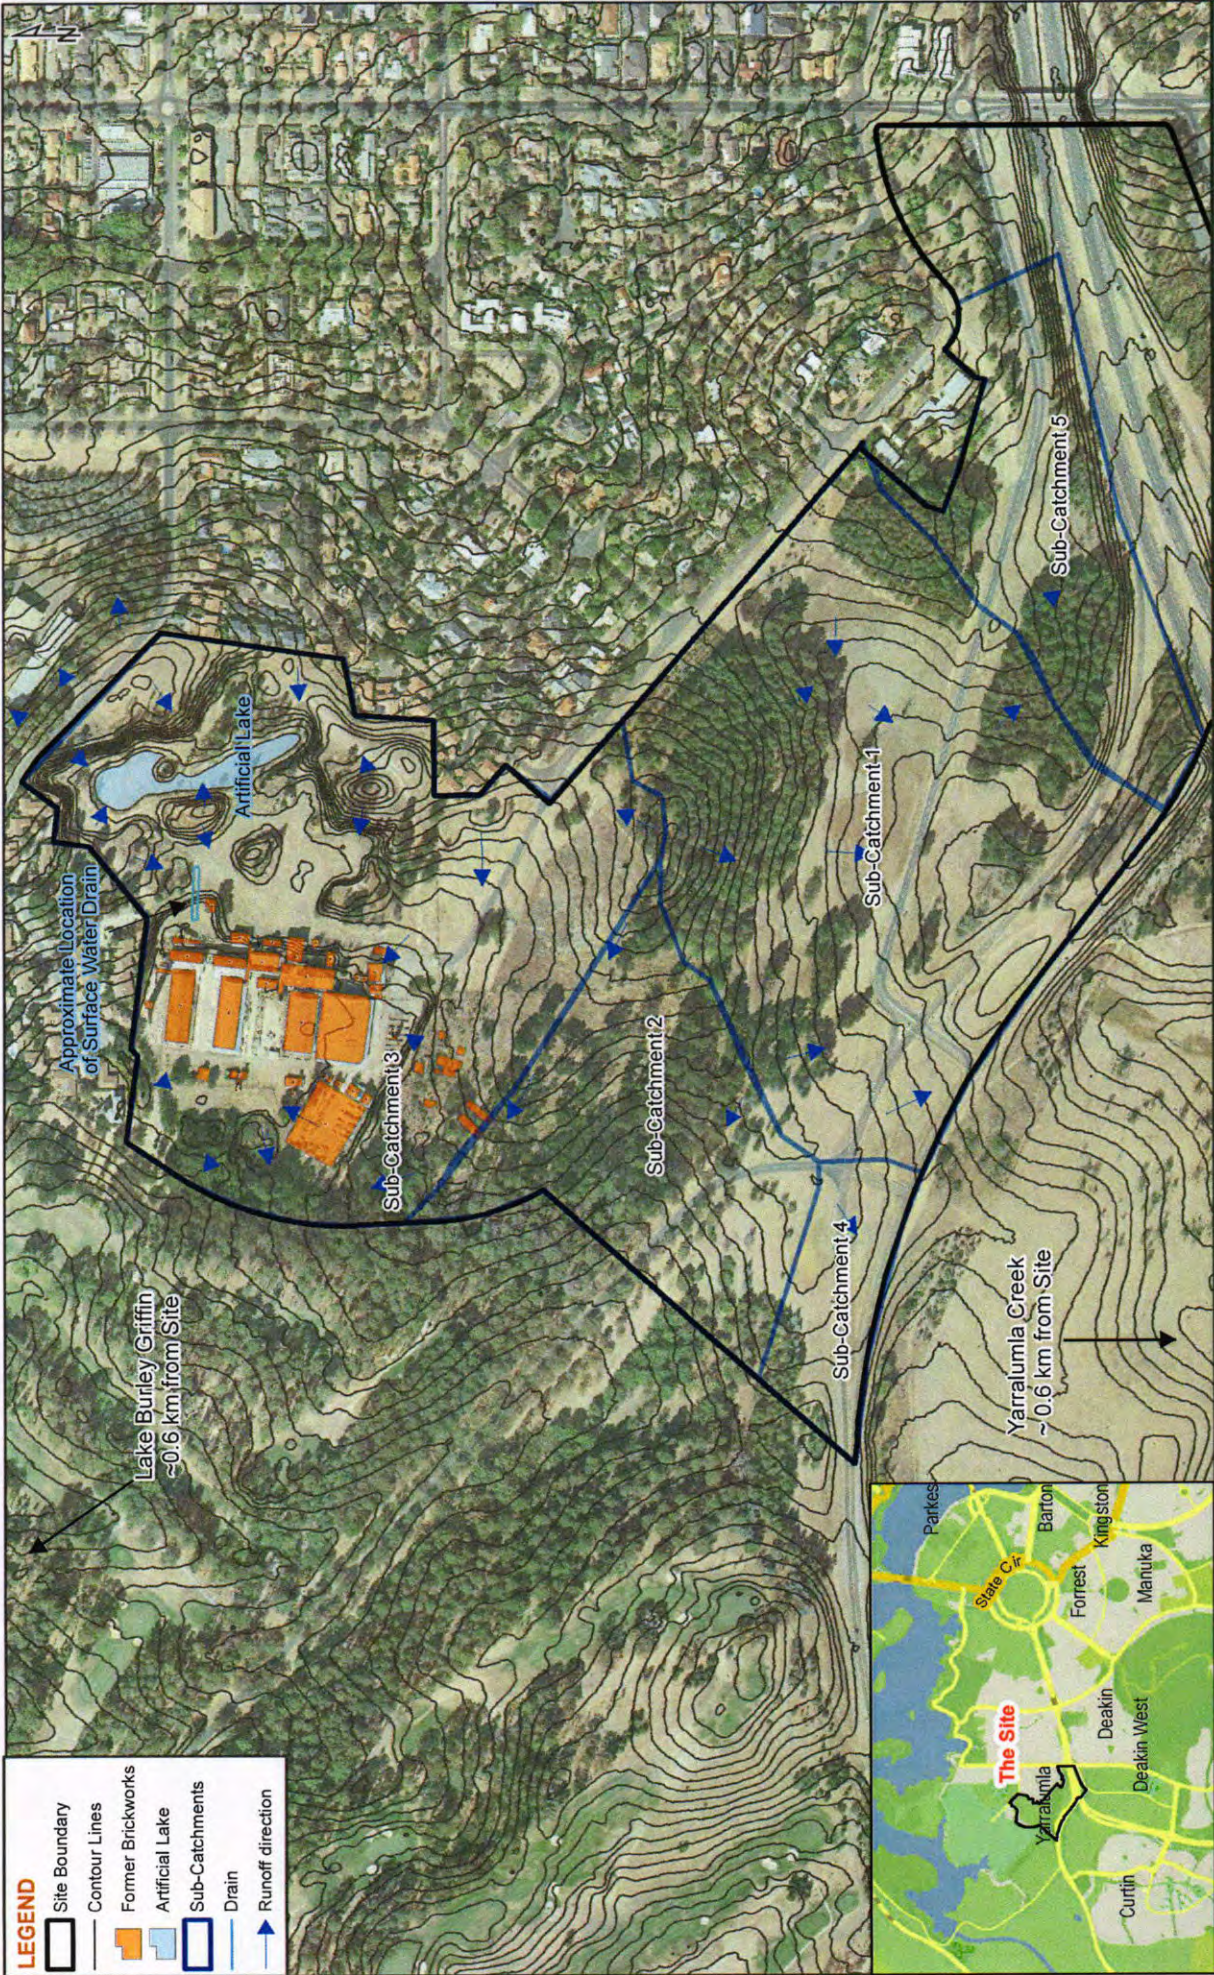
FIG NO.	FIGURE TITLE	DATE	PAGE SIZE	COORDINATE SYSTEM
2c	Topography, Sub-Catchments and Drainage	17/02/2014	A4	ACT Grid 1986
PROJECT NO. 3002369	PROJECT TITLE Canberra Brickworks Preliminary Site Investigation	CREATED BY J. Seng	SOURCES Imagery © BingMaps, Imagery © Roadnet

LEGEND	
	Site Boundary
	Contour Lines
	Former Brickworks
	Artificial Lake
	Sub-Catchments
	Drain
	Runoff direction

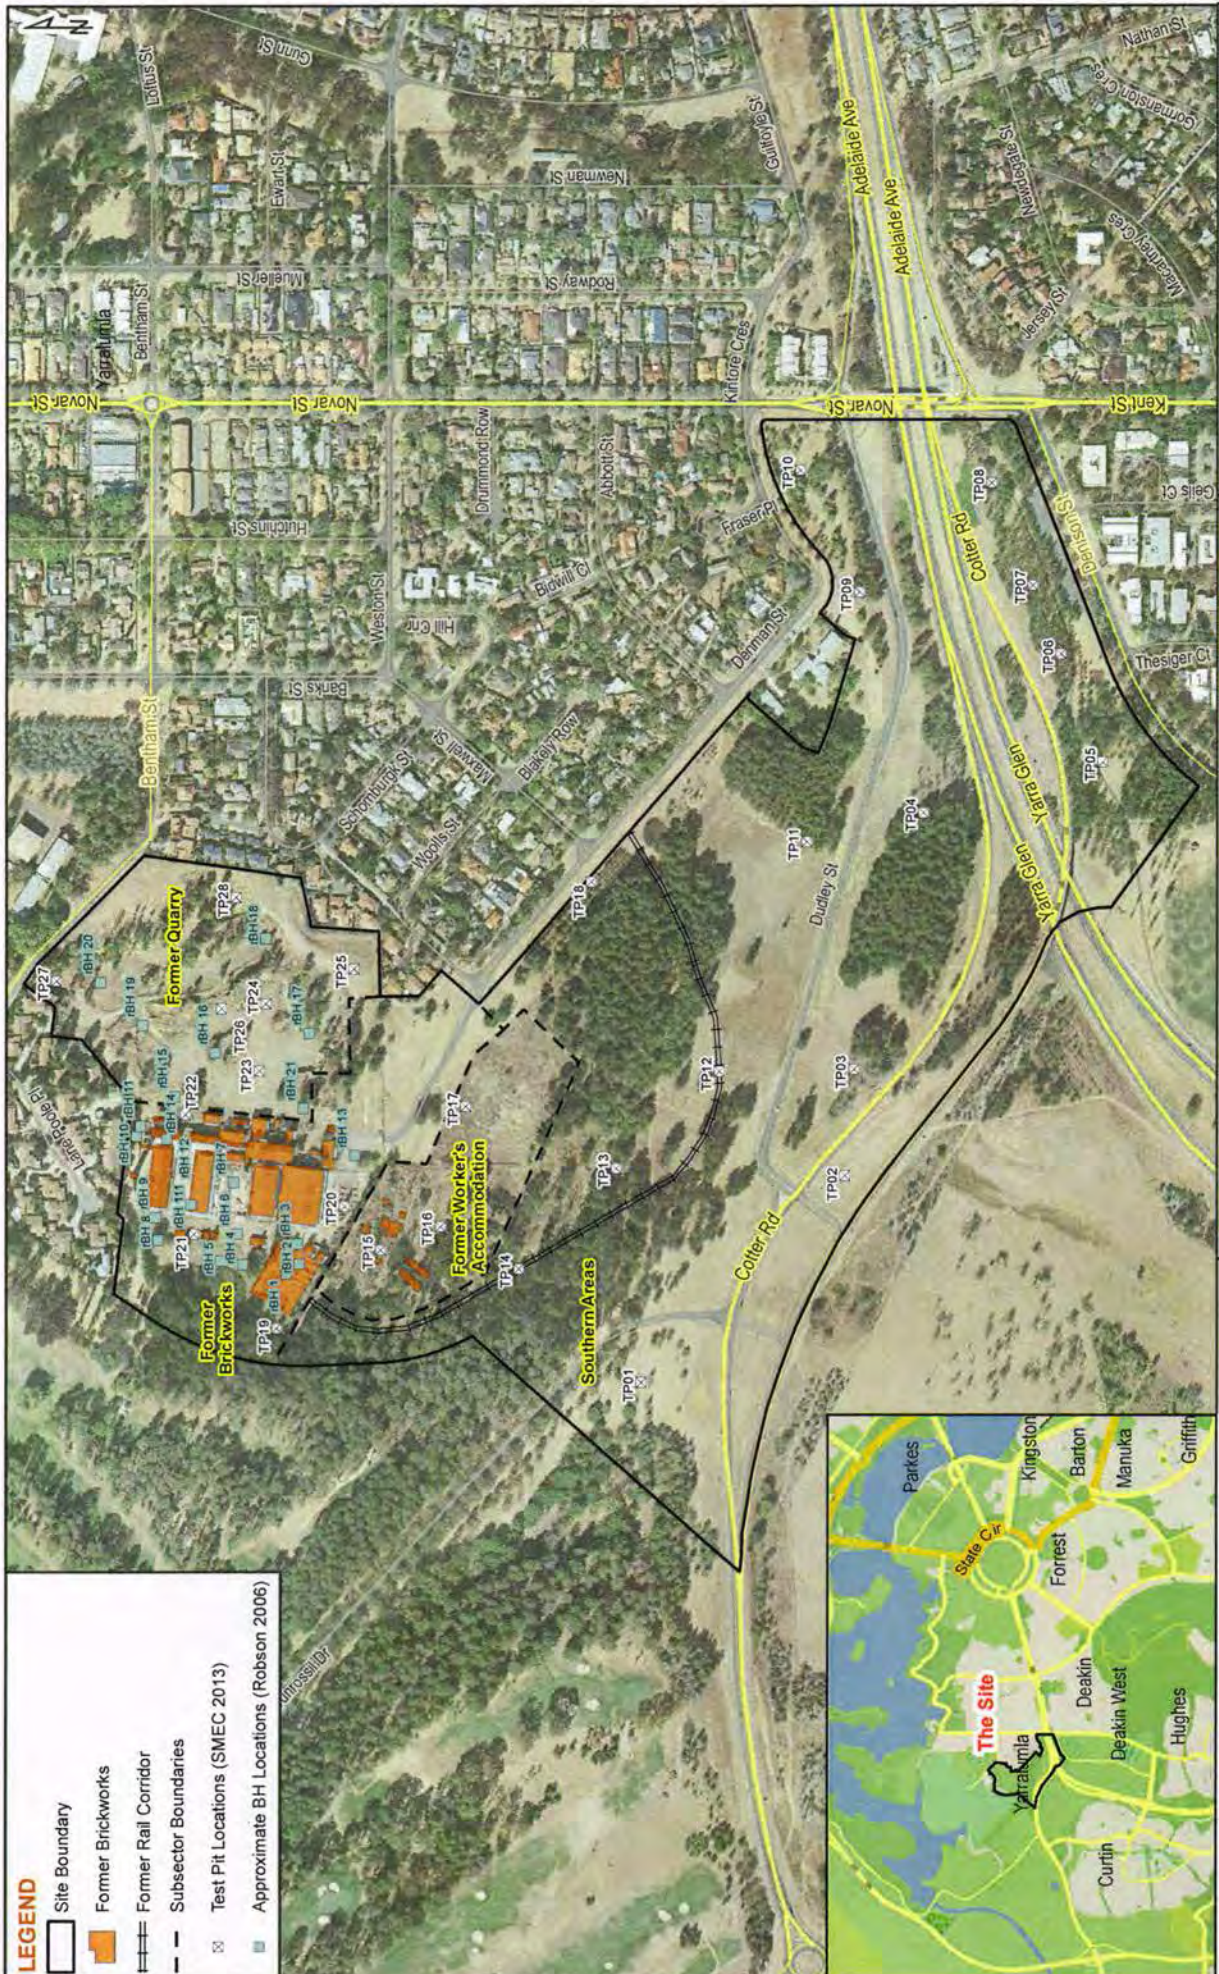
- LEGEND**
- Site Boundary
  - Former Brickworks
  - Former Rail Corridor
  - Subsector Boundaries
  - Test Pit Locations (SMEC 2013)
  - Approximate BH Locations (Robson 2006)

The remainder of the sampling locations were targeted to either confirm previous soil data or to fill data gaps to better inform the recommendations outlined in this PSI. The sampling location plan is presented in Figure 4, **Appendix A**.

Test Pit Location	Targeted AEC	Comment
TP01 to TP13, excluding TP12	General Site / AEC 1 Waste Fill	General Site coverage – to describe general site subsurface conditions including identification of filled areas
TP12 and TP14	AEC 29 Rail Corridor	Targeted – to assess impacts associated with treated timber sleepers (pesticides), asbestos from brake pads and vegetation control (in corridor)
TP15 to TP17	Targeted: AEC 21 Brickworks Workers Accommodation (former) – General Areas	General coverage Brickworks Workers Accommodation (former) – to describe subsurface conditions including the nature and extent of filled areas
TP18	Targeted: Grove of Deciduous Trees / Open Space Areas	Targeted – to assess the potential former use of pesticides
TP19	Targeted: AEC 5 Explosives Store	Targeted – to assess impacts from storage of explosive compounds
TP20	Targeted: AEC 2 General Areas - Recycled Timber Holding Yard	Targeted – to assess potential metal impacts leaching from treated timbers

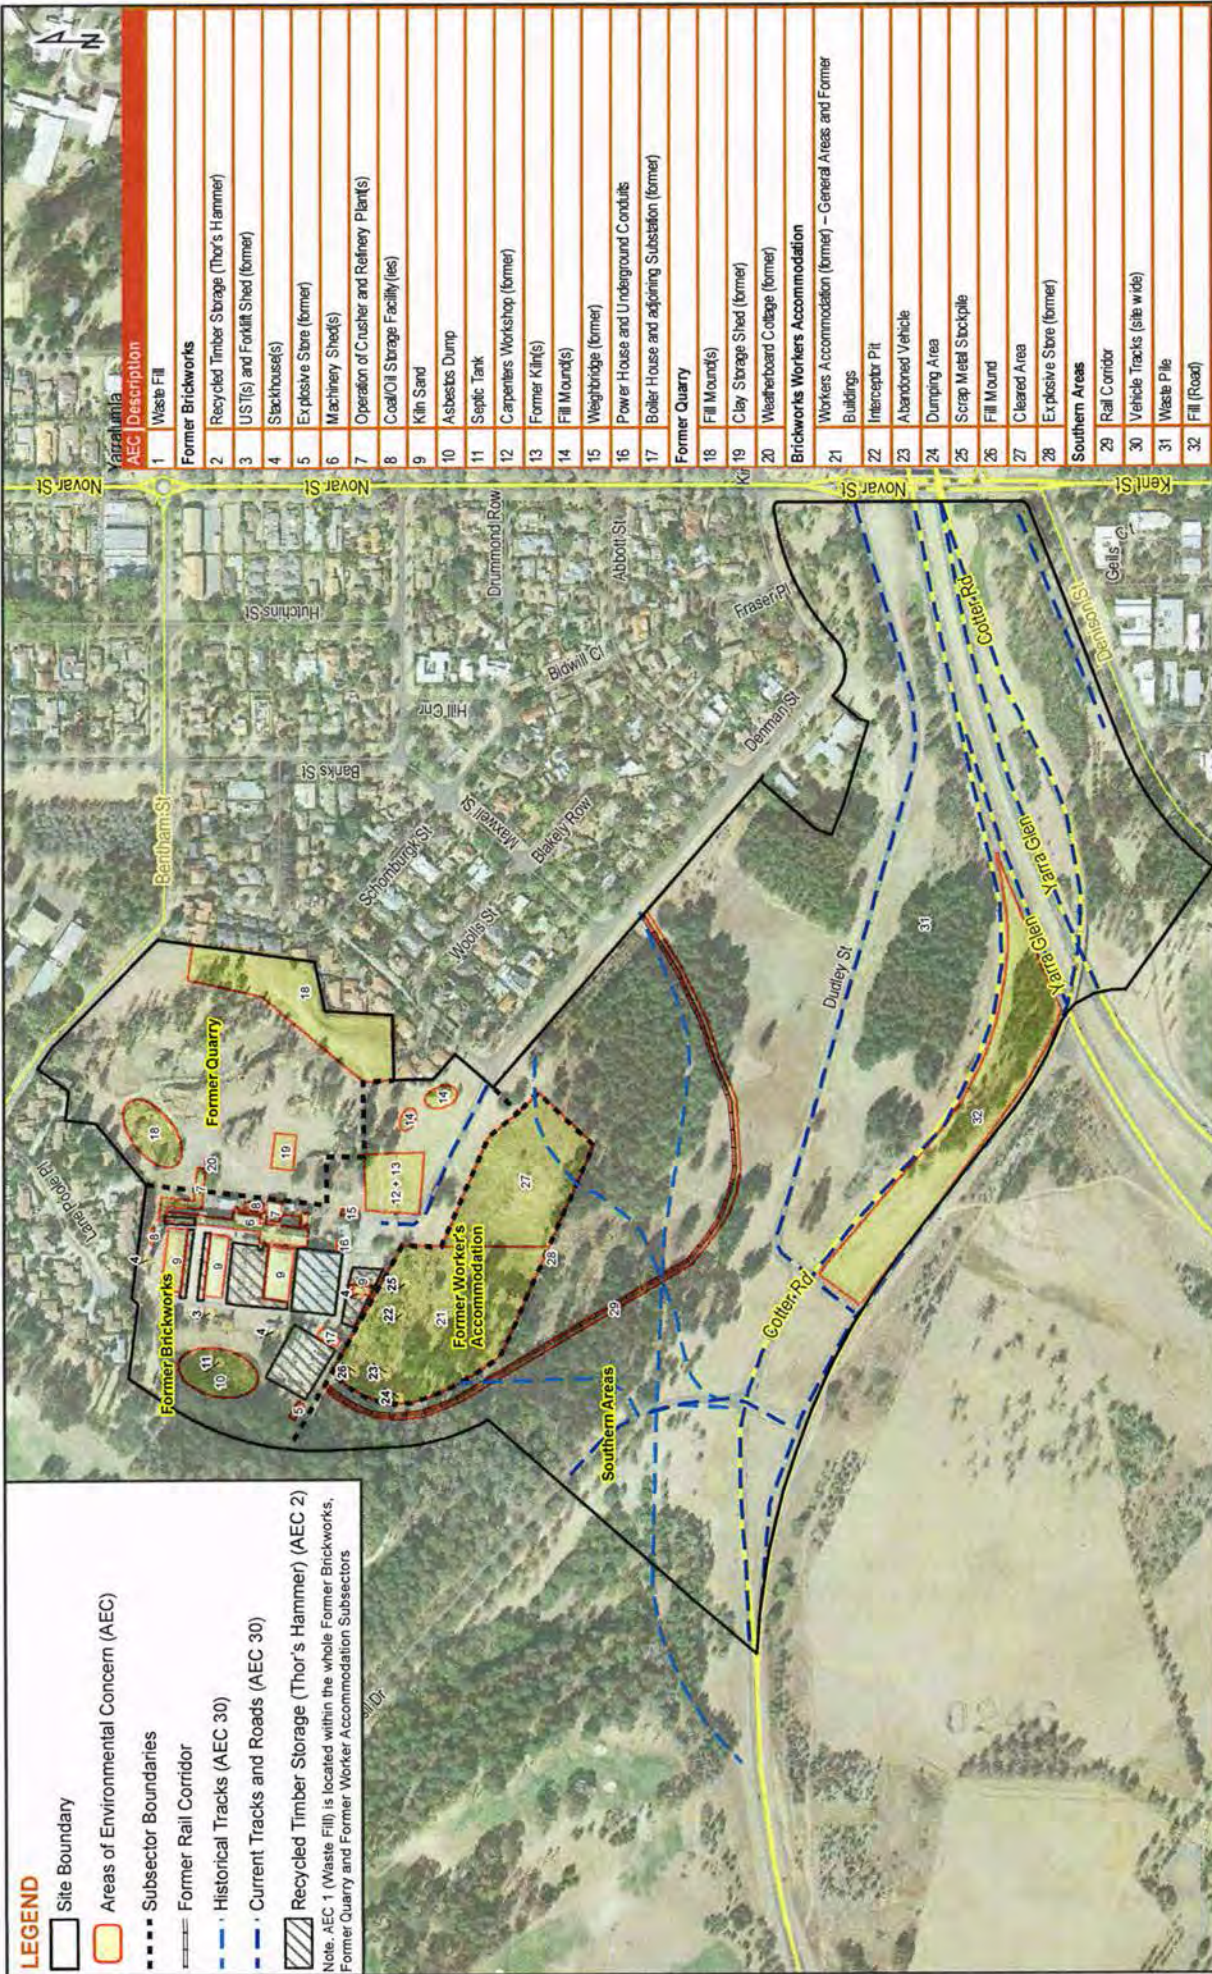
- Site Boundary
- Areas of Environmental Concern (AEC)
- Subsector Boundaries
- Former Rail Corridor
- Historical Tracks (AEC 30)
- Current Tracks and Roads (AEC 30)
- Recycled Timber Storage (Thor's Hammer) (AEC 2)
